CS7 TEMPORARY CYCLE PROVISION, SOCIAL DISTANCING MEASURES

SHORT TERM – Tooting Bec to Balham - Stage 2 Road Safety Audit

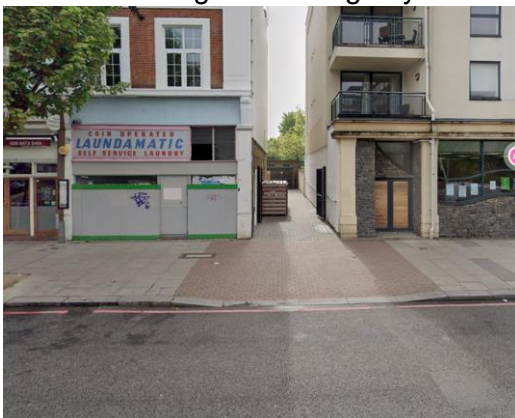
8. Elmfield Road junction. Vehicles in the floating loading bay may reduce intervisibility to / from vehicles emerging from Elmfield Road, leading to an increased risk of turning collisions. The loading bay should be moved away from the junction. It is not clear whether the access/crossover shown below is used by vehicles but it is assumed not since the loading bay when occupied would restrict left turns out or right turns into the access. As such moving the loading bay northwards appears to be viable.
