3589.02.02 CS7 Tooting Bec to Balham – Post Construction

In accordance with *TLRN: Recovery and Restart - TfL Engineering - Road Safety Assurance of Designs (12 May 2020)* a post-construction safety review (equivalent to Stage 3 Road Safety Audit) was requested and has been undertaken on the CS7 measures (Section 7) installed between Tooting Bec and Balham.

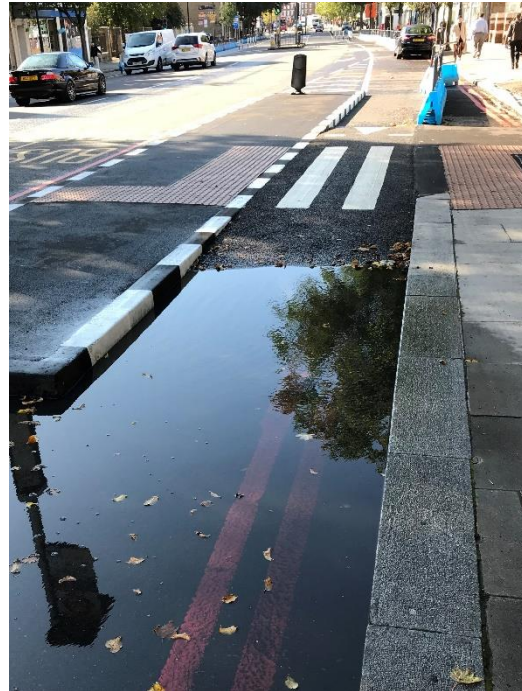
1. Northbound floating bus stop by Du Cane court (Balham High Road). There was significant ponding noted at the raised crossing to the bus stop island at the time of the site visit. Whilst the raised table has been installed with a drainage pipe, this had become blocked with leaves. Cyclists were observed to brake suddenly or swerve onto the footway to avoid the large puddle. There is also a risk of loss of control / skidding if surface water does not drain away, especially under freezing conditions.

It is recommended that measures are provided to prevent drainage channels becoming blocked by leaves, especially since there are a large number of mature trees nearby. This may also require regular maintenance during autumn leaf fall.

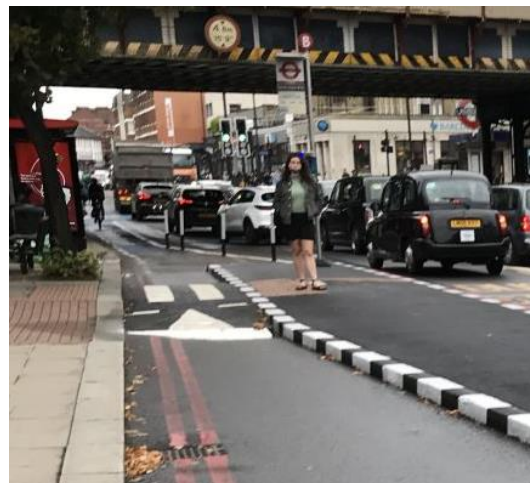
2. Northbound floating bus stop by Balham Station. There was ponding noted on the south side of the raised crossing to the bus stop island. This may create a skid risk with cyclists braking for the crossing on the approach.

It is recommended that measures are provided to ensure surface water does not collect at the foot of ramps. This may require regular maintenance during autumn leaf fall.

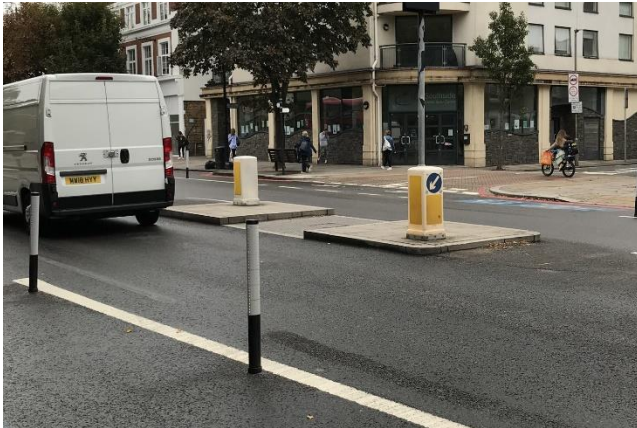
3. Pedestrian refuge island by Elmfield Road – The absence of centerline markings on the northbound approach to the island results in a risk of the corner of the island being struck albeit an illuminated bollard is present.

It is recommended that centerline markings are provided, offset from the corner of the island, to guide road users past it.

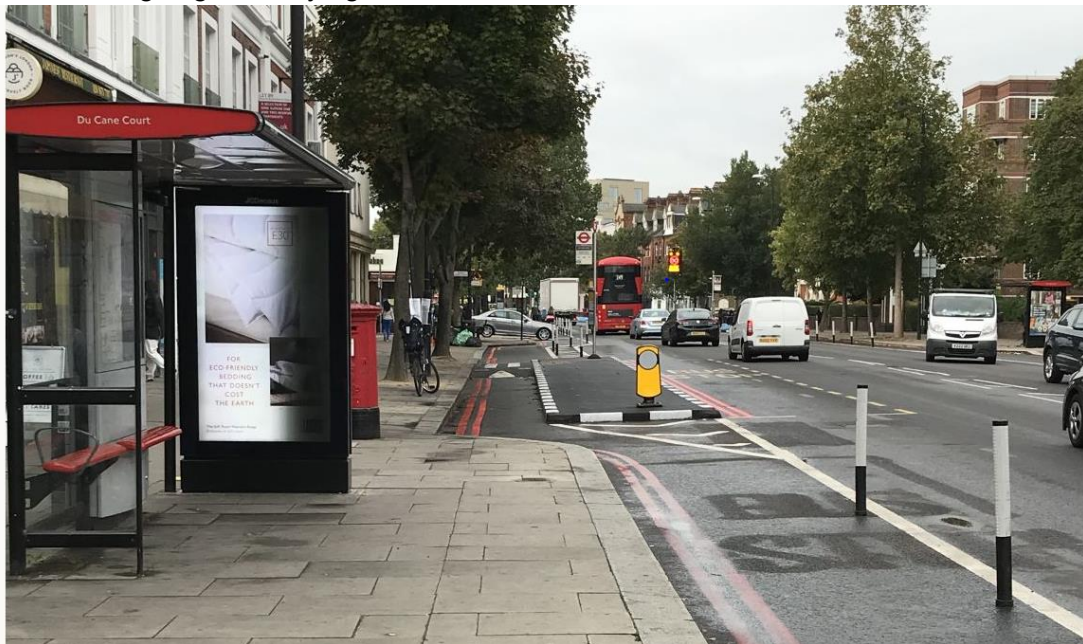
4. Southbound floating bus stop south by Ravenstone Road – The layout of the floating bus stop by-pass creates excessive deflection for cyclists and increases the risk of pedal cyclists colliding with the raised kerbs and being unseated. This is exacerbated by the road marking alignment tying into the end of the island.

It is recommended that the deflection angle is reduced by amending the kerbs on the corner of the island and offsetting the markings to guide cyclists past it. It also appears that painting the corner kerb white may make it more distinct.

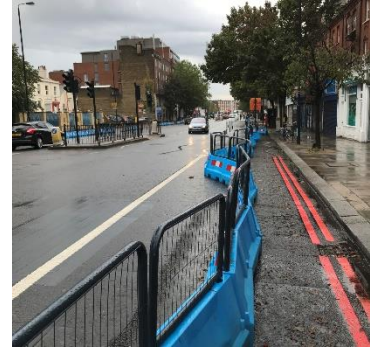
6. The water filled barrier has been moved and results in a very narrow cycle lane. This results in cyclists having to swerve to avoid it and enter the traffic lane, at risk of side-swipes.

It is recommended that the barriers are realigned and checked regularly to ensure they do not encroach into the adjacent cycle lane.

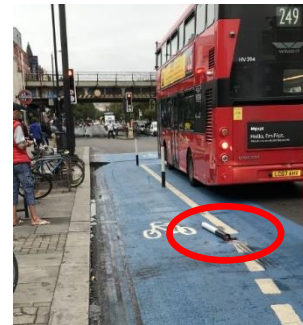
7. Whilst beyond the section extents, it was noted that the northernmost of the three cylinders on the southbound approach to the Balham Station crossroads had been knocked over. It is recommended that bus movements are tracked to check that buses pulling away from the stop are able to do so without overrunning the cylinder to determine whether to replace or remove it.

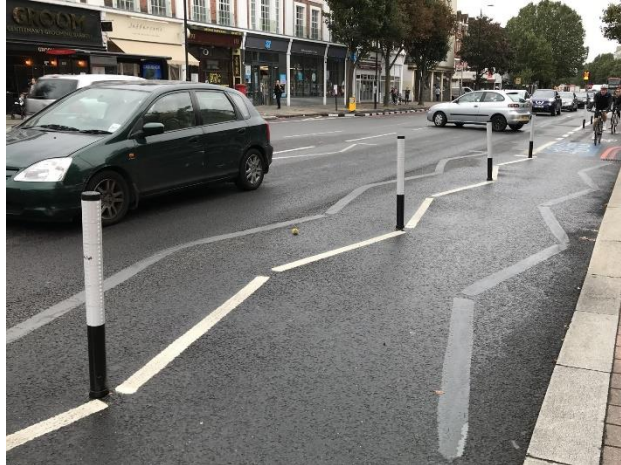
9. General – There is significant ‘ghosting’ associated with the masked road markings. Whilst not forming a significant safety concern on this section of the route, consideration should be given to an alternative method of removing redundant markings so that the old alignments are not so clearly visible.

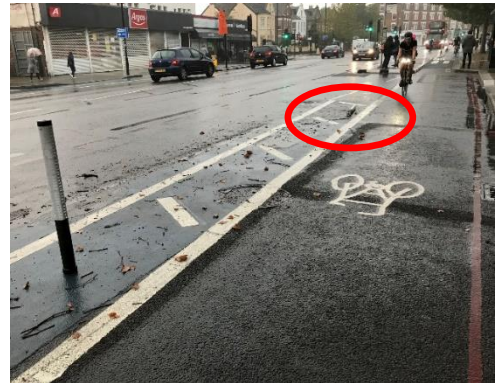
10. The southernmost cylinder north of the Ritherdon Road northbound floating bus stop had been knocked over. It is not clear how it occurred but may require the crossover turning movements to be tracked to check that manoeuvres can be completed without overrunning the cylinder to determine whether to replace or remove it.
