Investigation Report

Bus/Tram Collision 7th September 2008

Park Lane/George Street/Wellesley Road,
Croydon

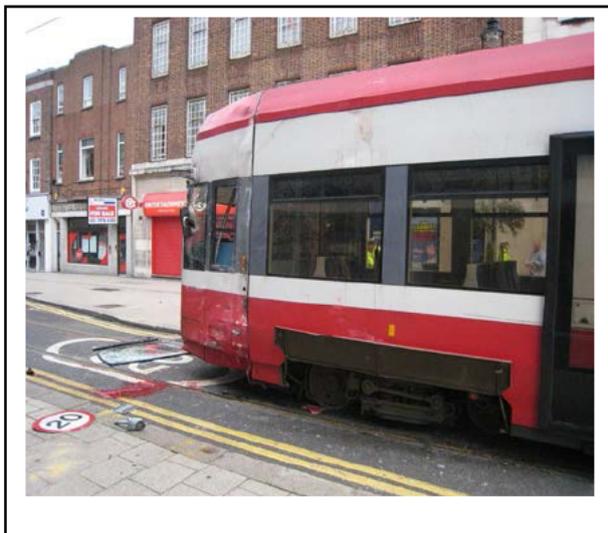
Fig 1

- 4.4 The tram was derailed and came to rest some metres along George Street at its junction with Wellesley Road (fig 1). The bus, striking the nearside of the tram, was forced through 90 degrees by the impact and ended up facing west down George Street. The bus then continued under motive power down the left hand side pavement of George street (travelling away from the junction) before striking a parked car. The car and bus came to rest on the opposite side of the road when the car struck a building (fig 2). The bus caused damage to a number of shop fascias and to street furniture (see Appendix c).

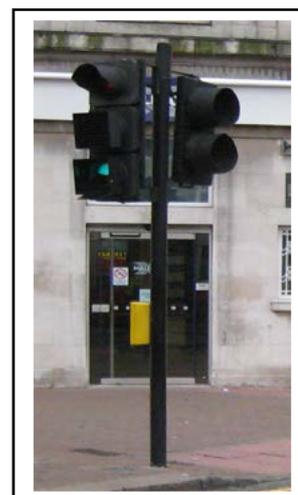
Fig 3

- 5.5 The signals controlling pedestrian and traffic movement at the junction of Wellesley Road are fitted with louvred hoods on the amber and green aspects of the signal. This is standard practice throughout London at similar junctions and is employed at this junction to minimise the risk of misjudgement by drivers waiting at the Park Lane/George Streets stop line, approximately 30 meters to the south of the crossing (see map appendix D). On the day of the incident it was noted by DTO staff on site that the louvers to the signals had been damaged, enabling a green signal to be seen from the stop line at Park Lane (fig 3). This was the first report of damaged louvres.

- 5.6 The signals at the junction were inspected on the 30th August 2008 with no defects identified. The damage to the louvers identified on the day of the incident was not the result of vehicle collision suggesting a more likely cause being vandalism.

- 16.5 DTO should review their preventative maintenance inspection programme and consider increasing inspection frequency.

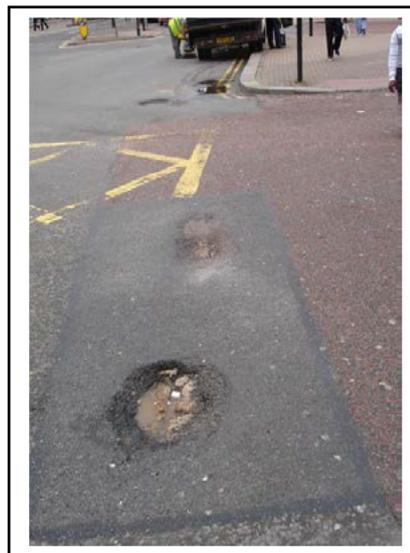
Fig
4

- 8.2 Ahead of the stop sign at Park Lane/George Street there were two large 'pot holes' in the carriage way and road markings showed signs of wear (fig 4). However it was determined that these did not contribute to the incident

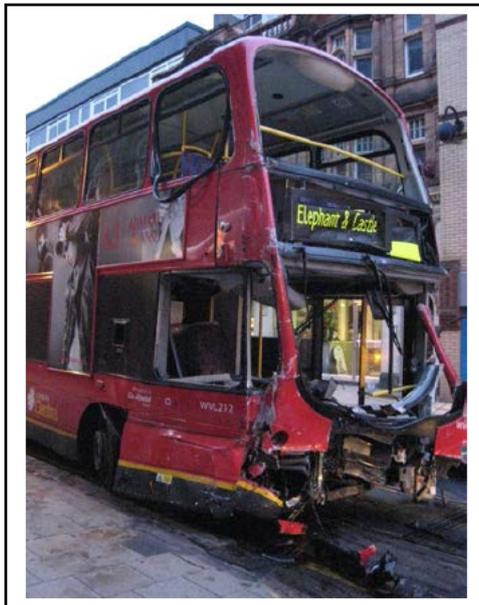
Extensive damage to front of bus

- 16.6 LBSL and/or the bus operator should consider having discussions with the bus manufactures to explore the possibility of strengthening the top deck front side windows, with a view of preventing them from falling out if struck from the inside.

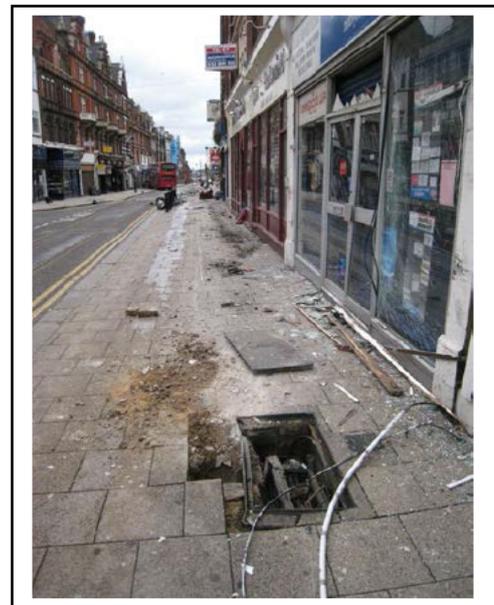
Damage to street furniture and shop fronts (taken up George Street (West) towards junction)

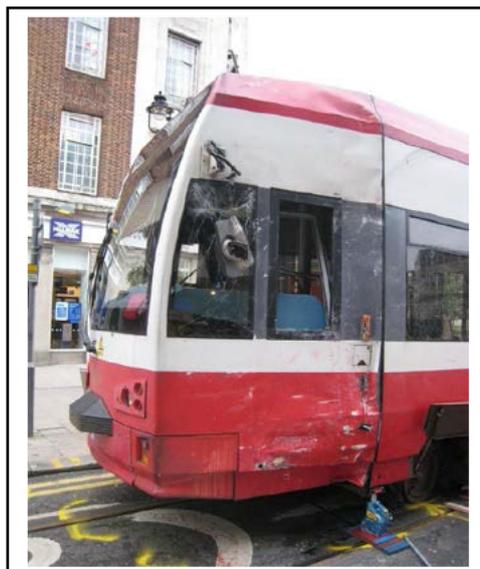
Damage to carriage of tram

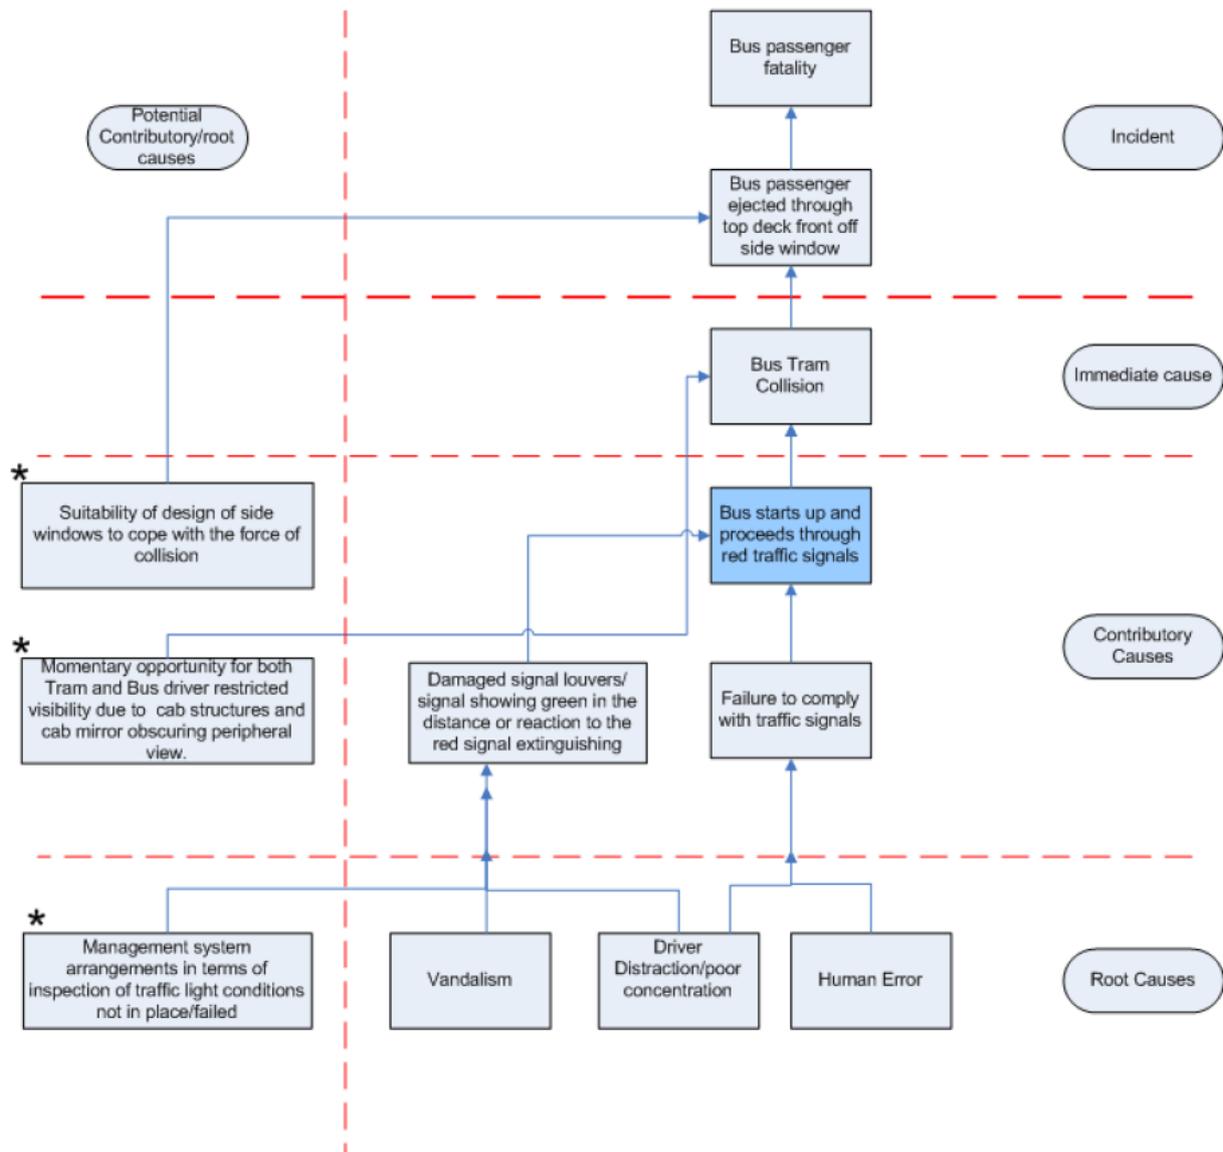
Root cause diagram for the Bus Tram fatality George St /Wellesley Road

* These items were considered in the root cause analysis but the investigation panel were unable to confirm that they were definite causes.
