Hazardous Materials - TfL Engineering

Re-inspection Sign-Off for Brixton

Re-inspection Reference: V059/4RS-200403

Station	Brixton
Original Management Survey	R346601
Date of Original Management	31st August 2012
Re-inspection Reference:	V059-4RS-200403
Next Planned Re-inspection	Periodical re-inspection according to HM Management Plan

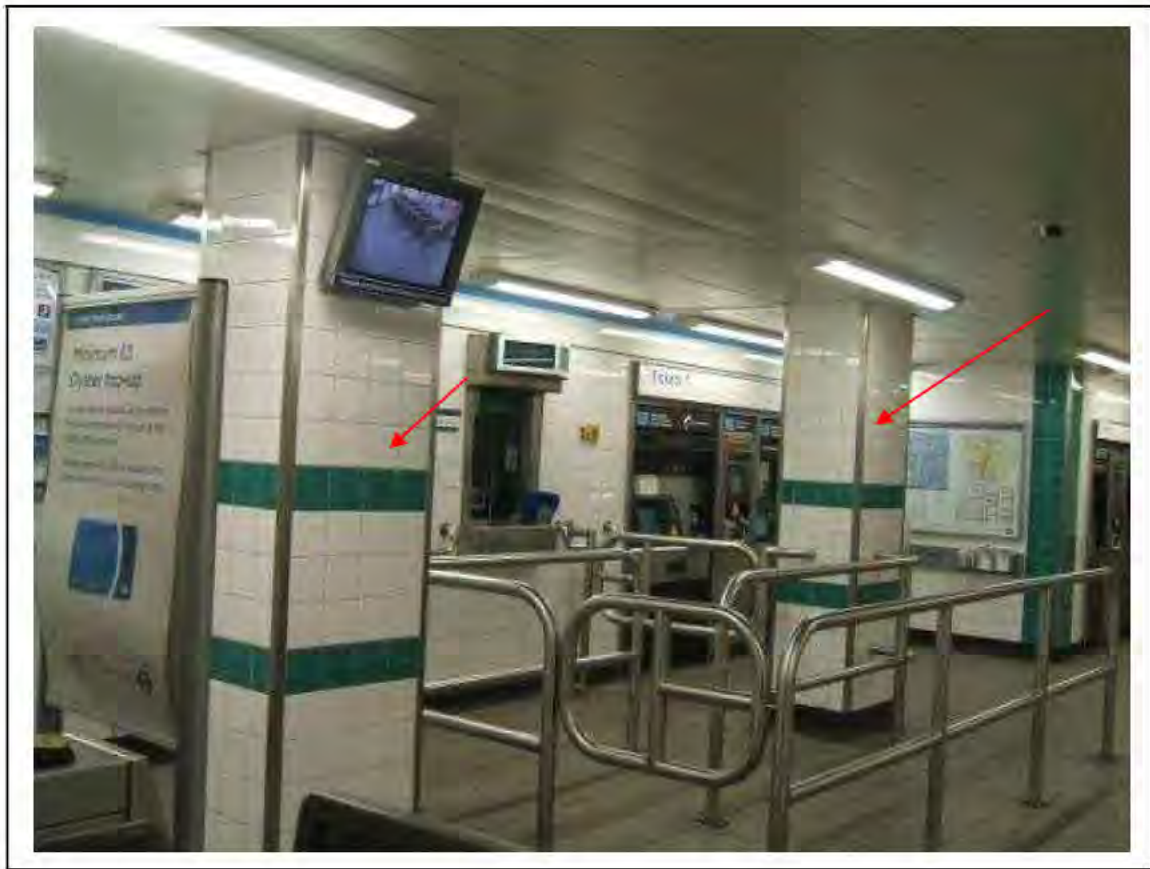
FIGURE 1: PRESUMED ASBESTOS IN RESIDUE IN PILLARS IN TICKET HALL , 2/001 - DESCRIPTION & RESULT OF ASSESSMENT (SAMPLE REF. P1&2(1))

Sample Number	P1&2(1)
Location	Ticket Hall , 2/001
Material Description	Residue in pillars
Material Comment	Possible asbestos within refer to report reference 4RS-BIM-034523-R34777
Quantity	-
Product Type	-
Current Condition	-
Surface Treatment	-
Asbestos Type	Presumed Amosite and Chrysotile
Material Assessment Rating	-
Accessibility	
Further Comment	Not applicable

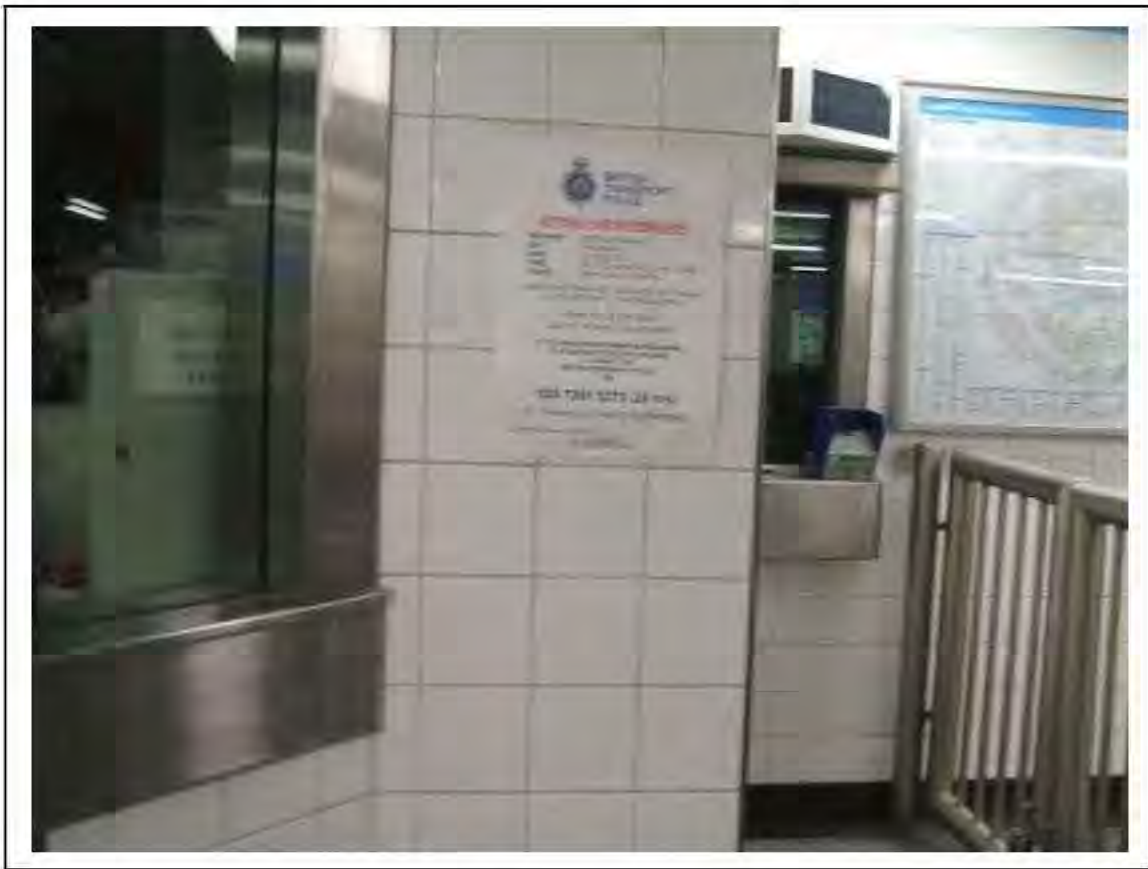
Sample Number	P1&2(11)
Location	Circulation Area, 2/071
Material Description	Residues suspected within circulation area
Material Comment	Pillar (tiled)
Quantity	-
Product Type	-
Current Condition	-
Surface Treatment	-
Asbestos Type	Presumed Amosite & Chrysotile
Material Assessment Rating	-
Accessibility	
Further Comment	Not applicable

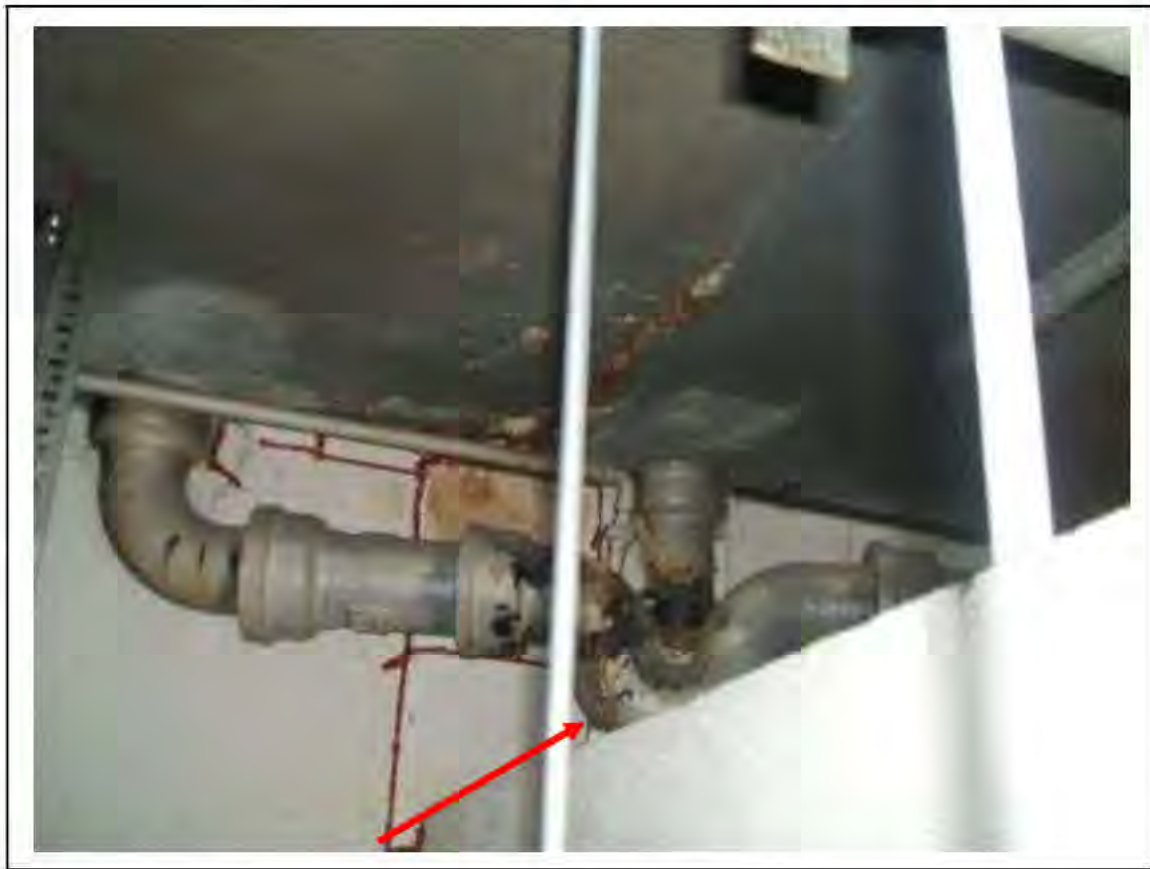
Sample Number	P1&2(61)
Location	UMC Access , 2/151
Material Description	Possible residue within concrete roof around soil pipe
Material Comment	See R34777 page 48, Fig 35
Quantity	-
Product Type	-
Current Condition	-
Surface Treatment	-
Asbestos Type	Presumed Amosite & Chrysotile
Material Assessment Rating	-
Accessibility	
Further Comment	Not applicable

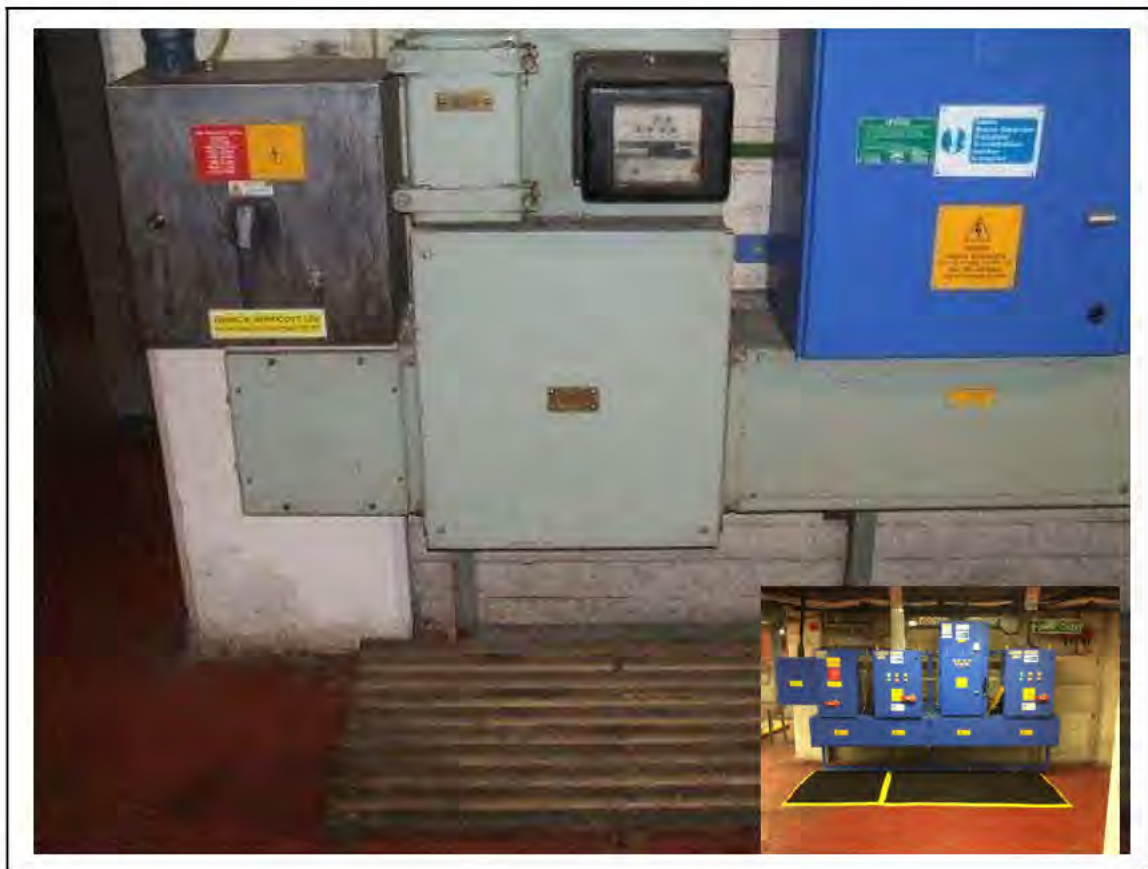
Sample Number	P1(1)
Location	UMC, 2/151
Material Description	Watt hour meter / fuseboard
Material Comment	Possible asbestos rope, seals and paper within
Quantity	-
Product Type	-
Current Condition	-
Surface Treatment	-
Asbestos Type	Presumed Chrysotile
Material Assessment Rating	-
Accessibility	Low
Further Comment	Not applicable

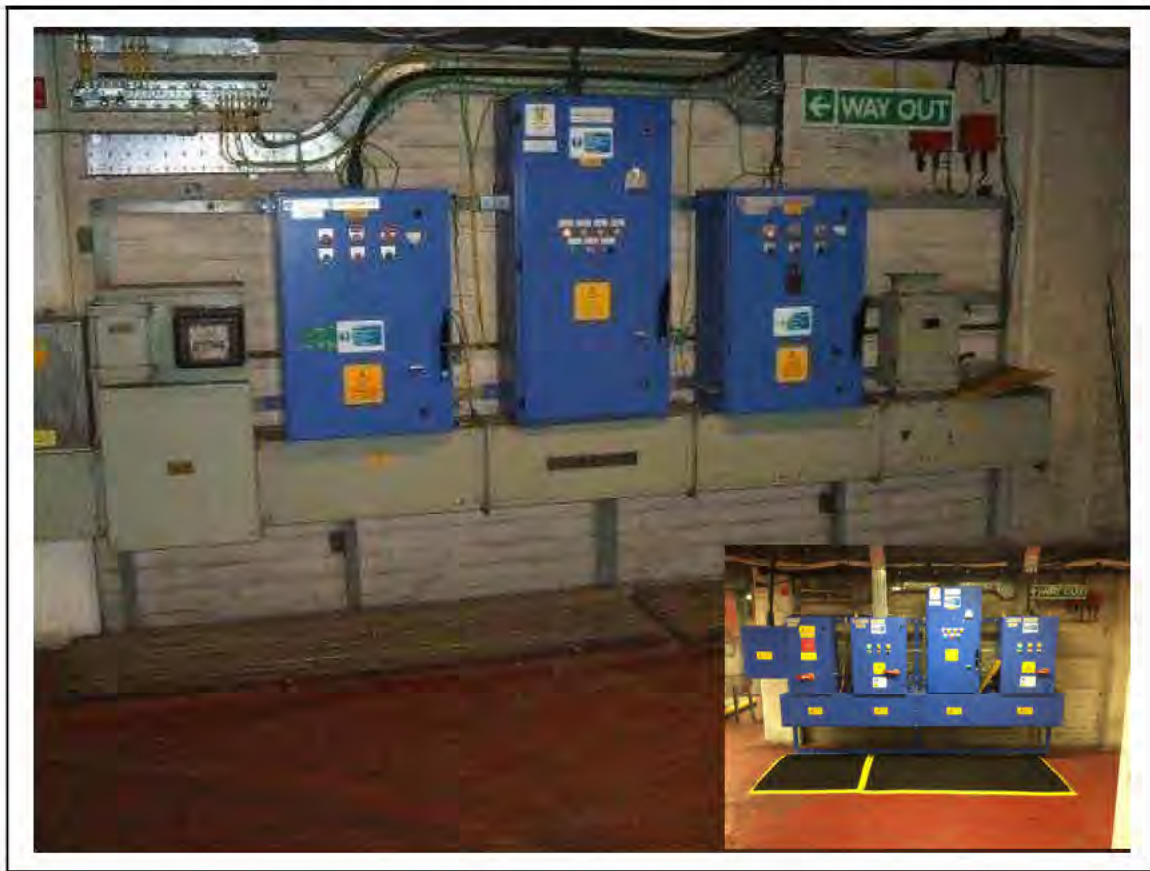
Sample Number	P1(2)
Location	UMC, 2/151
Material Description	Bus bar box
Material Comment	Possible asbestos
Quantity	-
Product Type	-
Current Condition	-
Surface Treatment	-
Asbestos Type	Presumed Chrysotile
Material Assessment Rating	-
Accessibility	Low
Further Comment	Not applicable

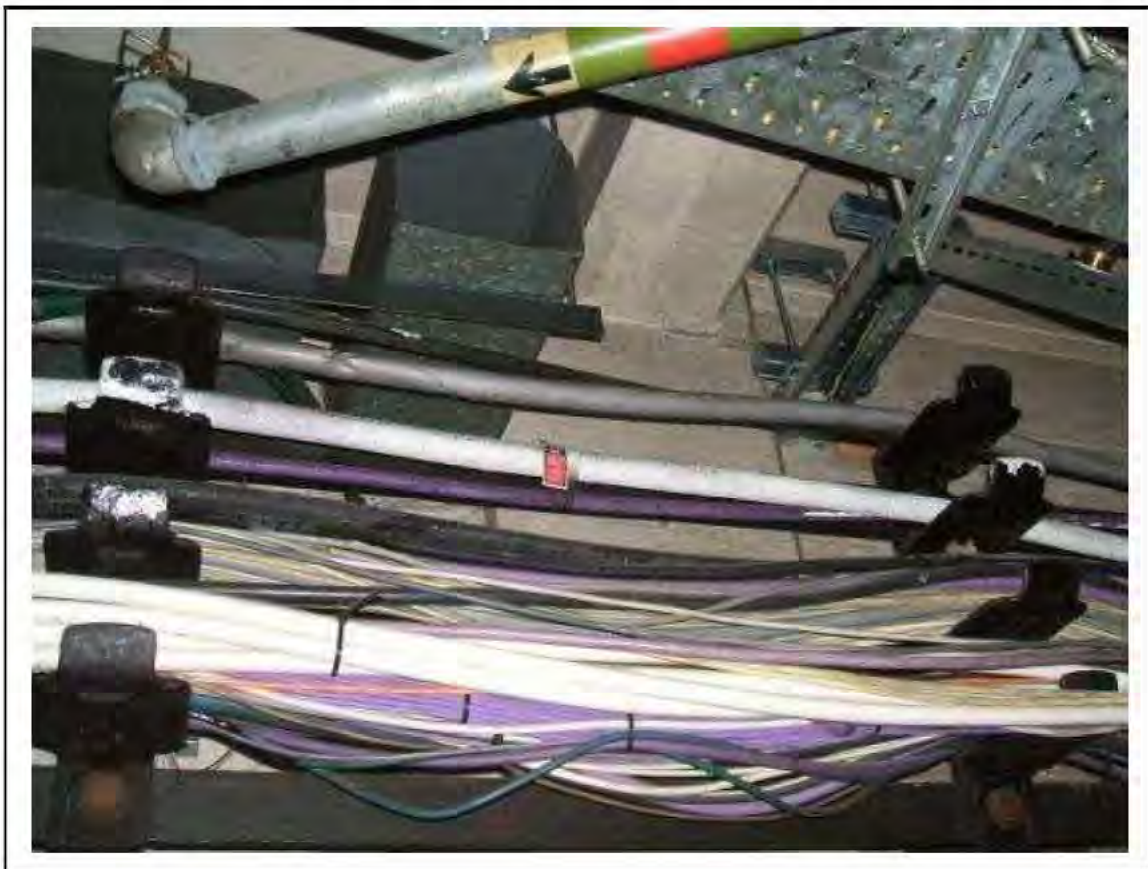
Sample Number	K1(2)
Location	UMC, 2/151
Material Description	Braided cables
Material Comment	Run around rear of UMC, one part wrapped in alphameritex
Quantity	1/2no
Product Type	Medium density
Current Condition	Slight damage
Surface Treatment	Encapsulated medium density
Asbestos Type	Known Chrysotile
Material Assessment Rating	Low
Accessibility	Low
Further Comment	Not applicable

Encapsulated March 2014

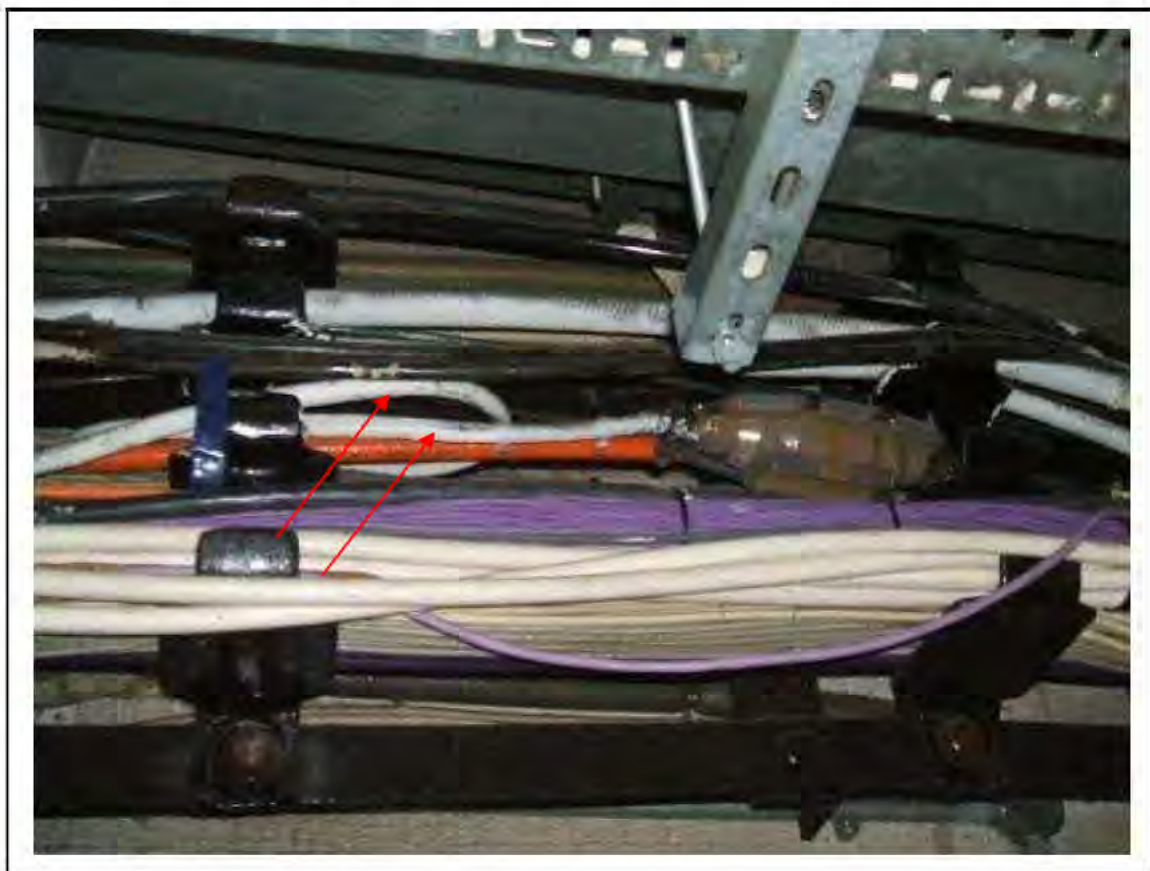
Sample Number	K1(3)
Location	UMC, 2/151
Material Description	Braided cables
Material Comment	-
Quantity	2no 4lm
Product Type	Medium density
Current Condition	Slight damage
Surface Treatment	Encapsulated medium density
Asbestos Type	Known Chrysotile
Material Assessment Rating	Low
Accessibility	Low
Further Comment	Not applicable

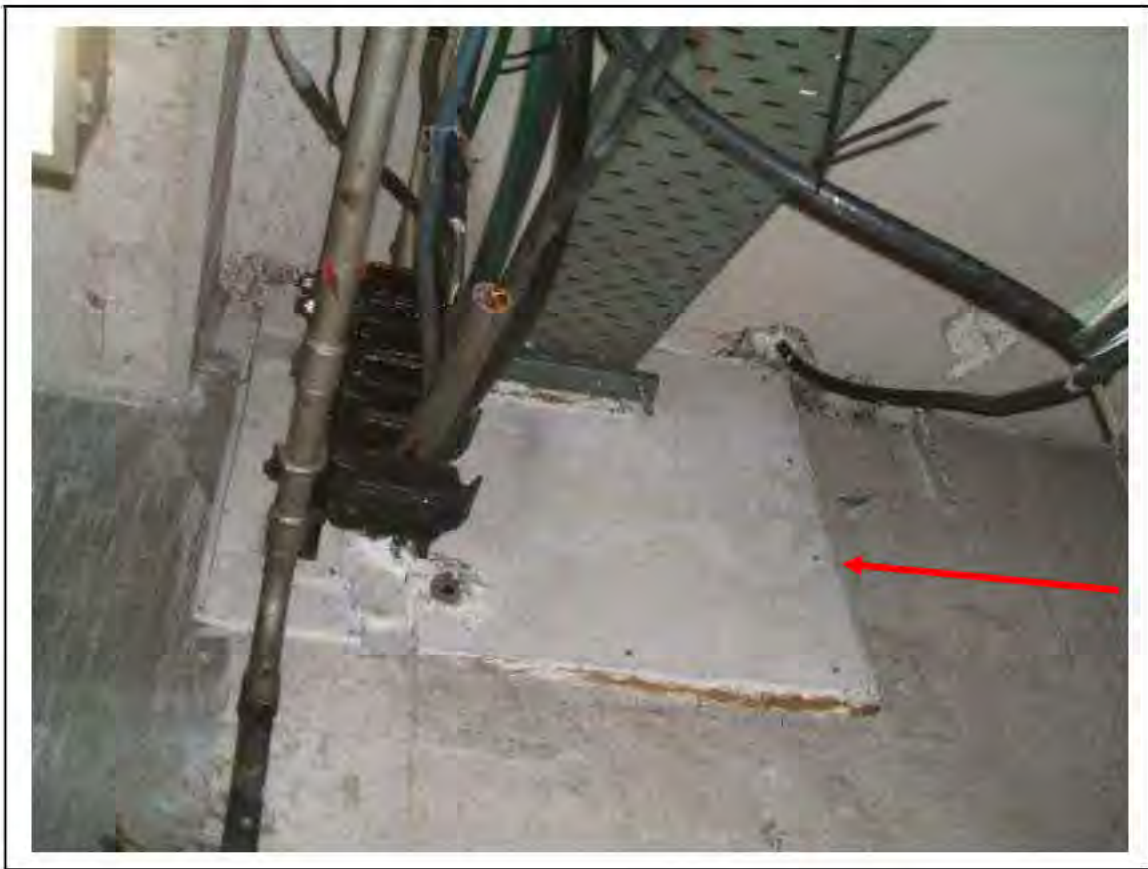
Sample Number	P1(5)
Location	UMC, 2/151
Material Description	Supalux panel (possible ducts behind)
Material Comment	Possible asbestos cement ducts behind
Quantity	-
Product Type	-
Current Condition	-
Surface Treatment	-
Asbestos Type	Presumed Chrysotile
Material Assessment Rating	-
Accessibility	
Further Comment	Not applicable

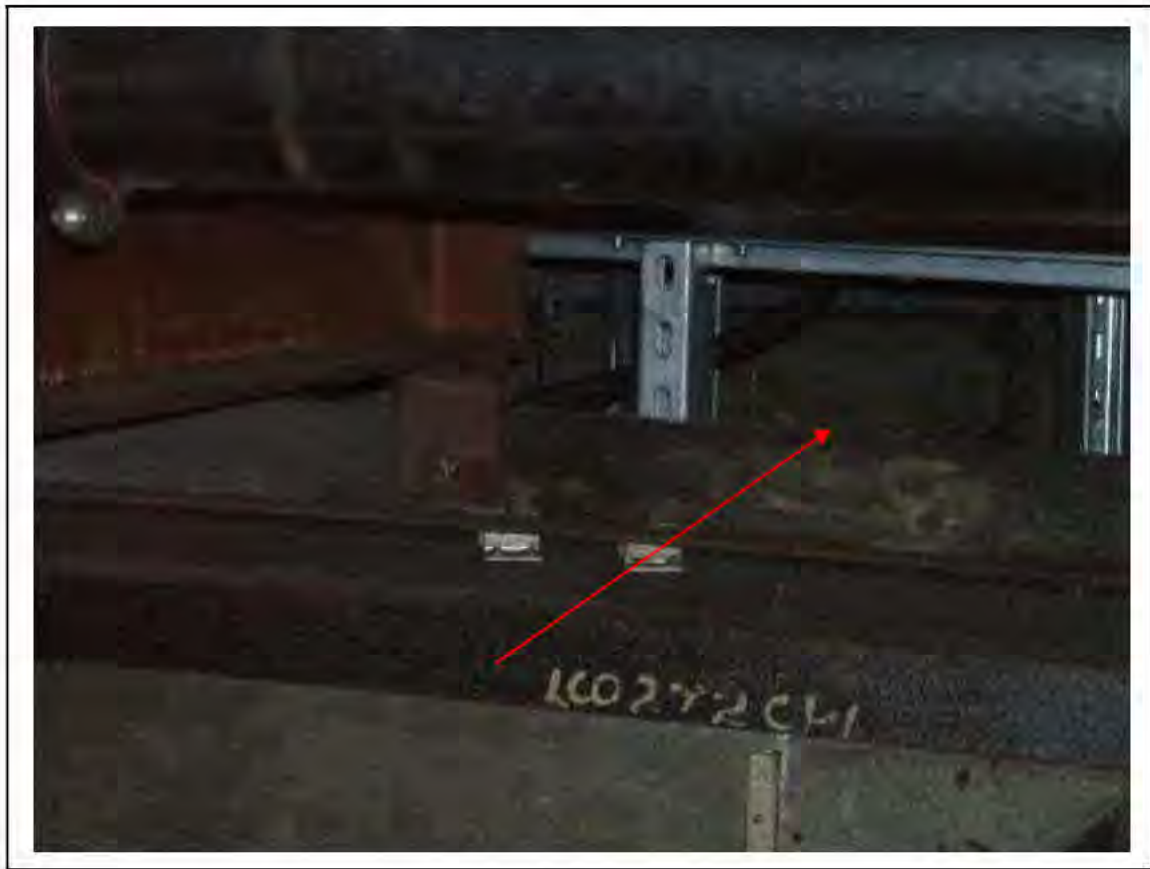
Sample Number	P1&2(20)
Location	UMC , 2/151
Material Description	Possible residues below foam
Material Comment	Foam at high level, right hand side, looking down escalator
Quantity	-
Product Type	-
Current Condition	-
Surface Treatment	-
Asbestos Type	Presumed Amosite and Chrysotile
Material Assessment Rating	-
Accessibility	
Further Comment	Not applicable

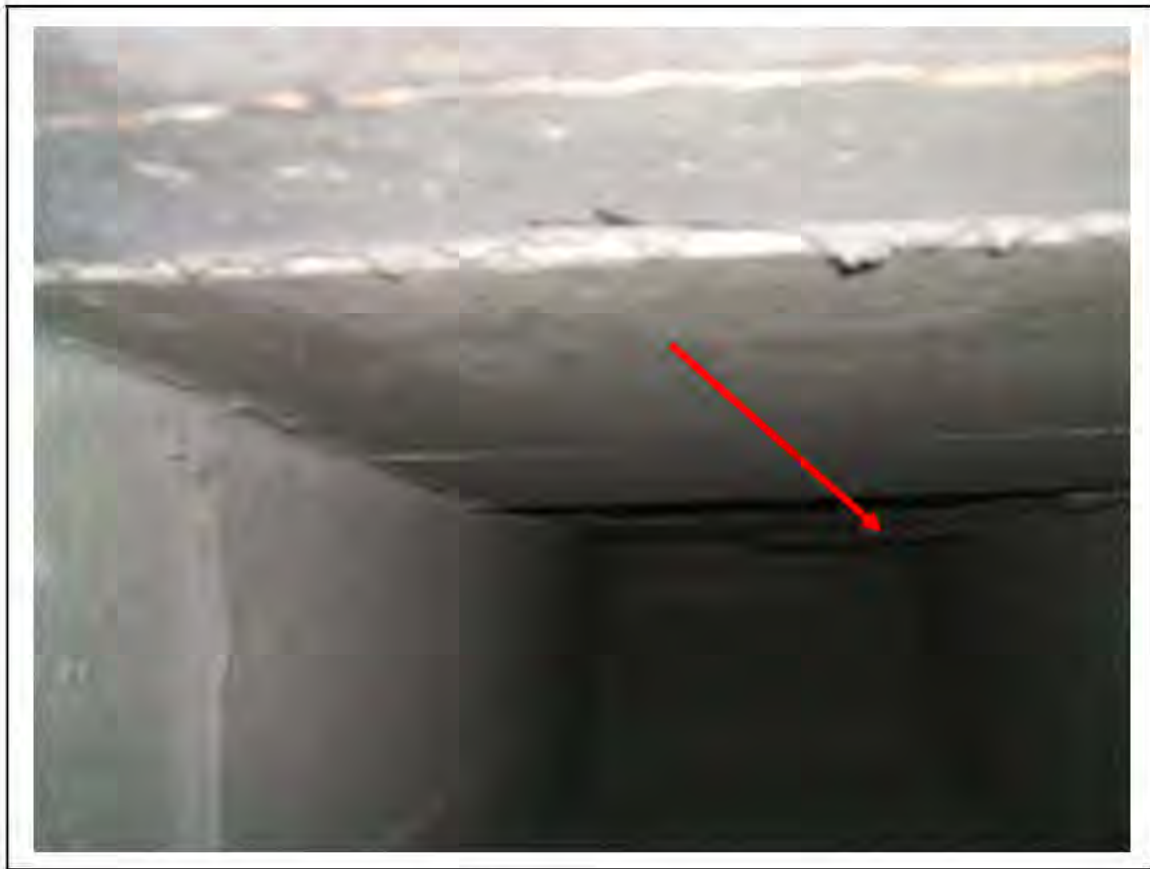
Sample Number	120445/150812/2
Location	UMC , 2/151
Material Description	Cement board shuttering
Material Comment	Shuttering used in under floor ventilation concrete ducts more may be present further into the duct system
Quantity	0.1m ²
Product Type	Composite
Current Condition	Moderate damage
Surface Treatment	Composite
Asbestos Type	Chrysotile
Material Assessment Rating	Very low
Accessibility	Low
Further Comment	Not applicable

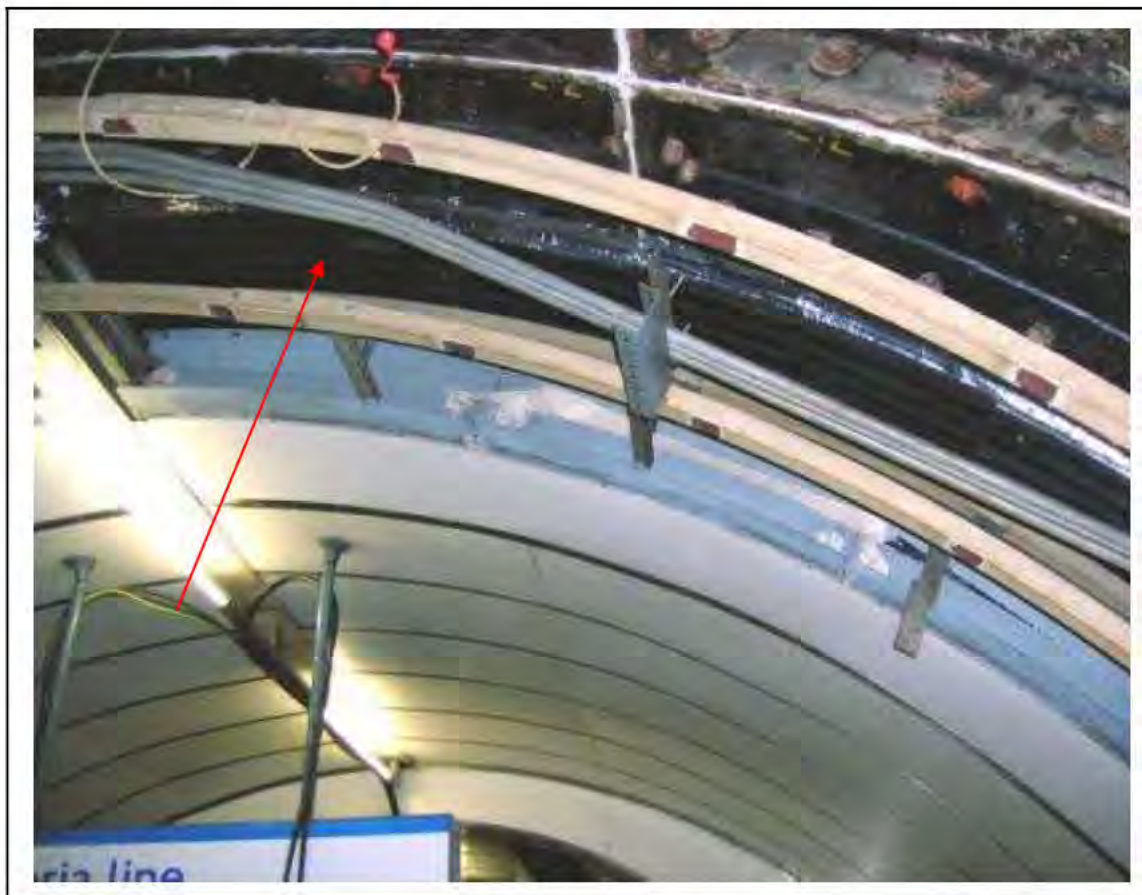
Sample Number	K1(6)
Location	Escalator Incline, 2/171
Material Description	Cellactite
Material Comment	4RS-BIM-051542-R126627, Fig 7
Quantity	remaining to bottom of shaft
Product Type	Composite
Current Condition	Good condition
Surface Treatment	Composite
Asbestos Type	Chrysotile
Material Assessment Rating	Very low
Accessibility	Low
Further Comment	Not applicable

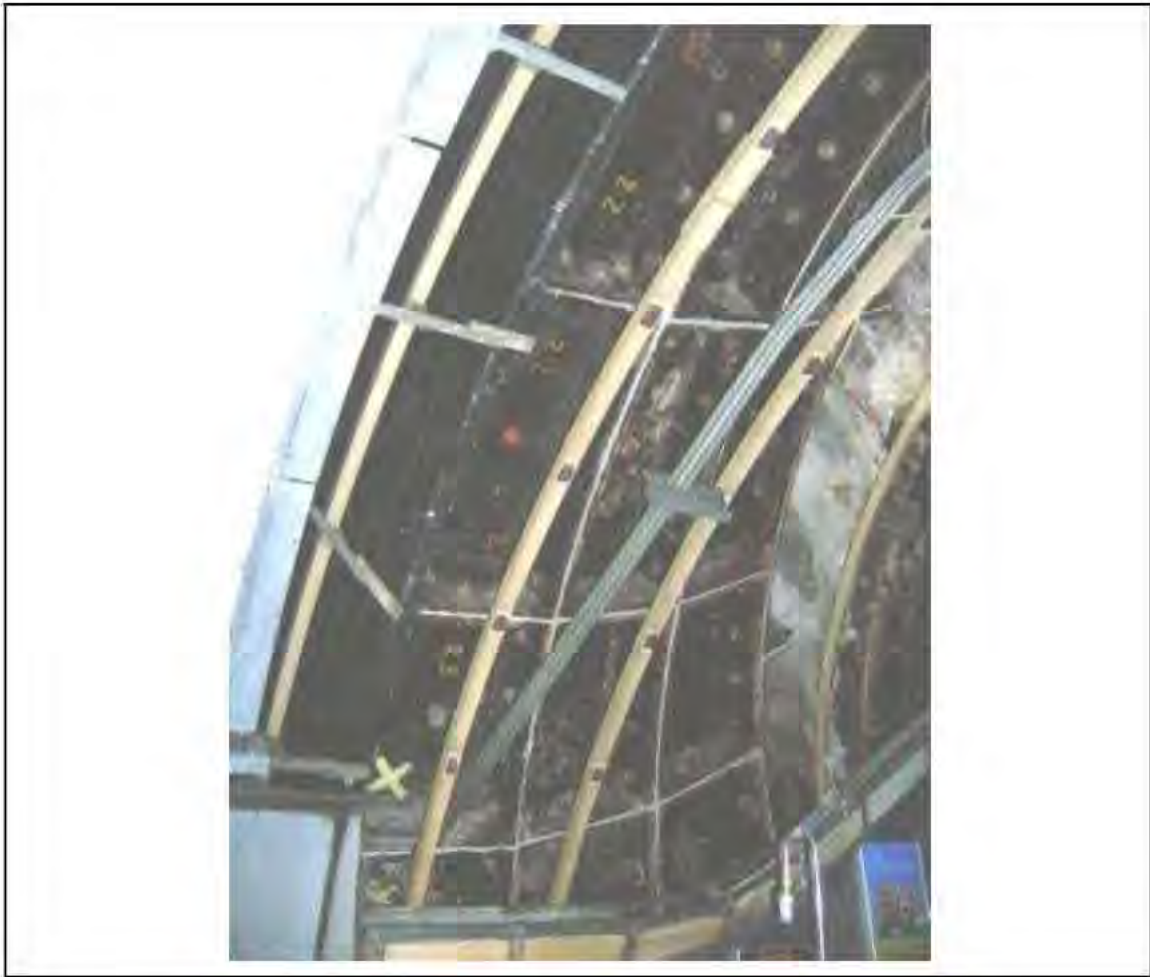
Sample Number	P1&2(23)
Location	Escalator Incline, 2/171
Material Description	Caulking
Material Comment	4RS-BIM-051542-R126627, Fig 6
Quantity	to bottom of shaft
Product Type	Medium density
Current Condition	Slight damage
Surface Treatment	Encapsulated medium density
Asbestos Type	Presumed Amosite & Chrysotile
Material Assessment Rating	Low
Accessibility	Low
Further Comment	Not applicable

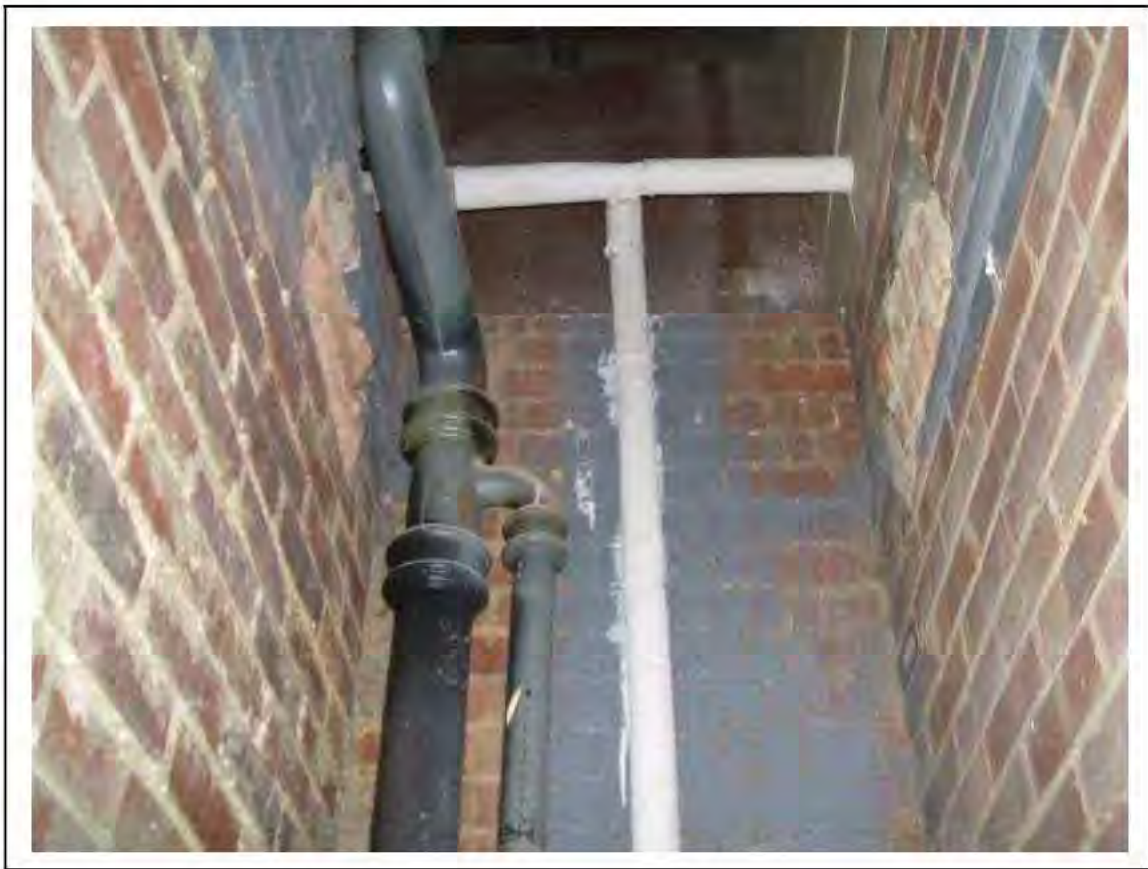
Sample Number	P1&2(24)
Location	Riser to End Corridor , 2/237
Material Description	Possible asbestos residues in cavity
Material Comment	Behind external wall
Quantity	-
Product Type	-
Current Condition	-
Surface Treatment	-
Asbestos Type	Presumed Amosite & Chrysotile
Material Assessment Rating	-
Accessibility	
Further Comment	Not applicable

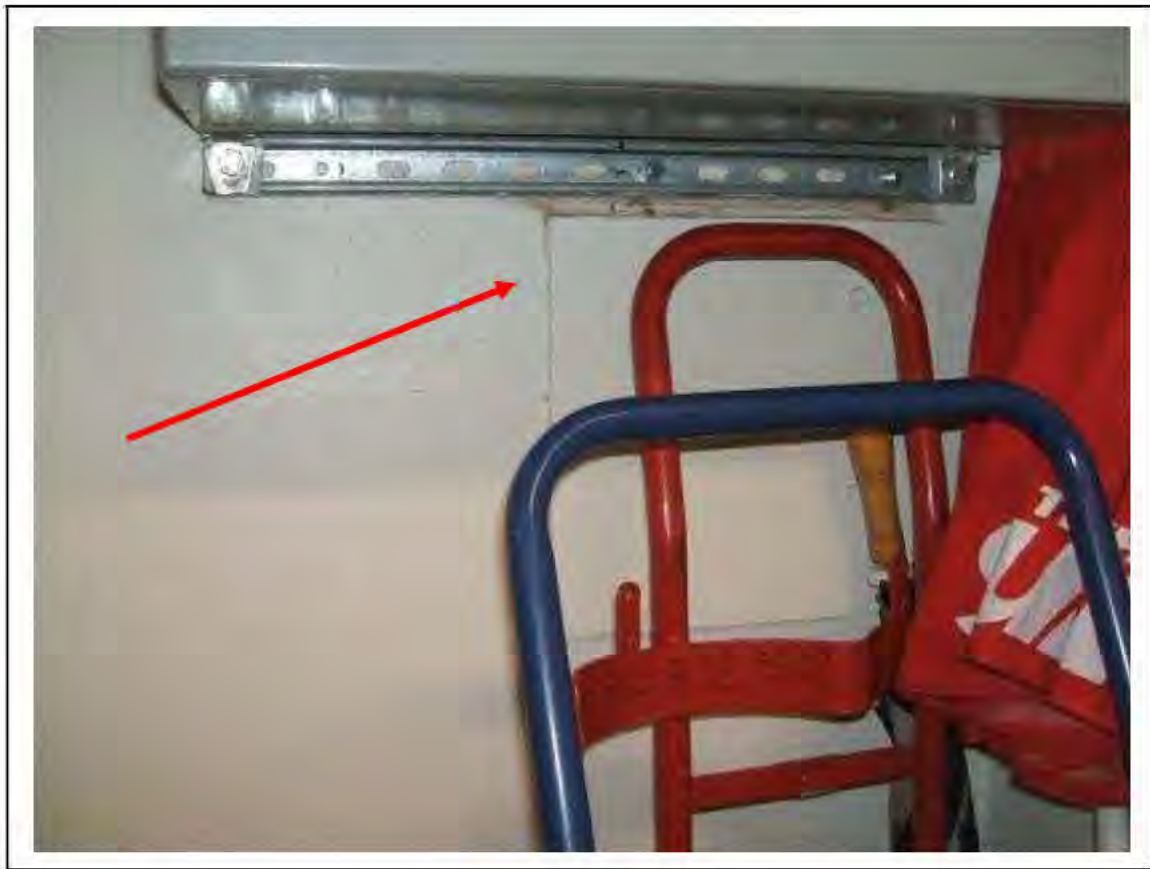
Sample Number	P1&2(25)
Location	Passage , 2/238
Material Description	Render on brick wall possible residues behind
Material Comment	Wall 2 (Note: asbestos residues behind wall in cavity)
Quantity	-
Product Type	-
Current Condition	-
Surface Treatment	-
Asbestos Type	Presumed Amosite and Chrysotile
Material Assessment Rating	-
Accessibility	
Further Comment	Not applicable

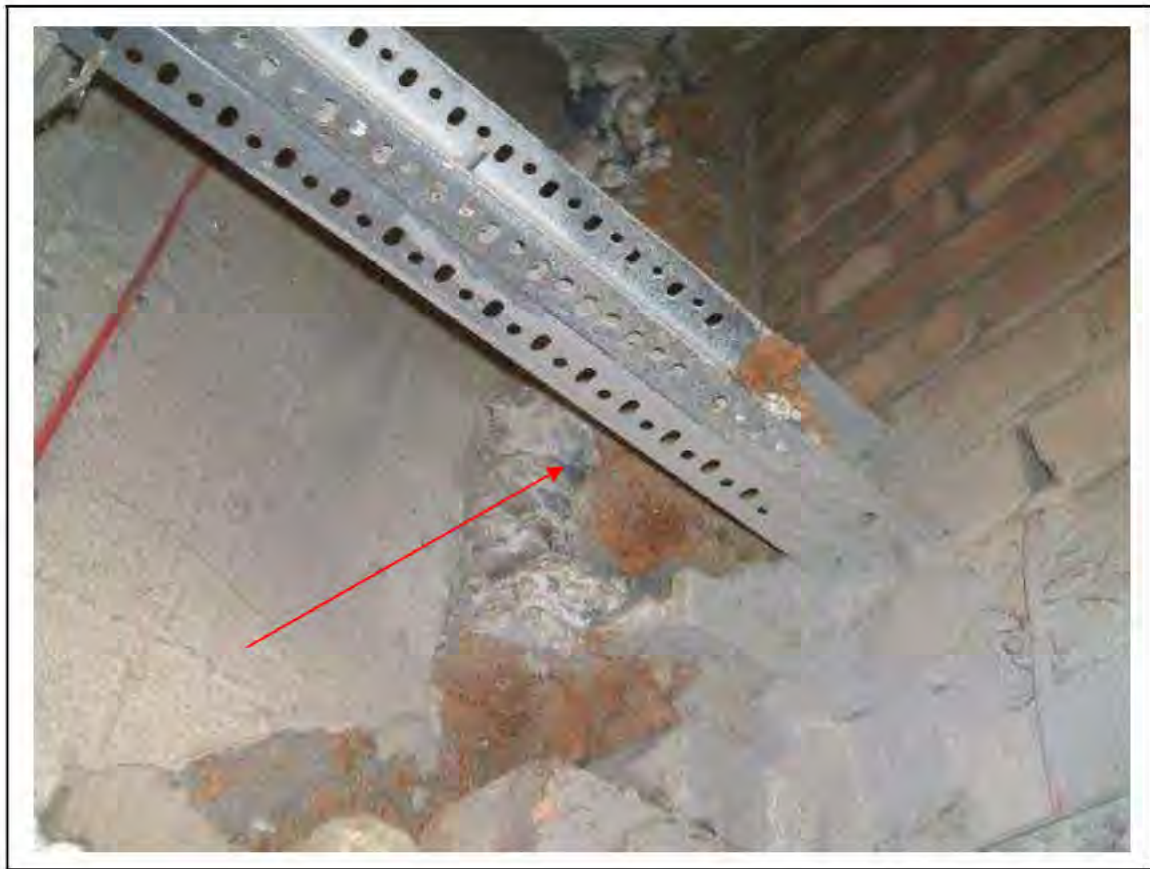
Sample Number	P1&2(28)
Location	Passage , 2/238
Material Description	Foam seal possible residues behind
Material Comment	Foam to wall corner, high level walls 6 and 7 possible asbestos behind
Quantity	-
Product Type	-
Current Condition	-
Surface Treatment	-
Asbestos Type	Presumed Amosite and Chrysotile
Material Assessment Rating	-
Accessibility	
Further Comment	Not applicable

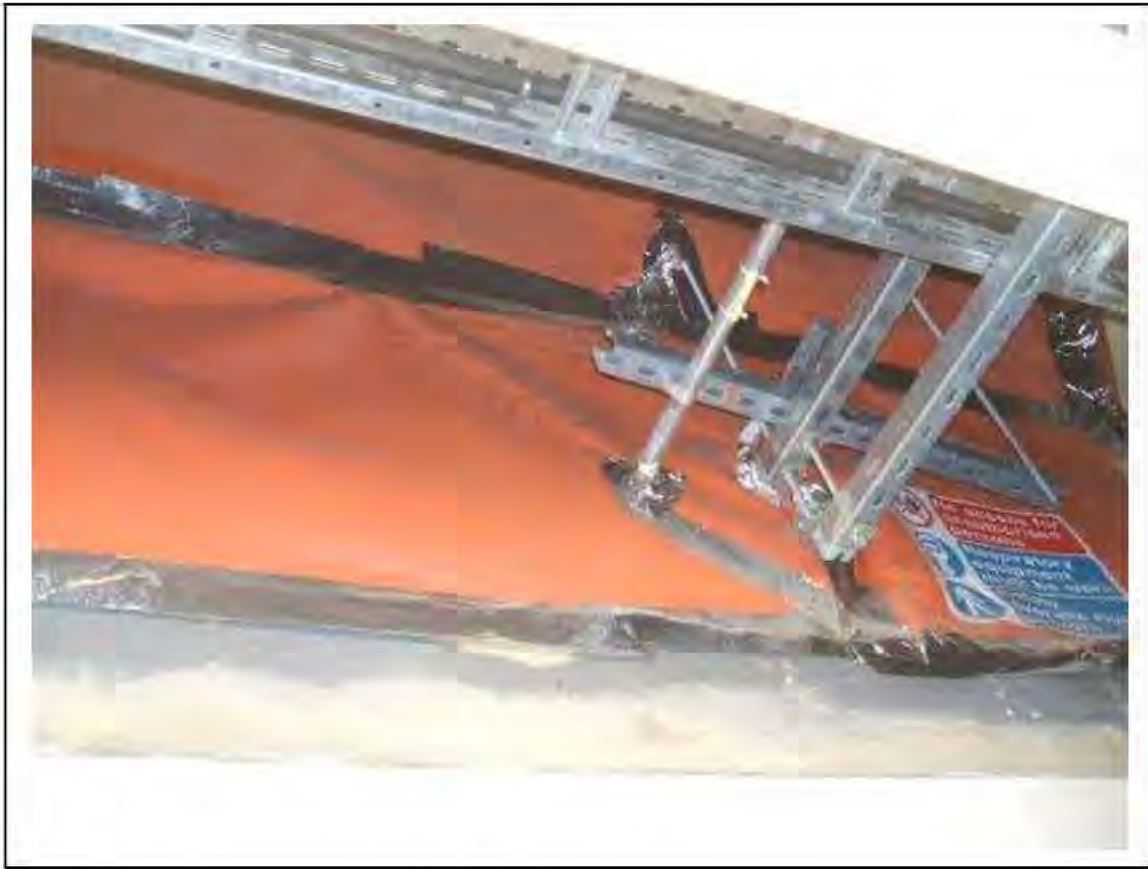
Sample Number	P1&2(29)
Location	Passage , 2/238
Material Description	Void over room 2/LFI and escalators
Material Comment	See report 4RS-IRG-034523-R34778
Quantity	-
Product Type	-
Current Condition	-
Surface Treatment	-
Asbestos Type	Presumed Amosite and Chrysotile
Material Assessment Rating	-
Accessibility	
Further Comment	Now boarded over with supalux, as behind the polythene is a wall beyond which is the void over the escalators

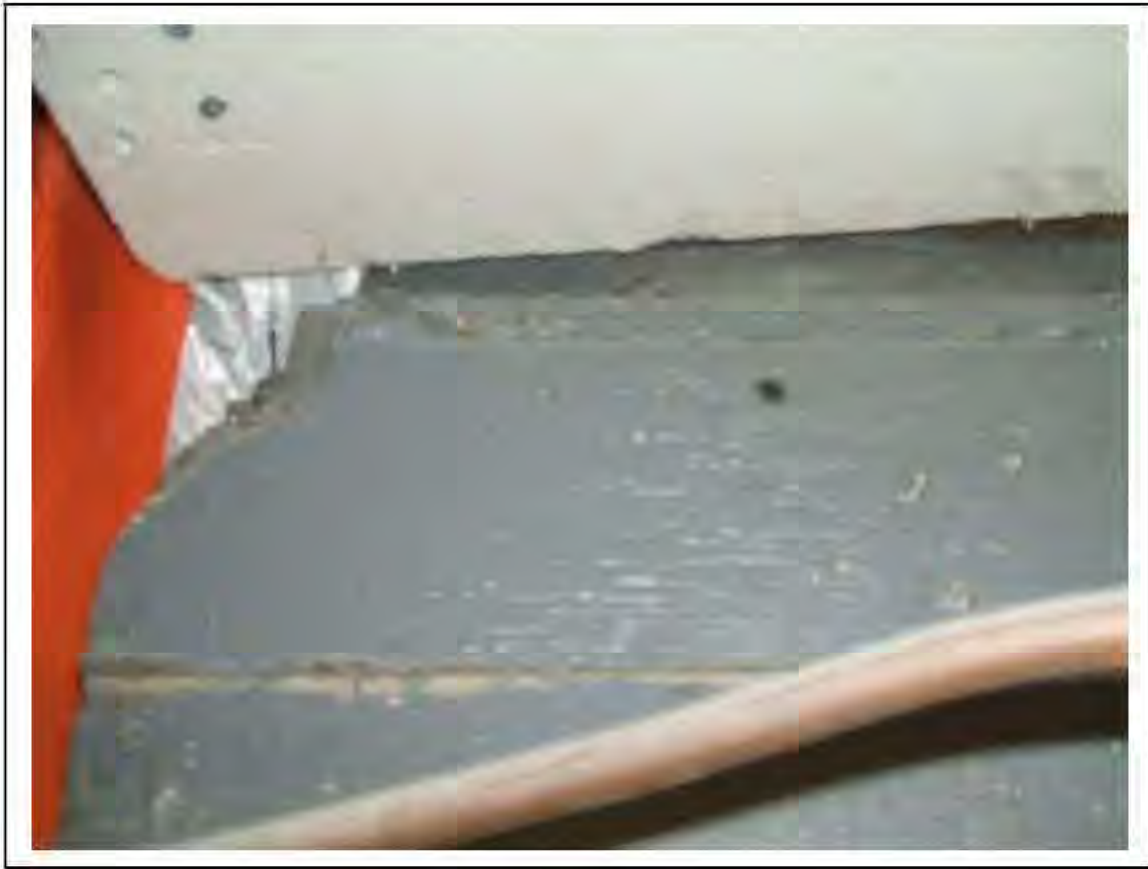
Sample Number	P1&2(31)
Location	Passage , 2/238
Material Description	Beam fibreboard clad over 2/668 and end of 2/407
Material Comment	Asbestos residue where beam passes into walls
Quantity	-
Product Type	-
Current Condition	-
Surface Treatment	-
Asbestos Type	Presumed Amosite and Chrysotile
Material Assessment Rating	-
Accessibility	
Further Comment	Not applicable

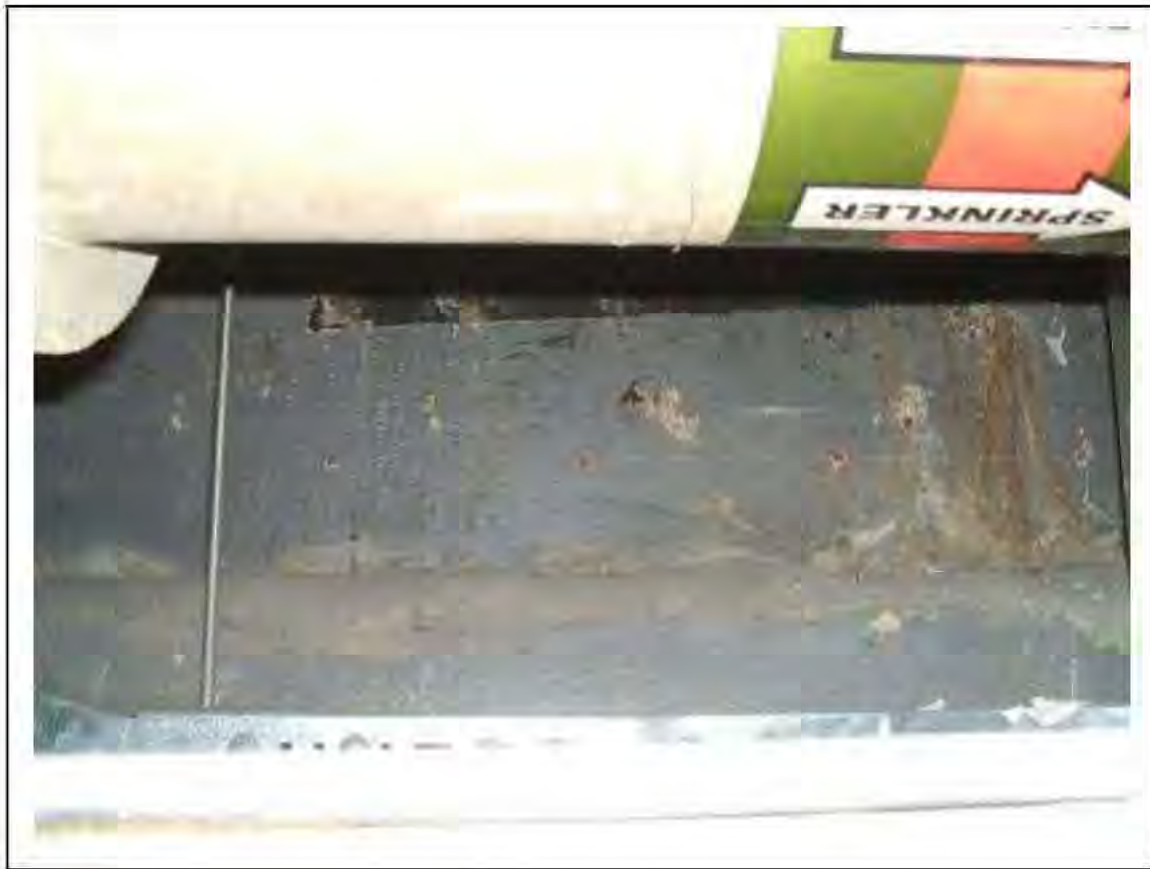
Sample Number	P1&2(32)
Location	Passage , 2/238
Material Description	Fibreboard clad beam over end of 2/407 and 2/669
Material Comment	Previously stripped but possible residue in walls where beam passes through external wall
Quantity	-
Product Type	-
Current Condition	-
Surface Treatment	-
Asbestos Type	Presumed Amosite and Chrysotile
Material Assessment Rating	-
Accessibility	
Further Comment	Not applicable

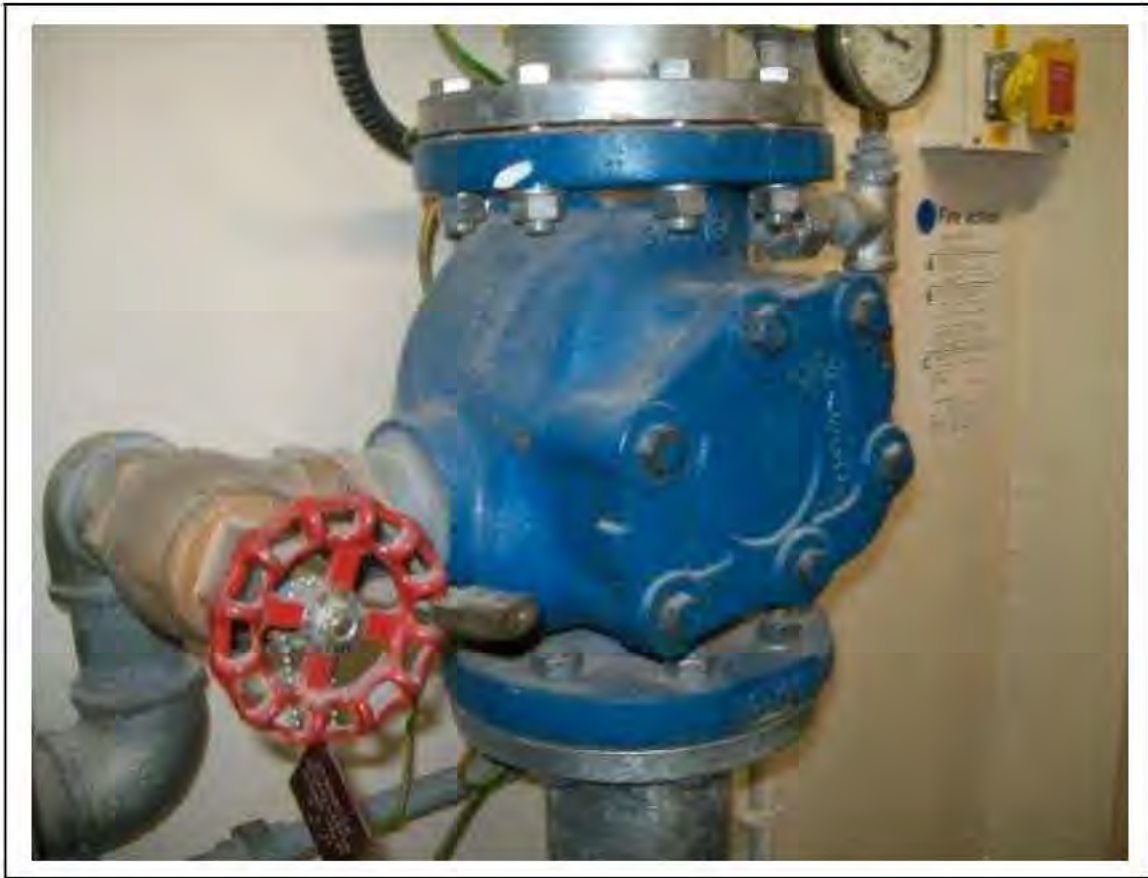
Sample Number	120445/160812/02
Location	SVC, 2/401
Material Description	Gasket
Material Comment	Flange and pipework throughout
Quantity	3no
Product Type	Composite
Current Condition	Good condition
Surface Treatment	Composite
Asbestos Type	Chrysotile
Material Assessment Rating	Very low
Accessibility	Low
Further Comment	Not applicable

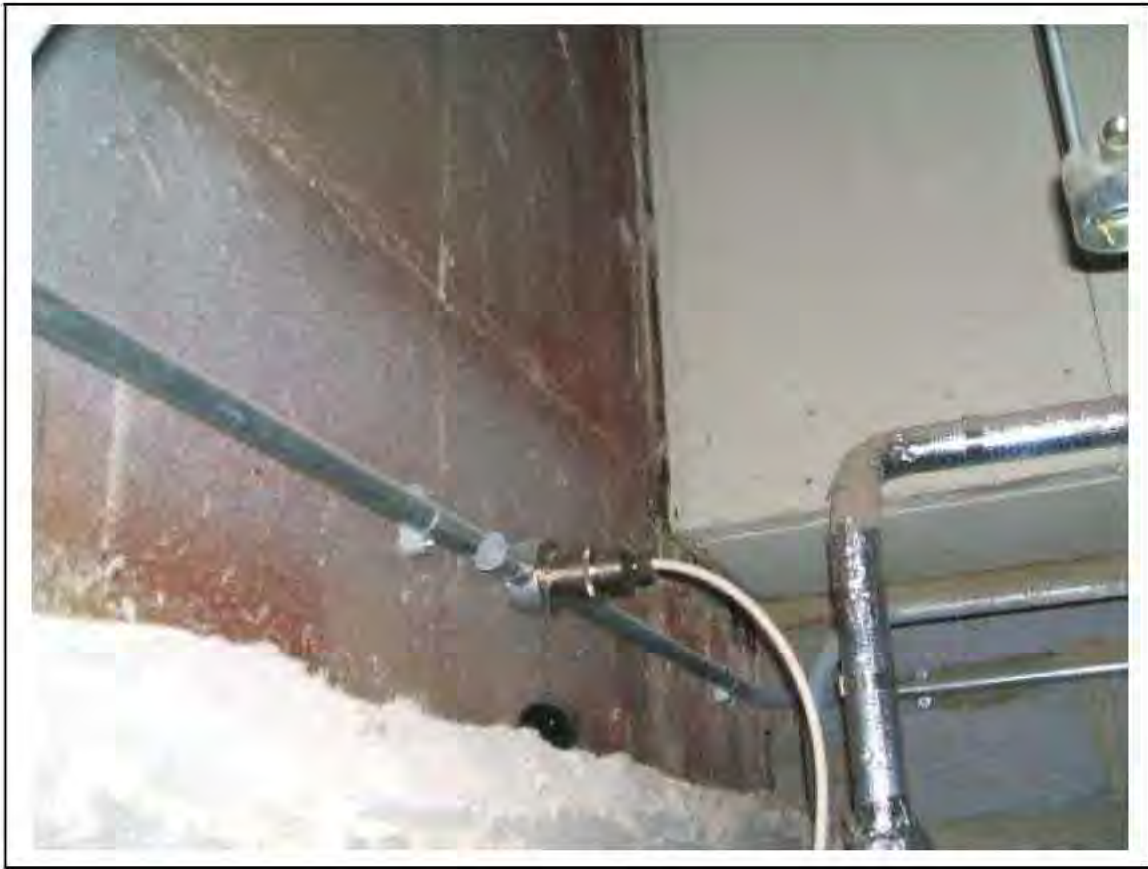
Sample Number	P1&2(38)
Location	Female W/C, 2/416
Material Description	Possible residue
Material Comment	Within wall where beam enters
Quantity	-
Product Type	-
Current Condition	-
Surface Treatment	-
Asbestos Type	Presumed Amosite & Chrysotile
Material Assessment Rating	-
Accessibility	
Further Comment	Not applicable
