Hazardous Materials - TfL Engineering

Re-inspection Sign-Off for Brixton

Re-inspection Reference: V059/4RS-200403

Station	Brixton
Original Management Survey	R346601
Date of Original Management	31st August 2012
Re-inspection Reference:	V059-4RS-200403
Next Planned Re-inspection	Periodical re-inspection according to HM Management Plan

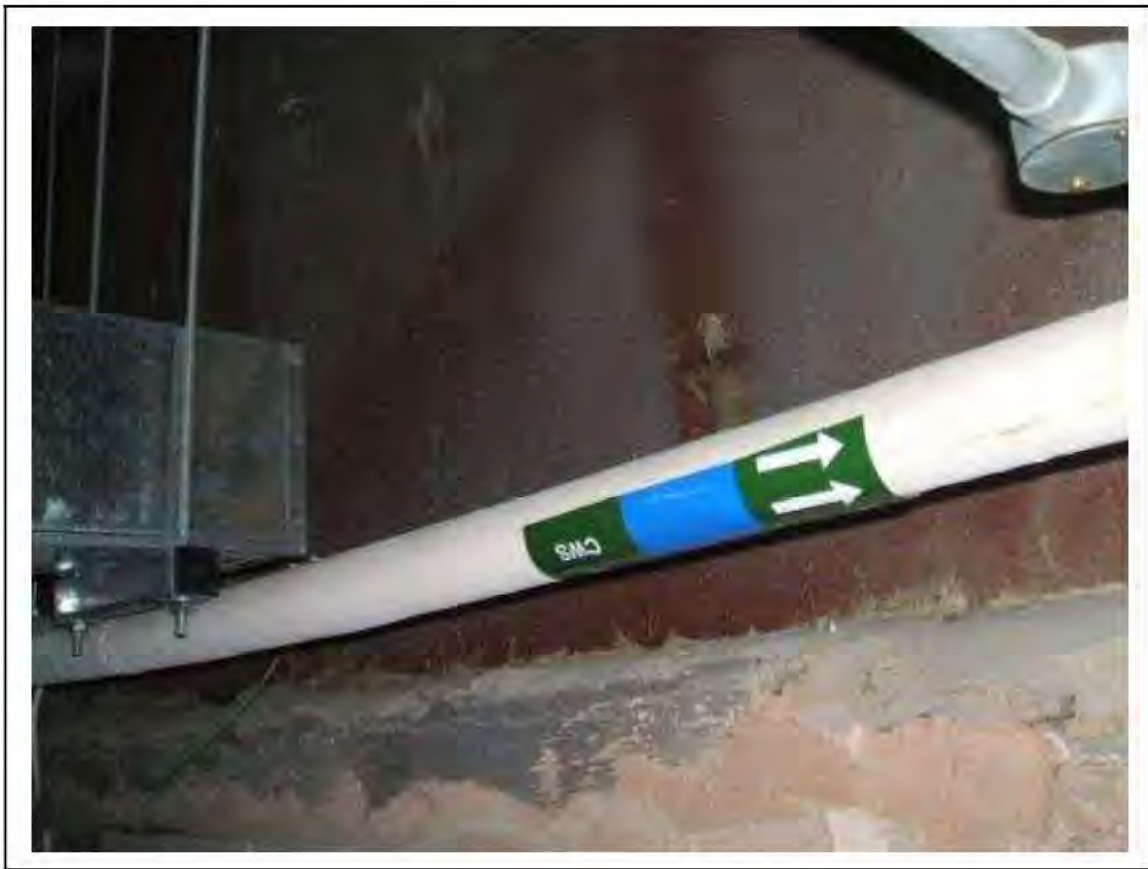
Sample Number	P1&2(39)
Location	Female W/C, 2/416
Material Description	Possible residue
Material Comment	Within cavity behind inner wall to external wall
Quantity	-
Product Type	-
Current Condition	-
Surface Treatment	-
Asbestos Type	Presumed Amosite & Chrysotile
Material Assessment Rating	-
Accessibility	
Further Comment	Not applicable

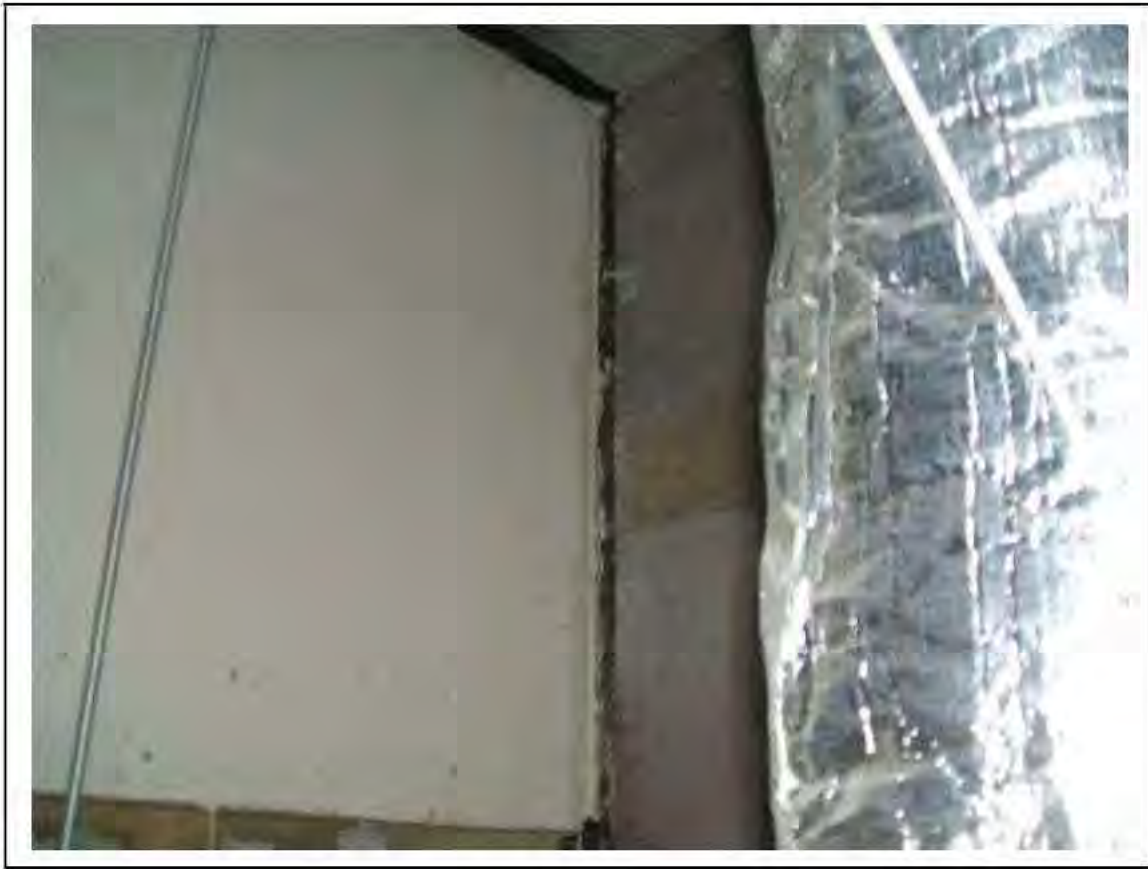
Sample Number	P1&2(41)
Location	Male W/C, 2/417
Material Description	Possible residues
Material Comment	Beam where it passes into wall then over escalator
Quantity	-
Product Type	-
Current Condition	-
Surface Treatment	-
Asbestos Type	Presumed Amosite & Chrysotile
Material Assessment Rating	-
Accessibility	
Further Comment	Not applicable

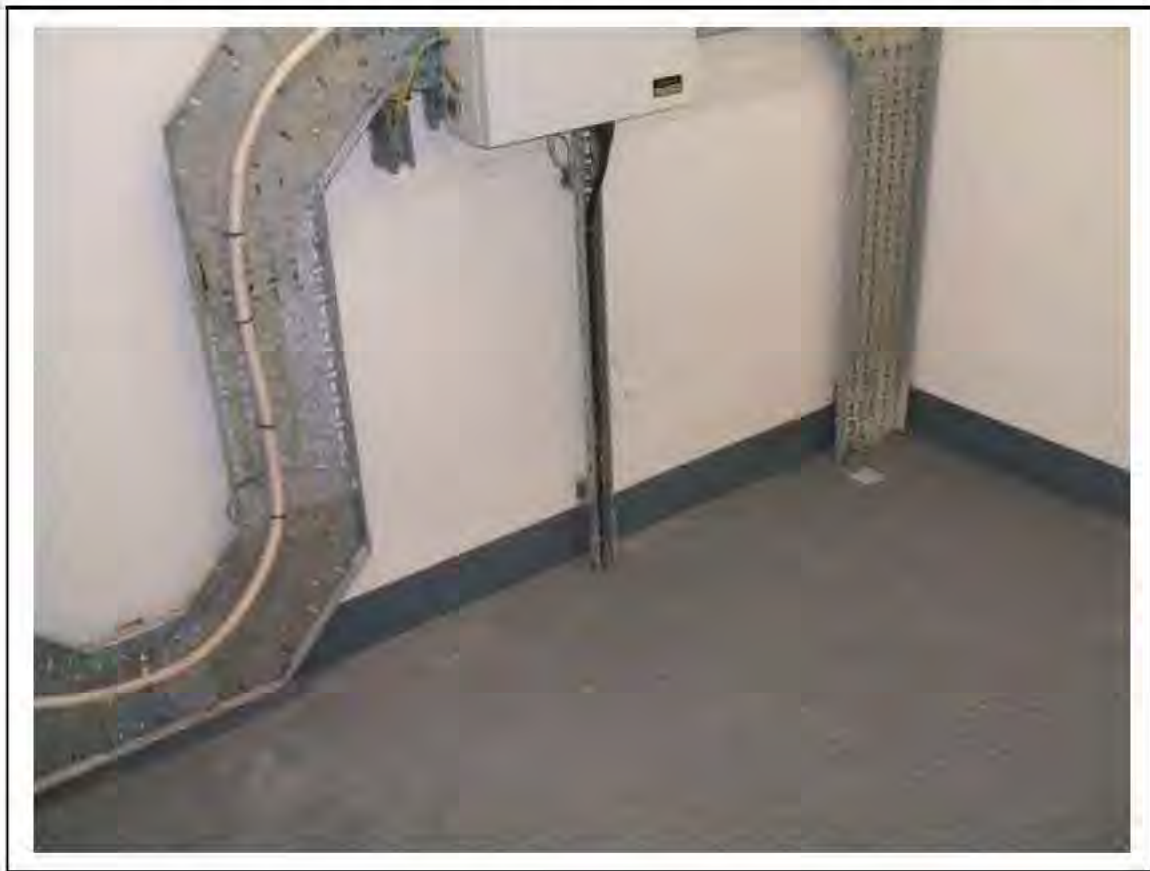
Sample Number	P1(6)
Location	Switch Room E1, 2/661
Material Description	Ducts
Material Comment	Possible ducts in floor
Quantity	-
Product Type	-
Current Condition	-
Surface Treatment	-
Asbestos Type	Presumed Chrysotile
Material Assessment Rating	-
Accessibility	
Further Comment	Not applicable

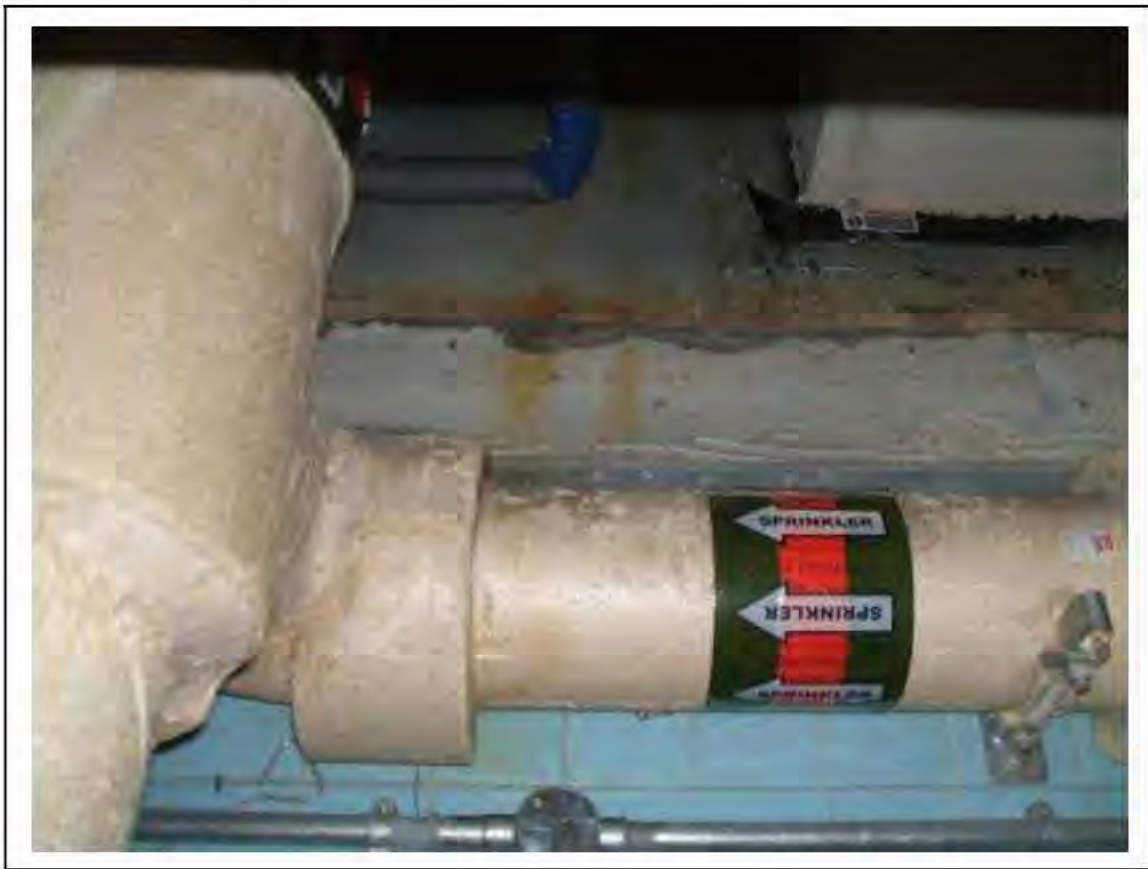
Sample Number	P1&2(47)
Location	Service Void , 2/901
Material Description	Possible residues within external wall
Material Comment	Behind the inner external wall
Quantity	-
Product Type	-
Current Condition	-
Surface Treatment	-
Asbestos Type	Presumed Amosite & Chrysotile
Material Assessment Rating	-
Accessibility	
Further Comment	Not applicable

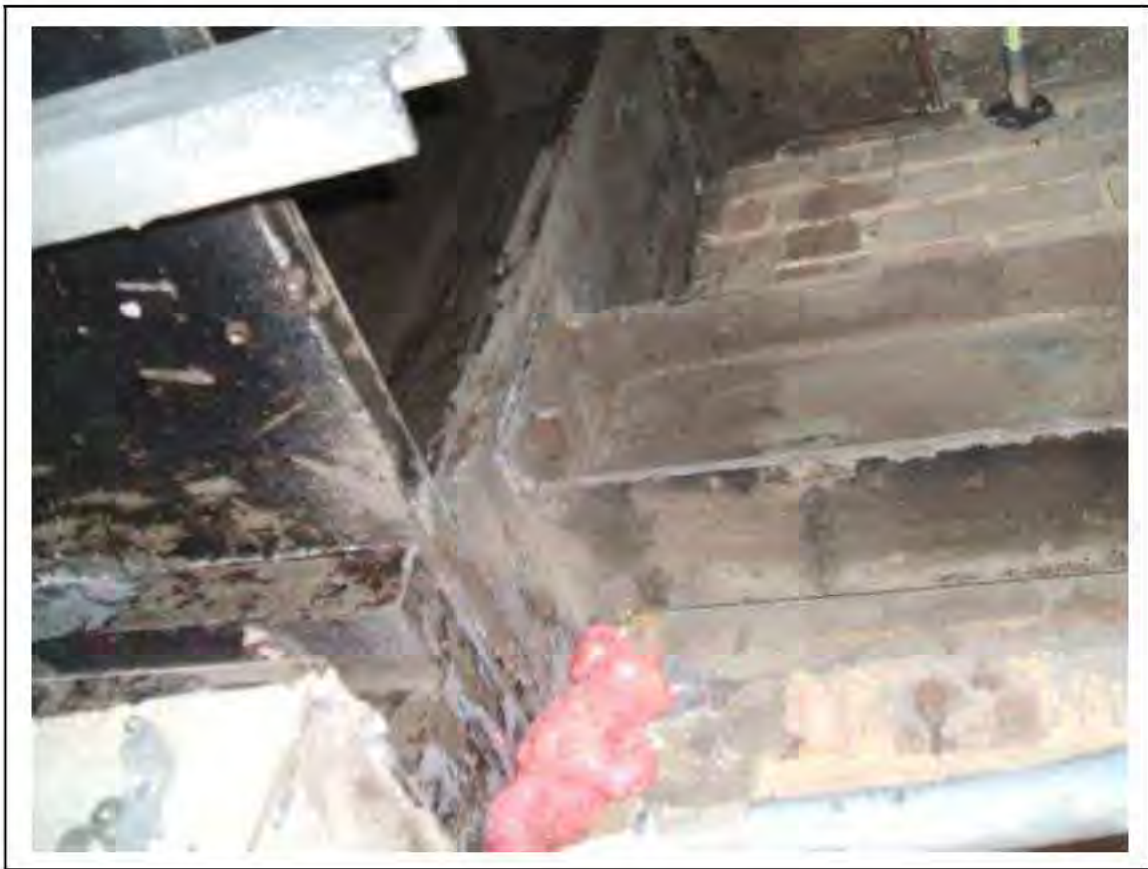
Sample Number	P1&2(51)
Location	Vent Access , 2/953
Material Description	Potential residues in void by beam S12
Material Comment	Where it goes into corridor
Quantity	-
Product Type	-
Current Condition	-
Surface Treatment	-
Asbestos Type	Presumed Amosite & Chrysotile
Material Assessment Rating	-
Accessibility	
Further Comment	Not applicable

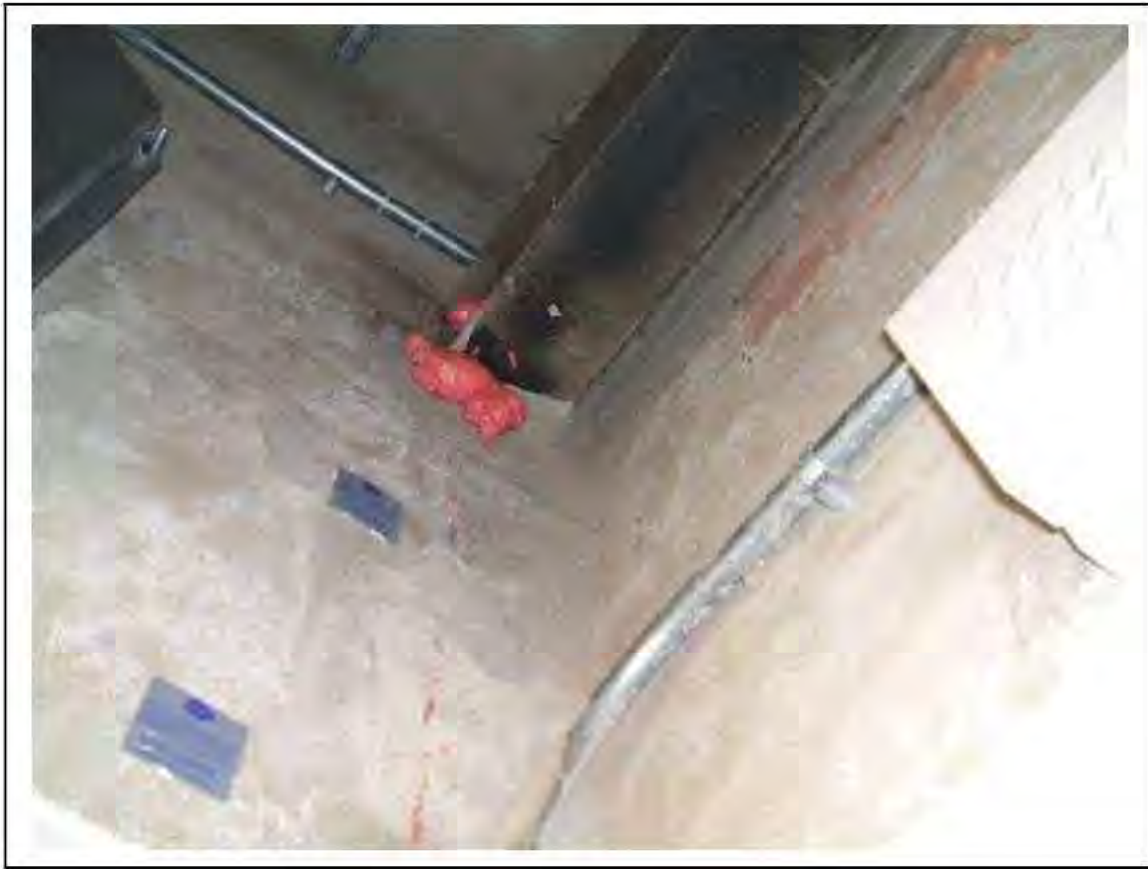
Sample Number	P1&2(52)
Location	Vent Access , 2/953
Material Description	Potential residues
Material Comment	In wall where small beam goes into void above escalator
Quantity	-
Product Type	-
Current Condition	-
Surface Treatment	-
Asbestos Type	Presumed Amosite & Chrysotile
Material Assessment Rating	-
Accessibility	
Further Comment	Not applicable

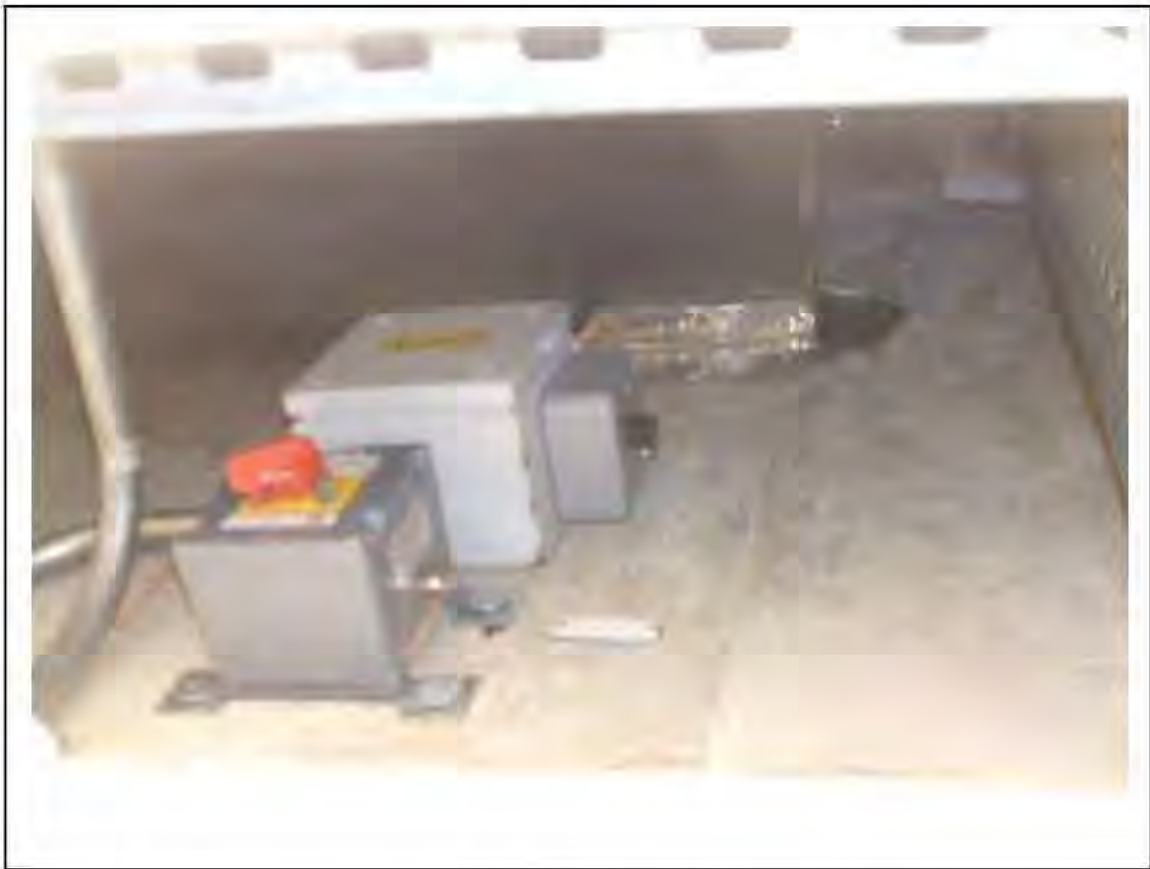
Sample Number	P1&2(53)
Location	Vent Access , 2/953
Material Description	Possible residues
Material Comment	In wall where S12 passes through wall to over escalator incline
Quantity	-
Product Type	-
Current Condition	-
Surface Treatment	-
Asbestos Type	Presumed Amosite & Chrysotile
Material Assessment Rating	-
Accessibility	
Further Comment	Not applicable

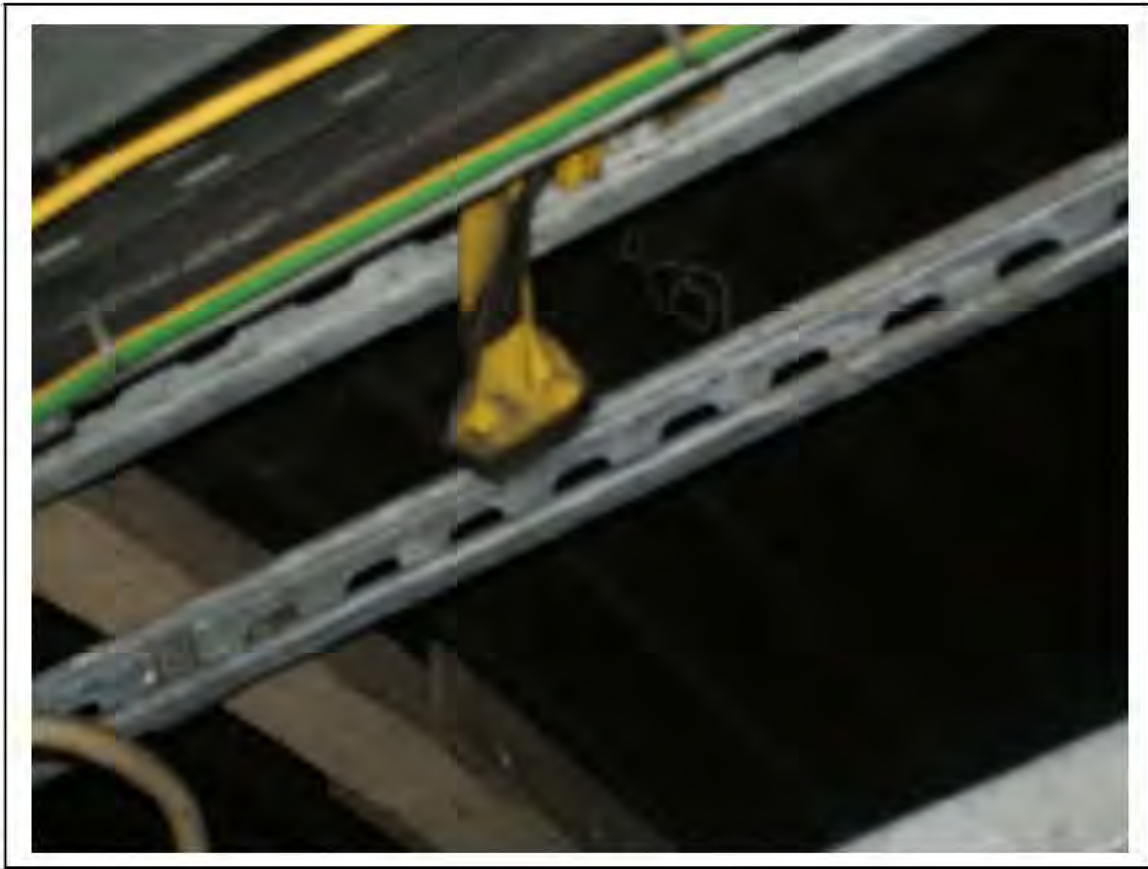
Sample Number	K1(10)
Location	Lower Concourse , 3/081
Material Description	Cellactite
Material Comment	Above false ceiling
Quantity	100m ²
Product Type	Composite
Current Condition	Good condition
Surface Treatment	Composite
Asbestos Type	Known Chrysotile
Material Assessment Rating	Very low
Accessibility	Low
Further Comment	Not applicable

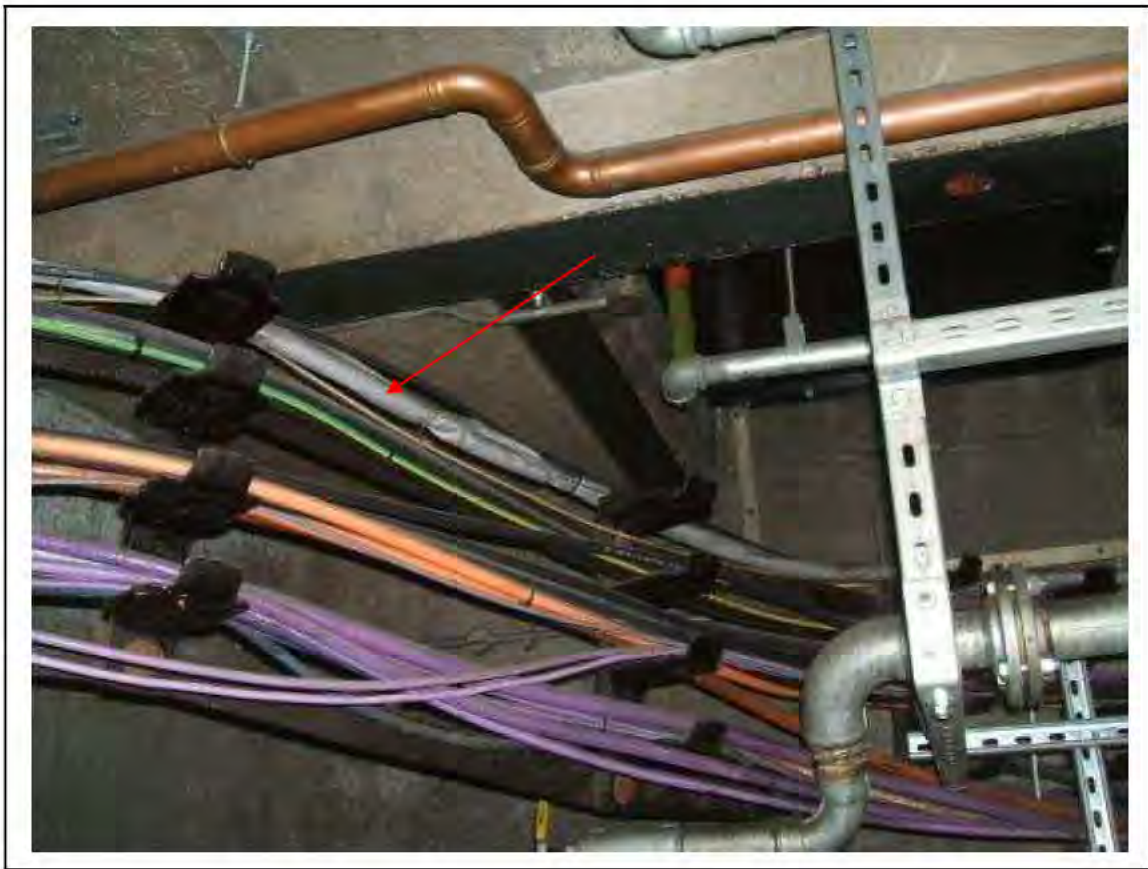
Sample Number	K1(12)
Location	LMC, 3/161
Material Description	Braided cables
Material Comment	Encapsulated in alphameritex
Quantity	10lm
Product Type	Medium density
Current Condition	Slight damage
Surface Treatment	Encapsulated medium density
Asbestos Type	Known Chrysotile
Material Assessment Rating	Low
Accessibility	Low
Further Comment	Not applicable

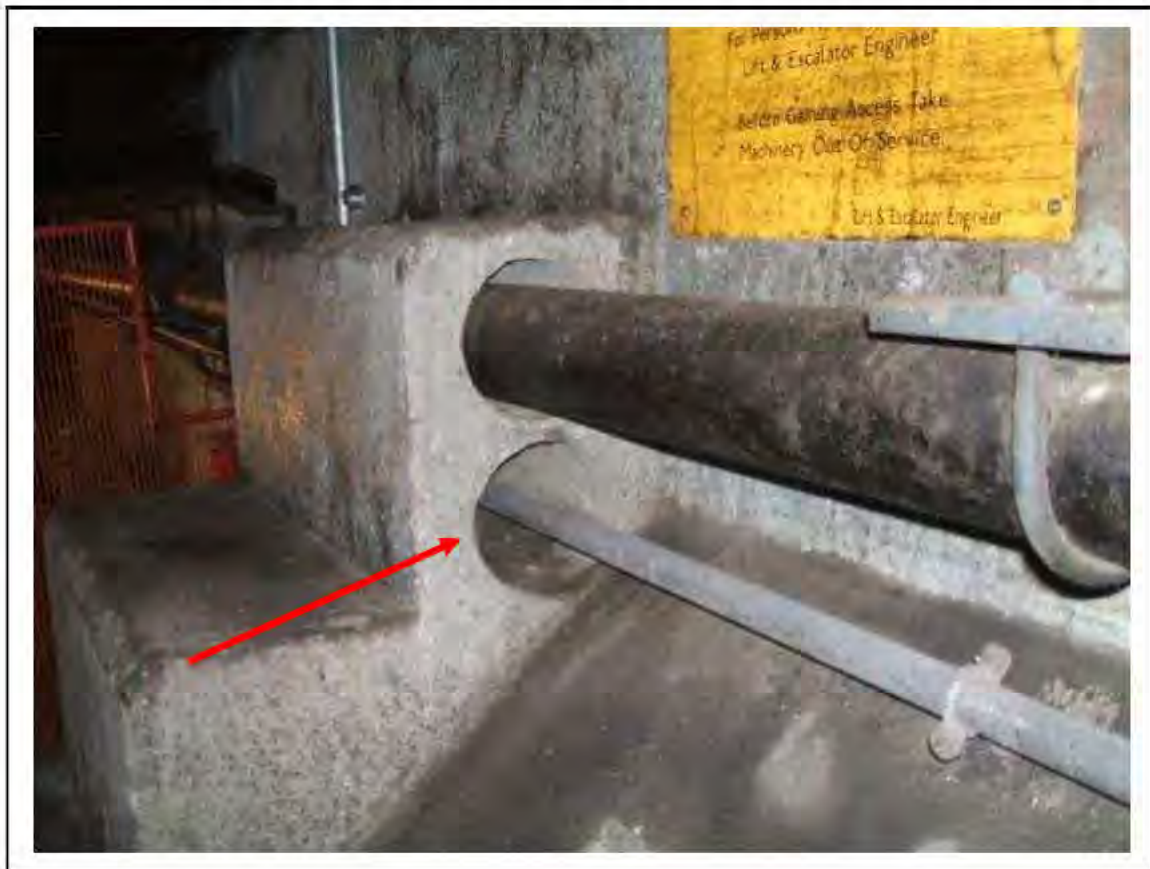
Sample Number	120445/130812/1
Location	LMC, 3/161
Material Description	Ducts
Material Comment	To iron pipes
Quantity	2
Product Type	Composite
Current Condition	Slight damage
Surface Treatment	Encapsulated medium density
Asbestos Type	Chrysotile
Material Assessment Rating	Very low
Accessibility	Low
Further Comment	Not applicable

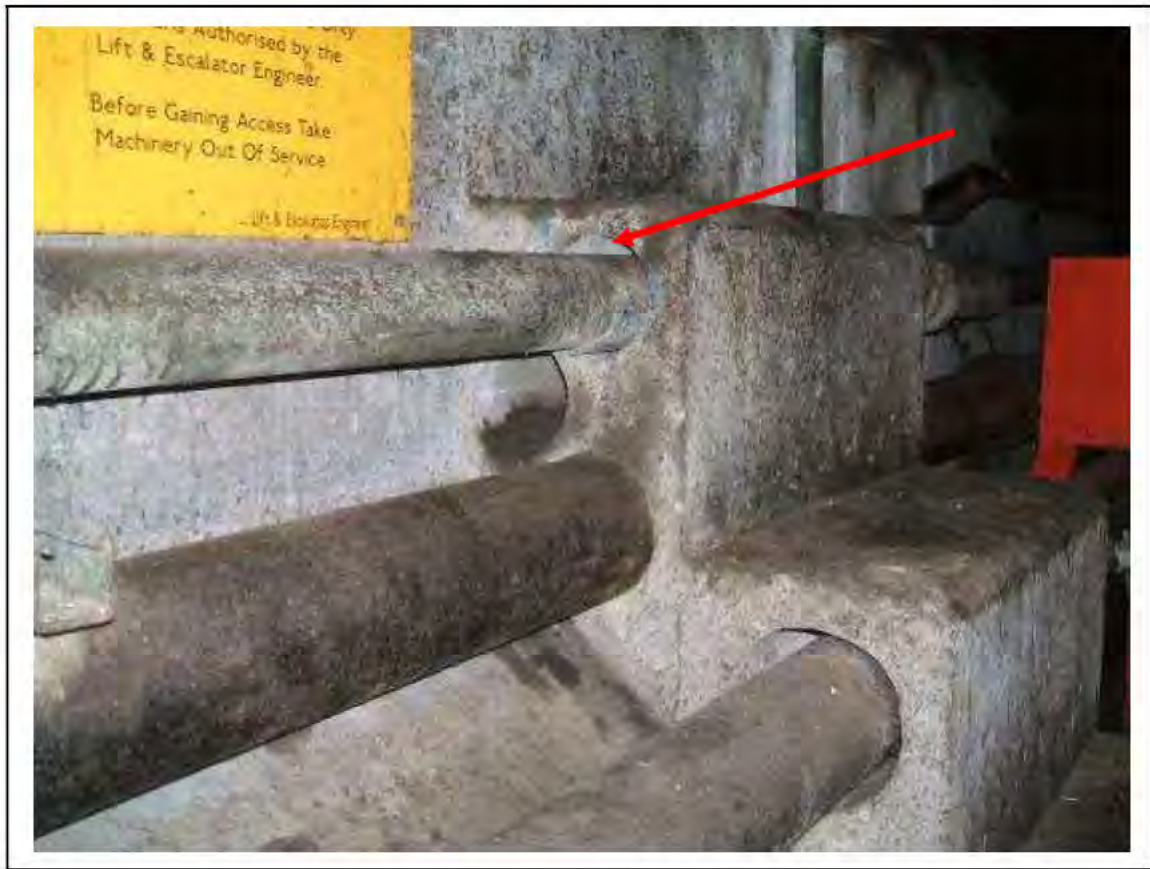
Sample Number	Same as 120445/130812/1
Location	LMC, 3/161
Material Description	Ducts
Material Comment	To iron pipes
Quantity	3
Product Type	Composite
Current Condition	Slight damage
Surface Treatment	Encapsulated medium density
Asbestos Type	Chrysotile
Material Assessment Rating	Very low
Accessibility	Low
Further Comment	Not applicable

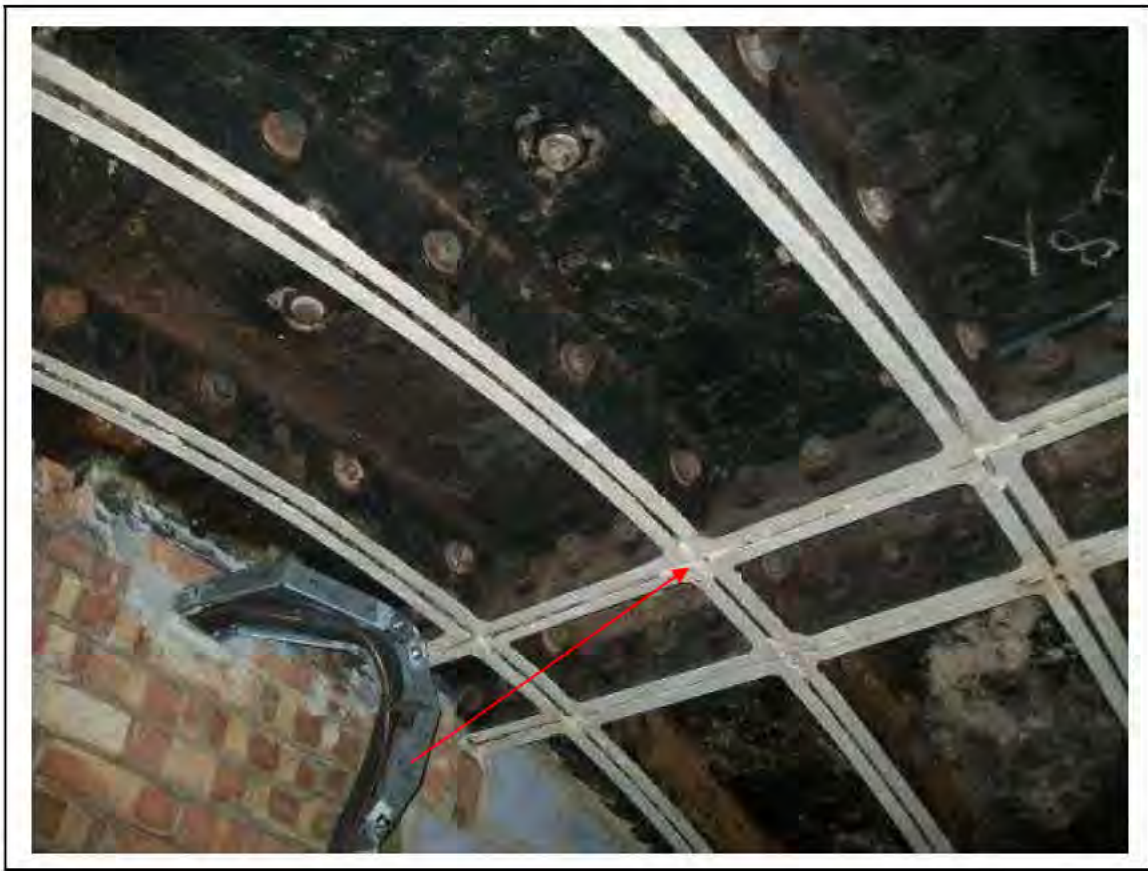
Sample Number	As 120445/150812/03
Location	Passage , 3/207
Material Description	Caulking
Material Comment	Seen where cellactite removed/not present
Quantity	throughout
Product Type	Medium density
Current Condition	Good condition
Surface Treatment	Encapsulated medium density
Asbestos Type	Amosite & Chrysotile
Material Assessment Rating	Low
Accessibility	Low
Further Comment	Not applicable

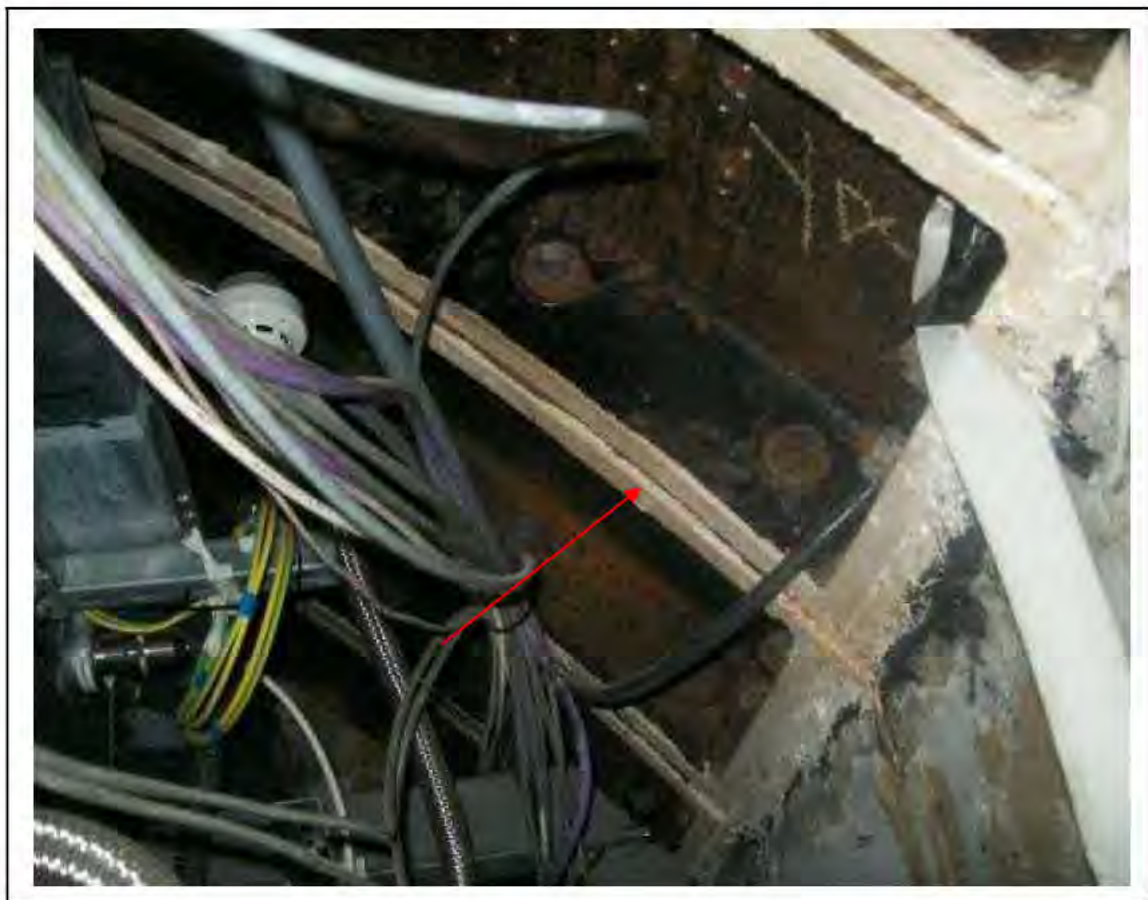
Sample Number	Same as 120445/150812/03
Location	Corridor, 3/237
Material Description	Caulking
Material Comment	Tunnel ring flanges within false ceiling
Quantity	throughout
Product Type	Medium density
Current Condition	Slight damage
Surface Treatment	Encapsulated medium density
Asbestos Type	Amosite and Chrysotile
Material Assessment Rating	Low
Accessibility	Low
Further Comment	Not applicable

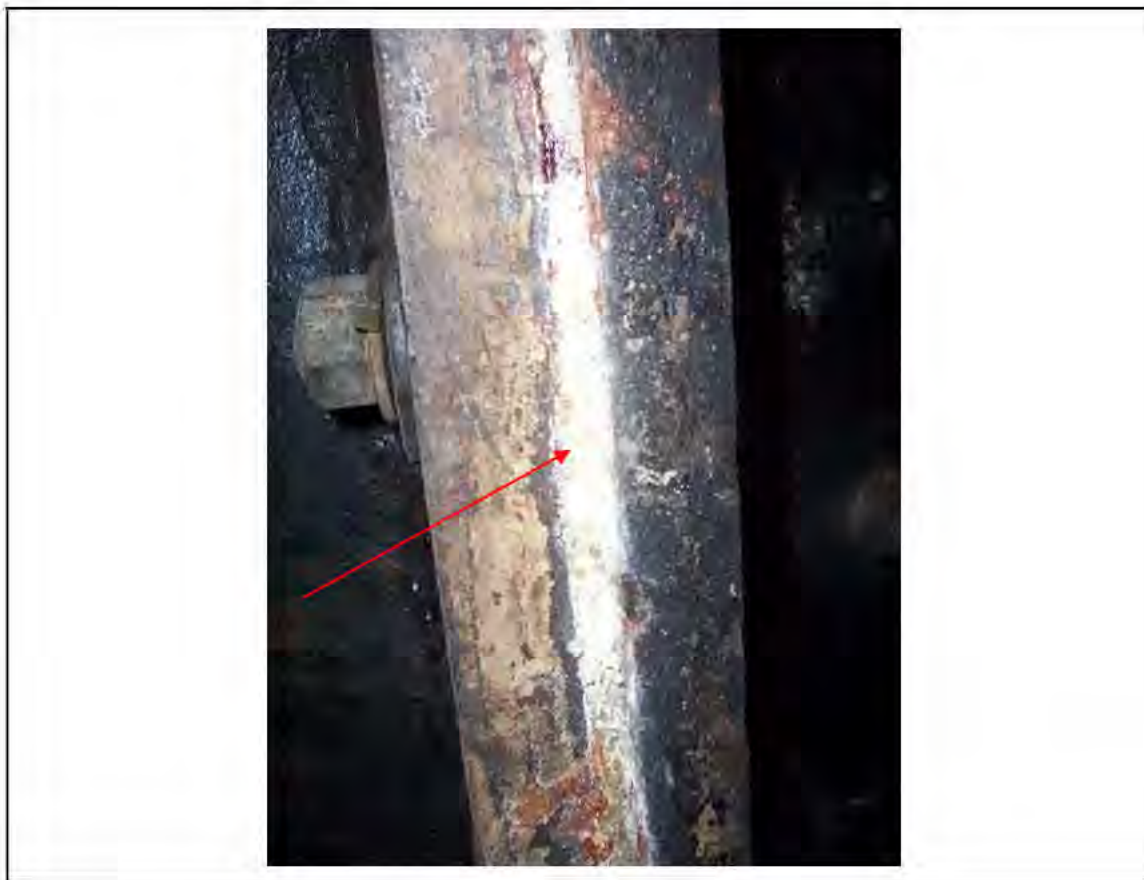
Sample Number	061128/24SPH
Location	Platforms 1 & 2, 3/261 & 3/262
Material Description	Caulking
Material Comment	-
Quantity	throughout
Product Type	Medium density
Current Condition	-
Surface Treatment	Unencapsulated medium density
Asbestos Type	Amosite
Material Assessment Rating	Low
Accessibility	Low
Further Comment	Not applicable

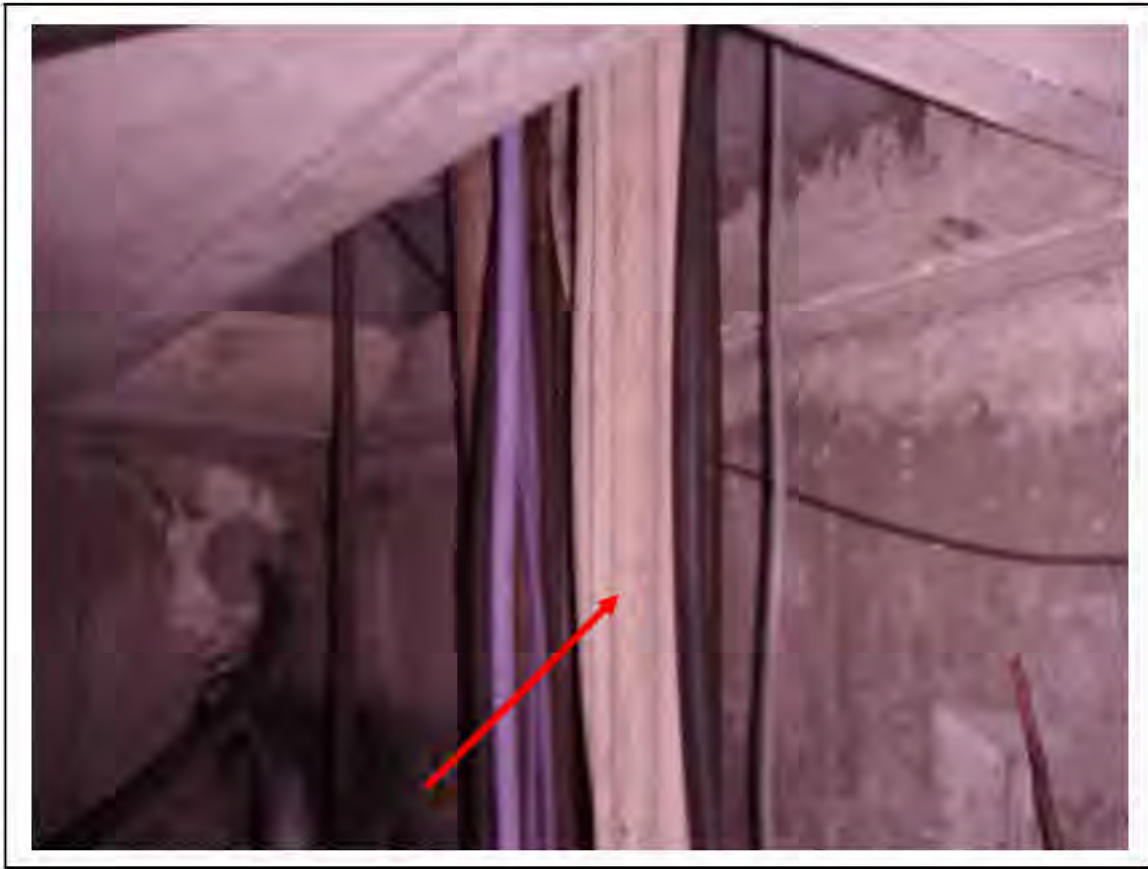
Sample Number	K1(25)
Location	Victoria Line, Platform 1, 3/261, Down hatch near 3/711
Material Description	Cables
Material Comment	Pit side along invert
Quantity	3x5cm Ø 3x2cm Ø 4x0.5cm Ø Approx 150m length)
Product Type	Medium density
Current Condition	Good condition
Surface Treatment	Unencapsulated medium density
Asbestos Type	Known Chrysotile
Material Assessment Rating	Low
Accessibility	Low
Further Comment	Not applicable

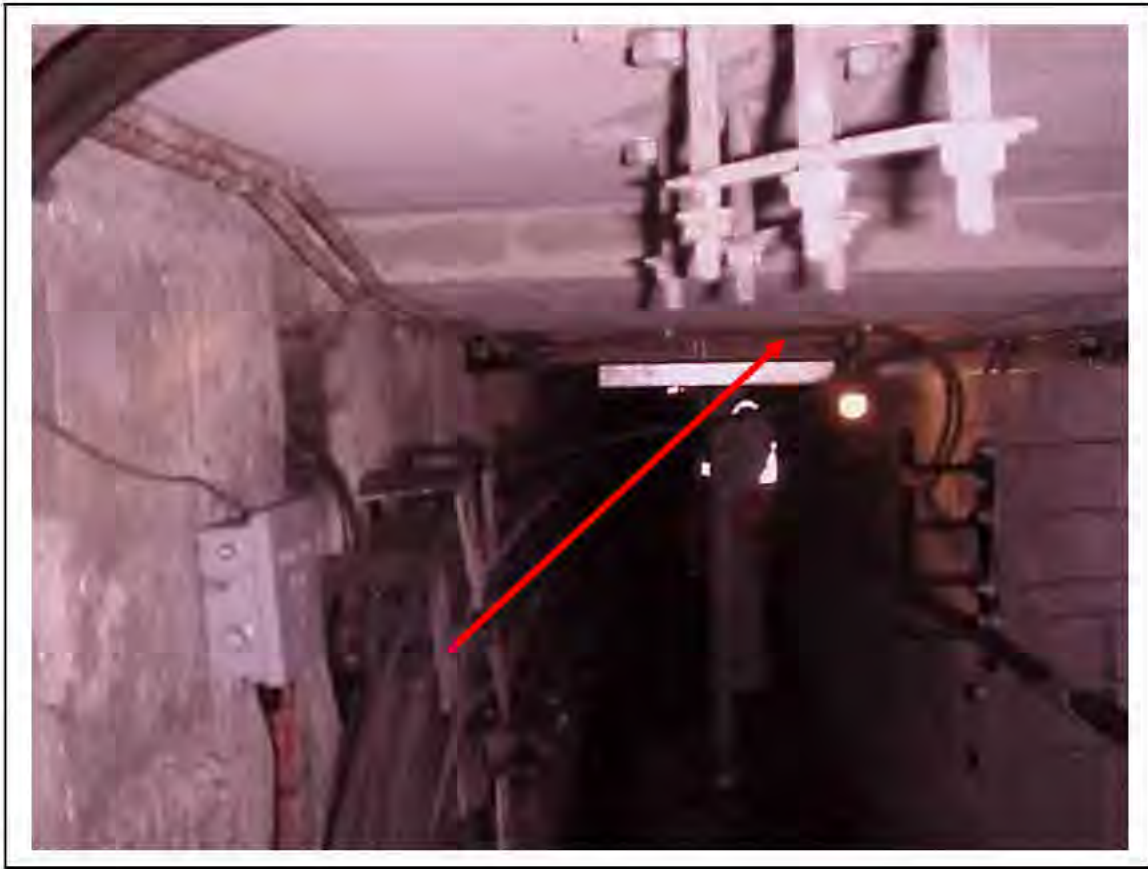
Sample Number	K1(26)
Location	Victoria Line, Platform 1, 3/261, Down hatch near 3/711
Material Description	Cable
Material Comment	From cable sleeves cross running hangers along
Quantity	2x1 cm Ø
Product Type	Medium density
Current Condition	Good condition
Surface Treatment	Unencapsulated medium density
Asbestos Type	Known Chrysotile
Material Assessment Rating	Low
Accessibility	Low
Further Comment	Not applicable

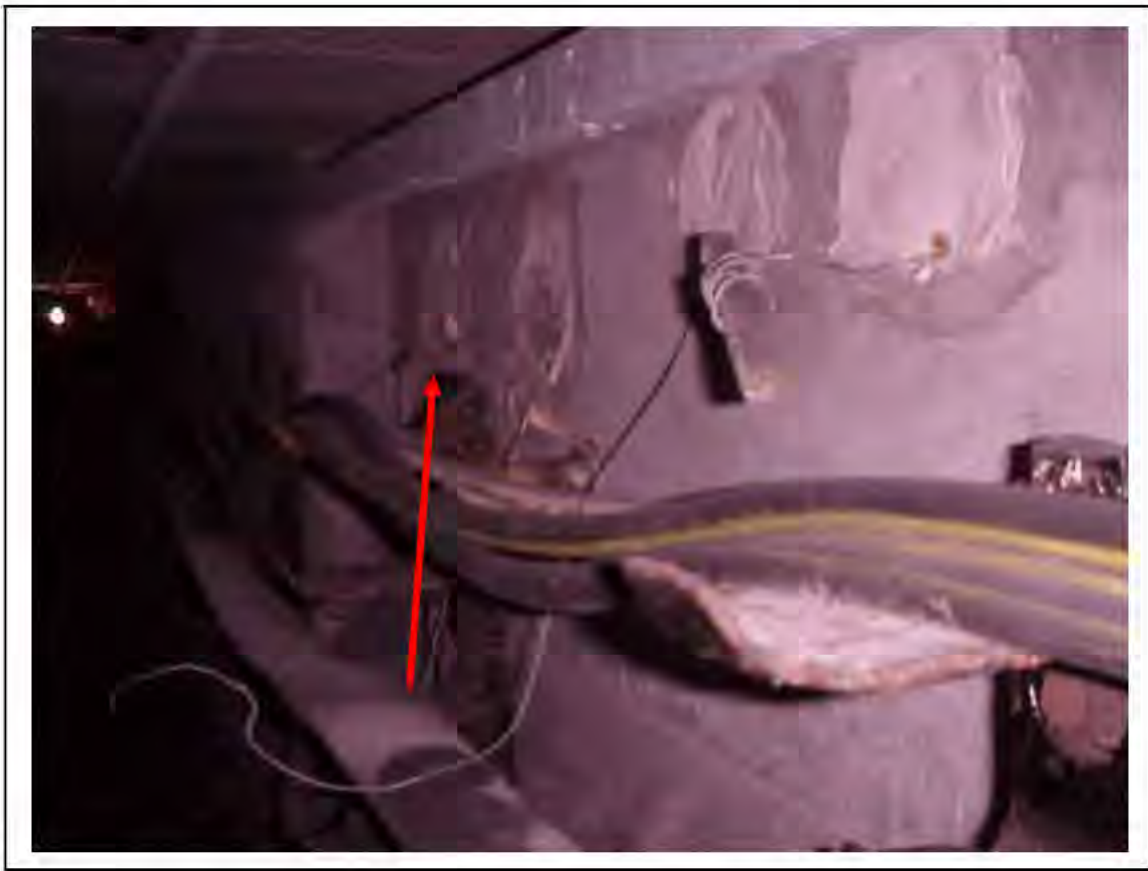
Sample Number	P1(8)
Location	Victoria Line, Platform 1, 3/261, 30m up
Material Description	Cable sleeves
Material Comment	Platform side, filled in
Quantity	x20
Product Type	-
Current Condition	-
Surface Treatment	-
Asbestos Type	Presumed Chrysotile
Material Assessment Rating	-
Accessibility	
Further Comment	Not applicable

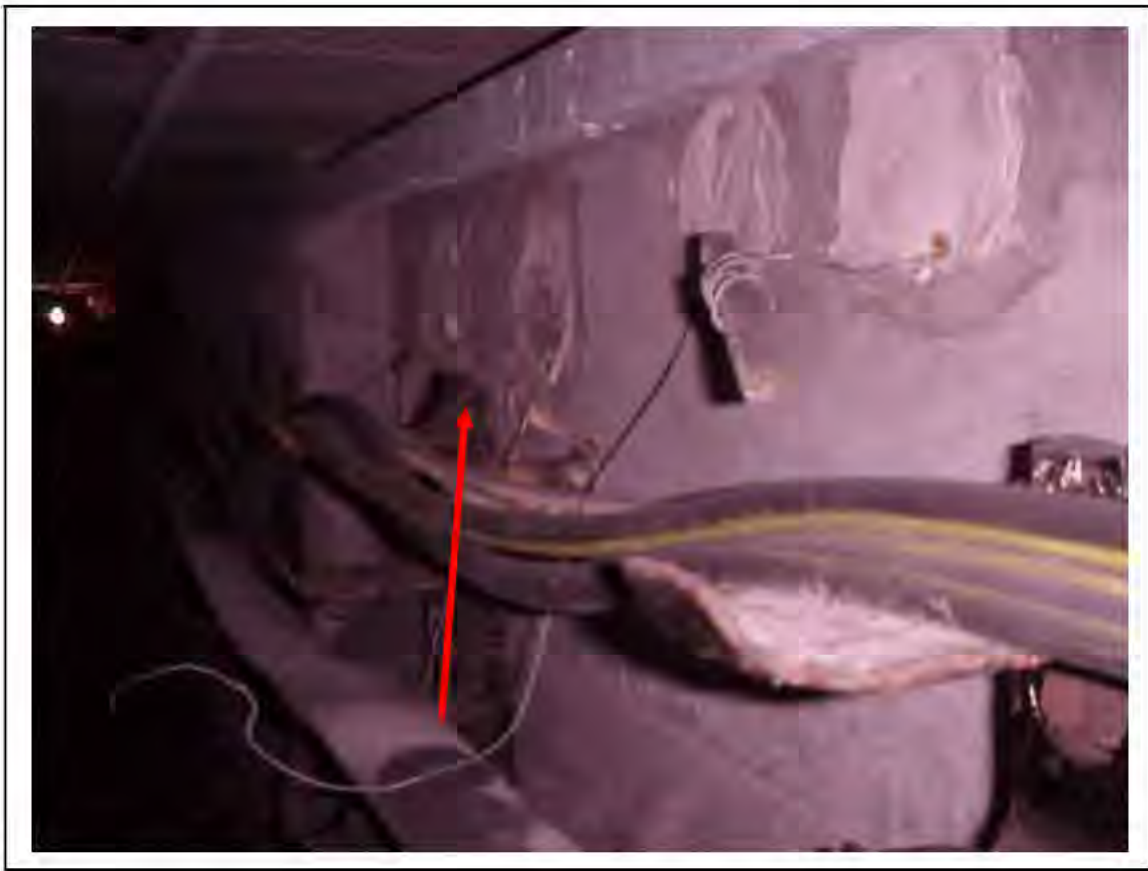
Sample Number	K1(27)
Location	Victoria Line, Platform 1, 3/261, 30m up
Material Description	Cables
Material Comment	Going into cable sleeves
Quantity	2x1 cm Ø
Product Type	Medium density
Current Condition	Good condition
Surface Treatment	Unencapsulated medium density
Asbestos Type	Known Chrysotile
Material Assessment Rating	Low
Accessibility	Low
Further Comment	Not applicable

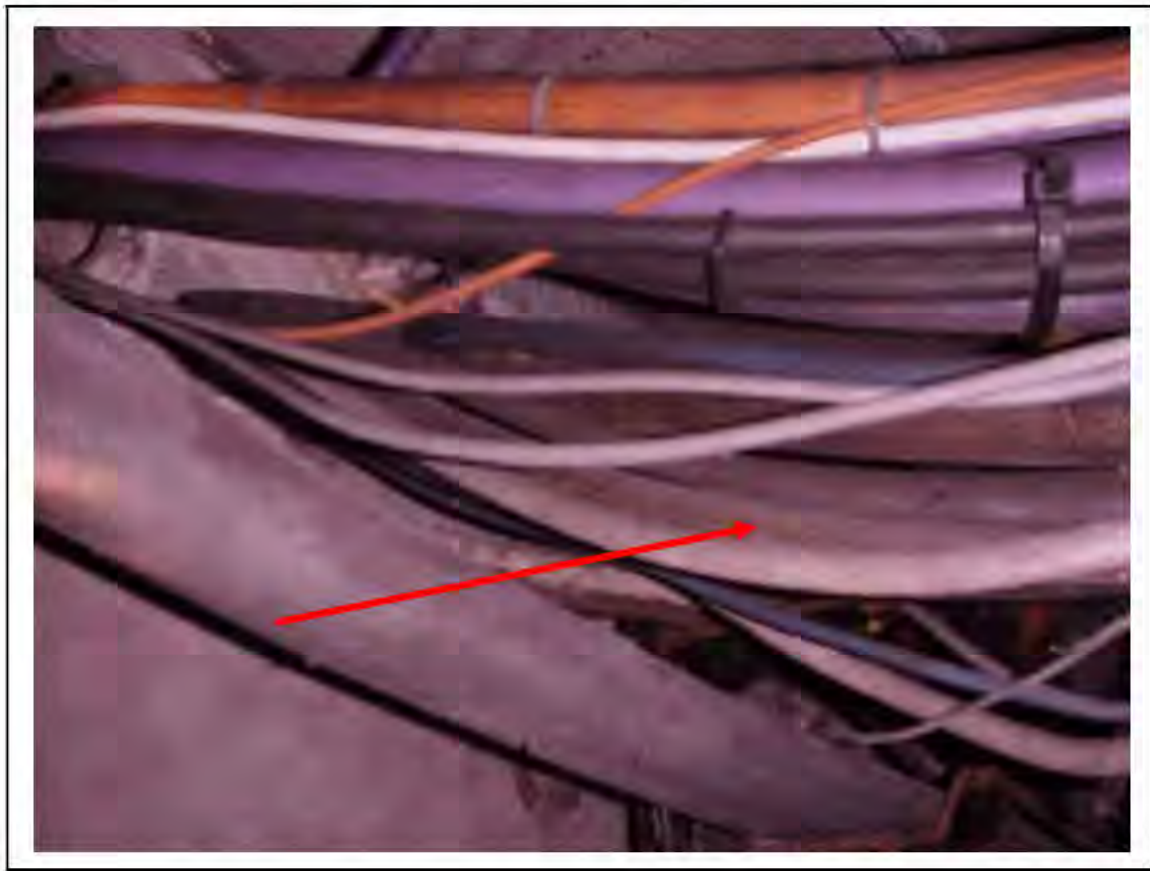
Sample Number	K1(28)
Location	Victoria Line, Platform 1, 3/261, 30m up
Material Description	Cables
Material Comment	Across from pit side to platform side
Quantity	2x1 cm Ø
Product Type	Medium density
Current Condition	Good condition
Surface Treatment	Unencapsulated medium density
Asbestos Type	Known Chrysotile
Material Assessment Rating	Low
Accessibility	Low
Further Comment	Not applicable

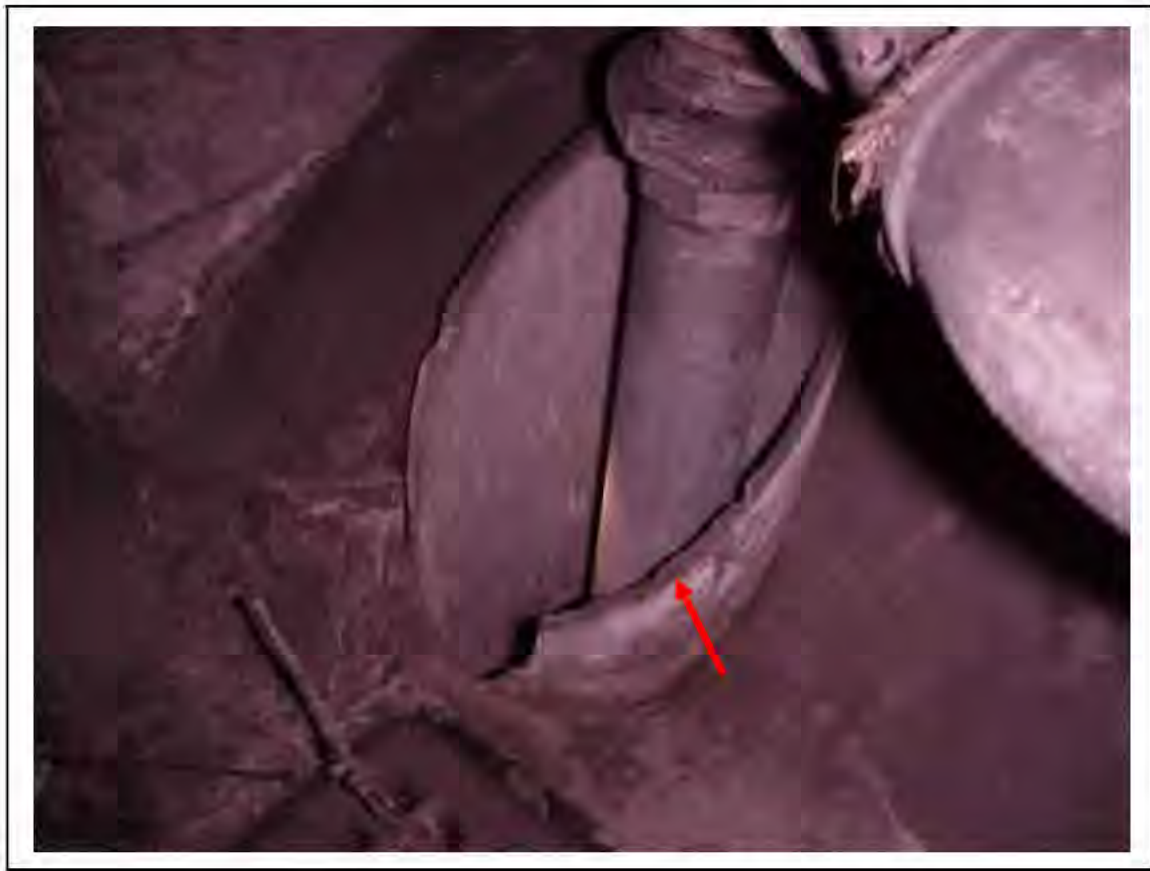
Sample Number	034219/10
Location	Victoria Line, Platform 1, 3/261, 10m on half way
Material Description	Cable sleeves
Material Comment	-
Quantity	x1
Product Type	Composite
Current Condition	Extensive damage
Surface Treatment	Composite
Asbestos Type	Chrysotile
Material Assessment Rating	Low
Accessibility	Low
Further Comment	Not applicable

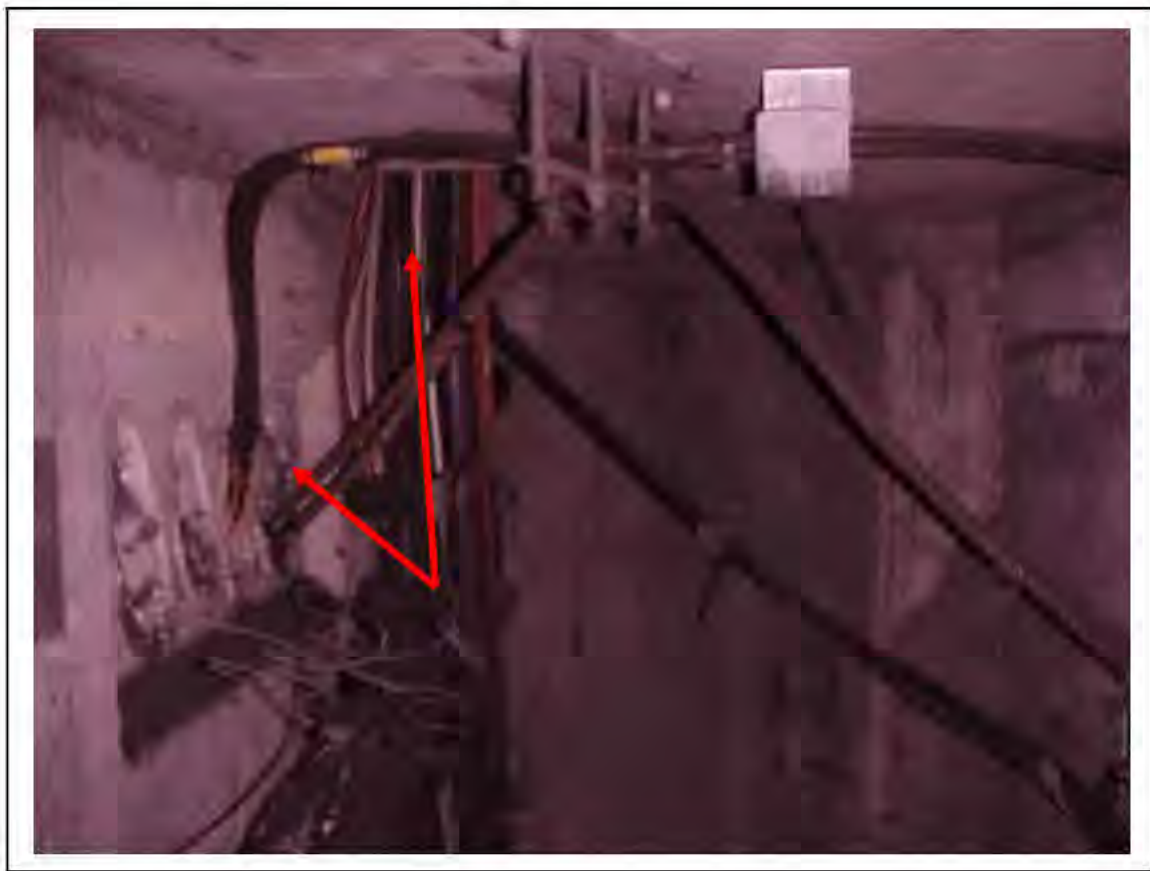
Sample Number	K1(29)
Location	Victoria Line, Platform 1, 3/261, Other end 3/706
Material Description	Cables
Material Comment	Going through other end, two from platform side cross invert
Quantity	x4
Product Type	Composite
Current Condition	Good condition
Surface Treatment	Composite
Asbestos Type	Known Chrysotile
Material Assessment Rating	Very low
Accessibility	Low
Further Comment	Not applicable
