Hazardous Materials - TfL Engineering

Re-inspection Sign-Off for Brixton

Re-inspection Reference: V059/4RS-200403

Station	Brixton
Original Management Survey	R346601
Date of Original Management	31st August 2012
Re-inspection Reference:	V059-4RS-200403
Next Planned Re-inspection	Periodical re-inspection according to HM Management Plan

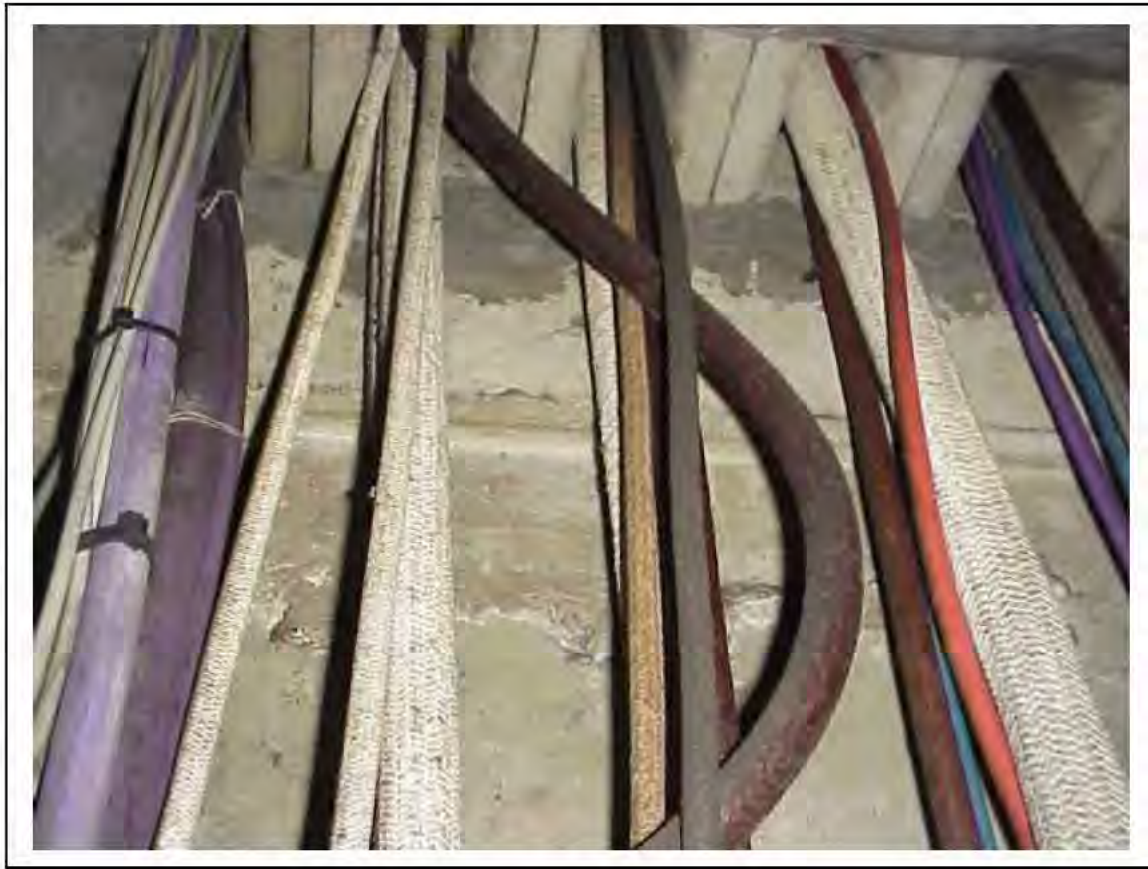
Sample Number	K1(30)
Location	Victoria Line, Platform 2, 3/262, Down hatch near 3/712
Material Description	Cables
Material Comment	From ceiling near head wall pit side along invert
Quantity	4x5cm Ø, 4x2cmØ, 4x1cmØ 4x2cm Ø 4x1cm Ø
Product Type	Medium density
Current Condition	Good condition
Surface Treatment	Unencapsulated medium density
Asbestos Type	Known Chrysotile
Material Assessment Rating	Low
Accessibility	Low
Further Comment	Not applicable

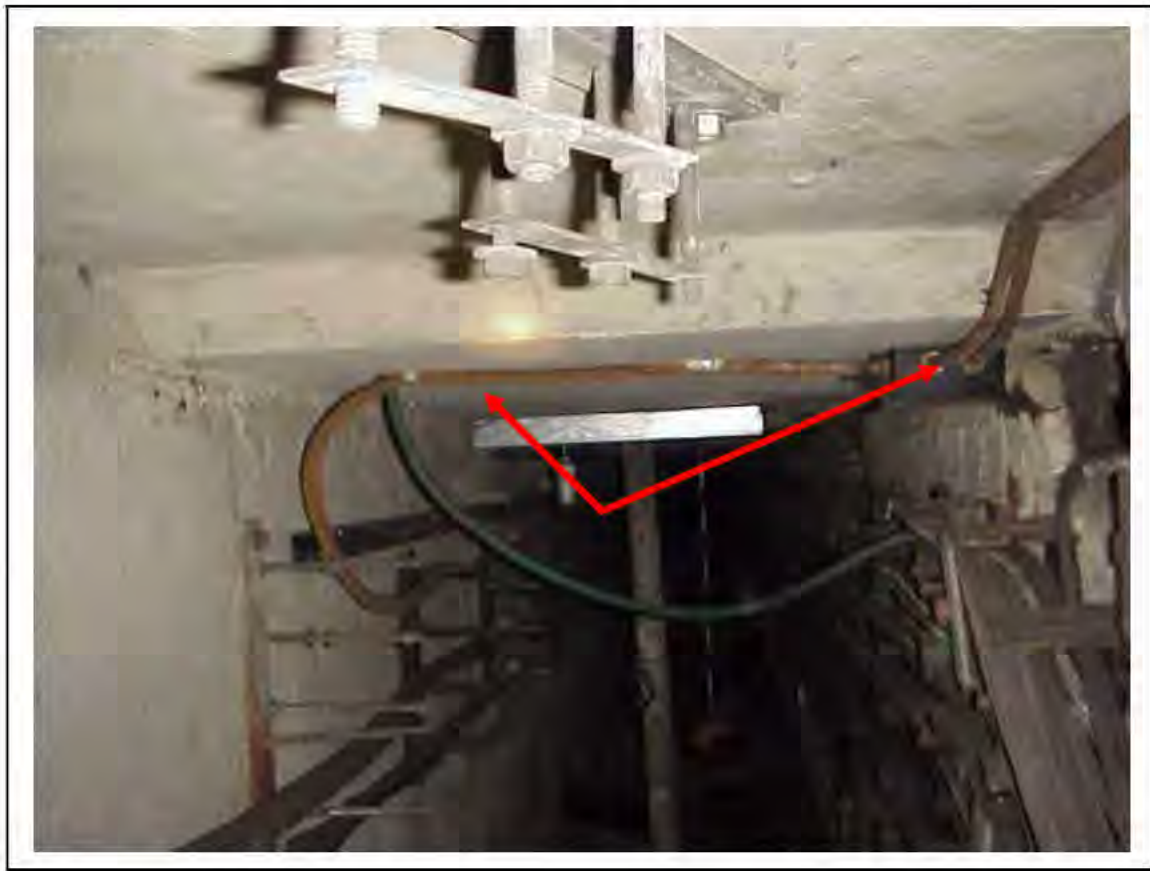
Sample Number	K1(31)
Location	Victoria Line, Platform 2, 3/262, Down hatch near 3/712
Material Description	Cables
Material Comment	From one cable sleeve pit side in area where stairs cross over to platform side running down
Quantity	2x1.5cm Ø
Product Type	Medium density
Current Condition	Good condition
Surface Treatment	Unencapsulated medium density
Asbestos Type	Known Chrysotile
Material Assessment Rating	Low
Accessibility	Low
Further Comment	Not applicable

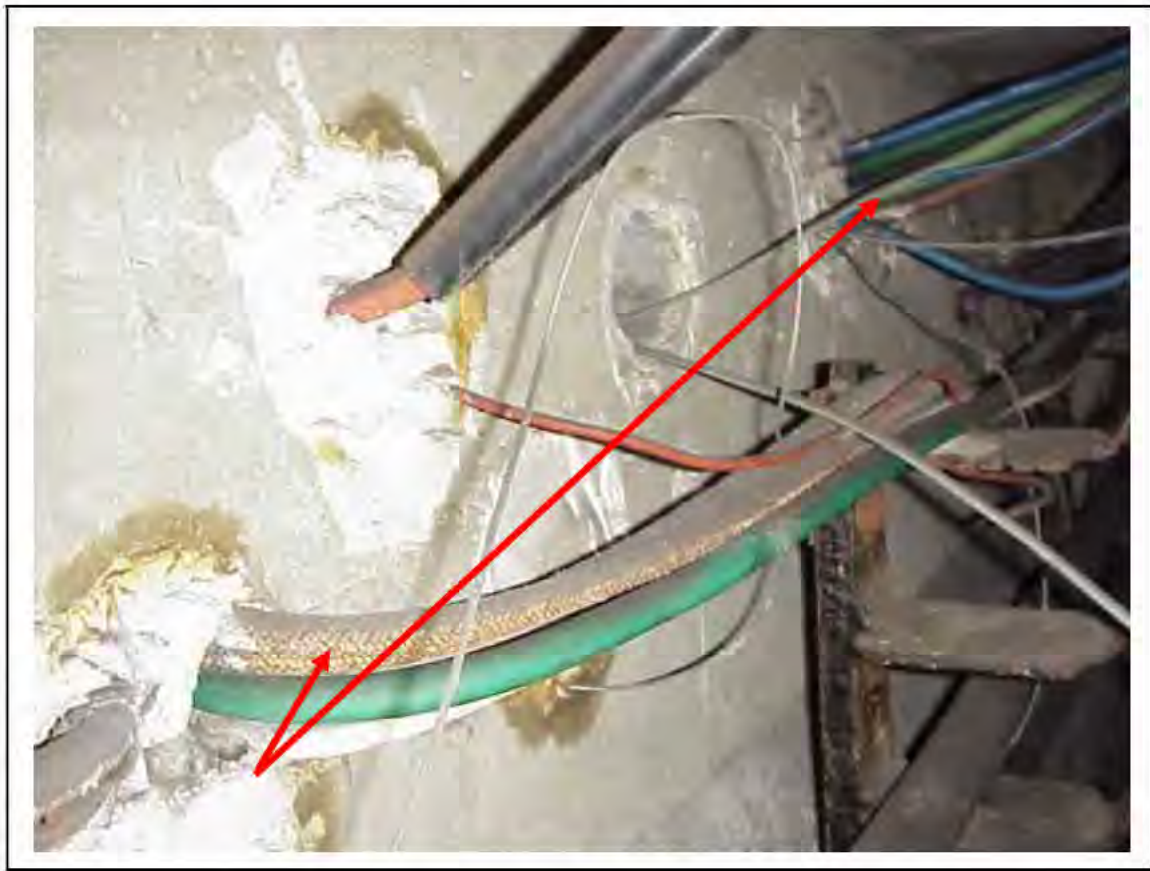
Sample Number	K1(32)
Location	Victoria Line, Platform 2, 3/262, 15m down
Material Description	Cables
Material Comment	From 3/712 coming out on platform side cross from other end
Quantity	2x1cm Ø, 3x1cmØ, 1x2cmØ 3x1cm Ø 1x2cm Ø
Product Type	Medium density
Current Condition	Good condition
Surface Treatment	Unencapsulated medium density
Asbestos Type	Known Chrysotile
Material Assessment Rating	Low
Accessibility	Low
Further Comment	Not applicable

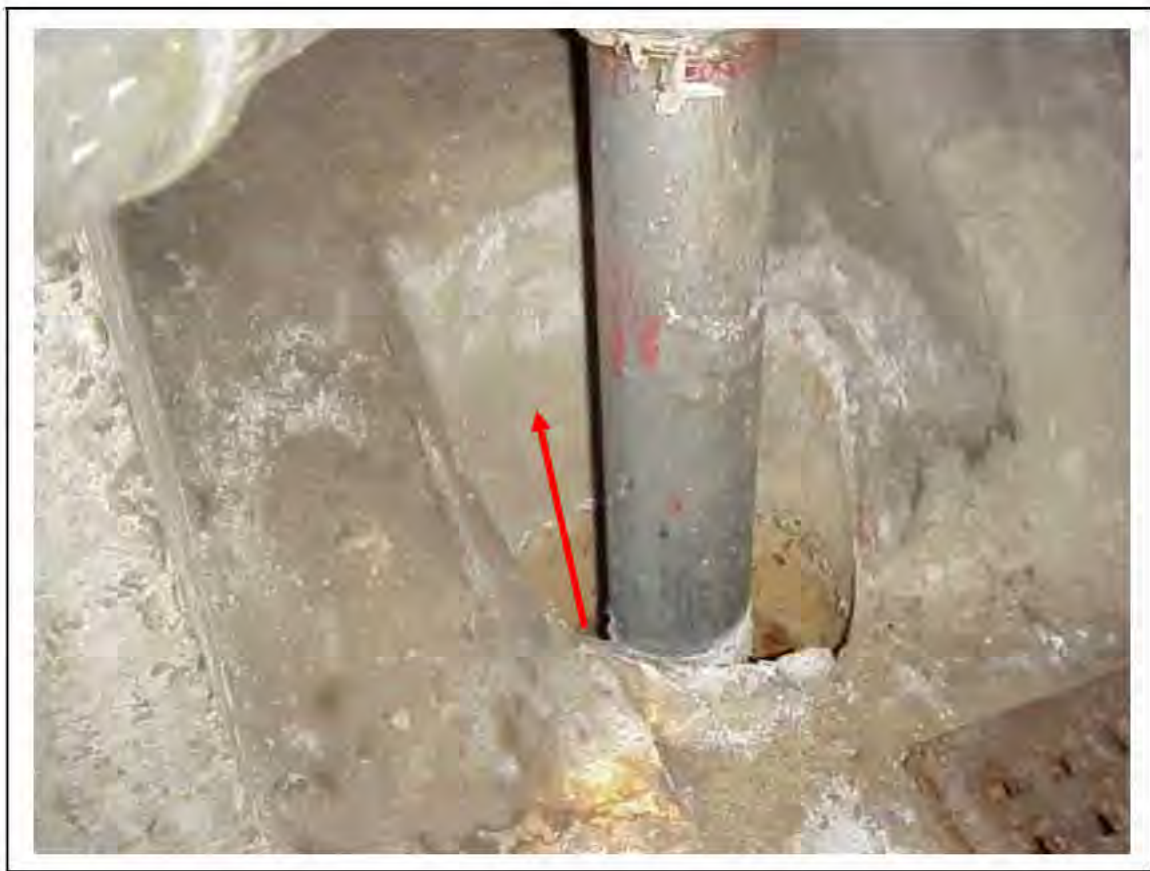
Sample Number	034219/5
Location	Victoria Line, Platform 2, 3/262, 10m on halfway
Material Description	Cable sleeve
Material Comment	On floor, pipe from pump goes through. Comes above floor a foot length
Quantity	1x200cm Ø
Product Type	Composite
Current Condition	Moderate damage
Surface Treatment	Composite
Asbestos Type	Chrysotile
Material Assessment Rating	Very low
Accessibility	Low
Further Comment	Not applicable

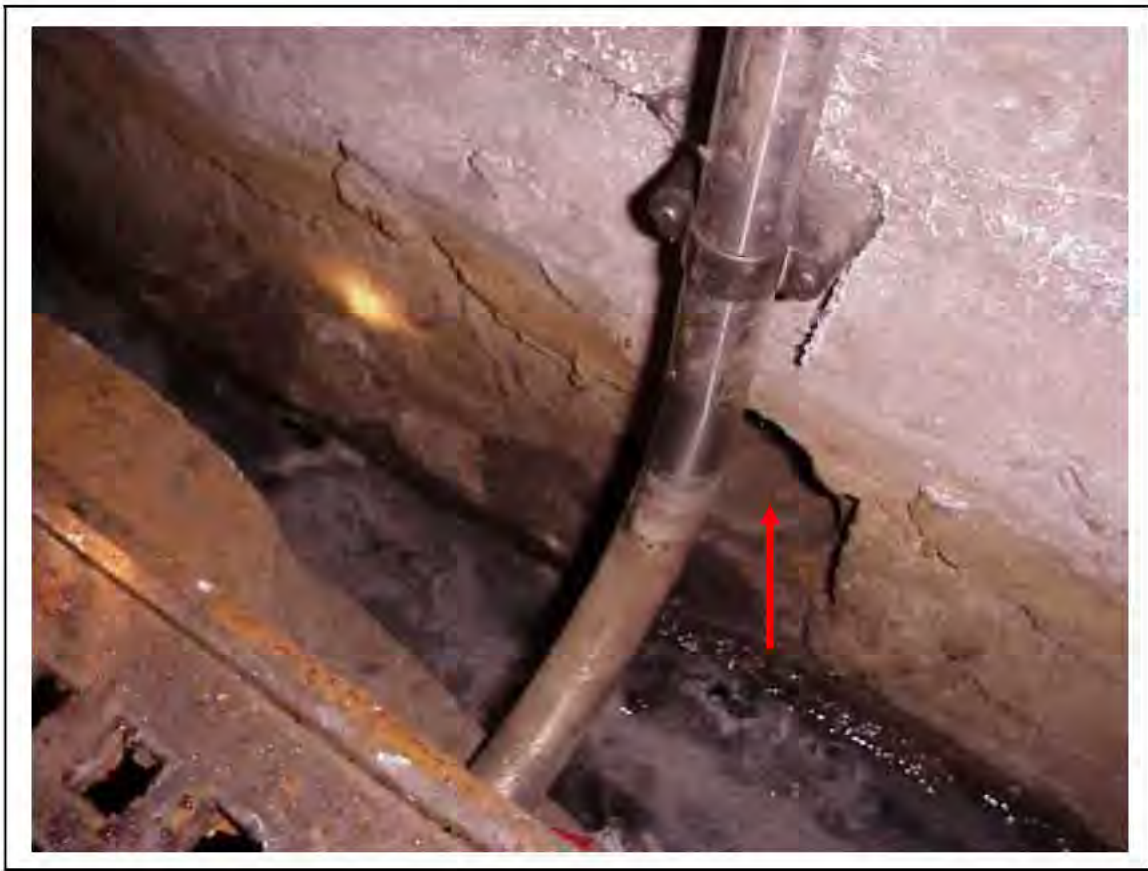
Sample Number	Same as 034219/5
Location	Victoria Line, Platform 2, 3/262, 10m on halfway
Material Description	Cable sleeves
Material Comment	Drainage sleeve to platform track
Quantity	x1
Product Type	Composite
Current Condition	Slight damage
Surface Treatment	Composite
Asbestos Type	Chrysotile
Material Assessment Rating	Very low
Accessibility	Low
Further Comment	Not applicable

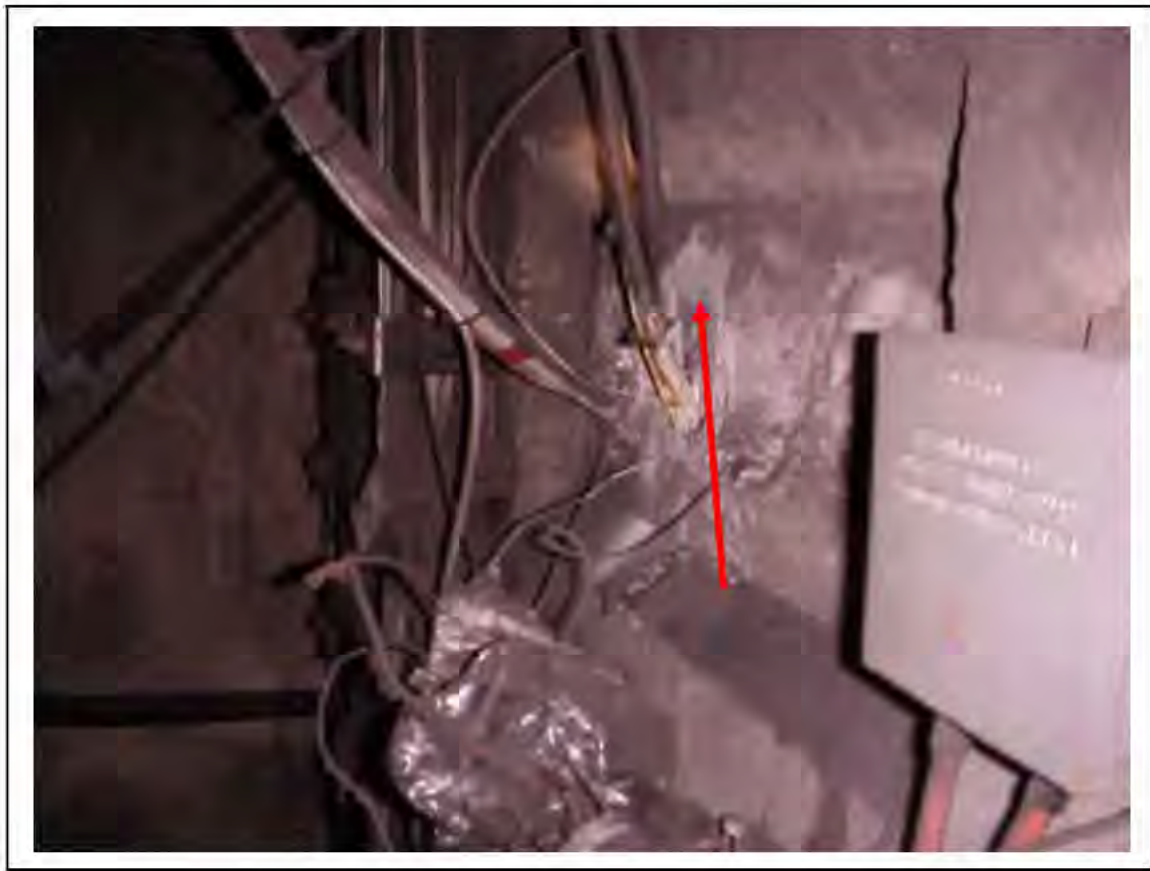
Sample Number	Same as 034219/5
Location	Victoria Line, Platform 2, 3/262, Other end 3/706
Material Description	Cable sleeves
Material Comment	Pit side
Quantity	x4
Product Type	Composite
Current Condition	Slight damage
Surface Treatment	Composite
Asbestos Type	Chrysotile
Material Assessment Rating	Very low
Accessibility	Low
Further Comment	Not applicable
