# Motor Car Underframe

# Metropolitan **Rolling Stock**

Location of Hazardous Materials Pictogram

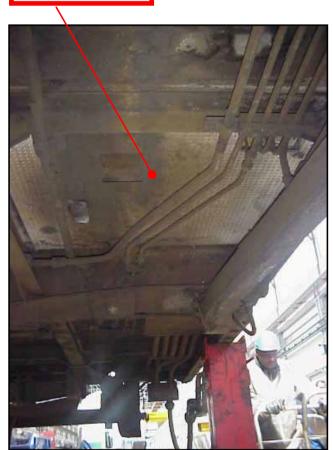
Figure 1 & 2

Motor Car 5099 panel to underframe, RHS and LHS Durasteel Panel - Chrysotile and Amosite

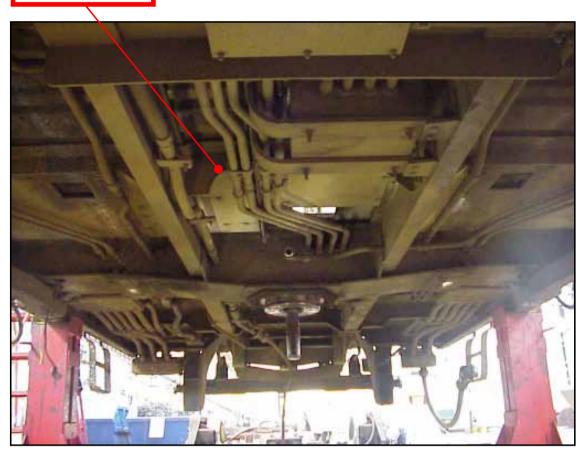
Figure 3 & 4

Motor Car 5099 panel to underframe, centre & RHS. Cementitous boarding

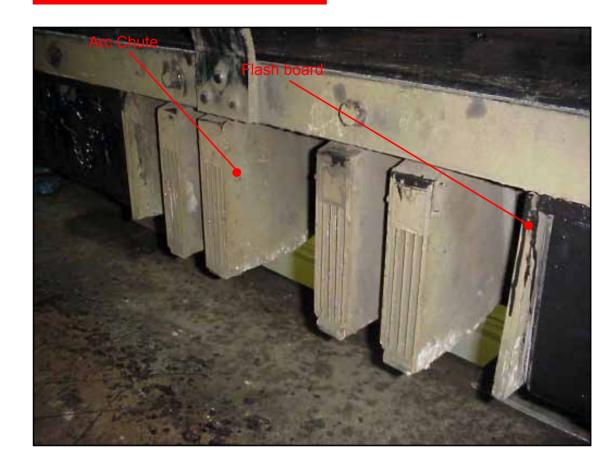
Figure 6 & 7

Motor Car 5099 Traction Equipment. Cementitous Arc Chutes. Chrysotile 014184/15

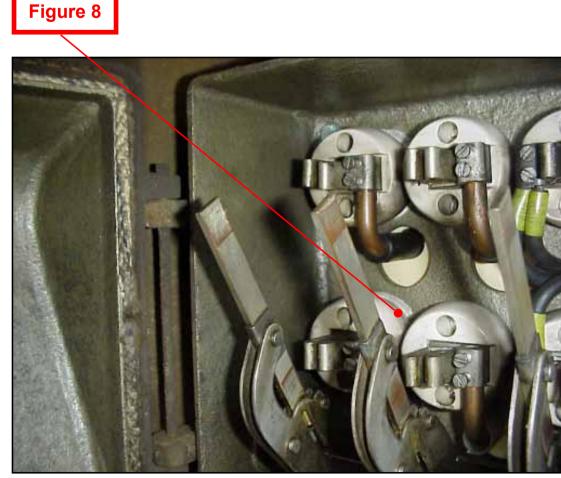
Motor Car 5099 - Gassing switch box. Insulating paper behind switches . Chrysotile

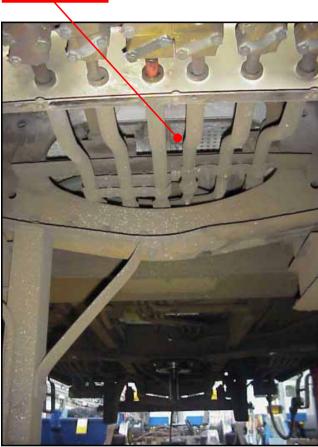
Motor Car 5099 panel to underframe, centre. Durasteel Panel - Chrysotile

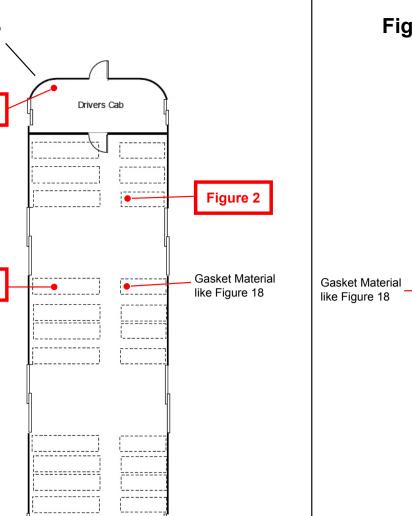
### Figure 1

Motor Car 5099 Saloon - Equipment in seat cavity. Gasket Material. Chrysotile

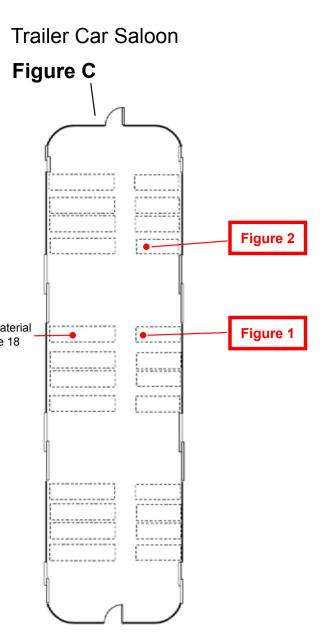
# Figure C & D

Trailer Car 6099 - Equipment in seat cavity. Gasket Material - Chrysotile

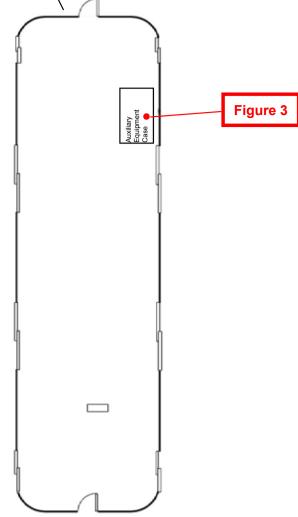
Trailer Car 6099 - Door open/close valves in seat cavity. Gasket Material.
