Report No. 4RS-JP-193302-R671476

**MANAGEMENT ASBESTOS SURVEY  
KINGS CROSS STATION  
PLATFORMS 5 AND 6 INVERTS - PICCADILLY LINE  
ES12122**

Issue Date: 22<sup>nd</sup> January 2020

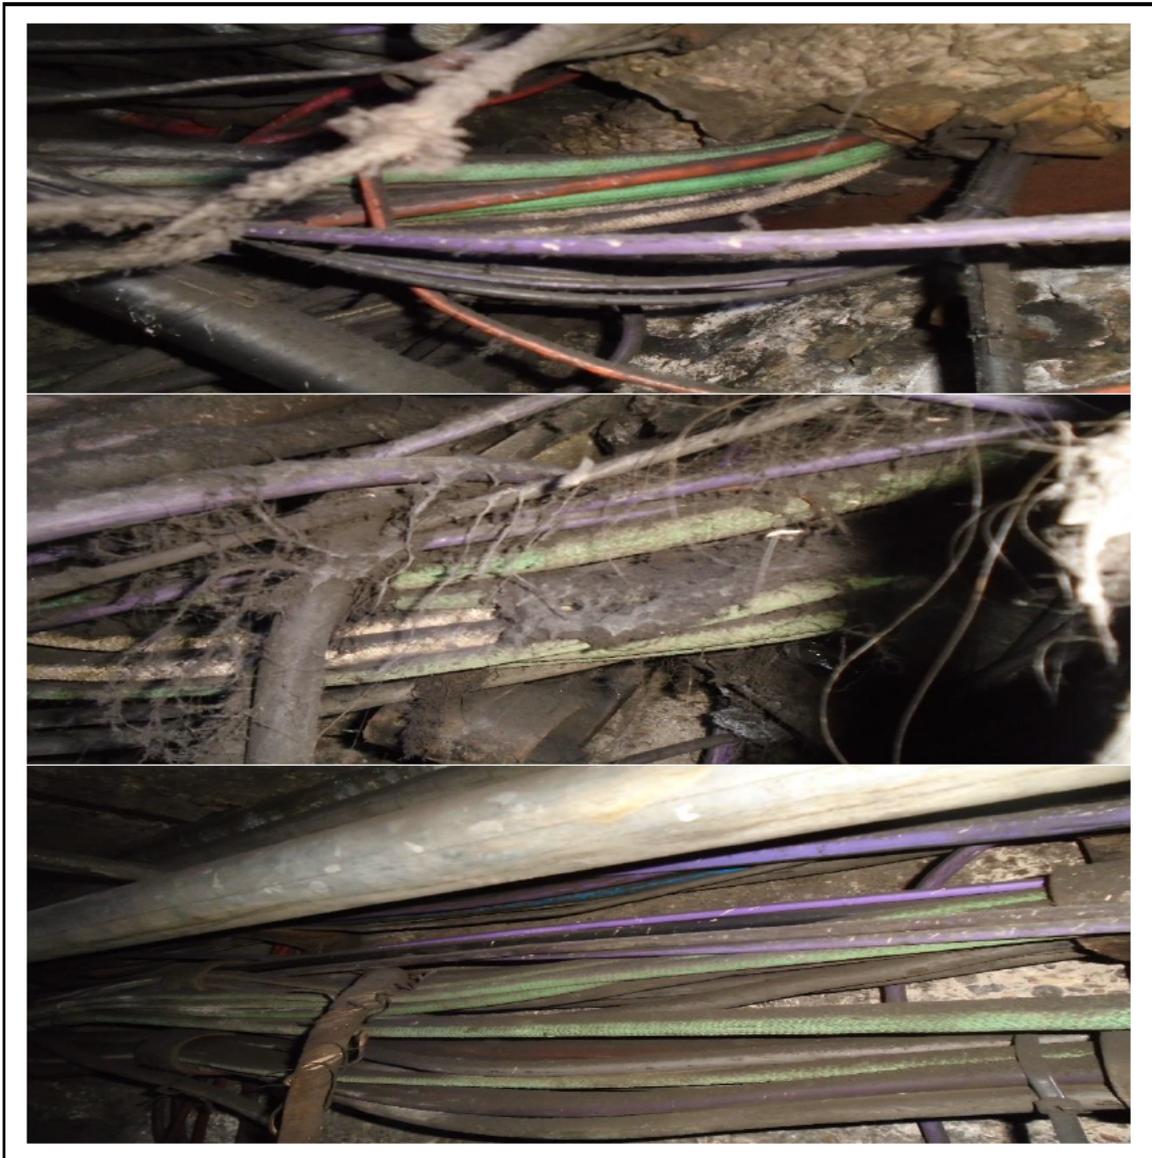
**FIGURE 1: KNOWN ASBESTOS IN BRAIDED CABLES IN PLATFORM 5 INVERT, PICCADILLY LINE - DESCRIPTION & RESULT OF ASSESSMENT (SAMPLE REF. K1 (1))**

Braided cables known to contain Chrysotile asbestos, Figure 1 - Material assessment rating: Low

Sample Number	K1 (1)
Location	Platform 5 Invert, Piccadilly Line
Material Description	Braided cables
Material Comment	To cable run on track wall side, running throughout
Quantity	>10 no
Product Type	Medium density
Current Condition	Slight damage
Surface Treatment	Unencapsulated medium density
Asbestos Type	Known Chrysotile
Material Assessment Rating	Low
Accessibility	Low
Further Comment	Not applicable

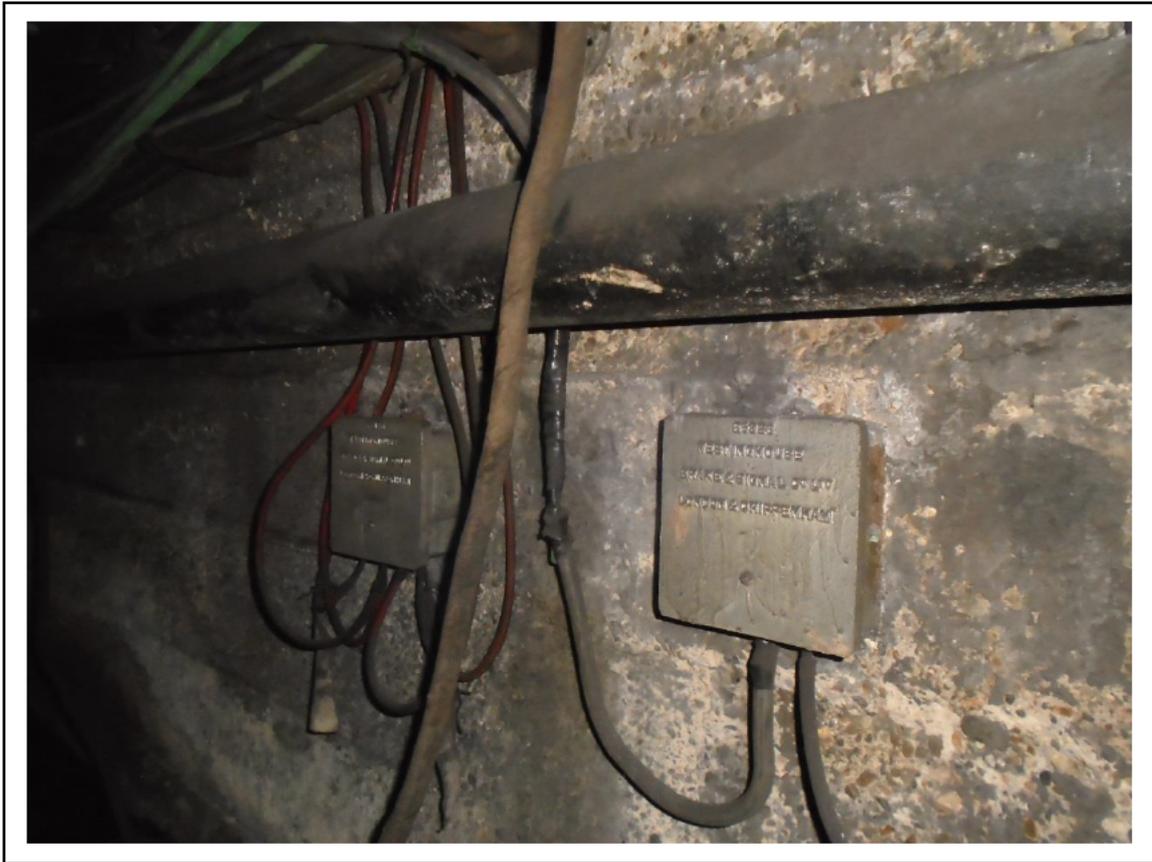
**FIGURE 2: PRESUMED ASBESTOS IN SMALL WESTINGHOUSE BOXES IN PLATFORM 5 INVERT, PICCADILLY LINE - DESCRIPTION & RESULT OF ASSESSMENT (SAMPLE REF. P1 (1))**

Small westinghouse boxes presumed to contain Chrysotile asbestos, Figure 2

Sample Number	P1 (1)
Location	Platform 5 Invert, Piccadilly Line
Material Description	Small westinghouse boxes
Material Comment	To wall trackside
Quantity	2 no
Product Type	-
Current Condition	-
Surface Treatment	-
Asbestos Type	Presumed Chrysotile
Material Assessment Rating	-
Accessibility	-
Further Comment	Not applicable

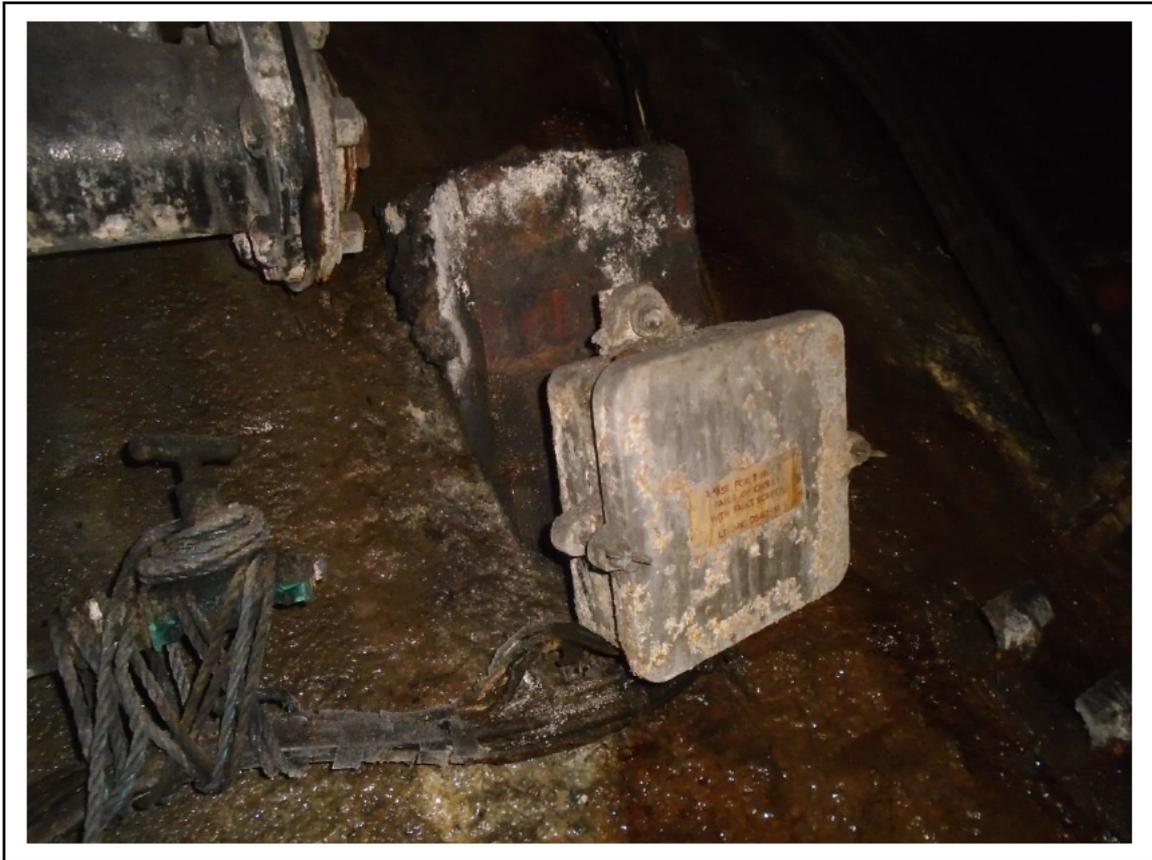
**FIGURE 3: PRESUMED ASBESTOS IN TEN CORE BOX IN PLATFORM 5 INVERT, PICCADILLY LINE - DESCRIPTION & RESULT OF ASSESSMENT (SAMPLE REF. P1 (2))**

Ten core box presumed to contain Chrysotile asbestos, Figure 3

Sample Number	P1 (2)
Location	Platform 5 Invert, Piccadilly Line
Material Description	Ten core box
Material Comment	To wall trackside
Quantity	1 no
Product Type	-
Current Condition	-
Surface Treatment	-
Asbestos Type	Presumed Chrysotile
Material Assessment Rating	-
Accessibility	-
Further Comment	Not applicable

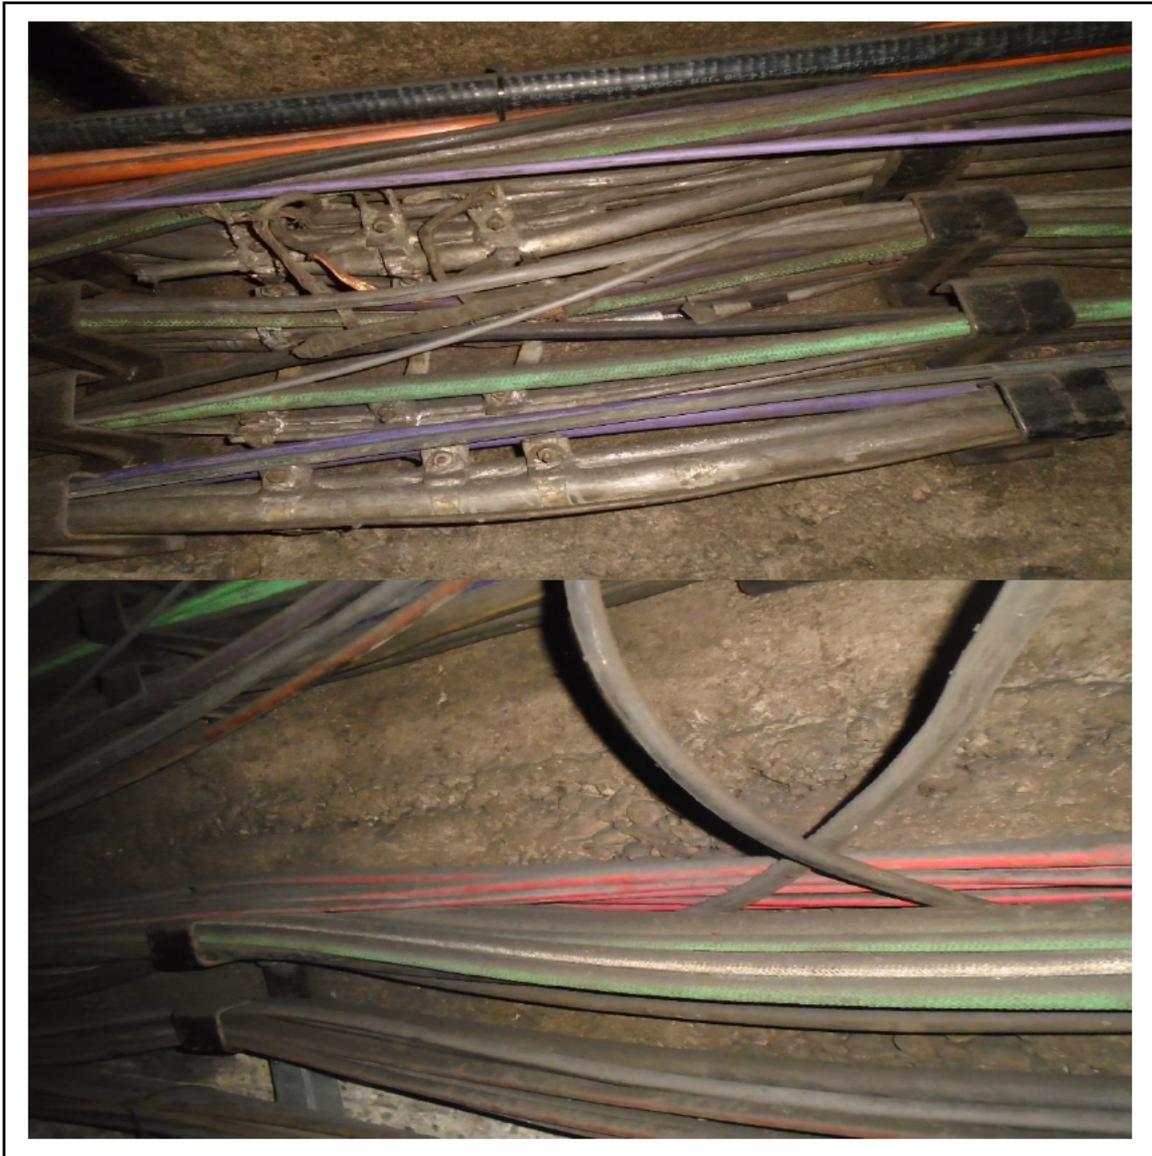
**FIGURE 4: KNOWN ASBESTOS IN BRAIDED CABLES IN PLATFORM 6 INVERT, PICCADILLY LINE - DESCRIPTION & RESULT OF ASSESSMENT (SAMPLE REF. K1 (2))**

Braided cables known to contain Chrysotile asbestos, Figure 4 - Material assessment rating: Low

Sample Number	K1 (2)
Location	Platform 6 Invert, Piccadilly Line
Material Description	Braided cables
Material Comment	To cable run on track wall side, running throughout
Quantity	>10 no
Product Type	Medium density
Current Condition	Slight damage
Surface Treatment	Unencapsulated medium density
Asbestos Type	Known Chrysotile
Material Assessment Rating	Low
Accessibility	Low
Further Comment	Not applicable

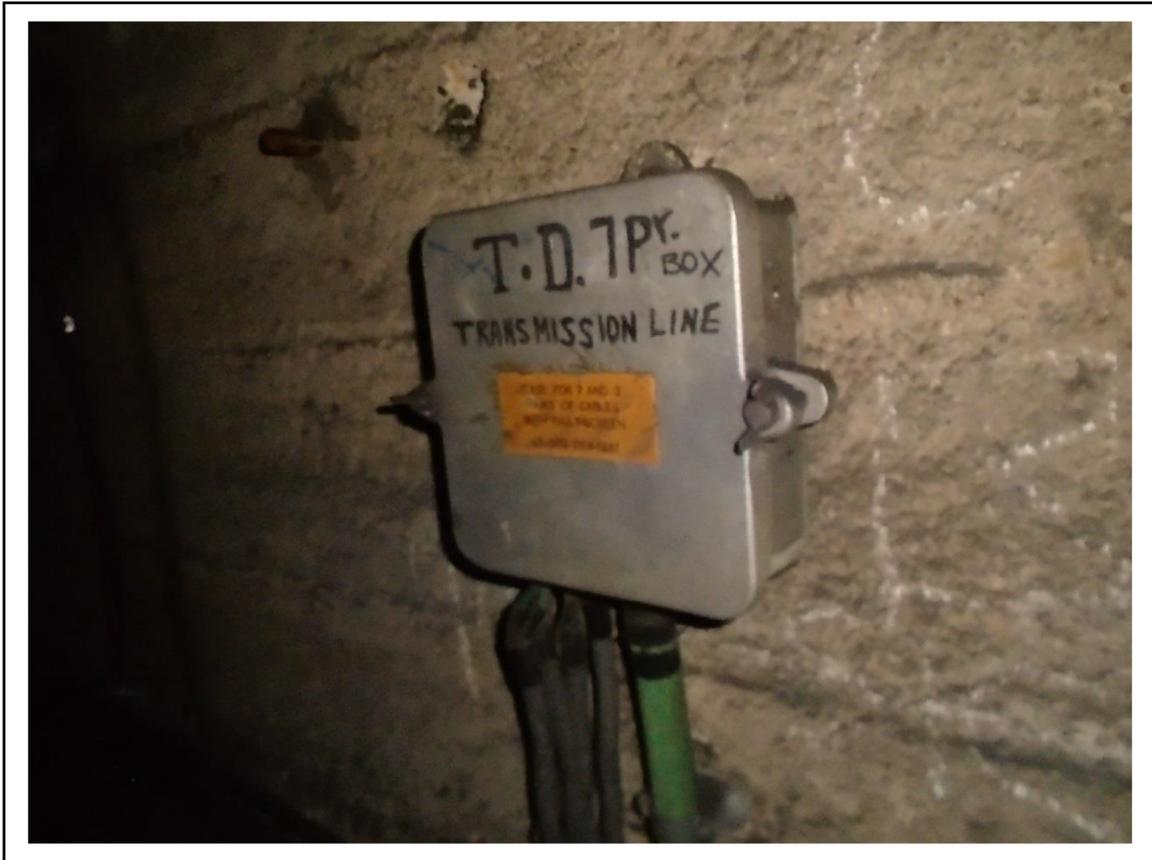
**FIGURE 5: PRESUMED ASBESTOS IN TEN CORE BOX IN PLATFORM 6 INVERT, PICCADILLY LINE - DESCRIPTION & RESULT OF ASSESSMENT (SAMPLE REF. P1 (3))**

Ten core box presumed to contain Chrysotile asbestos, Figure 5

Sample Number	P1 (3)
Location	Platform 6 Invert, Piccadilly Line
Material Description	Ten core box
Material Comment	To wall trackside
Quantity	1 no
Product Type	-
Current Condition	-
Surface Treatment	-
Asbestos Type	Presumed Chrysotile
Material Assessment Rating	-
Accessibility	-
Further Comment	Not applicable
