Fatal accident involving the derailment of a tram at Sandilands Junction, Croydon

9 November 2016

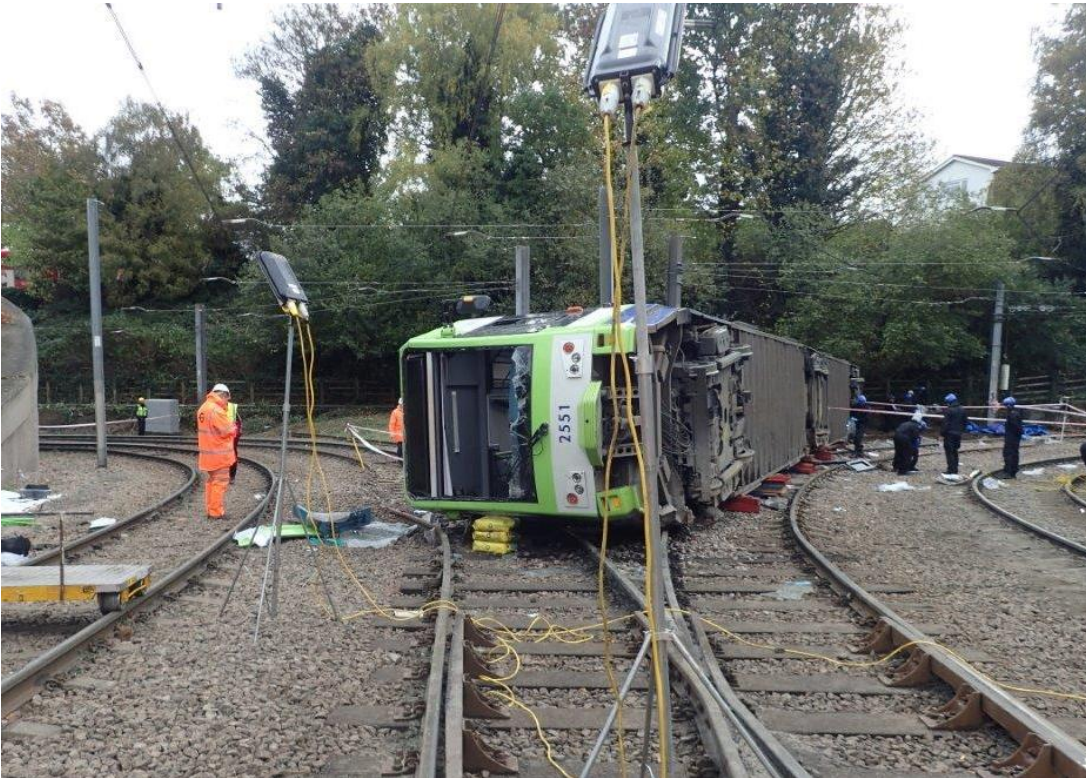
The overturned tram itself impacted an overhead electricity stanchion, lineside equipment cabinets as well as rails being stored nearby (see Figure 1 and Figure 2). Significant damage was sustained to both the tram and the adjacent infrastructure. Work is ongoing as a part of a separate workstream to investigate the performance of the tram structure during the overturn.

Figure 1 - Tram 2551 overview of resting position on adjacent tracks

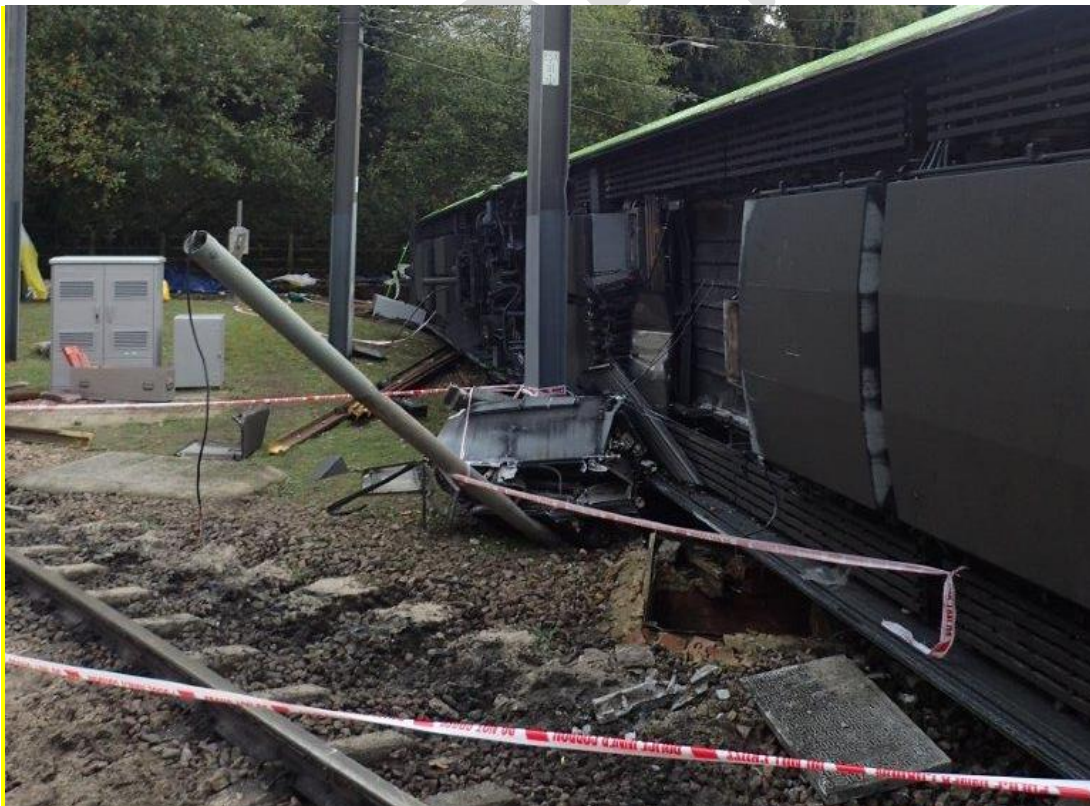
Figure 2 - Tram 2551 roof against infrastructure

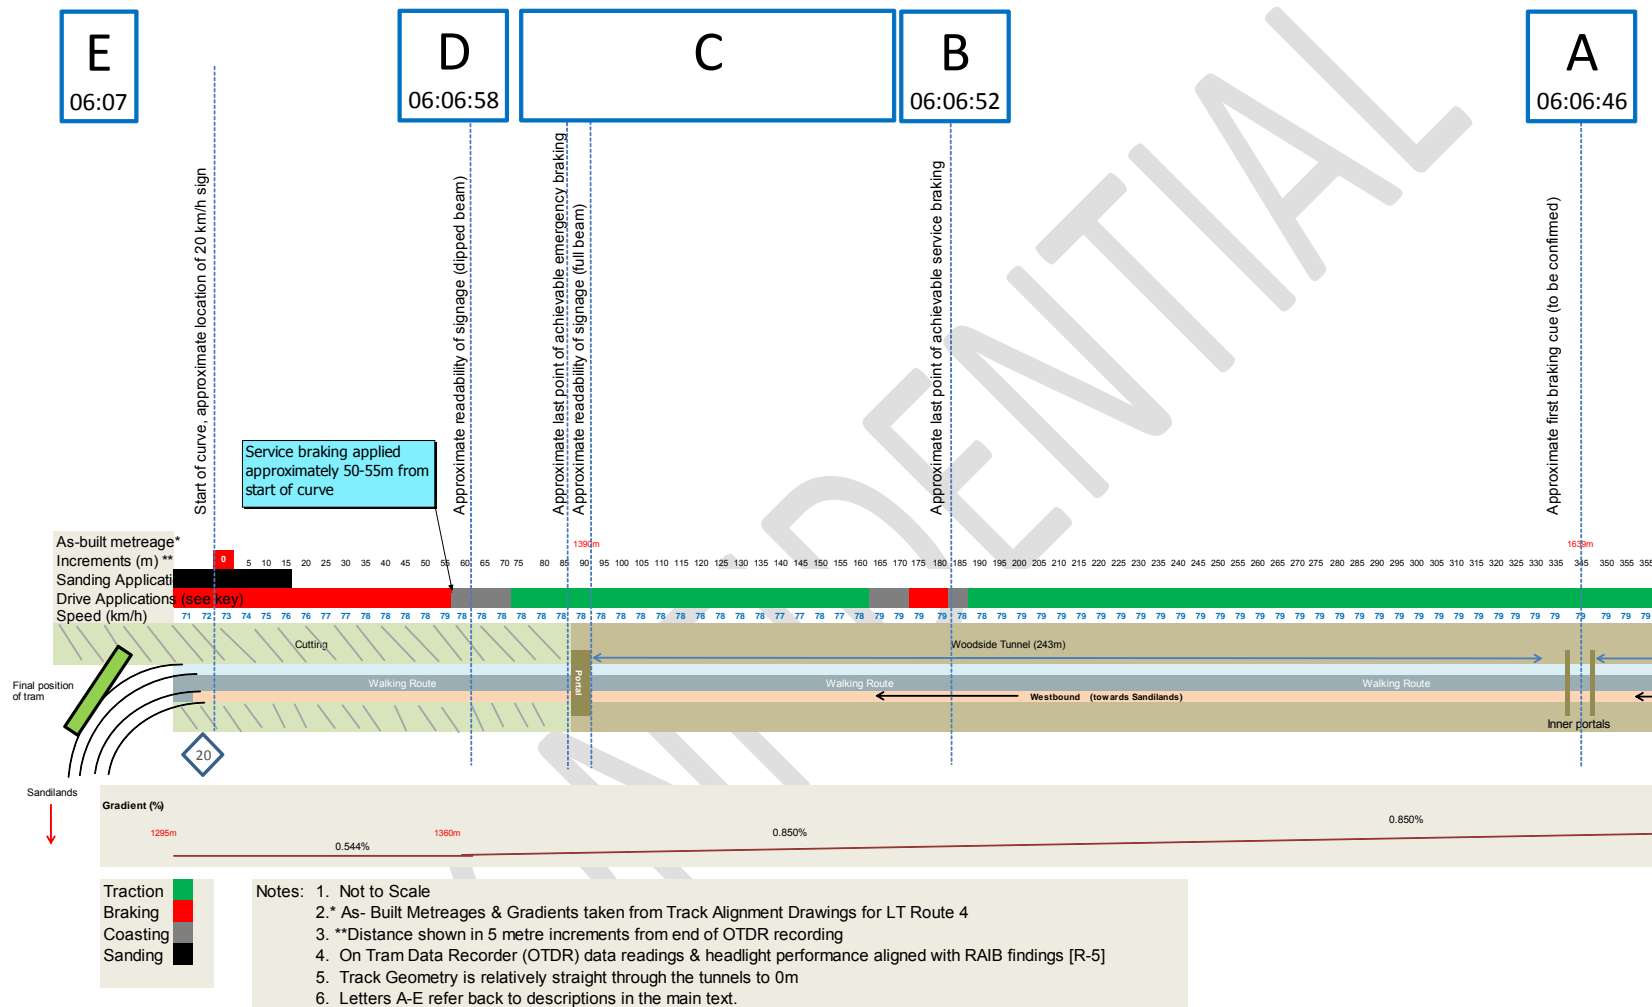
- 06:06:58 [denoted "D" on diagram] The tram braked, with a rate of retardation in line with that of a normal service braking applied by the driver (around 1.3 ms^{-2}), with the sanding system being initiated (either automatically by the wheel slip/slide protection system, or manually by the driver) at 06:06:59 until 06:07:01.

Figure 4 - Extract of Appendix A Sequence of events (schematic) over final 15s/330m (approximation) before curve.

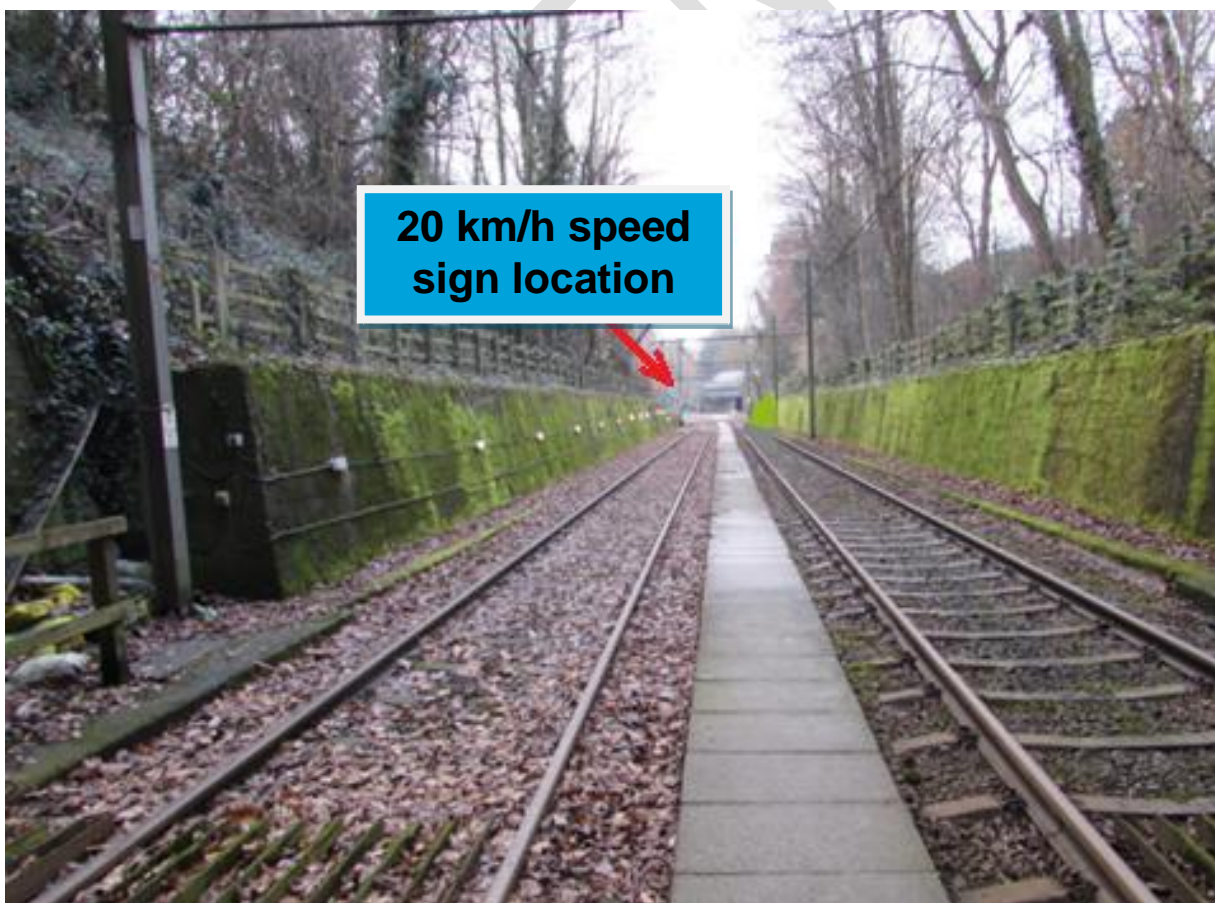
The reflective signage indicating the 20km/h PSR is readable (i.e. the numerals can be read) on a clear night, from the driving position of a tram driven at caution, from a distance of around 60m (dipped beam) and 90m (on full beam) [R-5]. This figure could be reduced by heavy rain, such as that experienced on the morning of the incident [R-5]. The ability of the driver to detect the signage will also be influenced by the tram speed, the driver's visual acuity, the local lighting as well as any other tasks that the driver was undertaking. See Figure 6 below.

Figure 6 - 20km/h board on exit from Woodside tunnel (photo taken around 85m from the start of the curve)

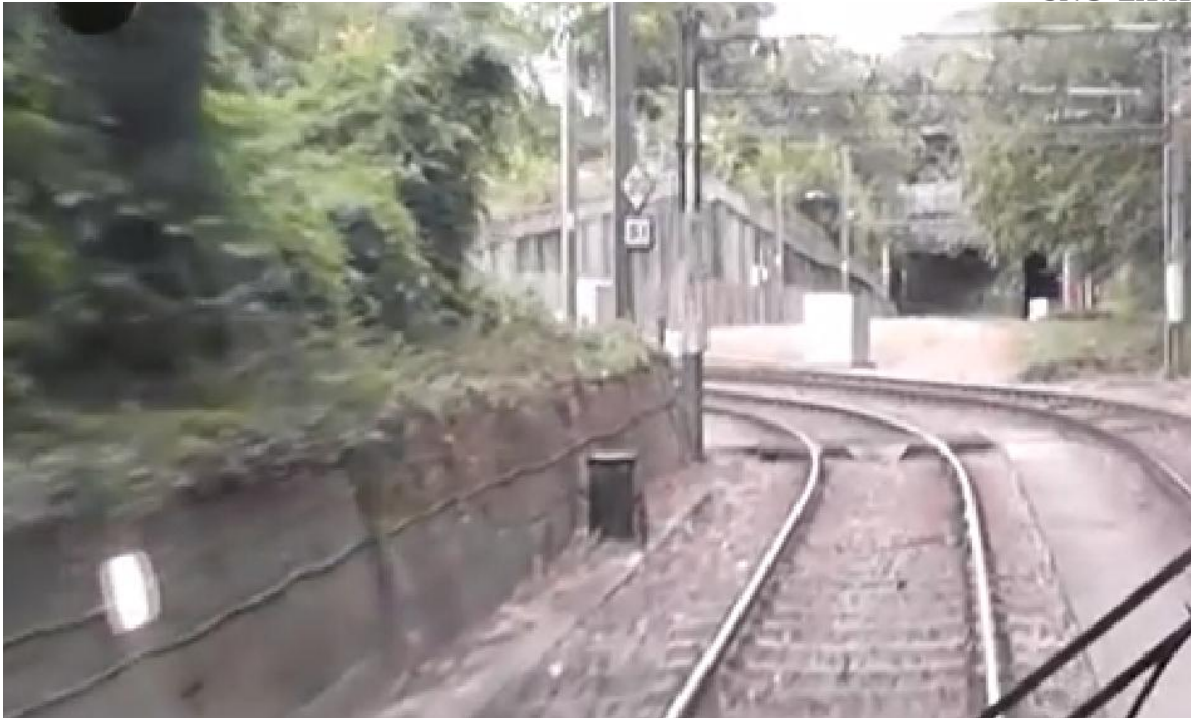
Figure 7 - 20 km/h PSR board on 30m radius curve, with the entrance to the Elmers End/Beckenham Junction branch line showing opposite

The incident has highlighted that there is no relevant signage that can be sighted from the required start of braking. Knowledge of the route and the next maximum permissible speed is therefore required and the ability to successfully complete this task is dependent on the driver correctly identifying the point for the start of braking.
