Report No. 4RS-AW-024661-R20486

ASBESTOS SURVEY, HATTON CROSS STATION

Issue Date: 1st July 2003

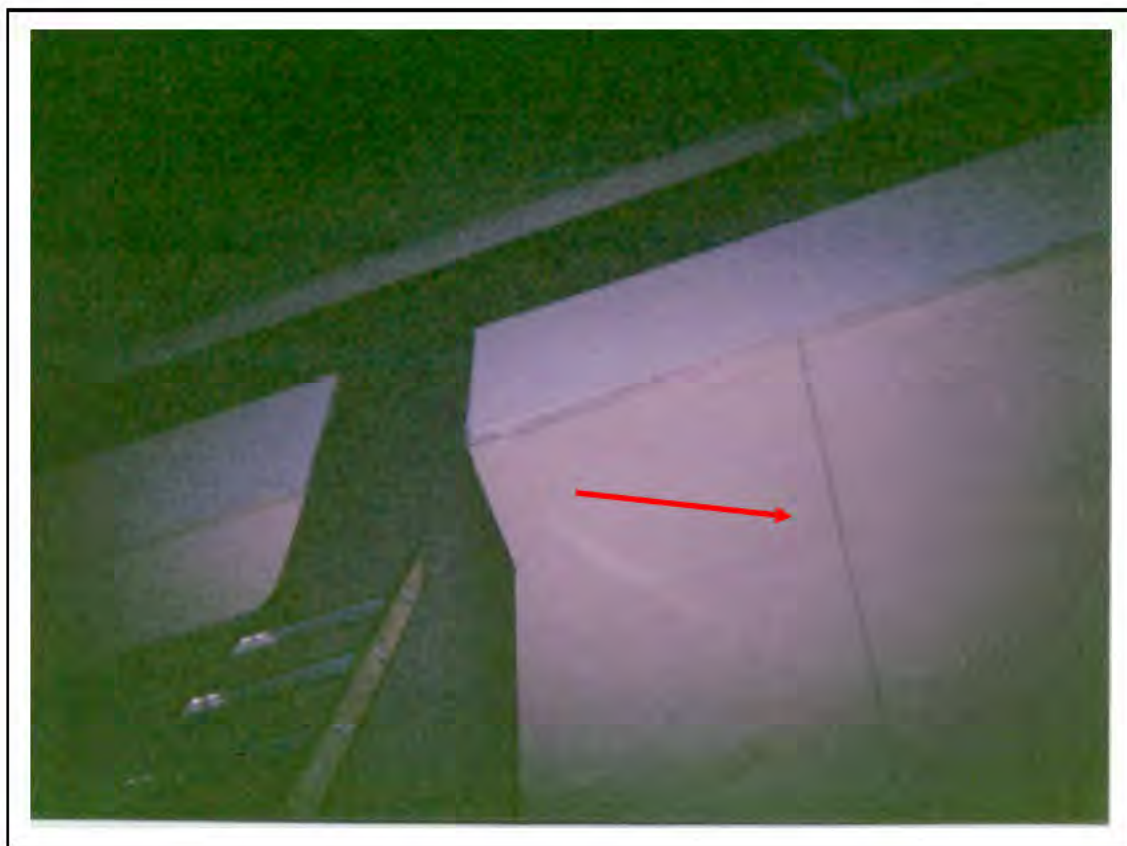
Figure 1: Sample No. 024661/6 – Description and Analysis Results

Sample number	024661/6
Location	Exterior bus Garage wall, North side
Description	Soffit 10m ²
Product Type	Composite
Current Condition	Slight damage
Surface Treatment	Composite
Asbestos Content	Chrysotile
<i>Material Assessment Factor</i>	3
Potential for disturbance	Very low
<i>Risk Assessment Factor</i>	3

Sample number	024661/8
Location	Exterior bus Garage wall, North side
Description	Canopy fascia
Product Type	Composite
Current Condition	Slight damage
Surface Treatment	Composite
Asbestos Content	Chrysotile
<i>Material Assessment Factor</i>	3
Potential for disturbance	Very low
<i>Risk Assessment Factor</i>	3

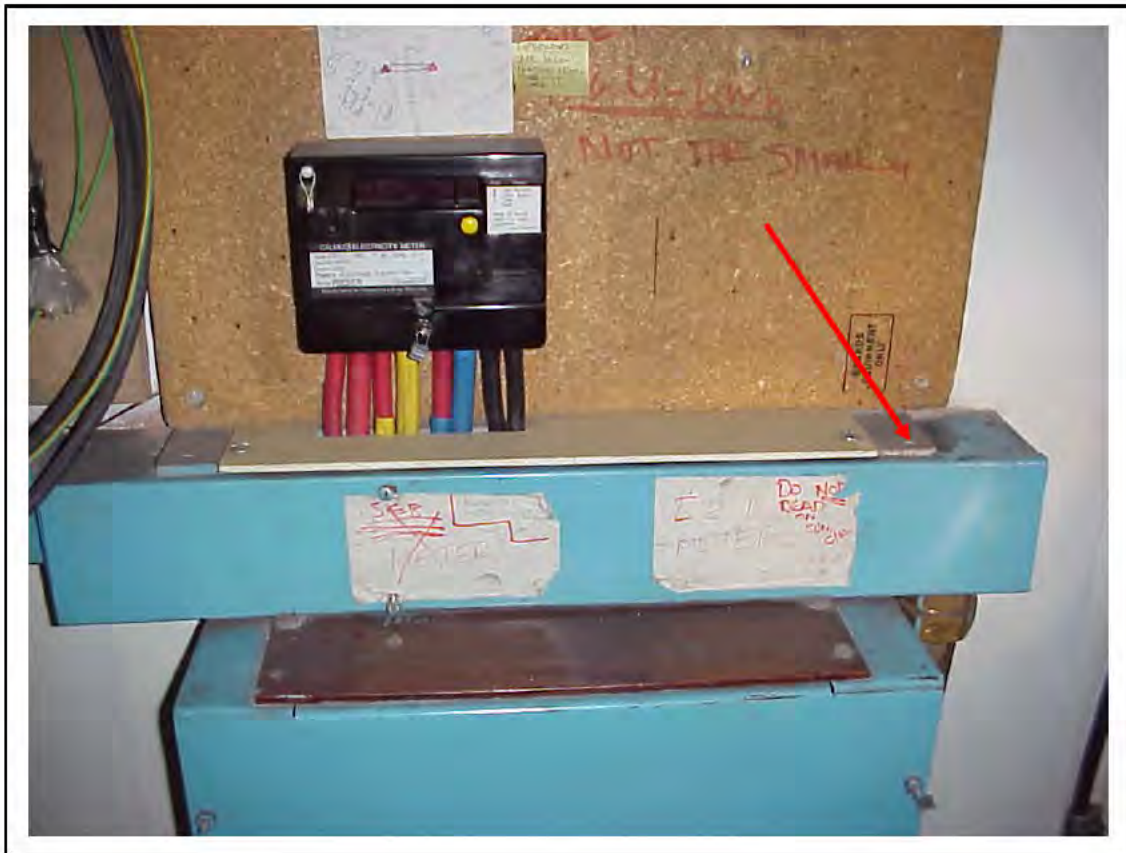
Figure 2: Sample No. 024661/10 – Description and Analysis Results

Sample number	024661/10
Location	Switch room 1/661
Description	Cementitious panel underneath electricity meter 0.05m ²
Product Type	Composite
Current Condition	Good condition
Surface Treatment	Composite
Asbestos Content	Chrysotile
Material Assessment Factor	2
Potential for disturbance	Low
Risk Assessment Factor	4

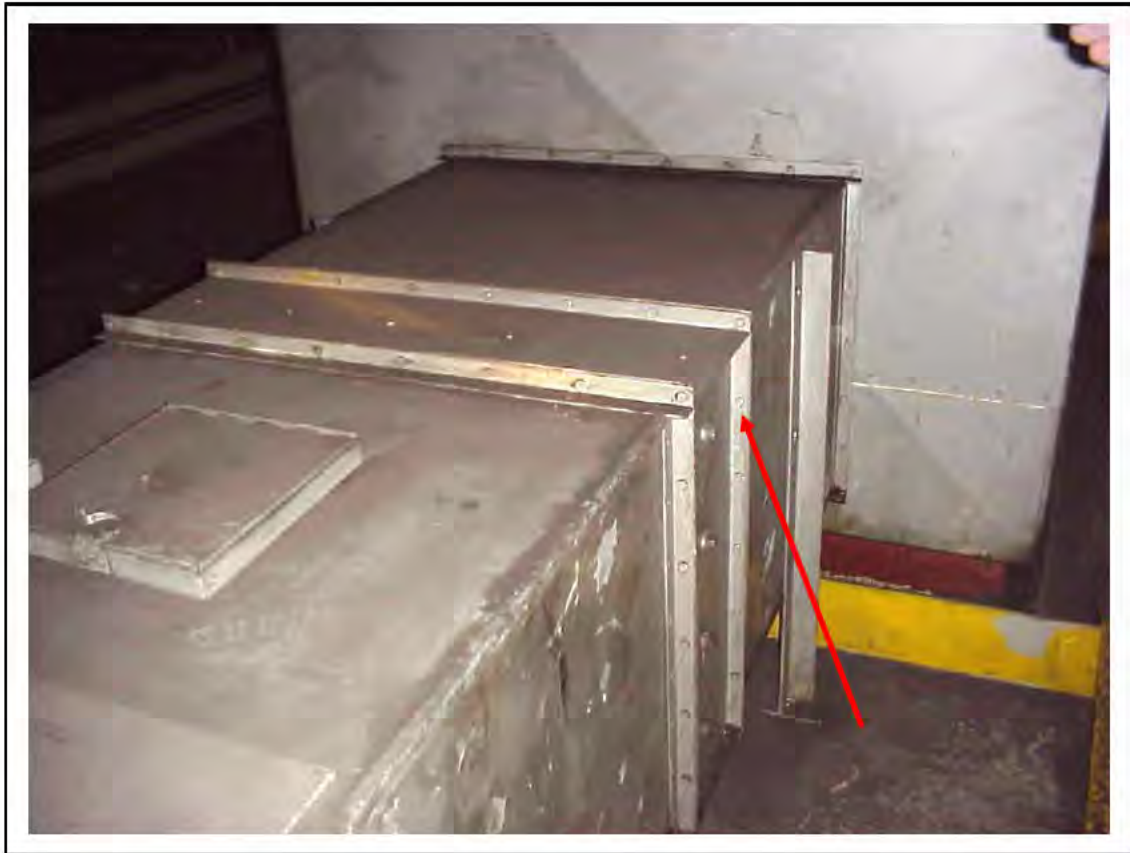
Figure 3: Sample No. 024661/9 – Description and Analysis Results

Sample number	024661/9
Location	Fan Room A/776
Description	Gaskets to vent equipment
Product Type	Medium density
Current Condition	Slight damage
Surface Treatment	Untreated highly friable
Asbestos Content	Chrysotile
<i>Material Assessment Factor</i>	7
Potential for disturbance	Low
<i>Risk Assessment Factor</i>	14

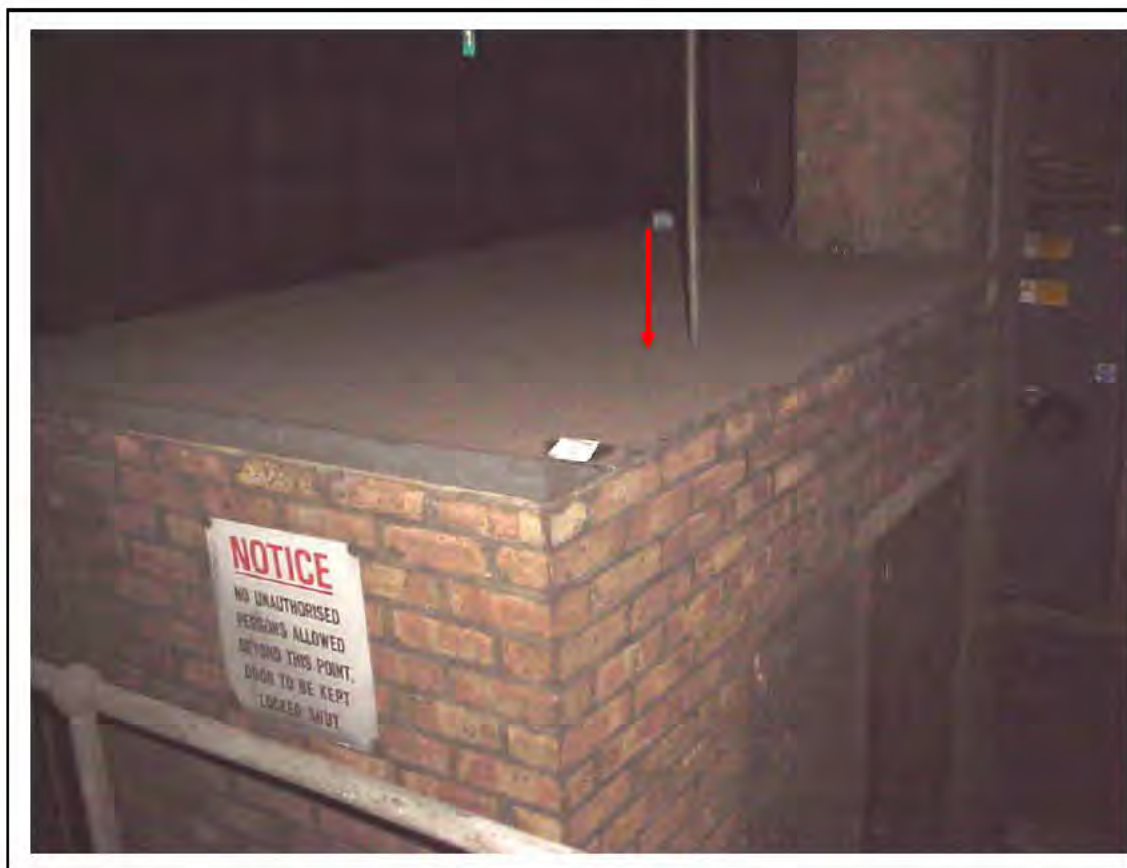
Figure 4: Sample No. 024661/8 – Description and Analysis Results

Sample number	024661/8
Location	Pump room 2/771
Description	Cellactite sheeting on roof
Product Type	Composite
Current Condition	Slight damage
Surface Treatment	Composite
Asbestos Content	Chrysotile
Material Assessment Factor	3
Potential for disturbance	Low
Risk Assessment Factor	6

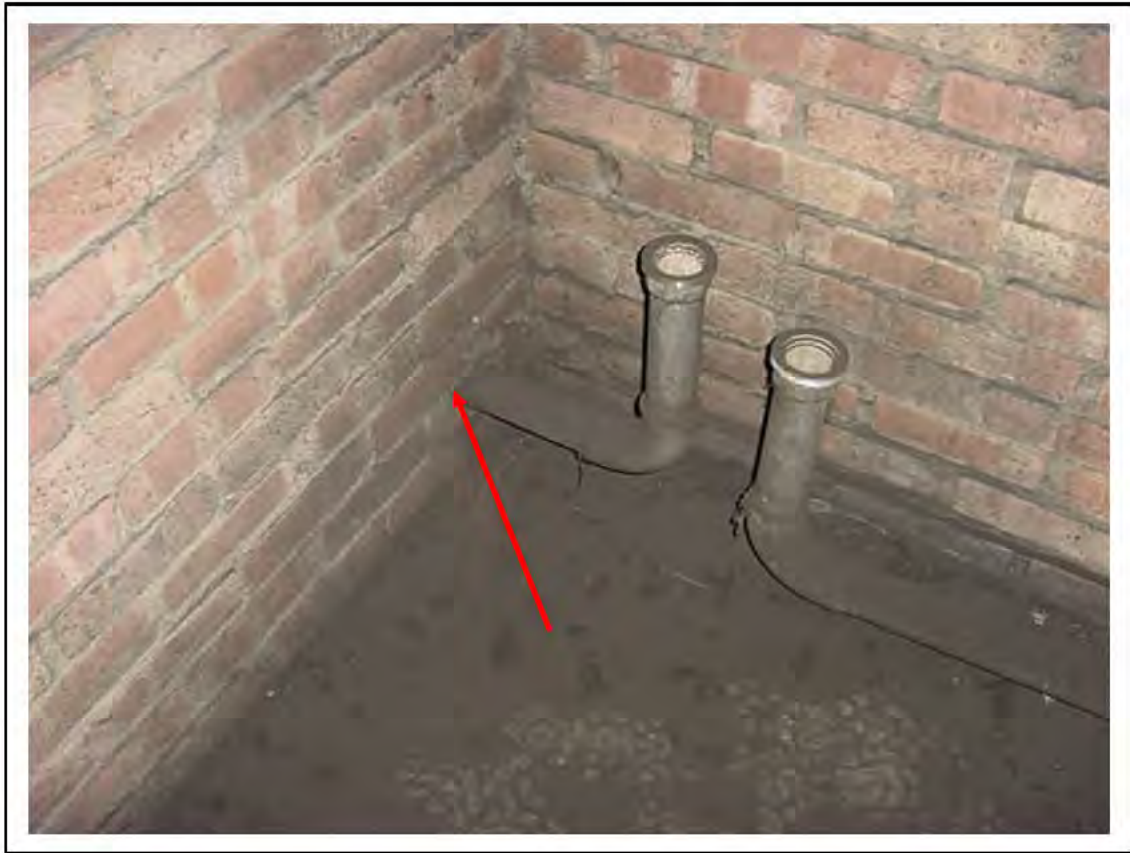
Figure 5: Sample No. 024661/19 – Description and Analysis Results

Sample number	024661/19
Location	Pump Room 2/772
Description	Three cable sleeves
Product Type	Composite
Current Condition	Extensive damage
Surface Treatment	Composite
Asbestos Content	Chrysotile
<i>Material Assessment Factor</i>	5
Potential for disturbance	Low
<i>Risk Assessment Factor</i>	10

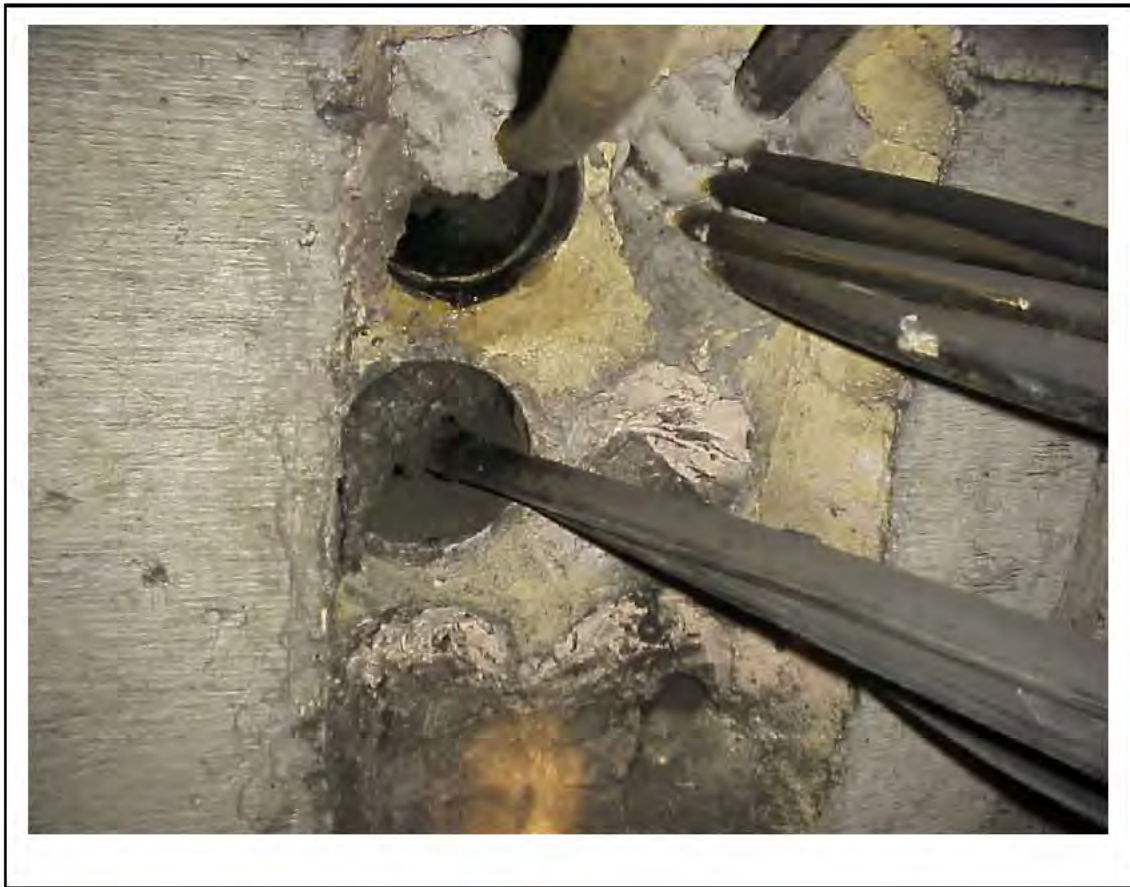
Figure 6: Sample No.024661/15 – Description and Analysis Results

Sample number	024661/15
Location	Platform 2 Invert near 2/414
Description	Six cable sleeves
Product Type	Composite
Current Condition	Slight damage
Surface Treatment	Composite
Asbestos Content	Chrysotile
<i>Material Assessment Factor</i>	3
Potential for disturbance	Low
<i>Risk Assessment Factor</i>	6

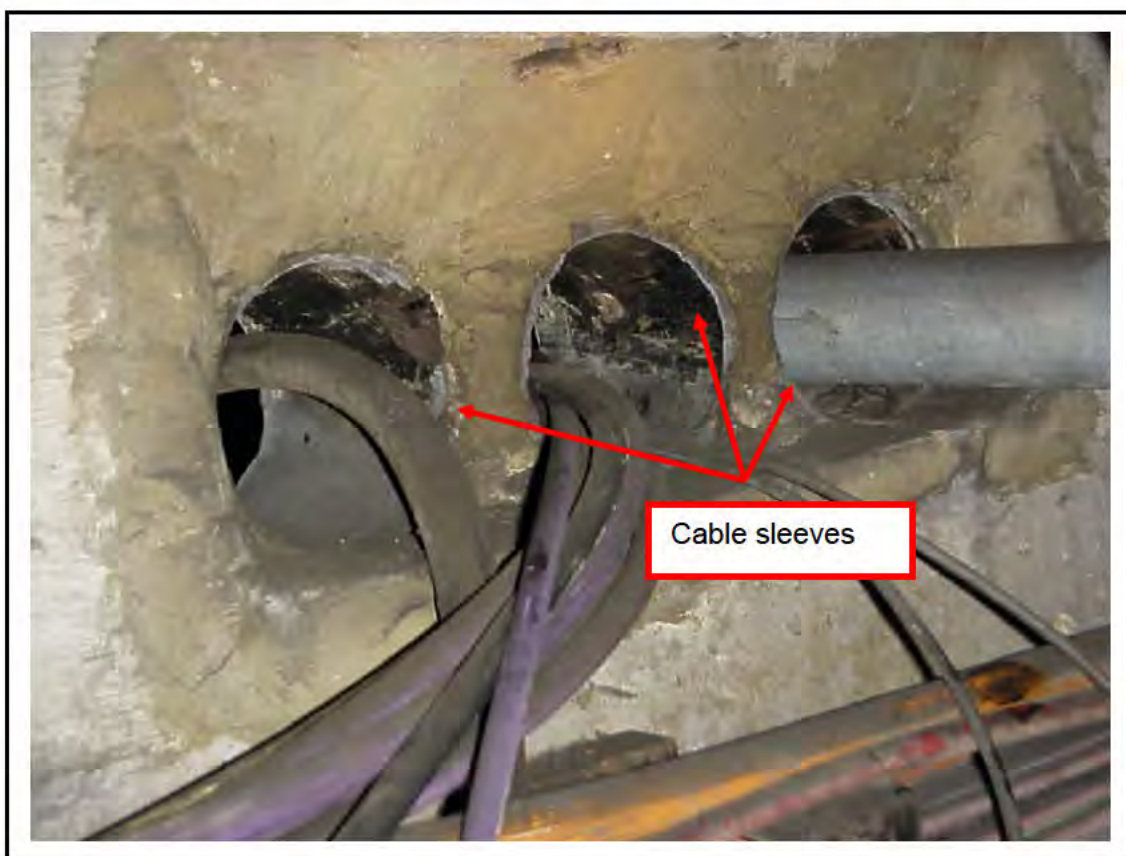
Figure 7: Sample No.024248/3 – Description and Analysis Results

Sample number	024894/3
Location	Platform 1 invert (down hatch 2/414), 1 metre towards concourse
Description	Four cable sleeves
Product Type	Composite
Current Condition	Good condition
Surface Treatment	Composite
Asbestos Content	Chrysotile
<i>Material Assessment Factor</i>	3
Potential for disturbance	Low
<i>Risk Assessment Factor</i>	4

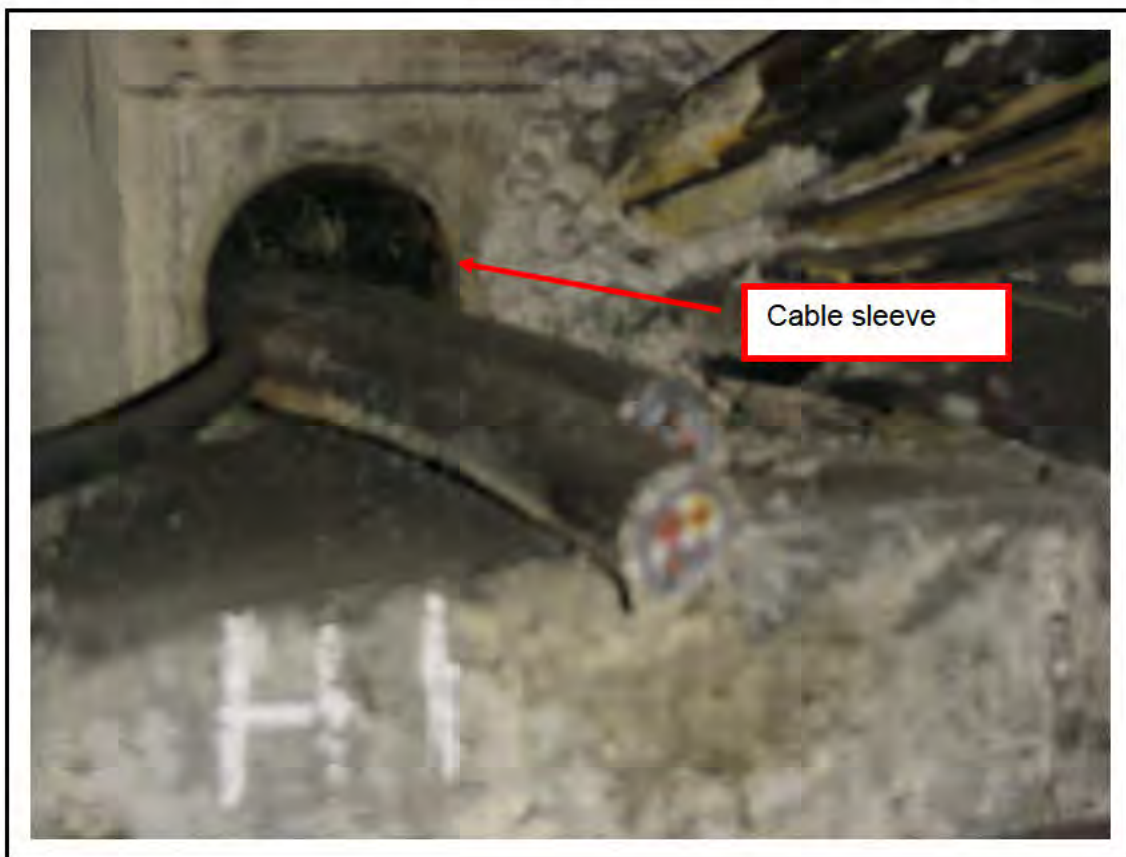
Figure 8: Same as Sample No.024248/3 – Description and Analysis Results

Sample number	024248/3
Location	Platform 1 invert down hatch by middle hatch from 2/414, 15 metres away
Description	Twelve cable sleeves
Product Type	Composite
Current Condition	Good
Surface Treatment	Composite
Asbestos Content	Chrysotile
<i>Material Assessment Factor</i>	2
Potential for disturbance	Low
<i>Risk Assessment Factor</i>	4

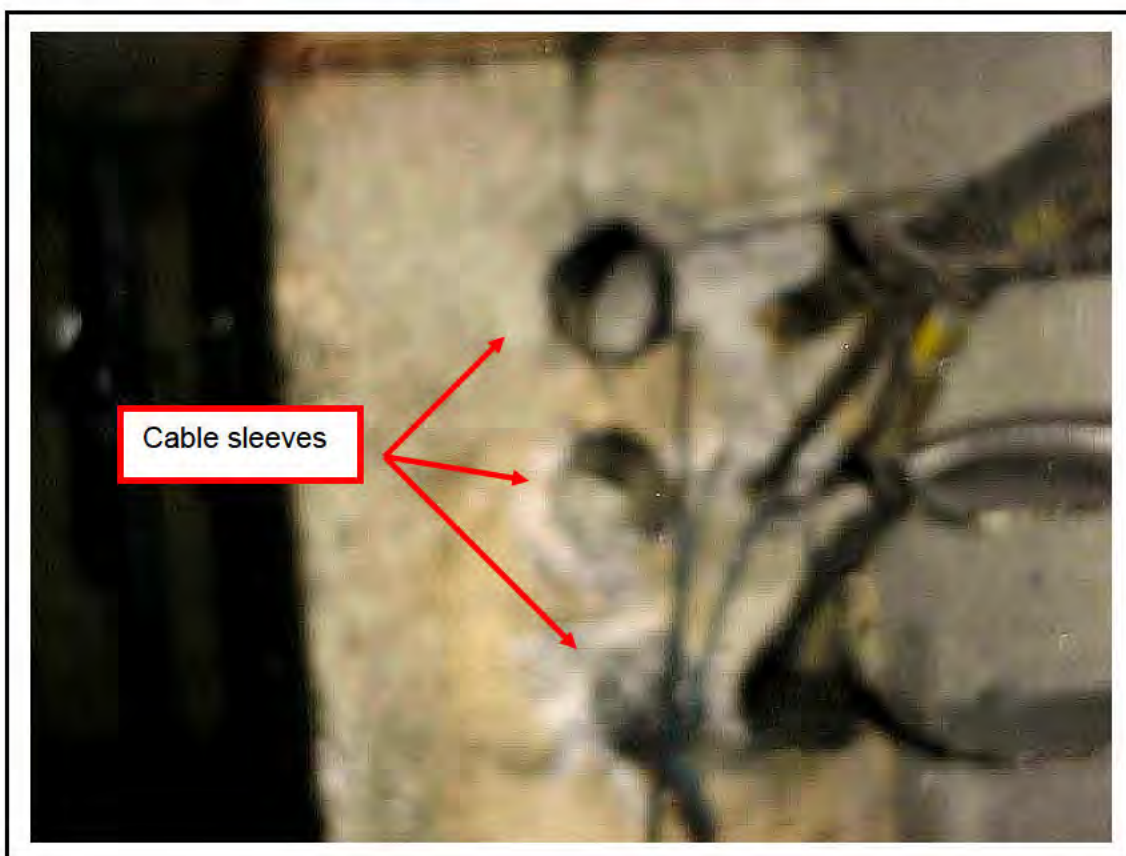
Figure 9: Sample No.024248/4 – Description and Analysis Results

Sample number	024248/4
Location	Platform 1 invert at far end down hatch 2/712
Description	Six cable sleeves
Product Type	Composite
Current Condition	Good
Surface Treatment	Composite
Asbestos Content	Chrysotile
<i>Material Assessment Factor</i>	2
Potential for disturbance	Low
<i>Risk Assessment Factor</i>	4
Potential for disturbance	Low
<i>Risk Assessment Factor</i>	12

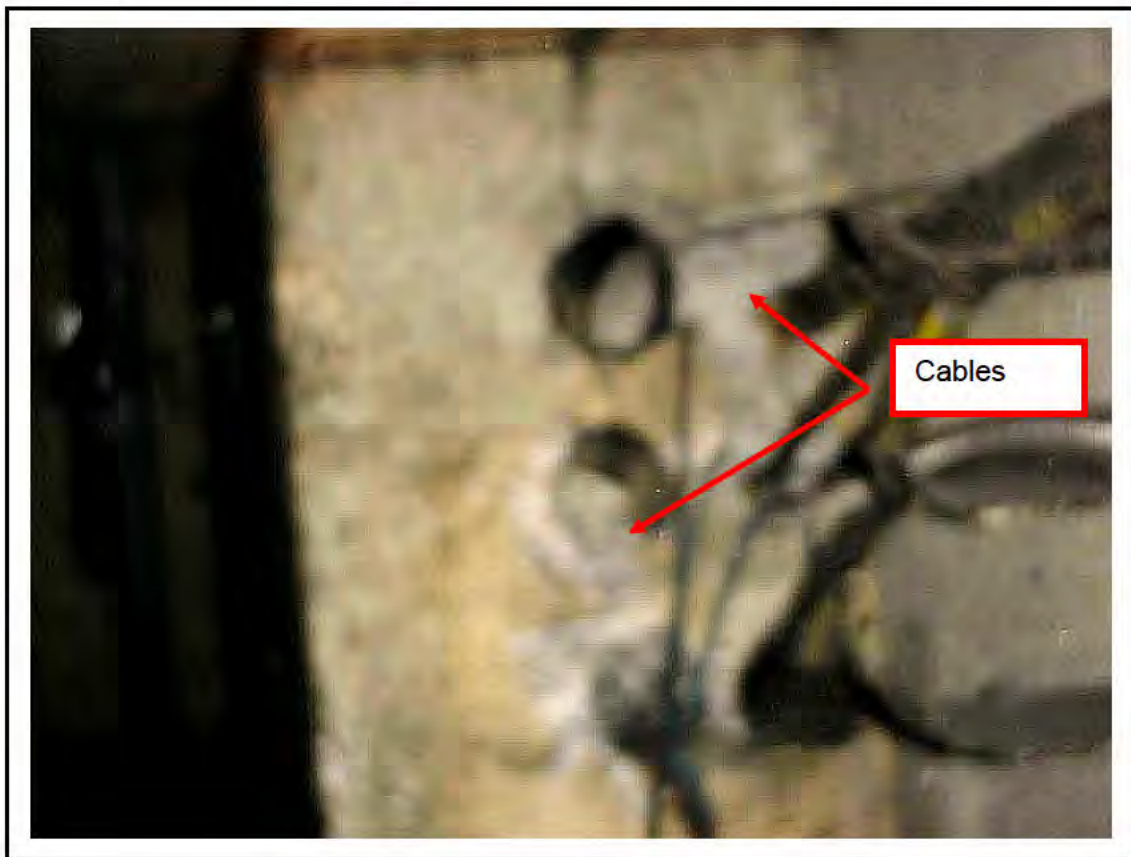
Figure 10: Sample No.024248/6 – Description and Analysis Results

Sample number	024248/6
Location	Down hatch 2/712 running towards 2/414, located 5 metres from hatch
Description	Two cut 10cm diameter white cables
Product Type	Highly friable
Current Condition	Extensive damage
Surface Treatment	Untreated highly friable
Asbestos Content	Chrysotile
<i>Material Assessment Factor</i>	10
Potential for disturbance	Medium
<i>Risk Assessment Factor</i>	30

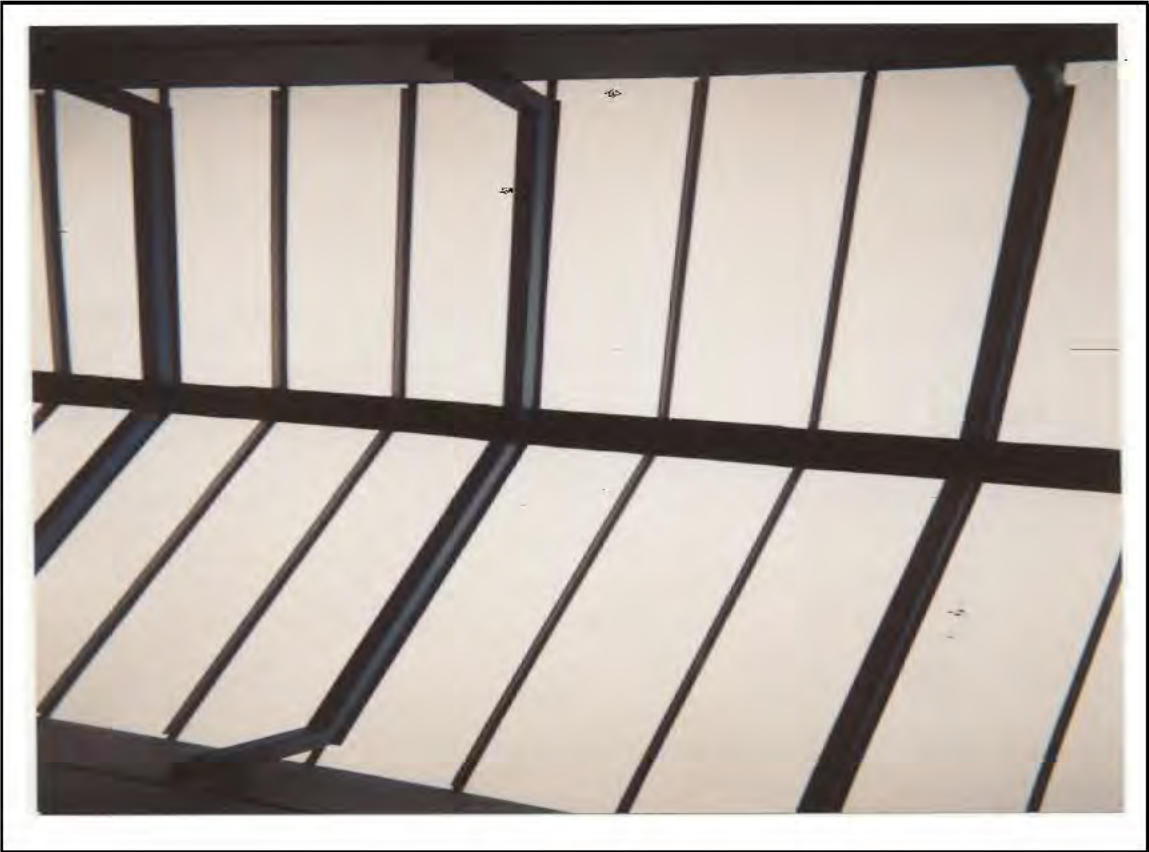
Figure 12: Material Strongly Presumed To Contain Asbestos

Location	Atrium Circulating Area 1/001
Description	Rope seals between metal glazing bars of glass canopy

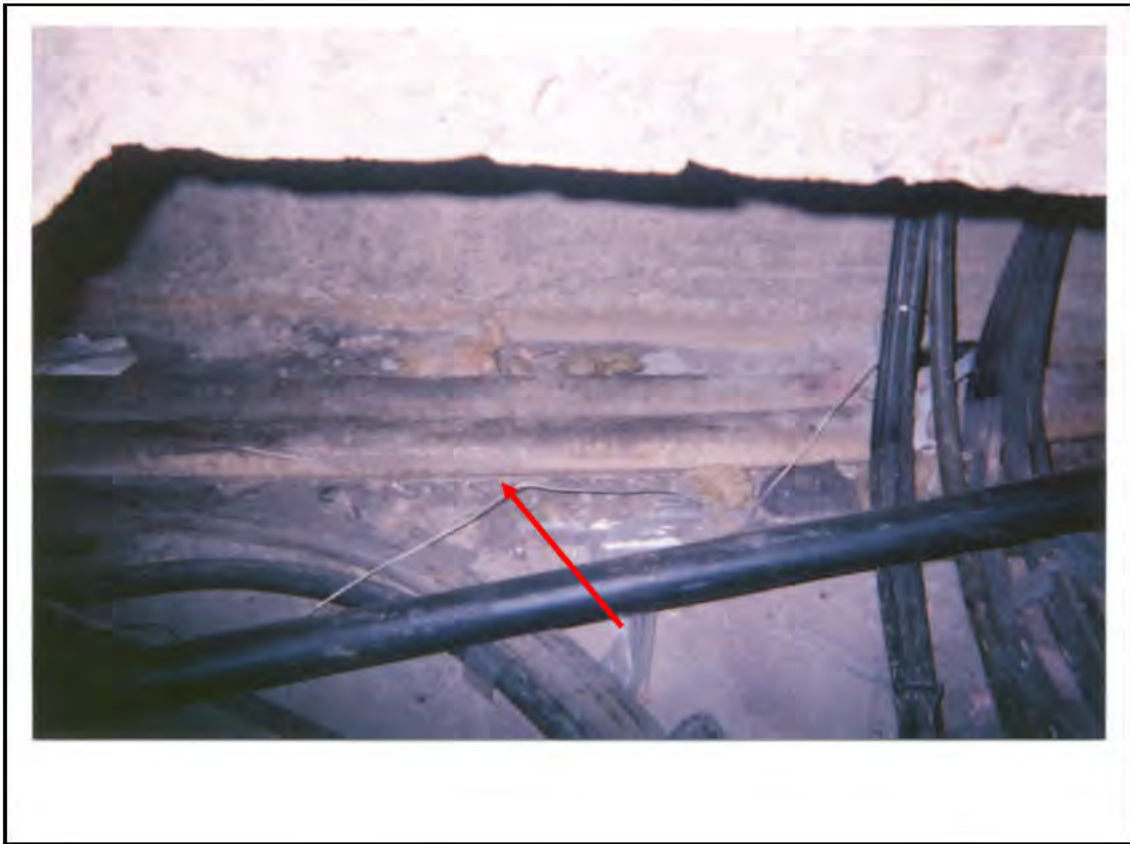
Figure 13: Material Strongly Presumed To Contain Asbestos

Location	Switch room 1/661
Description	Asbestos braided cables two x 4m visible white 10cm below manholes

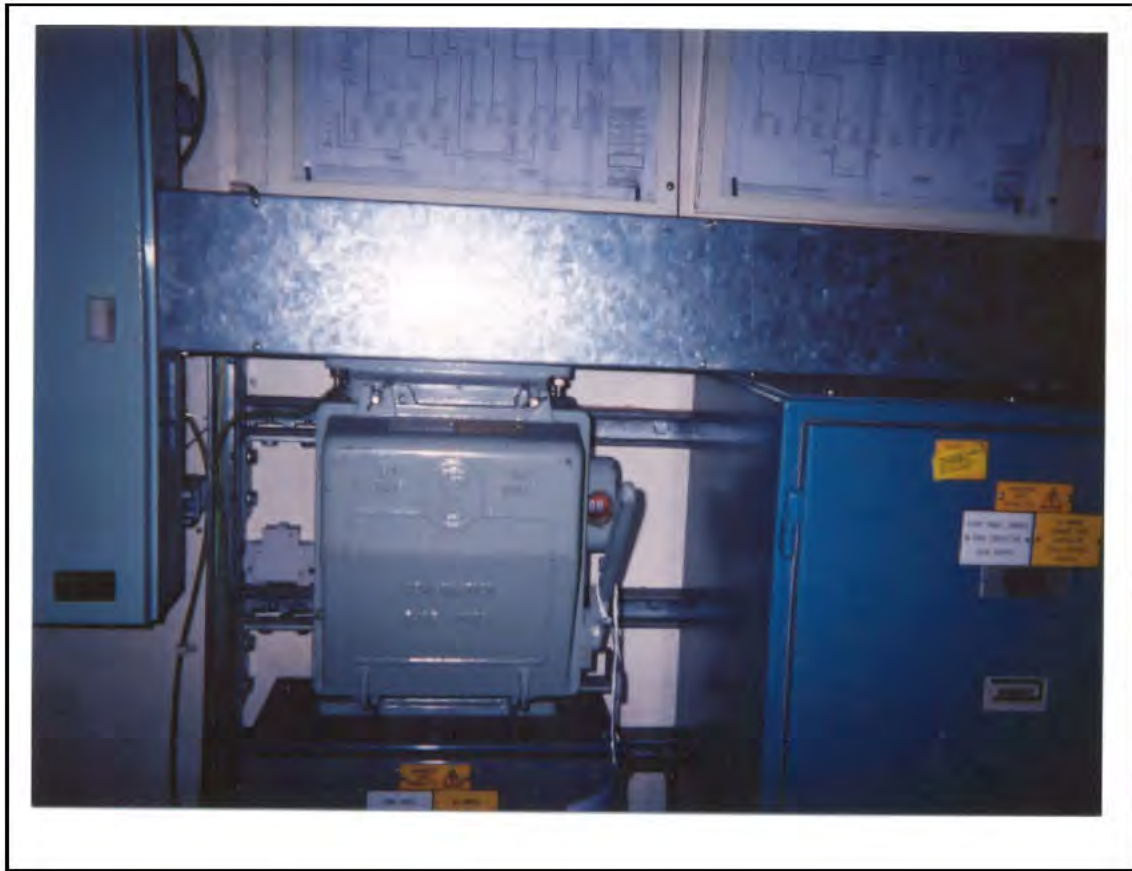
Figure 14: Material Strongly Presumed To Contain Asbestos

Location	Switch room 1/661
Description	Insulation inside iron clad isolator

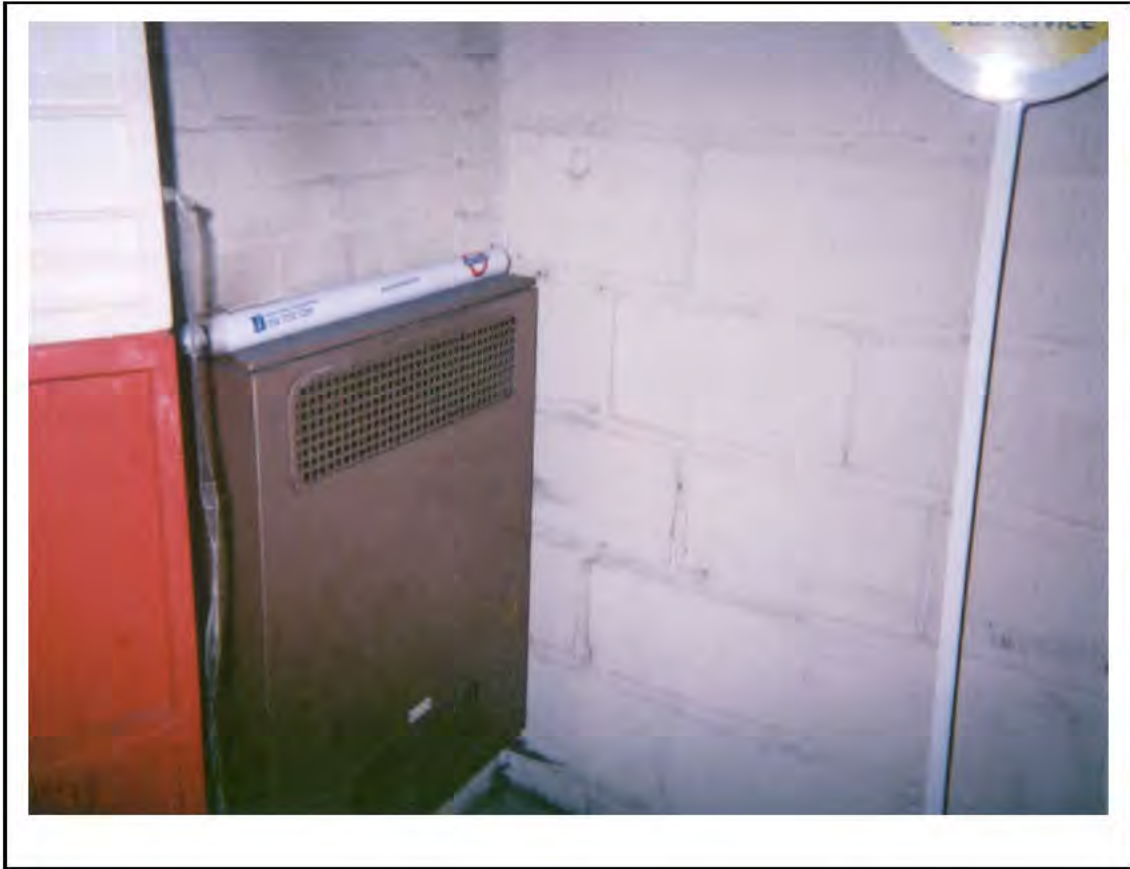
Figure 15: Material Strongly Presumed To Contain Asbestos

Location	Office 1/902, wall 1
Description	Insulation within LUL heater 0.5m ²

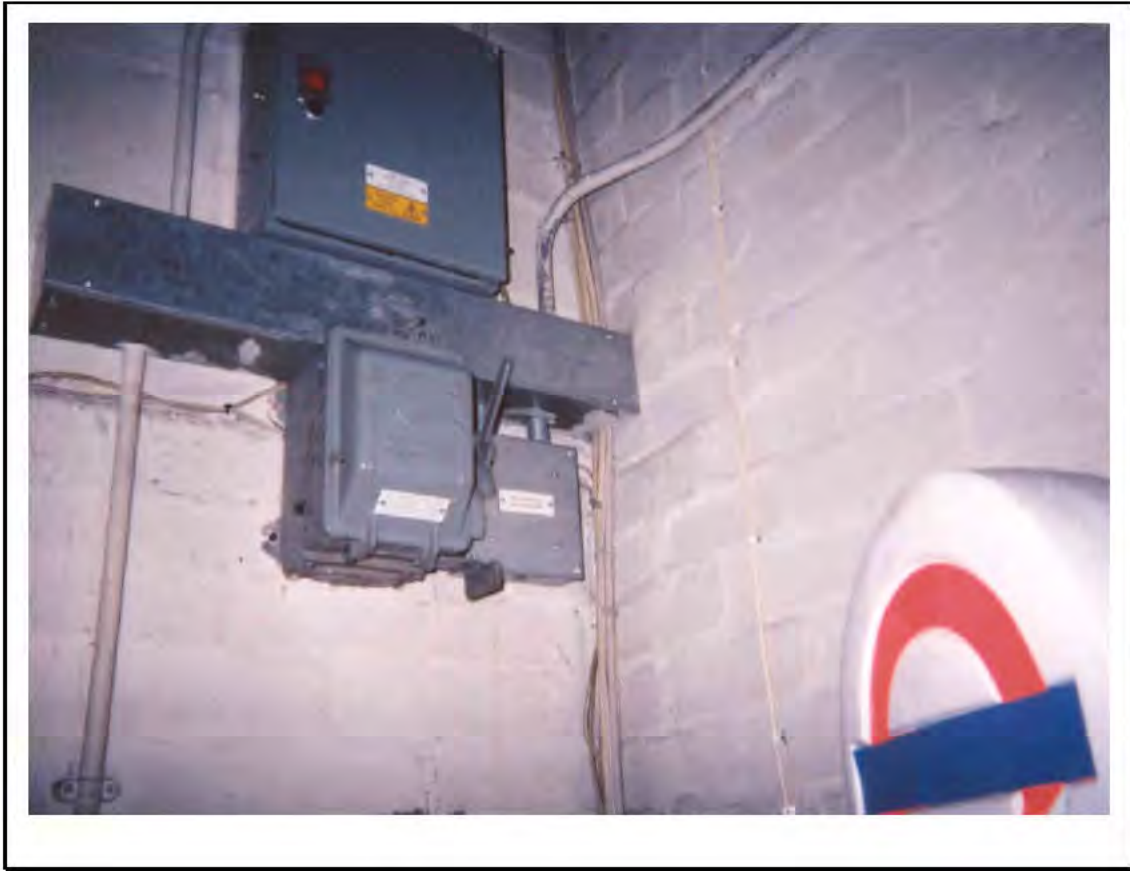
Figure 16: Material Strongly Presumed To Contain Asbestos

Location	Office 1/902, wall 4
Description	Insulation inside one iron clad isolator

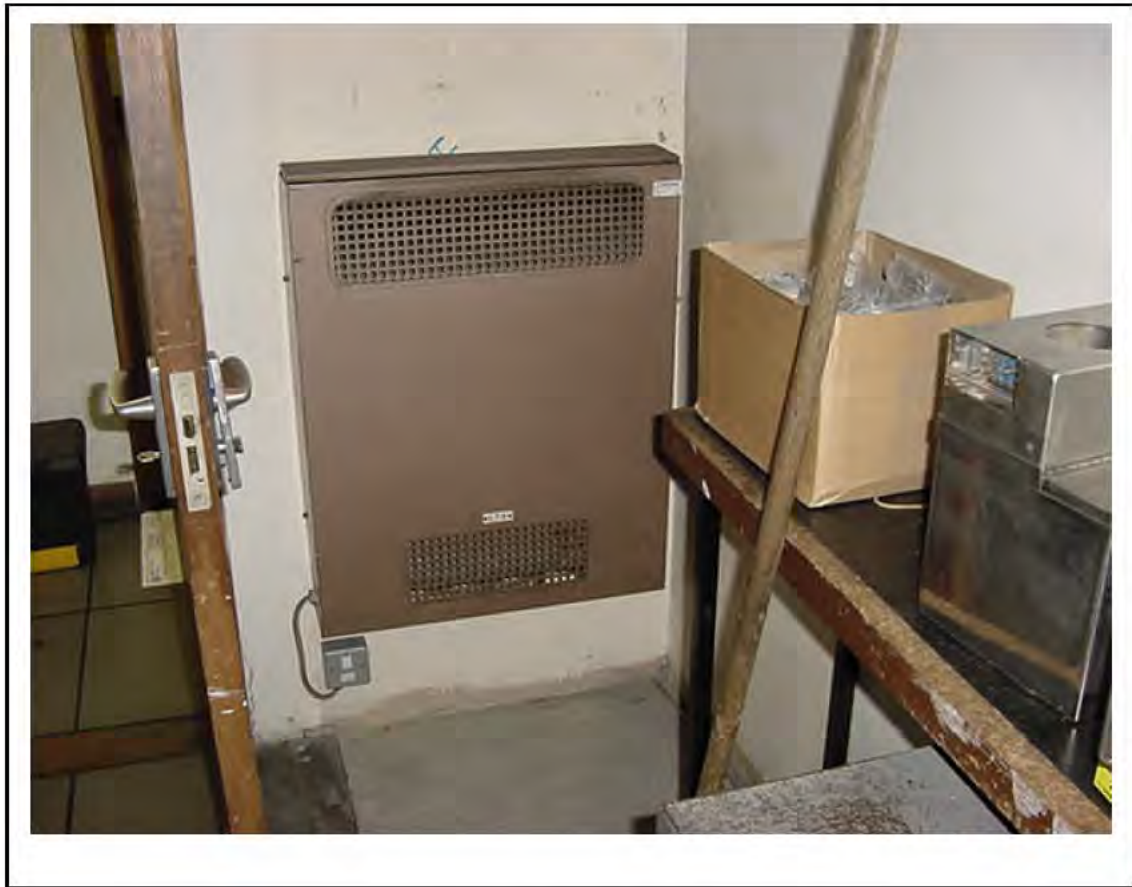
Figure 17: Material Strongly Presumed To Contain Asbestos

Location	POM 1/021, wall 4
Description	Insulation inside LTB, LUL heater

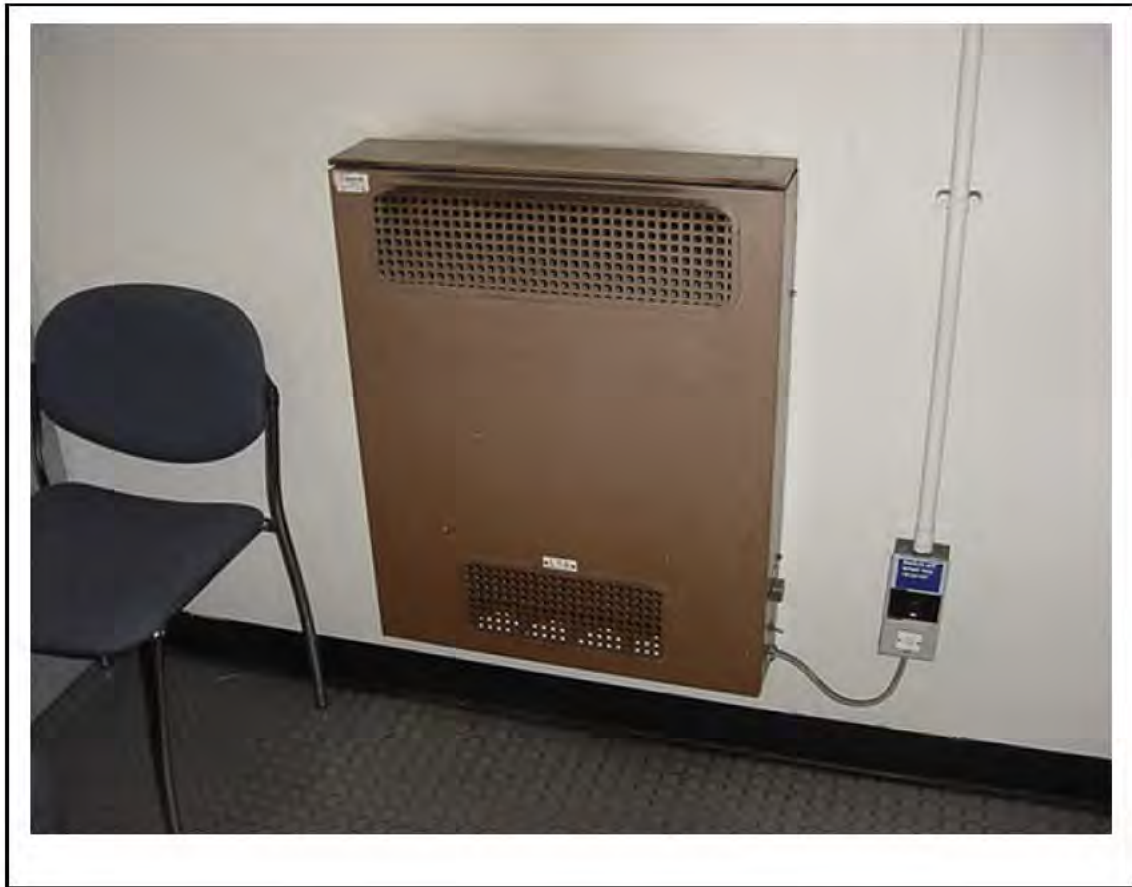
Figure 18: Material Strongly Presumed To Contain Asbestos

Location	Office 1/311, wall 3
Description	Insulation inside LTB, LUL heater

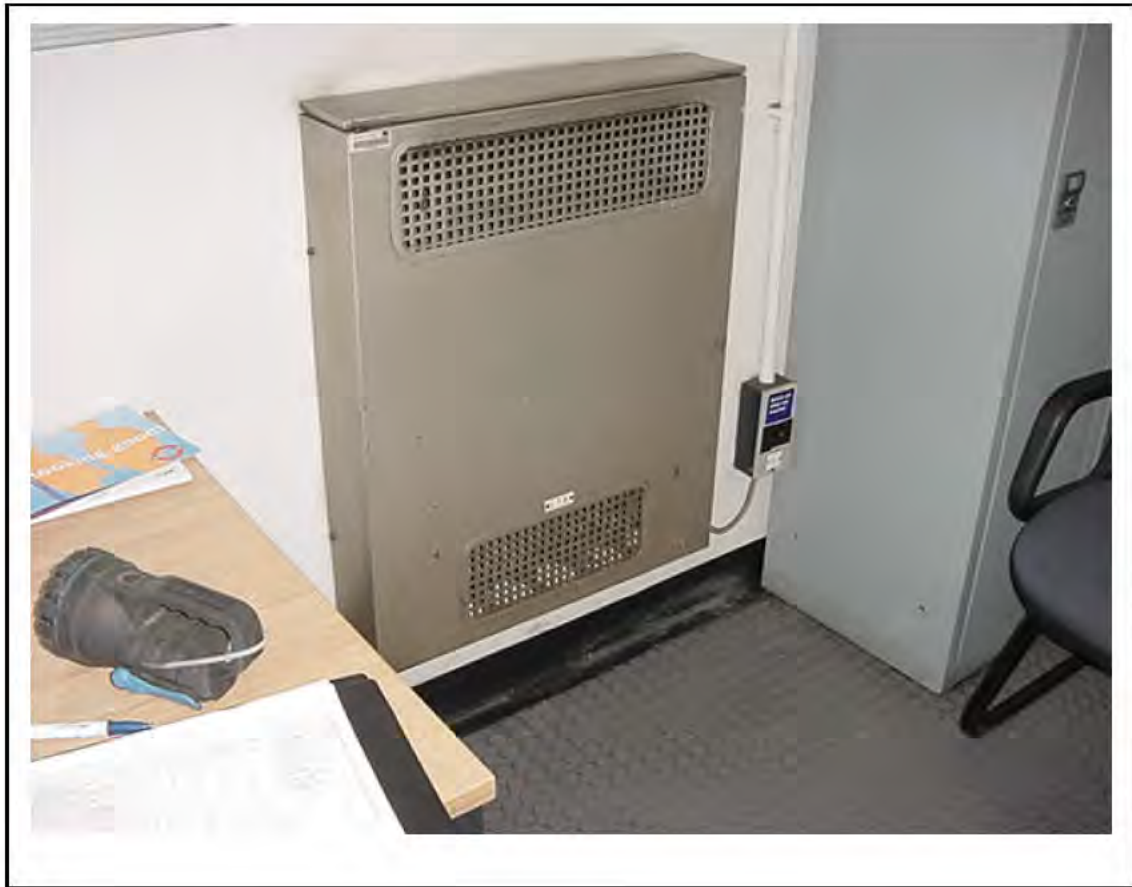
Figure 19: Material Strongly Presumed To Contain Asbestos

Location	Mess room 1/031, wall 1
Description	Insulation inside LTB, LUL heater

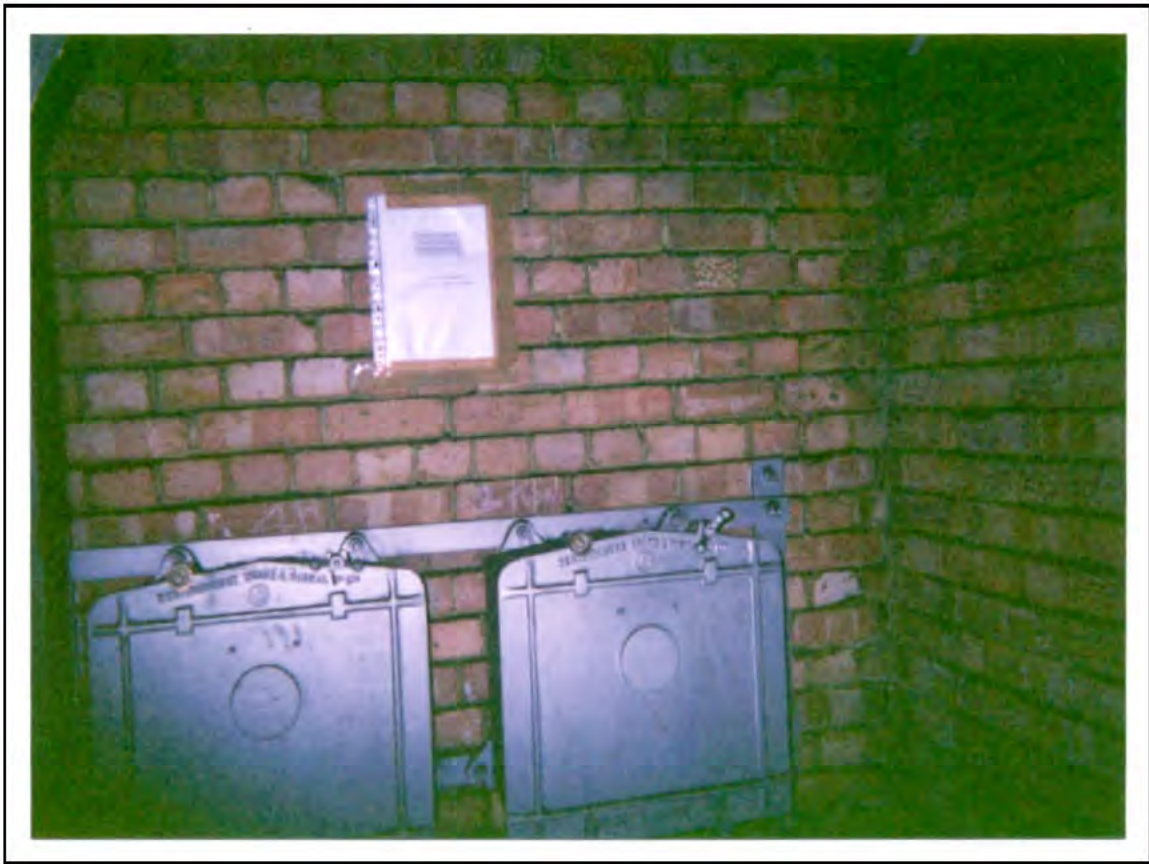
Figure 20: Material Strongly Presumed To Contain Asbestos

Location	Lobby 2/081
Description	Insulation inside Westinghouse boxes wall 1 and wall 4

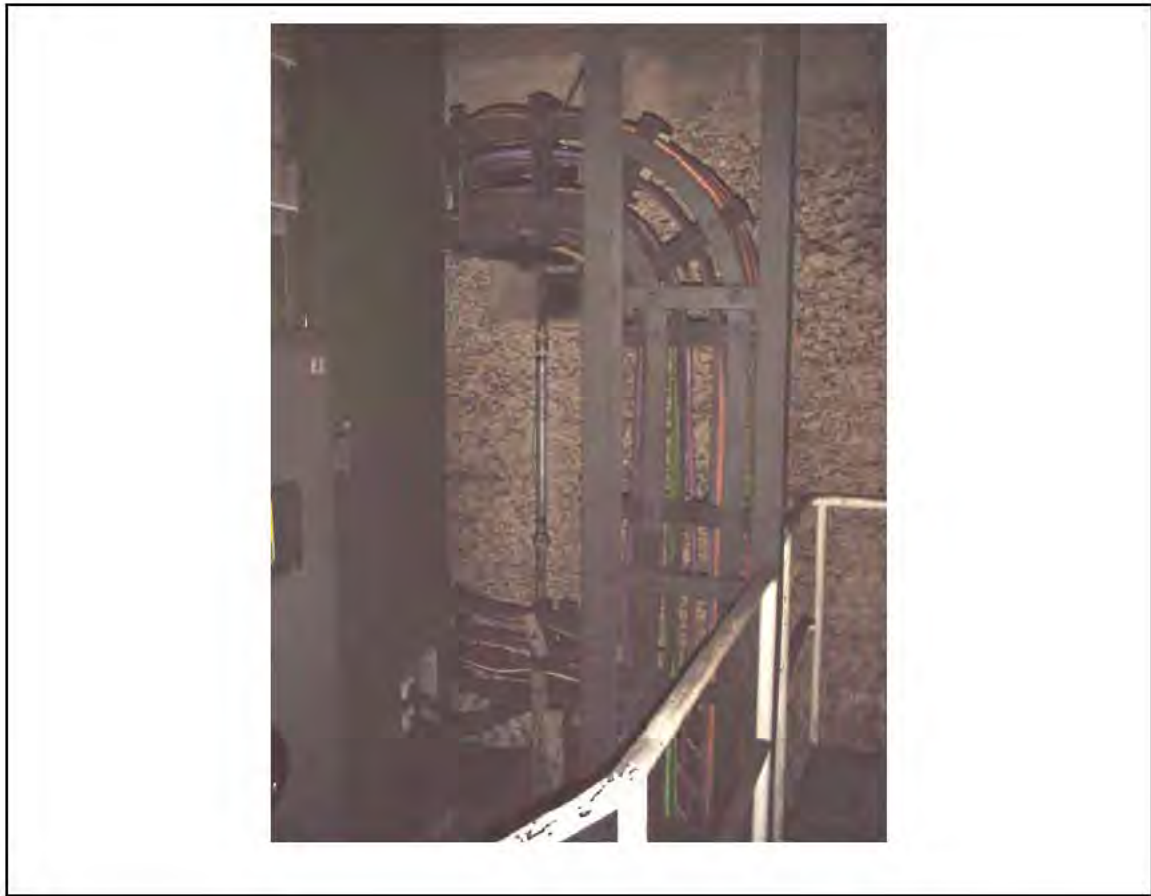
Figure 21: Material Strongly Presumed To Contain Asbestos

Location	Lobby 2/081 between walls 2 & 3 cables to invert and to IMR wall 3
Description	Two x 1cm diameter white cables Two x 1cm diameter green cables One x 2cm diameter brown cables Three x 1cm diameter green cables Four x 1cm diameter white cables Two x 1cm diameter brown cables One x 2cm diameter green cables Four x 1cm diameter green cables

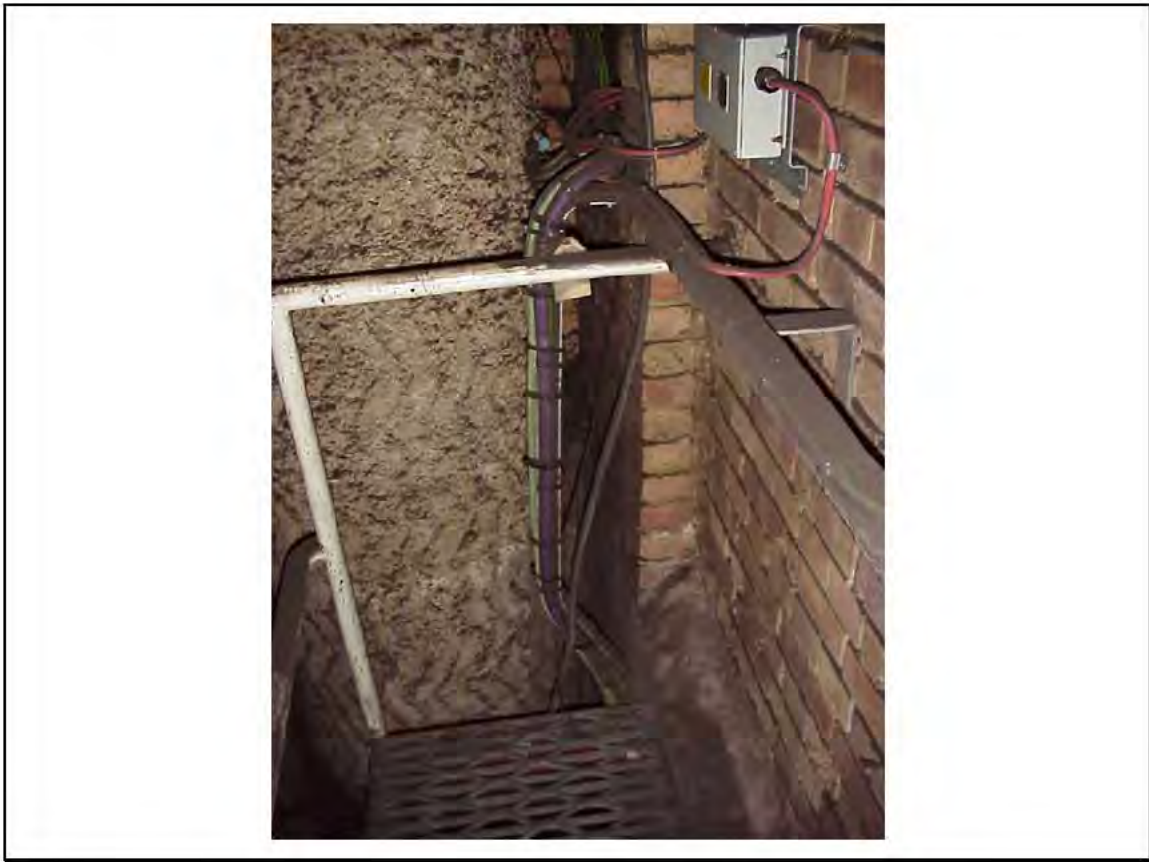
Figure 22: Material Strongly Presumed To Contain Asbestos

Location	Lobby 2/081 Invert to track wall 1
Description	One x 1cm diameter green cable One x 1 cm diameter white cable One x 1cm diameter brown cable
