Report No. 4RS-AW-024661-R20486

ASBESTOS SURVEY, HATTON CROSS STATION

Issue Date: 1st July 2003

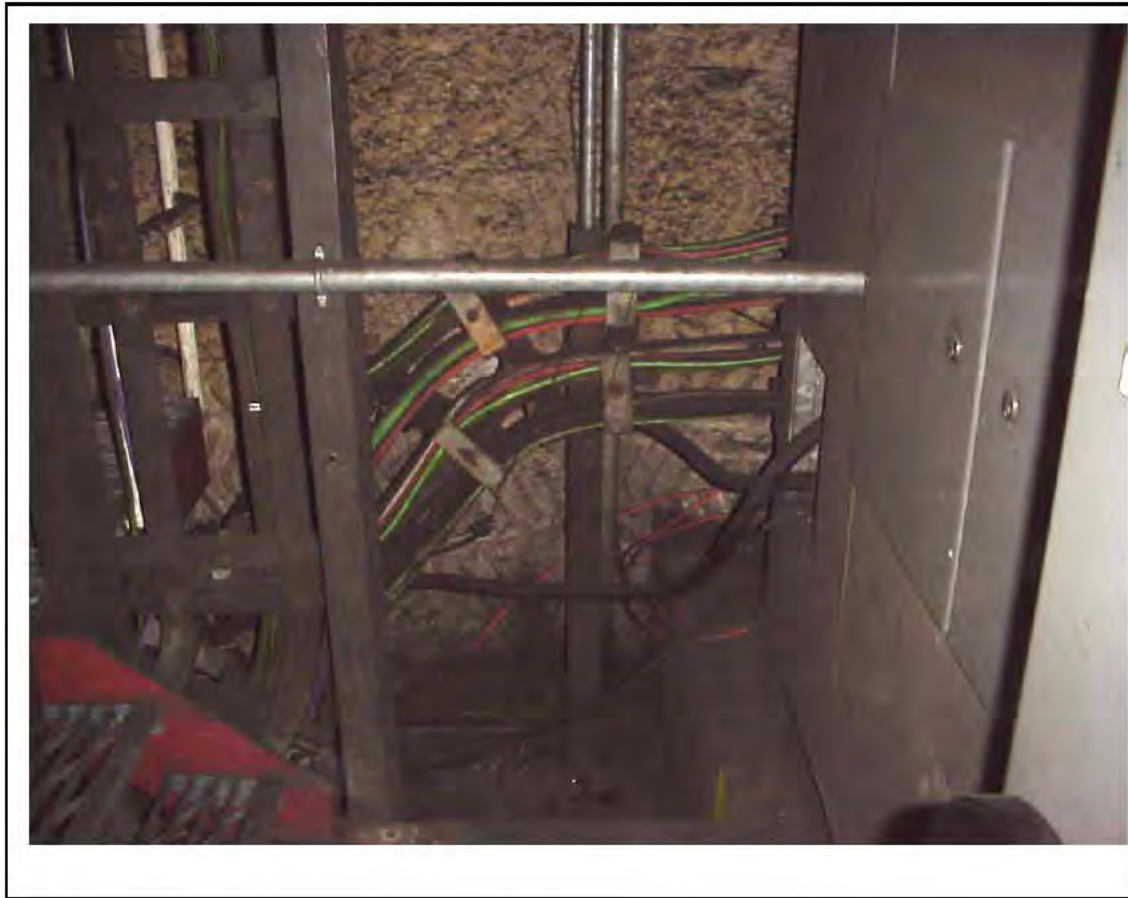
Figure 23: Material Strongly Presumed To Contain Asbestos

Location	Lobby 2/081 invert to IMR, wall 1
Description	Eight x 1cm diameter green cables Three x 1cm diameter white cables Two x 4cm diameter green cables One x 3cm diameter white cable

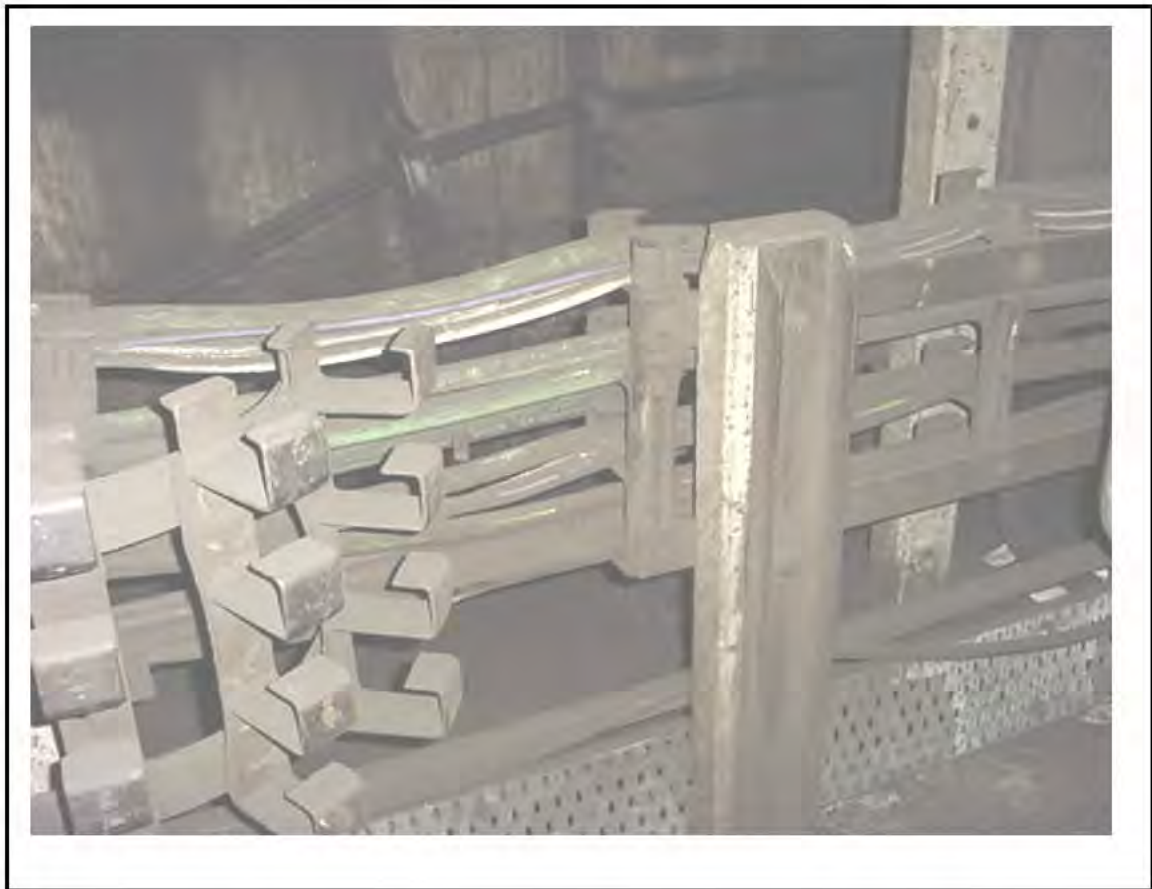
Figure 26: Material Strongly Presumed To Contain Asbestos

Location	Open area cable run eastbound cable hangers 2/414
Description	Four x 1cm diameter white cables Four x 1cm diameter green cables One x 4cm diameter green cable Three x 4cm diameter green cables One x 4cm diameter green cable One x 1cm diameter white cable

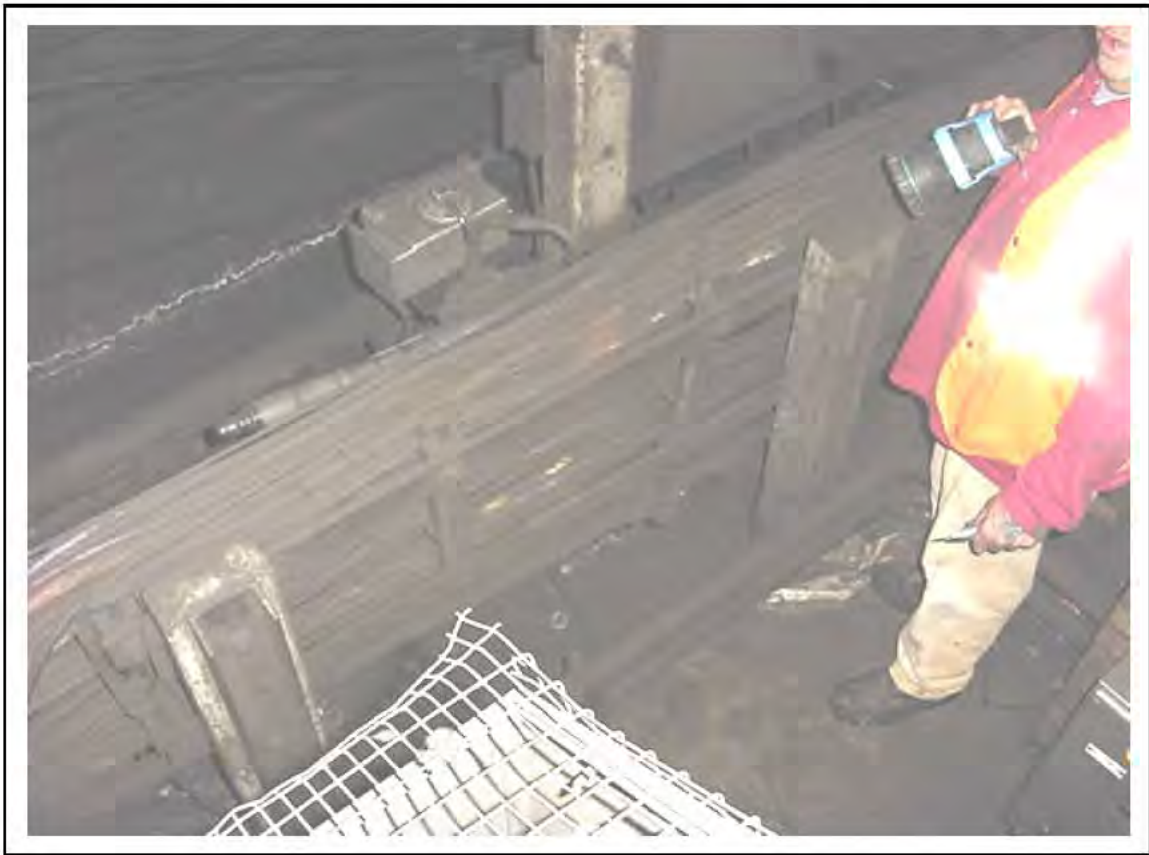
Figure 27: Material Strongly Presumed To Contain Asbestos

Location	Open area cable run westbound cable hangers and trackside wall 2/414
Description	Three x 1cm diameter white cables Three x 1cm diameter green cables One x 1cm diameter white cable One x 1cm diameter cable

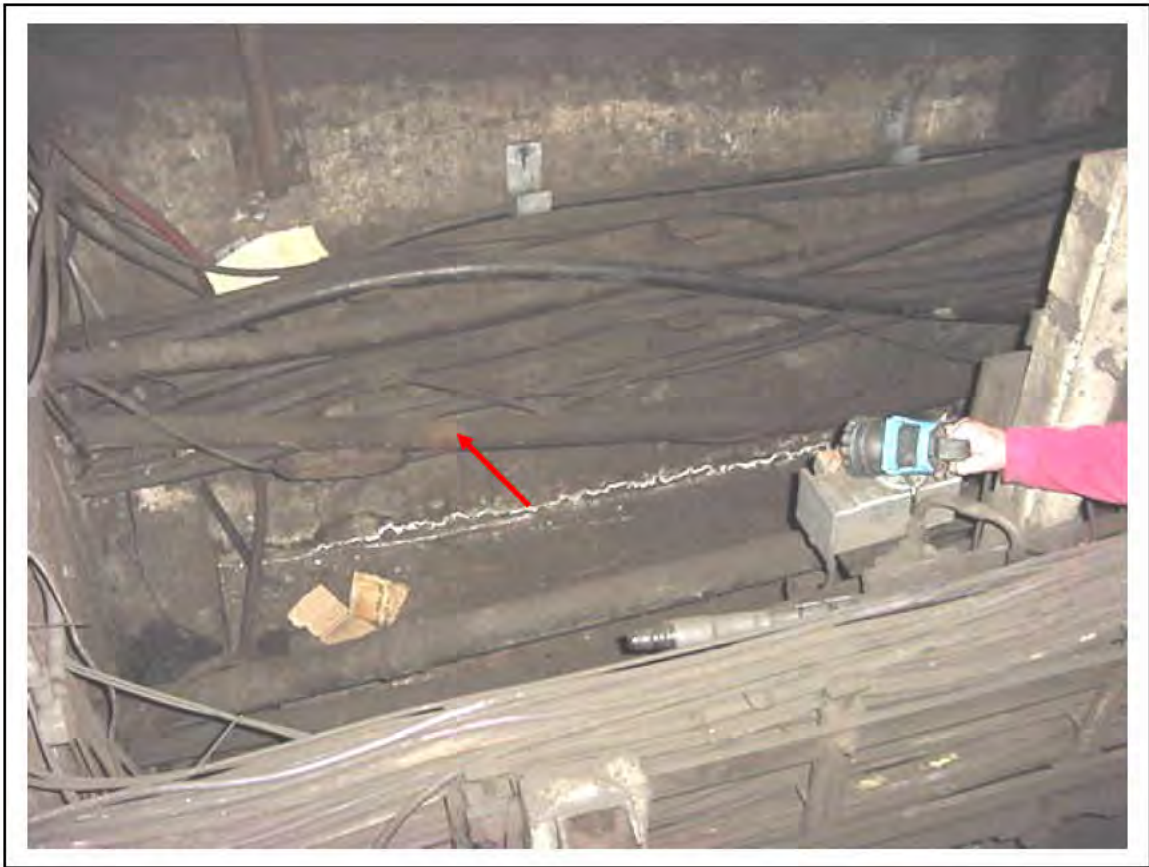
Figure 28: Material Strongly Presumed To Contain Asbestos

Location	Open area westbound side track side wall 2/414
Description	One x 10cm diameter white cable

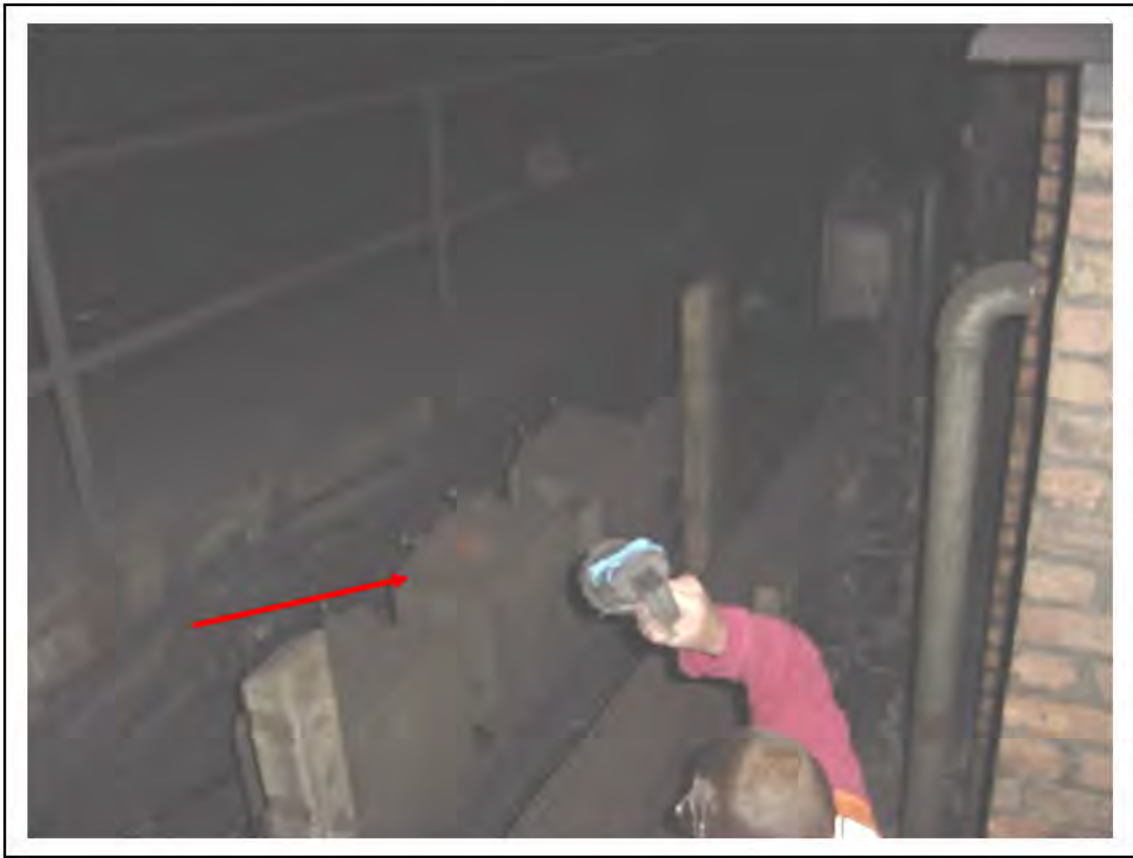
Figure 29: Material Strongly Presumed To Contain Asbestos

Location	Open area westbound side track side wall 2/414
Description	Insulation inside for Westinghouse boxes

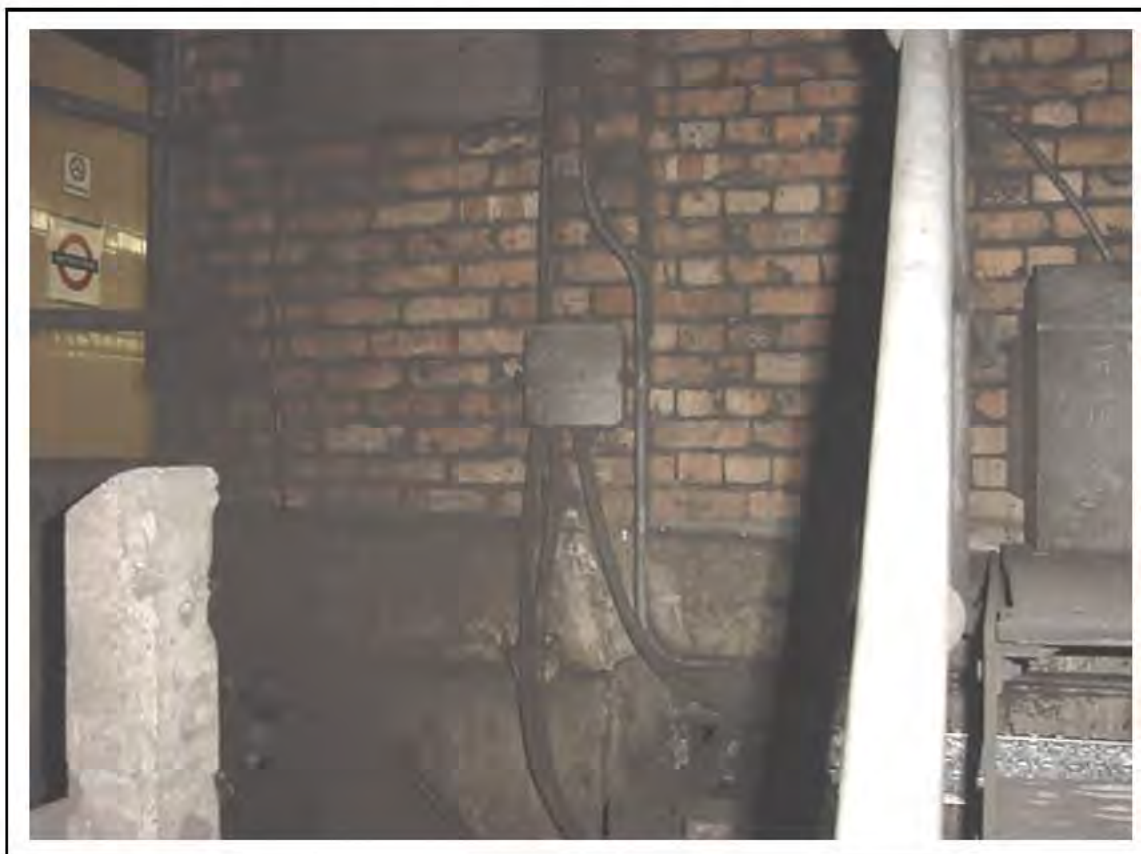
Figure 30: Material Strongly Presumed To Contain Asbestos

Location	Wall by invert Eastbound side 2/414
Description	Insulation inside Westinghouse box and Two x 4cm green cables

Location	Wall by invert Eastbound side and Westbound side 2/414
Description	Six cable sleeves in each encapsulated in concrete

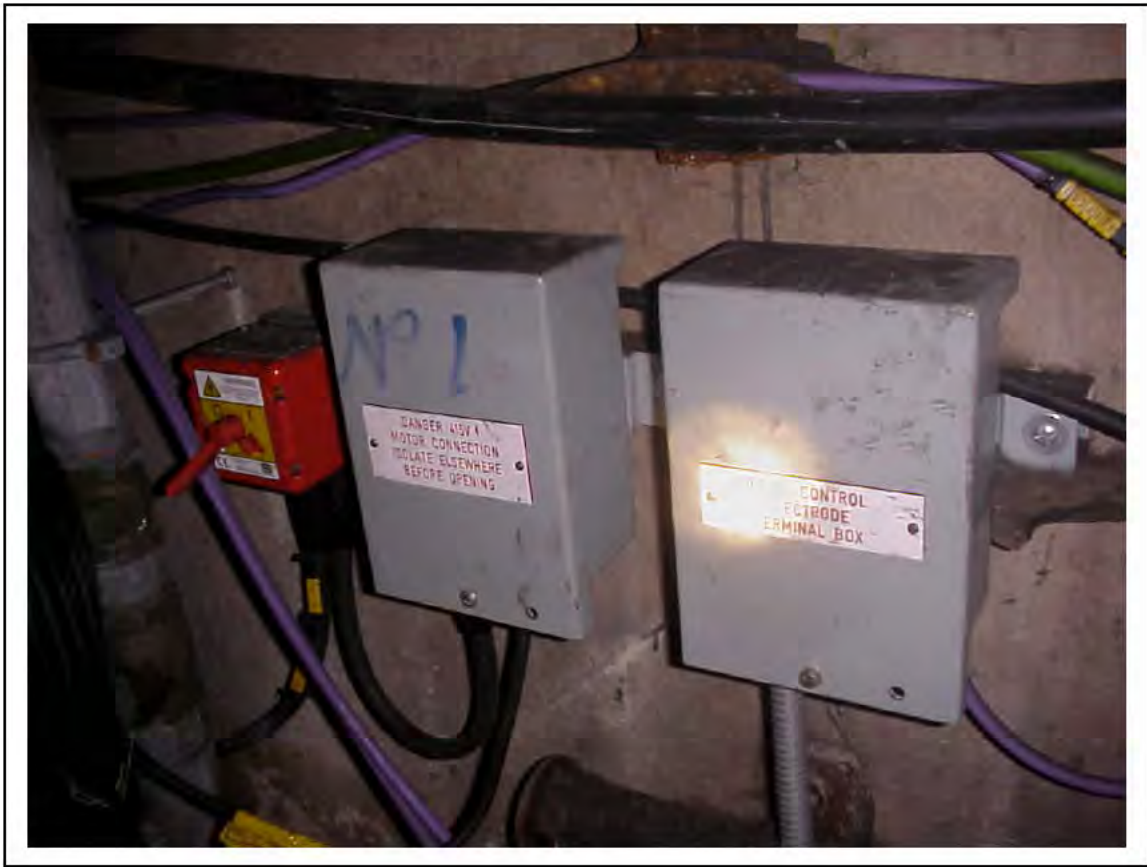
Figure 32: Material Strongly Presumed To Contain Asbestos

Location	Platform 2 concourse invert hatch near 2/081
Description	Insulation inside three metal fuse boxes 10m from hatch

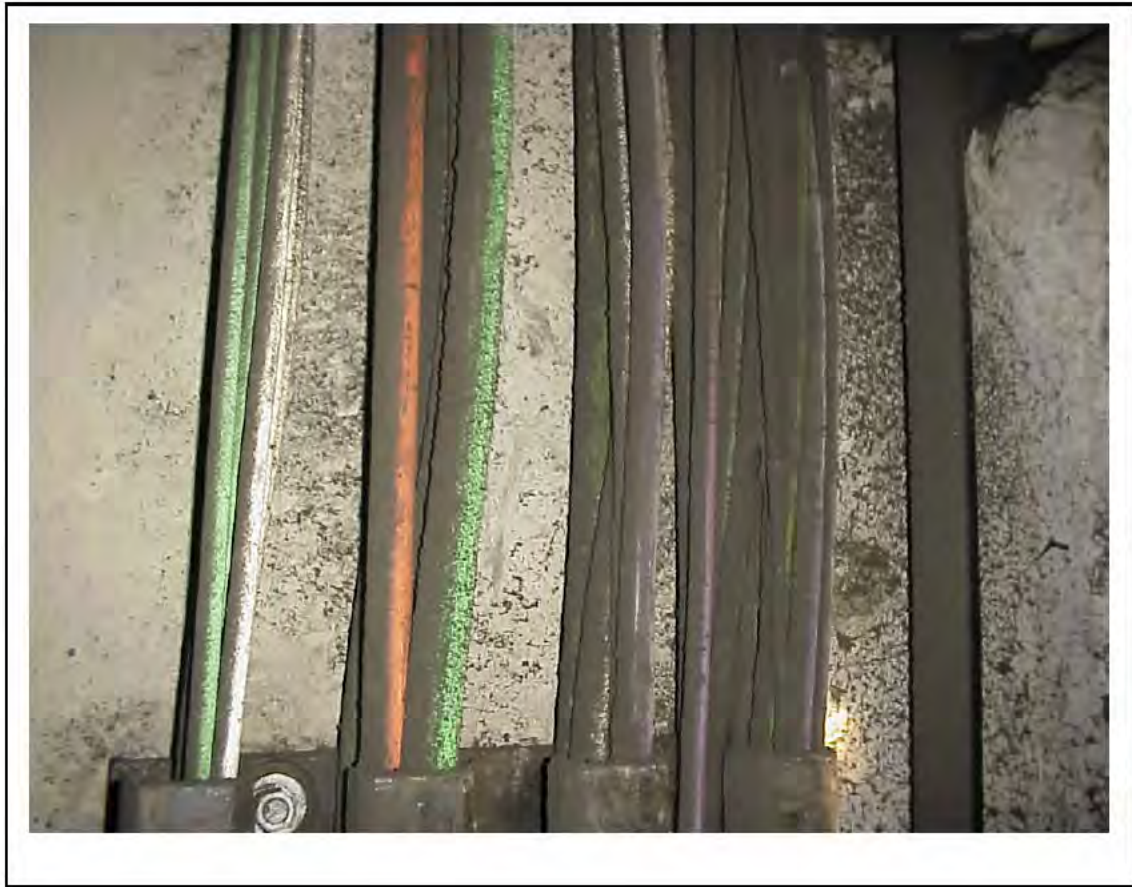
Figure 33: Material Strongly Presumed To Contain Asbestos

Location	Platform 2 invert down hatch near 2/414
Description	Six x 1cm diameter white, 5m length visible cable

Location	Platform 2 invert down hatch near 2/414
Description	Five x 1cm diameter green, 5m length visible cable

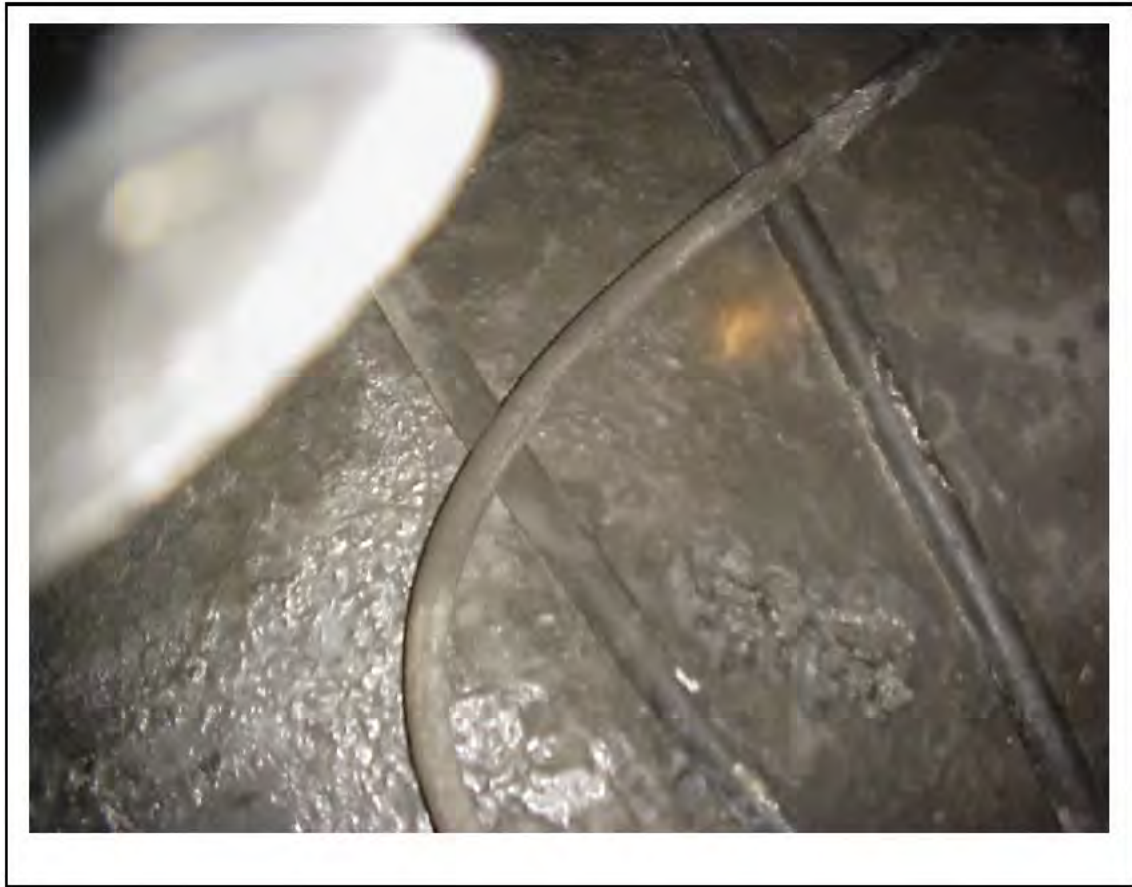
Figure 34: Material Strongly Presumed To Contain Asbestos

Location	Platform 2 invert 25 metres from entrance
Description	Cables cut

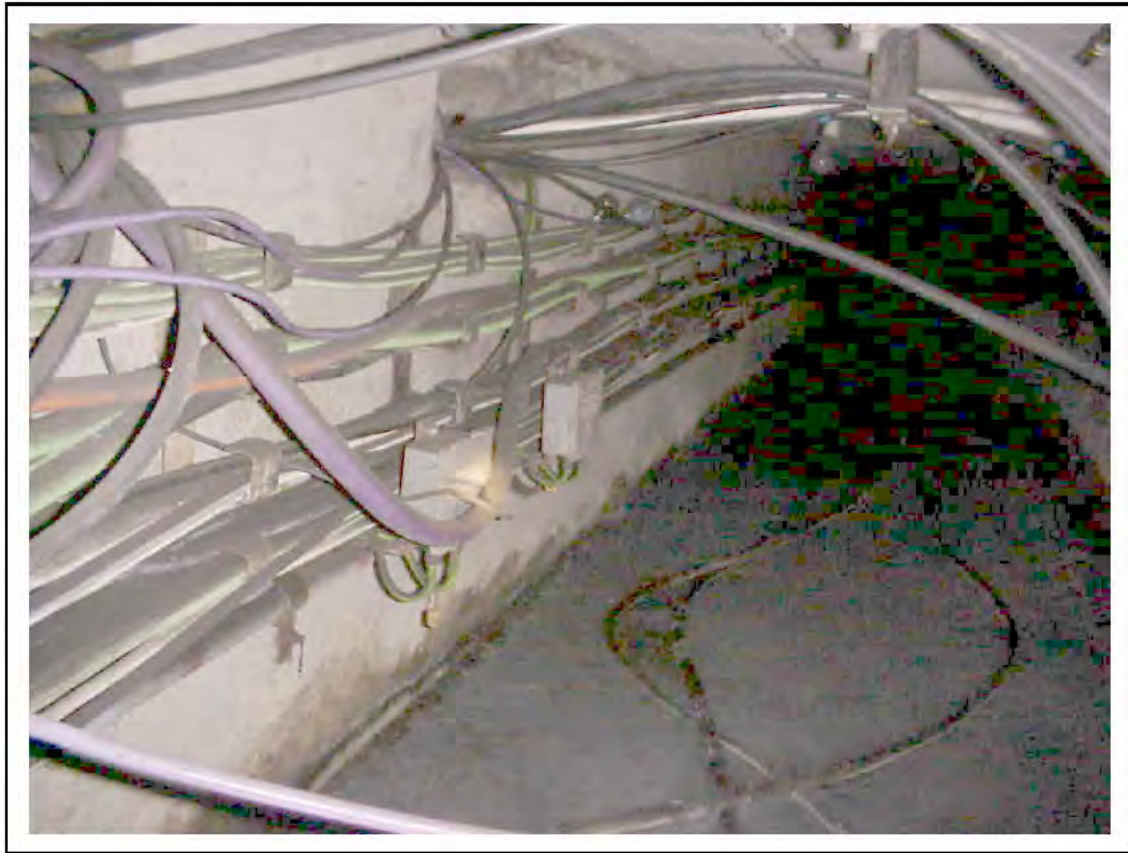
Figure 35: Material Strongly Presumed To Contain Asbestos

Location	Platform 2 invert
Description	Two Westinghouse boxes, potential chrysotile rope door seals

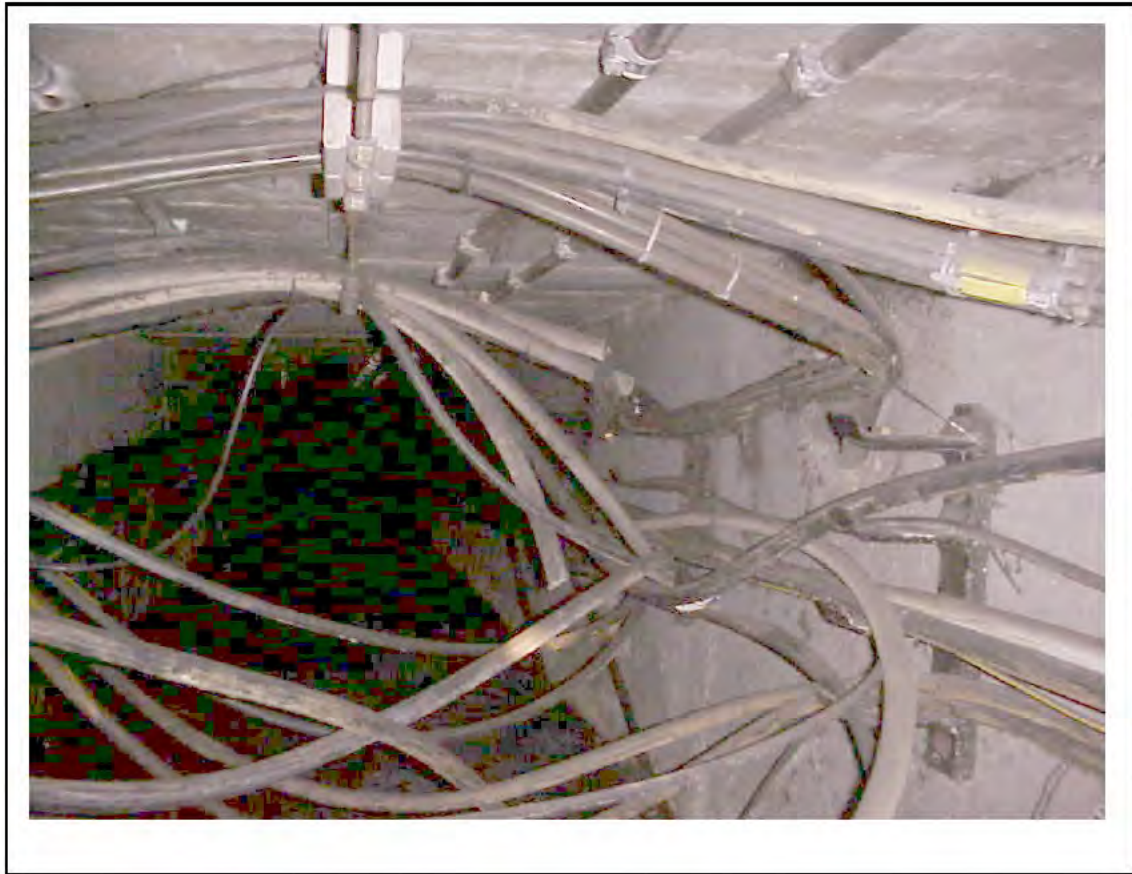
Figure 36: Material Strongly Presumed To Contain Asbestos

Location	Platform 2 invert near 2/732
Description	Cables, 2 x 25 metres and 2 x 20 metres, white

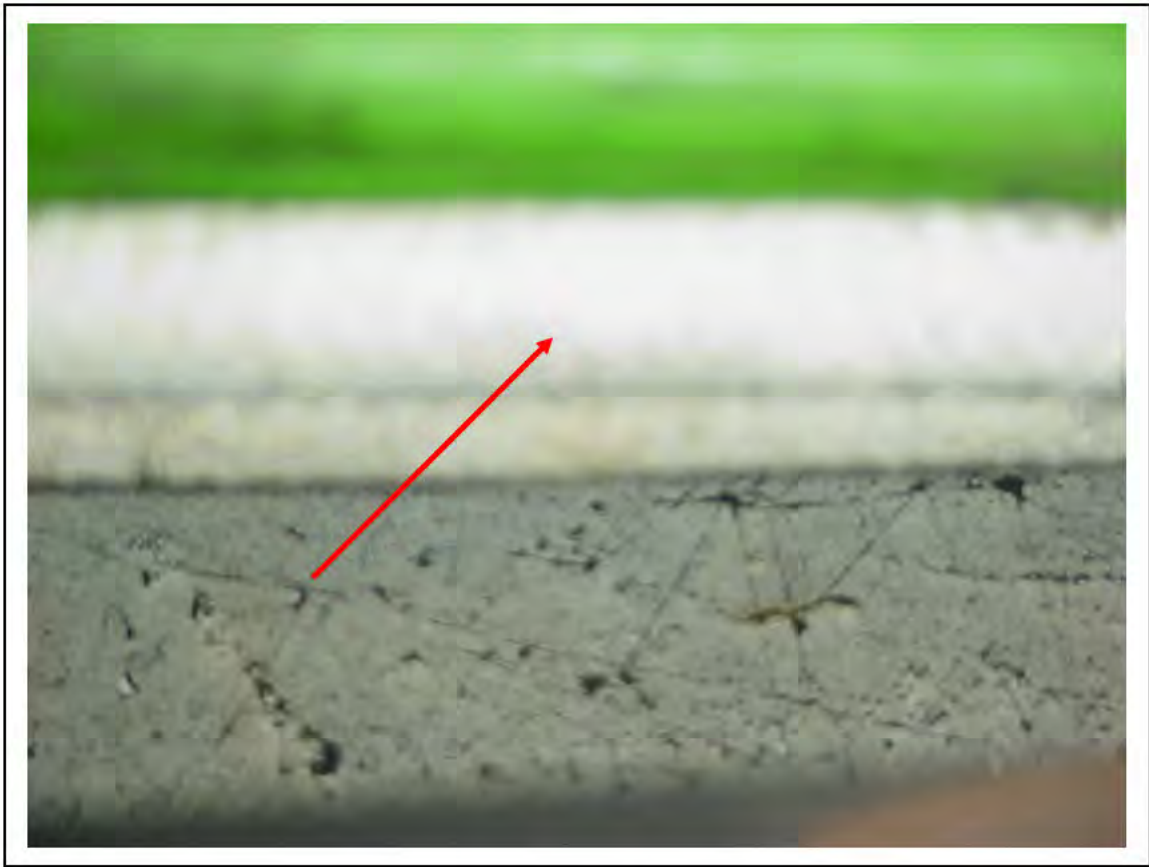
Figure 37: Material Strongly Presumed To Contain Asbestos

Location	Platform 1 invert down hatch 2/414 along platform side
Description	Three x 1cm diameter cables

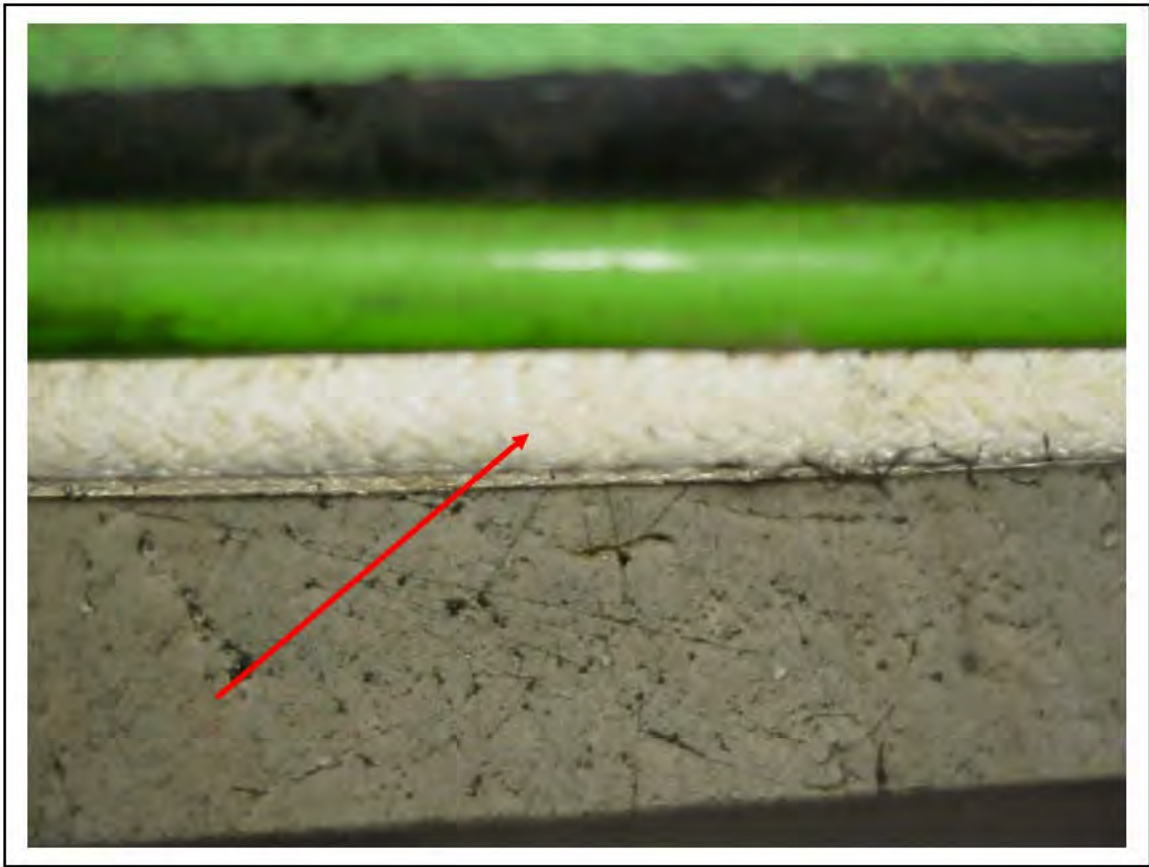
Figure 38: Material Strongly Presumed To Contain Asbestos

Location	Platform 1 invert down hatch 2/414 down platform side
Description	One x 1cm diameter green cable

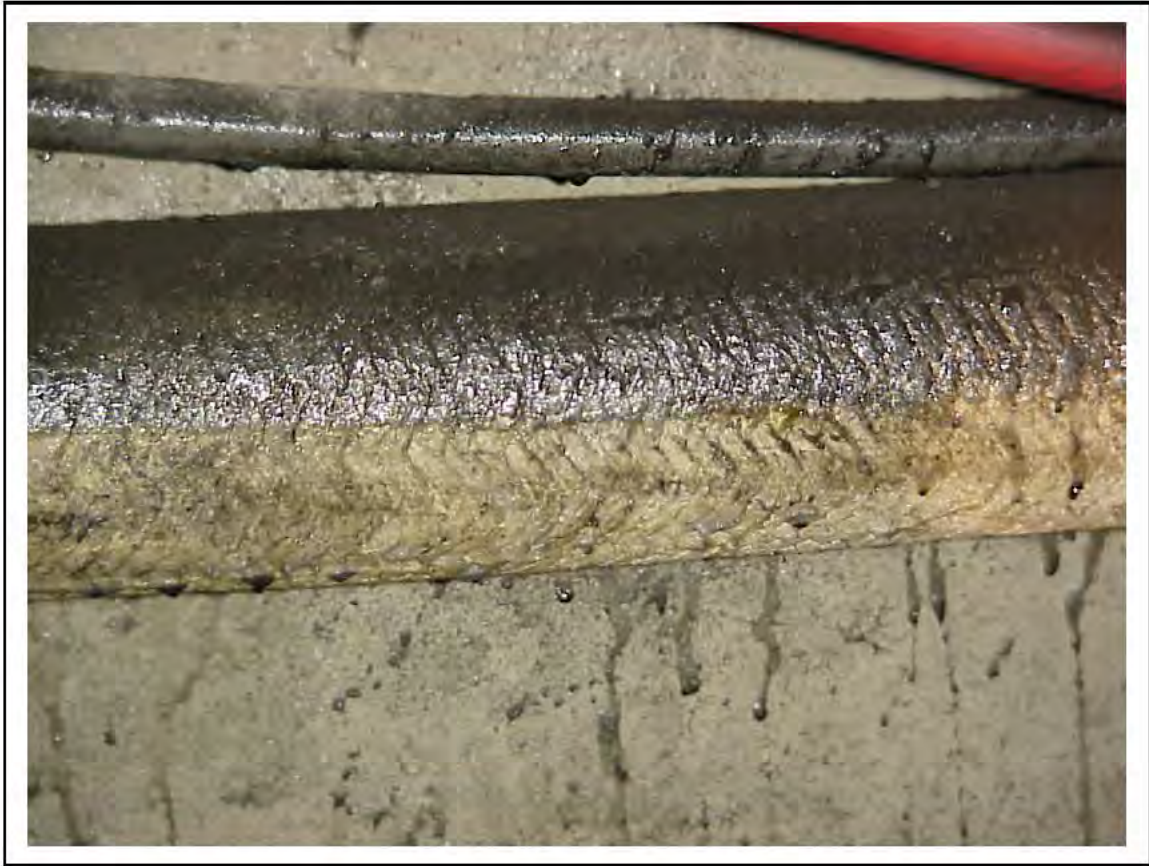
Figure 39: Material Strongly Presumed To Contain Asbestos

Location	Platform 1 invert down hatch 2/414 down pit side
Description	One x 40cm diameter cables

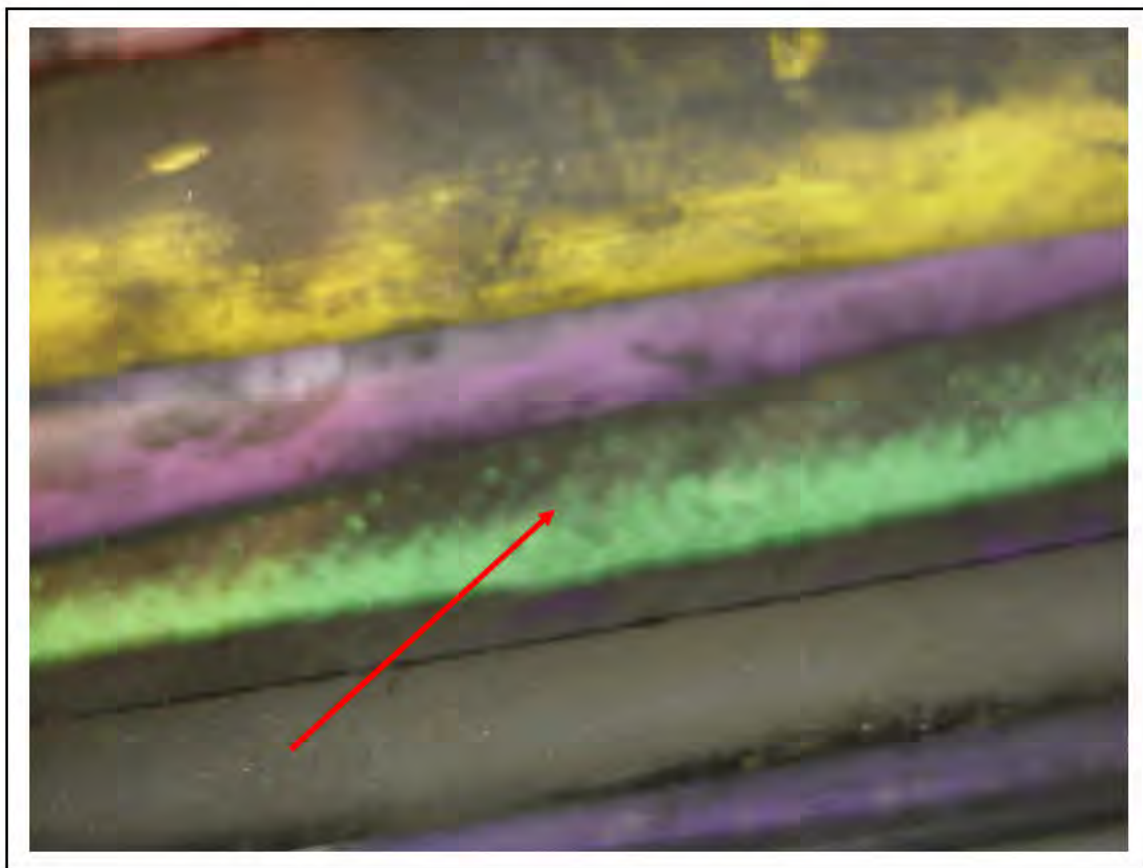
Figure 40: Material Strongly Presumed To Contain Asbestos

Location	Platform 1 invert down hatch 2/414 down platform side
Description	Two x 5cm diameter cables

Location	Platform 1 invert down hatch 2/414 from concourse side along pit wall side
Description	Two cut cables

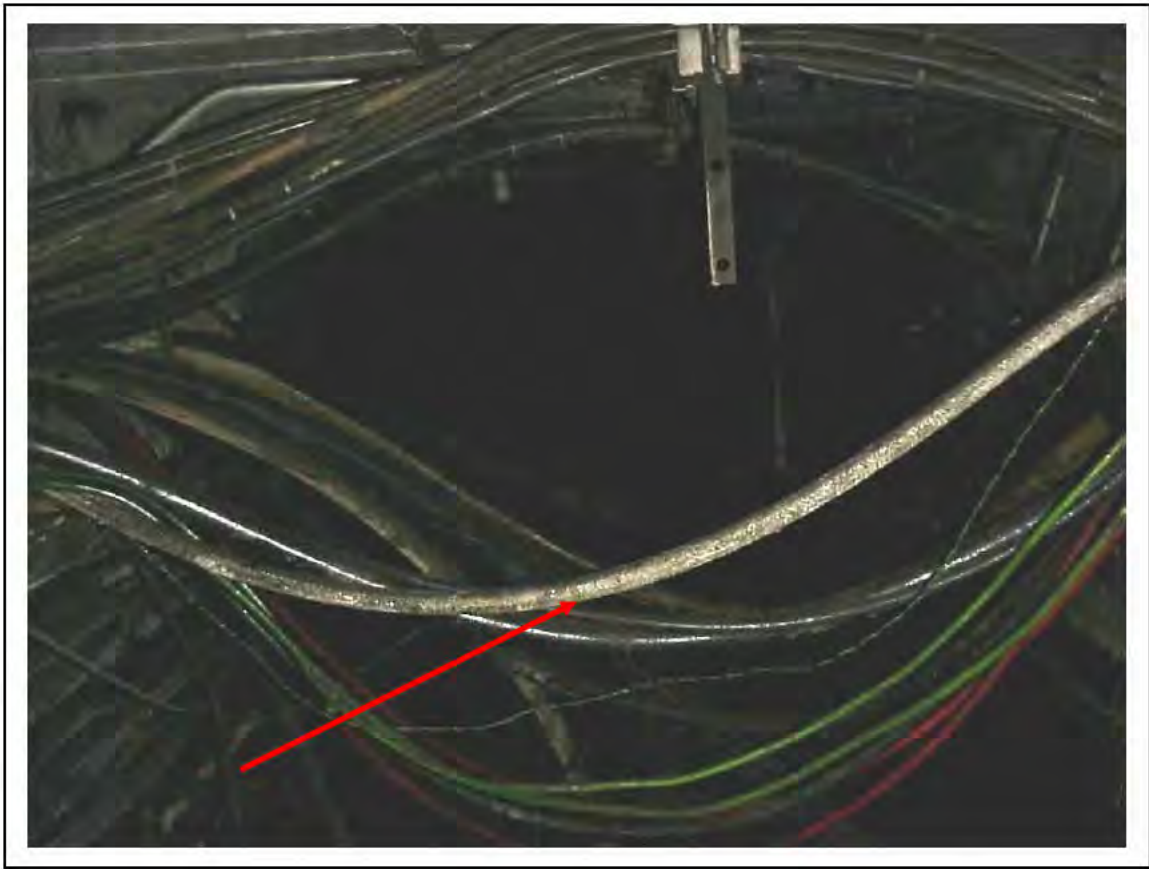
Figure 41: Material Strongly Presumed To Contain Asbestos

Location	Platform 1 invert half way along, pit wall to concourse side, other cables crossing between concourse and invert
Description	One 40cm and six other cables

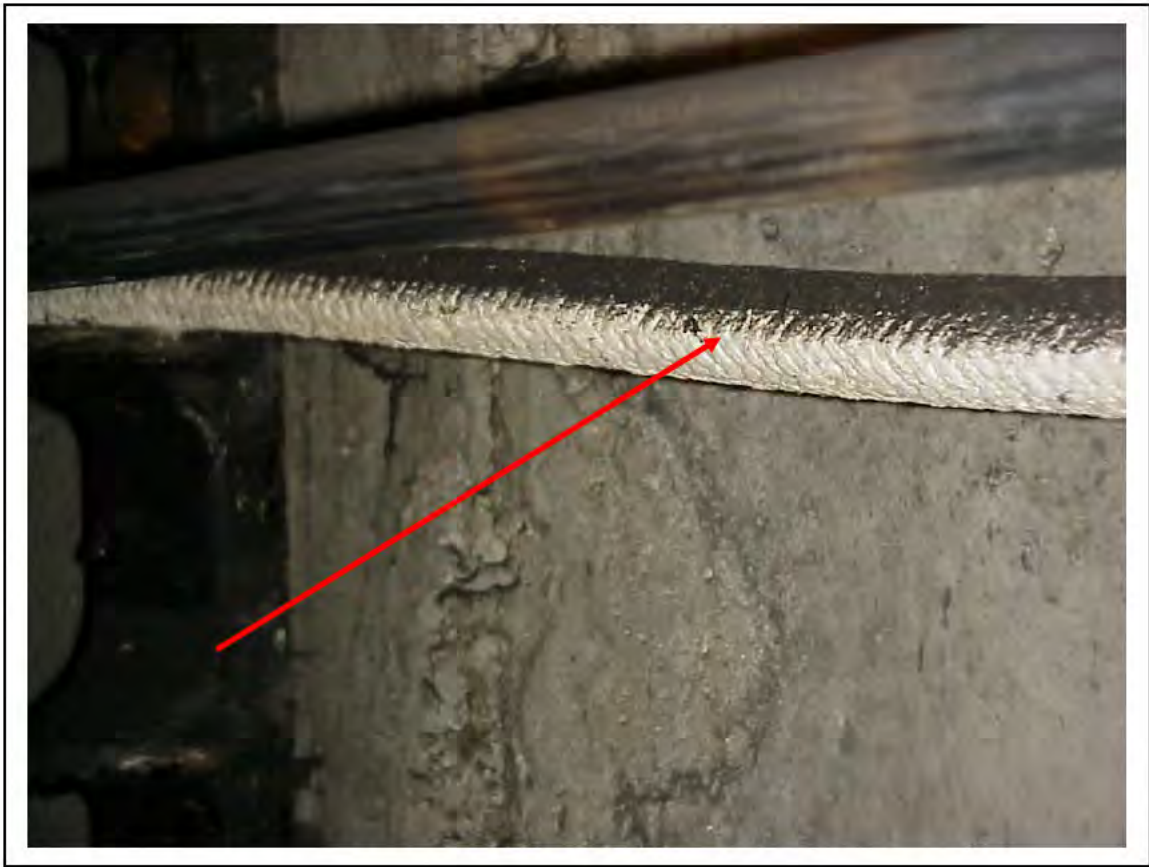
Figure 42: Material Strongly Presumed To Contain Asbestos

Location	Platform 1 invert from end hatch near room 2/712, pit side
Description	One x 1.5cm diameter cable

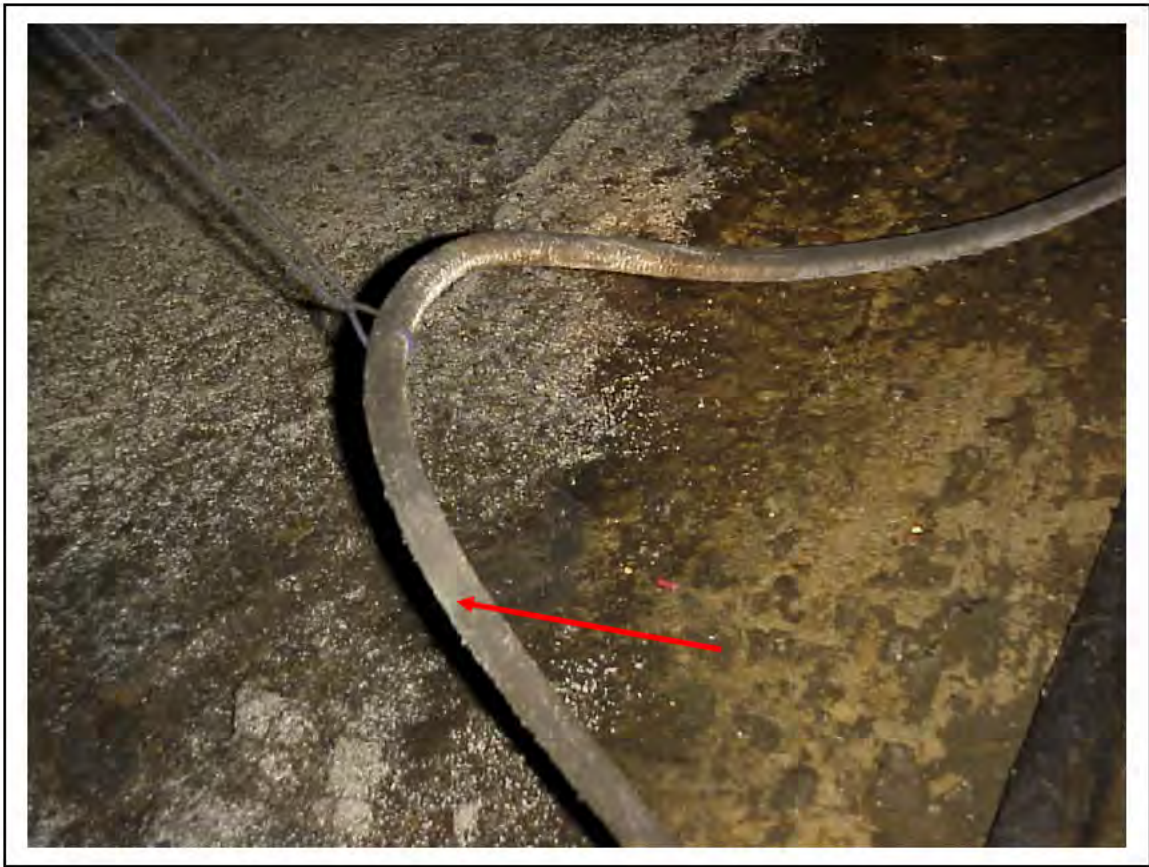
Figure 43: Material Strongly Presumed To Contain Asbestos

Location	Platform 1 invert from end hatch near room 2/712 from concourse to pit wall then along invert
Description	One x 1cm diameter cable

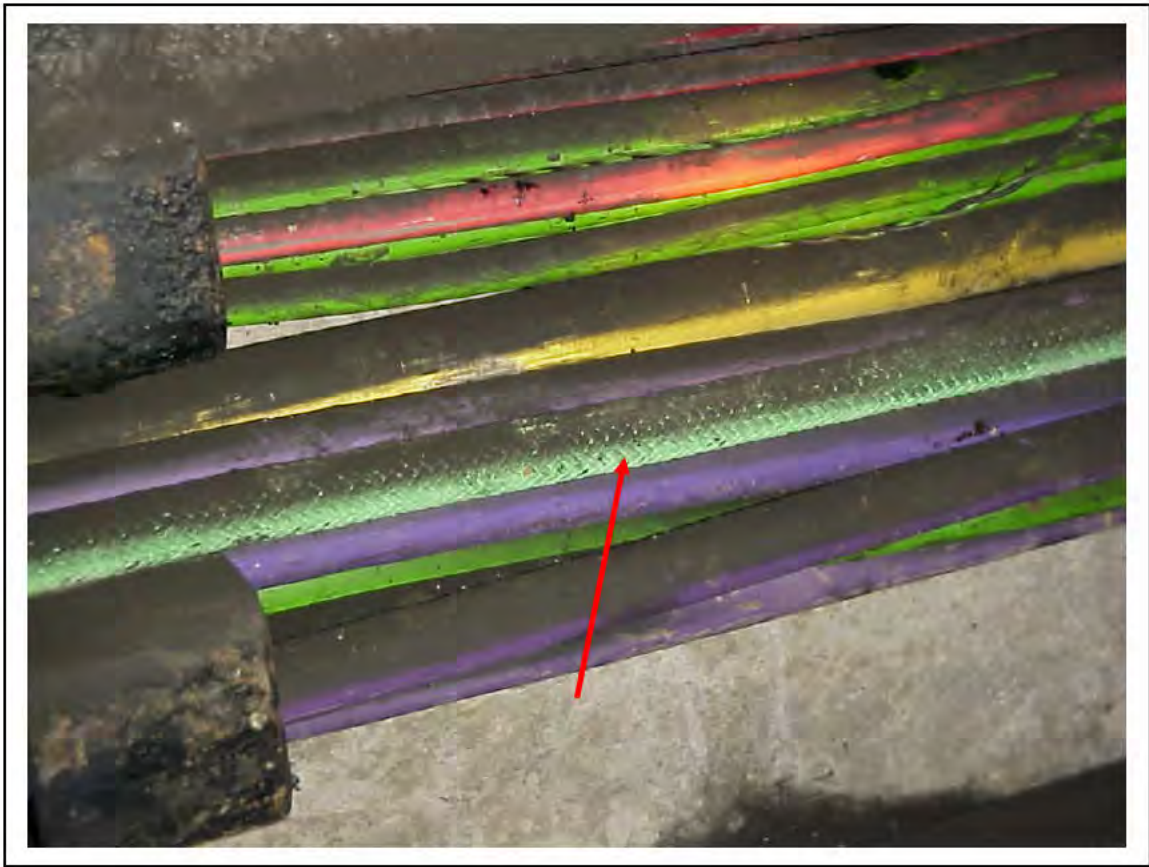
Figure 44: Material Strongly Presumed To Contain Asbestos

Location	Platform 1 invert from end hatch near room 2/712 halfway down concourse, running down concourse side
Description	Two x 5cm diameter and one x 1cm diameter cable

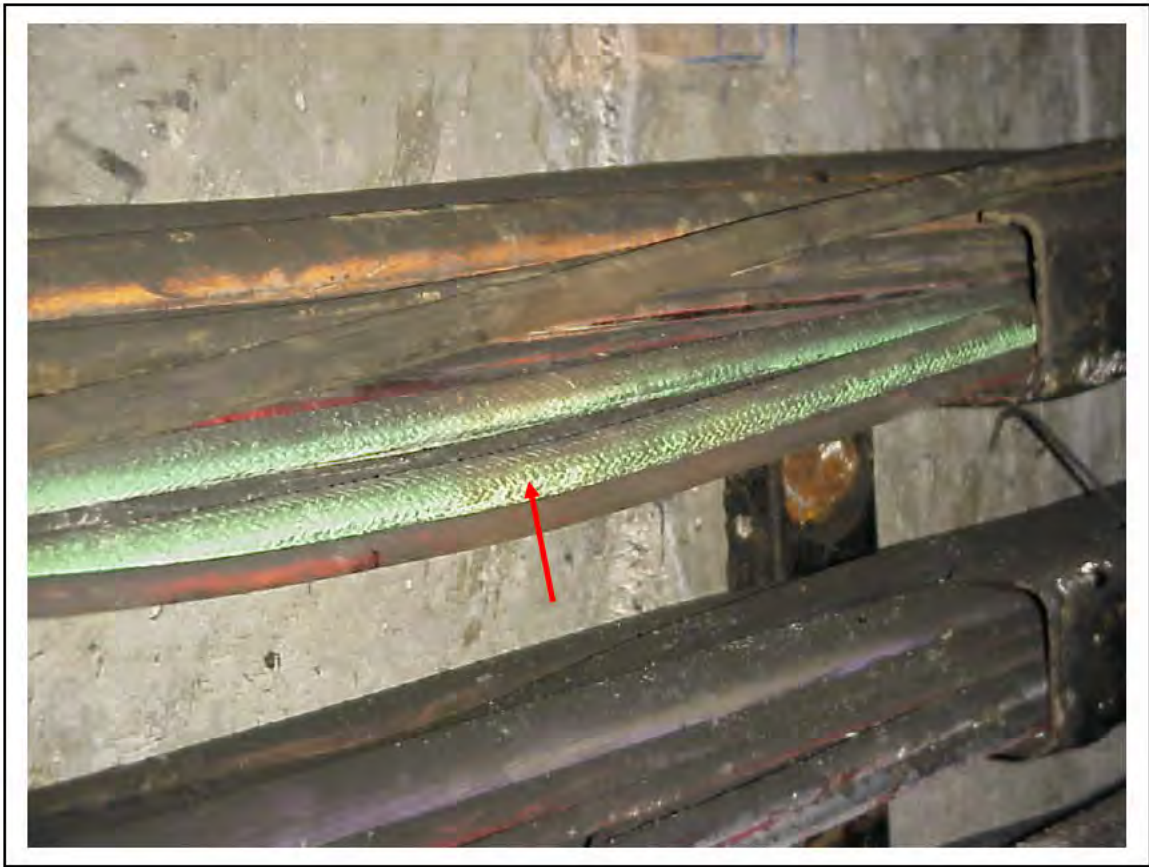
Figure 45: Material Strongly Presumed To Contain Asbestos

Location	Platform 1 invert from end hatch near room 2/712
Description	Seven x 1cm diameter cable
