Report No. 4RS-AW-024663-R20488

## TYPE 2 ASBESTOS SURVEY OF HEATHROW TERMINAL 4 STATION

Prepared for: **Chris Thompson**  
**Rail Asbestos Control Unit**  
**Tube Lines Limited**

Issue Date: 16<sup>th</sup> June 2003

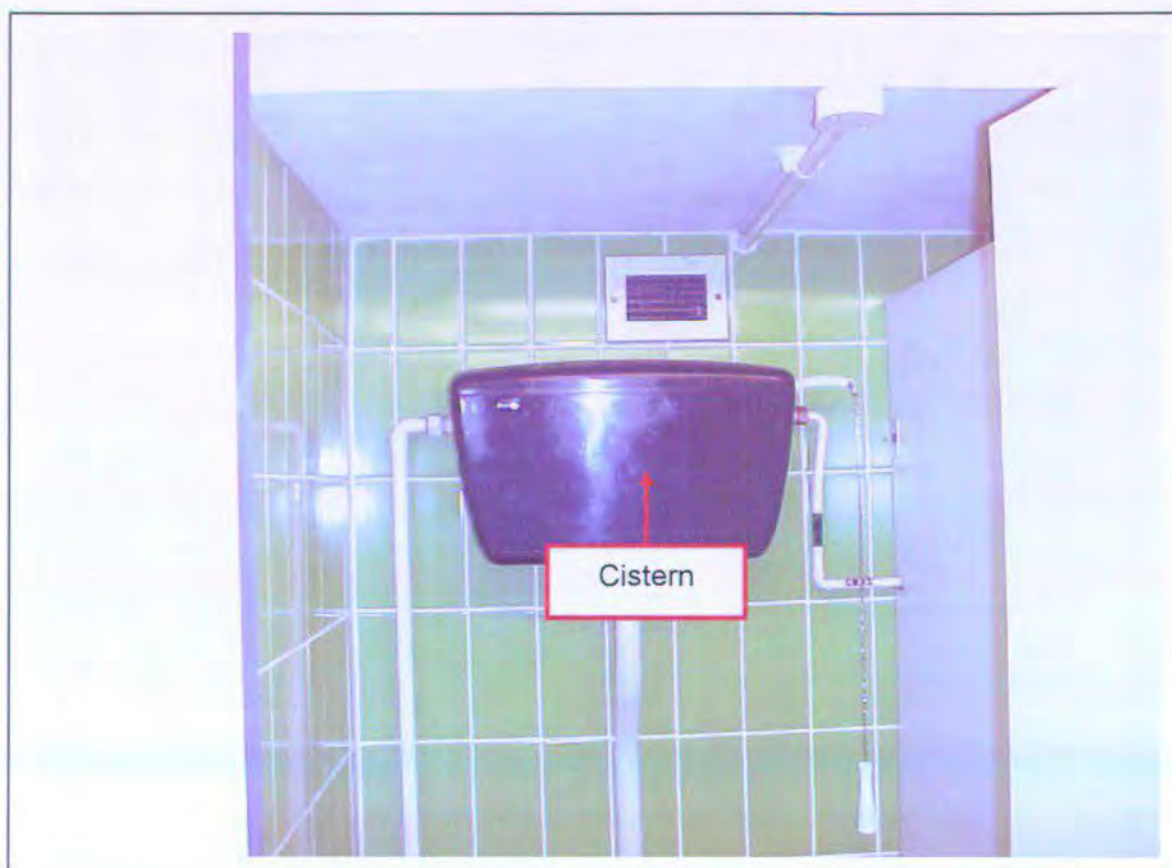
Figure 1: Sample No. 024663/2 – Description and Analysis Results

Sample number	024663/2
Location	Toilet 2/417, second toilet
Description	Toilet cistern to wall
Product Type	Composite
Current Condition	Slight damage
Surface Treatment	Composite
Asbestos Content	Chrysotile
Material Assessment Factor	3
Potential for disturbance	Low
Risk Assessment Factor	6

Sample number	Same as 024663/2
Location	Toilet 2/417
Description	Toilet cistern to wall, first toilet
Product Type	Composite
Current Condition	Slight damage
Surface Treatment	Composite
Asbestos Content	Chrysotile
Material Assessment Factor	3
Potential for disturbance	Low
Risk Assessment Factor	6

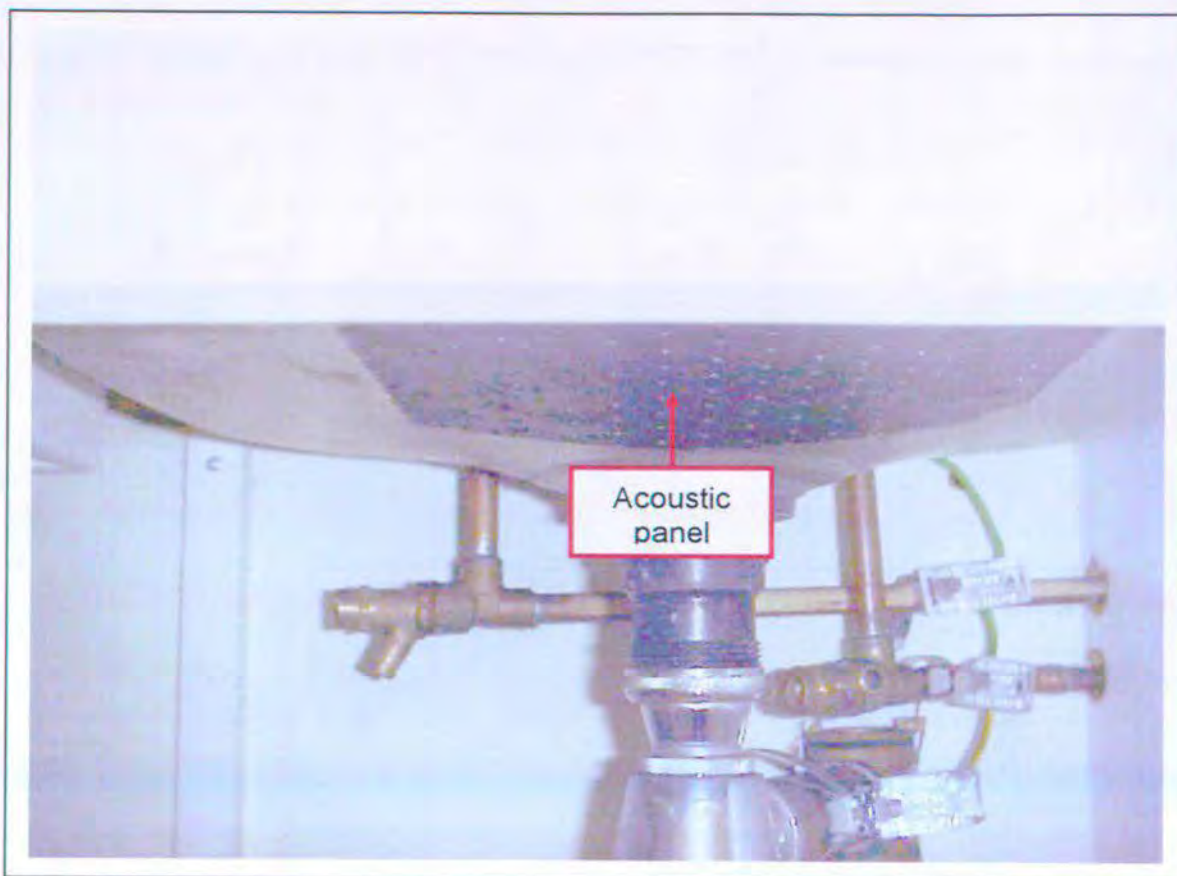
Figure 2: Sample No. 024663/3 – Description and Analysis Results

Sample number	024663/3
Location	Toilet 2/417, second toilet
Description	Under sink acoustic panel
Product Type	Composite
Current Condition	Slight damage
Surface Treatment	Composite
Asbestos Content	Chrysotile
<i>Material Assessment Factor</i>	3
Potential for disturbance	Very low
<i>Risk Assessment Factor</i>	6

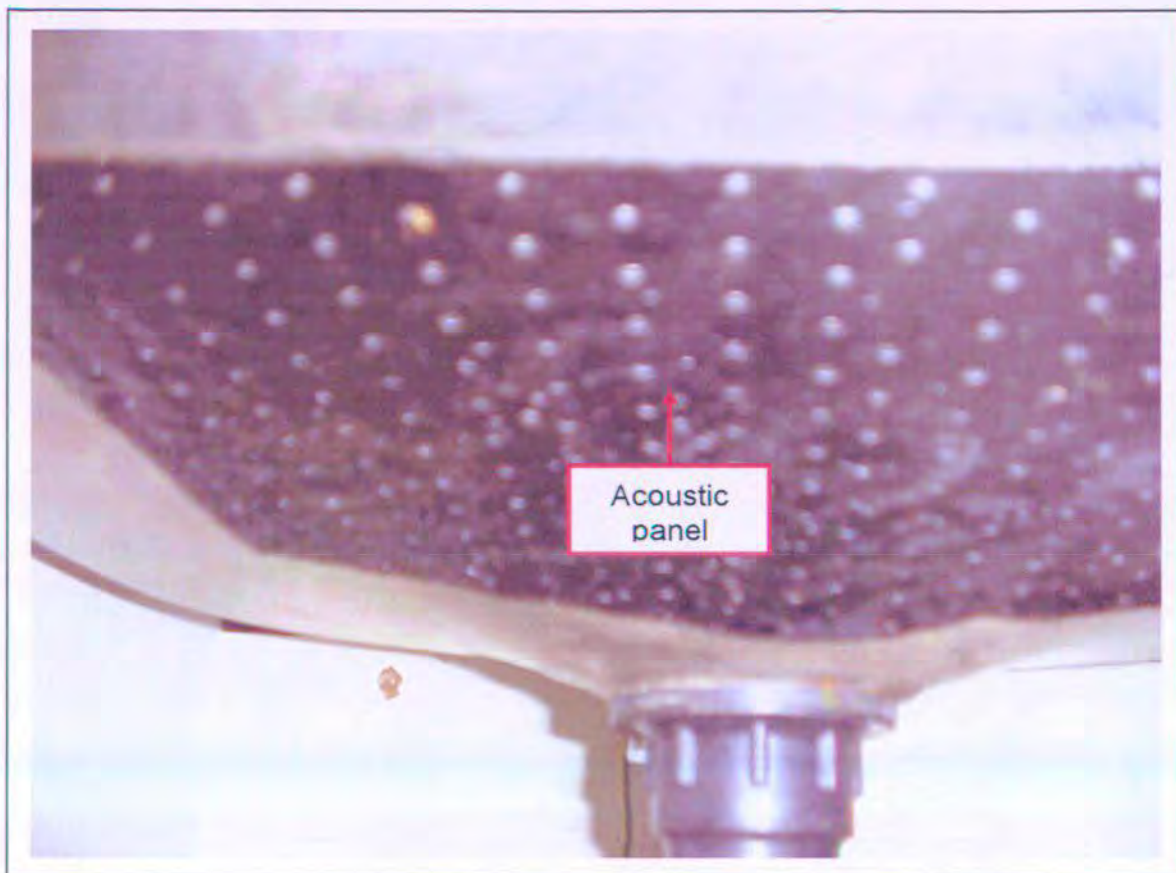
Figure 3: Sample No. 024663/7 – Description and Analysis Results

Sample number	024663/7
Location	Mess/ Locker Room 2/332, Wall 3
Description	Under sink acoustic panel
Product Type	Composite
Current Condition	Slight damage
Surface Treatment	Composite
Asbestos Content	Chrysotile
Material Assessment Factor	3
Potential for disturbance	Very low
Risk Assessment Factor	6

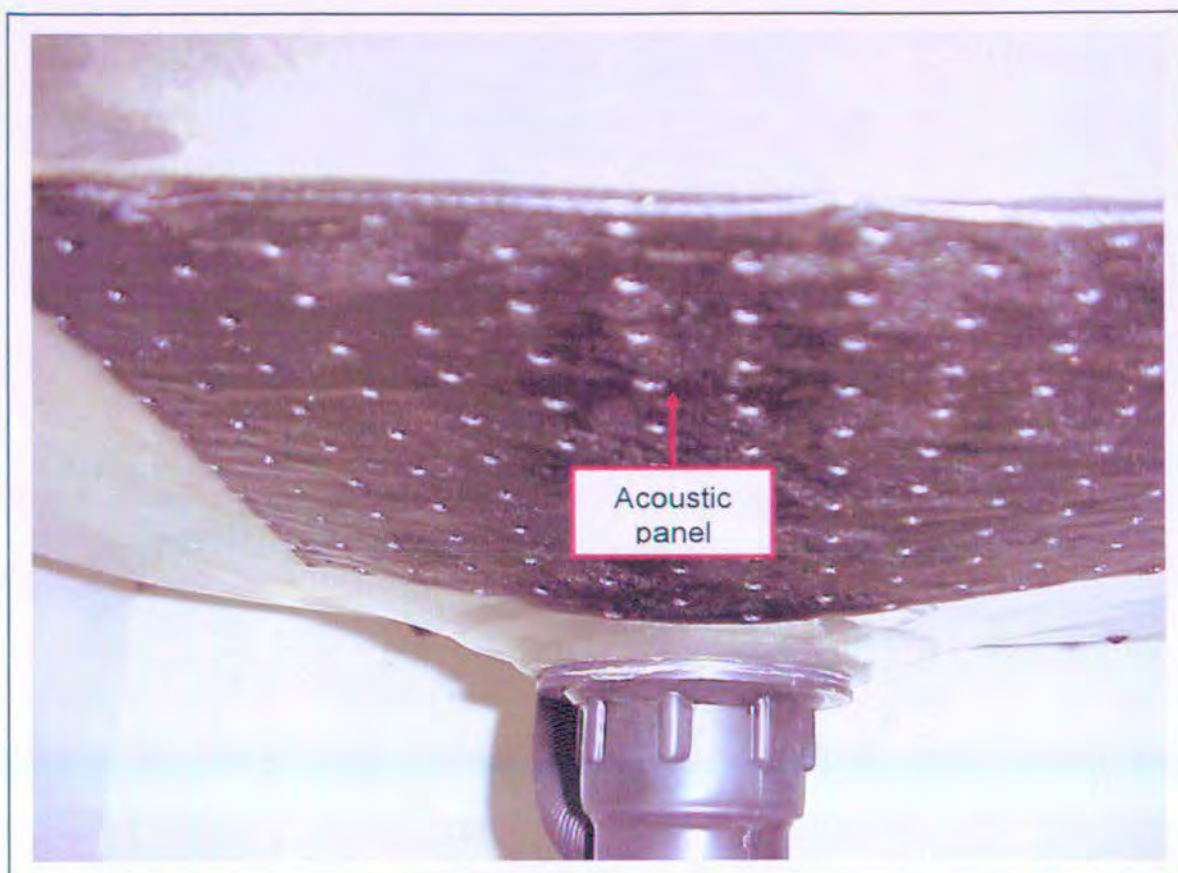
Figure 4: Sample No. 024663/8 – Description and Analysis Results

Sample number	024663/8
Location	Office 2/382, Wall 2
Description	Under sink acoustic panel
Product Type	Composite
Current Condition	Slight damage
Surface Treatment	Composite
Asbestos Content	Chrysotile
Material Assessment Factor	3
Potential for disturbance	Very low
Risk Assessment Factor	6

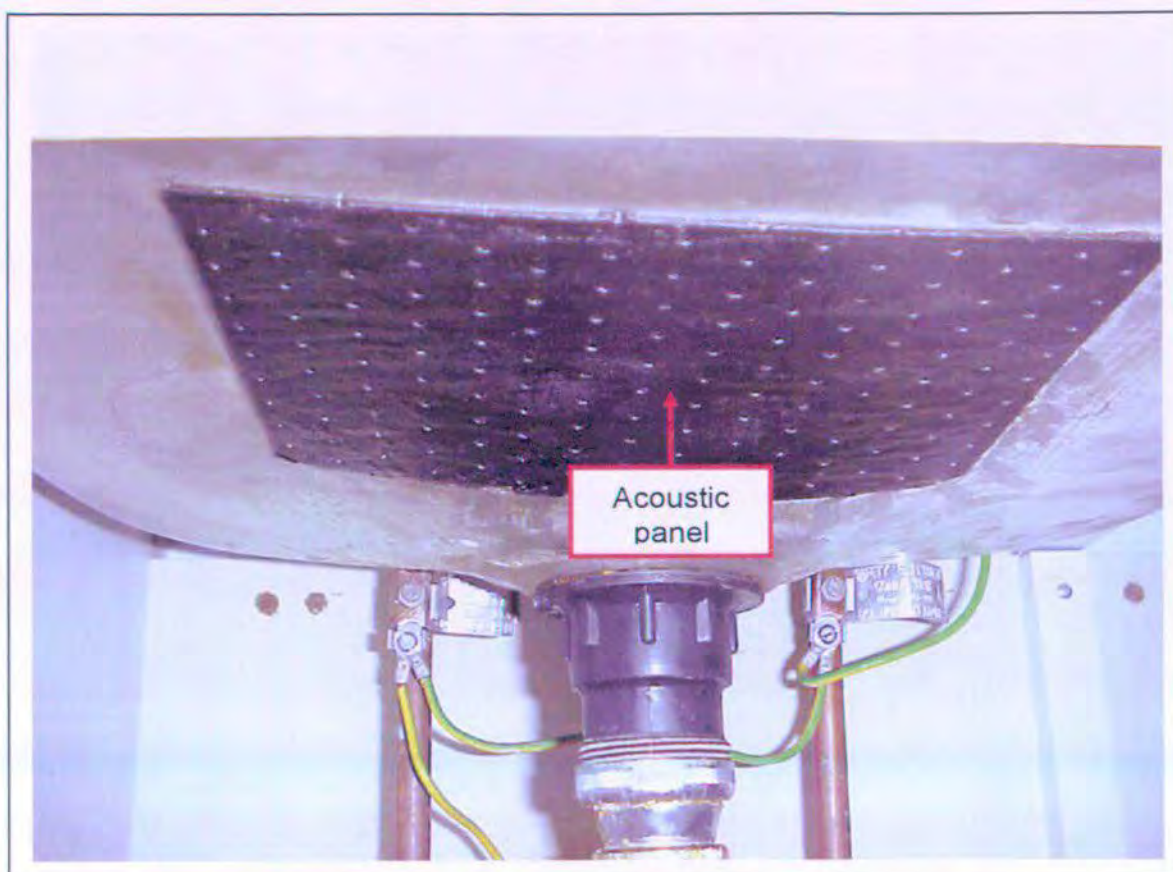
Figure 5: Sample No. 024663/9 – Description and Analysis Results

Sample number	024663/9
Location	Store 2/331, Wall 2
Description	Under sink acoustic panel
Product Type	Composite
Current Condition	Slight damage
Surface Treatment	Composite
Asbestos Content	Chrysotile
<i>Material Assessment Factor</i>	3
Potential for disturbance	Very low
<i>Risk Assessment Factor</i>	6

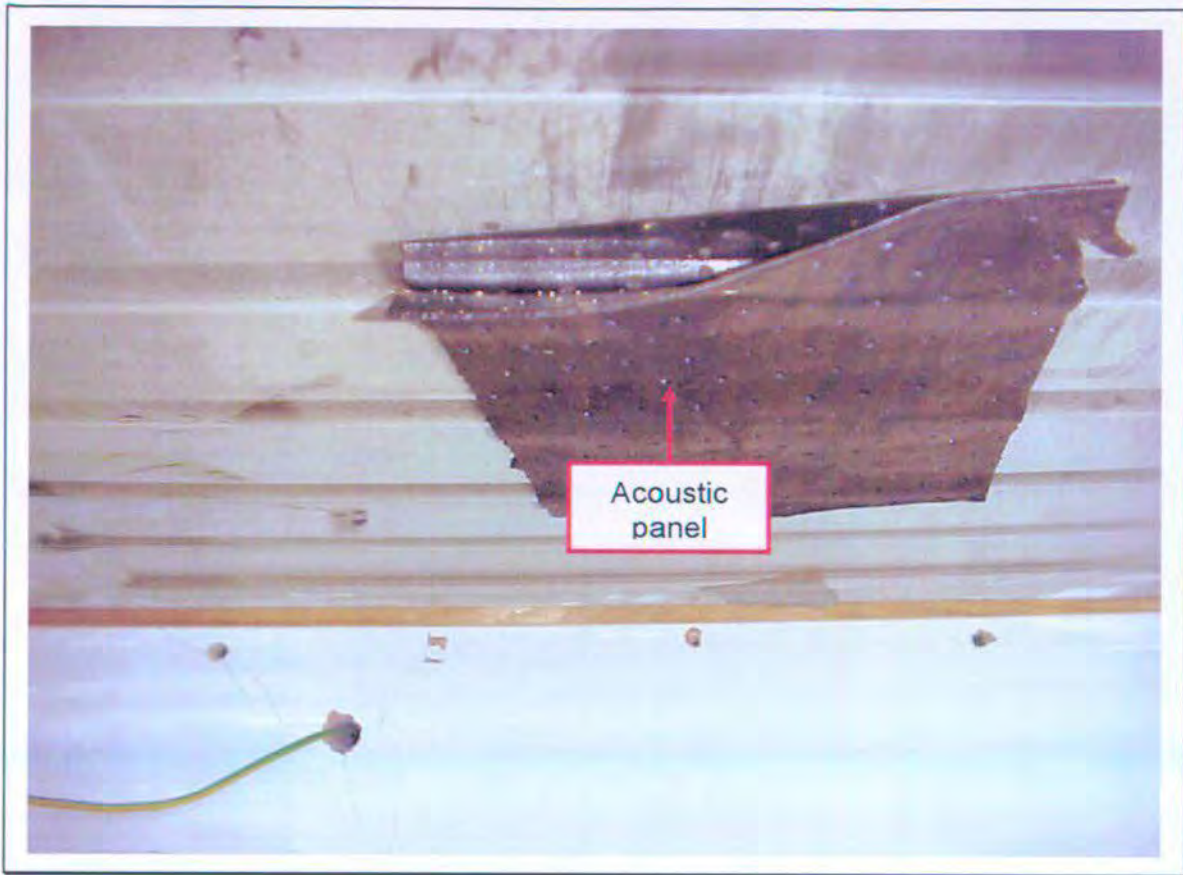
Figure 6: Sample No. 024663/10 – Description and Analysis Results

Sample number	024663/10
Location	Store 2/331, Wall 2
Description	Under sink acoustic panel
Product Type	Composite
Current Condition	Slight damage
Surface Treatment	Composite
Asbestos Content	Chrysotile
<i>Material Assessment Factor</i>	3
Potential for disturbance	Low
<i>Risk Assessment Factor</i>	6

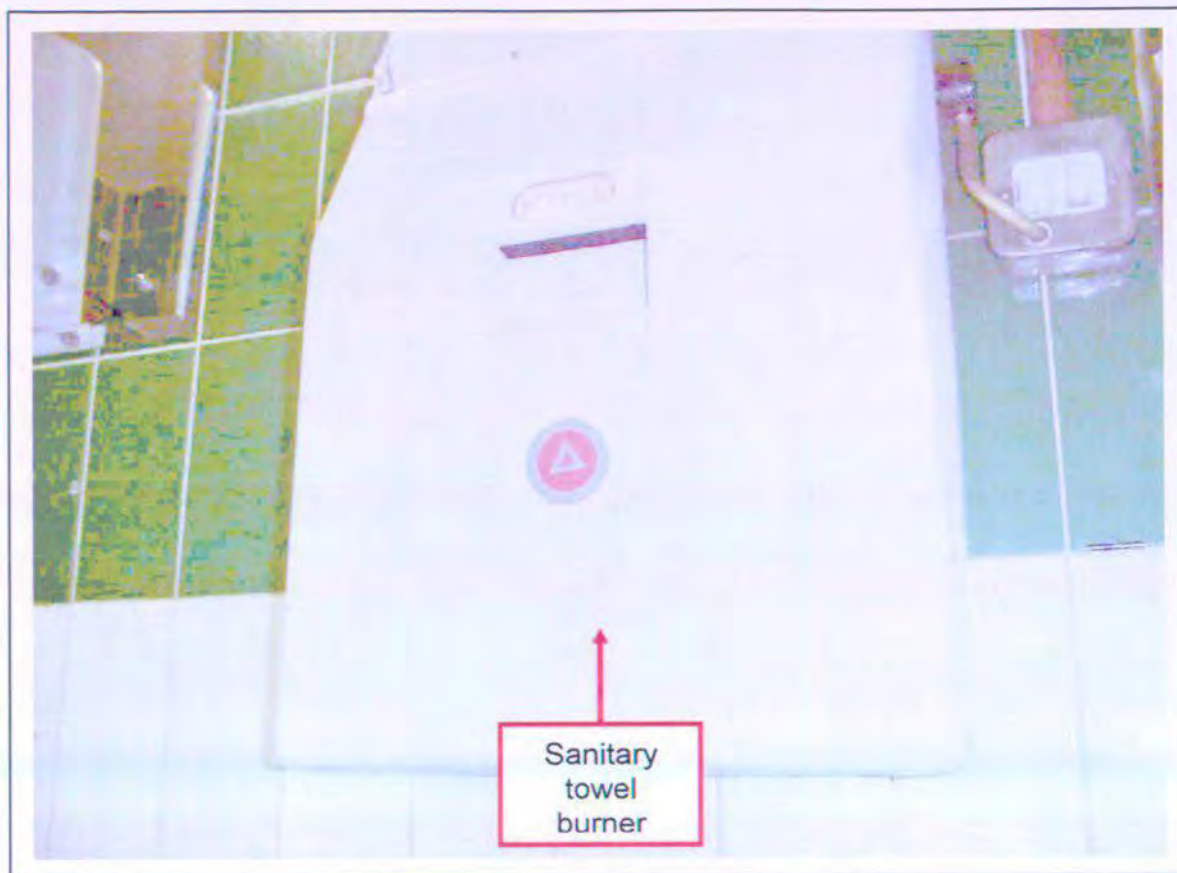
Figure 7: Material Strongly presumed To Contain Asbestos

Location	Toilet 3/036, Wall 3
Description	Insulation inside one sanitary towel burner

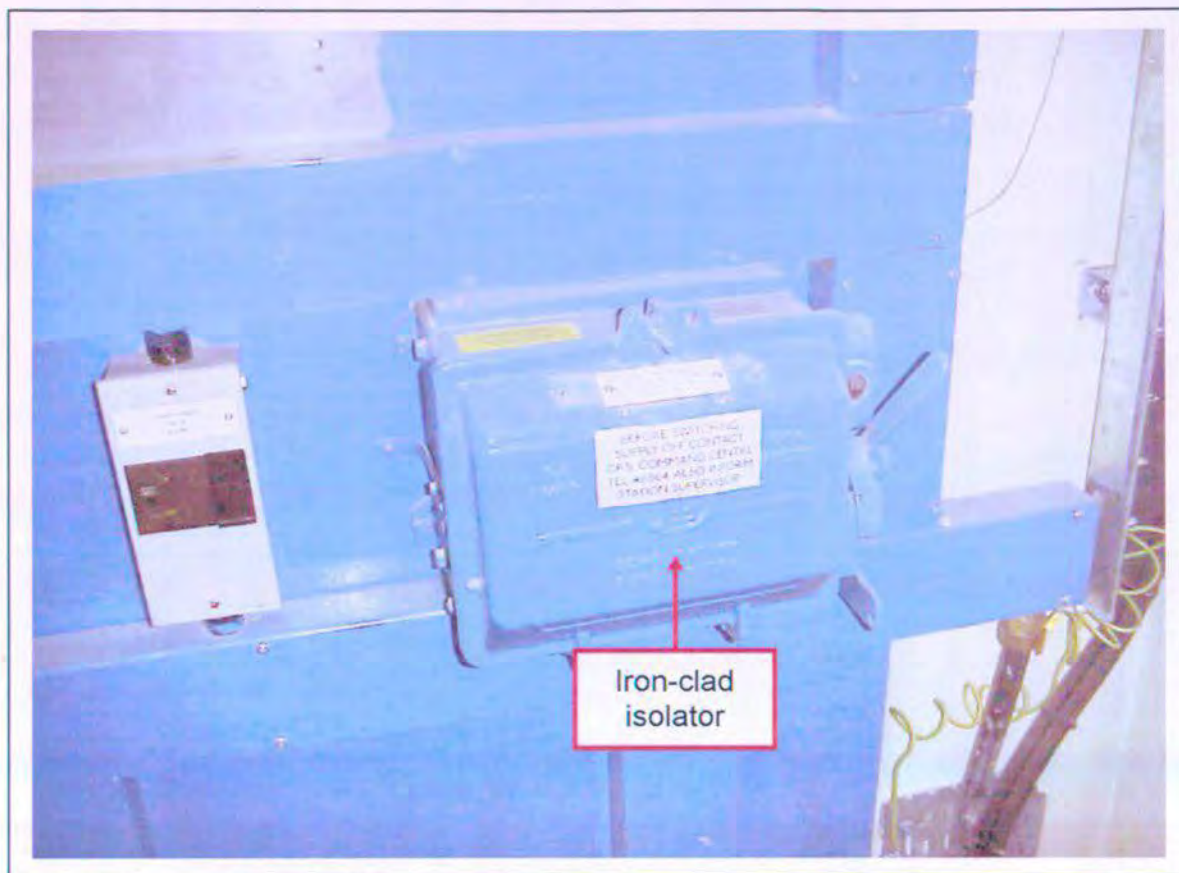
Figure 8: Material Strongly presumed To Contain Asbestos

Location	Switch Room 3/665
Description	Insulation inside one iron-clad isolator

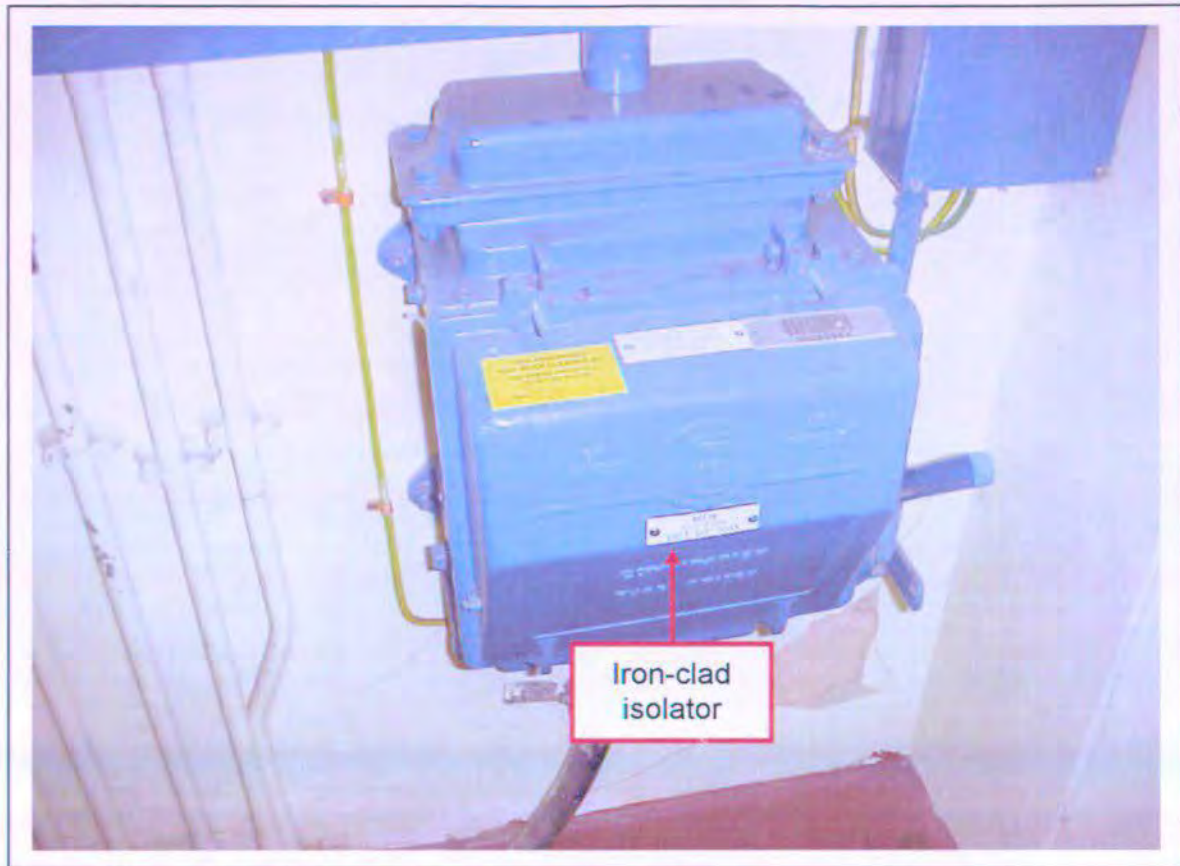
Figure 9: Material Strongly presumed To Contain Asbestos

Location	Switch Room 3/664, Wall 2
Description	Insulation inside one iron-clad isolator

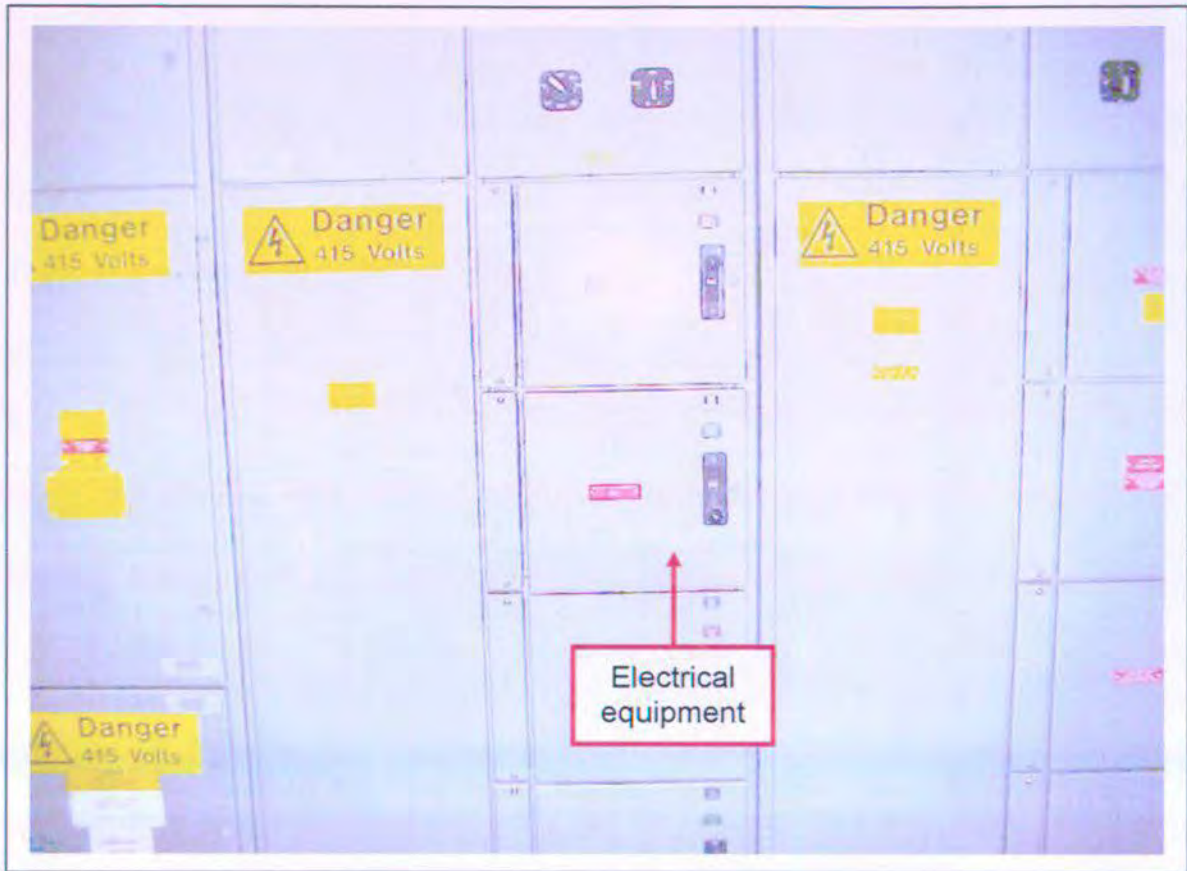
Figure 10: Material Strongly presumed To Contain Asbestos

Location	Switch Room 3/662, Wall 2
Description	Insulation inside electrical equipment

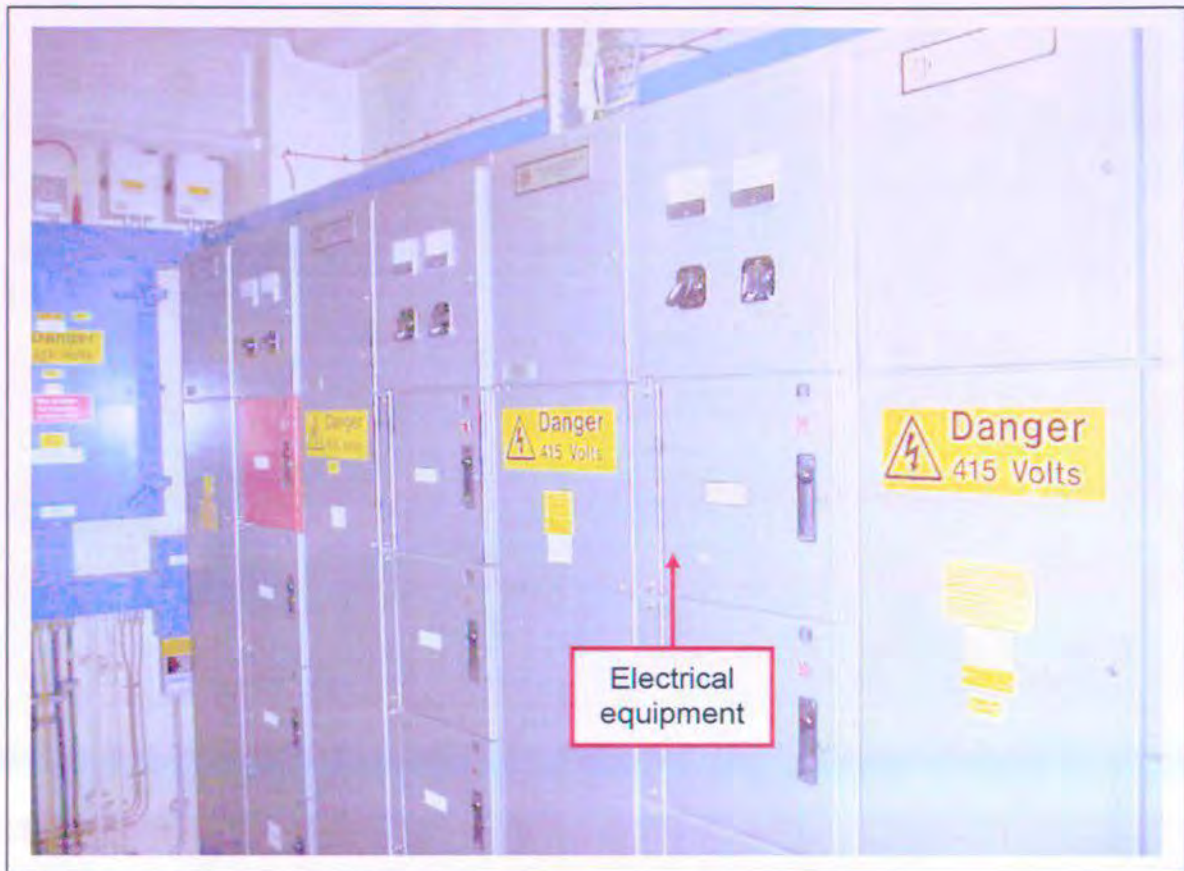
**Figure 11: Material Strongly presumed To Contain Asbestos**

Location	Switch Room 3/661, Wall 2
Description	Insulation inside electrical equipment

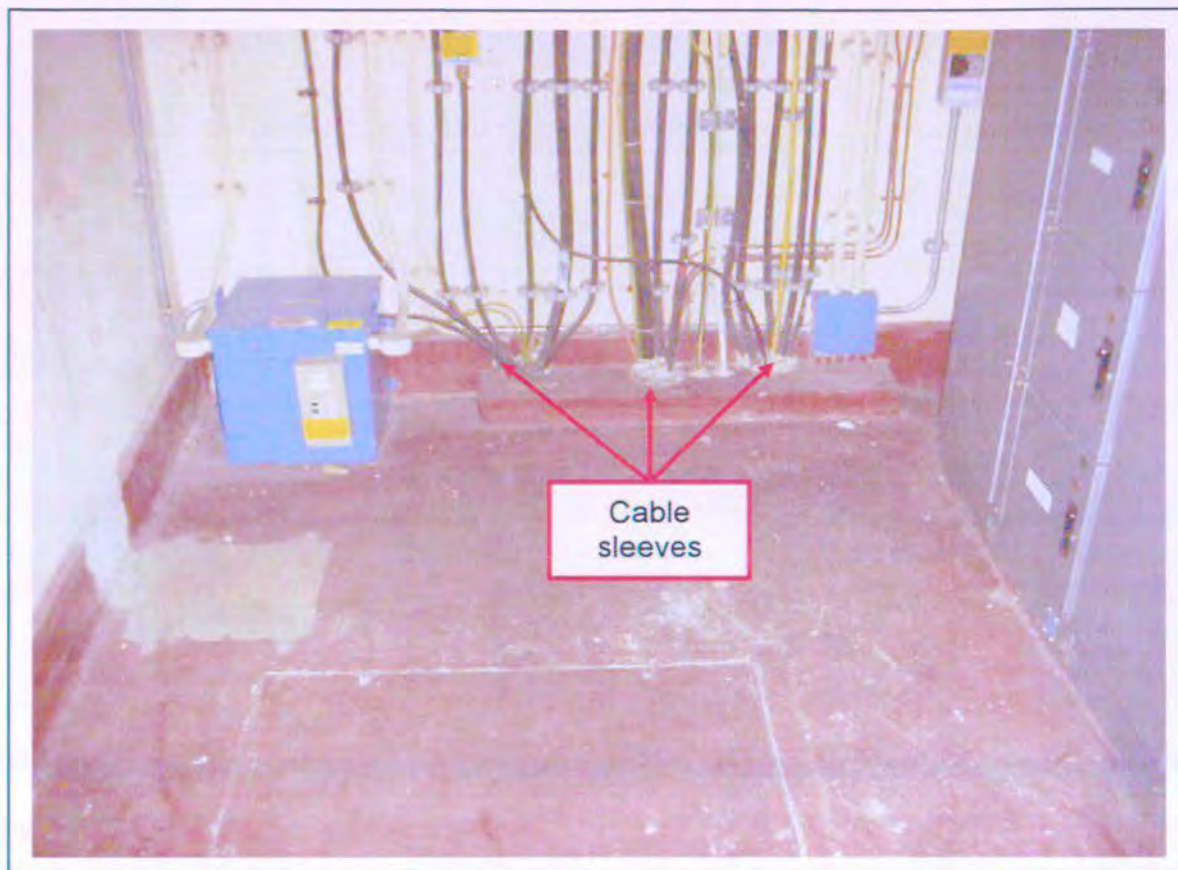
Figure 12: Material Strongly presumed To Contain Asbestos

Location	Switch Room 3/661, Wall 2
Description	Four filled cable sleeves in floor

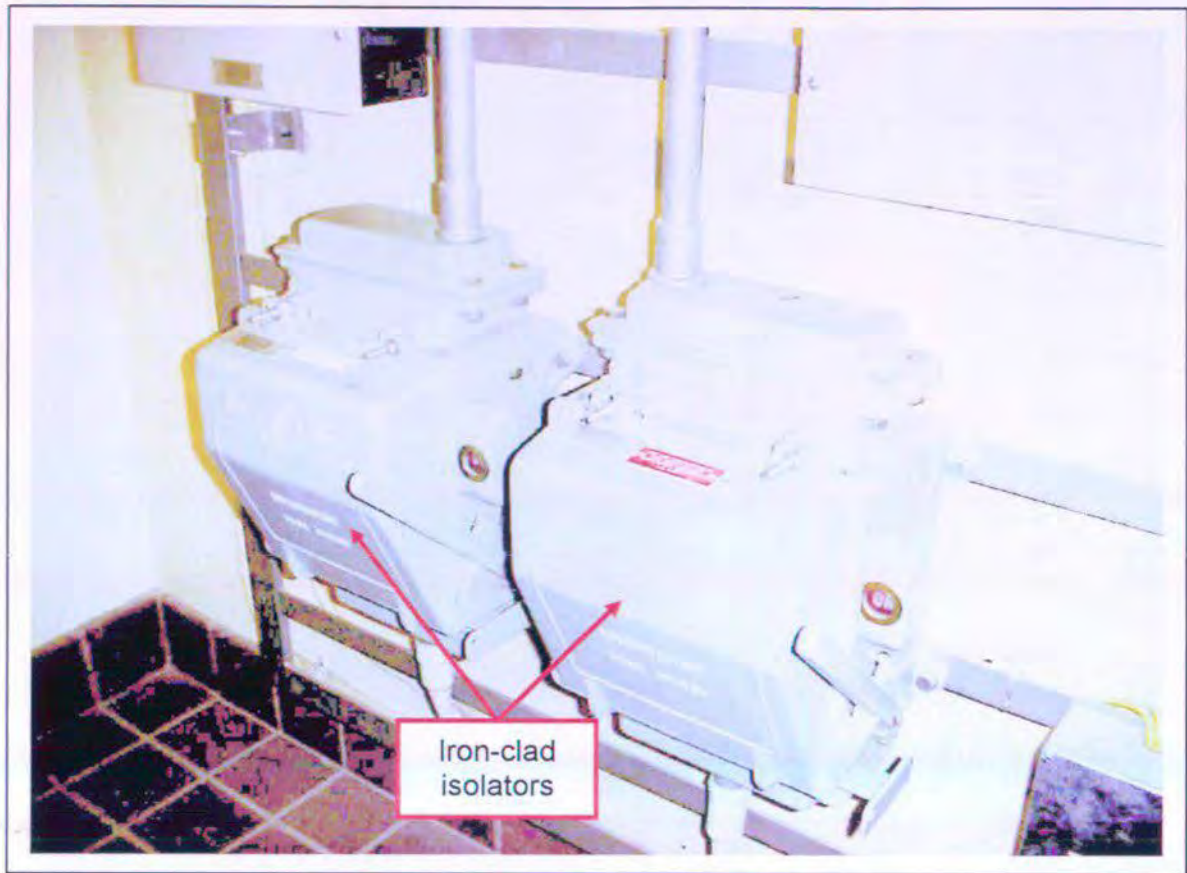
Figure 13: Material Strongly presumed To Contain Asbestos

Location	CER 3/731, Wall 2
Description	Insulation inside two grey iron-clad isolators

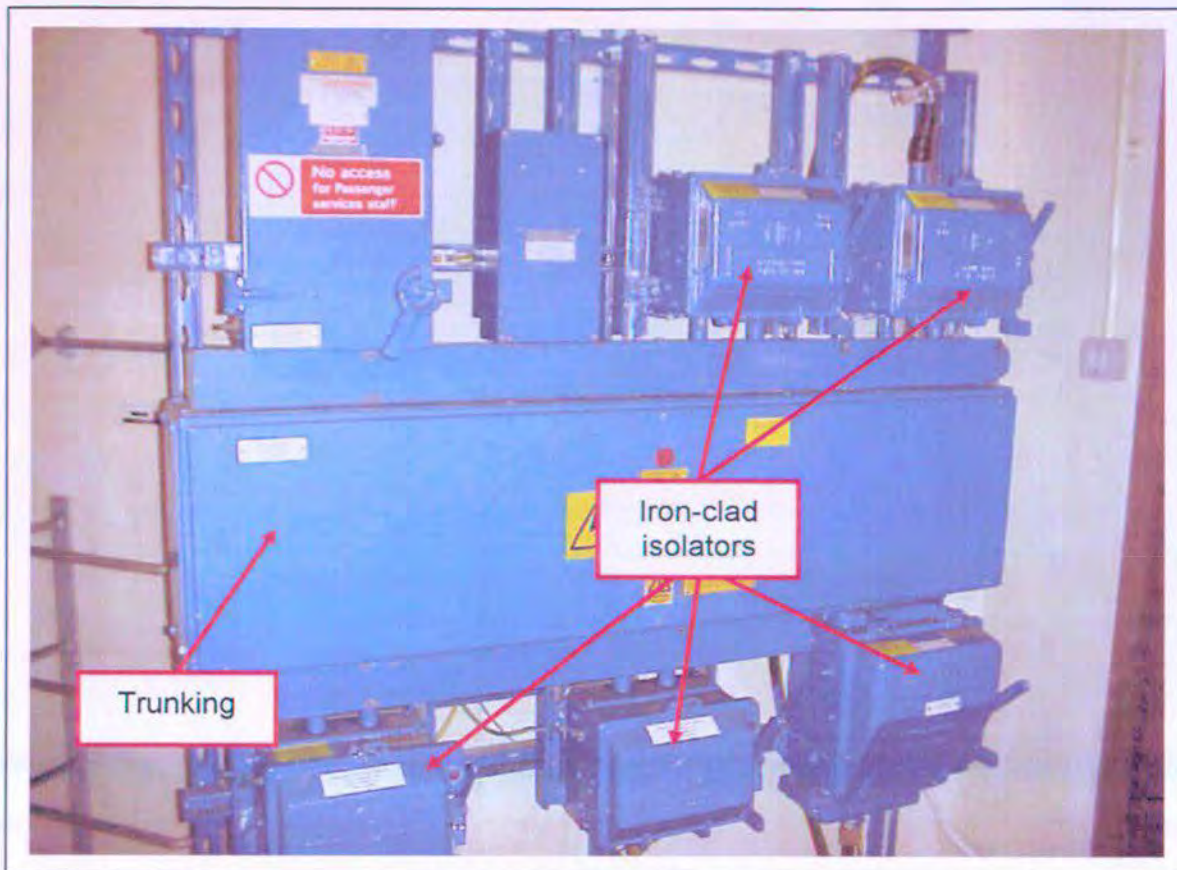
Figure 14: Material Strongly presumed To Contain Asbestos

Location	Pump Room 3/771
Description	Potential Insulation inside five blue iron-clad isolators

Location	Pump Room 3/771
Description	Insulation inside trunking next to five blue iron-clad isolators

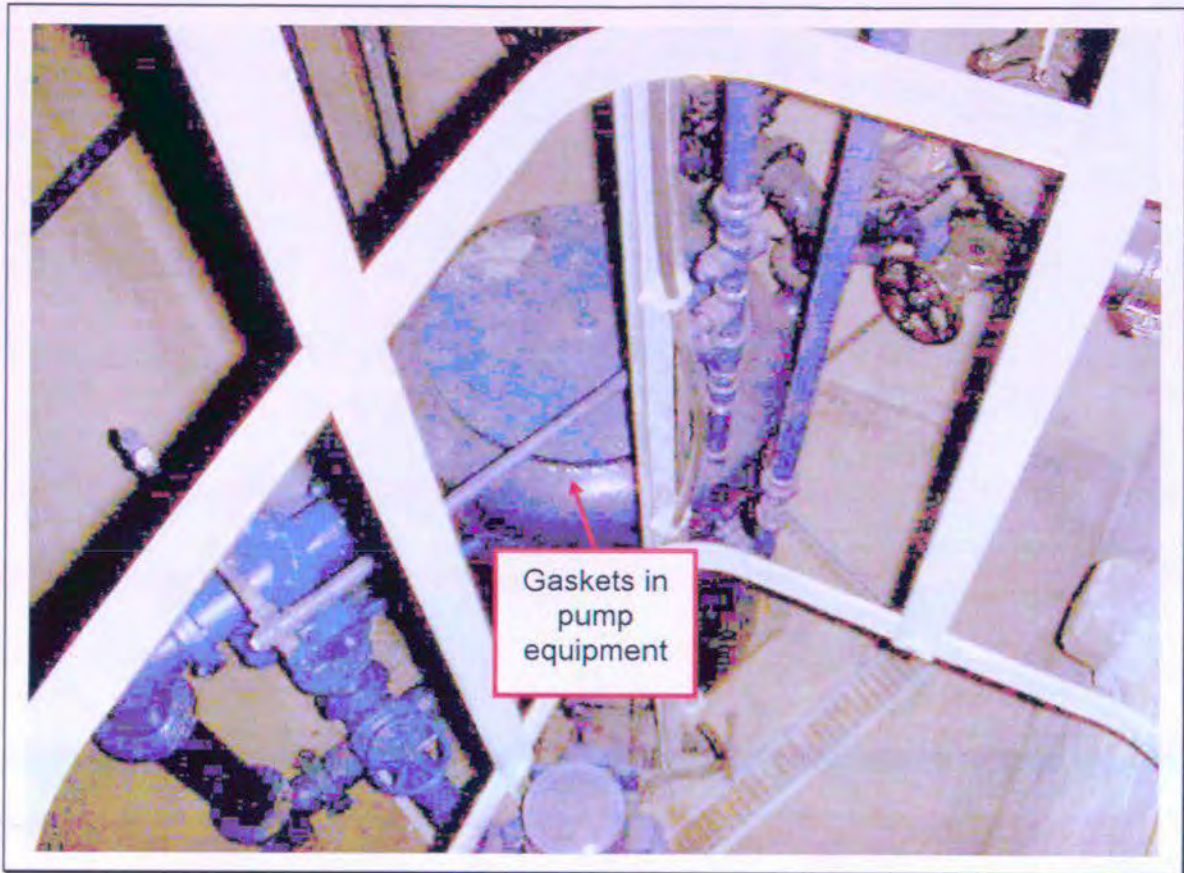
Figure 15: Material Strongly presumed To Contain Asbestos

Location	Pump Room 3/771
Description	Gaskets between pump equipment and pipework joints

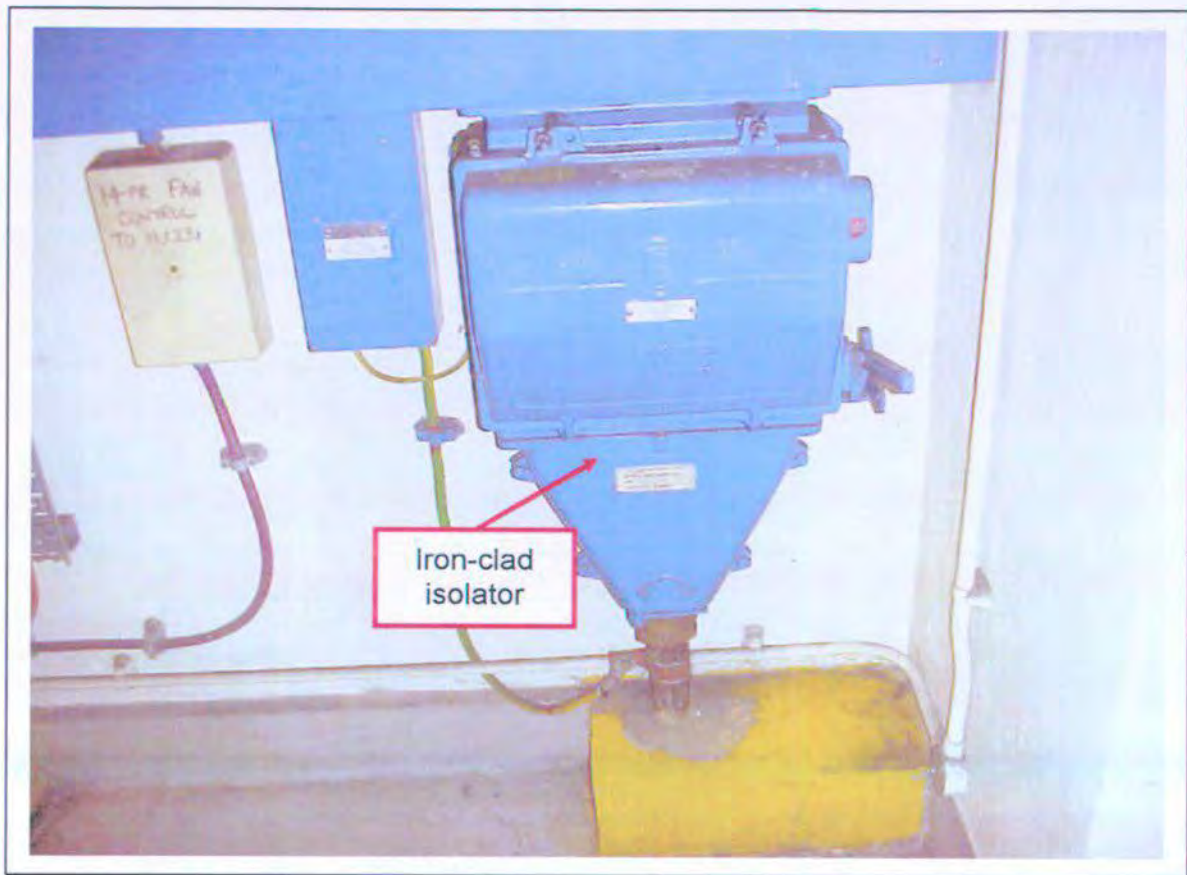
Figure 16: Material Strongly presumed To Contain Asbestos

Location	Vent Room 3/762
Description	Insulation inside one iron-clad isolator

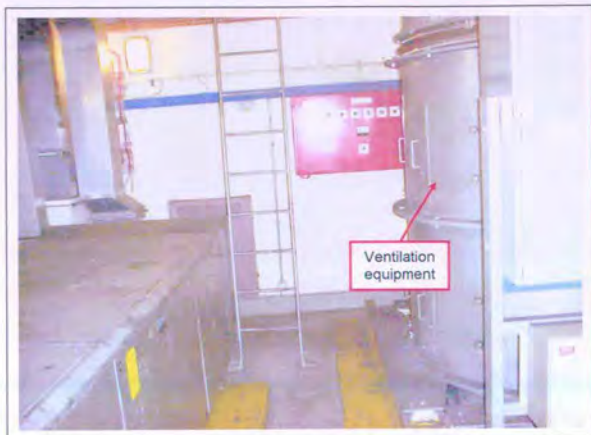
Figure 17: Material Strongly presumed To Contain Asbestos

Location	Vent Room 3/762
Description	Gasket material between joint of ventilation equipment

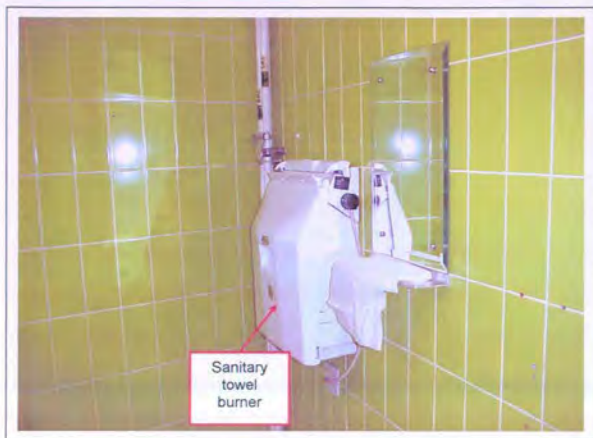
Figure 18: Material Strongly presumed To Contain Asbestos

Location	Toilet 2/417, Wall 2
Description	Insulation inside sanitary towel burner to wall

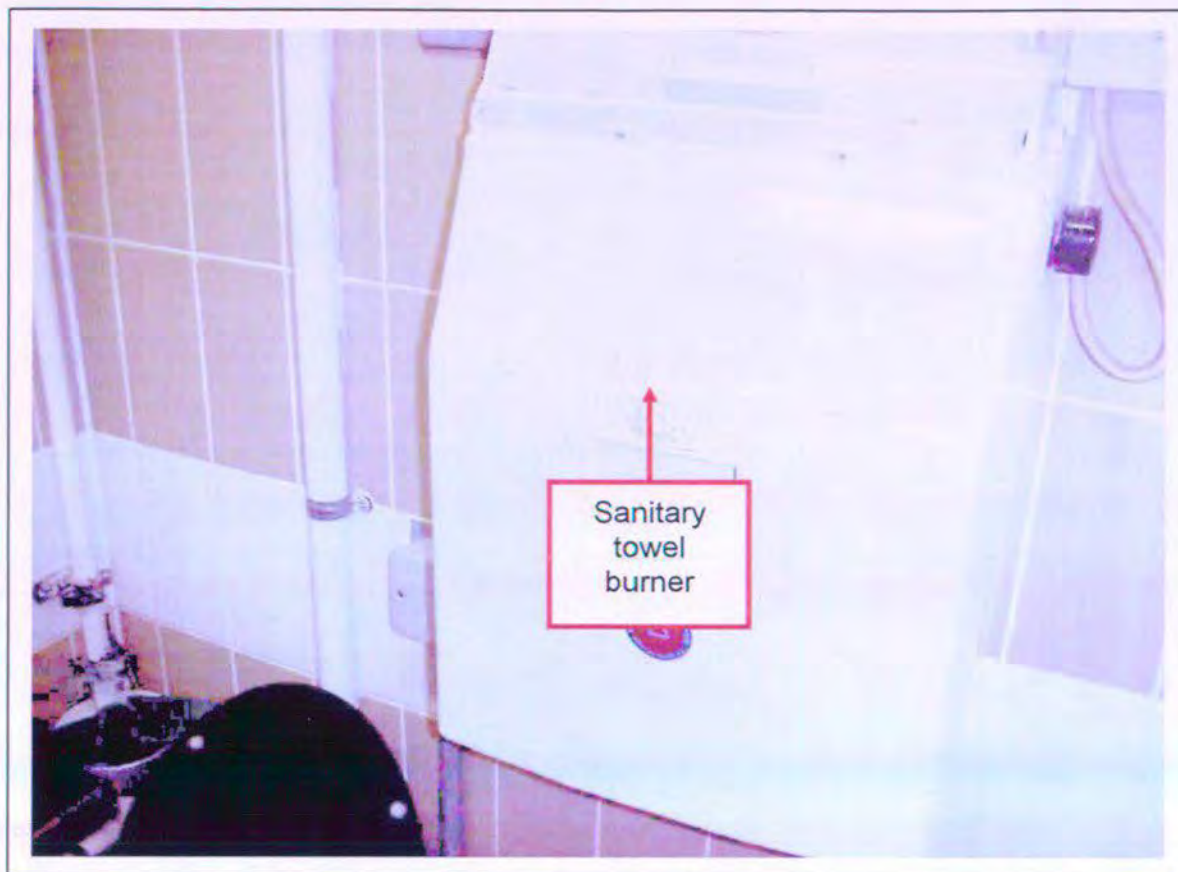
Figure 19: Material Strongly presumed To Contain Asbestos

Location	Toilet 2/419, Wall 3
Description	Insulation inside one sanitary towel burner to wall

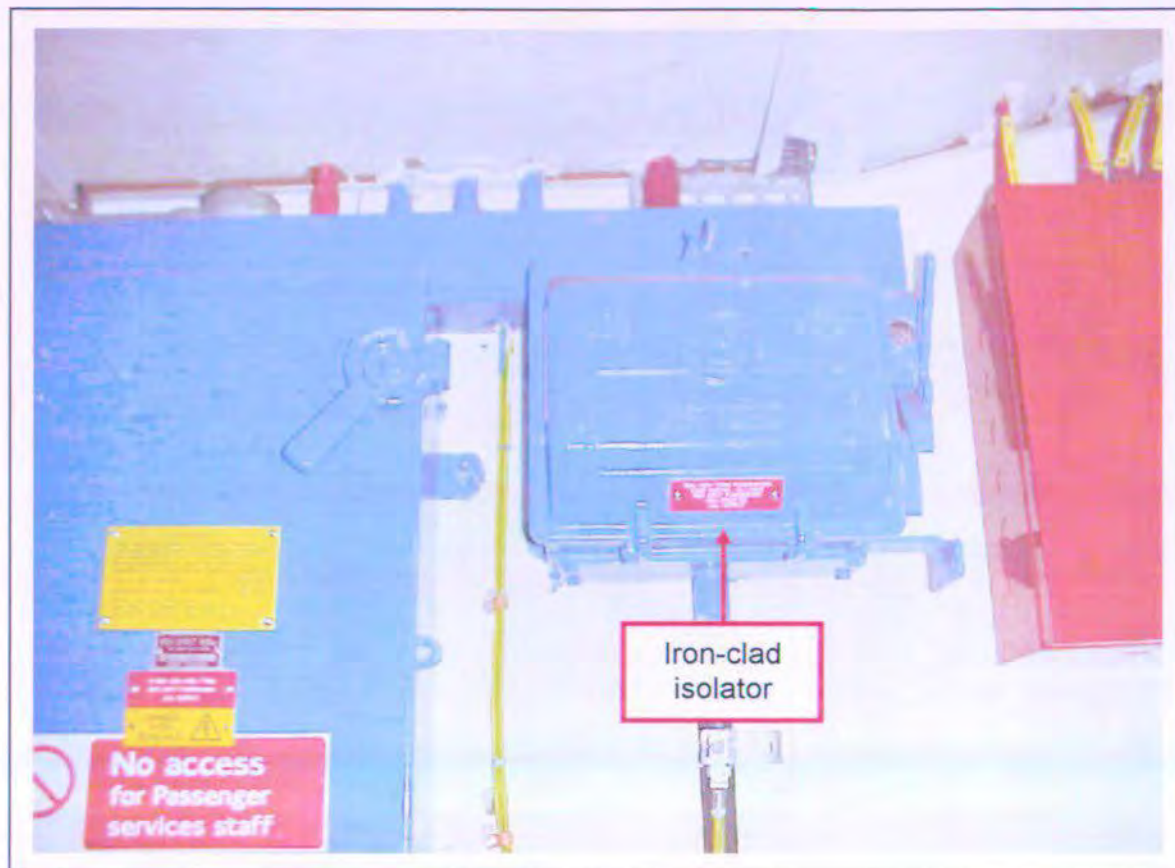
Figure 20: Material Strongly presumed To Contain Asbestos

Location	Stairs 2/243, Wall 1
Description	Insulation inside one iron-clad isolator

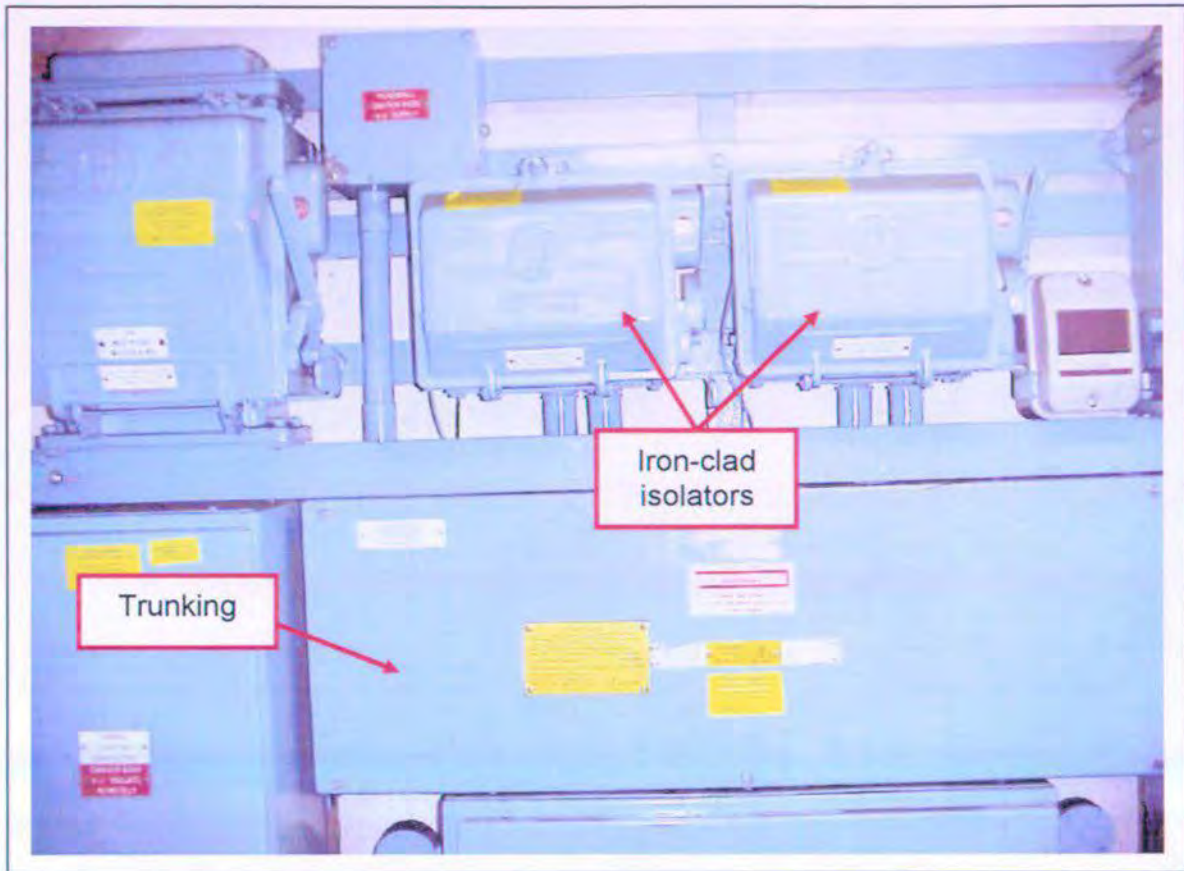
Figure 21: Material Strongly presumed To Contain Asbestos

Location	Switch Room 3/663
Description	Insulation inside six iron-clad isolators

Location	Switch Room 3/663
Description	Insulation inside trunking next to six iron-clad isolators
