Report No. 4RS-SP-110701-R370083

**REINSPECTION OF ASBESTOS CONTAINING MATERIALS
WARREN STREET UNDERGROUND STATION**

Issue Date: 31st January 2013

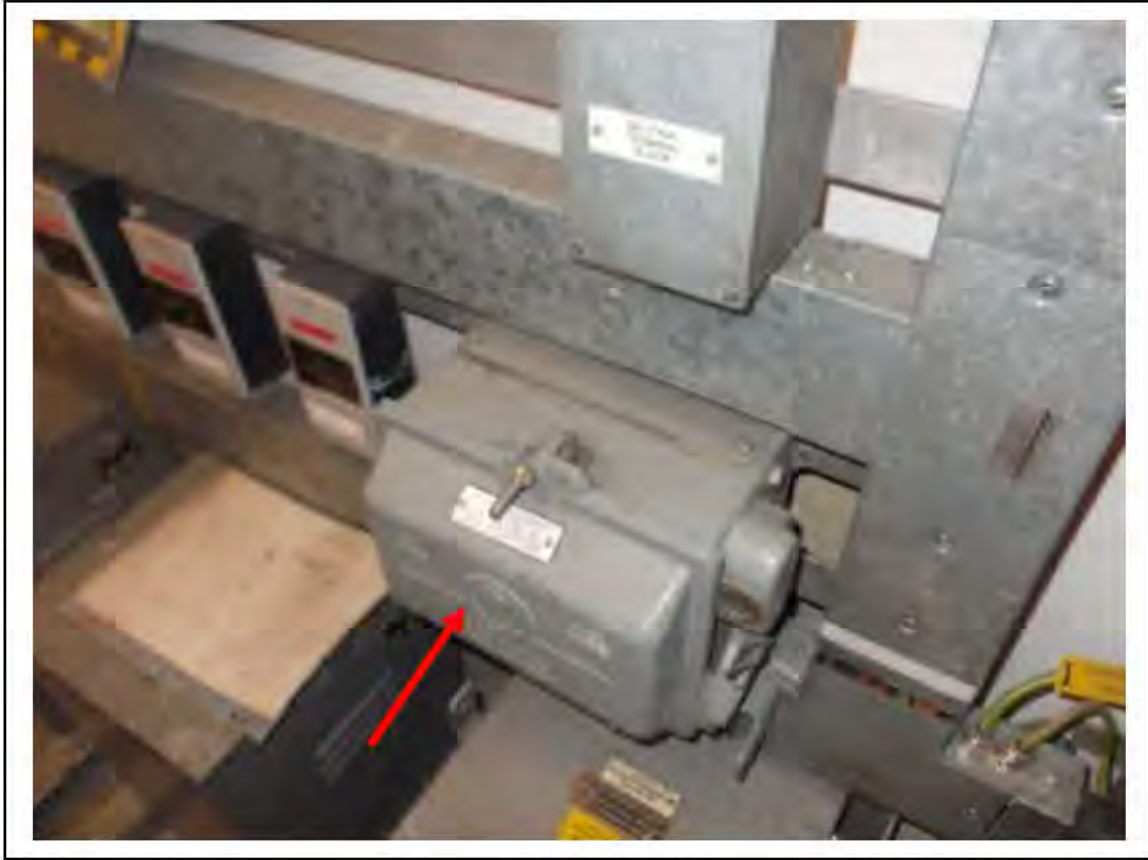
FIGURE 1: POSSIBLE ACMS WITHIN SWITCH GEAR IN SWITCH ROOM, 1/662 - DESCRIPTION & RESULT OF ASSESSMENT (SAMPLE REF. P1(1))

Sample Number	P1(1)
Location	Switch Room, 1/662
Material Description	Possible asbestos containing materials
Material Comment	Within combination switch box to wall 2
Quantity	1 No.
Product Type	-
Current Condition	-
Surface Treatment	-
Asbestos Type	Presumed Chrysotile
Material Assessment Rating	-
Accessibility	-
Further Comment	Not applicable

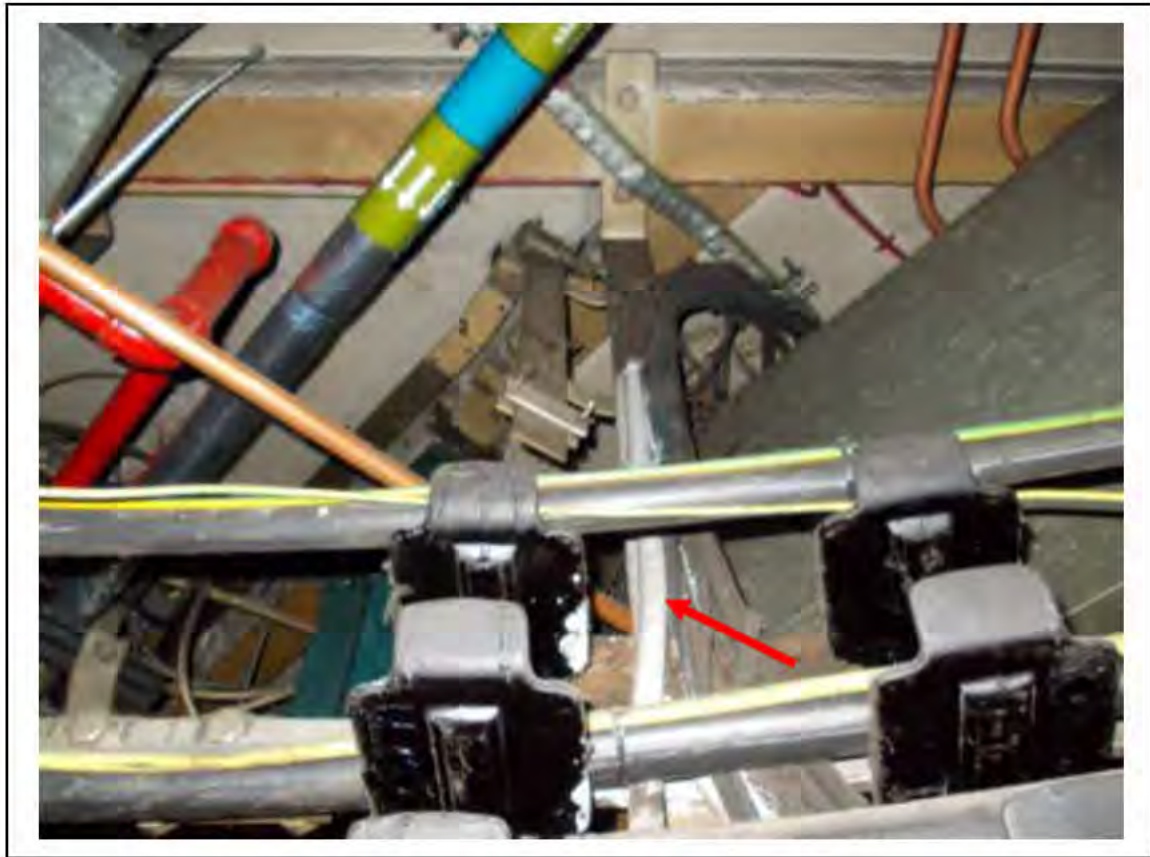
**FIGURE 2: STRONGLY PRESUMED ASBESTOS IN CLOTH CABLE WRAP
UMC ACCESS, 2/151 - DESCRIPTION & RESULT OF
ASSESSMENT (SAMPLE REF. SP1(2))**

Woven cables strongly presumed to contain Chrysotile asbestos, Figures 2 - 6 - Material assessment rating: Very low. Condition – Good.

Sample Number	SP1(2)
Location	UMC Access, 2/151
Material Description	Asbestos cloth
Material Comment	Cable sleeve
Quantity	90m
Product Type	Medium density
Current Condition	Good condition
Surface Treatment	Encapsulated medium density
Asbestos Type	Strongly Presumed Chrysotile
Material Assessment Rating	Very low
Accessibility	Low
Further Comment	Not applicable

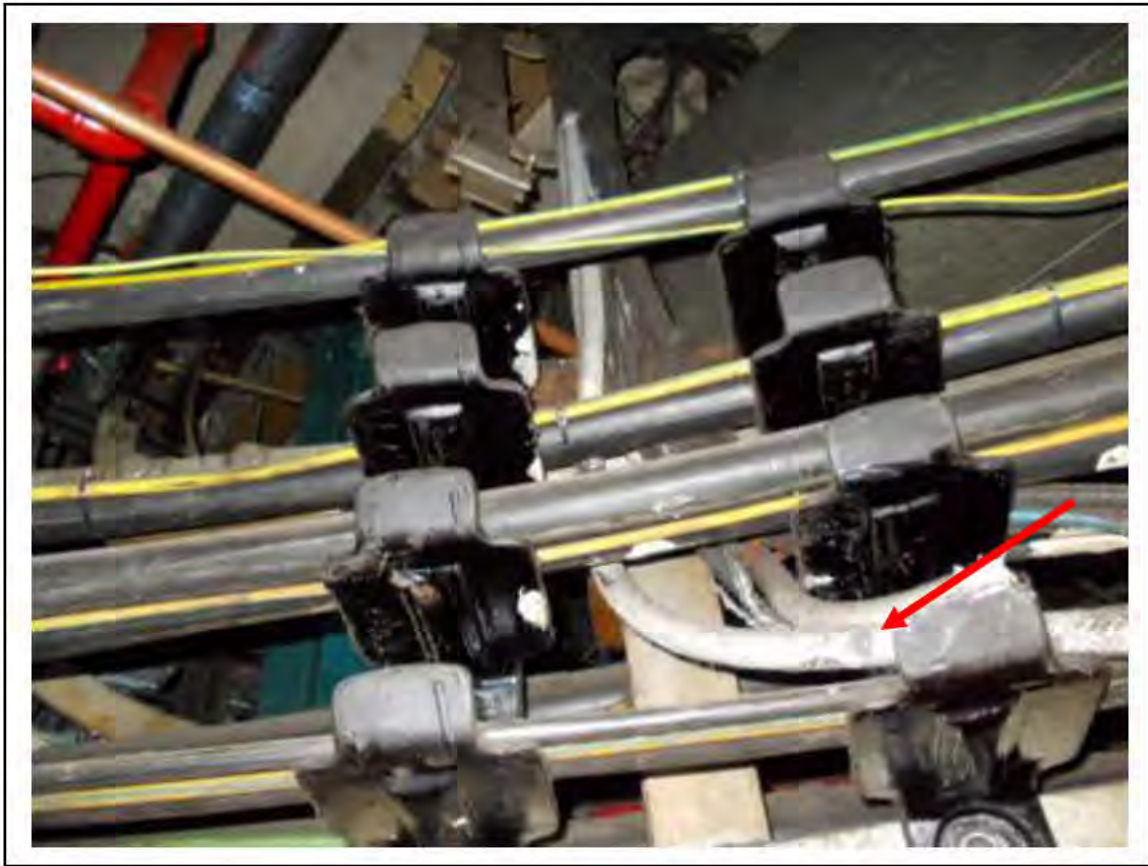
**FIGURE 3: STRONGLY PRESUMED ASBESTOS IN CLOTH CABLE WRAP
UMC ACCESS, 2/151 - DESCRIPTION & RESULT OF
ASSESSMENT (SAMPLE REF. SP1(3))**

Sample Number	SP1(3)
Location	UMC Access, 2/151
Material Description	Asbestos cloth
Material Comment	Cable sleeve
Quantity	90m
Product Type	Medium density
Current Condition	Good condition
Surface Treatment	Encapsulated medium density
Asbestos Type	Strongly Presumed Chrysotile
Material Assessment Rating	Very low
Accessibility	Low
Further Comment	Not applicable

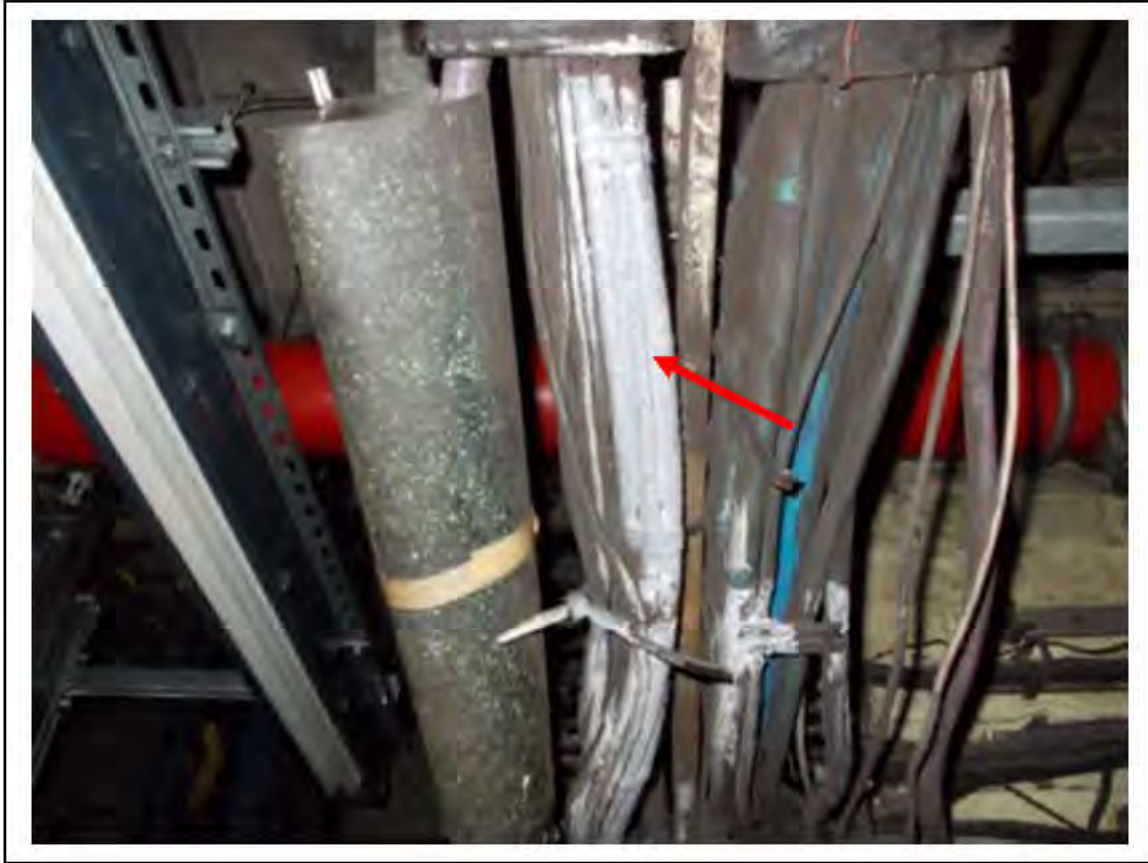
**FIGURE 4: STRONGLY PRESUMED ASBESTOS IN CLOTH CABLE WRAP
UMC ACCESS, 2/151 - DESCRIPTION & RESULT OF
ASSESSMENT (SAMPLE REF. SP1(4))**

Sample Number	SP1(4)
Location	UMC Access, 2/151
Material Description	Asbestos cloth
Material Comment	Cable sleeve
Quantity	90m
Product Type	Medium density
Current Condition	Good condition
Surface Treatment	Encapsulated medium density
Asbestos Type	Strongly Presumed Chrysotile
Material Assessment Rating	Very low
Accessibility	Low
Further Comment	Not applicable

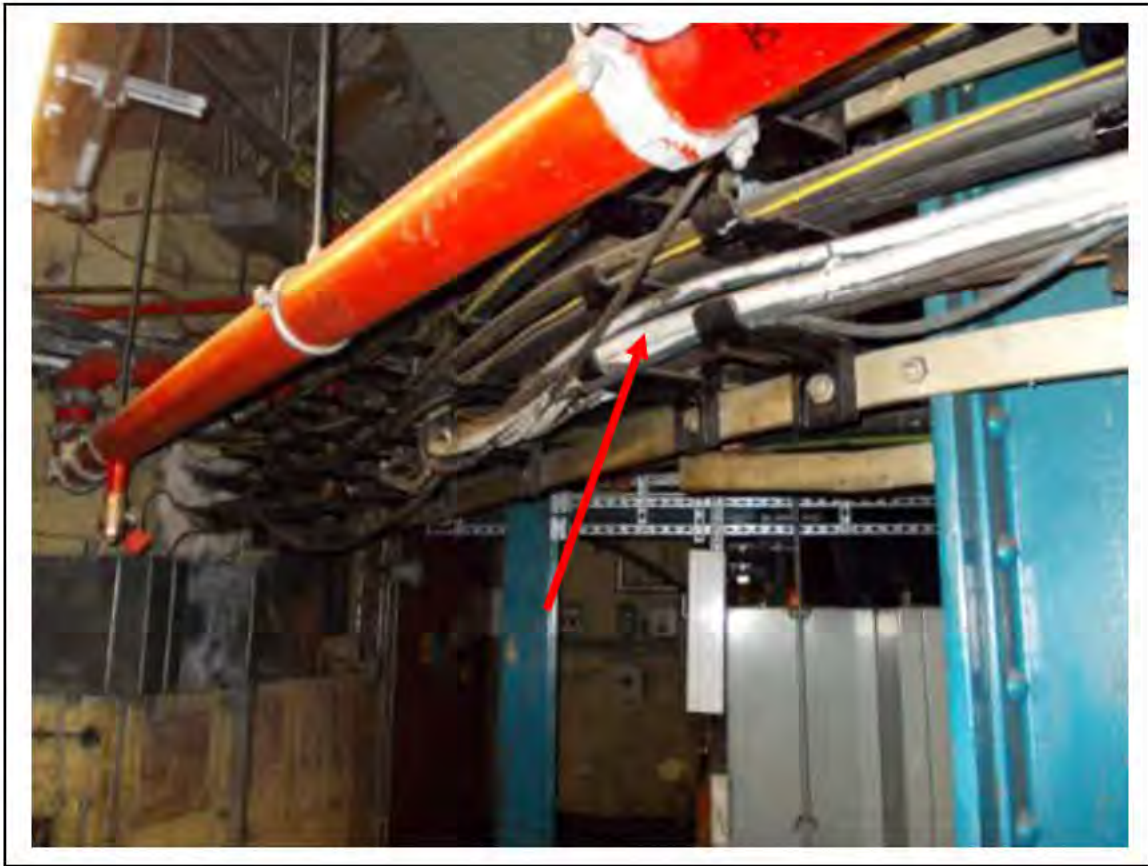
**FIGURE 5: STRONGLY PRESUMED ASBESTOS IN CLOTH CABLE WRAP
UMC ACCESS, 2/151 - DESCRIPTION & RESULT OF
ASSESSMENT (SAMPLE REF. SP1(5))**

Sample Number	SP1(5)
Location	UMC Access, 2/151
Material Description	Asbestos cloth
Material Comment	Cable sleeve
Quantity	80m
Product Type	Medium density
Current Condition	Good condition
Surface Treatment	Encapsulated medium density
Asbestos Type	Strongly Presumed Chrysotile
Material Assessment Rating	Very low
Accessibility	Low
Further Comment	Not applicable

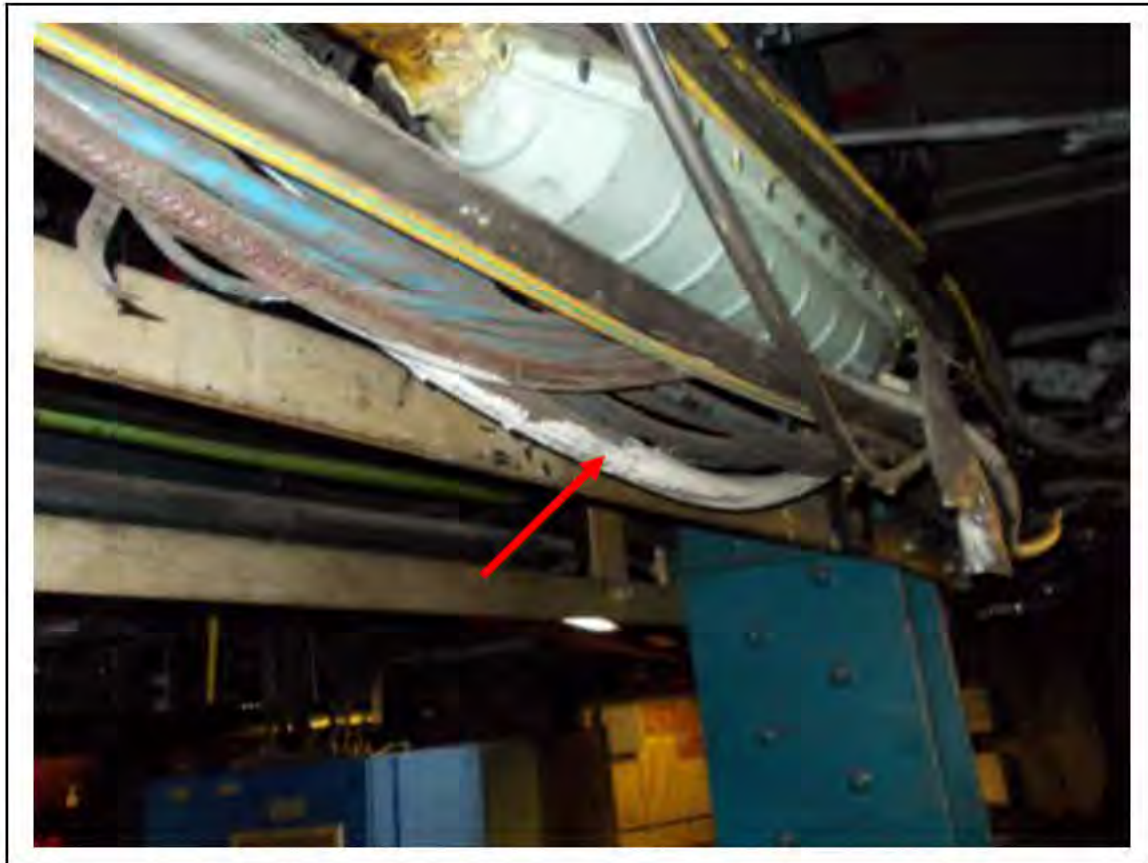
**FIGURE 6: STRONGLY PRESUMED ASBESTOS IN CLOTH CABLE WRAP
UMC ACCESS, 2/151 - DESCRIPTION & RESULT OF
ASSESSMENT (SAMPLE REF. SP1(6))**

Sample Number	SP1(6)
Location	UMC Access, 2/151
Material Description	Asbestos cloth
Material Comment	Cable sleeve
Quantity	80m
Product Type	Medium density
Current Condition	Good condition
Surface Treatment	Encapsulated medium density
Asbestos Type	Strongly Presumed Chrysotile
Material Assessment Rating	Very low
Accessibility	Low
Further Comment	Not applicable

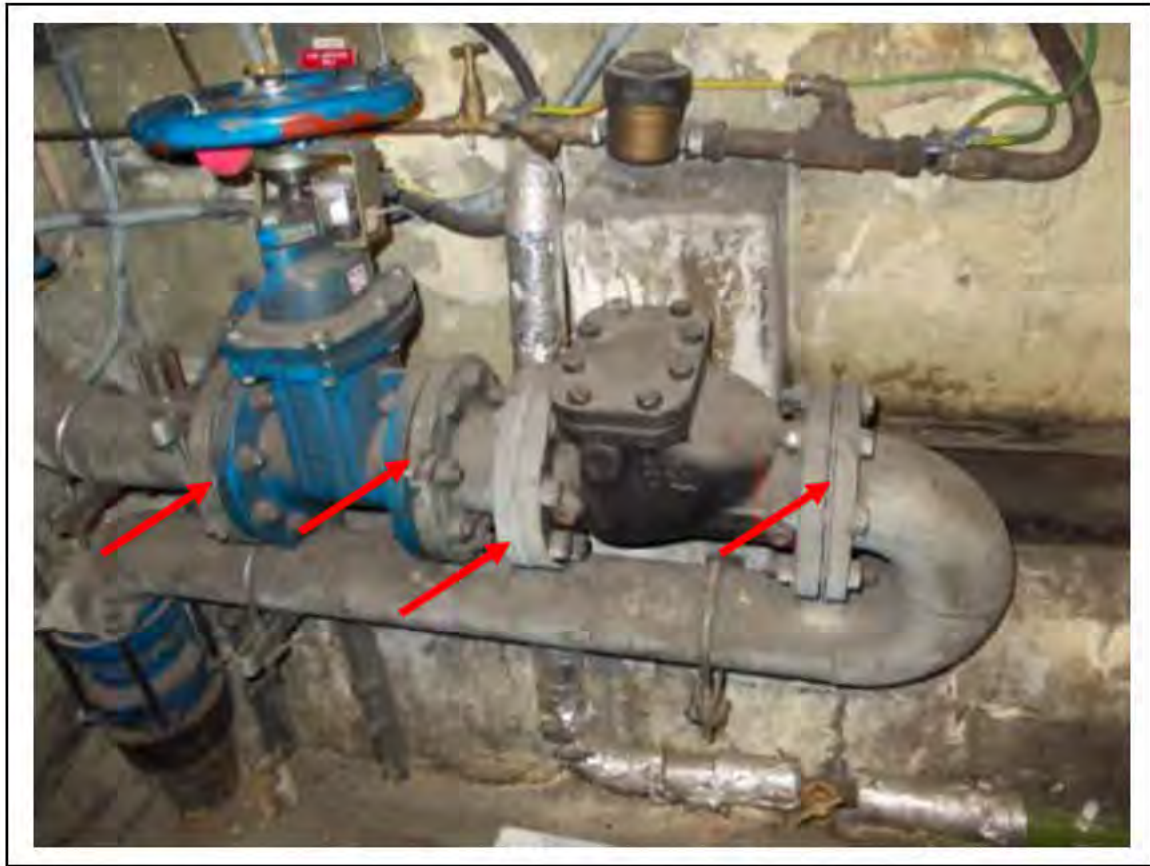
FIGURE 7: CONFIRMED ASBESTOS IN ASBESTOS GASKET IN UMC ACCESS, 2/151 - DESCRIPTION & RESULT OF ASSESSMENT (SAMPLE REF. ECS 81597)

Asbestos gasket confirmed to contain Chrysotile asbestos, Figure 7 - Material assessment rating: Very low. Condition – Good.

Sample Number	ECS 81597
Location	UMC Access, 2/151
Material Description	Asbestos gasket
Material Comment	Between flanges
Quantity	1m ²
Product Type	Composite
Current Condition	Good condition
Surface Treatment	Composite
Asbestos Type	Chrysotile
Material Assessment Rating	Very low
Accessibility	Low
Further Comment	Not applicable

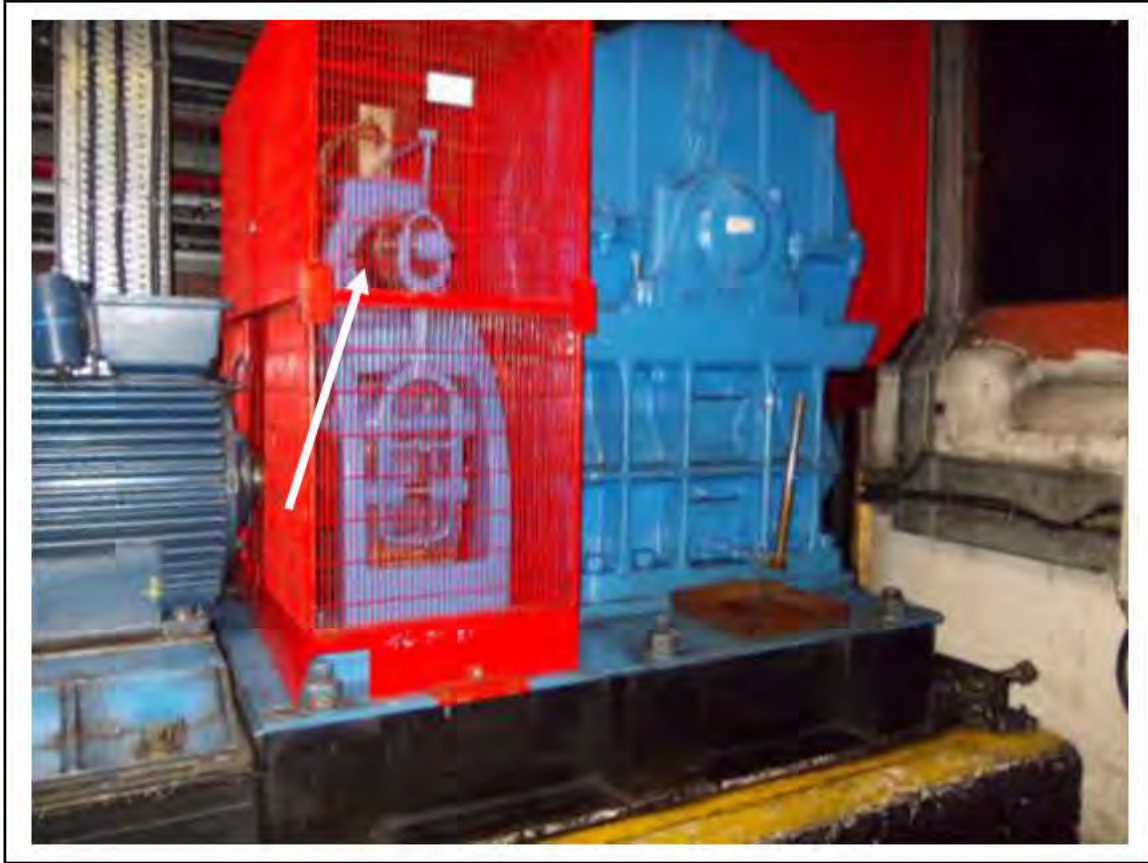
FIGURE 8: STRONGLY PRESUMED ASBESTOS IN BRAKE PADS IN UMC ACCESS, 2/151 - DESCRIPTION & RESULT OF ASSESSMENT (SAMPLE REF. SP1(1))

Sample Number	SP1(1)
Location	UMC Access, 2/151
Material Description	Brake pads
Material Comment	In lift equipment
Quantity	1m ²
Product Type	Composite
Current Condition	-
Surface Treatment	Composite
Asbestos Type	Strongly Presumed Chrysotile
Material Assessment Rating	-
Accessibility	Low
Further Comment	Not applicable

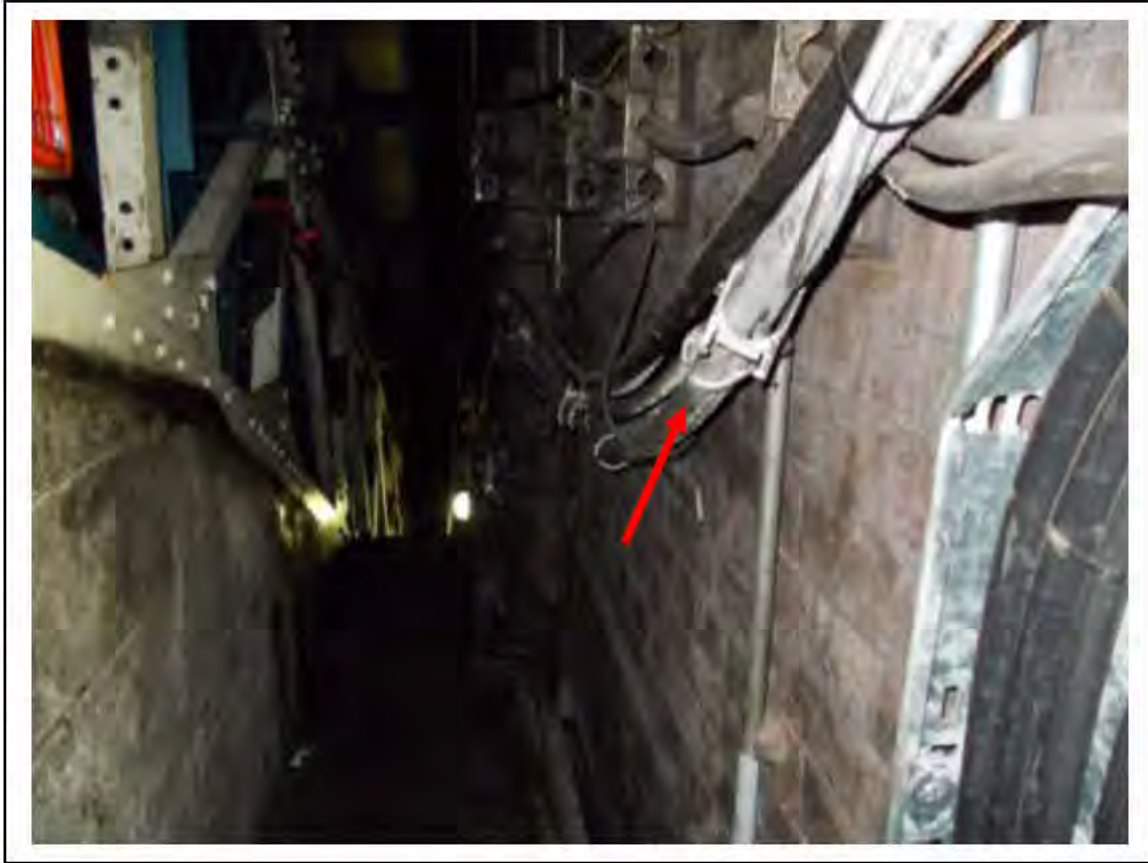
FIGURE 9: STRONGLY PRESUMED ASBESTOS IN WOVEN CABLE SHEATH IN ESC SHAFT, 2/171 - DESCRIPTION & RESULT OF ASSESSMENT (SAMPLE REF. SP1(7))

Sample Number	SP1(7)
Location	ESC Shaft, 2/171
Material Description	Woven cable sheath
Material Comment	Right hand side adjacent to escalator shaft
Quantity	90m
Product Type	Medium density
Current Condition	Good condition
Surface Treatment	Encapsulated medium density
Asbestos Type	Strongly Presumed Chrysotile
Material Assessment Rating	Very low
Accessibility	Low
Further Comment	Not applicable

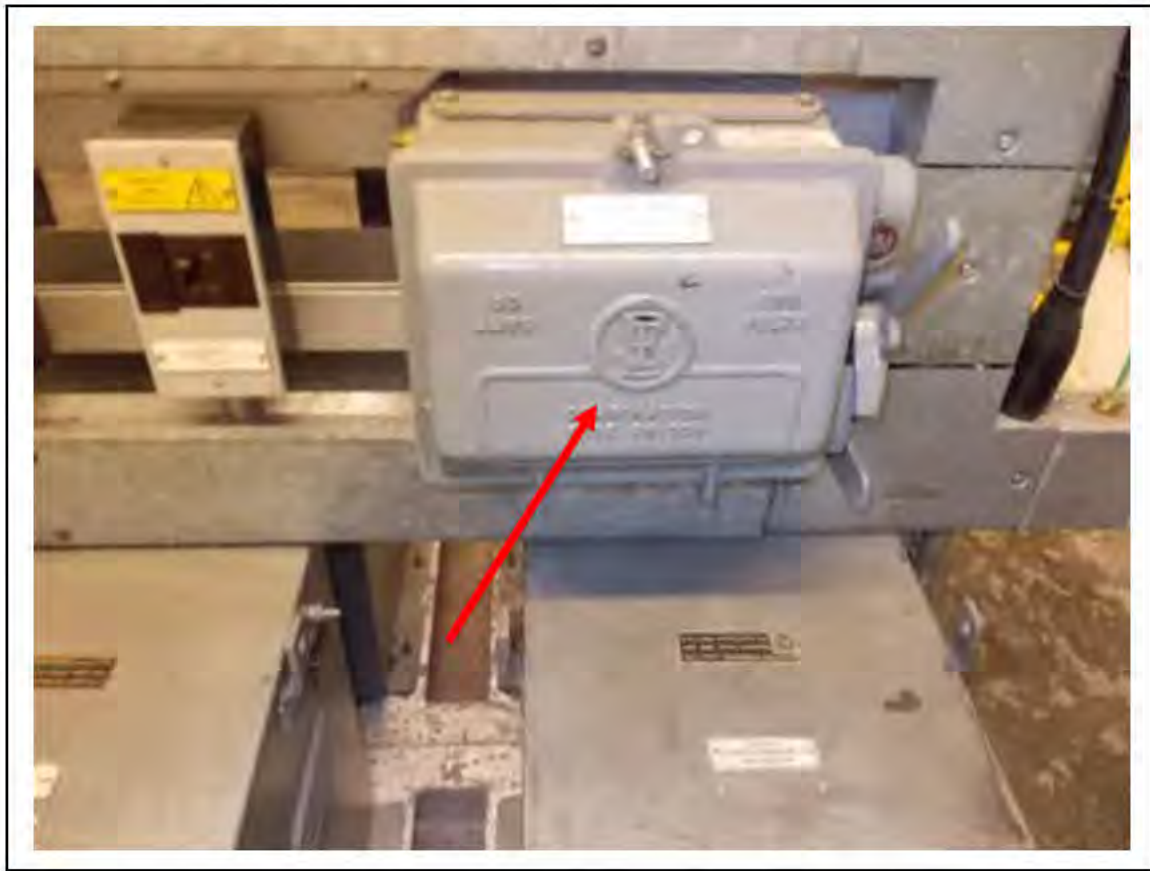
FIGURE 10: POSSIBLE ACMS WITHIN SWITCHGEAR IN CER, 2/746 - DESCRIPTION & RESULT OF ASSESSMENT (SAMPLE REF. P1(2))

Sample Number	P1(2)
Location	CER, 2/746
Material Description	Possible ACMs within switchgear
Material Comment	Switchgear
Quantity	2 No.
Product Type	-
Current Condition	-
Surface Treatment	-
Asbestos Type	Presumed Chrysotile
Material Assessment Rating	-
Accessibility	-
Further Comment	Not applicable

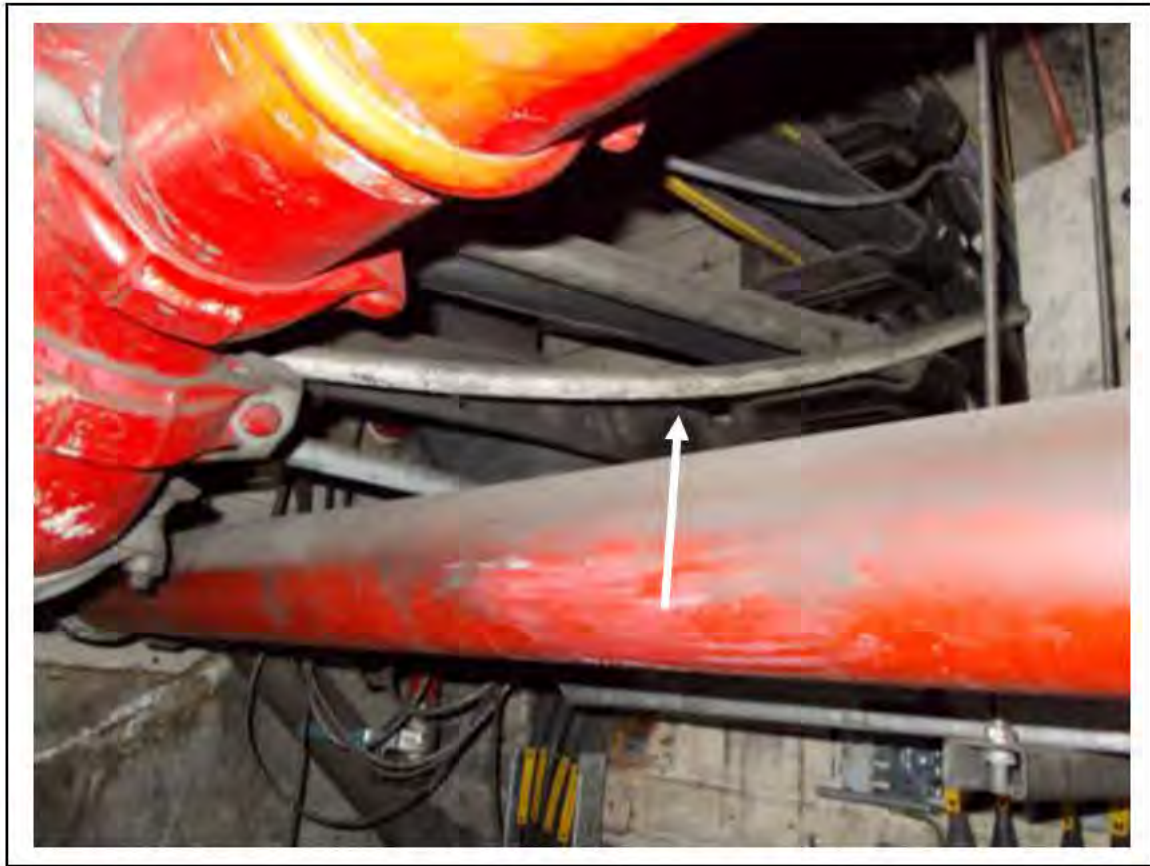
**FIGURE 11: STRONGLY PRESUMED ASBESTOS IN CLOTH CABLE WRAP
UMC ACCESS, 3/151 - DESCRIPTION & RESULT OF
ASSESSMENT (SAMPLE REF. SP1(8))**

Woven cables strongly presumed to contain Chrysotile asbestos, Figures 11 - 13 - Material assessment rating: Very low. Condition – Good.

Sample Number	SP1(8)
Location	UMC Access, 3/151
Material Description	Asbestos cloth
Material Comment	Cable sleeve
Quantity	3m
Product Type	Medium density
Current Condition	Good condition
Surface Treatment	Encapsulated medium density
Asbestos Type	Strongly Presumed Chrysotile
Material Assessment Rating	Very low
Accessibility	Low
Further Comment	Not applicable

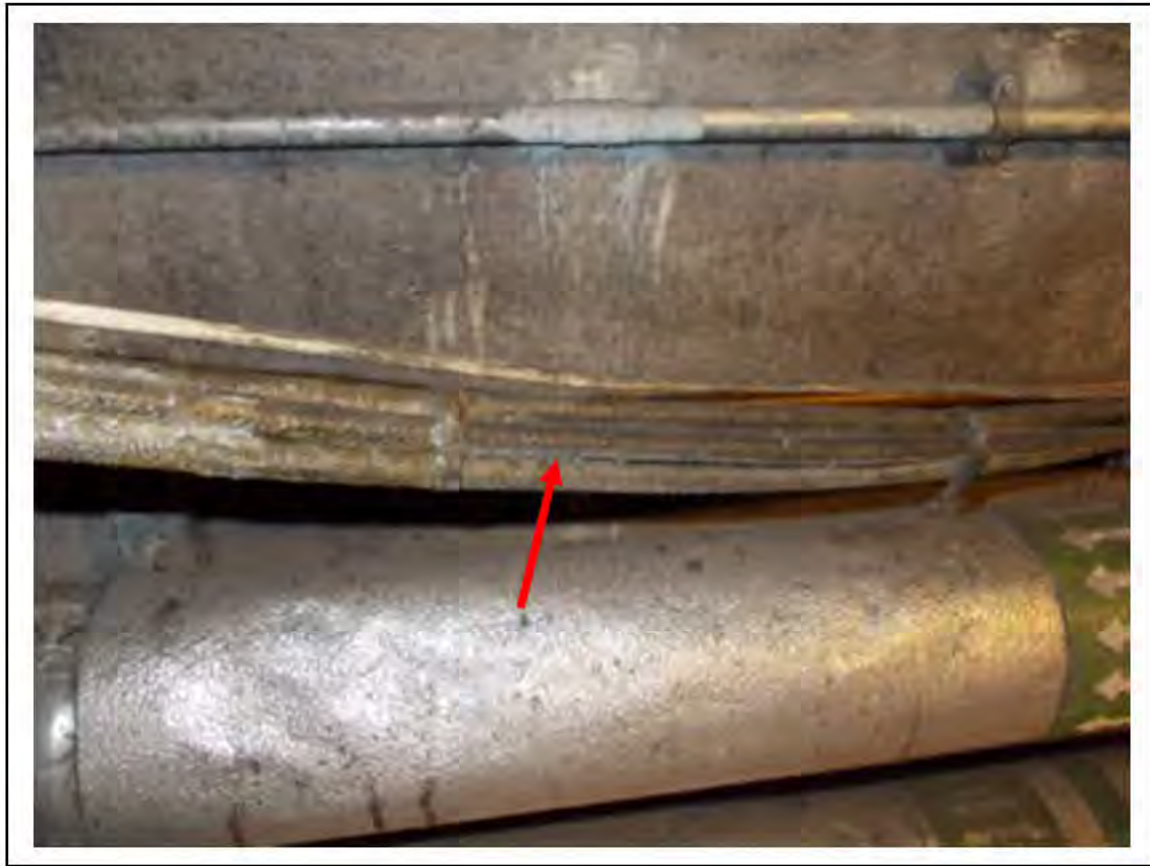
**FIGURE 12: STRONGLY PRESUMED ASBESTOS IN CLOTH CABLE WRAP
UMC ACCESS, 3/151 - DESCRIPTION & RESULT OF
ASSESSMENT (SAMPLE REF. SP1(9))**

Sample Number	SP1(9)
Location	UMC Access, 3/151
Material Description	Asbestos cloth
Material Comment	Cable sleeve
Quantity	4 No. x 15m
Product Type	Medium density
Current Condition	Good condition
Surface Treatment	Encapsulated medium density
Asbestos Type	Strongly Presumed Chrysotile
Material Assessment Rating	Very low
Accessibility	Low
Further Comment	Not applicable

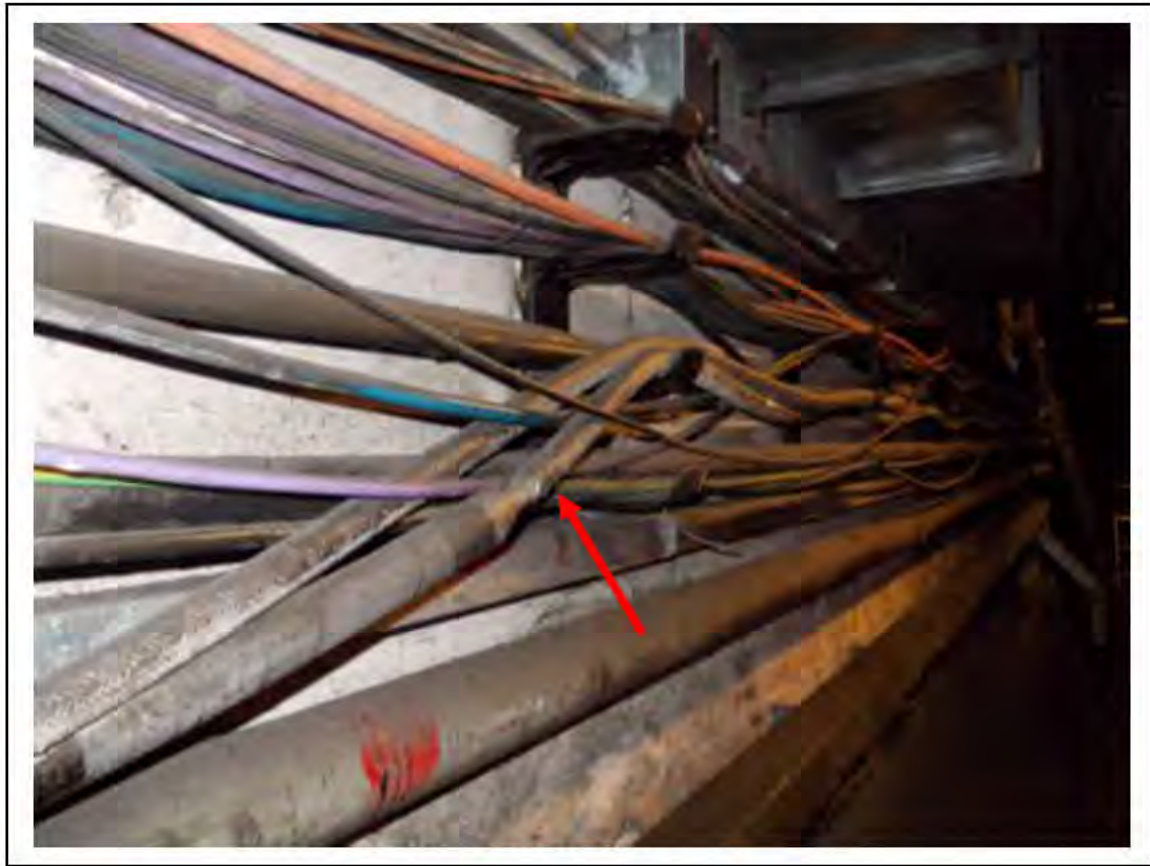
**FIGURE 13: STRONGLY PRESUMED ASBESTOS IN CLOTH CABLE WRAP
UMC ACCESS, 3/151 - DESCRIPTION & RESULT OF
ASSESSMENT (SAMPLE REF. SP1(10))**

Sample Number	SP1(10)
Location	UMC Access, 3/151
Material Description	Asbestos cloth
Material Comment	Cable sleeve
Quantity	2 No. x 25m
Product Type	Medium density
Current Condition	Good condition
Surface Treatment	Encapsulated medium density
Asbestos Type	Strongly Presumed Chrysotile
Material Assessment Rating	Very low
Accessibility	Low
Further Comment	Not applicable

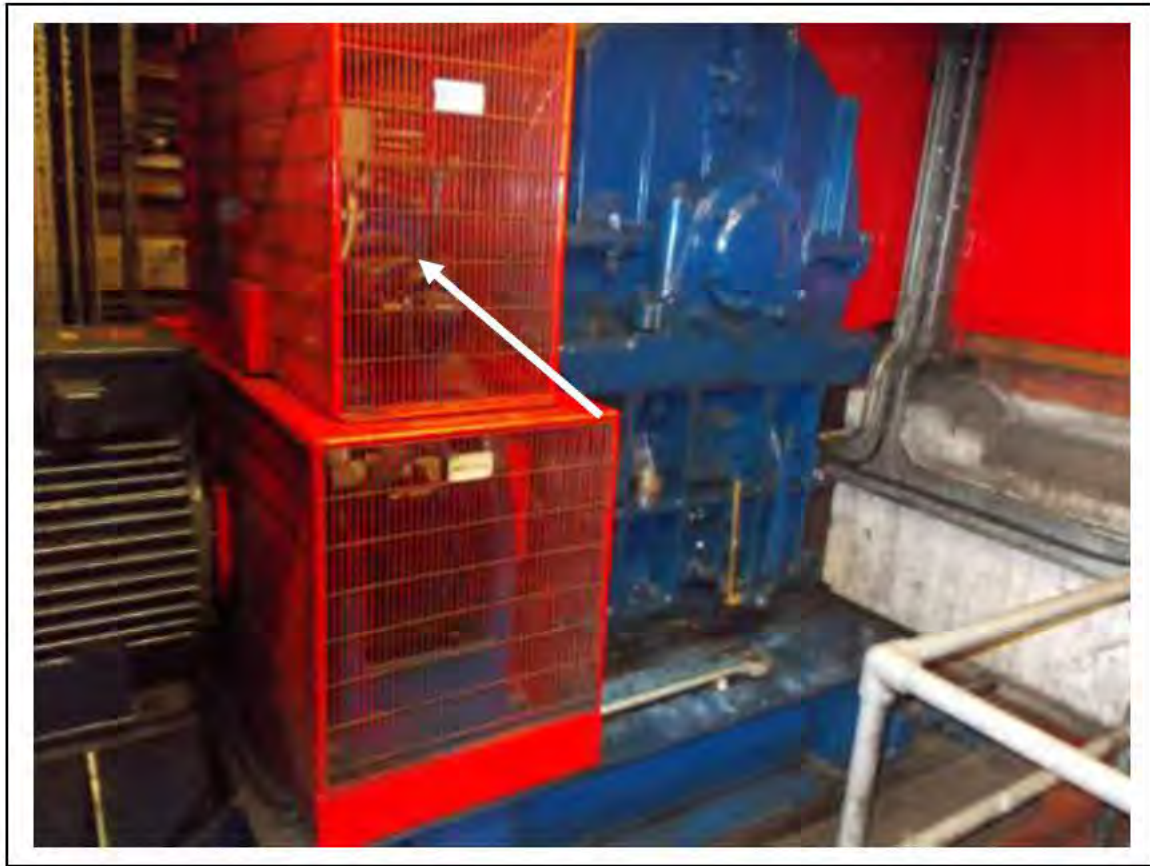
FIGURE 14: STRONGLY PRESUMED ASBESTOS IN BRAKE PADS IN UMC ACCESS, 3/151 - DESCRIPTION & RESULT OF ASSESSMENT (SAMPLE REF. SP1(11))

Sample Number	SP1(11)
Location	UMC Access, 3/151
Material Description	Brake pads
Material Comment	Within lift machinery
Quantity	1m ²
Product Type	Composite
Current Condition	Good condition
Surface Treatment	Composite
Asbestos Type	Strongly Presumed Chrysotile
Material Assessment Rating	Very low
Accessibility	Low
Further Comment	Not applicable

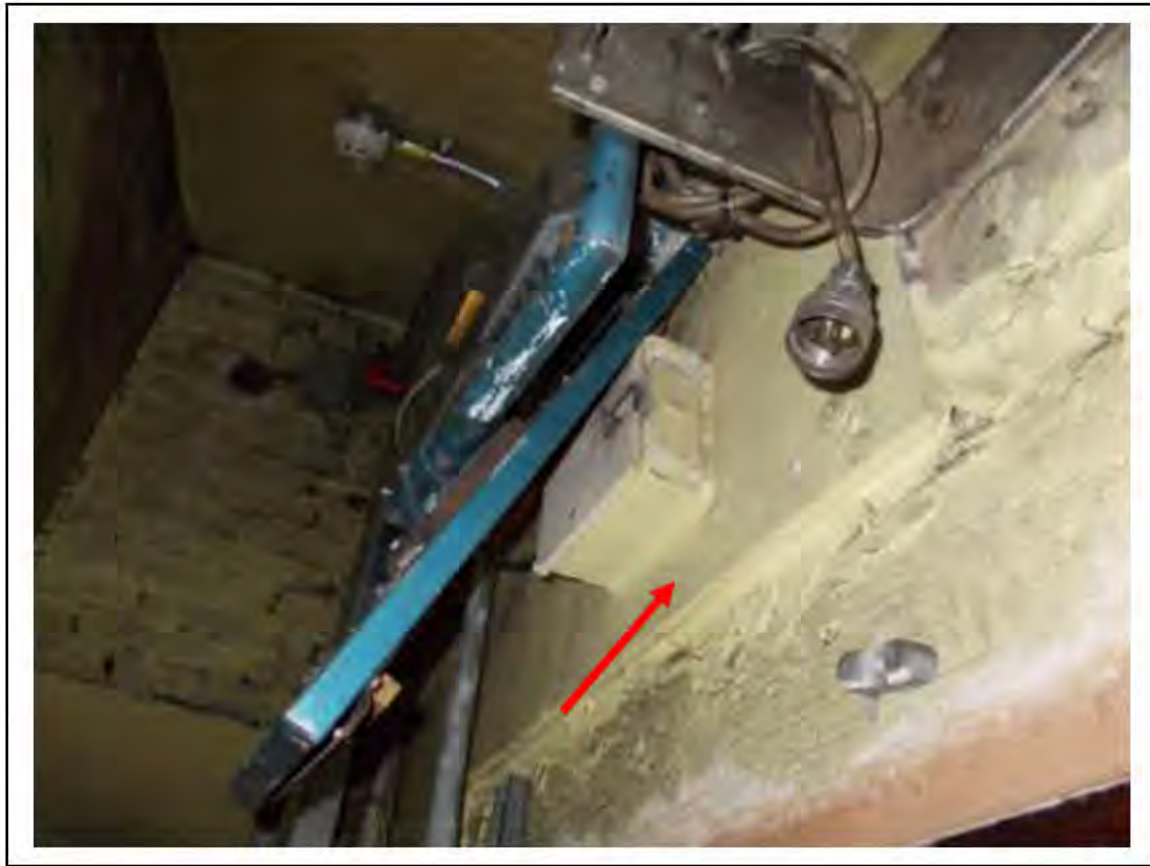
FIGURE 15: STRONGLY PRESUMED ASBESTOS IN INSULATION BOARD IN UMC ACCESS, 3/152 - DESCRIPTION & RESULT OF ASSESSMENT (SAMPLE REF. SP2(1))

Asbestos insulation board strongly presumed to contain Amosite asbestos, Figure 15 - Material assessment rating: Low. Condition – Good.

Sample Number	SP2(1)
Location	UMC Access, 3/152
Material Description	Asbestos insulation board
Material Comment	Wall infill panel
Quantity	1m ²
Product Type	Medium density
Current Condition	Slight damage
Surface Treatment	Encapsulated medium density
Asbestos Type	Strongly Presumed Amosite
Material Assessment Rating	Low
Accessibility	Low
Further Comment	Inaccessible to sample

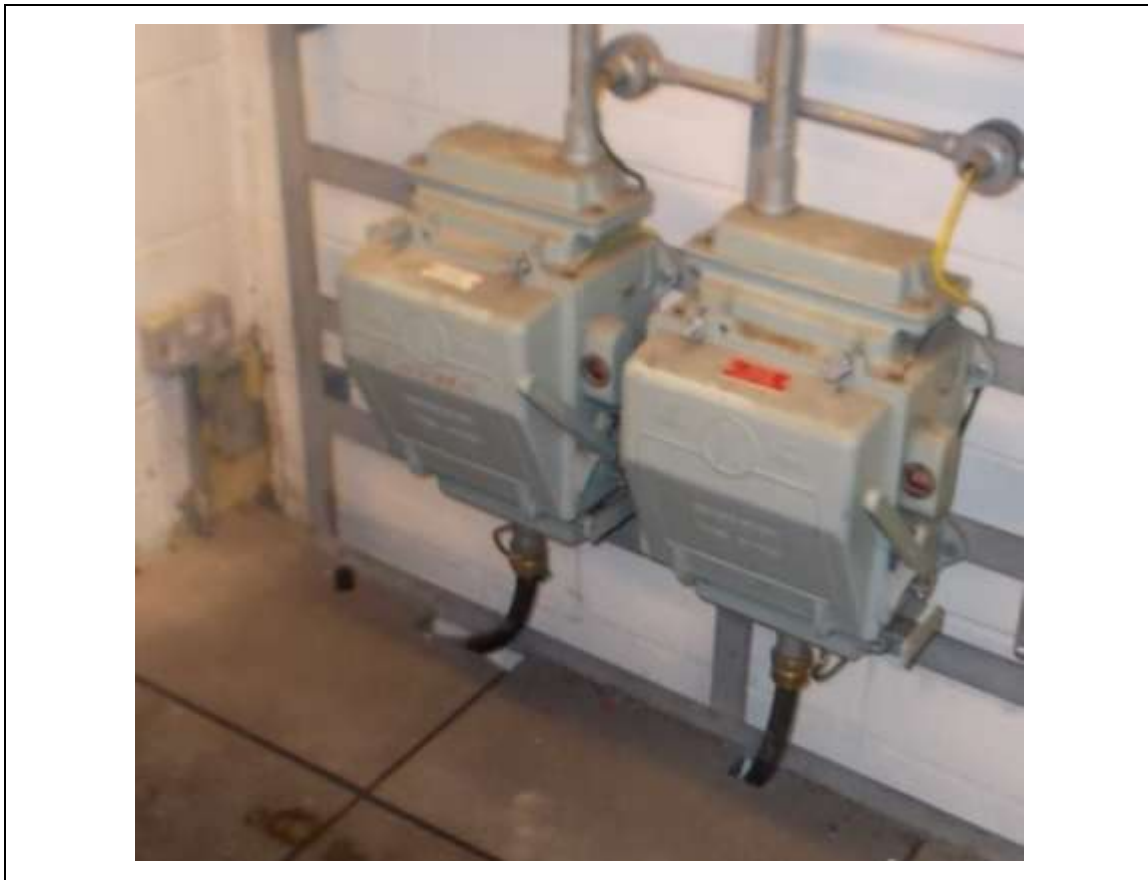
FIGURE 16: POSSIBLE ACMS WITHIN SWITCHGEAR IN CER, 3/731 - DESCRIPTION & RESULT OF ASSESSMENT (SAMPLE REF. P1(3))

Sample Number	P1(3)
Location	CER, 3/731
Material Description	Possible ACMs within switchgear
Material Comment	Switch gear
Quantity	2 No.
Product Type	-
Current Condition	-
Surface Treatment	-
Asbestos Type	Presumed Chrysotile
Material Assessment Rating	-
Accessibility	-
Further Comment	Not applicable

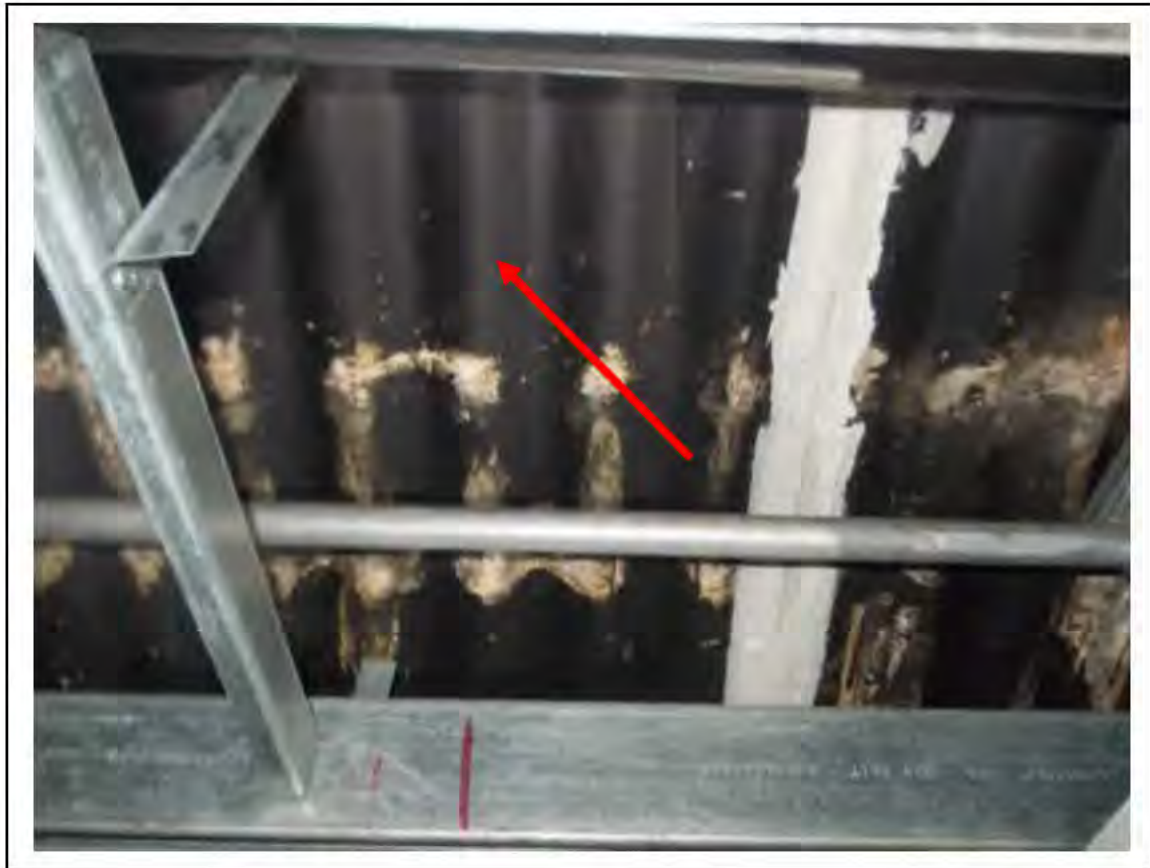
FIGURE 17: CONFIRMED ASBESTOS IN CELLACTITE IN OFFICE, 3/751 - DESCRIPTION & RESULT OF ASSESSMENT (SAMPLE REF. ECS 81505, ECS 81506, ECS 81507)

Cellactite confirmed to contain Chrysotile asbestos, Figure 17 - Material assessment rating: Very low. Condition – Good.

Sample Number	ECS 81505, ECS 81506, ECS 81507
Location	Office, 3/751
Material Description	Asbestos Cellactite
Material Comment	Within cupboard
Quantity	3m ²
Product Type	Composite
Current Condition	Good condition
Surface Treatment	Composite
Asbestos Type	Chrysotile
Material Assessment Rating	Very low
Accessibility	Low
Further Comment	Not applicable

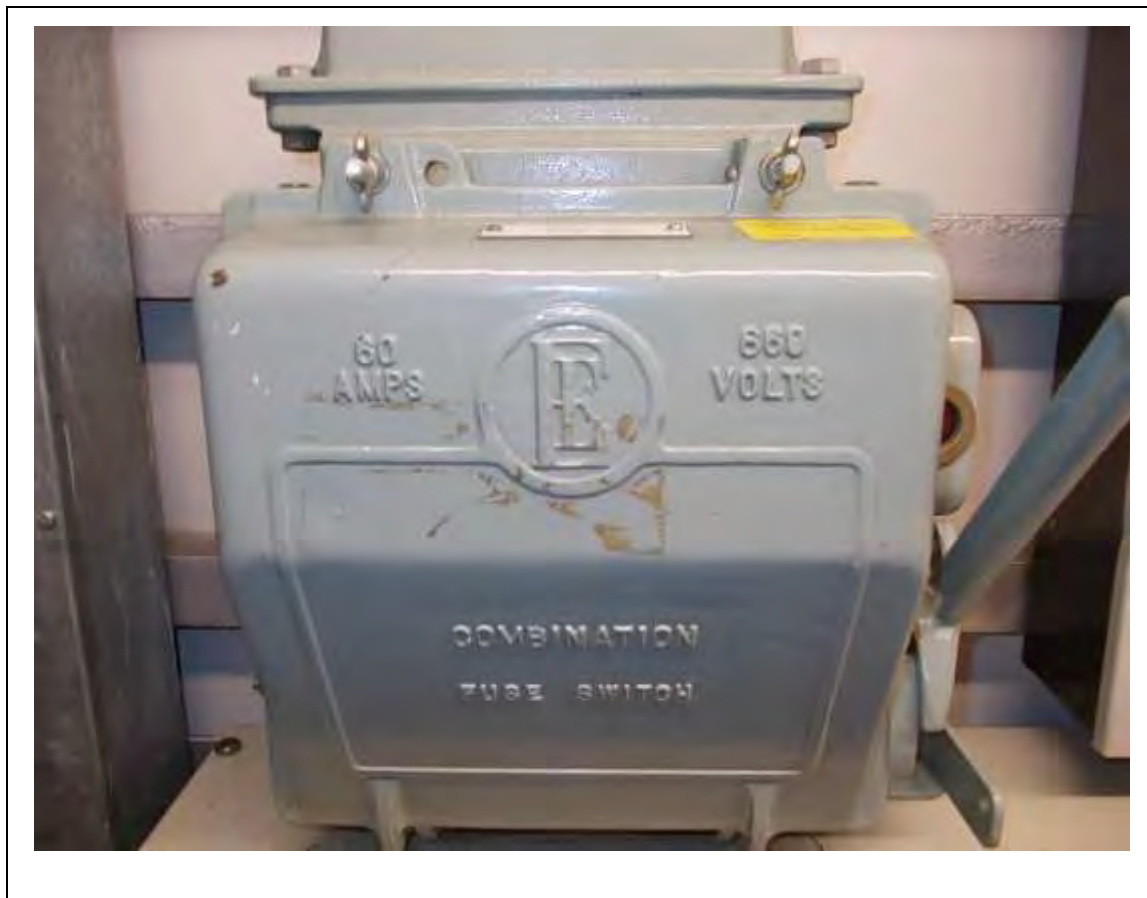
FIGURE 18: POSSIBLE ACMS WITHIN SWITCHGEAR IN PUMP ROOM, 3/776 - DESCRIPTION & RESULT OF ASSESSMENT (SAMPLE REF. P1(4))

Sample Number	P1(4)
Location	Pump Room, 3/776
Material Description	Possible ACMs within switchgear
Material Comment	On wall
Quantity	1 No.
Product Type	-
Current Condition	-
Surface Treatment	-
Asbestos Type	Presumed Chrysotile
Material Assessment Rating	-
Accessibility	-
Further Comment	Not applicable

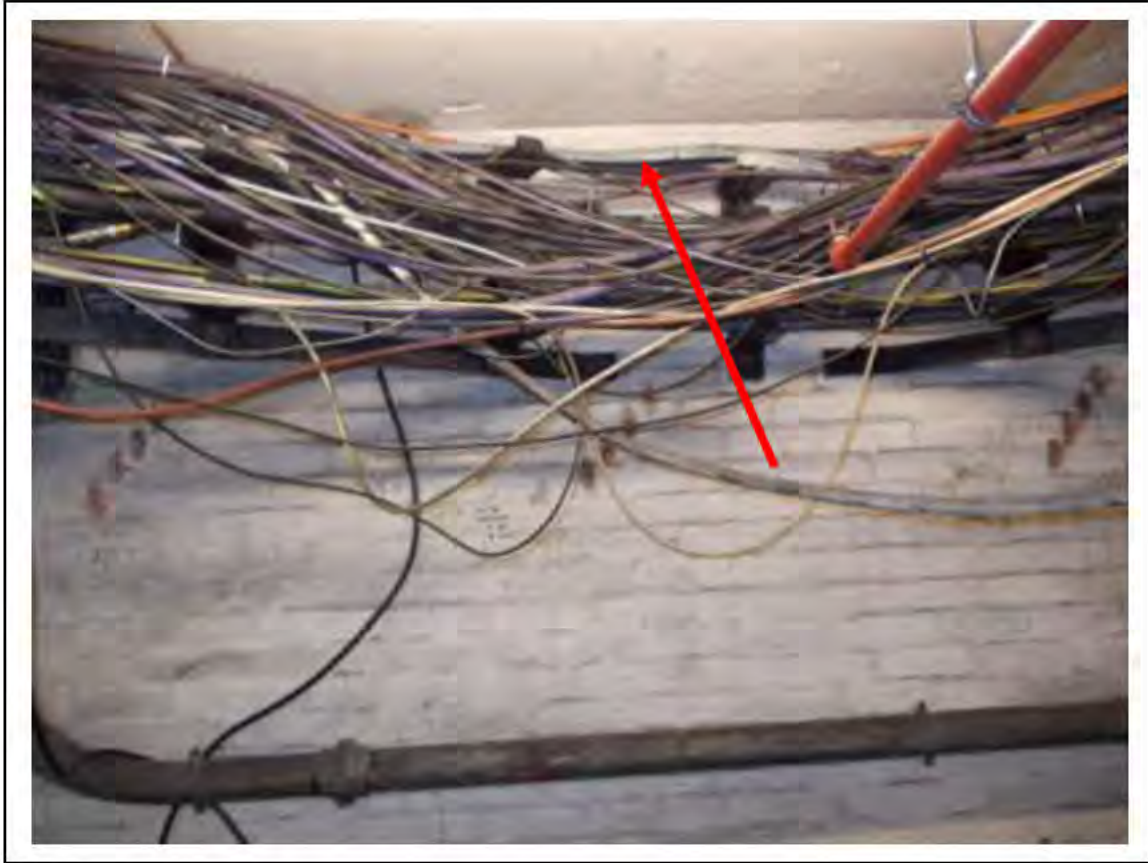
**FIGURE 19: STRONGLY PRESUMED ASBESTOS IN CLOTH CABLE WRAP
PUMP ROOM, 3/776 - DESCRIPTION & RESULT OF ASSESSMENT
(SAMPLE REF. SP1(12))**

Sample Number	SP1(12)
Location	Pump Room, 3/776
Material Description	Asbestos cloth
Material Comment	Cable sleeve
Quantity	100m
Product Type	Medium density
Current Condition	Good condition
Surface Treatment	Encapsulated medium density
Asbestos Type	Strongly Presumed Chrysotile
Material Assessment Rating	Very low
Accessibility	Low
Further Comment	Not applicable

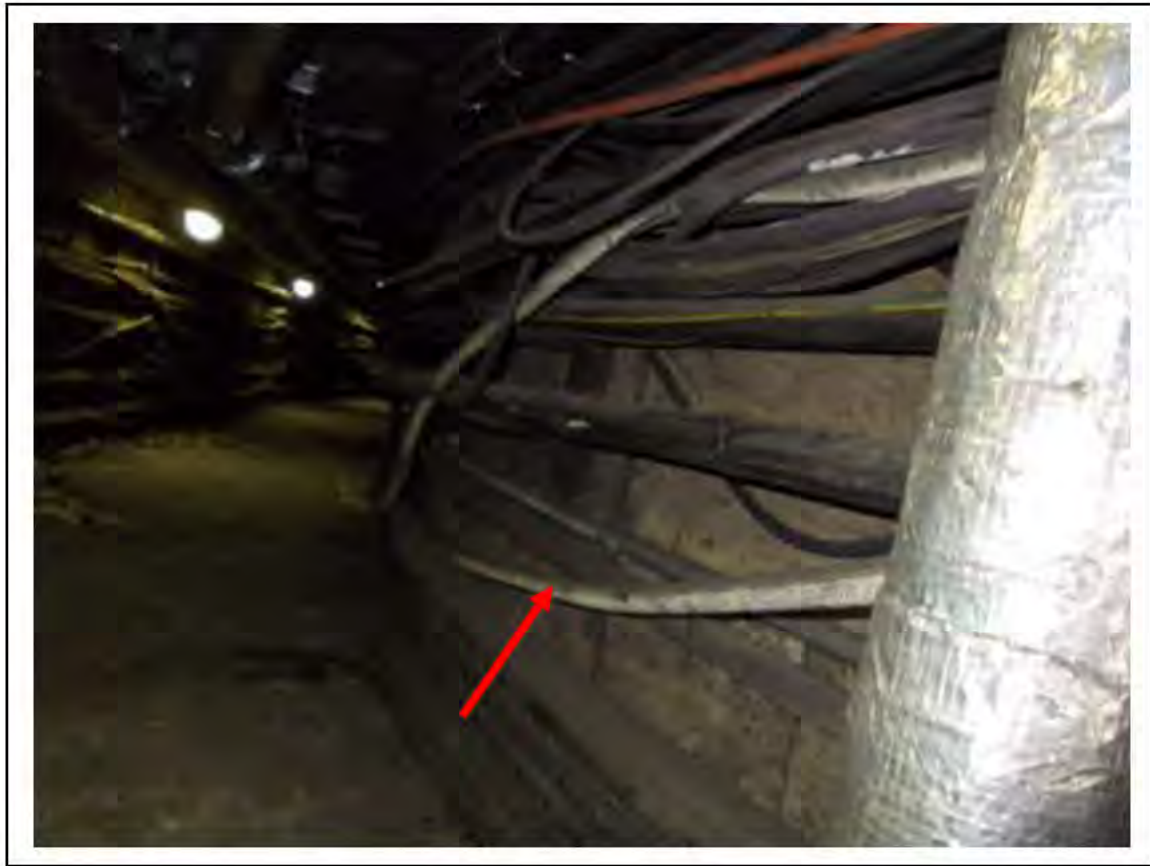
FIGURE 20: STRONGLY PRESUMED ASBESTOS IN CLOTH WOVEN CABLE SHEATH IN CABLE DUCT, 3/786 - DESCRIPTION & RESULT OF ASSESSMENT (SAMPLE REF. SP1(23))

Woven cables strongly presumed to contain Chrysotile asbestos, Figure 20 - Material assessment rating: Very low. Condition – Good.

Sample Number	SP1(23)
Location	Cable Duct, 3/786
Material Description	Asbestos cloth, woven cable sheath
Material Comment	Cable within service duct
Quantity	2 No. x 25m 3 No. x 15m
Product Type	Medium density
Current Condition	Good condition
Surface Treatment	Encapsulated medium density
Asbestos Type	Strongly Presumed Chrysotile
Material Assessment Rating	Very low
Accessibility	Low
Further Comment	Not applicable
