Report No. 4RS-SP-110701-R370083

**REINSPECTION OF ASBESTOS CONTAINING MATERIALS
WARREN STREET UNDERGROUND STATION**

Issue Date: 31st January 2013

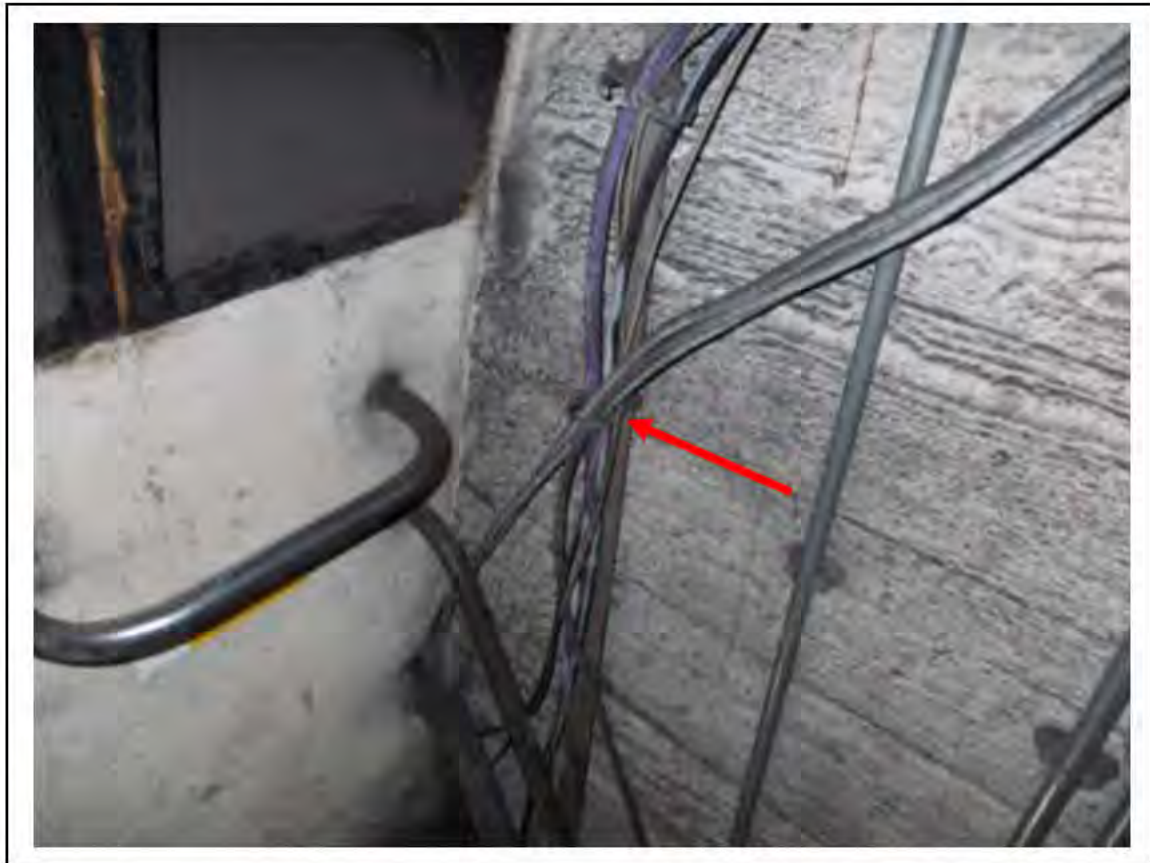
FIGURE 21: STRONGLY PRESUMED ASBESTOS IN WOVEN CABLE IN ACCESS TO LMC, 4/161 - DESCRIPTION & RESULT OF ASSESSMENT (SAMPLE REF. SP1(13))

Woven cables strongly presumed to contain Chrysotile asbestos, Figure 21 - Material assessment rating: Very low. Condition – Good.

Sample Number	SP1(13)
Location	Access to LMC, 4/161
Material Description	Woven cable
Material Comment	To walls
Quantity	3 x 15m
Product Type	Medium density
Current Condition	Good condition
Surface Treatment	Encapsulated medium density
Asbestos Type	Strongly Presumed Chrysotile
Material Assessment Rating	Very low
Accessibility	Low
Further Comment	Not applicable

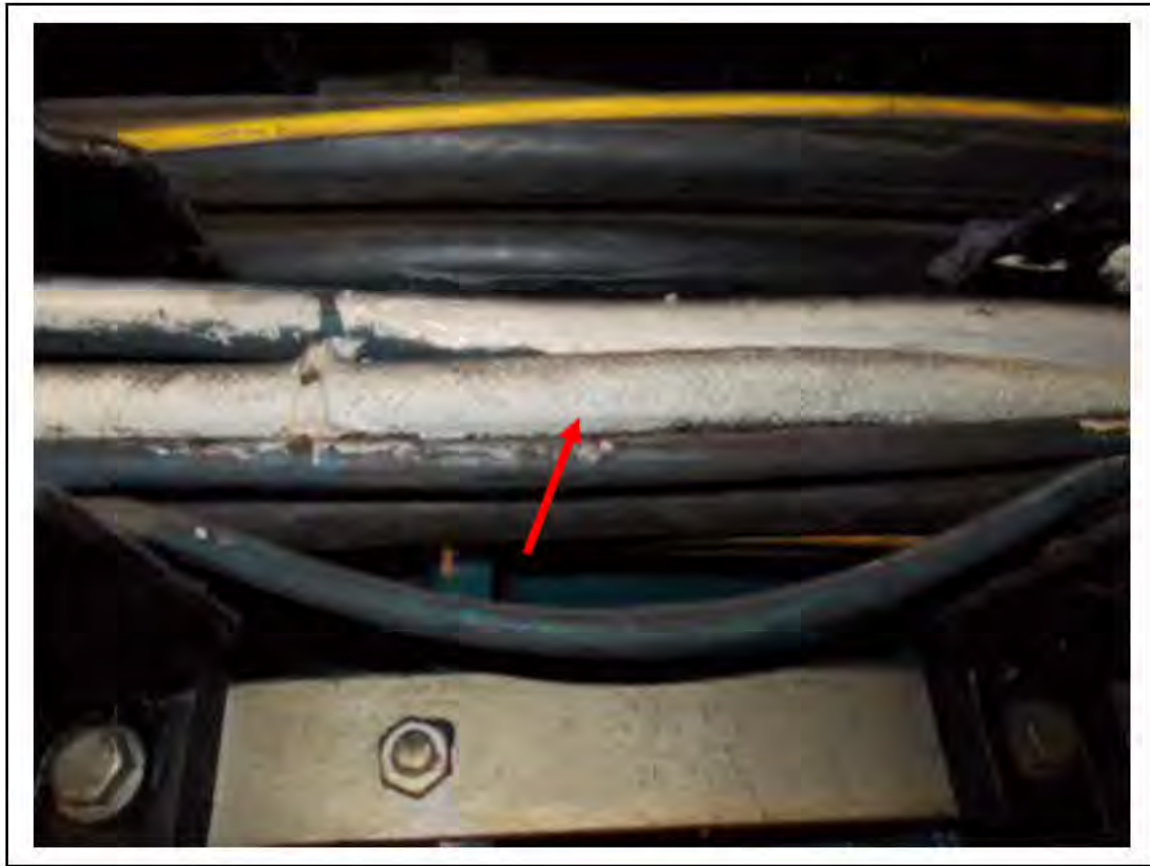
FIGURE 22: CONFIRMED ASBESTOS IN ASBESTOS CLOTH IN RELAY ROOM, 5/711 - DESCRIPTION & RESULT OF ASSESSMENT (SAMPLE REF. ECS 81549)

Woven cable confirmed to contain Chrysotile asbestos, Figure 22 - Material assessment rating: Low. Condition – Good.

Sample Number	ECS 81549
Location	Relay Room, 5/711
Material Description	Asbestos cloth
Material Comment	Cable sleeve
Quantity	4m
Product Type	Medium density
Current Condition	Good condition
Surface Treatment	Encapsulated medium density
Asbestos Type	Chrysotile
Material Assessment Rating	Low
Accessibility	Low
Further Comment	Not applicable

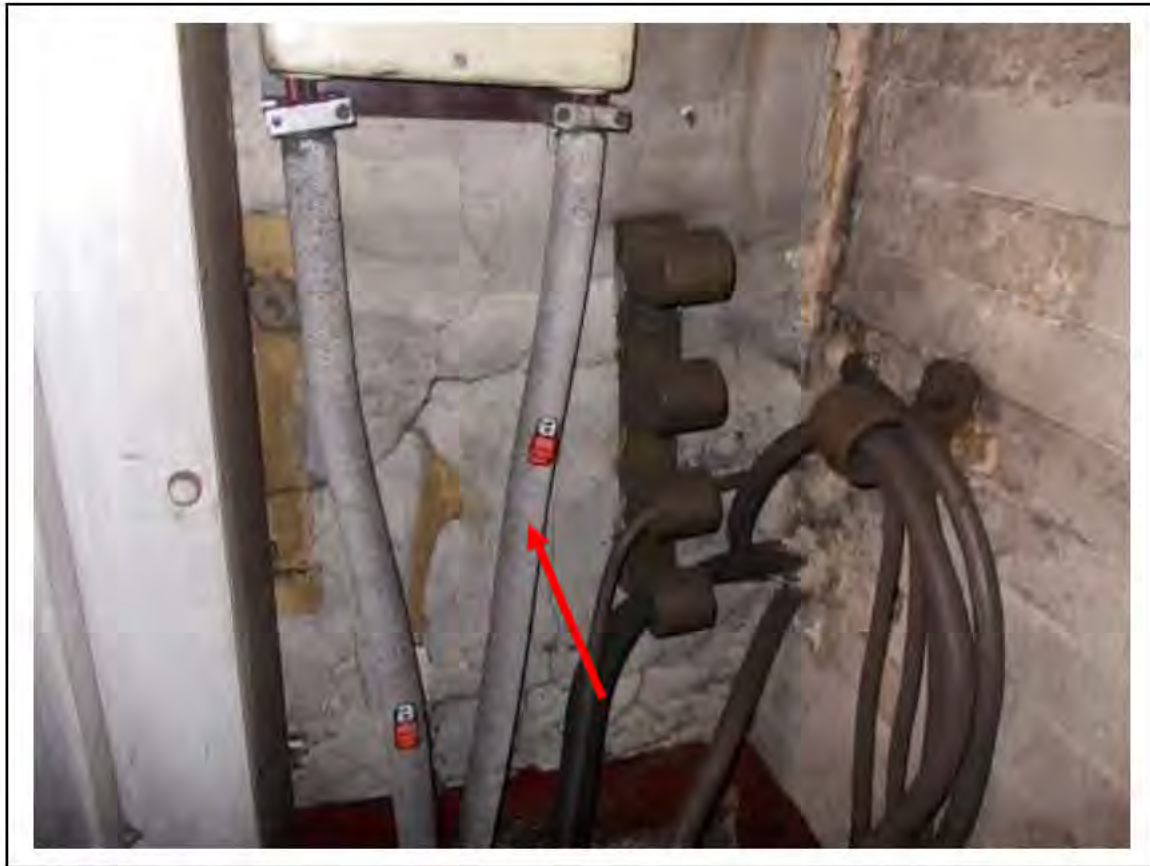
FIGURE 23: CONFIRMED ASBESTOS IN ASBESTOS CLOTH IN RELAY ROOM, 5/713 - DESCRIPTION & RESULT OF ASSESSMENT (SAMPLE REF. ECS 81540)

Woven cable confirmed to contain Chrysotile asbestos, Figure 23 - Material assessment rating: Very low. Condition – Good.

Sample Number	ECS 81540
Location	Relay Room, 5/713
Material Description	Asbestos cloth
Material Comment	Cable sleeve
Quantity	2m ²
Product Type	Composite
Current Condition	Good condition
Surface Treatment	Composite
Asbestos Type	Chrysotile
Material Assessment Rating	Very low
Accessibility	Low
Further Comment	Not applicable

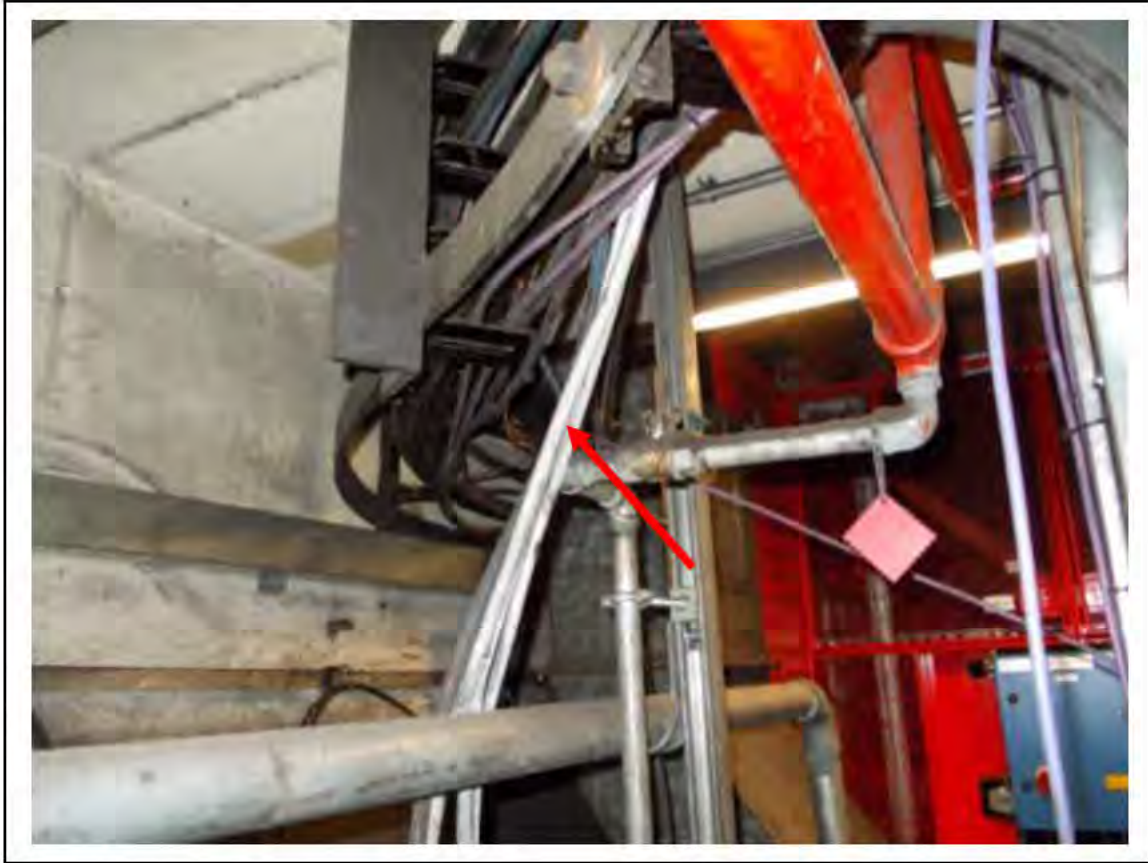
**FIGURE 24: STRONGLY PRESUMED ASBESTOS IN CLOTH CABLE WRAP
LMC ACCESS, 6/161 - DESCRIPTION & RESULT OF ASSESSMENT
(SAMPLE REF. SP1(14))**

Woven cables strongly presumed to contain Chrysotile asbestos, Figures 24 & 25 - Material assessment rating: Very low. Condition – Good.

Sample Number	SP1(14)
Location	LMC Access, 6/161
Material Description	Asbestos cloth
Material Comment	Cable sleeve
Quantity	70m
Product Type	Medium density
Current Condition	Good condition
Surface Treatment	Encapsulated medium density
Asbestos Type	Strongly Presumed Chrysotile
Material Assessment Rating	Very low
Accessibility	Low
Further Comment	Not applicable

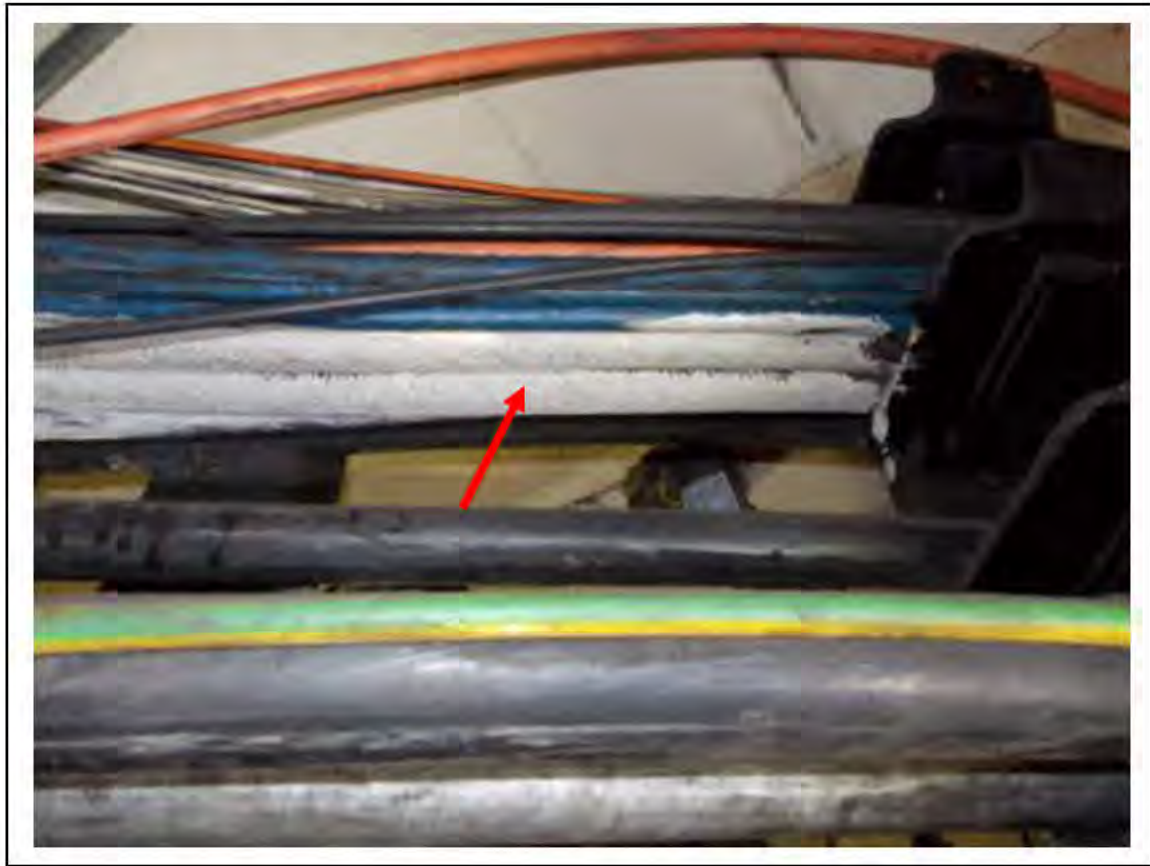
**FIGURE 25: STRONGLY PRESUMED ASBESTOS IN CLOTH CABLE WRAP
LMC ACCESS, 6/161 - DESCRIPTION & RESULT OF ASSESSMENT
(SAMPLE REF. SP1(15))**

Sample Number	SP1(15)
Location	LMC Access, 6/161
Material Description	Asbestos cloth
Material Comment	Cable sleeve
Quantity	40m ²
Product Type	Medium density
Current Condition	Good condition
Surface Treatment	Encapsulated medium density
Asbestos Type	Strongly Presumed Chrysotile
Material Assessment Rating	Very low
Accessibility	Low
Further Comment	Not applicable

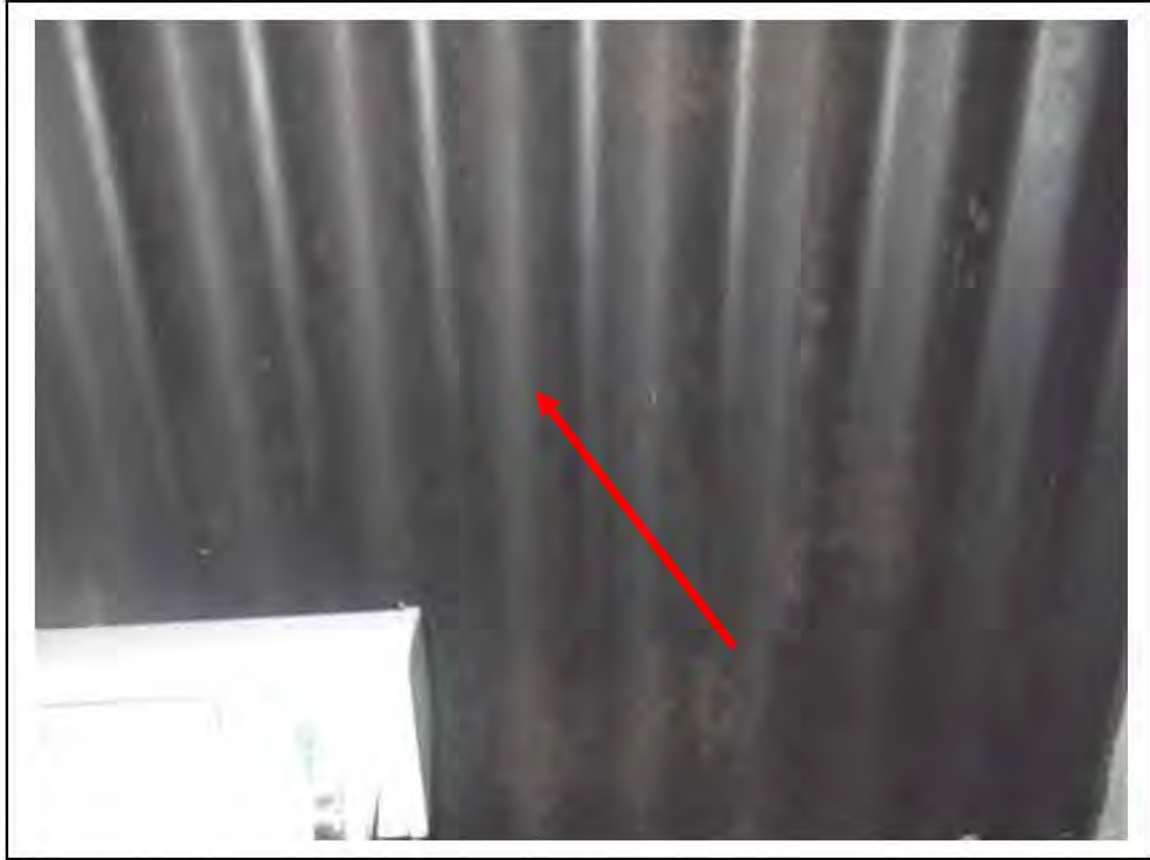
FIGURE 26: CONFIRMED ASBESTOS IN CELLACTITE IN LOBBY (PREVIOUSLY 6/236), 6/301 - DESCRIPTION & RESULT OF ASSESSMENT (SAMPLE REF. ECS 81579, ECS 81585)

Cellactite confirmed to contain Chrysotile asbestos, Figure 26 - Material assessment rating: Very low. Condition – Good.

Sample Number	ECS 81579, ECS 81585
Location	Lobby (previously 6/236), 6/301
Material Description	Asbestos Cellactite
Material Comment	Within ceiling void
Quantity	10m ²
Product Type	Composite
Current Condition	Good condition
Surface Treatment	Composite
Asbestos Type	Chrysotile
Material Assessment Rating	Very low
Accessibility	Low
Further Comment	Not applicable

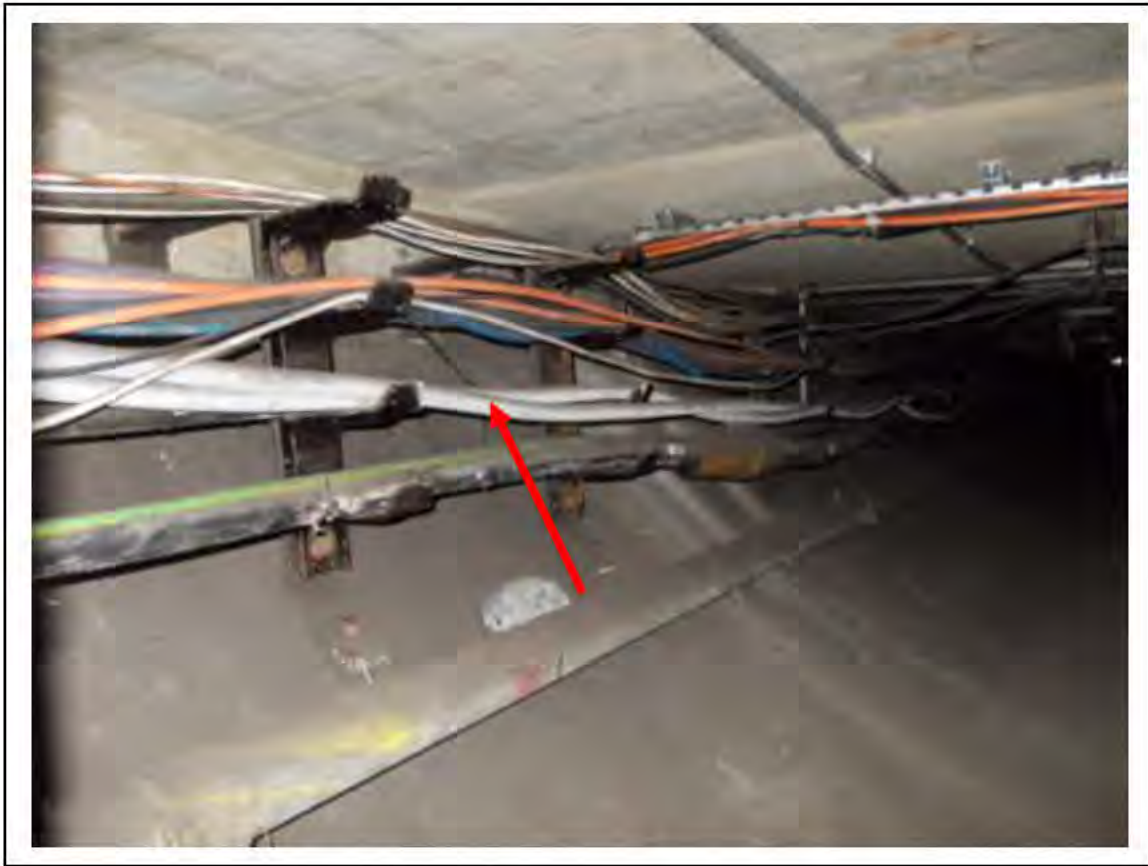
**FIGURE 27: STRONGLY PRESUMED ASBESTOS IN CLOTH CABLE WRAP
CABLE DUCT, 6/787 - DESCRIPTION & RESULT OF ASSESSMENT
(SAMPLE REF. SP1(21))**

Woven cable strongly presumed to contain Chrysotile asbestos, Figure 27 - Material assessment rating: Very low. Condition – Good.

Sample Number	SP1(21)
Location	Cable Duct, 6/787
Material Description	Asbestos cloth
Material Comment	Cable sleeve, within service duct
Quantity	20m
Product Type	Medium density
Current Condition	Good condition
Surface Treatment	Encapsulated medium density
Asbestos Type	Strongly Presumed Chrysotile
Material Assessment Rating	Very low
Accessibility	Low
Further Comment	Not applicable

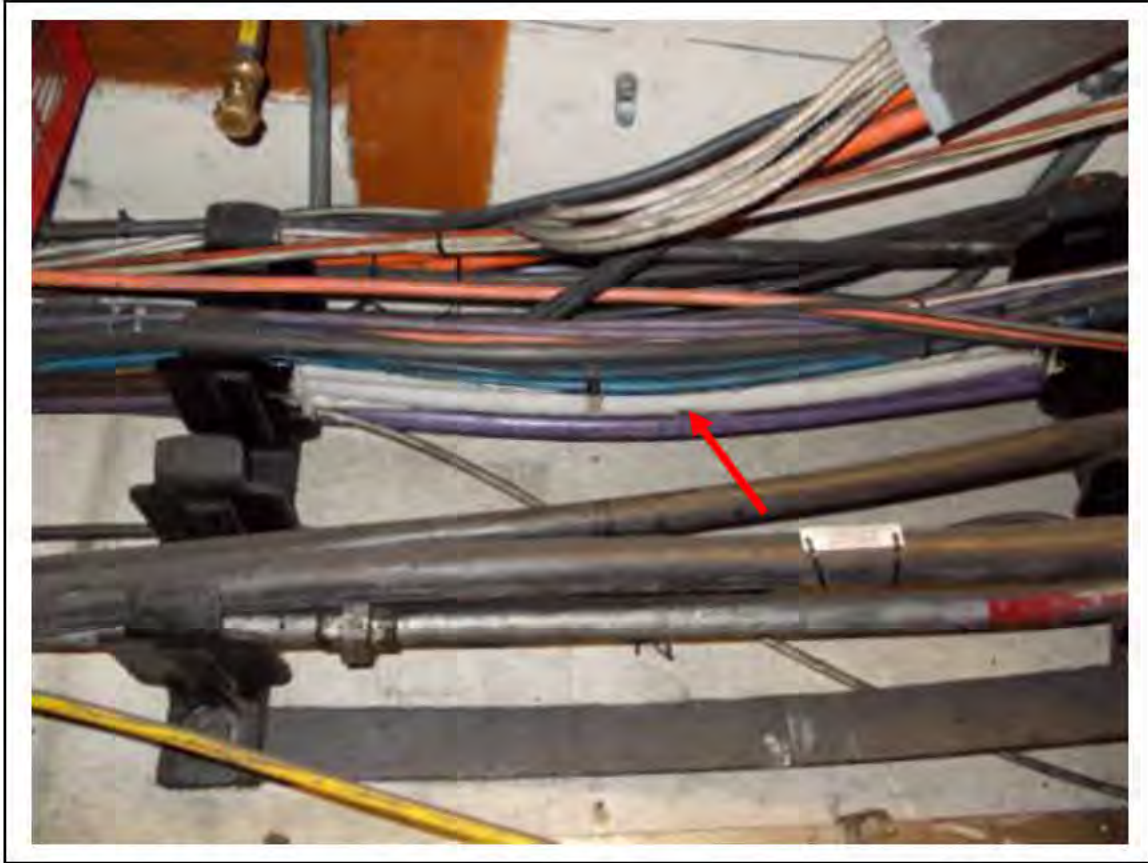
Woven cable strongly presumed to contain Chrysotile asbestos, Figure 28 - Material assessment rating: Low. Condition – Good.

Sample Number	SP1(16)
Location	Relay Room, 6/711
Material Description	Asbestos cloth
Material Comment	Cable sleeve
Quantity	20m
Product Type	Medium density
Current Condition	Good condition
Surface Treatment	Encapsulated medium density
Asbestos Type	Strongly Presumed Chrysotile
Material Assessment Rating	Low
Accessibility	Low
Further Comment	Not applicable

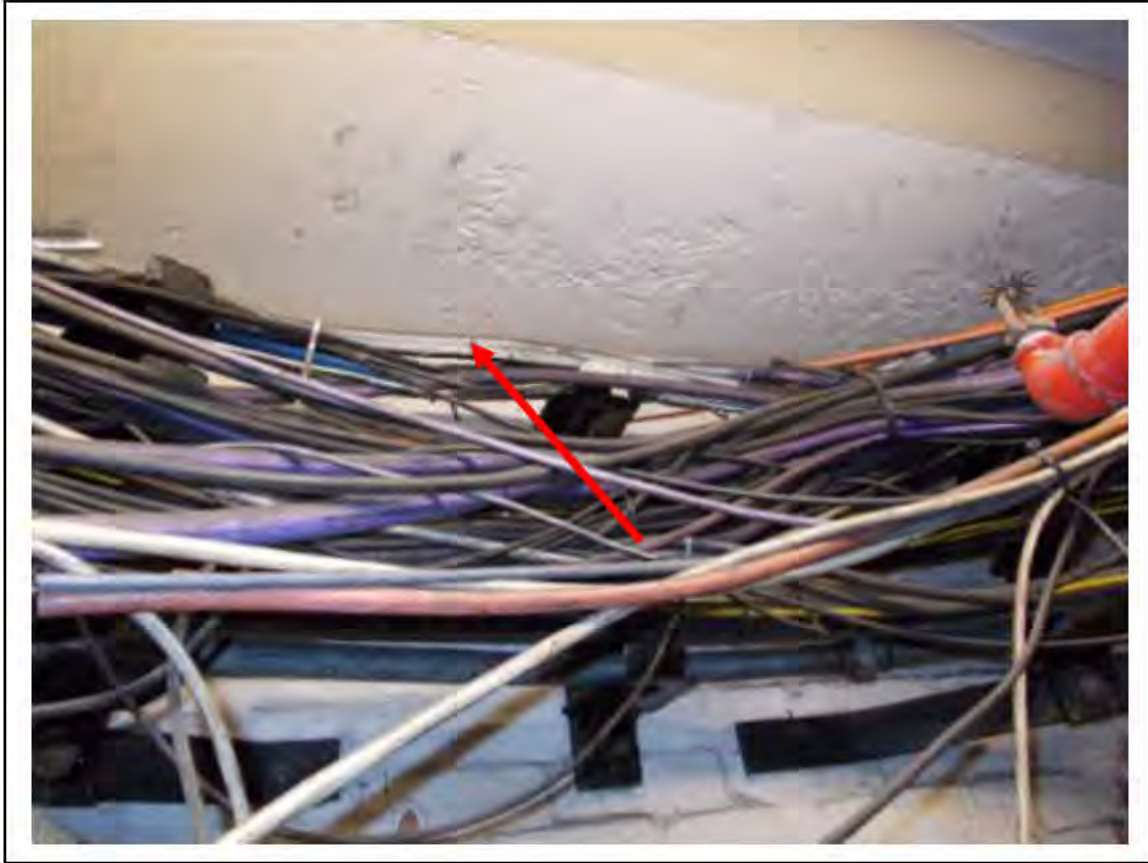
Woven cable strongly presumed to contain Chrysotile asbestos, Figure 29 - Material assessment rating: Low. Condition – Good.

Sample Number	SP1(22)
Location	Relay Room, 6/712
Material Description	Asbestos cloth
Material Comment	Cable sleeve
Quantity	30m
Product Type	Medium density
Current Condition	Good condition
Surface Treatment	Encapsulated medium density
Asbestos Type	Strongly Presumed Chrysotile
Material Assessment Rating	Low
Accessibility	Low
Further Comment	Not applicable

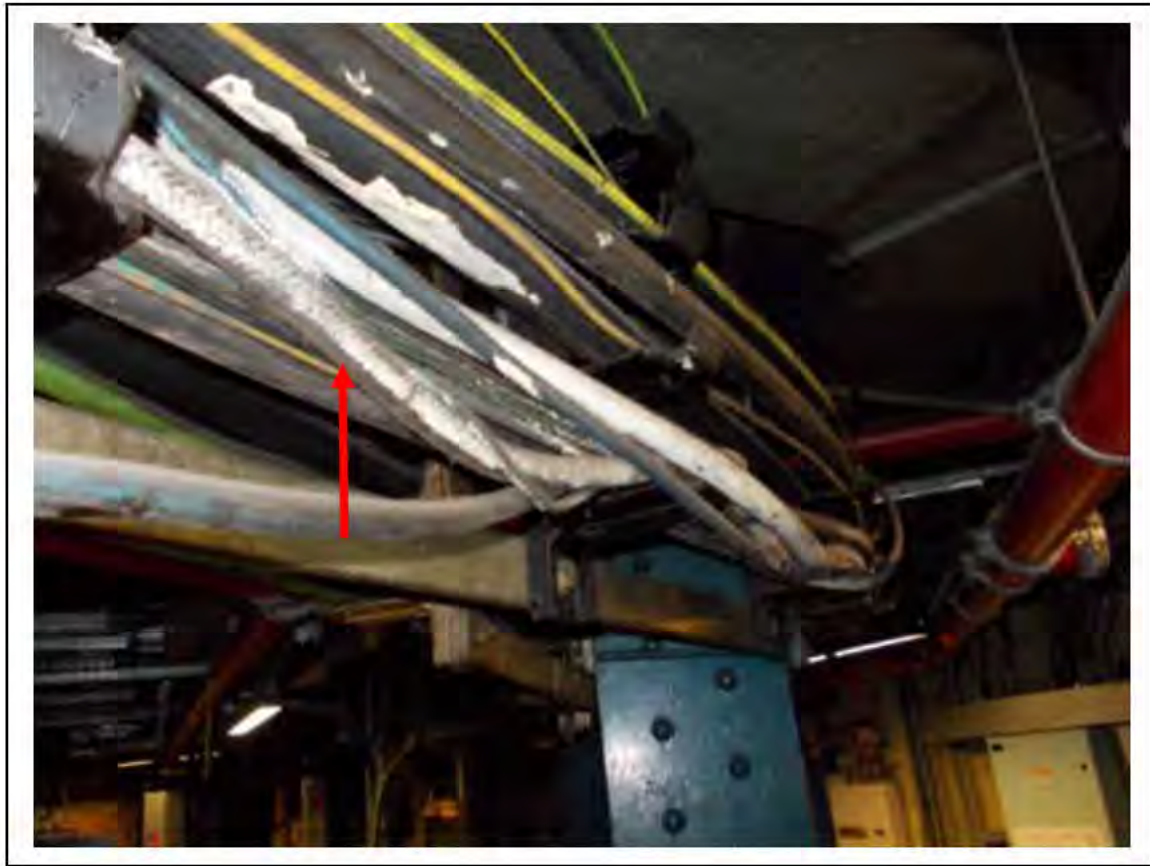
Woven cable strongly presumed to contain Chrysotile asbestos, Figure 30 - Material assessment rating: Low. Condition – Good.

Sample Number	SP1(17)
Location	Relay Room, 6/713
Material Description	Asbestos cloth
Material Comment	Cable sleeve
Quantity	20m
Product Type	Medium density
Current Condition	Good condition
Surface Treatment	Encapsulated medium density
Asbestos Type	Strongly Presumed Chrysotile
Material Assessment Rating	Low
Accessibility	Low
Further Comment	Not applicable

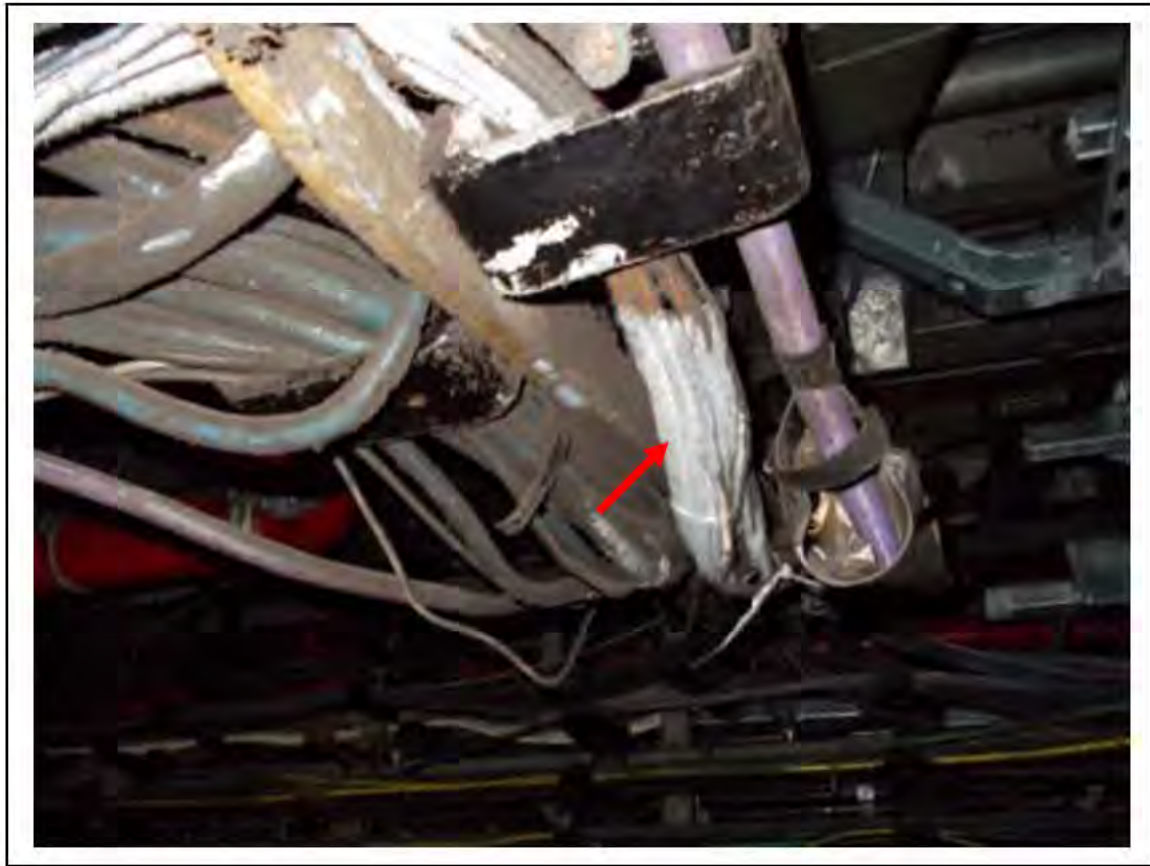
Woven cable strongly presumed to contain Chrysotile asbestos, Figure 31. Material assessment rating: Low. Condition – Good.

Sample Number	SP1(18)
Location	Relay Room, 6/714
Material Description	Asbestos cloth
Material Comment	Cable sleeve
Quantity	20m
Product Type	Medium density
Current Condition	Good condition
Surface Treatment	Encapsulated medium density
Asbestos Type	Strongly Presumed Chrysotile
Material Assessment Rating	Very Low
Accessibility	Low
Further Comment	Not applicable

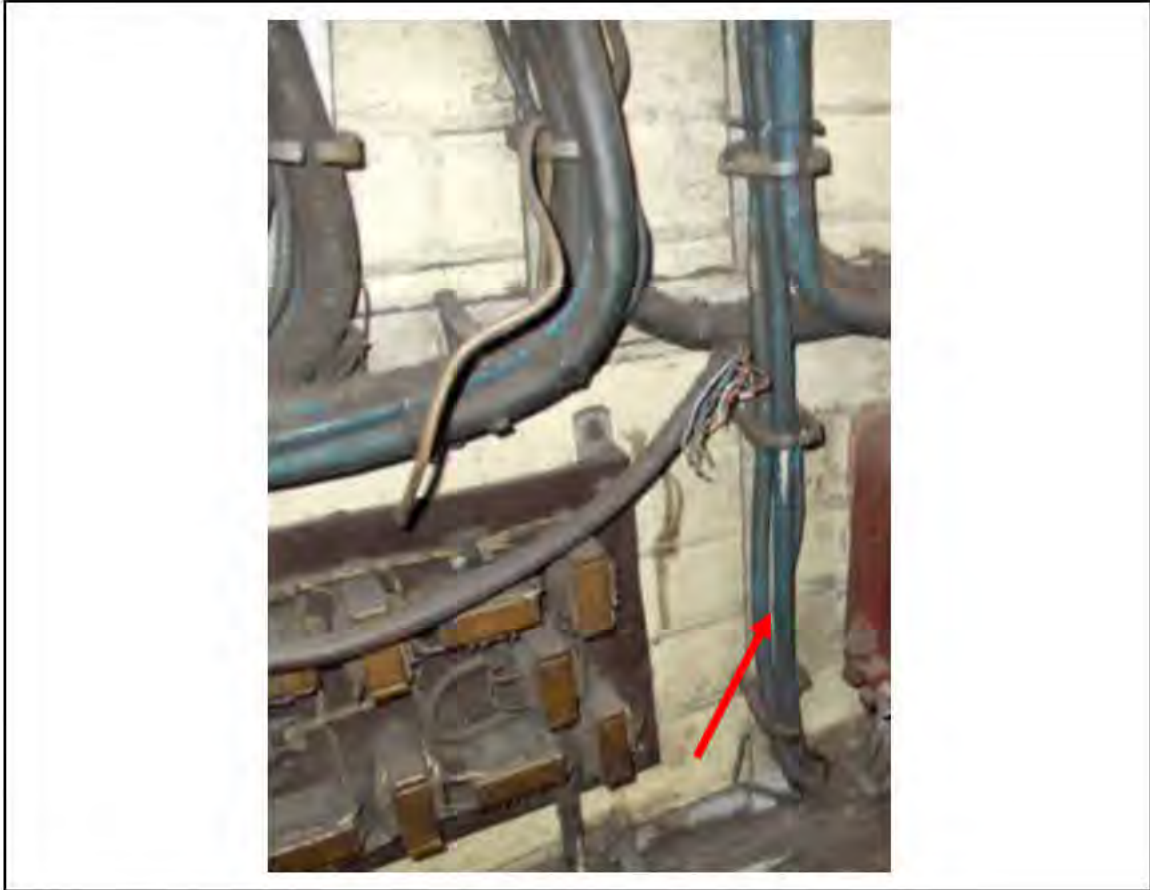
Woven cable strongly presumed to contain Chrysotile asbestos, Figure 32 - Material assessment rating: Low. Condition – Good.

Sample Number	SP1(19)
Location	CER, 6/731
Material Description	Asbestos cloth
Material Comment	Cable sleeve
Quantity	2m ²
Product Type	Medium density
Current Condition	Good condition
Surface Treatment	Encapsulated medium density
Asbestos Type	Strongly Presumed Chrysotile
Material Assessment Rating	Low
Accessibility	Low
Further Comment	Not applicable

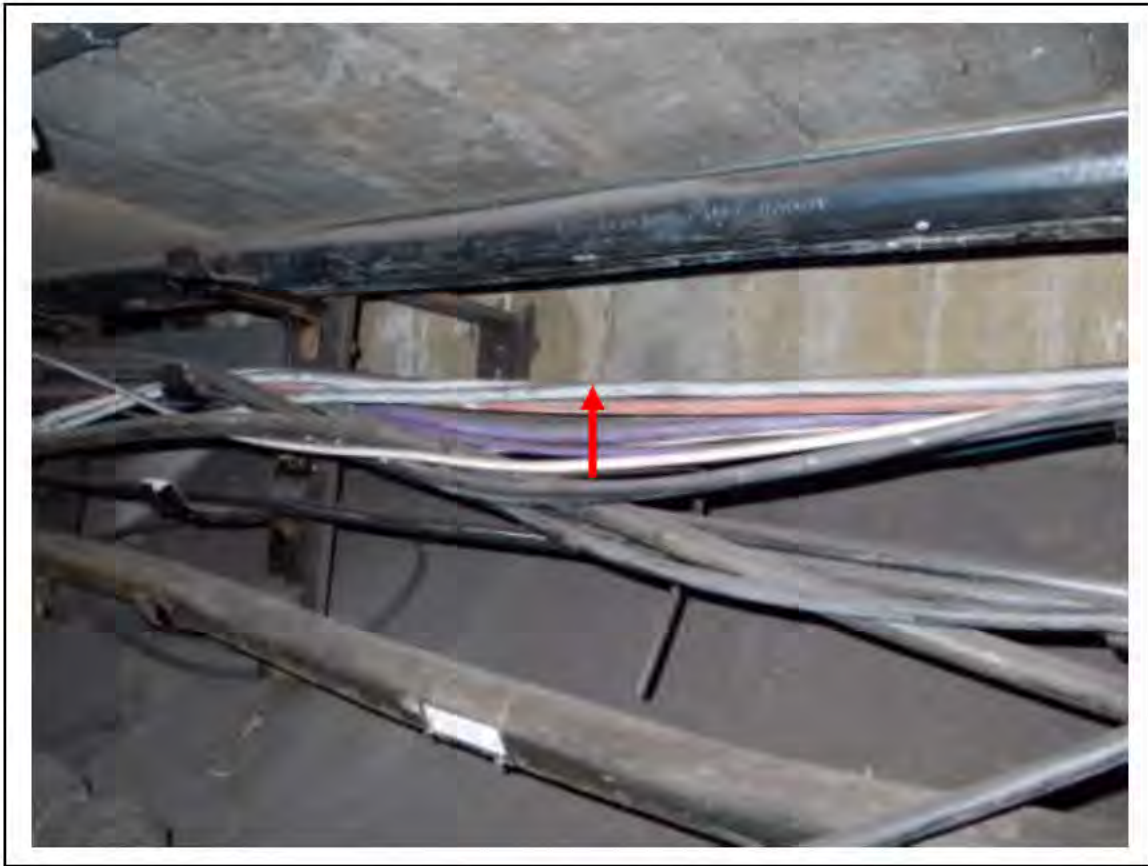
Woven cable strongly presumed to contain Chrysotile asbestos, Figure 33 - Material assessment rating: Very low. Condition – Good.

Sample Number	SP1(20)
Location	Cable Duct, 6/786
Material Description	Asbestos cloth
Material Comment	Cable sleeve, within service duct
Quantity	30m
Product Type	Medium density
Current Condition	Good condition
Surface Treatment	Encapsulated medium density
Asbestos Type	Strongly Presumed Chrysotile
Material Assessment Rating	Very low
Accessibility	Low
Further Comment	Not applicable

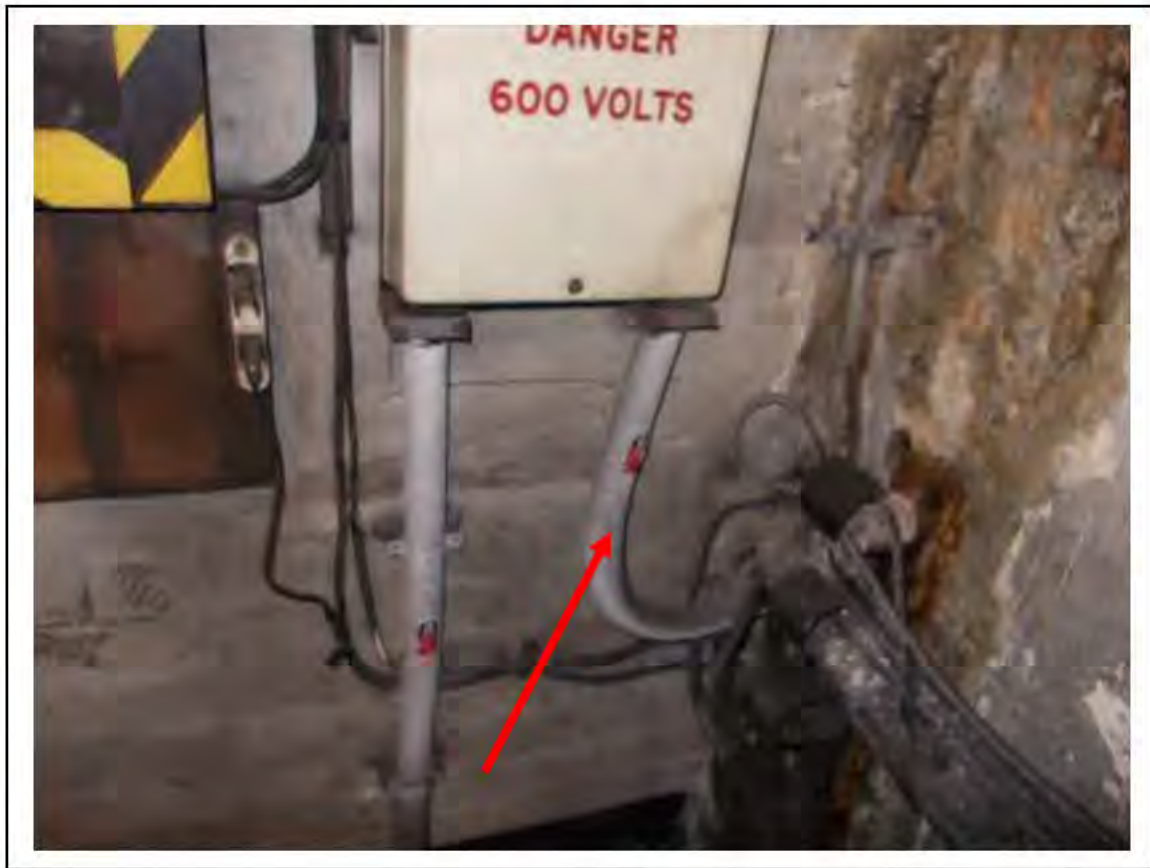
Woven cable confirmed to contain Chrysotile asbestos, Figure 34 - Material assessment rating: Low. Condition – Good.

Sample Number	ECS 81541
Location	Relay Room 5/712
Material Description	Asbestos cloth
Material Comment	Cable sleeve
Quantity	2m
Product Type	Medium density
Current Condition	Good condition
Surface Treatment	Encapsulated medium density
Asbestos Type	Confirmed Chrysotile
Material Assessment Rating	Low
Accessibility	Low
Further Comment	Not applicable
