## Environmental Visual Audit (EVA) – site visit report

Reason for EVA:	Collision data and resident complaints of speeding
Road name(s):	HITHER GREEN LANE AND TORRIDON ROAD (North of the A205) and COURTHILL ROAD (South of the A21)
Location type (station, underpass, road, etc.)	Roads
Nearest junction (s):	A205 South Circular junction with Hither Green Lane; and Torridon Road and A21 (Lewisham High Street) and Courthill Road
Borough:	LEWISHAM
Date of visit:	
Day of the week:	Choose an item.
Time (from and to, 24 hrs):	From:
Attendees: (incl. job title and organisation)	1.
	2.
	3.
	4.

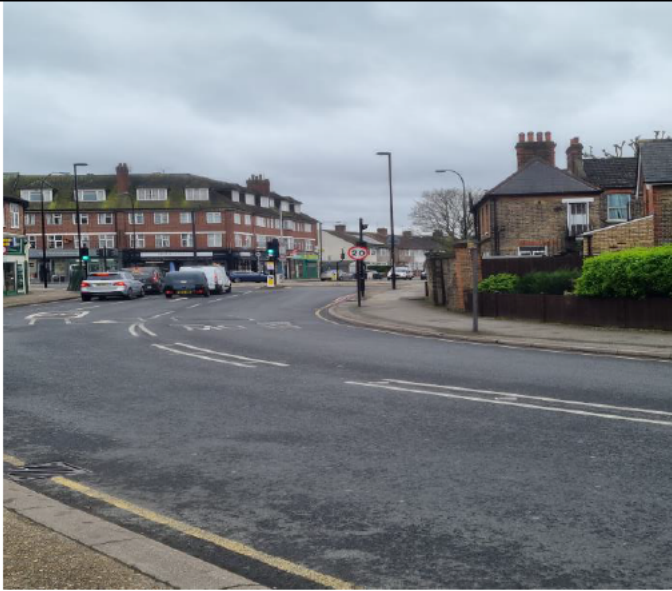
Photo 1 - Hither Green Lane towards A205

There is a lack of visual clues at the junction where traffic moves from the main A road (A205), the South Circular, to the residential side-roads (Hither Green Lane and Torridon Road).

- Absence of gateway/entry treatments at the junction of A205 and Hither Green Lane; and Torridon Road.
- Absence of gateway/entry treatments at the junction of A21 and Courthill Road leading to Hither Green Lane.
- Potential for high speeds due to lack of visual clues indicating a change in road character.
- Possible confusion for drivers unfamiliar with the area.
- Unlike the main A roads, there are no automatic operation safety cameras.

- The main cause of this issue is the lack of entry treatments that signal a change in the road environment.
- Entry treatments are typically used to indicate that drivers are leaving a major road and entering an area of different character, such as a residential road.
- They can also mark the start of a series of traffic calming measures or the boundary of a 20 mph zone.

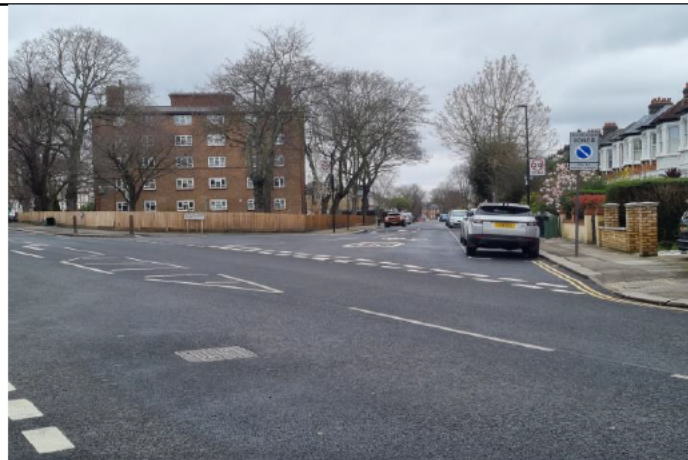
Photo 1 - Junction of Wellmeadow Road with Hither Green Lane

- The junction of Wellmeadow Road and Hither Green Lane is extremely wide, allowing vehicles to take the turning at speed.
- The pedestrian crossing width at this junction is approximately 37 meters.
- Kerbside parking and use of three spaced speed cushions across Hither Green Lane encourages vehicles to fully straddle the speed cushion, rendering them less effective at controlling speed and allows speed to rebuild before reaching the junction.

- Wide Junction: The junction's excessive width encourages vehicles to turn at higher speeds, posing a risk to pedestrians and other road users.
- Speeding Vehicles: Vehicles approaching the junction may exceed the 20 mph speed limit due to the wide turning area.
- Pedestrian Safety Concerns: The substantial crossing distance exposes pedestrians to potential hazards.
- Speed cushion design and kerbside parking impact. Speed cushion effectiveness is reduced.

- The wide junction design allows vehicles to maintain speed during turns.
- Lack of traffic calming measures contributes to speeding behaviour.
- The absence of physical narrowing elements encourages faster vehicle movements.

- Narrow the Crossing: Implement a narrower pedestrian crossing across Wellmeadow Road to reduce the distance pedestrians need to cross. This will enhance safety and encourage slower vehicle speeds.
- Traffic Calming Measures: Install traffic calming features, such as speed table/flat-top hump, or raised junction at this junction. These measures will naturally slow down vehicles as they approach the junction.

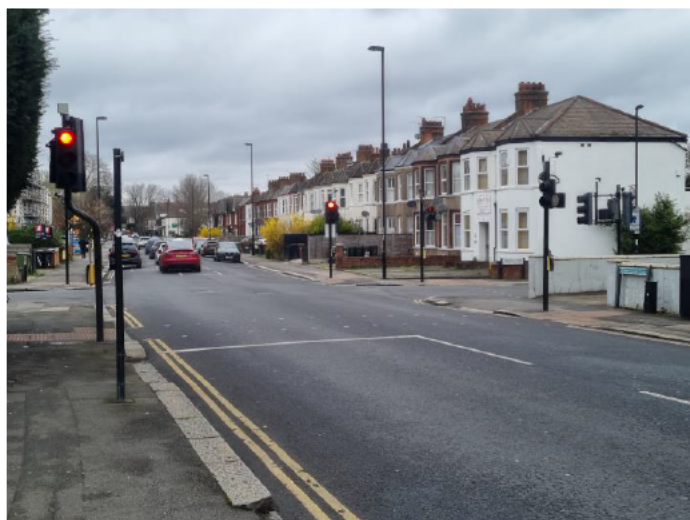
Photo 1 - Hither Green Lane and Torridon Road Junction

- The traffic lights at the junction of Hither Green Lane and Torridon Road serve as a busy pedestrian crossing point for pedestrians travelling down Torridon Road and across Hither Green Lane towards Hither Green train station in the morning and opposite direction in the evening.
- The distance between speed cushions on Hither Green Lane, through the Hither Green Lane and Torridon Road junction, exceeds 100 metres. This elongated spacing encourages traffic to pick up speed between the speed cushions in both northerly and southerly directions. Speed enforcement south of this junction, towards the A205, reinforces the observation that existing speed cushions have limited efficacy in reduce vehicle speeds and naturally calming speed to 20 mph or below.
- Several vehicle collisions have been recorded in close proximity to this junction.

- **Speeding Vehicles:** Vehicles approaching and passing through the junction may exceed the 20 mph speed limit due to ineffective / excessively distanced speed restrictions. The existing spacing between these measures generally ranges between 90 metres and 180 metres apart.
- **Pedestrian Safety Concerns:** The significance of this crossing and the distance from speed cushions exposes pedestrians to potential hazards.
- Existing traffic calming measures are ineffective at naturally controlling vehicular speed.
- The design and placement of speed cushions varies significantly along the length of Hither Green Lane.

- The absence of effective and appropriately spaced traffic calming measures contributes to speeding behaviour.

- Implement traffic calming measures such as speed tables on all arms of the junction to effectively control vehicular speed through the junction in all directions.

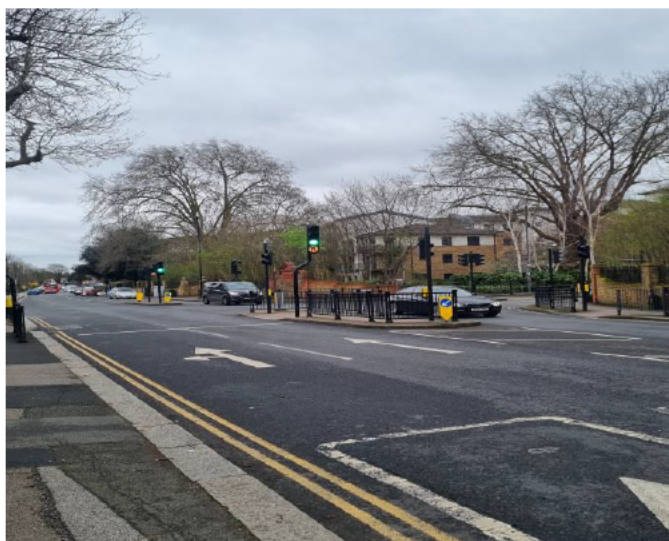
Photo 1 – Hither Green Lane / Duncrevie Road Junction

- At the junction of Duncrevie Road and Hither Green Lane, the southbound carriageway splits into two lanes. This configuration and wide road width appears unnecessary and encourages cars to overtake or undertake at speed, including when setting off from the traffic lights and when other vehicles are obeying the speed limit.
- A significant number of pedestrians on the southside of the junction do not use the pedestrian crossing on the north side of the junction, instead crossing the carriage way in unsafe ways.

- The southbound carriageway splits into two lanes at the junction of Duncrevie Road and Hither Green Lane.
- This configuration and wide road width encourages overtaking and undertaking at speed from and through the traffic lights, given the wide road configuration, including south of the traffic lights, adjacent to the commercial premises.

- The current road design at the junction allows for two lanes of traffic in the southbound direction.
- The two-lane configuration encourages drivers to overtake or undertake other vehicles that are obeying the speed limit.

- Implement traffic calming measures such as speed tables or flat-topped humps to naturally control traffic speed.
- Implement a pedestrian crossing to the south of the junction.
- Redesign the junction to remove the additional lane on the north side of the junction and narrow the southbound carriageway to one lane to prevent overtaking/undertaking.

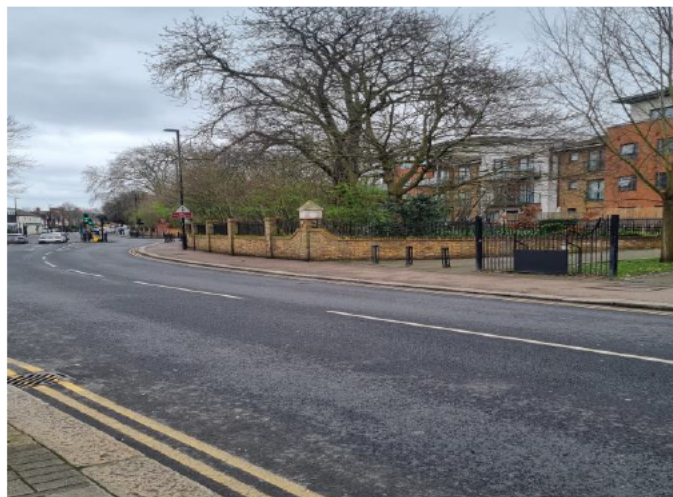
Photo 1 – Hither Green Lane and Elthruda Road Junction

- The junction of Hither Green Lane and Elthrua Road serves as a heavily used pedestrian crossing point. Pedestrians travelling from the Meridian Development utilise this crossing, with peak activity during the morning and evening hours.
- The existing speed cushions on Hither Green Lane, both preceding and following this junction are ineffective at reducing vehicle speed. This is observed both when approaching the traffic lights and after passing them.
- Pedestrians are observed waiting for extended periods to cross at this location, which increases the likelihood of unnecessary risks being taken while crossing the road.
- Pedestrians crossing from the Meridian Development lack appropriate sight lines for vehicles travelling northbound.

- Pedestrian Safety Concerns: The significance of this crossing and the distance from speed cushions exposes pedestrians to potential hazards.
- The existing traffic-calming measures are ineffective and do not naturally control vehicle speed.

- The absence of effective and appropriately spaced traffic calming measures contributes to speeding behaviour.

- Implement traffic calming measures such as speed tables or flat-topped humps on all arms of the junction to effectively control traffic speed through the junction in all directions.

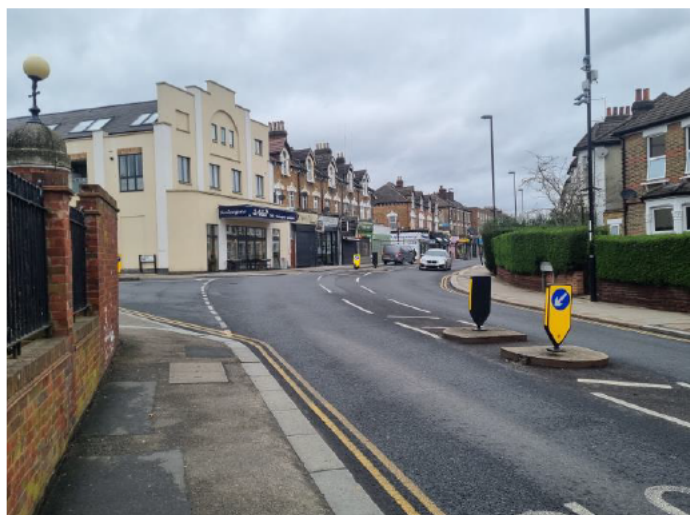
Photo 1 – Hither Green Lane / George Lane Junction

- The junction of George Lane and Hither Green Lane is wide, allowing vehicles to take the turning at speed.
- The pedestrian crossing width at this junction is approximately 21 meters.
- The pedestrian island is positioned such that, when facing south in the direction of A205, it is difficult to observe traffic travelling south along Hither Green Lane and turning onto George Lane.
- Pedestrians attempting to cross northbound in the direction of the A21 do not have adequate sightlines of vehicles turning off Hither Green Lane.

- Wide Junction: The junction's width encourages southbound vehicles to turn at higher speeds, posing a risk to pedestrians and other road users.
- Speeding Vehicles: northbound vehicles approaching the junction may exceed the 20 mph speed limit due to the wide turning area.
- Pedestrian Safety Concerns: The substantial crossing distance exposes pedestrians to potential hazards.
- The position of the pedestrian island poses a risk to pedestrians crossing where they are unable to observe traffic coming from behind (when facing south).

- The wide junction design allows vehicles to maintain speed during turns.
- Lack of traffic calming measures contributes to speeding behaviour.
- The absence of physical narrowing elements encourages faster vehicle movements.

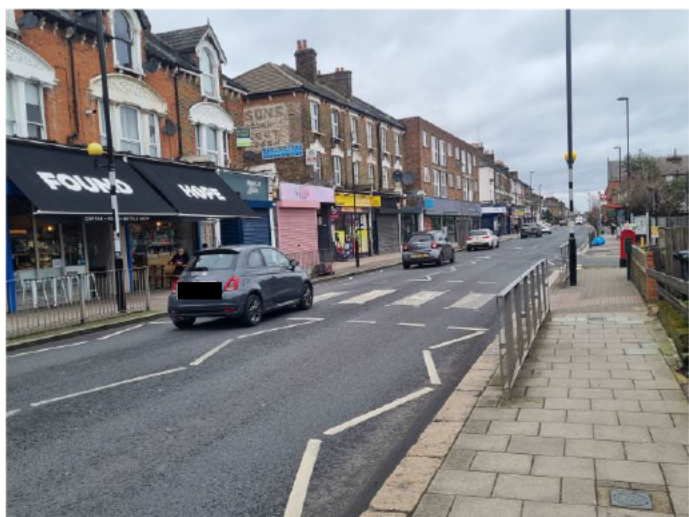
Photo 1 - Pedestrian Crossing on Hither Green Lane  
(adjacent to 218)

- The pedestrian crossing adjacent to 218 Hither Green Lane serves as the main thoroughfare for school children walking to and from Brindishie Green primary school and for residents accessing local shops.
- Northbound vehicles exhibit excessive speed between Brightside Road and the pedestrian crossing due to the absence of traffic calming measures. Southbound vehicles are observed easily straddling the existing speed cushions at this location without noticeable reduction in speed.
- Multiple incidents and near misses have been reported at this site, where vehicles have failed to yield to pedestrians at the crossing.
- Volunteer crossing guards are present for short durations before school and after school, contributing to the protection of children.

- Both northbound and southbound vehicles approaching the pedestrian crossing maintain excessive speed, occasionally failing to stop promptly for pedestrians attempting to cross.

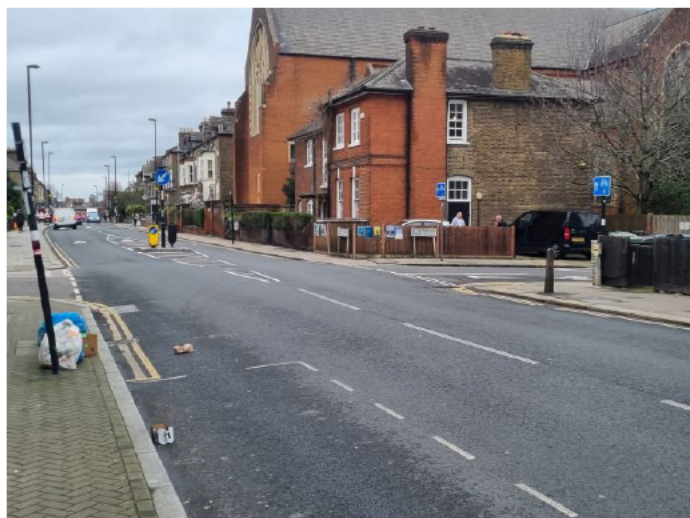
Photo 1 - Hither Green Lane and St Swithuns /  
Lanier Road Junction

- The existing speed cushions on Hither Green Lane, both preceding and following the junction with St Swithun's Road and Lanier Lane are ineffective at reducing vehicle speed.
- This junction, situated at the end of the parade of shops and adjacent to a church, marks a critical point. Vehicles travelling through this location are observed accelerating beyond the 20mph speed limit, particularly in the northbound direction.

- Current measures fail to naturally control vehicular speed.

- Implementation of traffic calming measures, such as speed tables on all arms of the junction, is recommended to regulate vehicle speed in all directions.

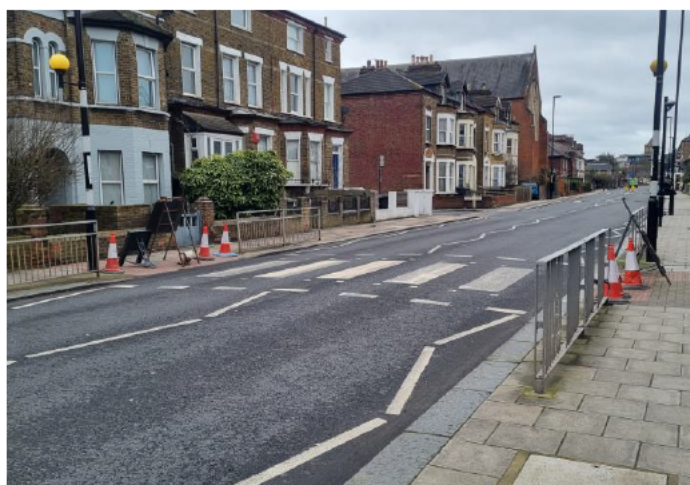
Photo 1 - Pedestrian Crossing on Hither Green Lane  
(adjacent 140)

- The pedestrian crossing adjacent to 140 Hither Green Lane also serves as a thoroughfare for school children walking to and from Brindishie Green primary school and for residents accessing local shops.
- Both Northbound and Southbound vehicles exhibit excessive speed approaching the pedestrian crossing due to the absence of effective traffic calming measures. Vehicles are observed easily straddling the existing speed cushions at this location without noticeable reduction in speed.
- Multiple incidents and near misses have been reported at this site, where vehicles have failed to yield to pedestrians at the crossing.

- Both northbound and southbound vehicles approaching the pedestrian crossing maintain excessive speed, occasionally failing to stop promptly for pedestrians attempting to cross.

- Implementation of a raised pedestrian crossing is recommended to enhance pedestrian safety and encourage natural speed reduction as vehicles approach the crossing.

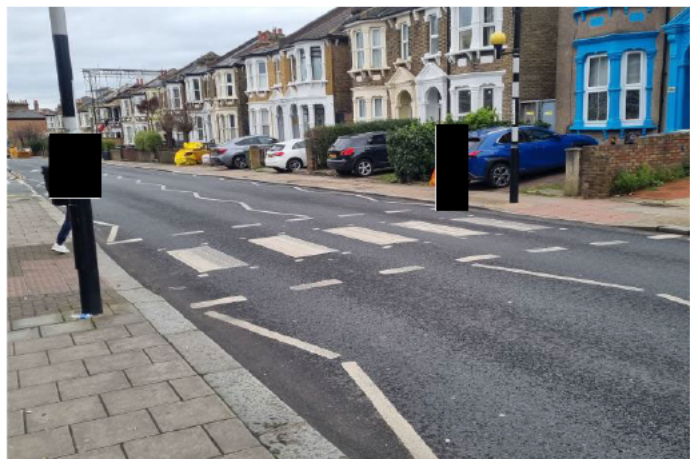
Photo 1 – Pedestrian Crossing on Hither Green Lane  
(Outside 110 & 145)

- The pedestrian crossing adjacent to 110 and 145 Hither Green Lane also serves as a thoroughfare for school children walking to and from Brindishie Green primary school and for residents accessing local shops. It is also adjacent to the retirement homes and sheltered retirement housing located at Merbury Close.
- Both Northbound and Southbound vehicles exhibit excessive speed approaching the pedestrian crossing due to the absence of effective traffic calming measures. Vehicles are observed easily straddling the existing speed cushions at this location without noticeable reduction in speed.
- Multiple incidents and near misses have been reported at this site, where vehicles have failed to yield to pedestrians at the crossing.

- Both northbound and southbound vehicles approaching the pedestrian crossing maintain excessive speed, occasionally failing to stop promptly for pedestrians attempting to cross.

- Implementation of a raised pedestrian crossing is recommended to enhance pedestrian safety and encourage natural speed reduction as vehicles approach the crossing.

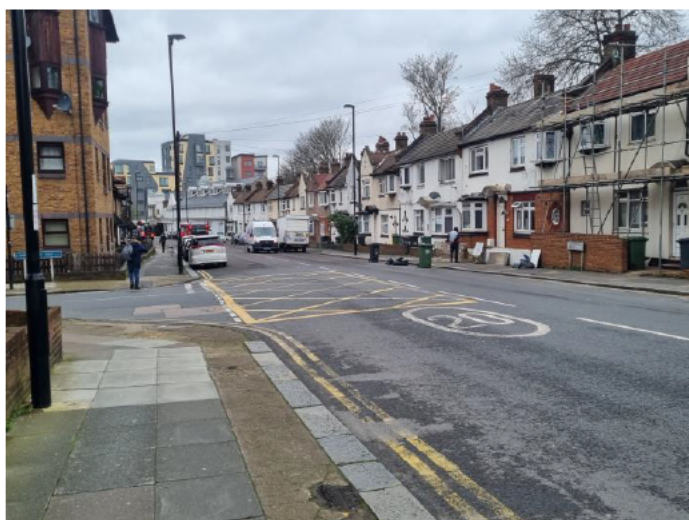
Photo 1 – Courthill Road and Longbridge Way Junction

- Vehicles exiting the A21 (Lewisham High Street) and Whitburn Road lack adequate speed control measures due to the absence of speed cushions on Courthill Road before the roundabout. Consequently, vehicles are observed exceeding the 20 mph speed limit.

- Implementation of traffic calming measures, such as speed tables on all arms of the junction, is recommended to regulate vehicle speed in all directions.

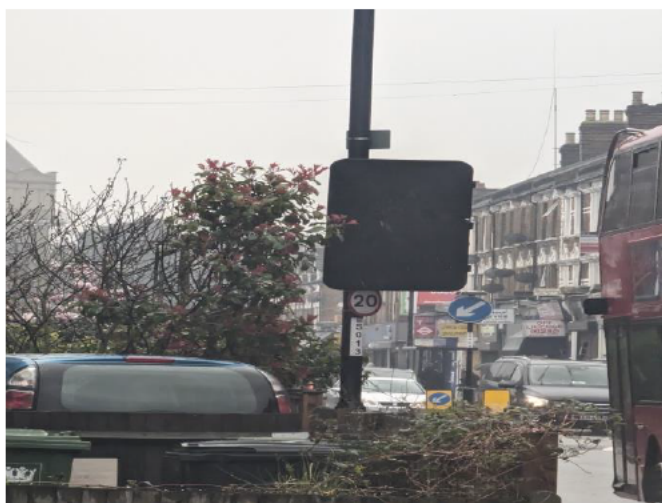
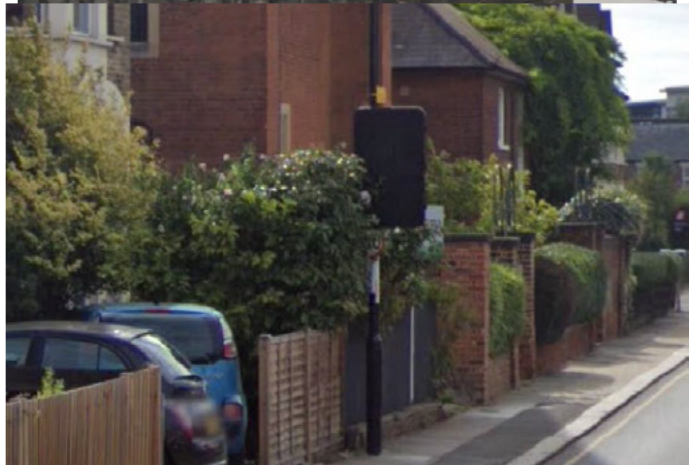
Observation 12
<p>Observation description (free text):</p> <ul style="list-style-type: none"> <li>Drivers repeatedly stated they were unaware Hither Green Lane and Torridon Road are 20mph limits.</li> </ul> <p>Key observation points (bullet points):</p> <ul style="list-style-type: none"> <li>There is a limited number of speed limit repeaters on Hither Green Lane (noting Northbound traffic has few lamp-posts facing the direction of traffic), and none on Torridon Road (between South Circular and Springbank Road)</li> <li>Speed Limit Roundel markings on both roads are few and worn.</li> <li>There are two speed activated signs on Hither Green Lane (adjacent 185 Hither Green Lane, partially obscured by vegetation) and opposite 281 Hither Green Lane (on a bend and partially obscured by vegetation).</li> </ul> <p>Observation causes (bullet points):</p> <ul style="list-style-type: none"> <li>Limited number of signs and worn road markings and poor sighting of vehicle activated signage.</li> </ul>

Photo 1 – Photo showing location of speed activated sign, with comparison from Google Street view showing signs obscured by vegetation (Near St. Swithuns Church on Hither Green Lane)

- Consider additional repeater signs along length of both roads where feasible.
- Consider adding additional speed limit roundel road markings on both Hither Green Lane and Torridon Road, and re-paint worn markings.
- Reposition speed activated signage on Hither Green Lane to make it more prominent, and/or remove surrounding vegetation.
- Installation of more (and more prominent) speed activated signage along Hither Green Lane and Torridon Road.

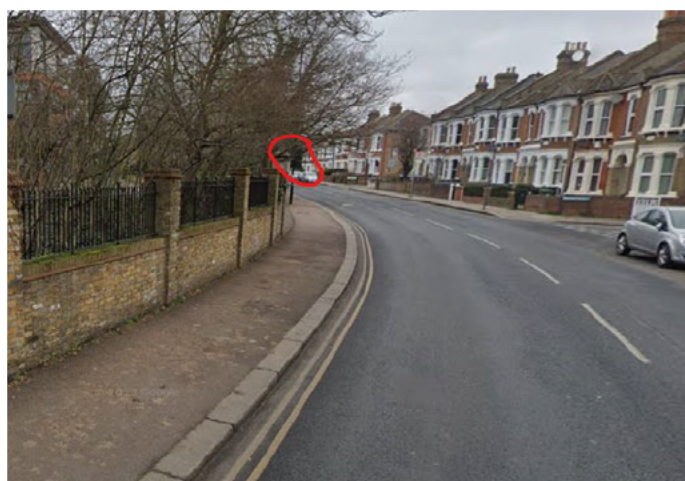
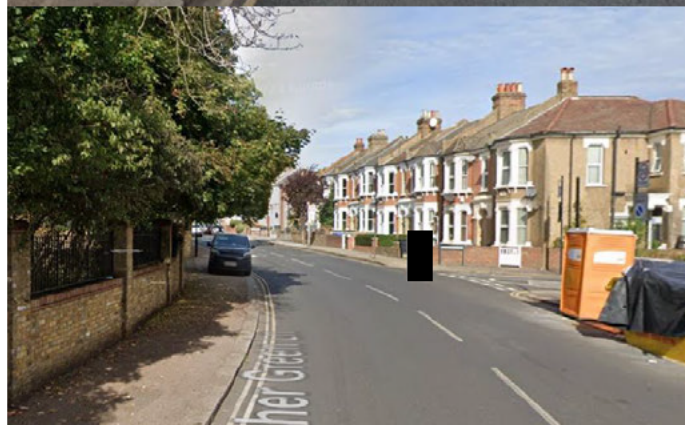
Photo 2 – Photo showing location of speed activated sign obscured by bend, with photo taken from Google Street View to illustrate potential issues with vegetation (Near Junction of Hither Green Lane and Elthruda Road)

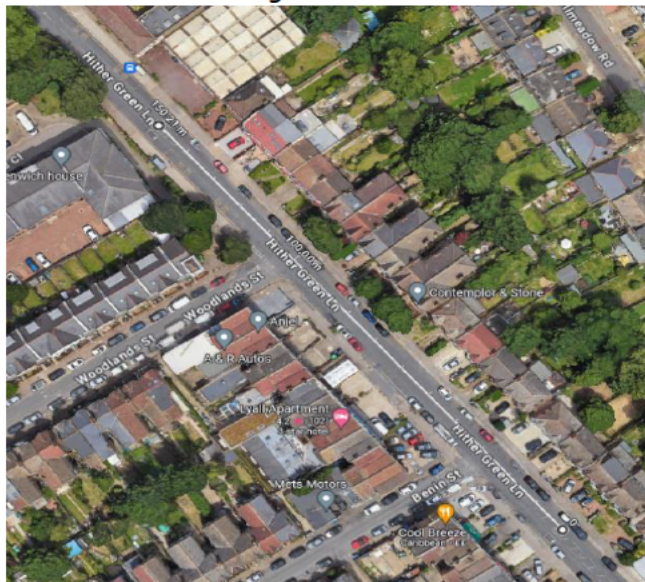
- Along the full length of Hither Green Lane, the current traffic calming measures, including the choice of speed hump/cushion, their configuration (often singular in each carriageway, or triple across both carriageways), cushion height, cushion width and cushion spacing (generally anywhere between 70m to 180 metres) are observed to be inadequate at naturally controlling traffic speed and inadequate for the road to be 'self enforcing'.

- Inadequate and inconsistent speed cushion height, width and spacing, and also adjacent uncontrolled parking.

Photo 1 - Satellite Image of inconsistent distances between speed restrictions / measures

150 metres

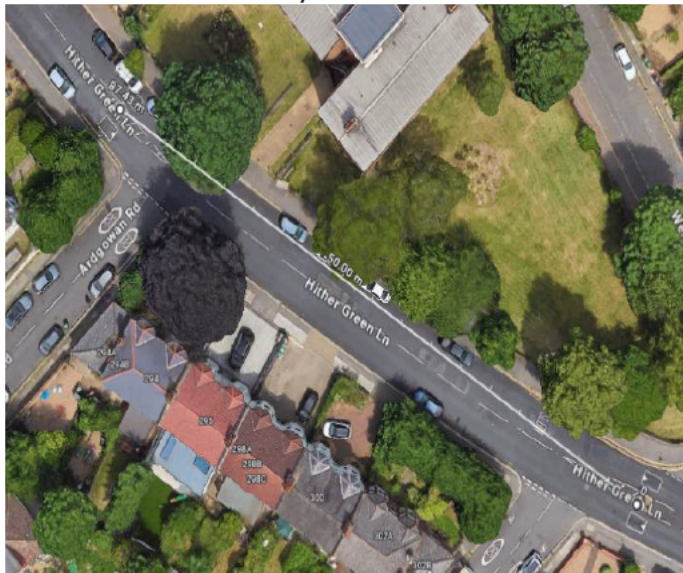
Photo 2 - Satellite Image of inconsistent distances between speed restrictions / measures

87 metres

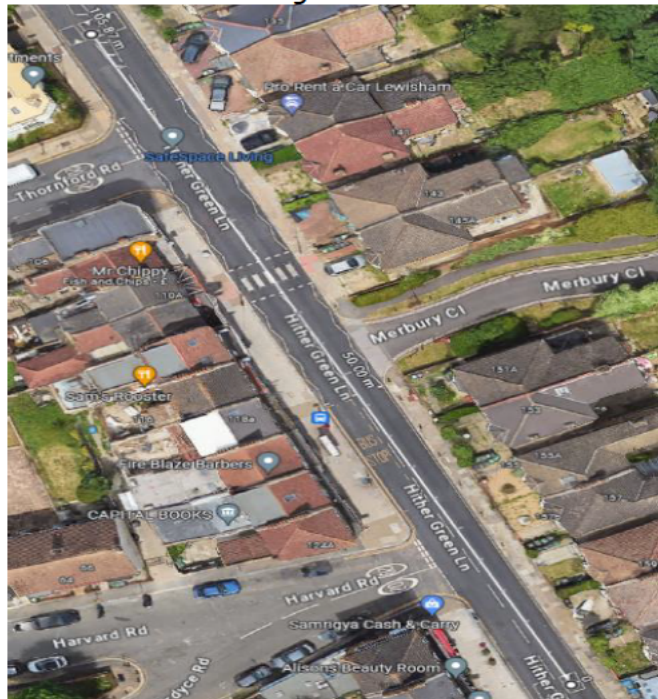
Photo 3 - Satellite Image of inconsistent distances between speed restrictions / measures

105 metres

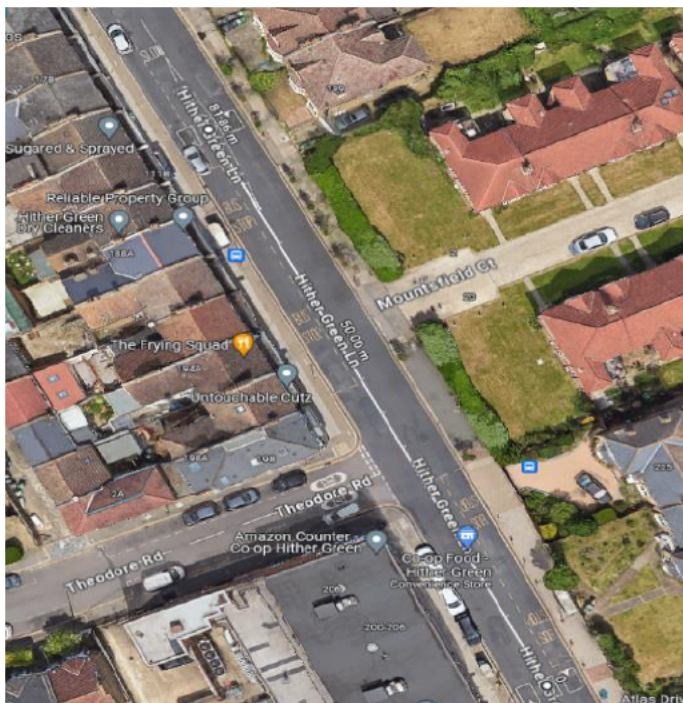
Photo 4 - Satellite Image of inconsistent distances between speed restrictions / measures

81 metres

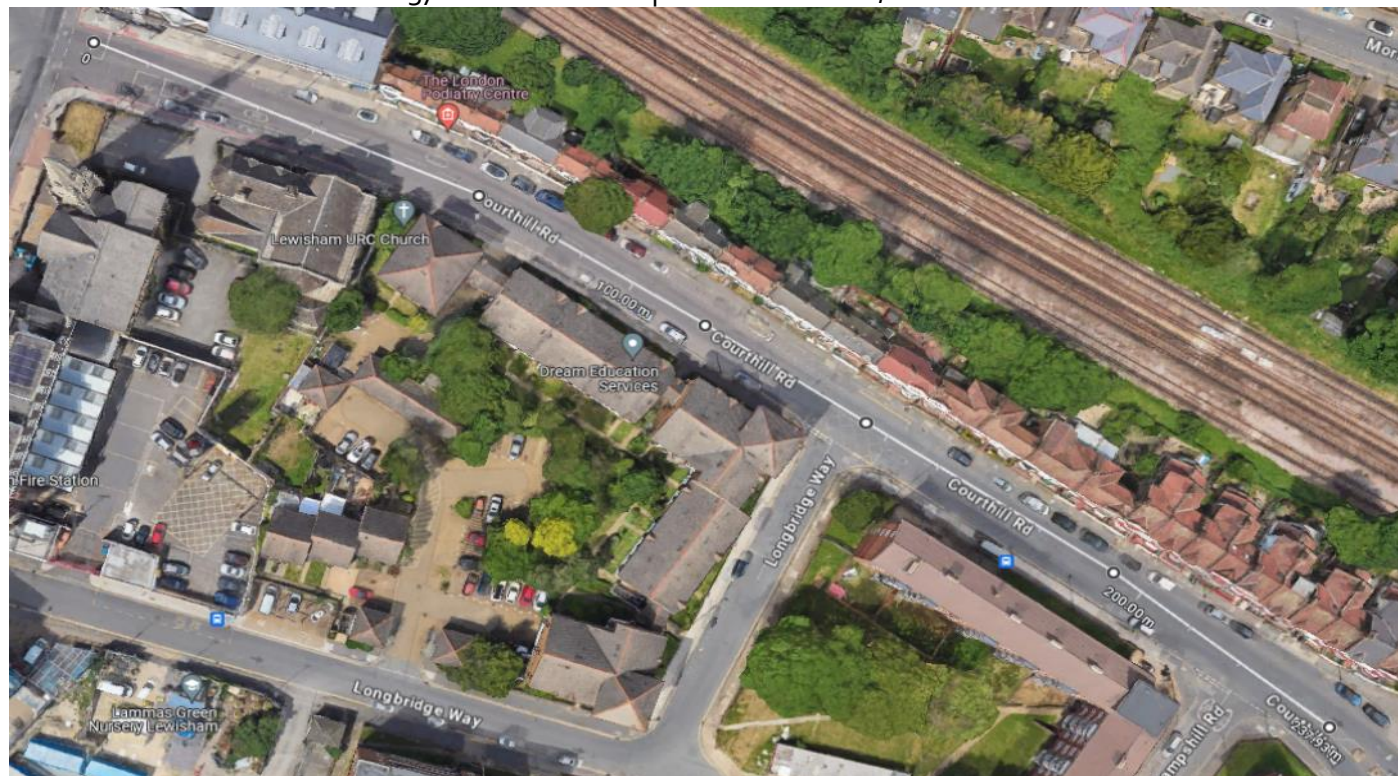
Photo 5 - Satellite Image of inconsistent distances between speed cushions

237 metres and no speed restrictions / measures
