A40 Western Avenue Vehicle Restraint System Serviceability Inspection

Engineering Inspection Report on the serviceability of the vehicle restraint systems on the A40 between Target Roundabout and Greenford Roundabout

Version	Prepared By	Checked By	Date
1.0	Herbert Micallef	Lixi Pan	14.12.2017

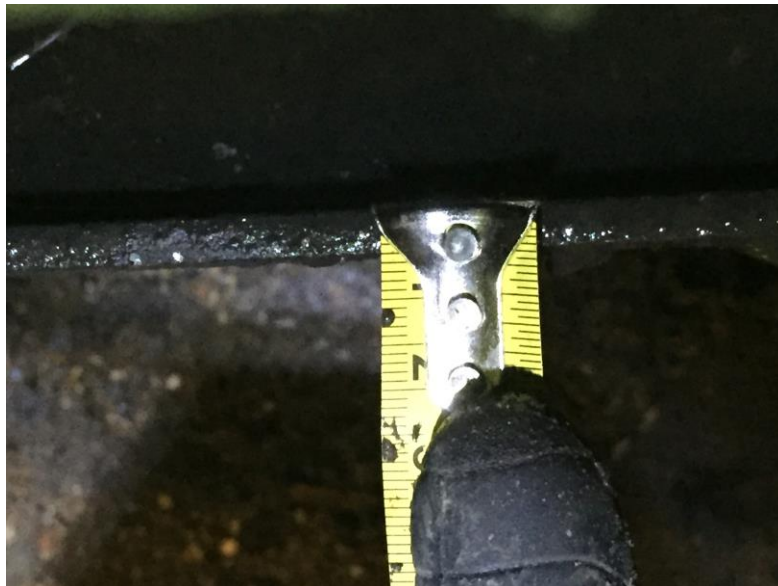
Hammer tapping was used to assess delamination corrosion. Albeit not complying with industry practice with regards to the size of hammer and the tapping distance, the test is very indicative and exposes major corrosion. With light tapping, the fixing plates and beams exfoliated severely leaving at times less than 2mm of the original 5mm thickness on the steel.

Photo 1 – Original fixing plate thickness – 5mm

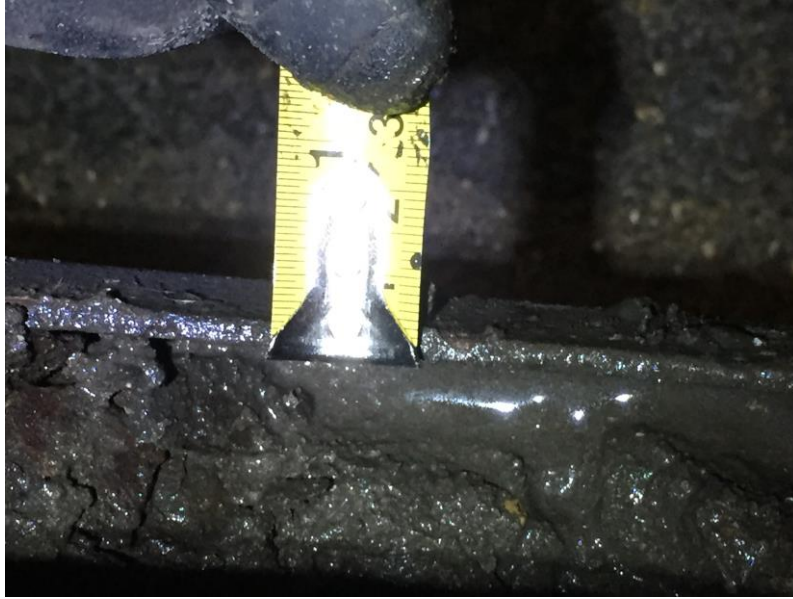
Photo 2 – Reduction in fixing plate thickness – 2mm

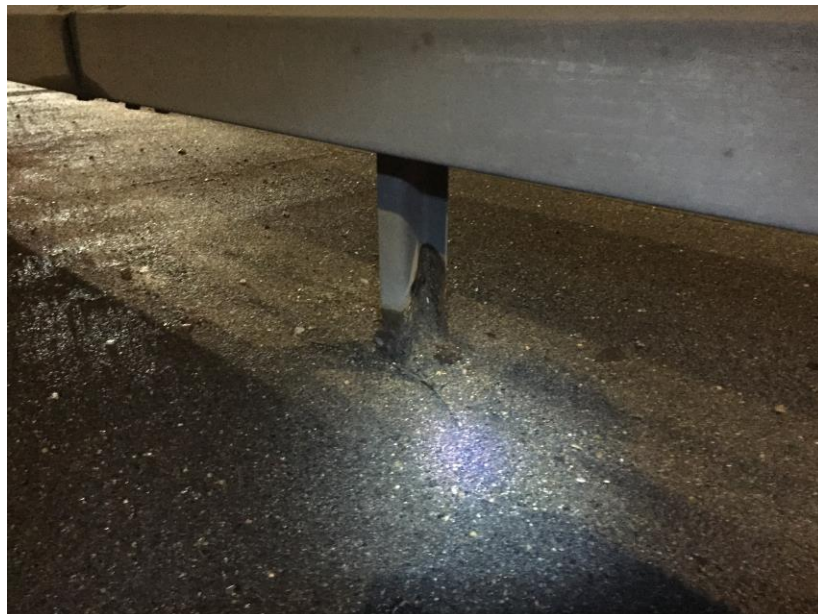
The corrosion on the posts is so extensive that mild hammer tapping on some of the posts resulted in perforation.

Photo 3 – Corrosion on posts

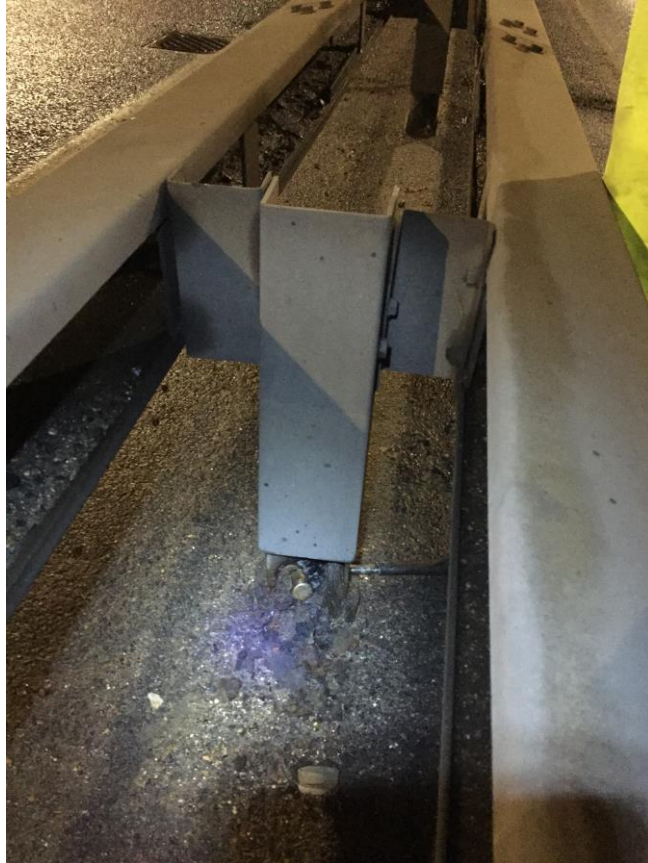
Photo 4 – Perforation of post with mild hammer tapping

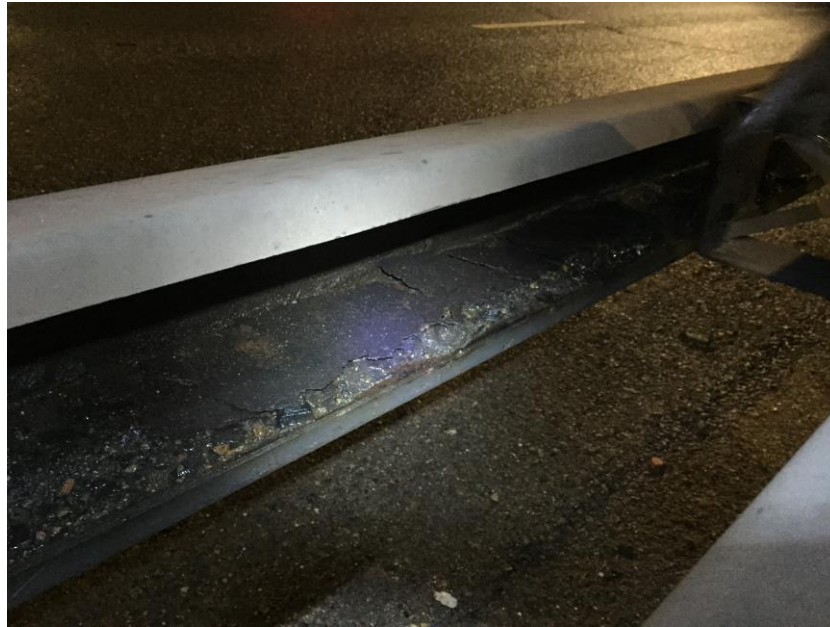
1. the post had split in two along the horizontal plane
2. the beam had exfoliated relatively thick pieces of steel; in the region of 3-4mm thick; leaving approximately 1-2mm of material. Some of these exfoliates were more than 30cm in length
3. bolts that had broken off due to the extensive corrosion around the fixing plates

In conclusion the section of DSOBB is at such an advanced stage of corrosion that it is reasonable to assume that its strength and its ability to withstand impact have been severely reduced. It is therefore deemed not fit for purpose.

Photo 5 – Beam Inner Face Exfoliation

It is recommended that the VRS at said location is replaced as it is deemed to be in disrepair
