Technical Report

Reference: N&V – R2943

**NOISE & VIBRATION INVESTIGATION AT ■ EFFRA GARDENS, ■ HEARTWELL
AVENUE, LONDON, E16 ■**

Issue Date: 18th June 2021

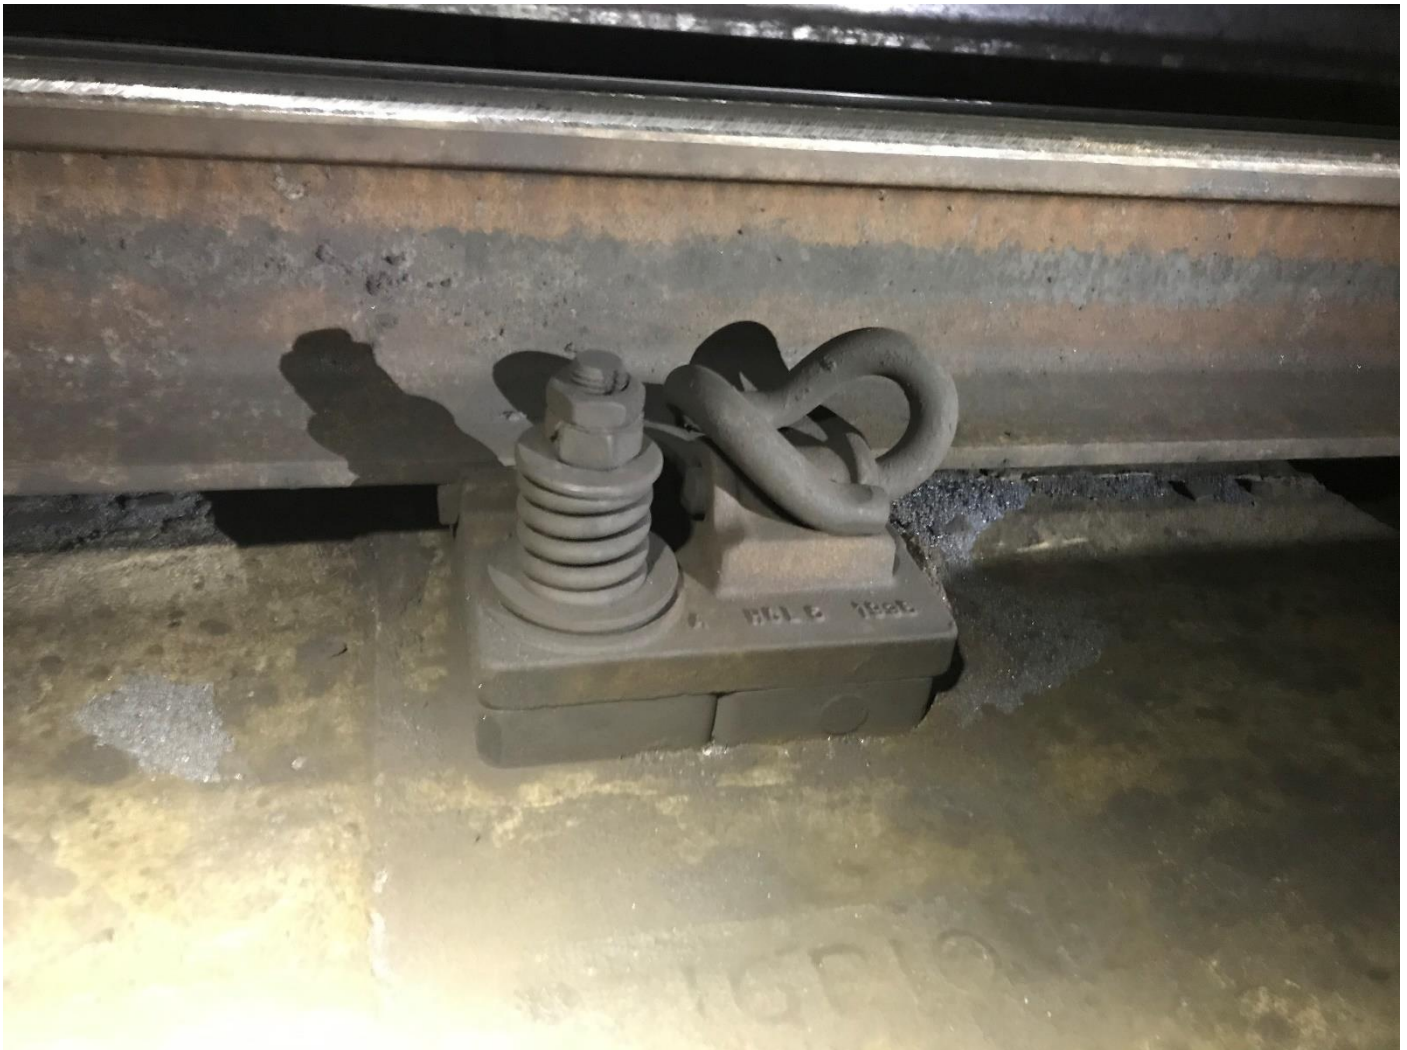
It was observed that, on both rails of both roads, the head of the rail was extremely smooth in the section over the concrete slab, with no evidence of corrugation or roughness. It is from this section that the tonal roar was observed to emanate. The ballasted section of, both rails of both roads, shows sporadic roughness which is in-keeping with noise observed from this section of track.

Figure 2 – Resilient track fixing on the eastbound Jubilee line, right-hand rail

The resident has stated that they are not disturbed by the noise from DLR services. The principal disturbing element of Jubilee line noise events is the tonal roar emanating from the concrete slab section of track.

The concrete slab and resilient fixings are present to mitigate vibration transmission into the ground and affecting surrounding properties. The frequency of the tone heard in property is independent of vehicle speed and there isn't any corrugation which could produce the tonal roar. As such, it can be surmised that the tonal roar is the result of a P2 resonance and that the energy which would normally be absorbed by the ground is instead transmitting into the air. Investigation of the vibration transfer dynamics would be required to determine which component of the support system is reflecting the energy back into the rail.

A 12th octave analysis of Jubilee line train events found that, both east and westbound roads present with a fundamental frequency of 364Hz. Eastbound services also present with 1.5th(550Hz), 2nd(730Hz) and 3rd(1090Hz) harmonics while

westbound services present with 2nd, 3rd and 4th(1460Hz) harmonics as well as broadband high frequency content.

Investigation of the vibration transfer dynamics would be required to determine which component of the support system is reflecting the energy back into the rail.
