Technical Services – Noise & Vibration  
Hearne House  
3 Museum Way  
London  
W3 9BQ

Technical Report

Reference: N&V – R2945

**NOISE & VIBRATION INVESTIGATION AT [REDACTED] EFFRA GARDENS, [REDACTED]  
SILVERTOWN WAY, LONDON, E16 [REDACTED]**

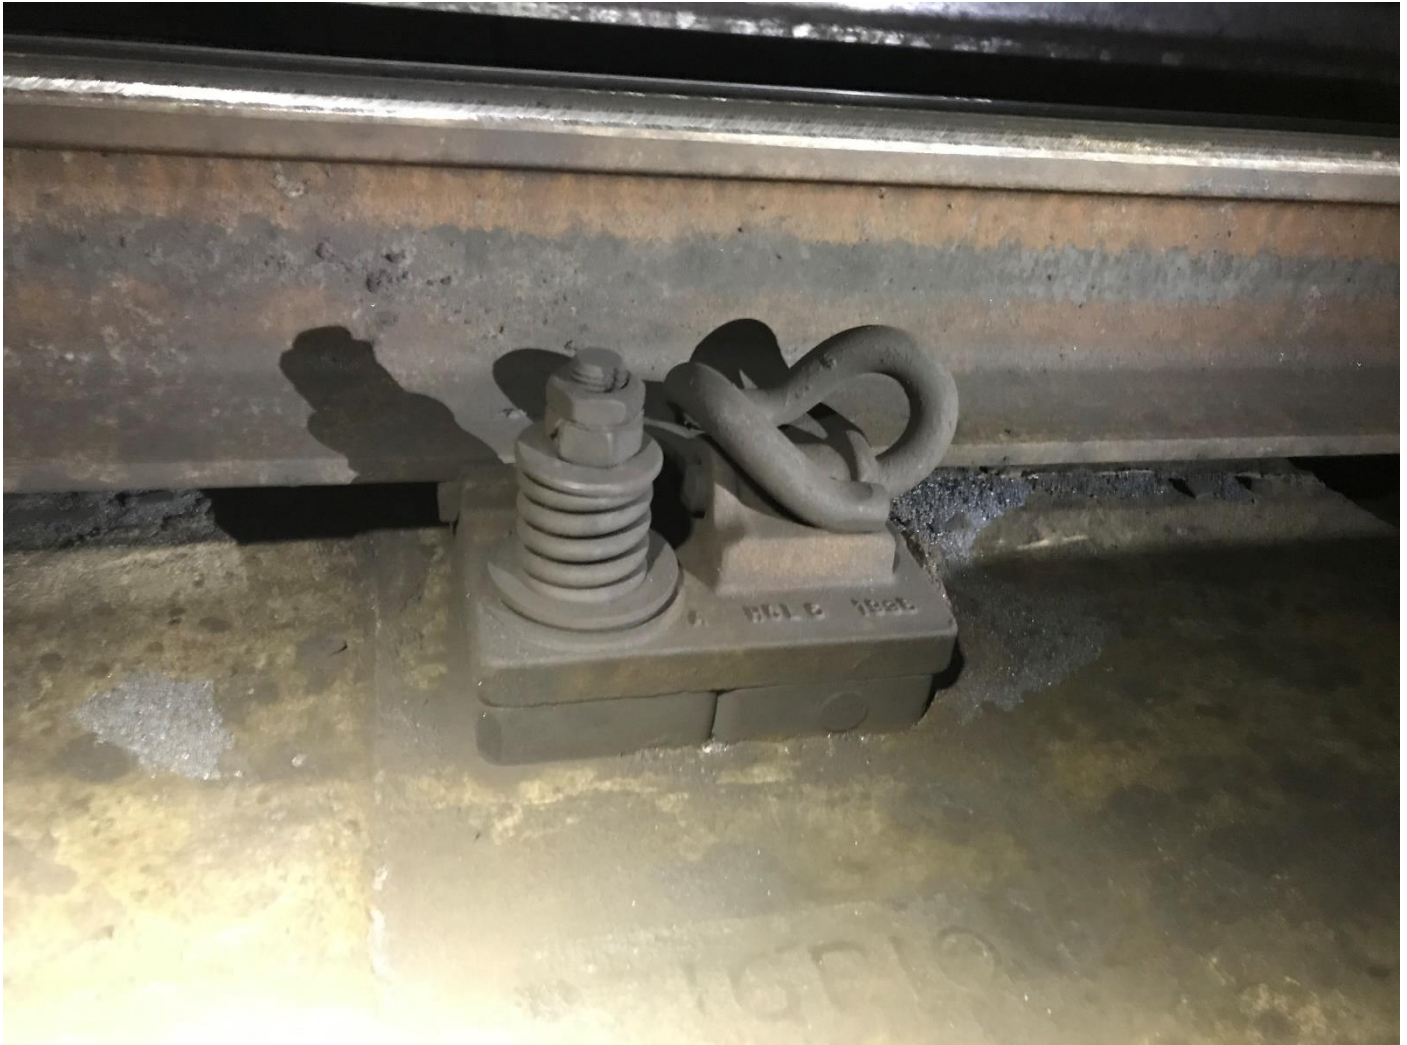
It was observed that, on both rails of both roads, the head of the rail was extremely smooth in the section over the concrete slab, with no evidence of corrugation or roughness. It is from this section that the tonal roar was observed to emanate. The ballasted section of, both rails of both roads, shows sporadic roughness which is in-keeping with noise observed from this section of track.

**Figure 2 – Resilient track fixing on the eastbound Jubilee line, right-hand rail**

The resident has stated that they are not disturbed by the noise from DLR services. The principal disturbing element of Jubilee line noise events is the tonal roar emanating from the concrete slab section of track.

The concrete slab and resilient fixings are present to mitigate vibration transmission into the ground and affecting surrounding properties. The frequency of the tone heard in property is independent of vehicle speed and there isn't any corrugation which could produce the tonal roar. As such, it can be surmised that the tonal roar is the result of a P2 resonance and that the energy which would normally be absorbed by the ground is instead transmitting into the air. Investigation of the vibration transfer dynamics would be required to determine which component of the support system is reflecting the energy back into the rail.
