**Jubilee line – Doors open on a train in service
between Finchley Rd and West Hampstead
stations**

1st September 2018

HSE Info Exchange Reference Number: 949522

Formal investigation report

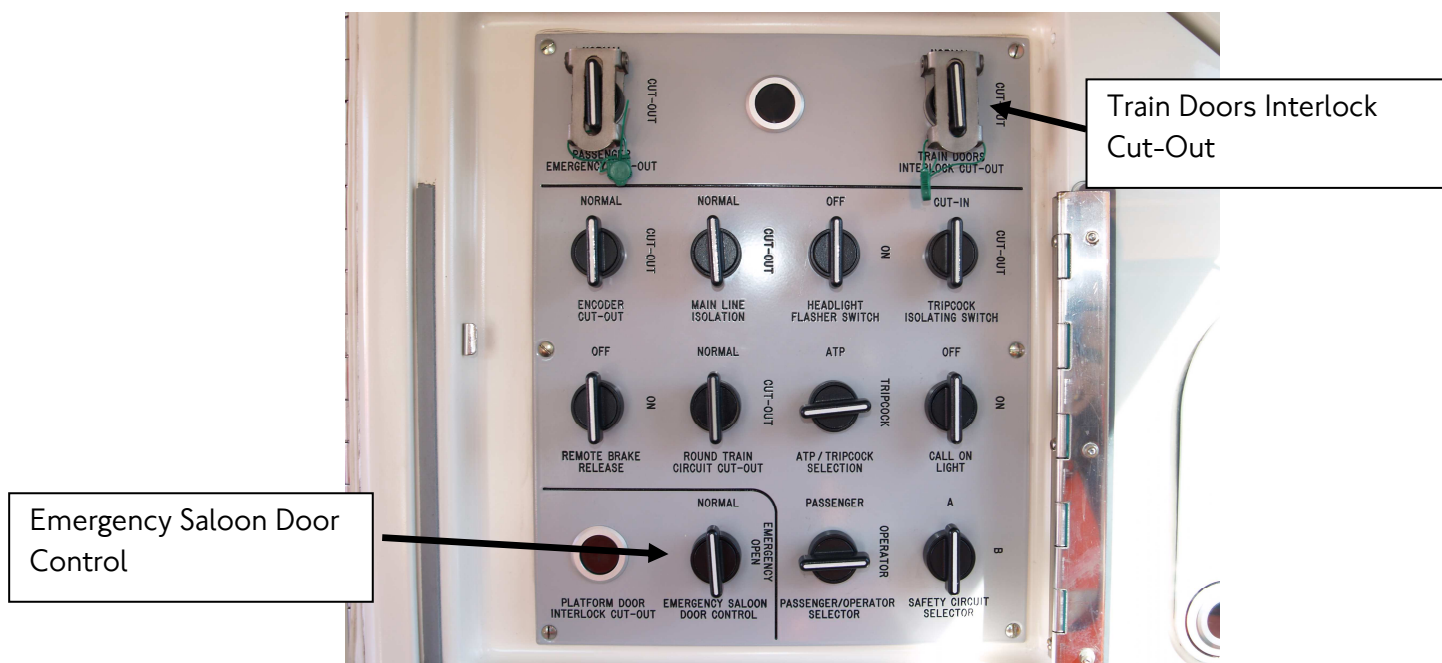
Figure 2 – A '96 stock switch panel

The TDIC switch is sealed with a plastic tag and a cover to prevent inadvertent operation, whilst the ESDC switch is not sealed. The T/Op considers he operated the TDIC switch in error whilst he was leaning out of the train cab, with one foot on the platform and looking down the train.

Recommendation 4	
To address Root Cause C	
Purpose	To reduce the risk of the TDIC being operated in error by a T/Op. Applicable to all present and future train stocks across the network.
Action	Explore how physical or software changes to the current design of the rotary switch and/or procedure can reduce the risk of T/Ops being able to operate a train in contravention to the relevant sections of Rule Book 7. This should include but not be limited to, the current design of the rotary switch and any covers, types of seals used, colour coding and labelling as well as associated alarms.
Action Owner	D Borgese - LU Principal Door Systems Engineer, LU
Action Target Date	30th March 2019.
Validation	To review any output from the action to identify if the risk of operating a TDIC in error is reduced as low as is reasonably practicable.
Validator	P Cooper – Senior HSE Manager
Validation Target Date	Within two weeks of the action being advised as completed.

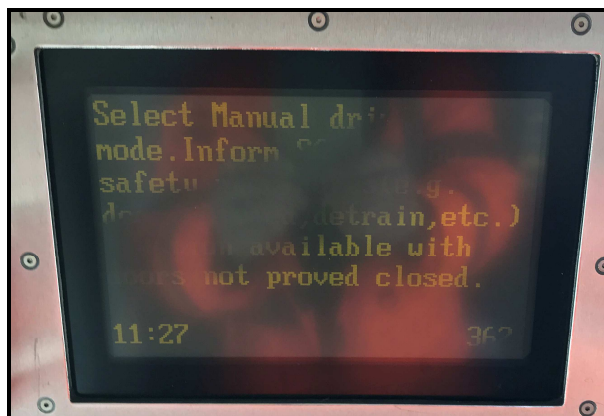
Figure 3 – TDIC Cut Out information displayed on TMS screen

Although the design of the stock allows the train to be driven in ATO mode with the TDIC cut out the advice given on the TMS screen states that the train should be driven in manual mode. It is not clear if this message only appears if the train is in non-ATO mode.

Recommendation 5	
To address Root Cause D	
Purpose	To ensure that Train Operators are fully aware that they are dealing with an abnormal condition having operated the TDIC's.
Action	<ol style="list-style-type: none"> 1. Review the current relevant standards (S1 I 80 / S2 I 80) and revise to ensure ATO operation is not possible following the operation of the TDIC switch 2. Review the way the Train Operator Display/TMS and associated audible alarms currently operate during the operation of the TDIC switch and issue ALARP based recommendations to minimise the risk of an operational error having undertaken a cost/benefit analysis as part of any recommendations.
Action Owner	D Borgese - Principal Door Systems Engineer.
Action Target Date	<ol style="list-style-type: none"> 1. 31st January 2019. 2. 30th March 2019
Validation	To review any output from the action to identify if the risks are reduced to a level which is as low as is reasonably practicable.

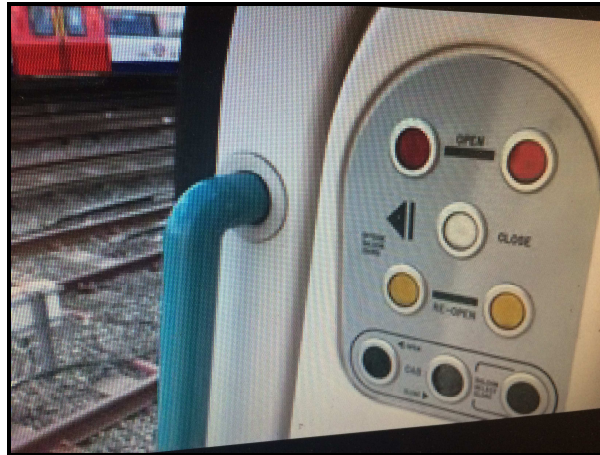
The FIR also noted that the visibility of the Outside Door Indicating Lights (ODILs), which identify open saloon doors by means of an orange light, were also affected by both sunlight and the recessed design. When viewing the ODILs from the CCTV monitors in the driving cab it was impossible to distinguish between the ODILs being illuminated and not. Further, by physically leaning out of the train it was only possible to see the first ODIL in the front saloon due to the recessed nature of the lights. In this incident the doors of the first saloon remained closed at the departure point at Finchley Road until detrainment commenced at West Hampstead, therefore the T/Op would have not had an indication that any doors were open from the ODILs.

Figure 4 – Image of DCIVs with saloon doors open on a sunny day

Recommendation 7	
To address Root Cause E	
Purpose	To ensure Train Operators are more easily able to see the Door Closed Visual Indicators, Train Operator Display and In Cab CCTV Screen in degraded operating conditions.
Action	<p>Review incidents of visibility/glare in train cabs to understand the safety risk. Should this review identify an issue:</p> <ol style="list-style-type: none"> 1. Carry out a feasibility study with a business case for the recommended option to improve the visibility of the in-cab saloon door closed visuals, and 2. Consider methods of limiting sunlight/glare from entering the cab that may lead to a reduction in the ability of the T/Op to see visual indications, this should include but not limited to improvements to the existing sun screening methods in place.
Action Owner	Howard Taylor
Action Target Date	27 September 2019
Validation	To review any output from the action to identify if the risks are reduced to a level which is as low as is reasonably practicable and progress accordingly.

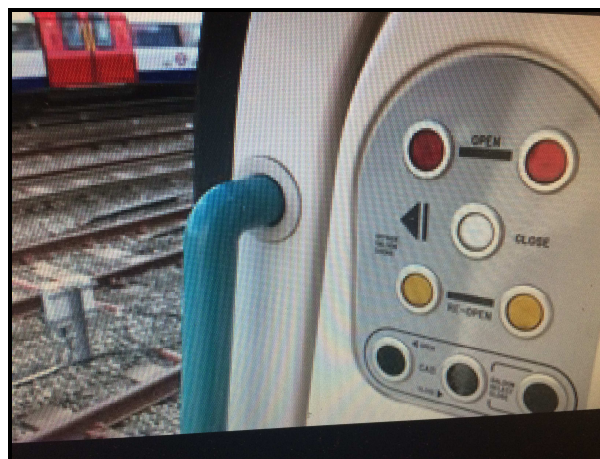
It was noted that the Door Closed Visual Indicators were brighter on the Jubilee Line fleet until a change effected around 2003 in response to complaints from T/Ops that they were distracting in tunnel sections. It was also noted that there are variations in the intensity of the illumination of the DCVIs on the current fleet. Three trains were utilised during the FIR site visit and some indicators were illuminated considerably brighter than others and one had a sticker over the lens. However, it must be reiterated that in all cases the illumination was severely affected by sunlight.

Figure 5– Image of DCIVs with saloon doors closed on a sunny day

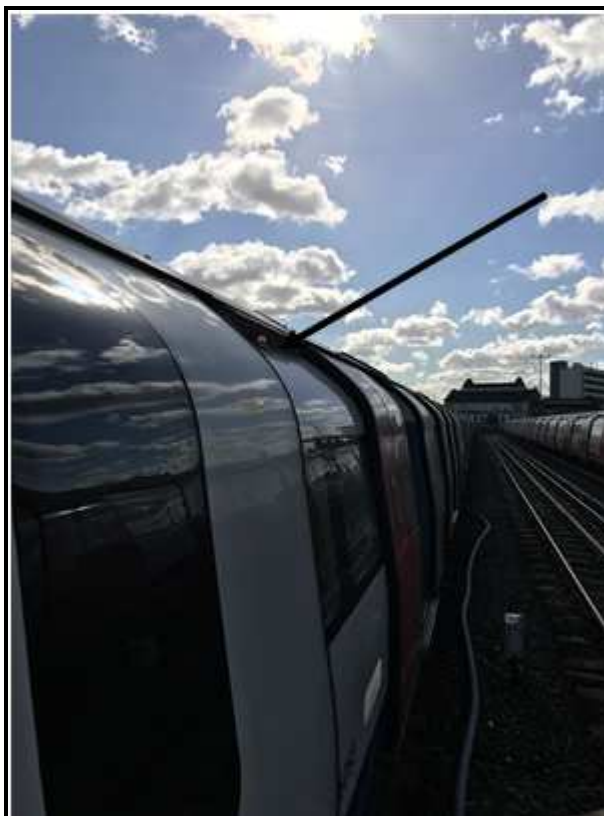
Figure 6 - Physical view of ODILs from driving side cab door
