Plane – *Platanus acerifolia* on the north east junction of Farringdon Road and Roseberry Avenue. Inspected by Grayham Tindal 15/10/18.

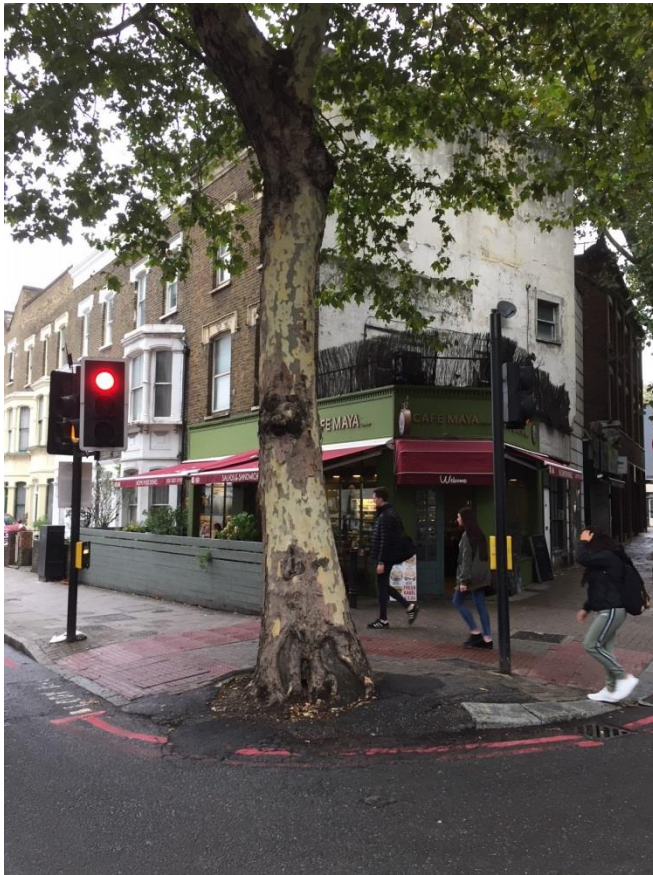
Image 1

There is visible wounding to the southern side of the base of the tree from ground level to approx. 50cm in height. The extent of the affected area is 70cm of the circumference. The diameter of the trunk at ground level was measured as 103cm (circumference at base 3.25m). Therefore 22% of the radius have been damaged and exposed. The probable cause of damage is vehicle impact by HGV or other long wheel based vehicles turning left when travelling south on Farringdon Road. There is no visible evidence of recent damage (within the last 6-12 months) at the base of the tree. As can be seen in images 1, 5 & 6 there is no other visible damage to the trunk. No fungal fruiting bodies were visible or present at the time of inspection. The crown and leaf area were considered normal for this age and size of tree, with no indication of a loss of vitality.

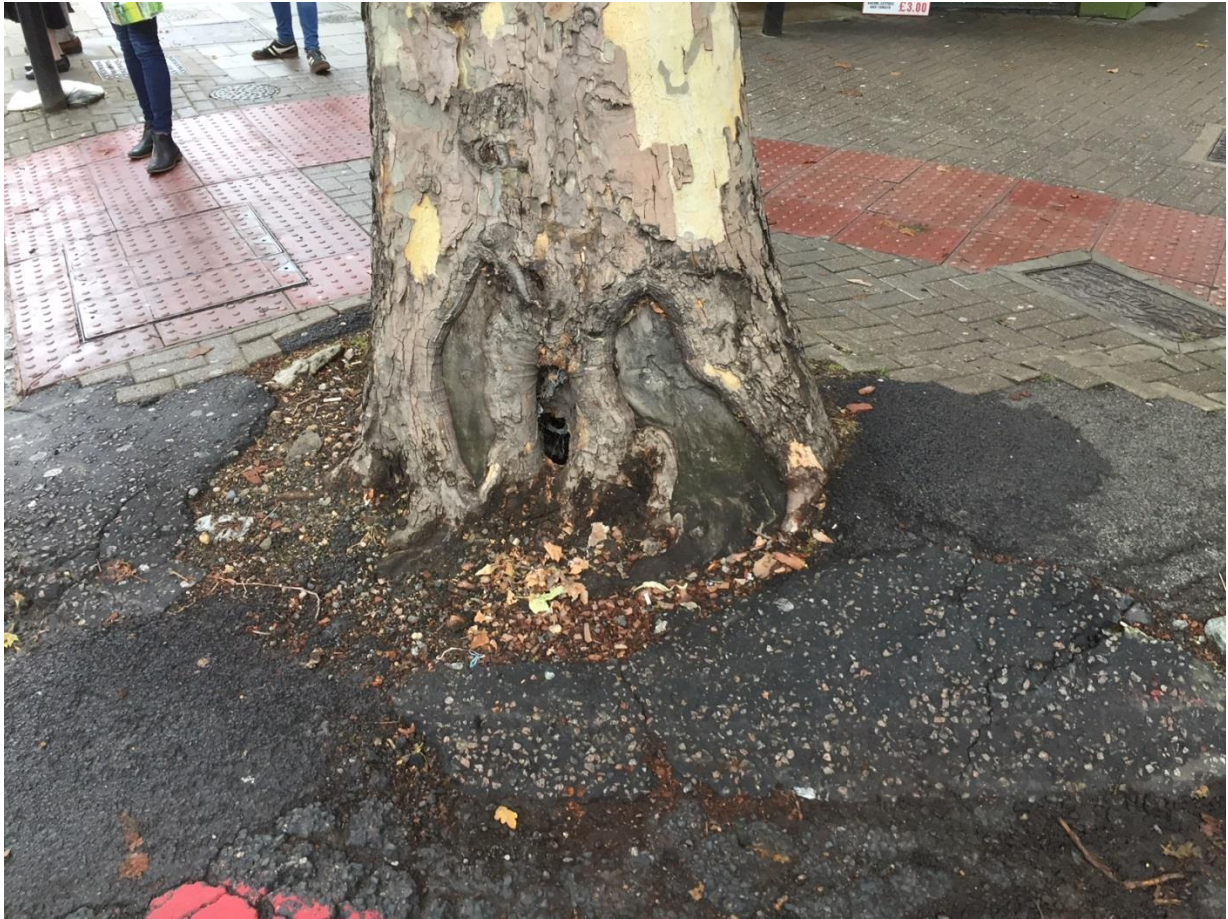
Image 2

Within the centre of the wound area there is a cavity on roadside which extends 40cm into trunk/base of tree. This is approximately 20cm at its widest point. The extent of the cavity is approximately 39% of the total diameter of the tree at ground level. The increased stresses on the surface of a tree resulting from its hollowing are only believed to be significant when the defect reaches 60-70% of the stem diameter. However, the extent of decaying or condition of wood around this cavity is not known. Therefore it is reasonable to assume the extent of the defect is greater than 39% of the total diameter. It is my opinion that further investigations would not be able to confirm the exact extent of the defect given the position at or just below ground level.

If this tree was positioned within a field or woodland and only subject to natural stress loading, I would consider it appropriate to retain and for the cavity/decay to be monitored on an annual basis. Due to the historical evidence of vehicle impact damage, this tree is at an increased risk of the abnormal stresses associated with a vehicle impact. Given the presence and position of the cavity and decay, there is an increased risk of catastrophic tree failure in the event of vehicle strike. Therefore to reduce the risk I believe there are only two reasonable solutions to consider. The first option would be to ban the left turn for south bound traffic on Farringdon Road or the second would be for the tree to be removed via a controlled fell. Both options will require further investigations as there are pros and cons to both solutions. Indecision will place TFL at significant financial and reputational risk in the event on an incident, given the target area, there are substantial risks to both property and persons in the event of a catastrophic failure.
