Report Reference: N&V-R2812

NOISE INVESTIGATION AT [Redacted]
[Redacted]

Issue Date: 25th August 2020

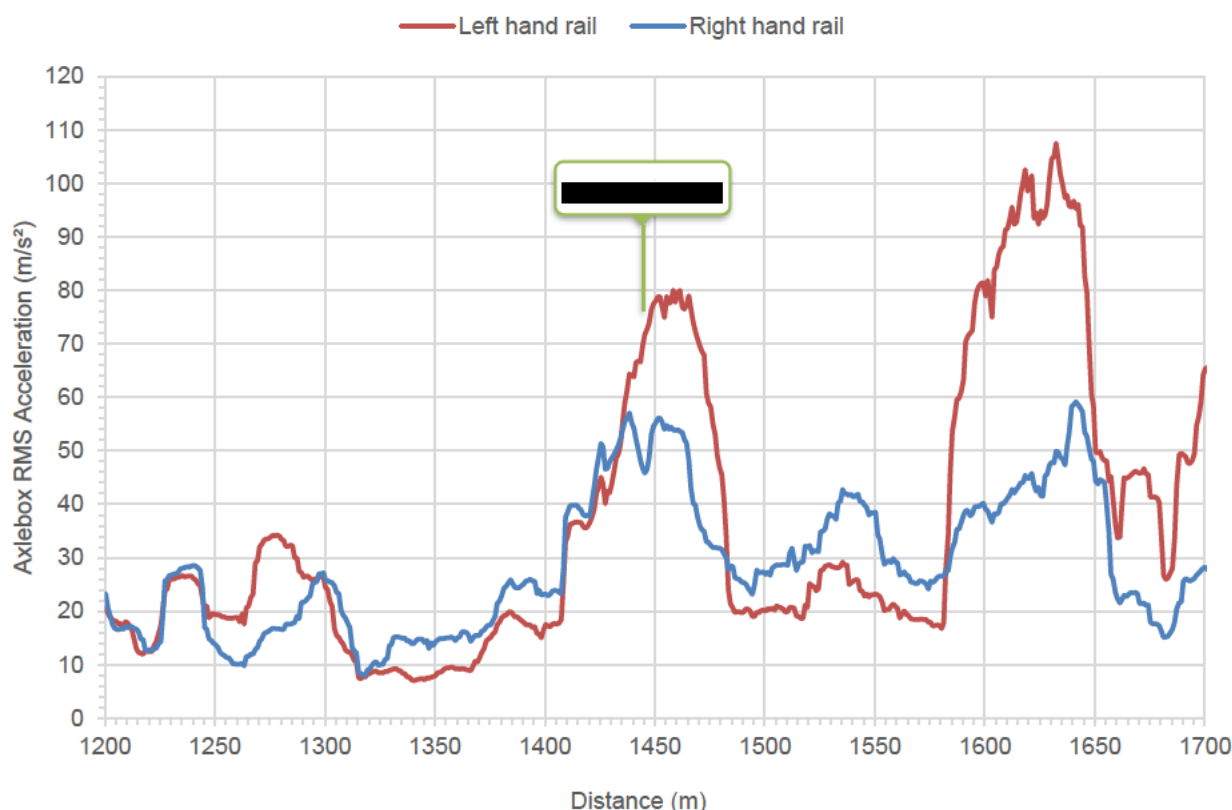
Within the property, only southbound trains were noticed, and this can be attributed to the fact that the southbound tunnel runs underneath the property, whereas the northbound tunnel, runs roughly 140m to the west. The perceived character of the train noise was a rumble, indicative of the presence of rail roughness.

Axle box vibration levels taken from an ATMS run on the Northern Line, in December 2019, show that the levels on the southbound road near the property, are increased, validating the presumption of increased rail roughness levels.

Figure 2 - Train axle box vibration on the SB road measured on an ATMS run: December 2019

Rail roughness data should allow a better understanding of the current condition of the southbound track, and therefore, measurements with a Corrugation Analysis Trolley (CAT) are recommended.
