Seven Sisters Market – Supply recommendations

1. Switch cupboard arrangements

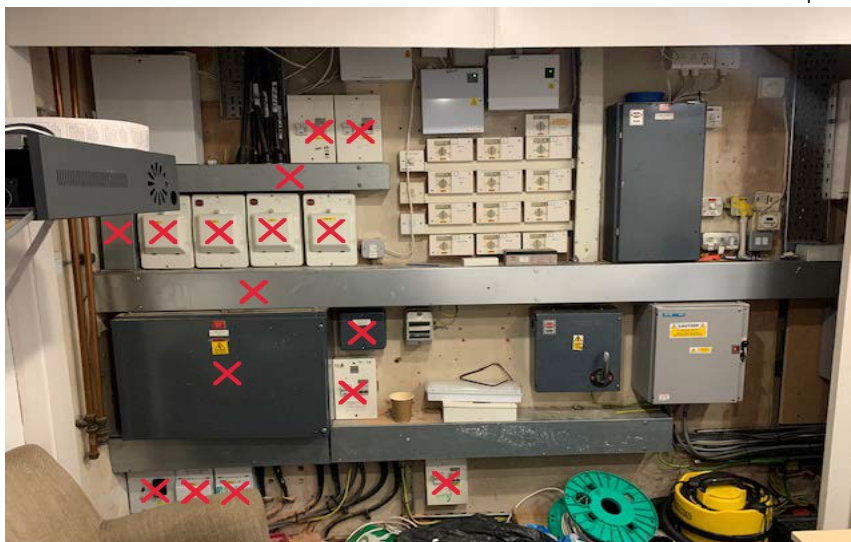
The existing three phase, 3-way fuse board does not have enough capacity to supply the 15 sub boards located within the market. The existing main fuses each have two supplies connected causing overloading. The fuse board also has damaged components and exposed live conductive parts.

Items marked red to be removed and new MCCB Distribution panel installed

- Remove existing MEM 3-way fuse board
- Remove existing fuse switches
- Remove existing trunking
- Install new 3 phase 12-way MCCB distribution panel
- Install new trunking
- Tidy existing SWA cables on new cable tray
- Re-locate and arrange earth bar
- Install Labels
- Test and commission

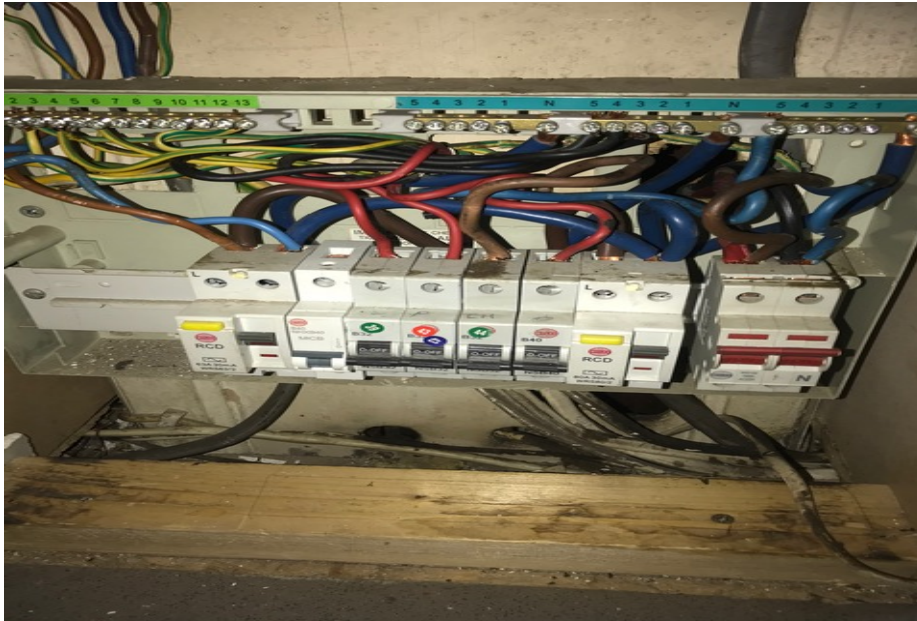
1L1 – DB1 – Units 44,37,38,43, (3)

There is not enough capacity for existing circuits, new DB is required.

- Existing sub main cable to remain
- Remove existing DB
- Re-locate supply to unit 3 to DB1
- Install with new 8-way DB with MCBs
- Install entry stuffing glands for incoming cables to DB
- Install labels
- Test and commission

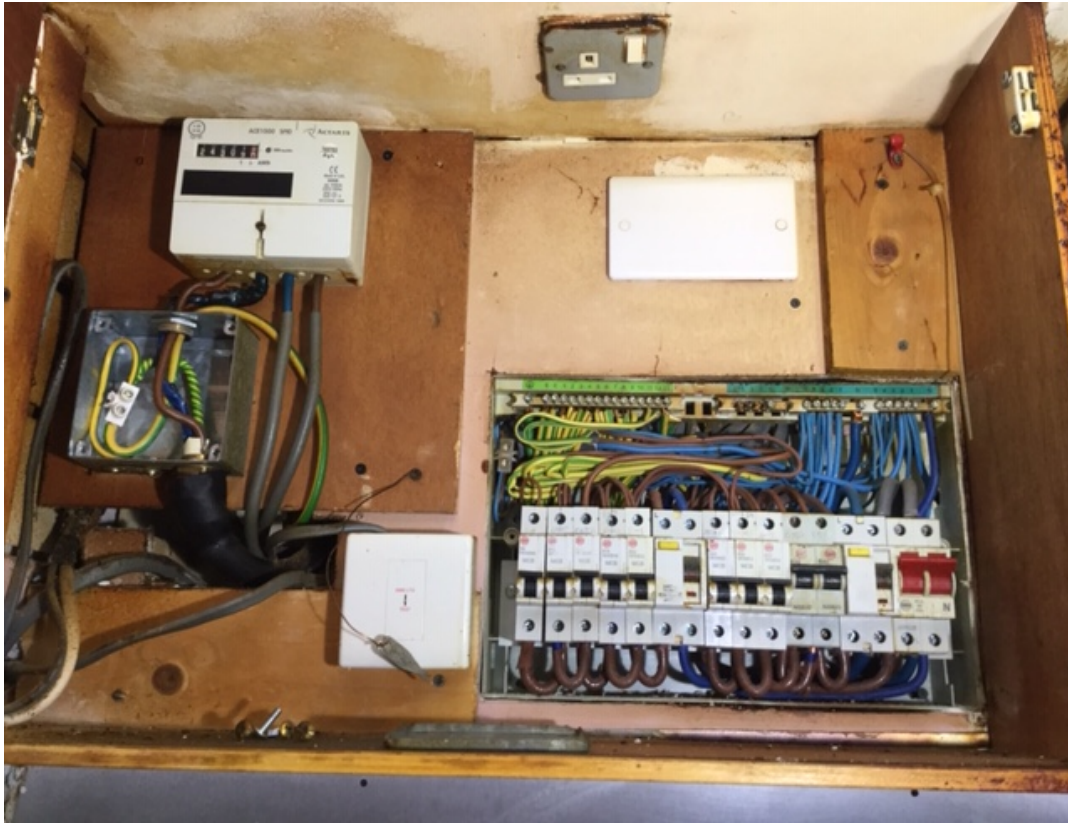
1L2 – DB2-units 36&29

Bus bar missing, mixed manufacturer MCBs and evidence of burning. Adaptable box not joined correctly with single core cables entering meter.

- Sub Main cable to remain
- Remove existing DB
- Install fixed base connectors and DI tails to meter
- Install new 10-way split RCD board
- Install labels
- Test and commission

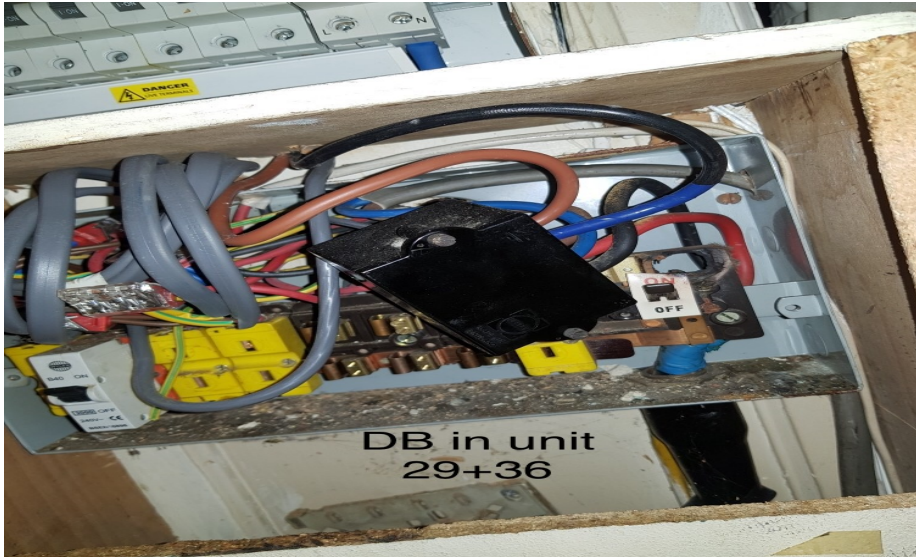
1L3 – DB3 – units 30,35,31,32,33,34

Distribution board used as joint boxes, mixed manufacturers MCBs, broken with exposed conductor parts

- Sub Main cable to remain
- Remove existing joint boxes and exposed parts
- Install new single phase 8-way MCB board with 6 x 32A MCBs
- Entry stuffing glands
- Install labels
- Test and commission

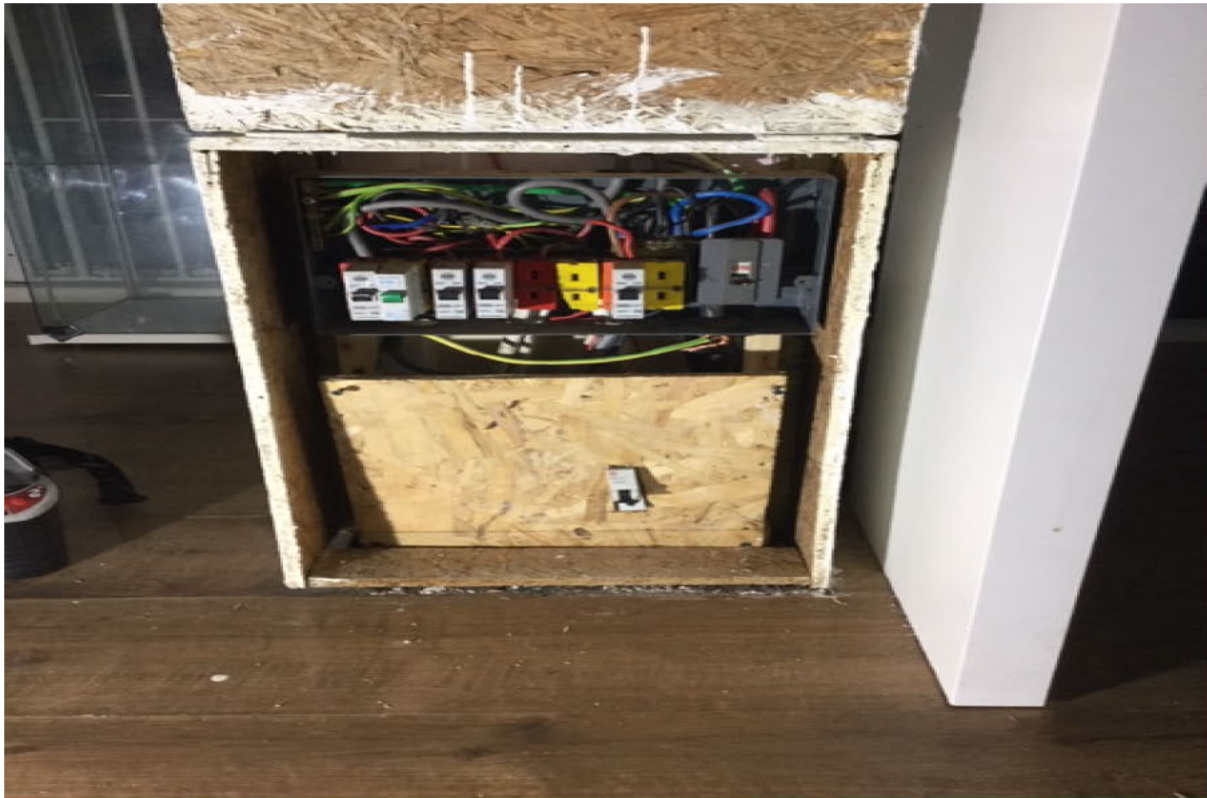
2L1 – DB4 – units 21,22,23,24,25,26,27,28

The DB has insufficient capacity with MCBs cut into the wood. The DB is damaged.

- Remove existing DB
- Remove boxing in
- Install new DB
- Install labels
- Test and commission

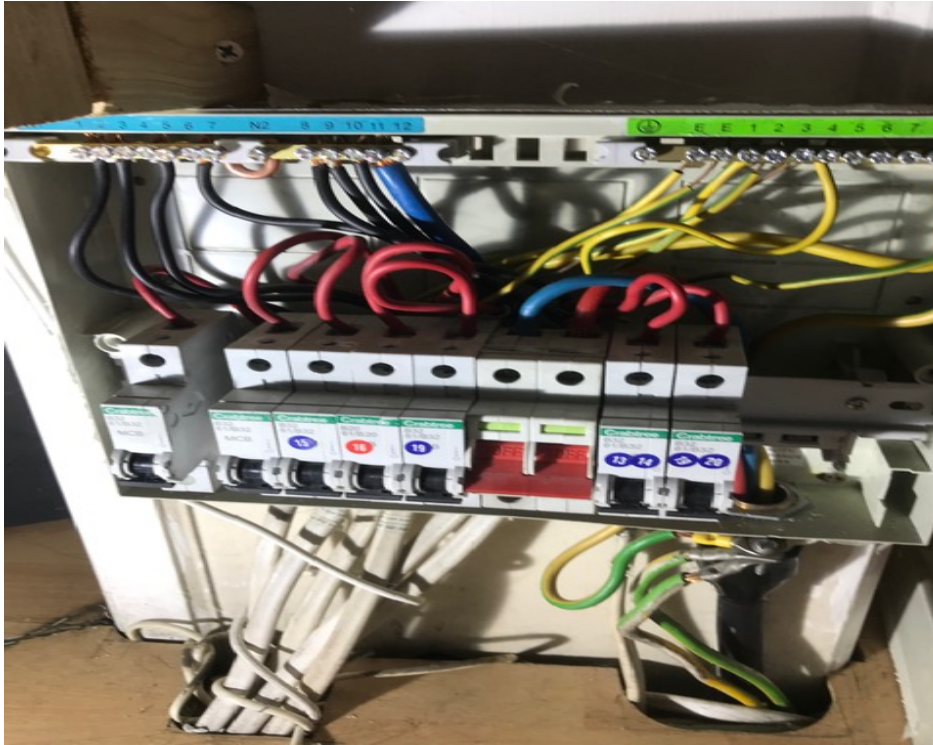
2L2 – DB5 units 13,14,15,16,17,18,19,20

Arrangement of MCBs incorrect. IP4X not achieved. These units have been suggested to be rewired, a new DB would be recommended to remove existing sub boards within units.

- Existing SWA sub main to remain
- Remove existing DB
- Install new metal DB
- Entry stuffing glands
- Labels
- Test and commission

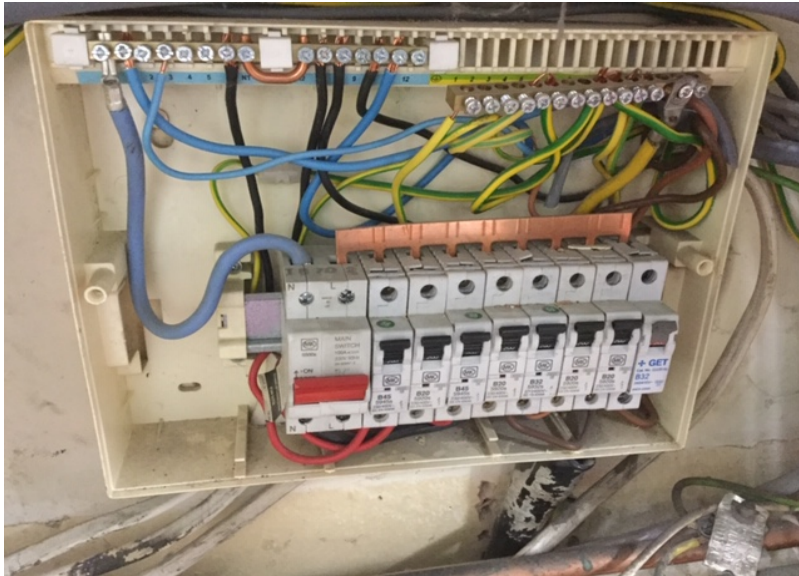
2L3 – DB6 – units 56,57,58,59a,59b

Bus bar installed incorrectly and mixed manufacturers MCBs.

- Existing sub main cable to remain
- Remove DB
- Install new DB
- Install new labels
- Test and commission

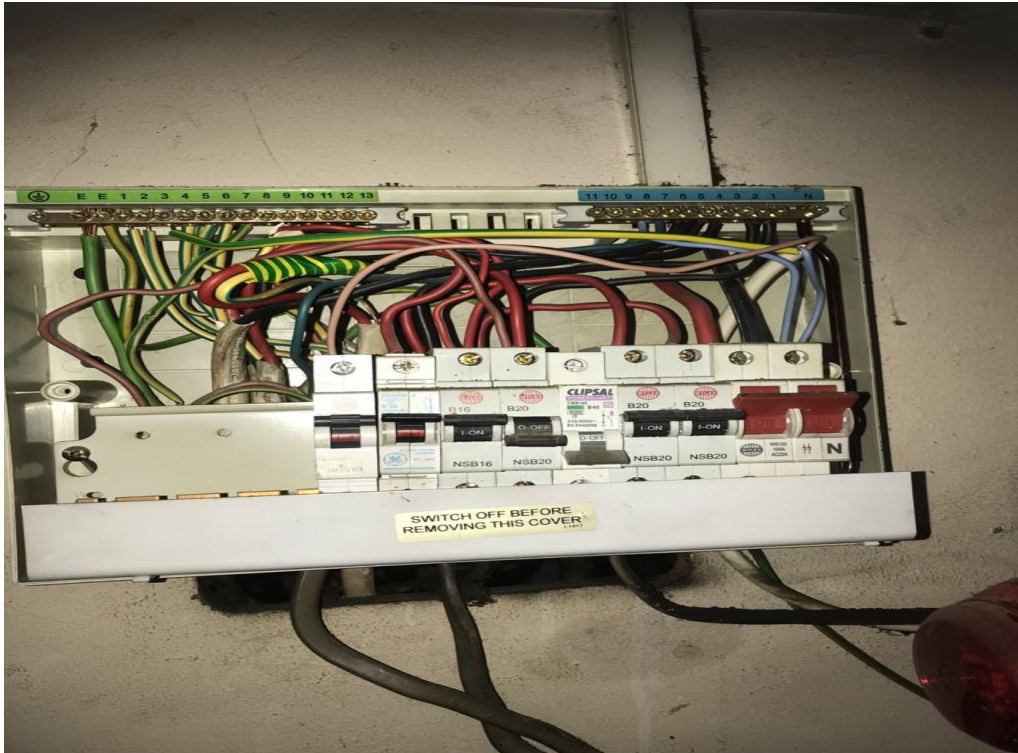
4L1 – DB8 – units, 3,7,8,9, communal lighting, and power

DB contains MCBs from mixed manufacturers. Holes in DB

- Existing S WA sub main to remain
- Remove existing DB
- Install new metal DB
- Entry stuffing glands
- Labels
- Test and commission

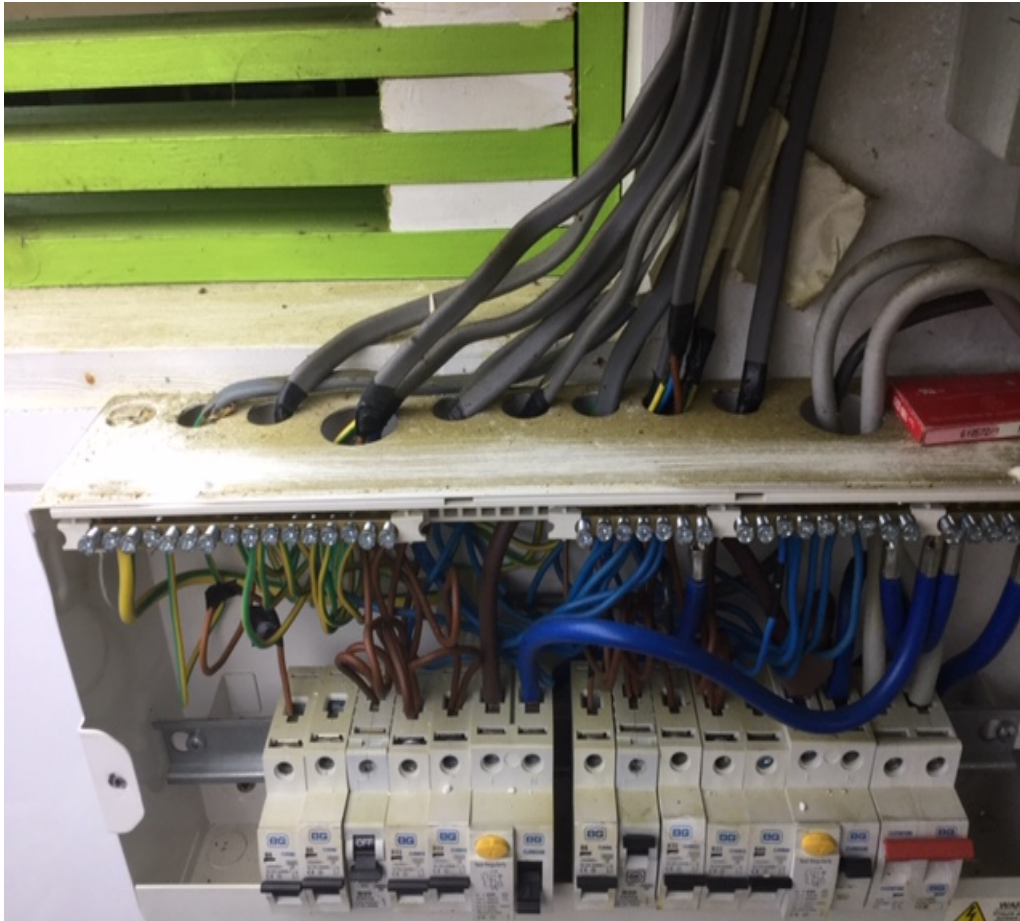
4L2 – DB9 – unit 48

IP4X not achieved, mixed manufacturers MCBs

- Existing SWA sub main to remain
- Remove existing DB
- Install new metal DB
- Entry stuffing glands
- Labels
- Test and commission

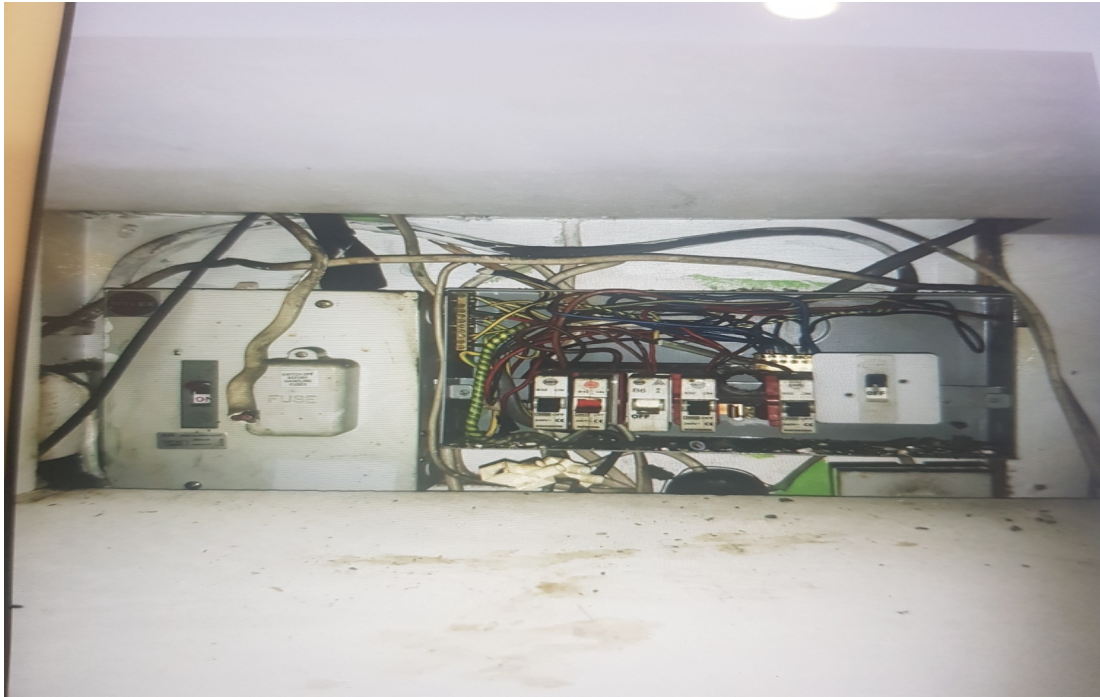
4L3 – DB10 – units, 50,51,54,55

DB contains mixed manufacturers MCBs. Existing DB is damaged. DB is obsolete. Re-wire the configuration.

- Sub Main cable to remain
- Remove existing DB
- Remove existing isolator
- Install new metal DB
- Entry stuffing glands
- Labels
- Test and commission

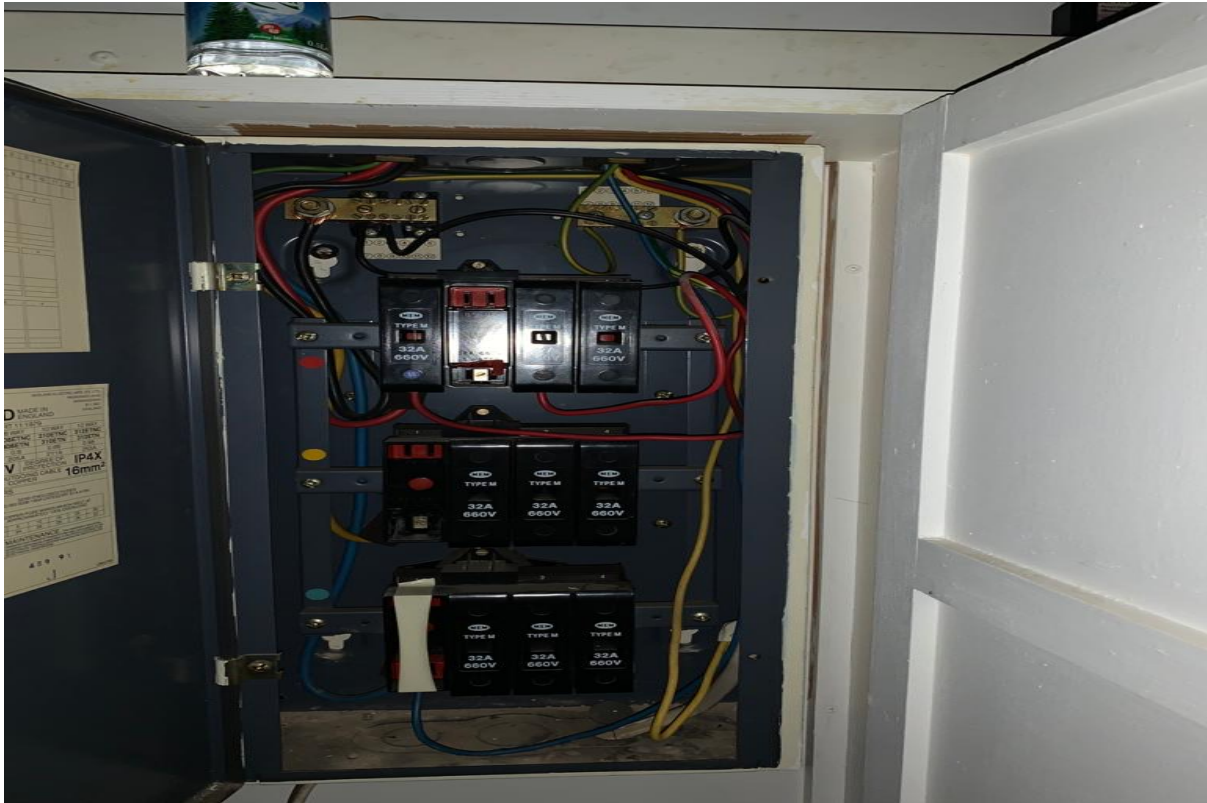
5L1/2/3 – DB11 – unit 52,53

DB damaged with exposed conductive parts and obsolete.

- Existing single core cables supplying board to remain
- Remove existing DB
- Install new three phase metal MCB board
- Entry stuffing glands
- Labels
- Test and commission
-

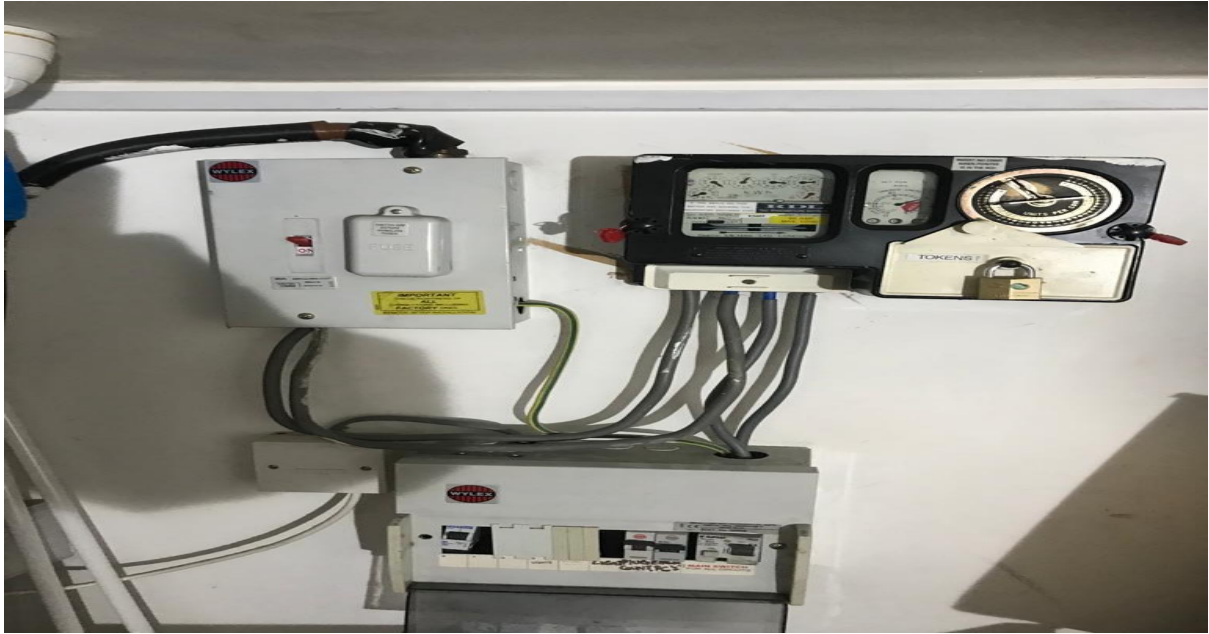
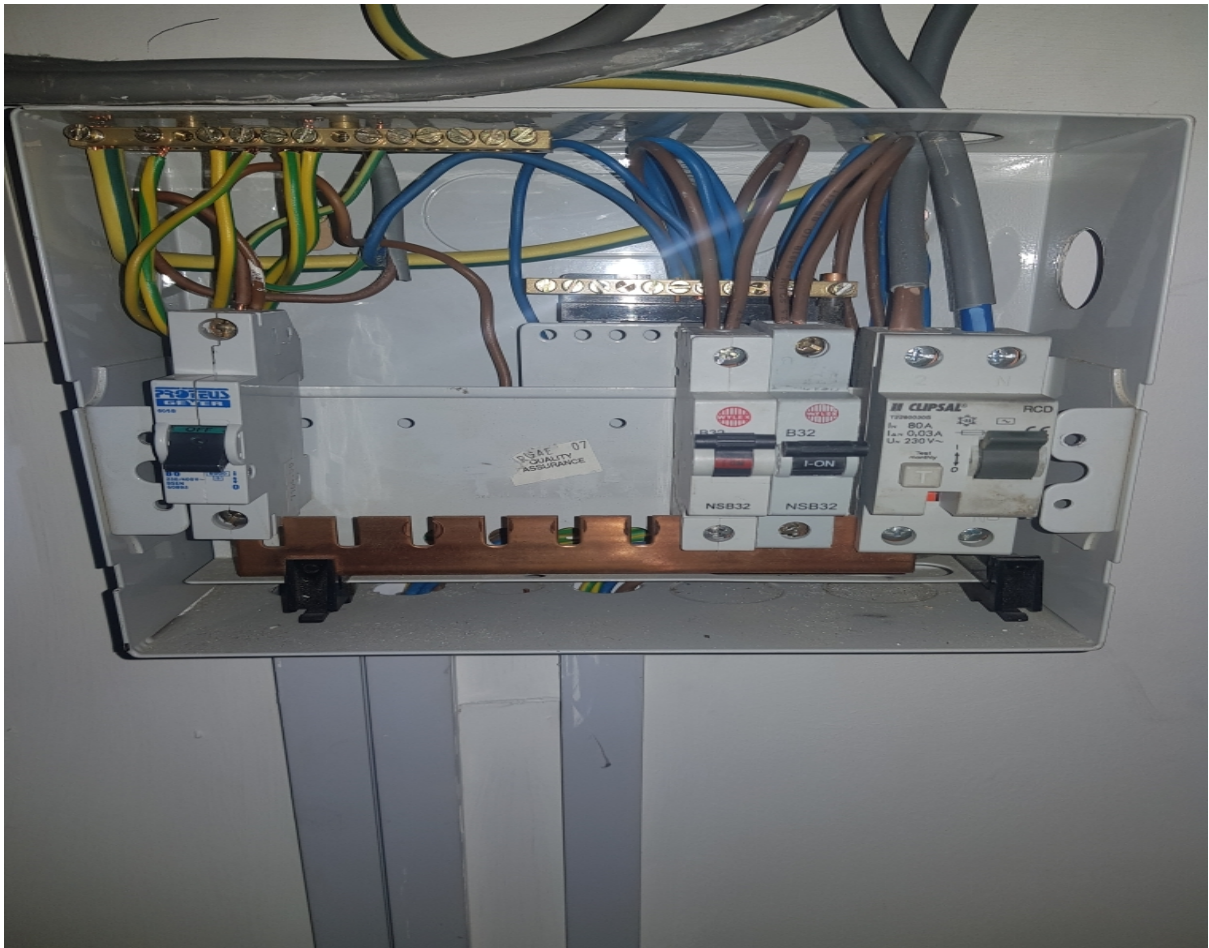
6L2 – DB13 – unit 10

DB is damaged, SWA not terminated correctly, mixed installation of different manufactured MCBs

- Existing SWA sub main to remain

- Remove existing DB
- Install new metal DB
- Entry stuffing glands
- Labels
- Test and commission

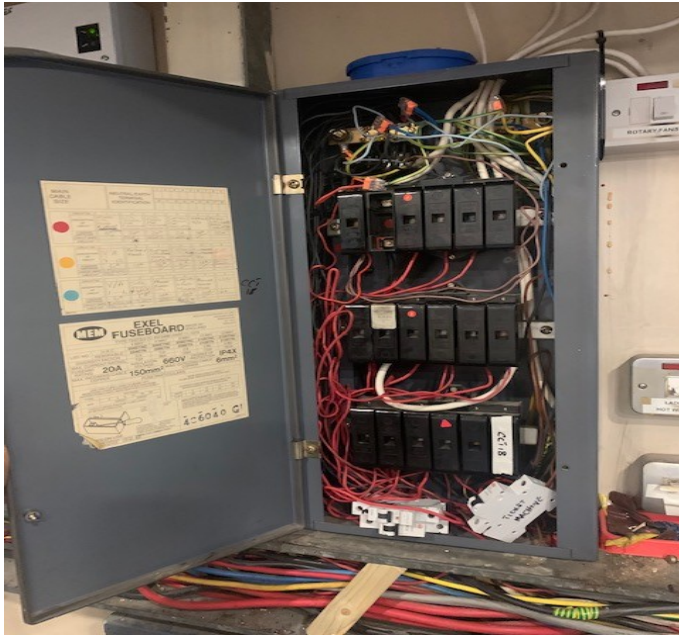
DB 15 – 7L1/2/3 - units, communal power and lighting, outside lights, ladies and gents' toilets and fans

Fuse board not enough capacity, exposed live parts and floating MCBs

The works are recommended because there is not enough capacity for existing circuits present. There are floating MCBs within the DB and exposed conductive parts with fuse carriers missing and no blanking plates fitted.

- Remove existing fuse board
- Install new Three phase 10-way MCB board
- Re-wire contactors
- Re-locate local electrical equipment, switches, contactor, FCU's
- Install labels
- Re-test each individual circuit
