# Feasibility Report into the required improvements at the crossing of

## A2203 Blackwall Lane by Tunnel Avenue

### TFL Signal Ref: 06/248

Date of Report: 20/07/2019

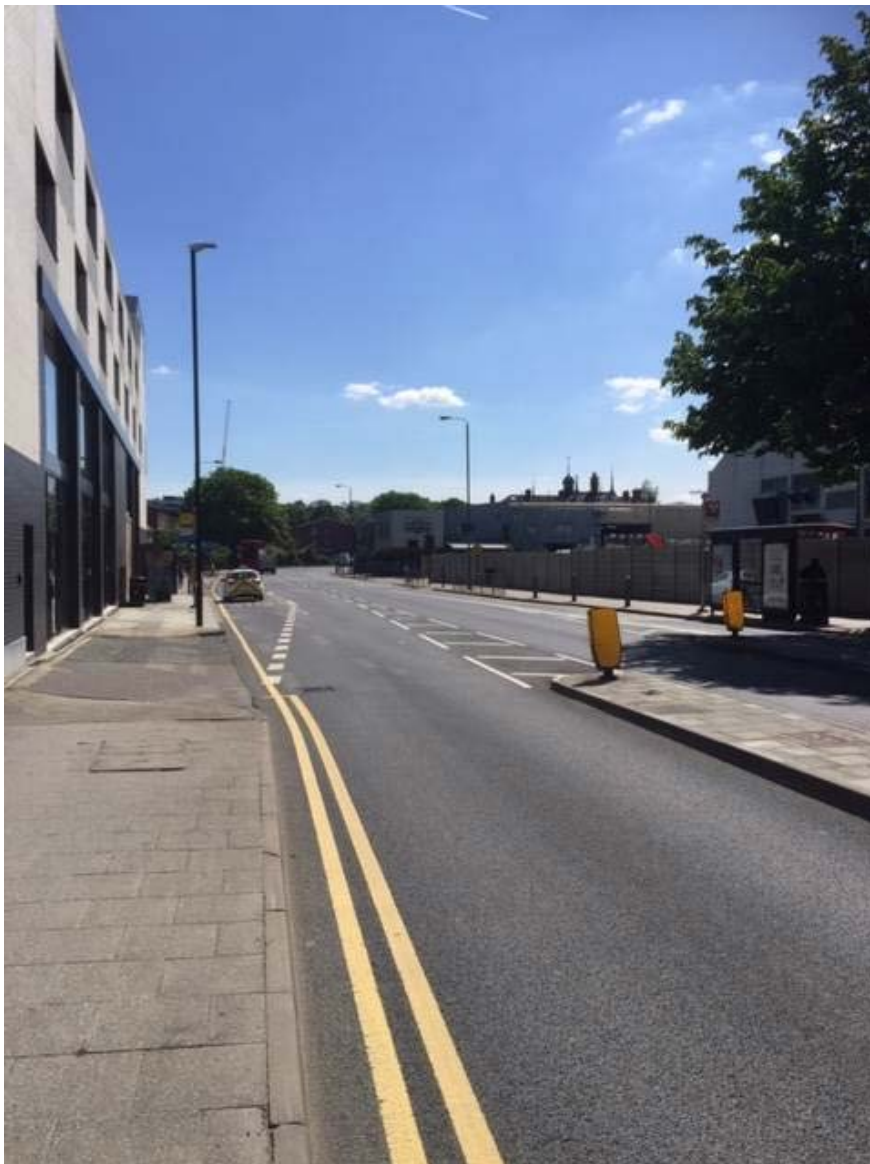
Despite the level and straight section of road on which this crossing sits the visibility of the signal, even without traffic blocking the approaches is less than adequate, as can be seen in the picture above.

The crossing has dual lane (one bus lane and one general traffic lane) approaches in both directions, however the Southbound has two traffic signal heads and the north bound three. When high sided traffic is present, some or all of these signal heads are blocked to other approaching vehicles.

If a bus were to be waiting at the bus stop on the south bound approach the prominence of the crossing would be almost non-existent to other vehicles.

Despite the fact that this is a stand along crossing it does not have zig-zag markings. It has been a requirement for these marking to be in place at all stand-alone crossings since the beginning of 2007. In the time since then and now this site has been modified and should have been rectified by now.

The lack of correct road markings adds to the inconspicuousness of the crossing point. Zig-zags would forewarn traffic that they were approaching a crossing point and users would be more alert to visibly seek out confirmation of the state of the crossing.

First of all the crossing needs to have zig-zag markings installed. It is not acceptable for this to be left non-compliant more than a decade after the deadline to add these markings to stand-alone toucan crossings.

Secondly the prominence of the traffic signal heads needs to be greatly improved. Simply adding an additional secondary signal or offsetting a pole would not be sufficient as this would be just another signal head blocked by buses / high sided vehicles.

1. Install a centre island and mount poles and head in the middle of the crossing.
2. Install a mast arm with associated additional signal heads.
3. Install 6m poles on the crossing and add to the signals with high level aspects.

In summary the crossing should be modified to include centre islands and addition traffic signal equipment added to those islands. This can be easily achieved and coupled with the inclusion of the required zig-zag markings would completely remove the issue that has been identified.
