Type: Site Visit Photo - Site made safe

Site Visit Status: Completed - First time permanent repair

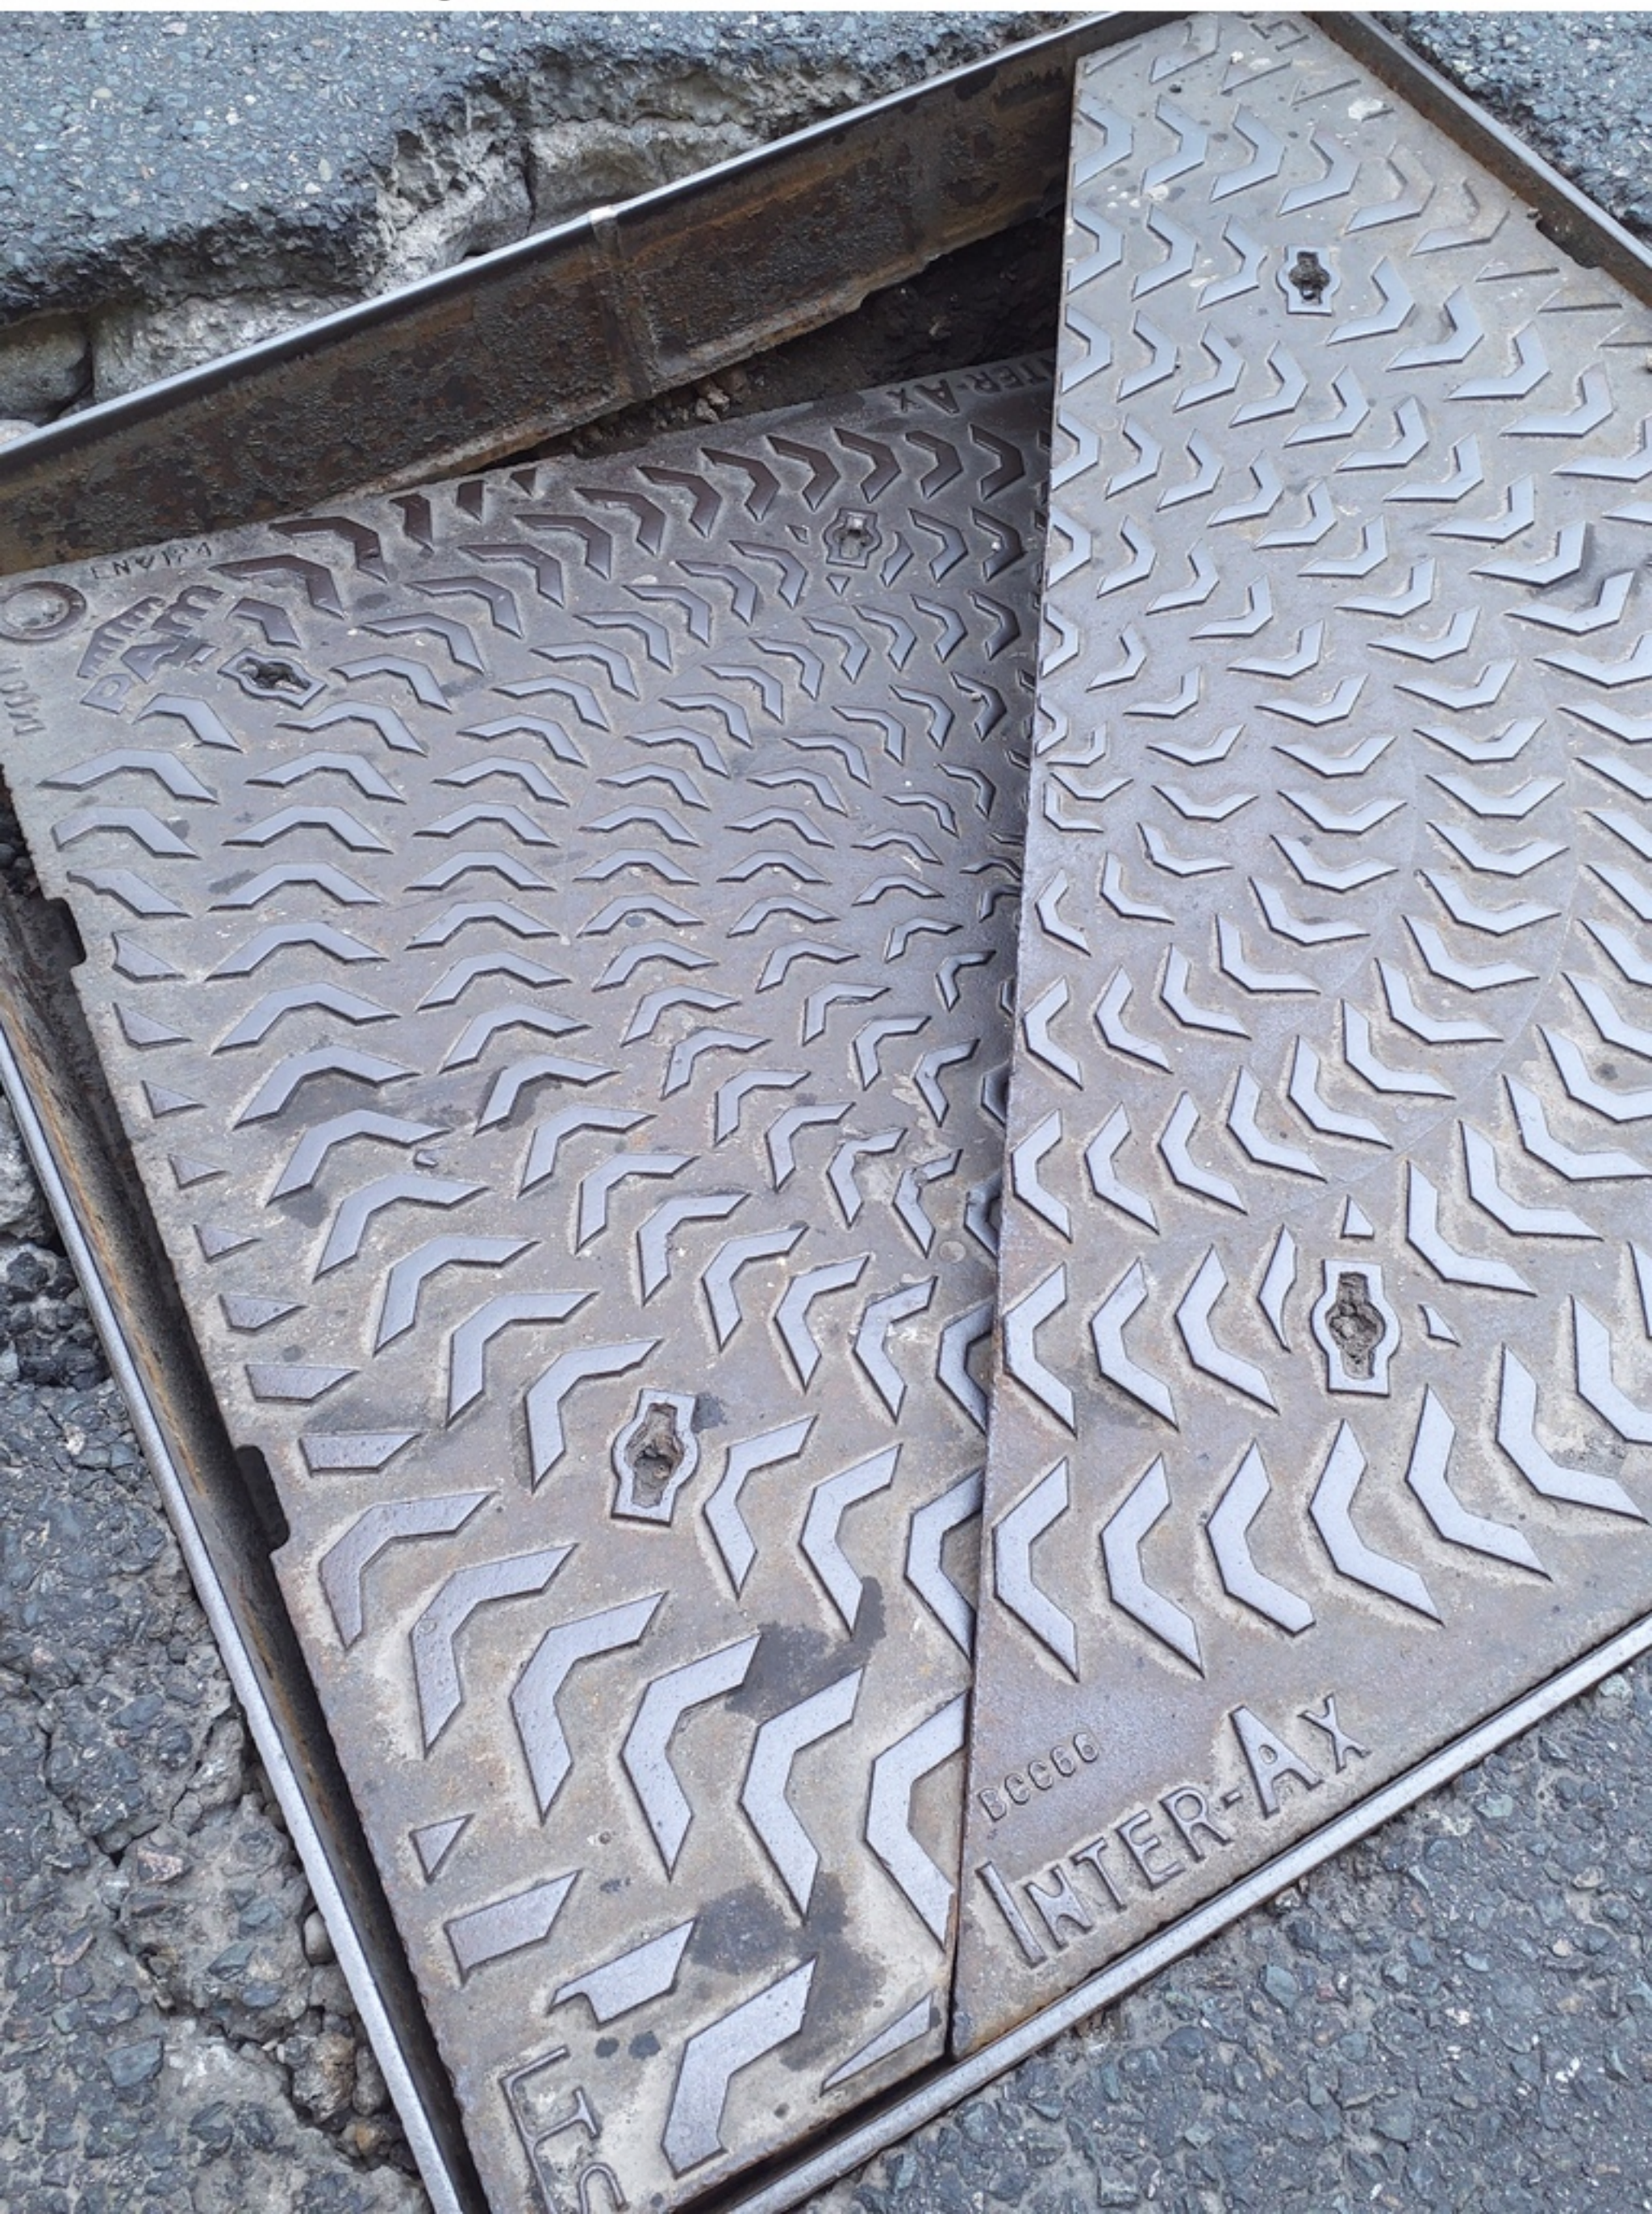
2024-03-09-135159.jpg

Type: Site Visit Photo - Before Work Commenced

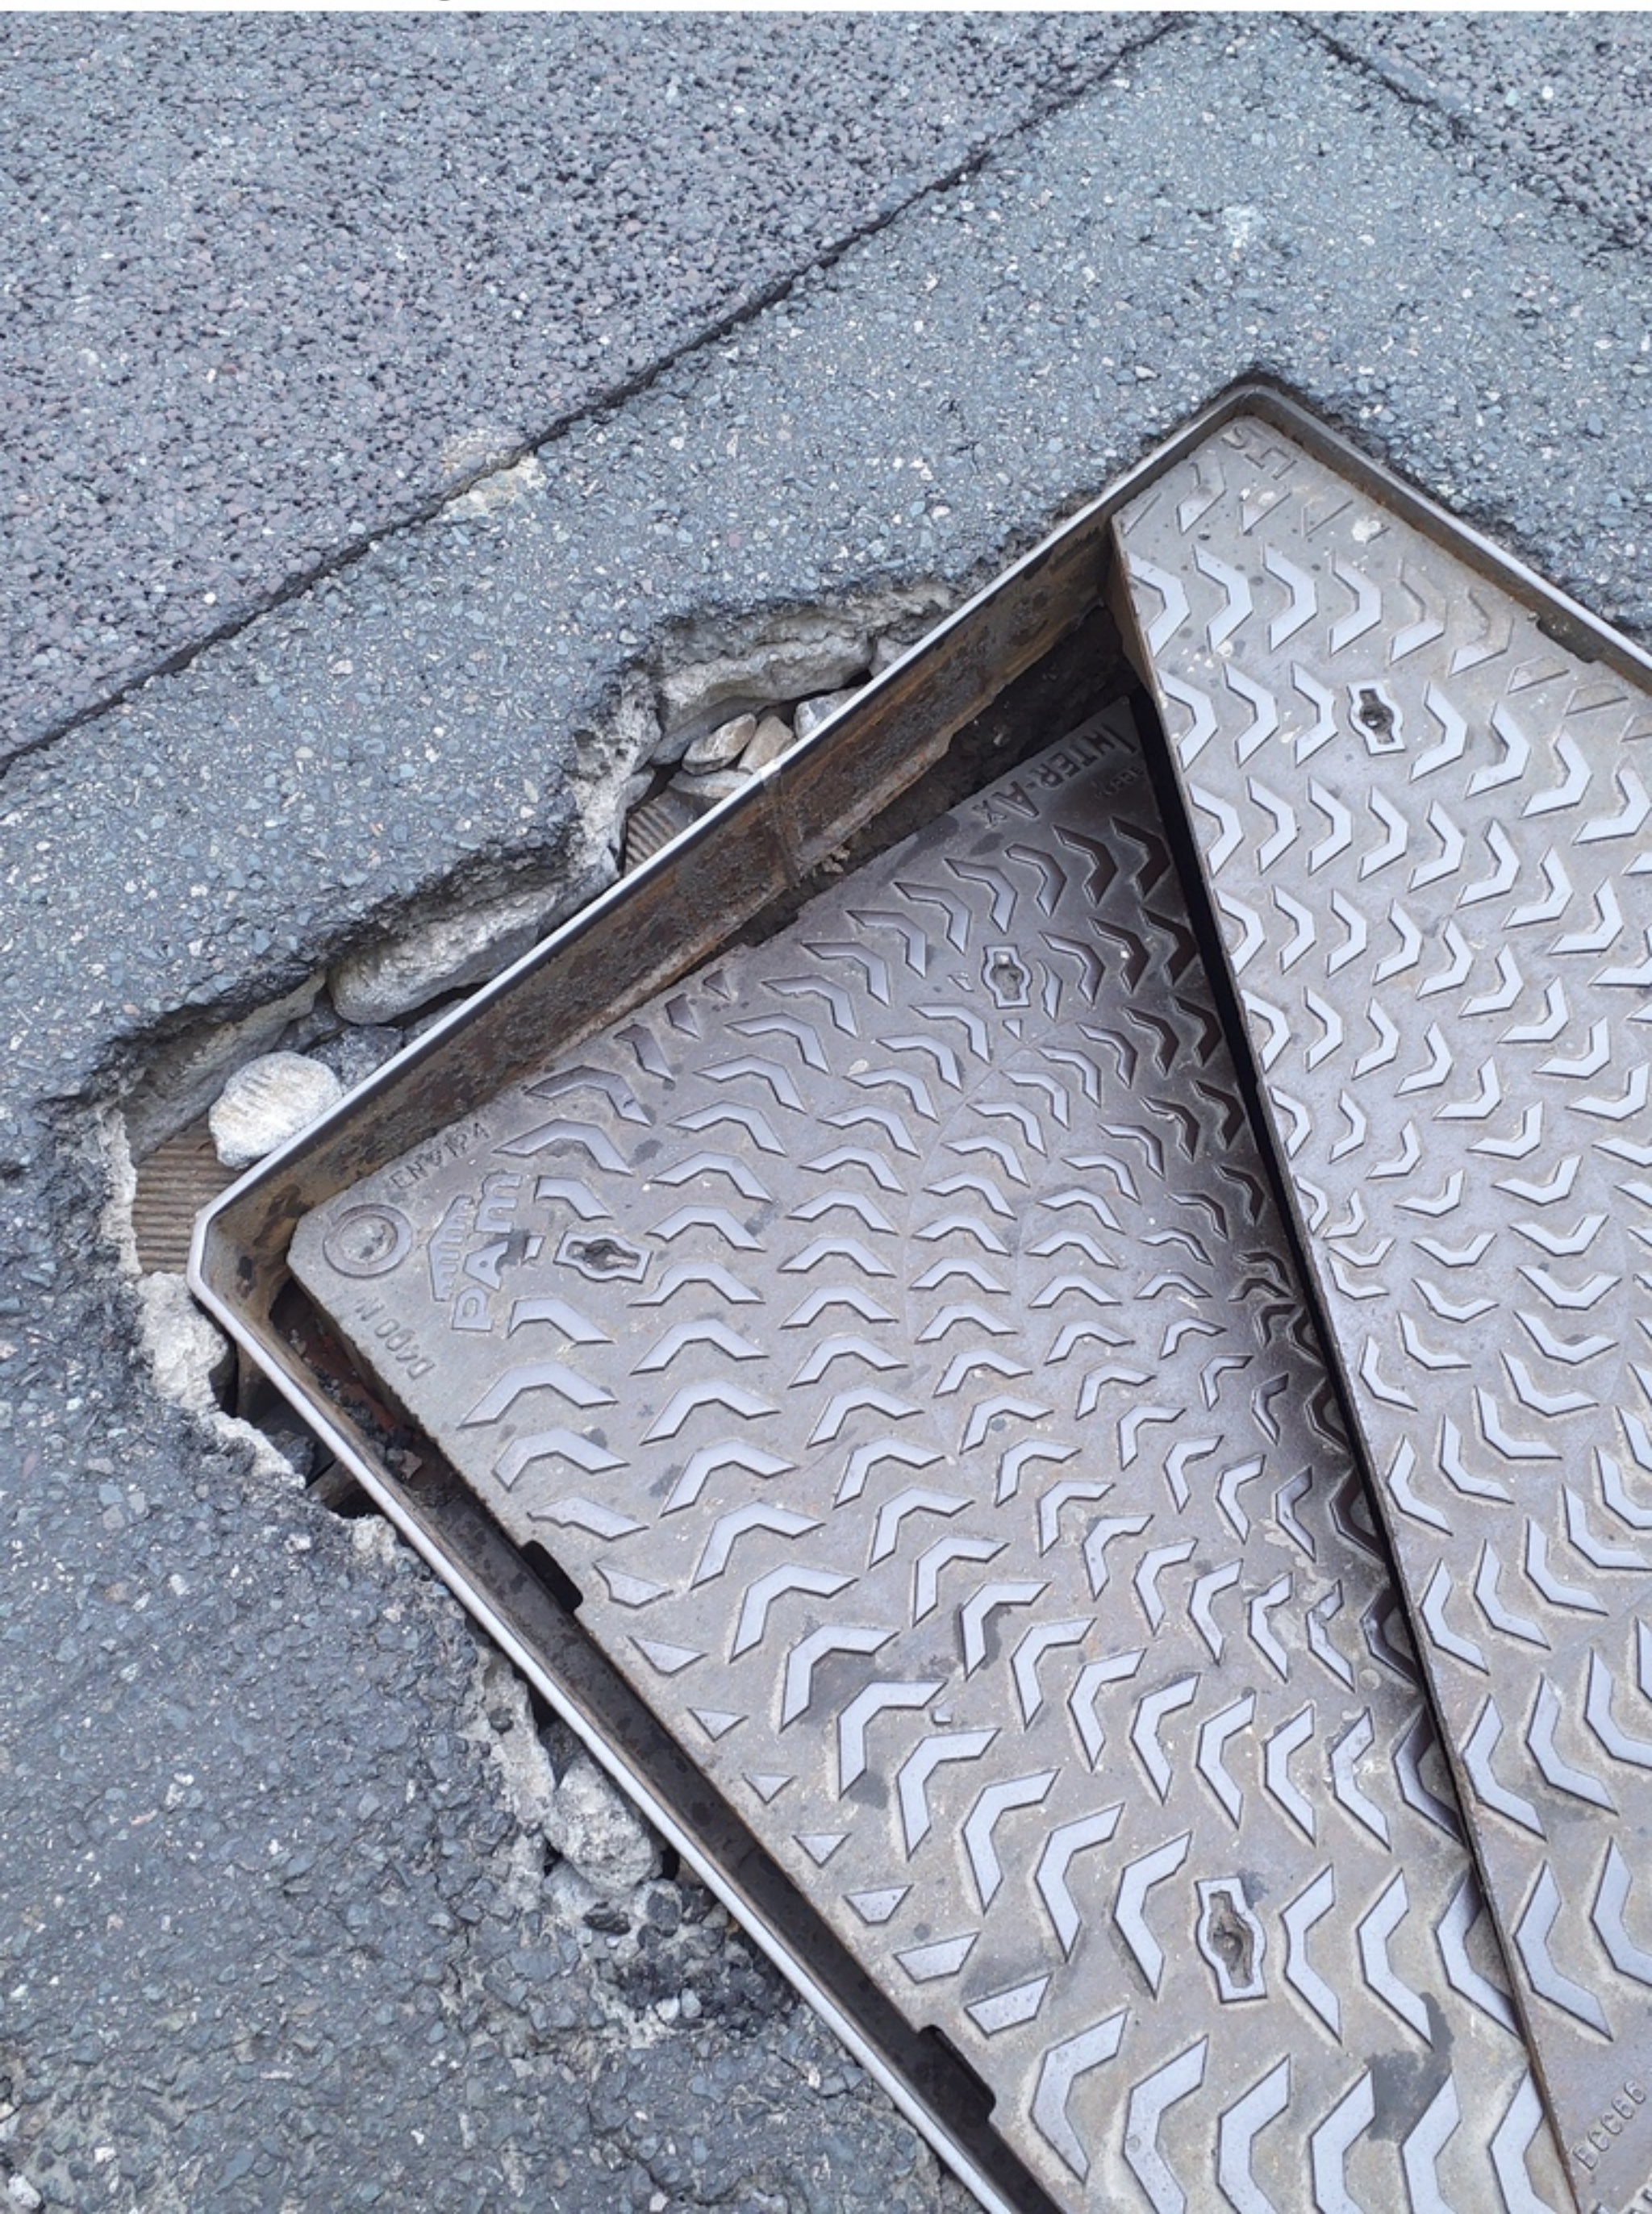
2024-03-09-135208.jpg

Type: Site Visit Photo - Before Work Commenced

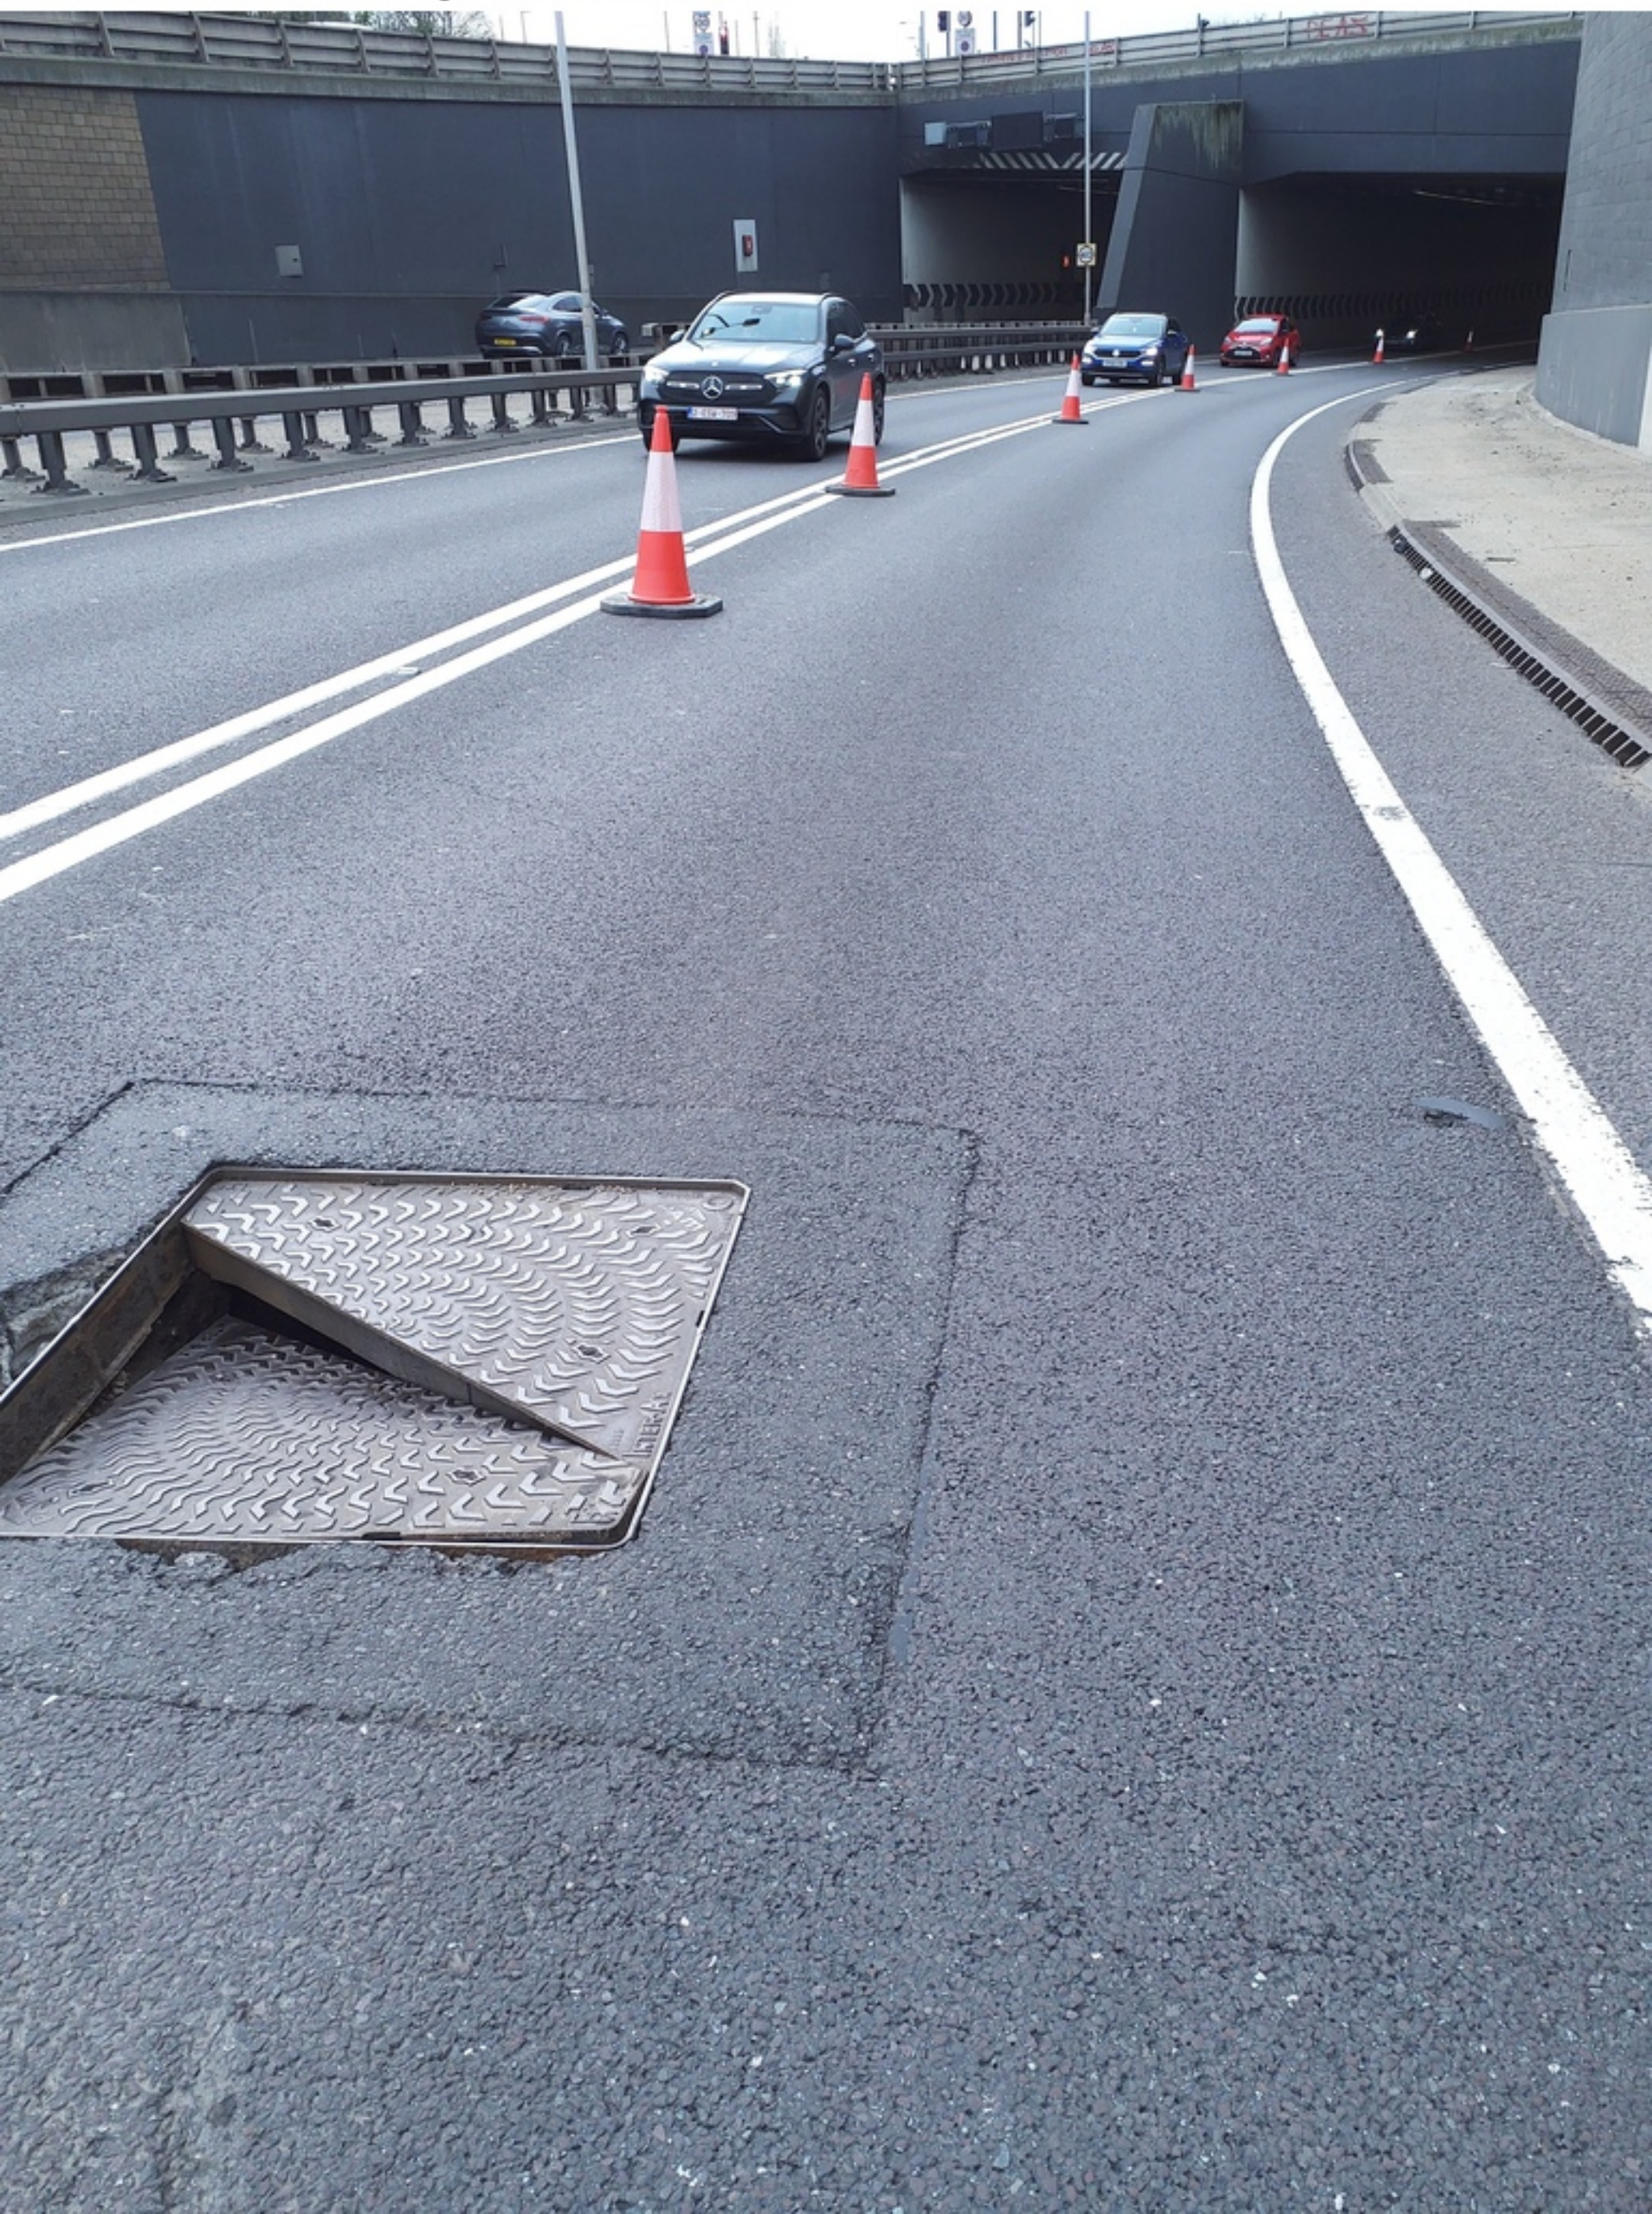
2024-03-09-161316.jpg

Type: Site Visit Photo - Interim Photo

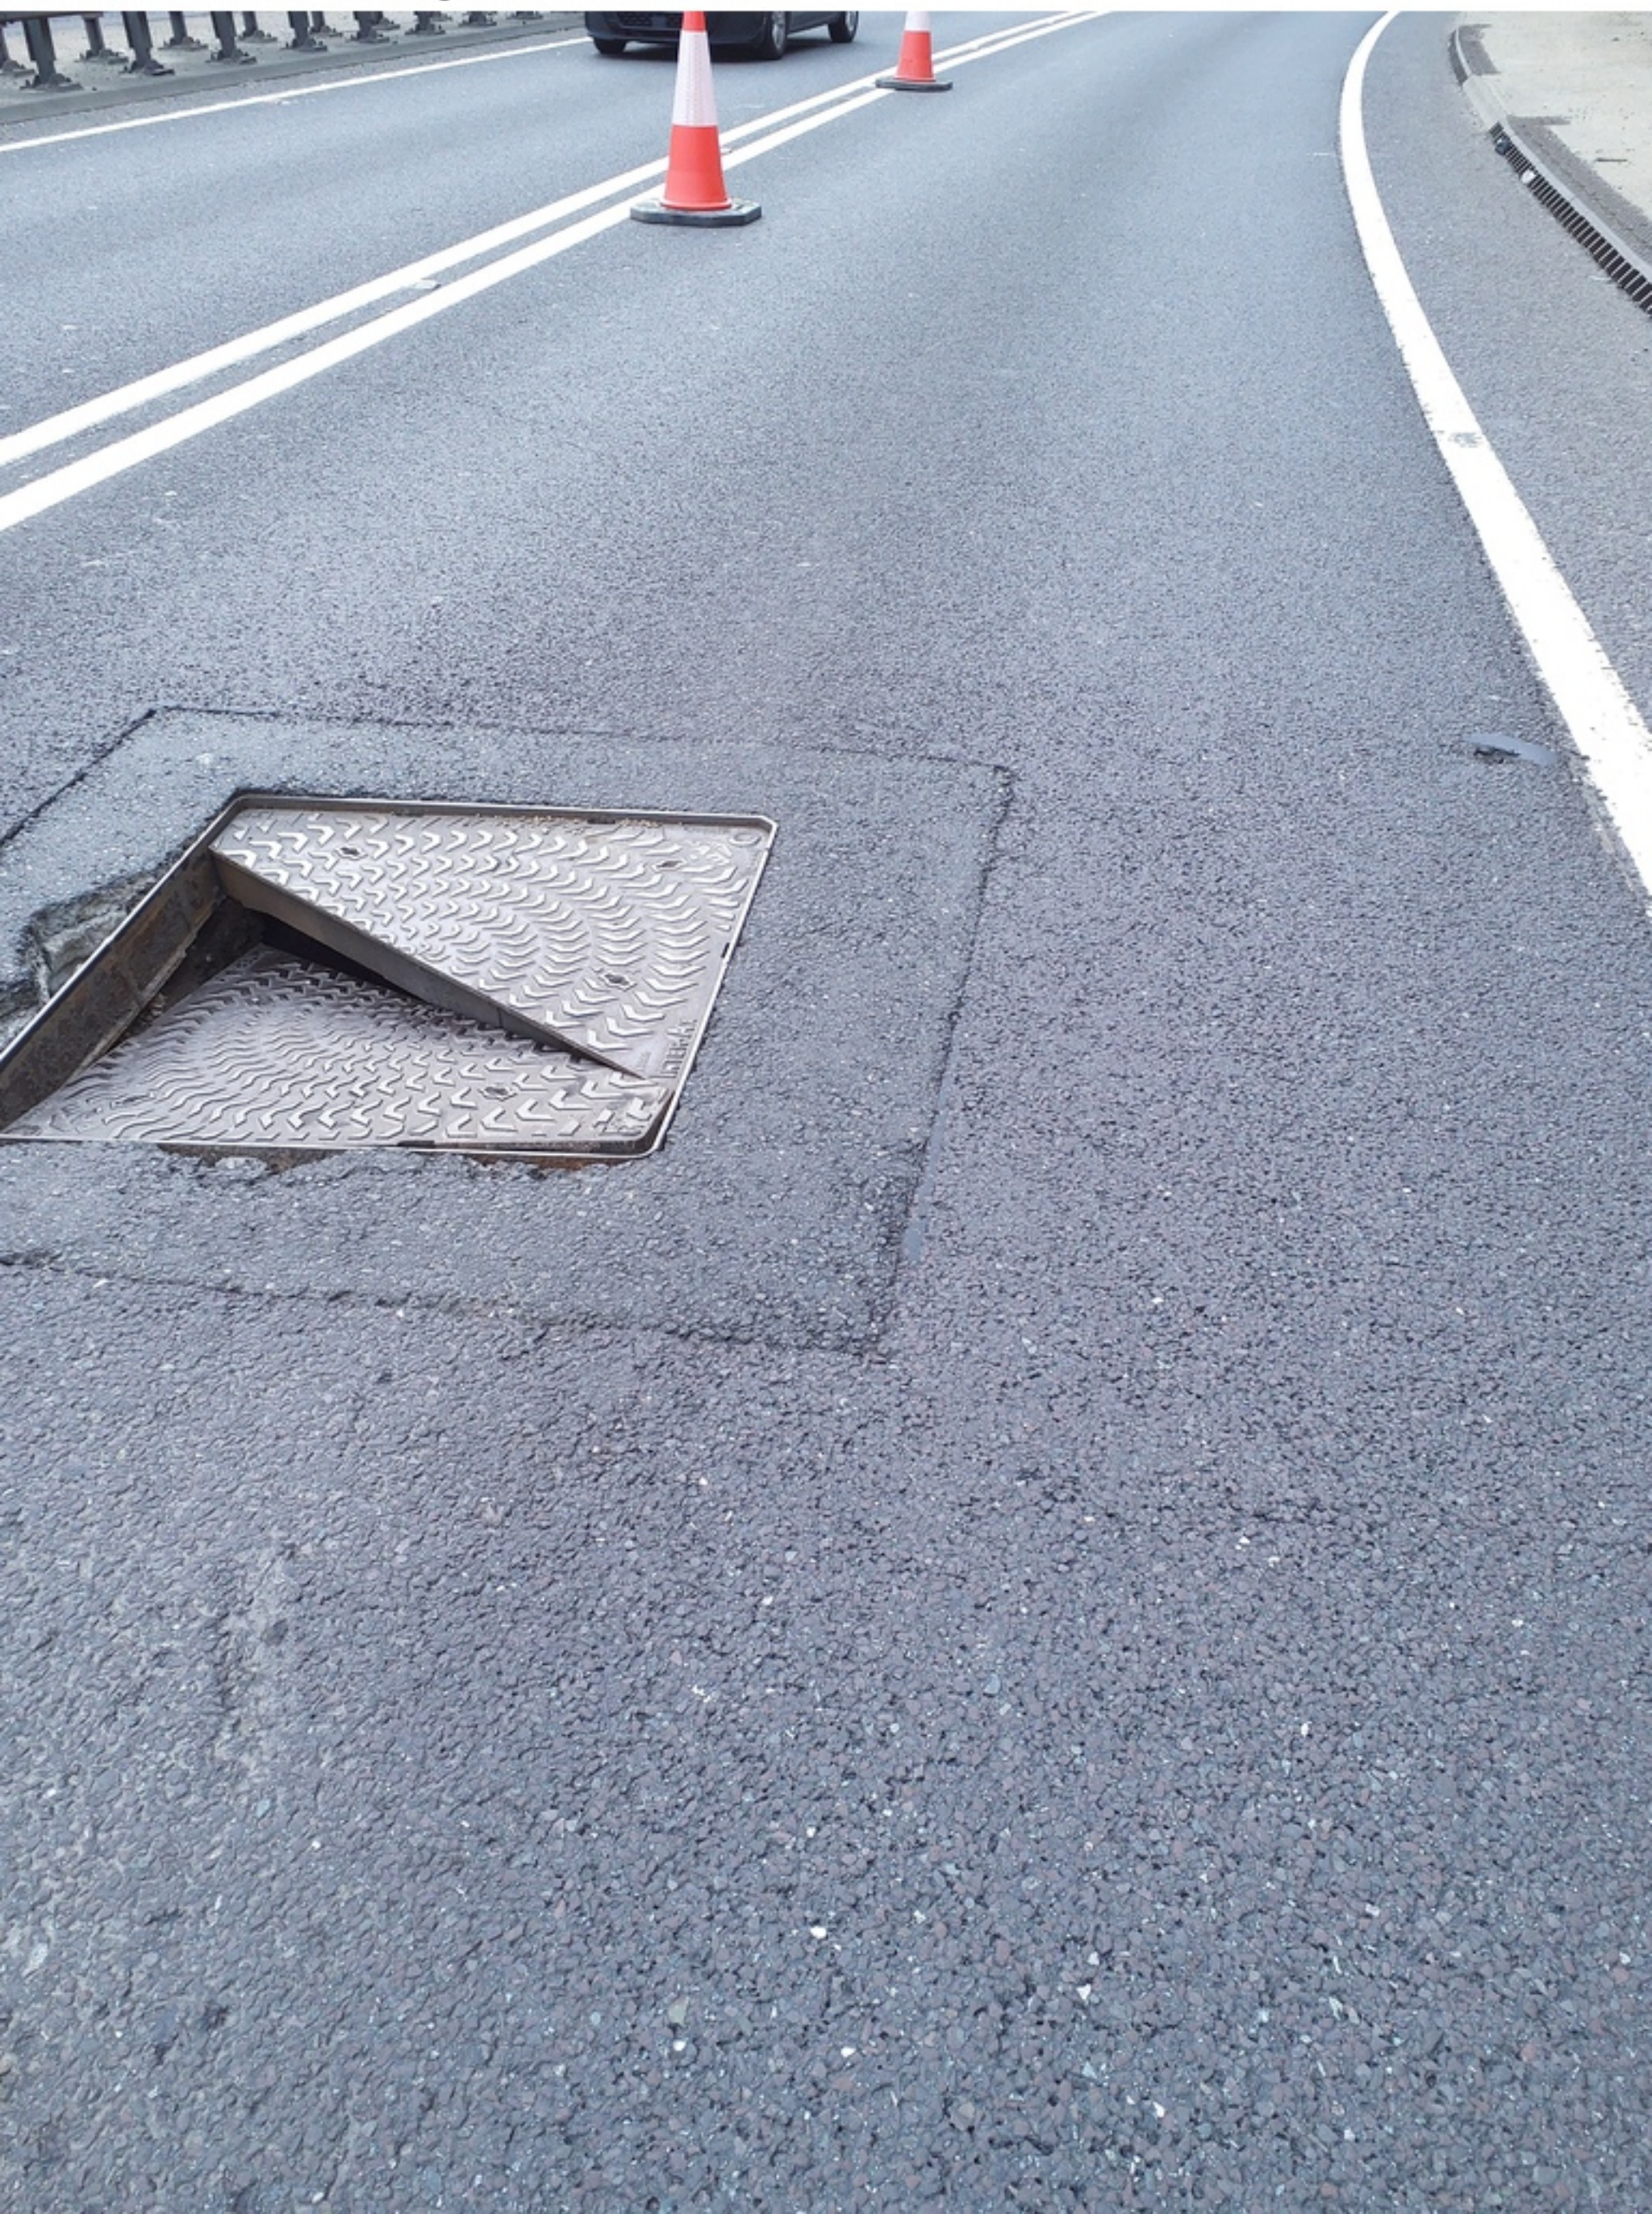
2024-03-09-161323.jpg

Type: Site Visit Photo - Interim Photo

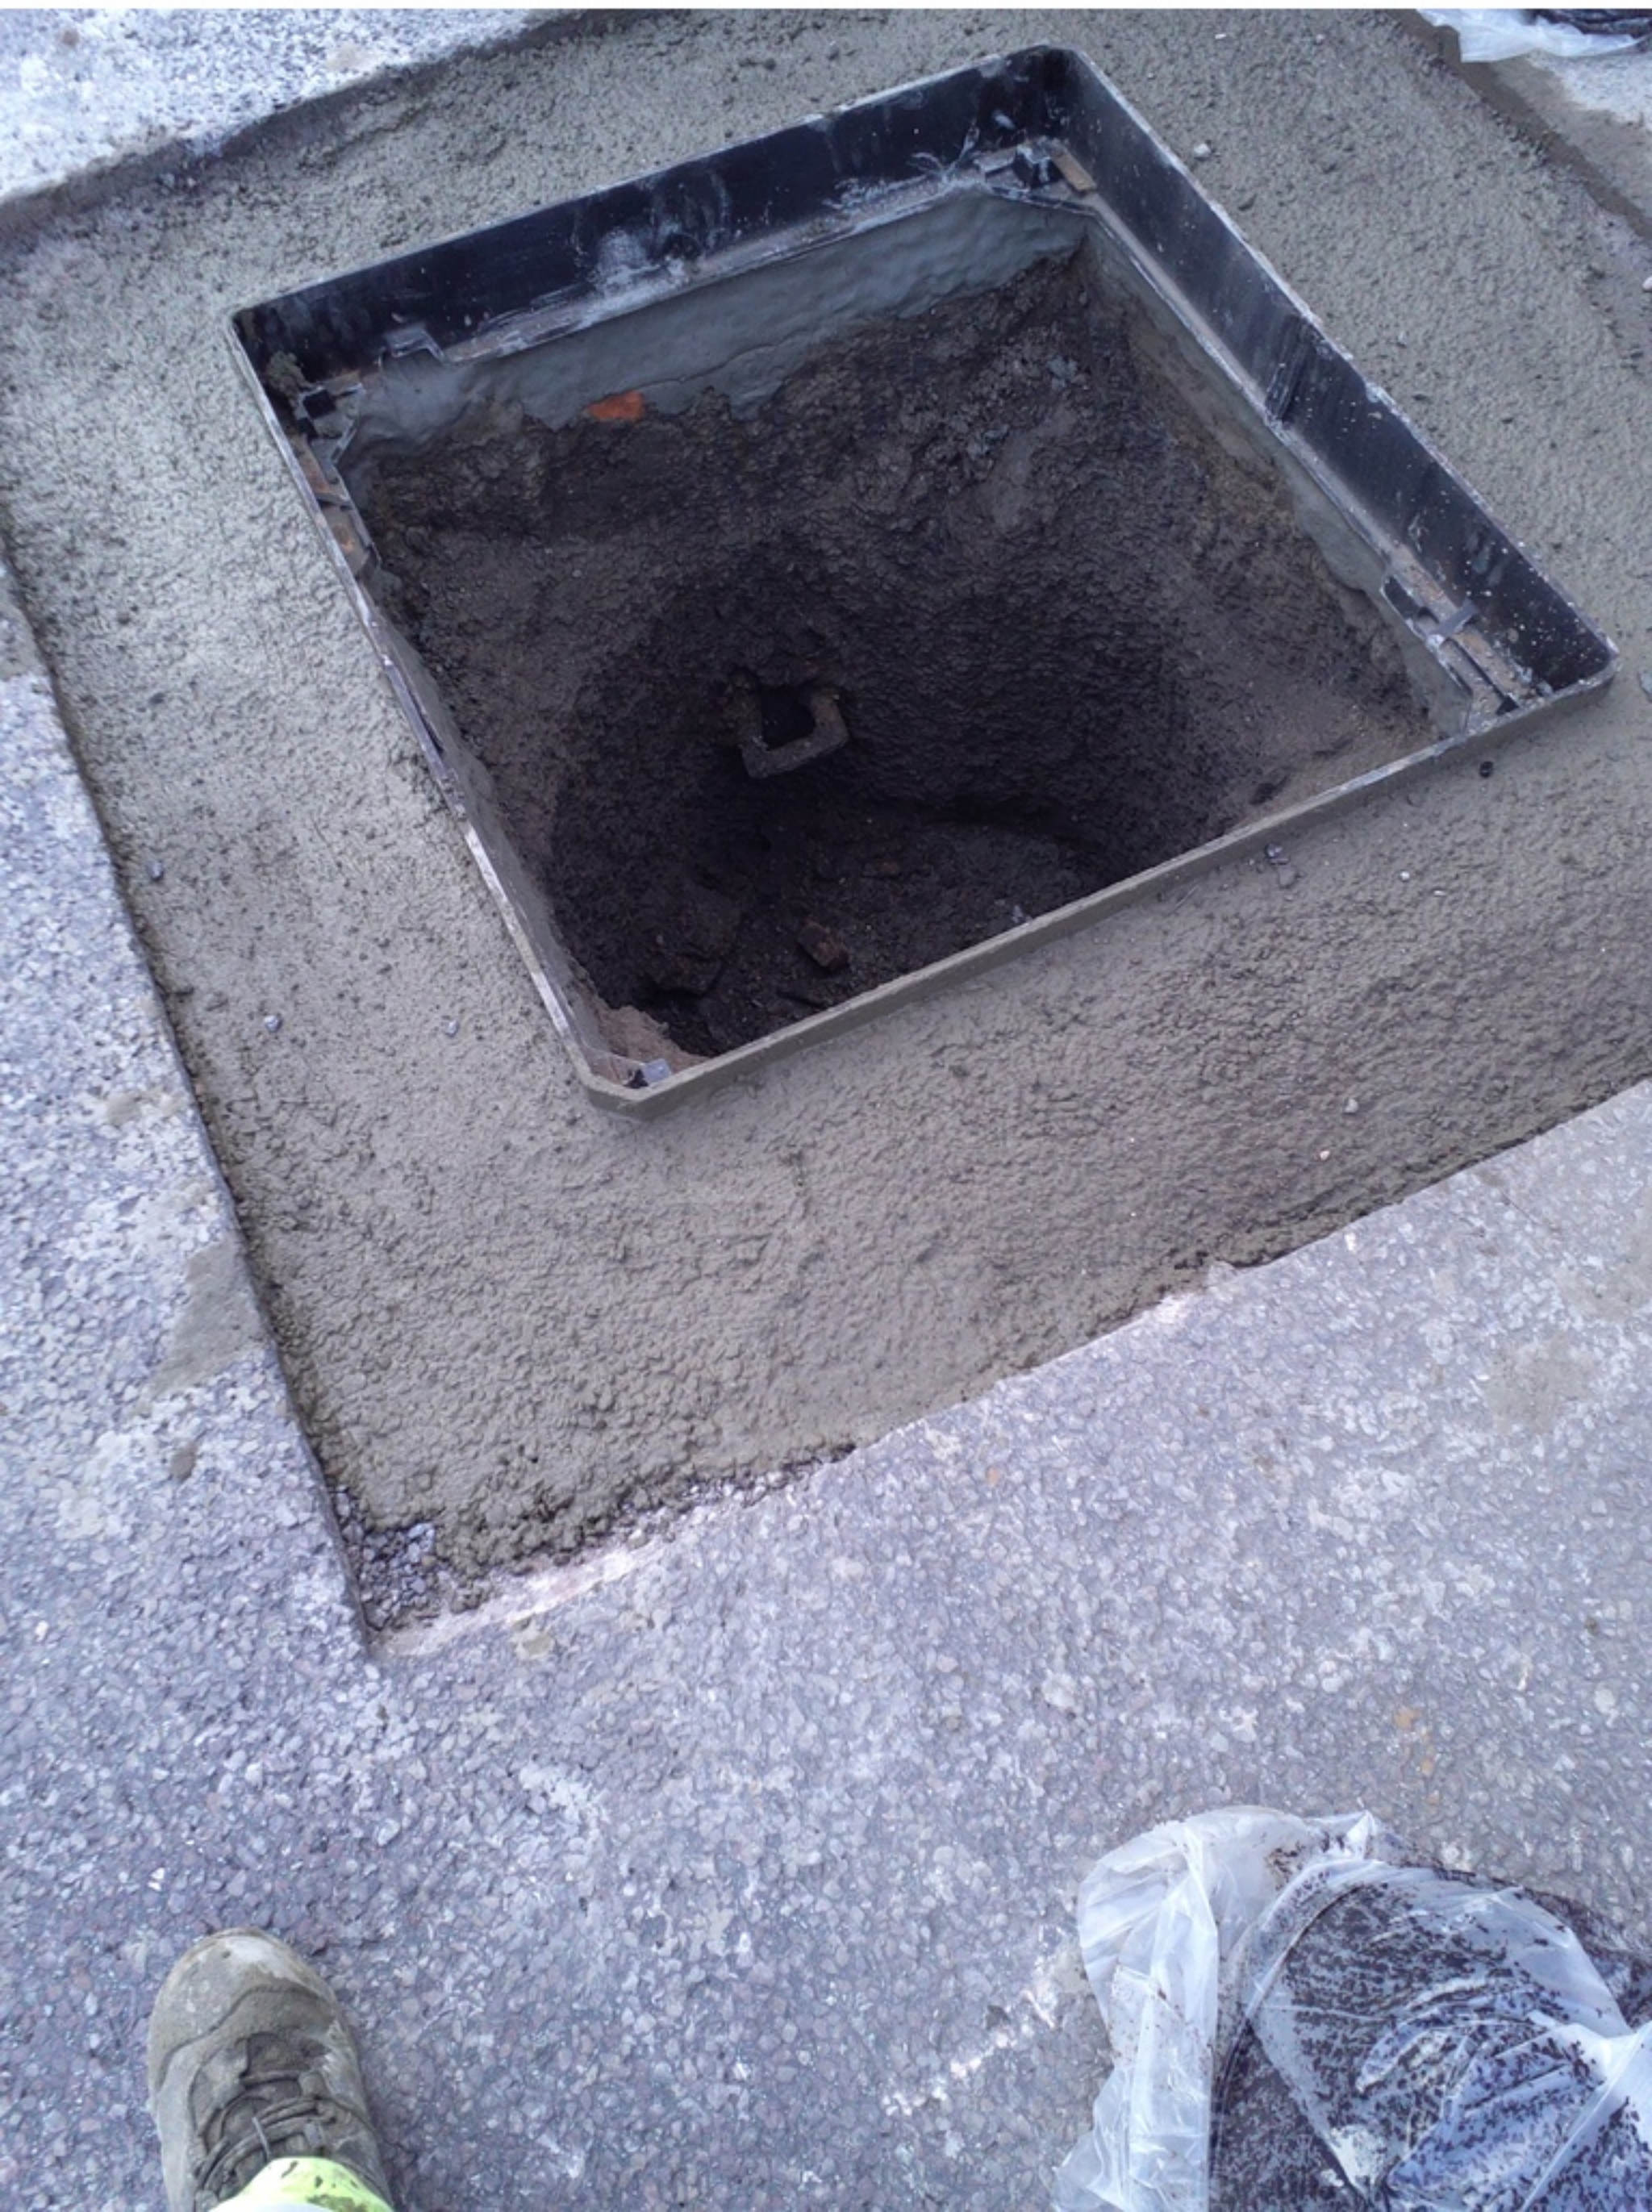
2024-03-09-172931.jpg

Type: Site Visit Photo - After Work Completed

Site Visit Status: Completed - First time permanent repair

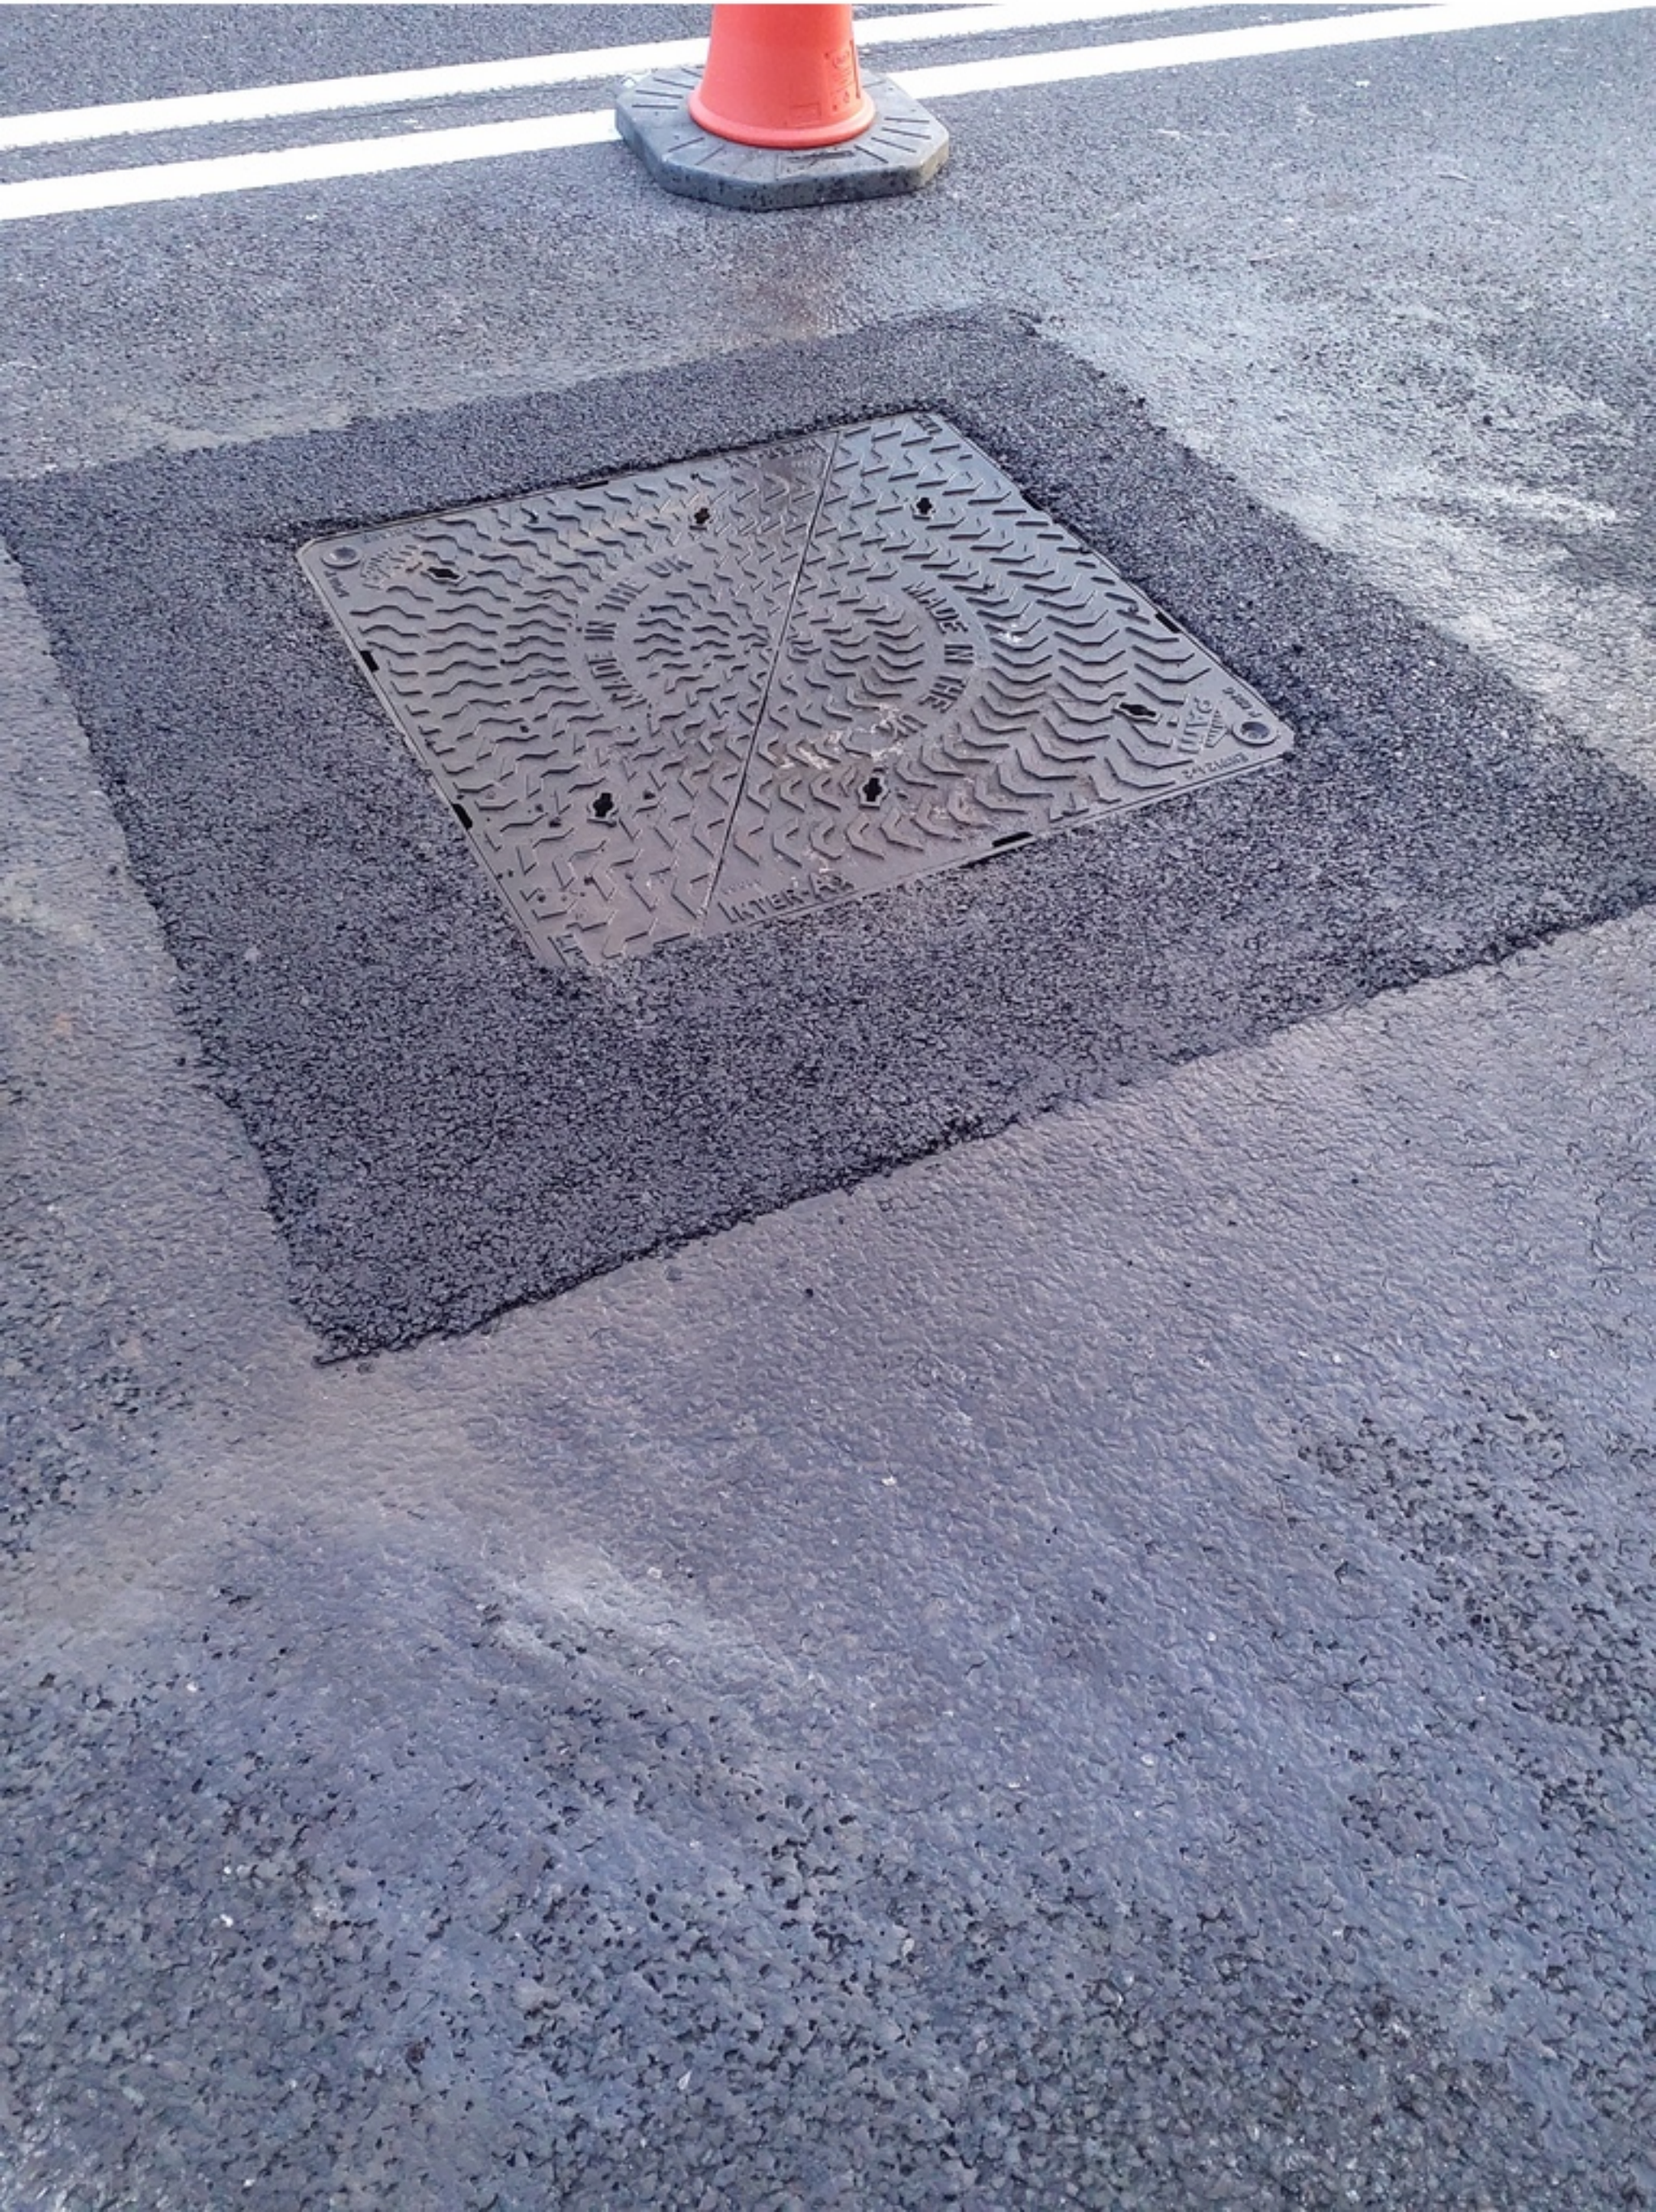
2024-03-09-174350.jpg

Type: Site Visit Photo - After Work Completed

Site Visit Status: Completed - First time permanent repair
