Report No. 4RS-JP-161057-R524751

**MANAGEMENT ASBESTOS SURVEY
BOND STREET UNDERGROUND STATION**

Issue Date: 3rd January 2017

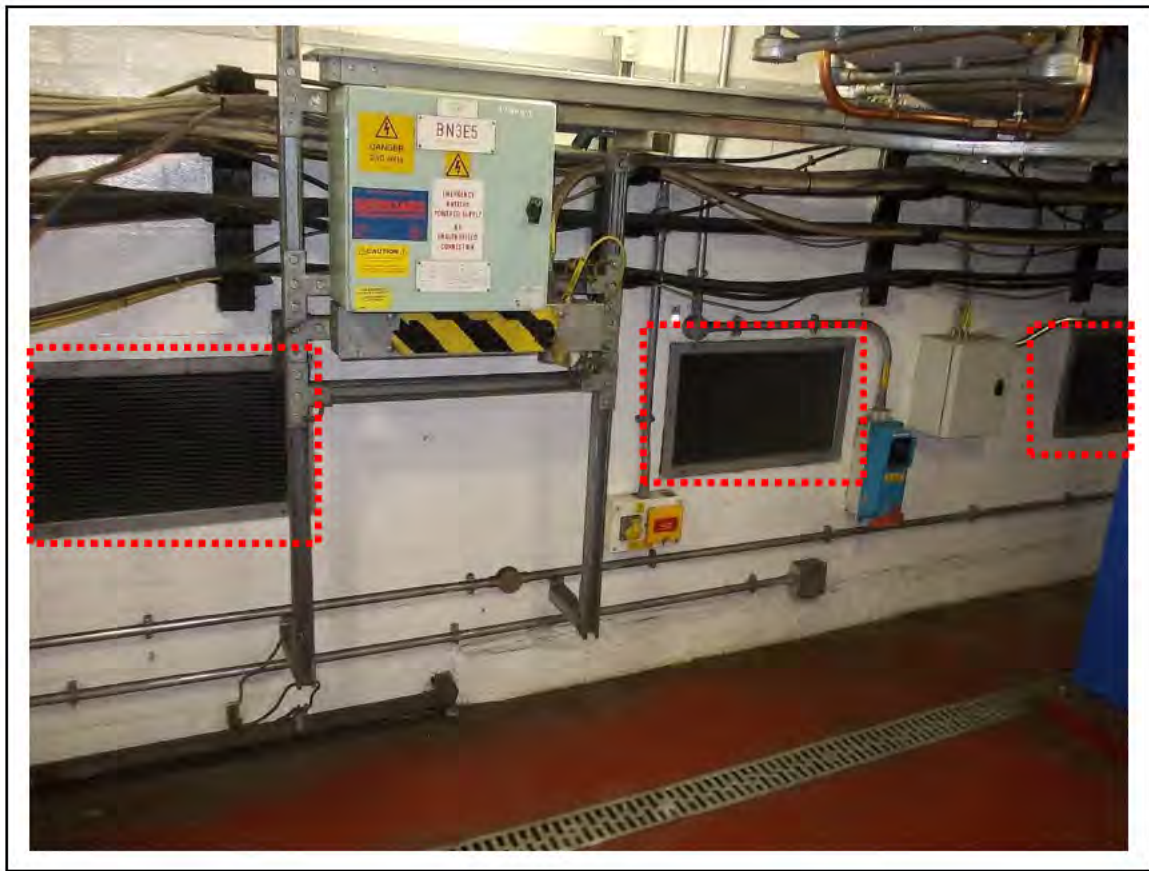
FIGURE 1: CONFIRMED ASBESTOS IN MASTIC IN UMC 1 & 2, 2/151 - DESCRIPTION & RESULT OF ASSESSMENT (SAMPLE REF. 110696/011111/01)

Sample Number	110696/011111/01
Location	UMC 1 & 2, 2/151
Material Description	Mastic
Material Comment	To ventilation ductwork (previously sampled)
Quantity	Throughout to each grill present
Product Type	Composite
Current Condition	Slight damage
Surface Treatment	Composite
Asbestos Type	Chrysotile
Material Assessment Rating	Very low
Accessibility	Low
Further Comment	Not applicable

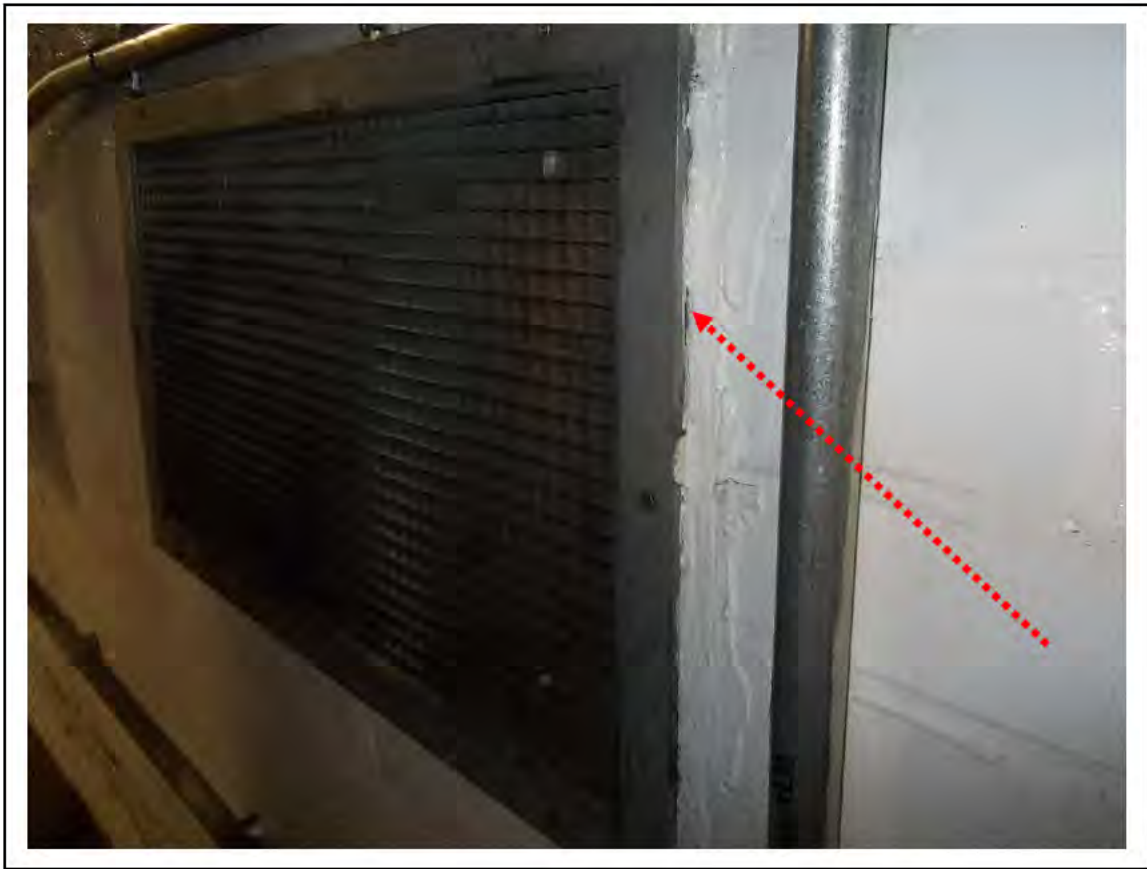
Sample Number	110696/011111/02
Location	UMC 1 & 2, 2/151
Material Description	Mastic
Material Comment	To ventilation ductwork (previously sampled)
Quantity	Throughout to each grill present
Product Type	Composite
Current Condition	Slight damage
Surface Treatment	Composite
Asbestos Type	Chrysotile
Material Assessment Rating	Very low
Accessibility	Low
Further Comment	Not applicable

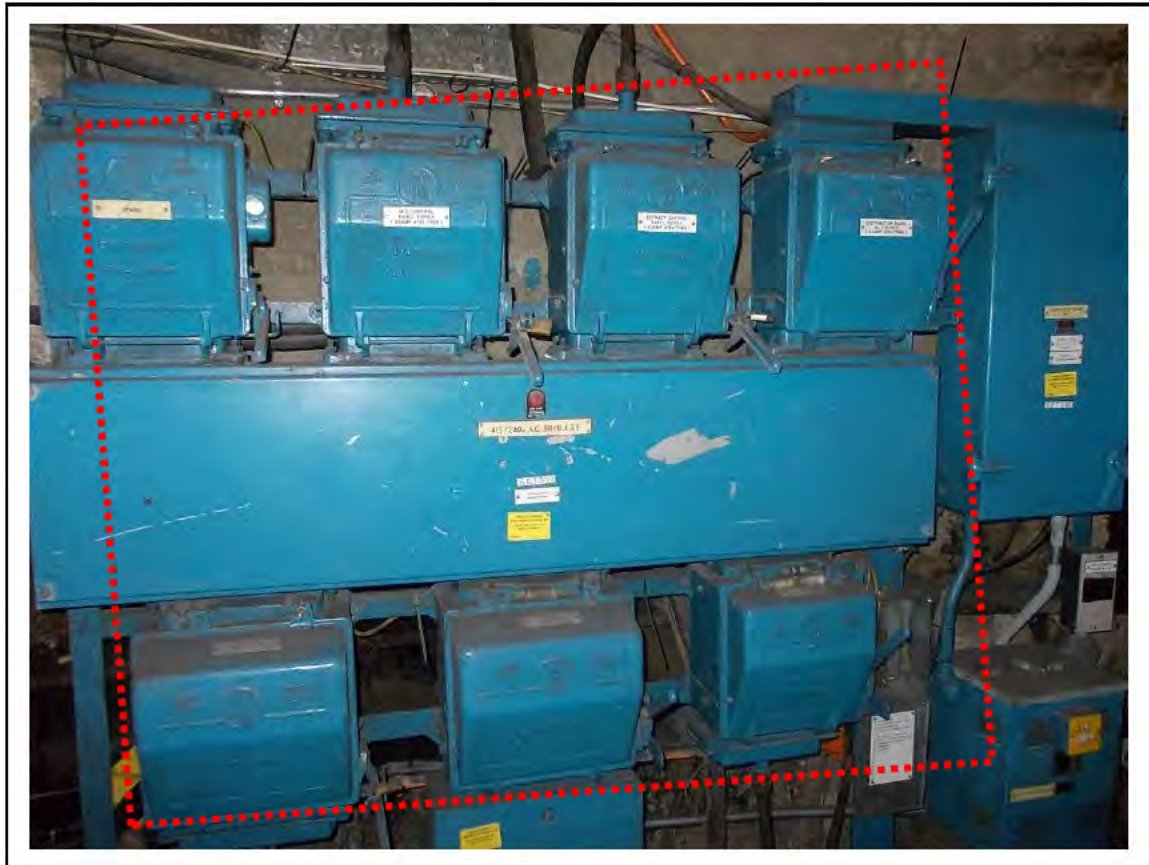
Sample Number	SP1 (1)
Location	Worksite (Fan Room), 2/776
Material Description	Materials within combination of fuse switches and busbar
Material Comment	To wall at intermediate level
Quantity	7 no
Product Type	-
Current Condition	-
Surface Treatment	-
Asbestos Type	Strongly Presumed Chrysotile
Material Assessment Rating	-
Accessibility	-
Further Comment	Not applicable

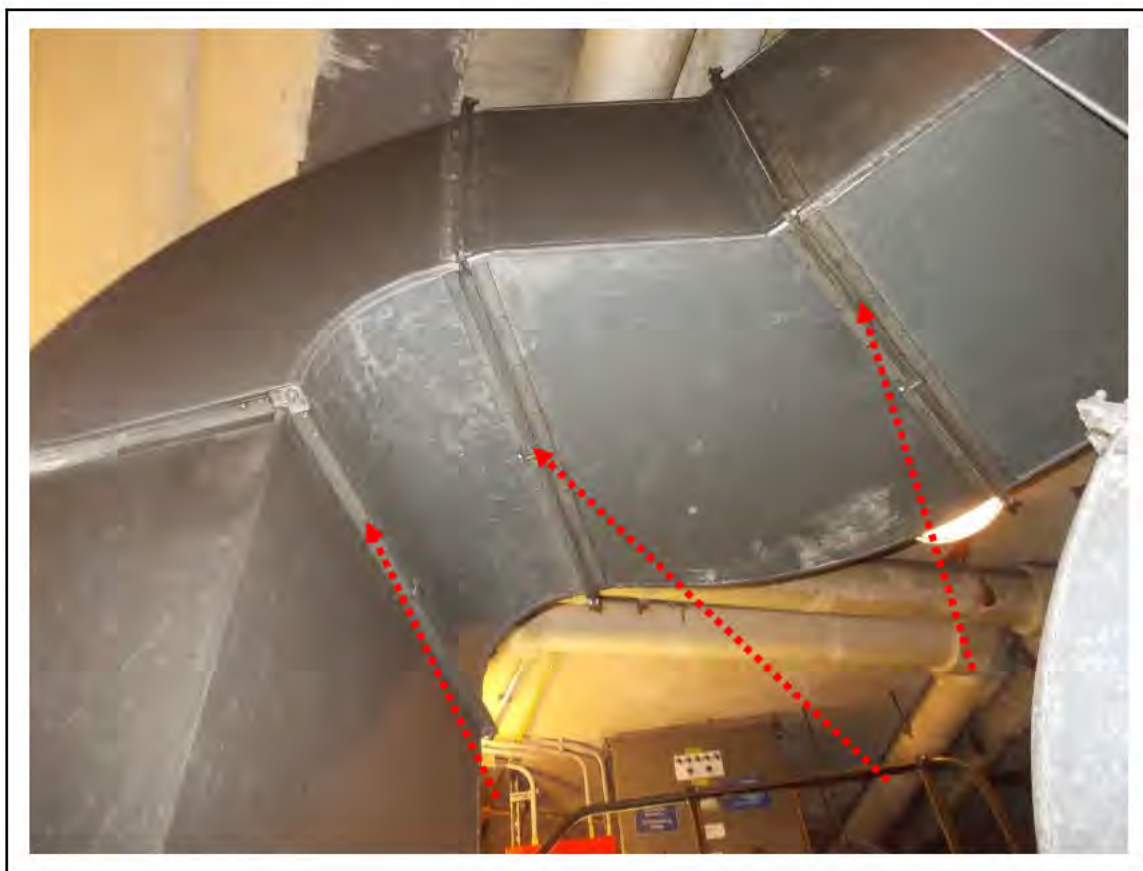
Sample Number	014003/10
Location	Worksite (Fan Room), 2/776
Material Description	Rope seal
Material Comment	On vent duct joints to old A/C ducts (previously sampled)
Quantity	unknown/partial (not fully accessible)
Product Type	Medium density
Current Condition	Slight damage
Surface Treatment	Unencapsulated medium density
Asbestos Type	Chrysotile
Material Assessment Rating	Low
Accessibility	Low
Further Comment	Not applicable

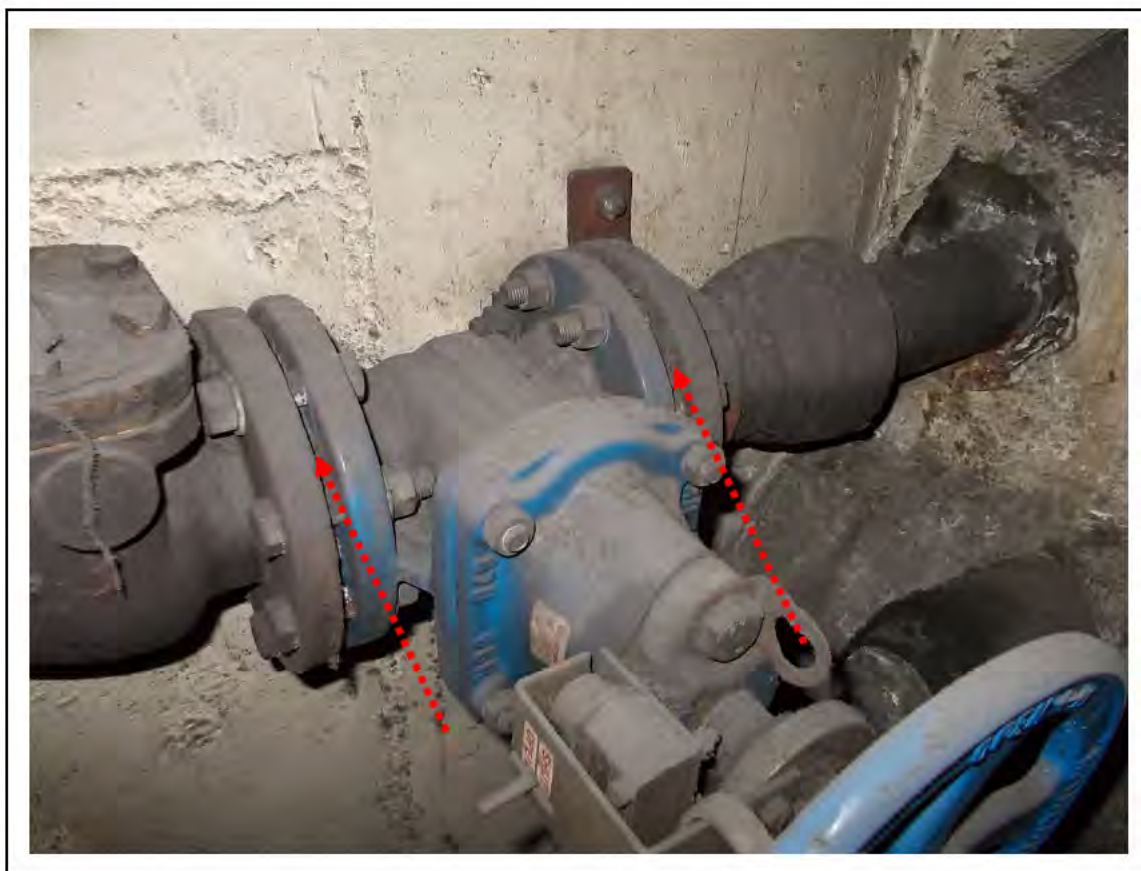
Sample Number	161057/280616/02
Location	UMC 6,7,8, 2/152
Material Description	Gaskets
Material Comment	To pipework in lobby area to wall 2
Quantity	2 no
Product Type	Medium density
Current Condition	Slight damage
Surface Treatment	Unencapsulated medium density
Asbestos Type	Chrysotile
Material Assessment Rating	Low
Accessibility	Low
Further Comment	Not applicable

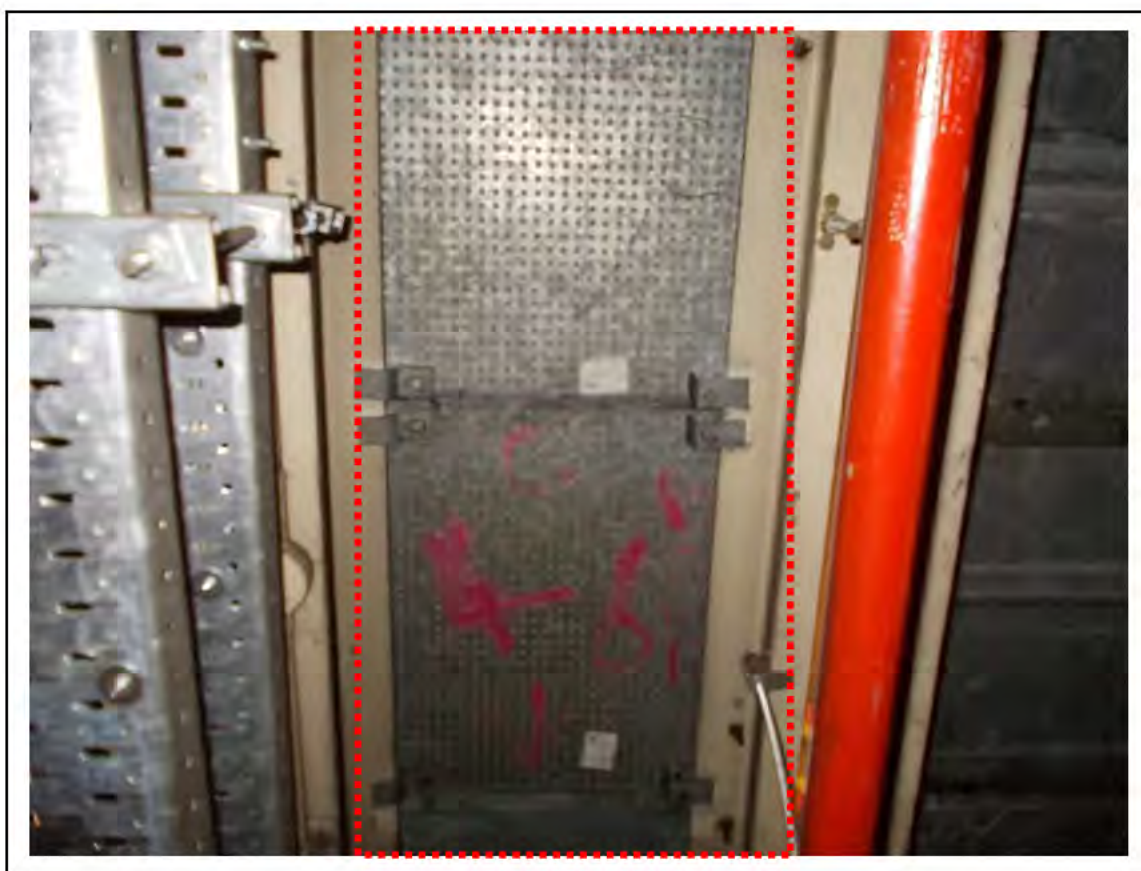
Sample Number	100675/241110/04
Location	UMC 6,7,8, 2/152
Material Description	Durasteel panels
Material Comment	To ceiling above escalator motors
Quantity	10m ²
Product Type	Medium density
Current Condition	Good condition
Surface Treatment	Unencapsulated medium density
Asbestos Type	Amosite & Chrysotile
Material Assessment Rating	Low
Accessibility	Low
Further Comment	Not applicable

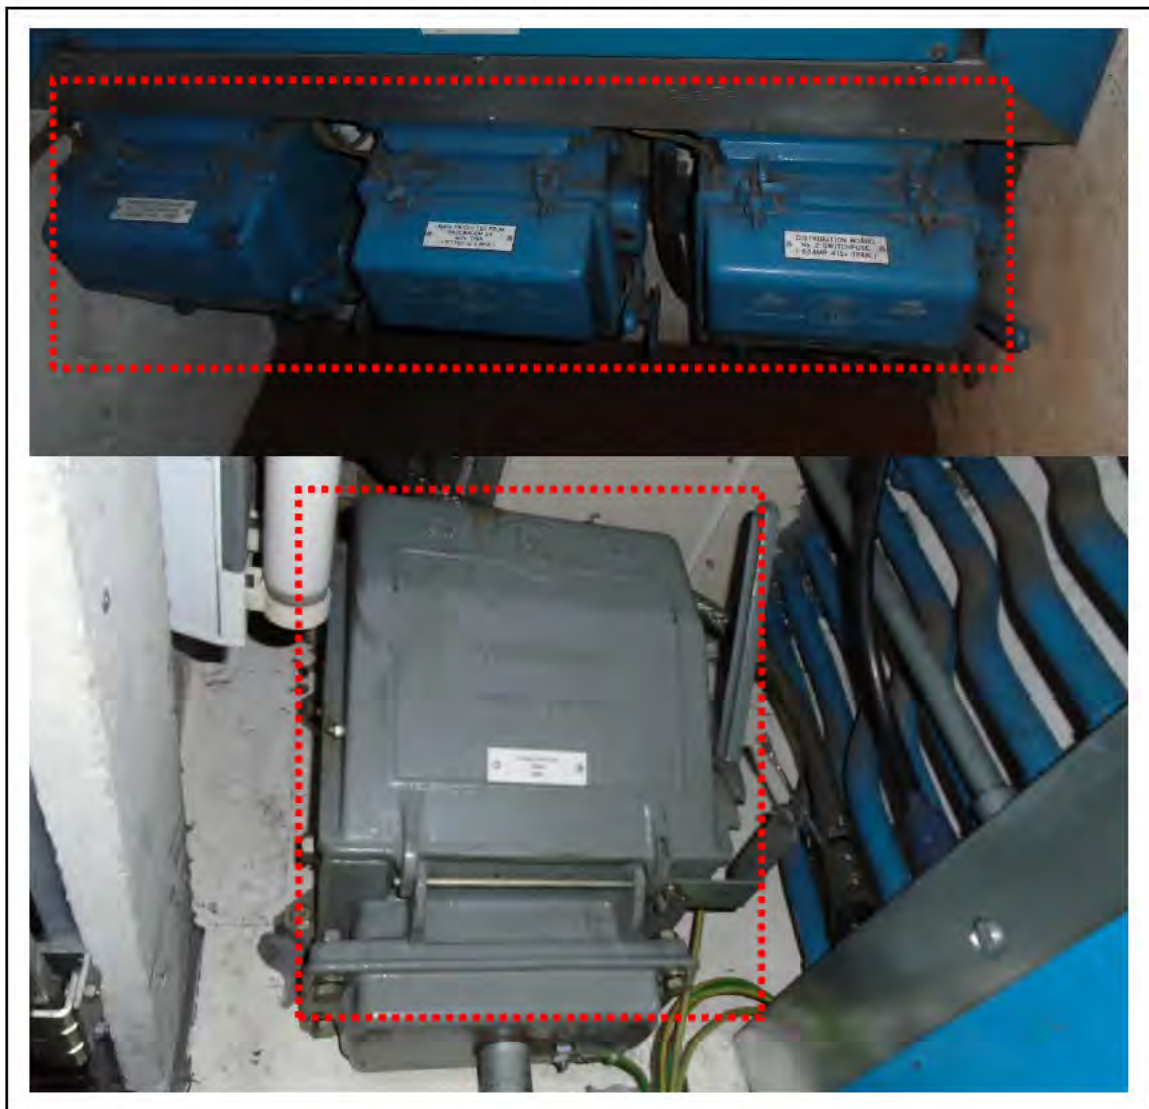
Sample Number	SP1 (3)
Location	Switchroom E3, 2/663
Material Description	Combination fuse switches
Material Comment	Materials within
Quantity	4 no
Product Type	-
Current Condition	-
Surface Treatment	-
Asbestos Type	Strongly Presumed Chrysotile
Material Assessment Rating	-
Accessibility	-
Further Comment	Not applicable

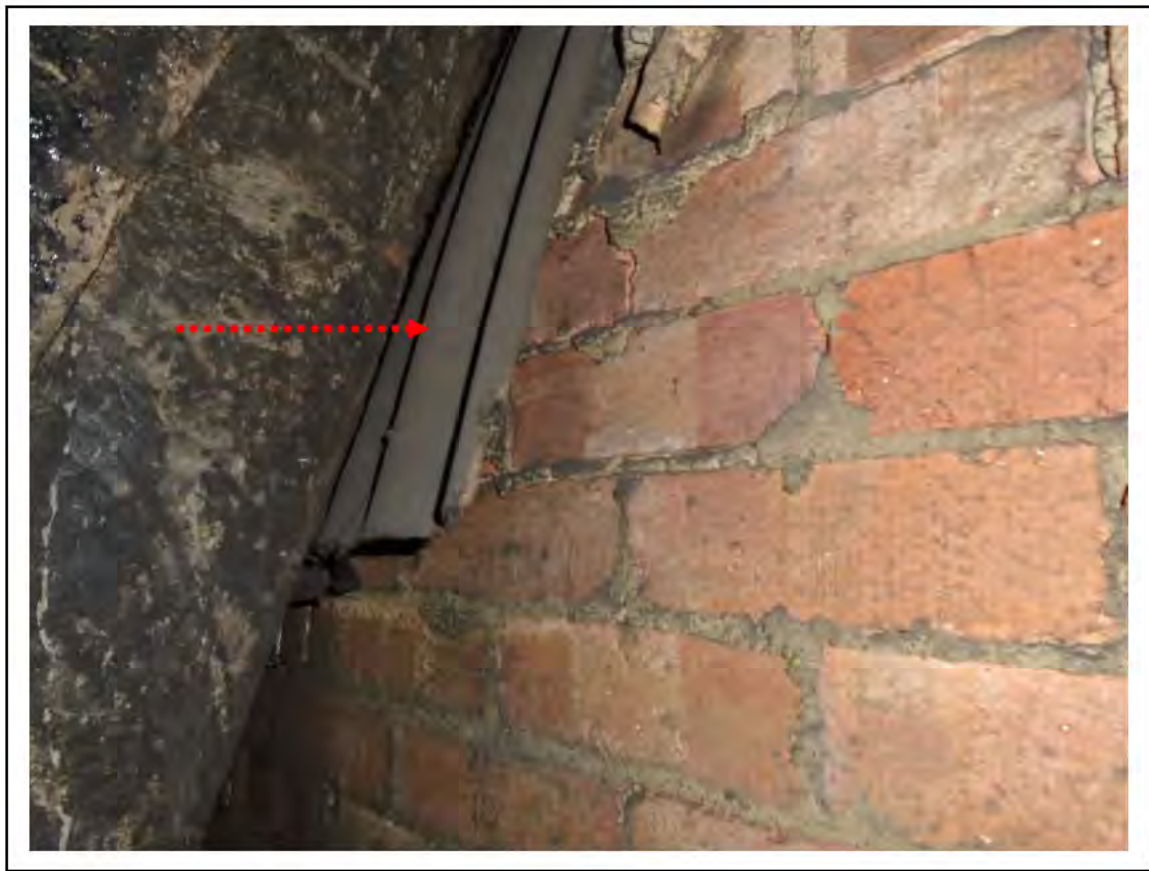
Sample Number	161057/220816/01
Location	UMC 3,4,5 Lobby to Chamber, 4/161
Material Description	Cellactite sheeting
Material Comment	To cavity wall by entrance door
Quantity	<1m ²
Product Type	Composite
Current Condition	Slight damage
Surface Treatment	Composite
Asbestos Type	Chrysotile
Material Assessment Rating	Very low
Accessibility	Low
Further Comment	Not applicable

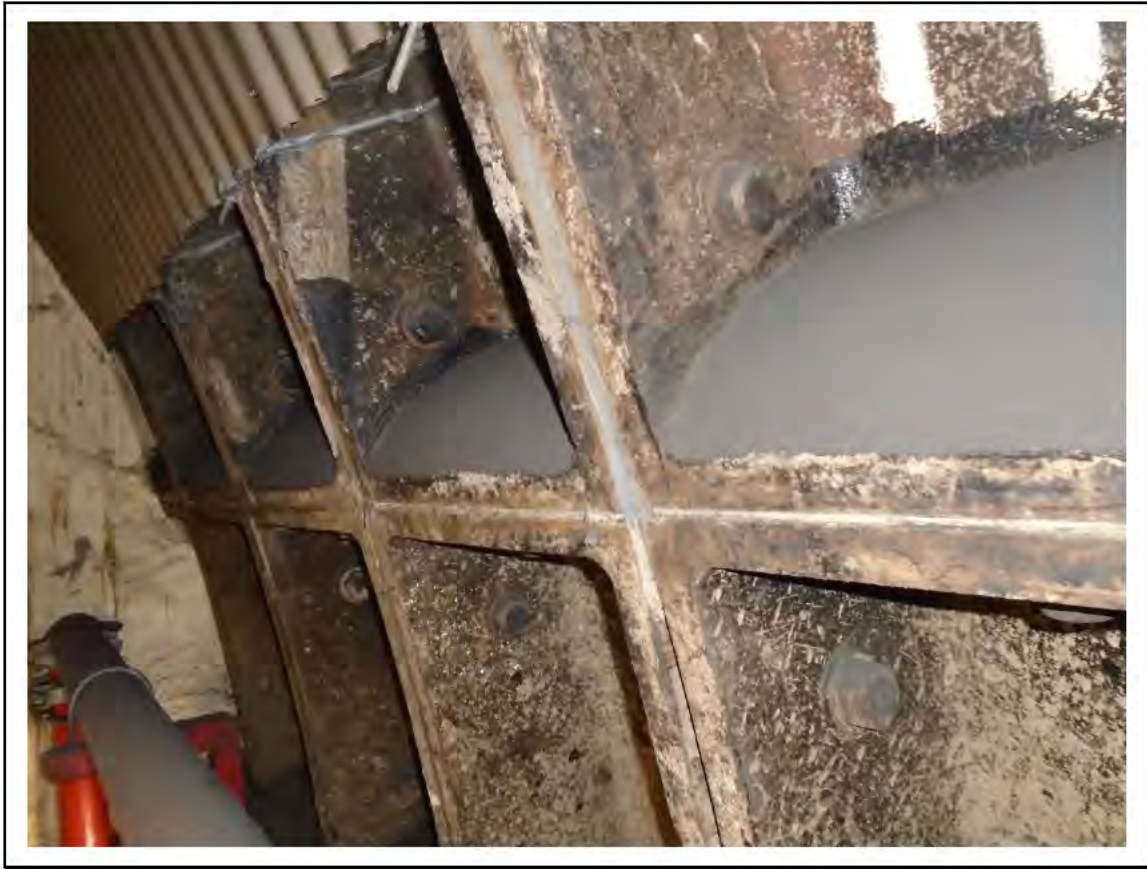
Sample Number	100558/121010/8
Location	UMC 3,4,5 Lobby to Chamber, 4/161
Material Description	Tunnel ring caulking
Material Comment	Partial encapsulation with mastic to joints/ flanges (previously sampled) to wall
Quantity	Throughout to all tunnel rings
Product Type	Highly friable
Current Condition	Slight damage
Surface Treatment	Untreated highly friable
Asbestos Type	Amosite & Chrysotile
Material Assessment Rating	Medium
Accessibility	Medium
Further Comment	Not applicable

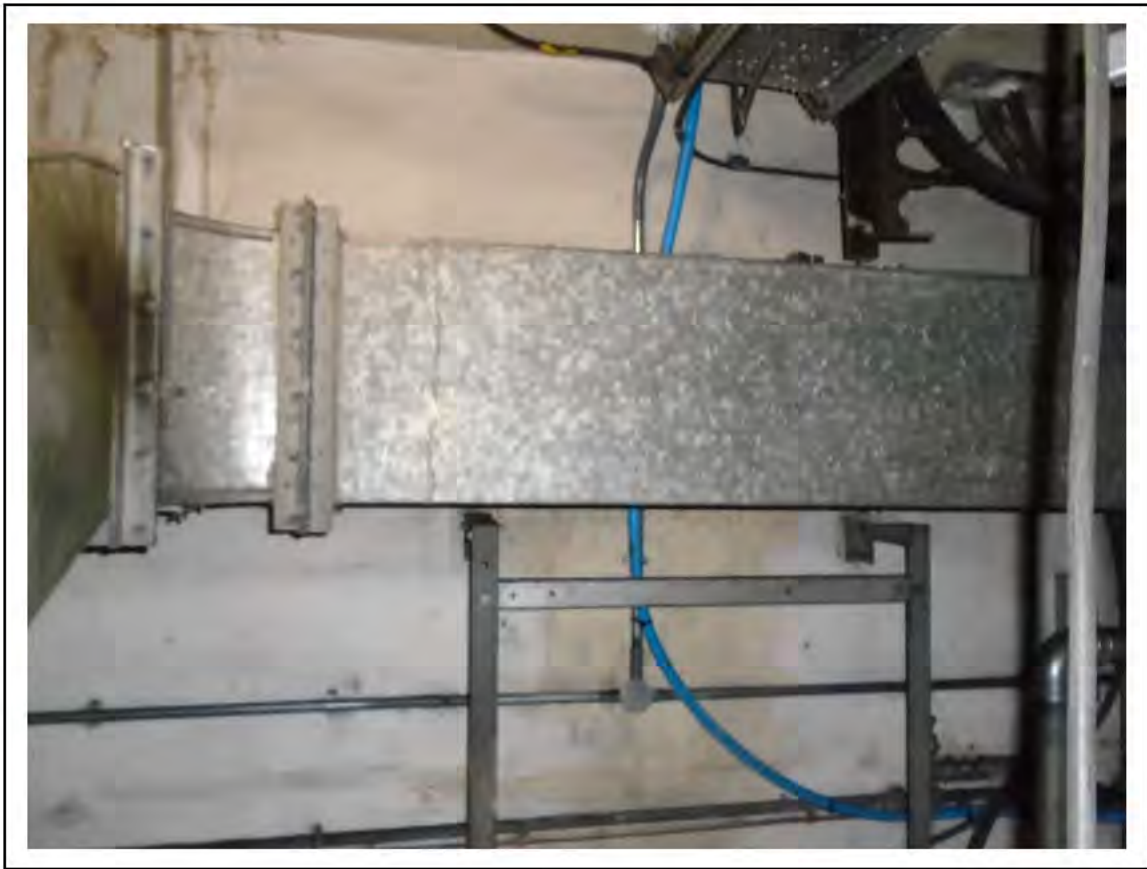
Sample Number	100558/121010/14
Location	UMC 3,4,5, 4/161
Material Description	Gaskets
Material Comment	To large ducting, previously sampled
Quantity	Throughout to all ducting joints
Product Type	Medium density
Current Condition	Good condition
Surface Treatment	Encapsulated medium density
Asbestos Type	Chrysotile
Material Assessment Rating	Very low
Accessibility	Low
Further Comment	Not applicable

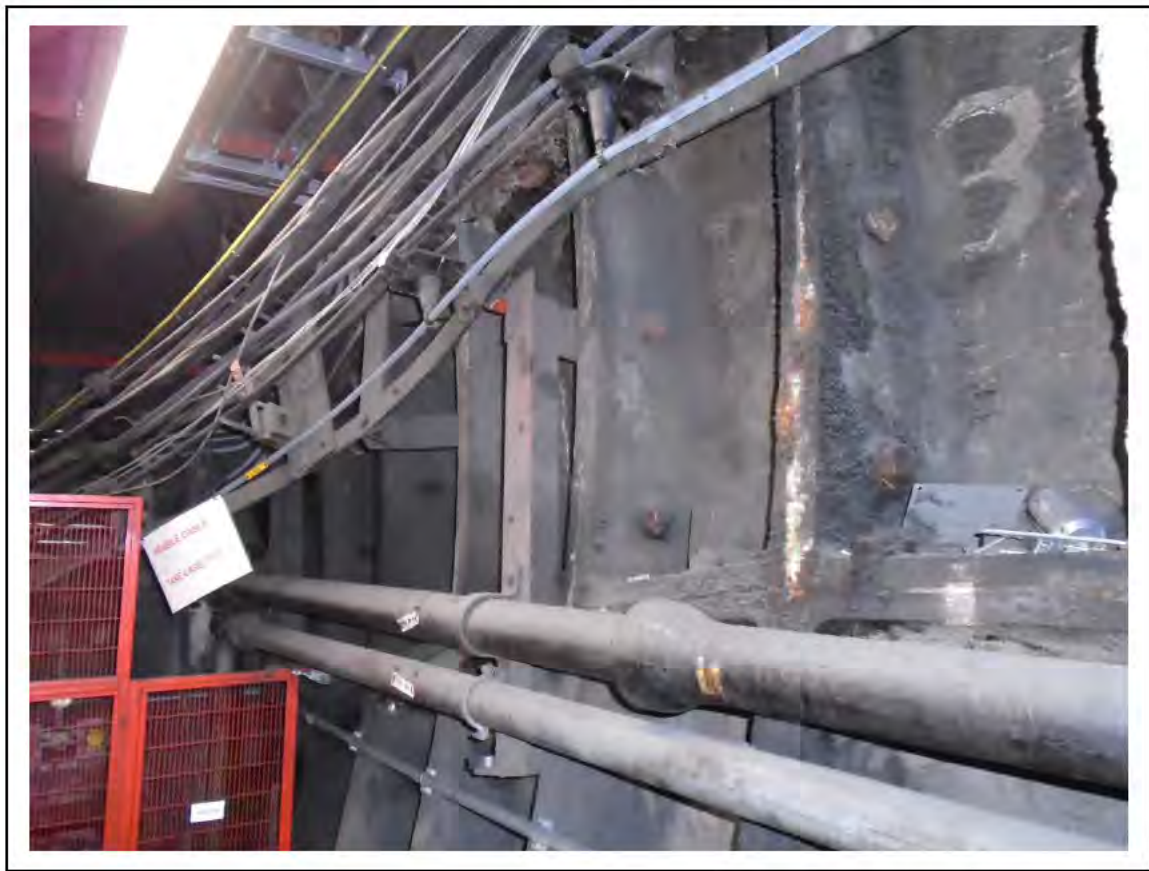
Sample Number	100558/121010/16
Location	UMC 3,4,5, 4/161
Material Description	Tunnel ring caulking
Material Comment	By escalator 3, to wall previously sampled
Quantity	Throughout to all tunnel ring flanges
Product Type	Highly friable
Current Condition	Slight damage
Surface Treatment	Untreated highly friable
Asbestos Type	Amosite & Chrysotile
Material Assessment Rating	Medium
Accessibility	Medium
Further Comment	Not applicable

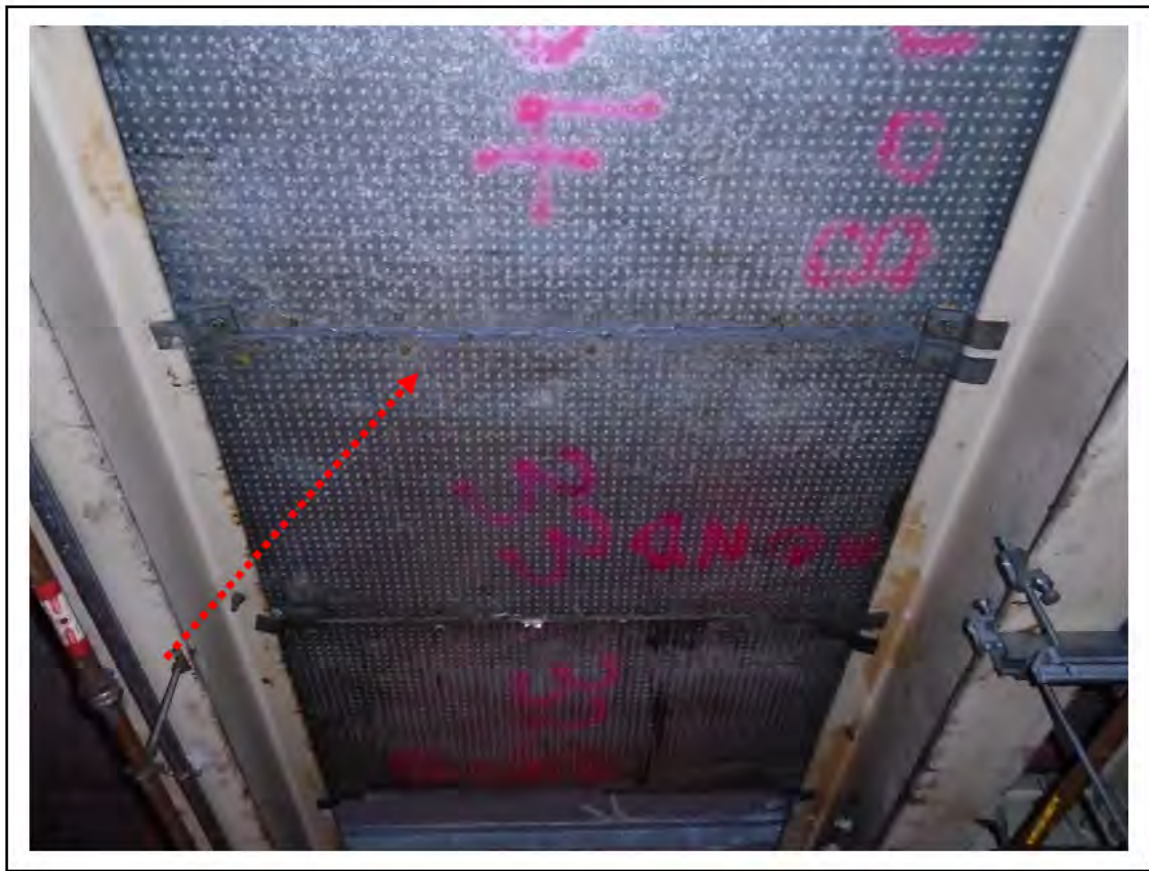
Sample Number	161057/220816/02
Location	UMC 3,4,5, 4/161
Material Description	Durasteel panels
Material Comment	Above escalators to ceiling
Quantity	~39 no x <1m ²
Product Type	Medium density
Current Condition	Slight damage
Surface Treatment	Encapsulated medium density
Asbestos Type	Amosite & Chrysotile
Material Assessment Rating	Low
Accessibility	Low
Further Comment	None

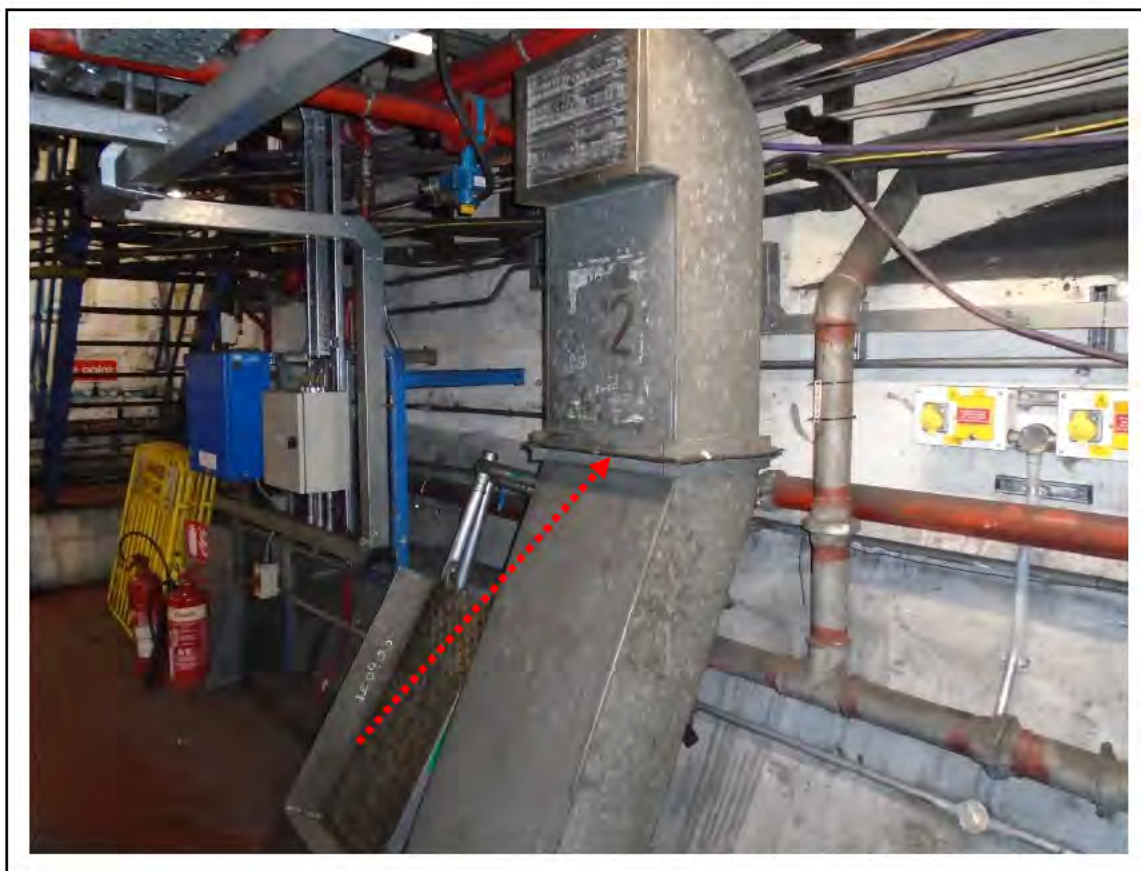
Sample Number	As 100558/121010/12
Location	UMC 3,4,5, 4/161
Material Description	Gaskets
Material Comment	To vent ducting to wall 1 and 3
Quantity	4 no throughout to joints
Product Type	Medium density
Current Condition	Good condition
Surface Treatment	Encapsulated medium density
Asbestos Type	Chrysotile
Material Assessment Rating	Very low
Accessibility	Low
Further Comment	Not applicable

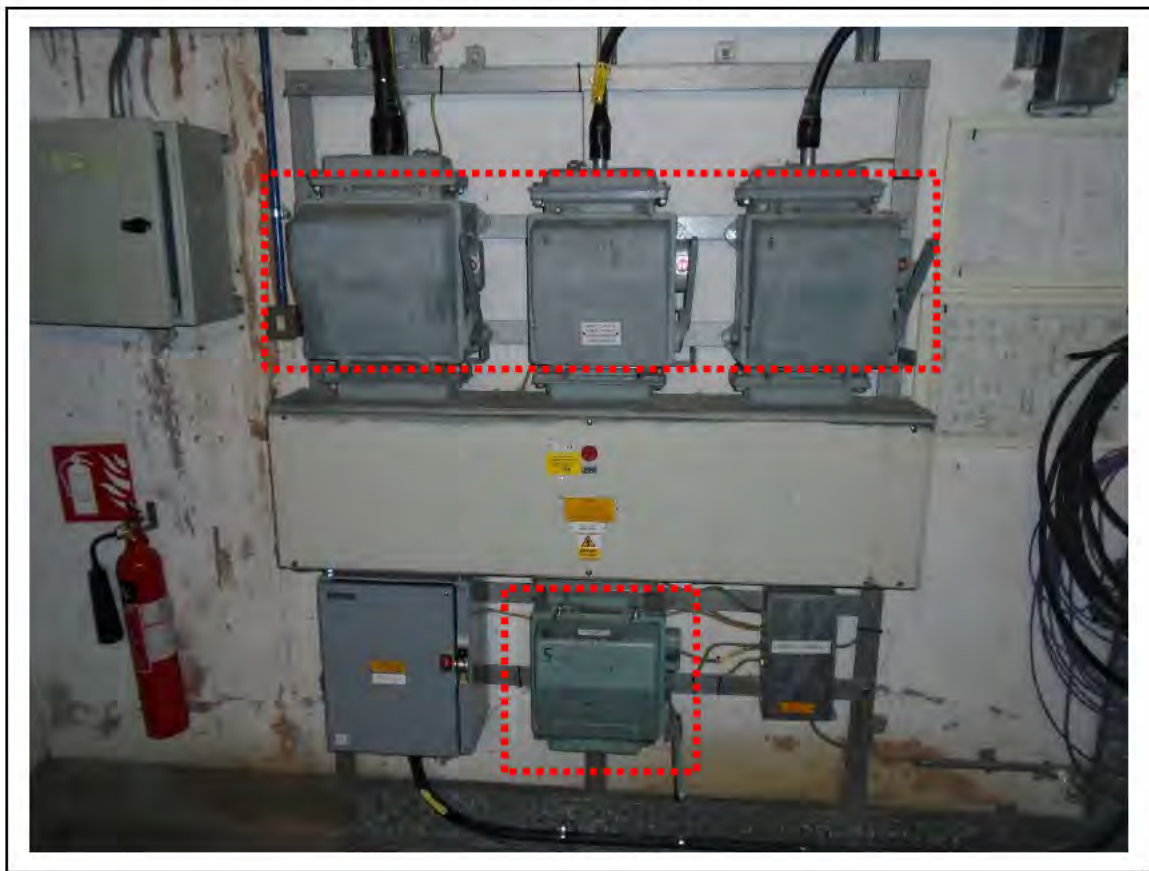
Sample Number	SP1 (4)
Location	Switchroom E4, 2/664
Material Description	Combination fuse switches
Material Comment	To wall 1, no isolation for inspection within
Quantity	4 no
Product Type	-
Current Condition	-
Surface Treatment	-
Asbestos Type	Strongly Presumed Chrysotile
Material Assessment Rating	-
Accessibility	-
Further Comment	Not applicable

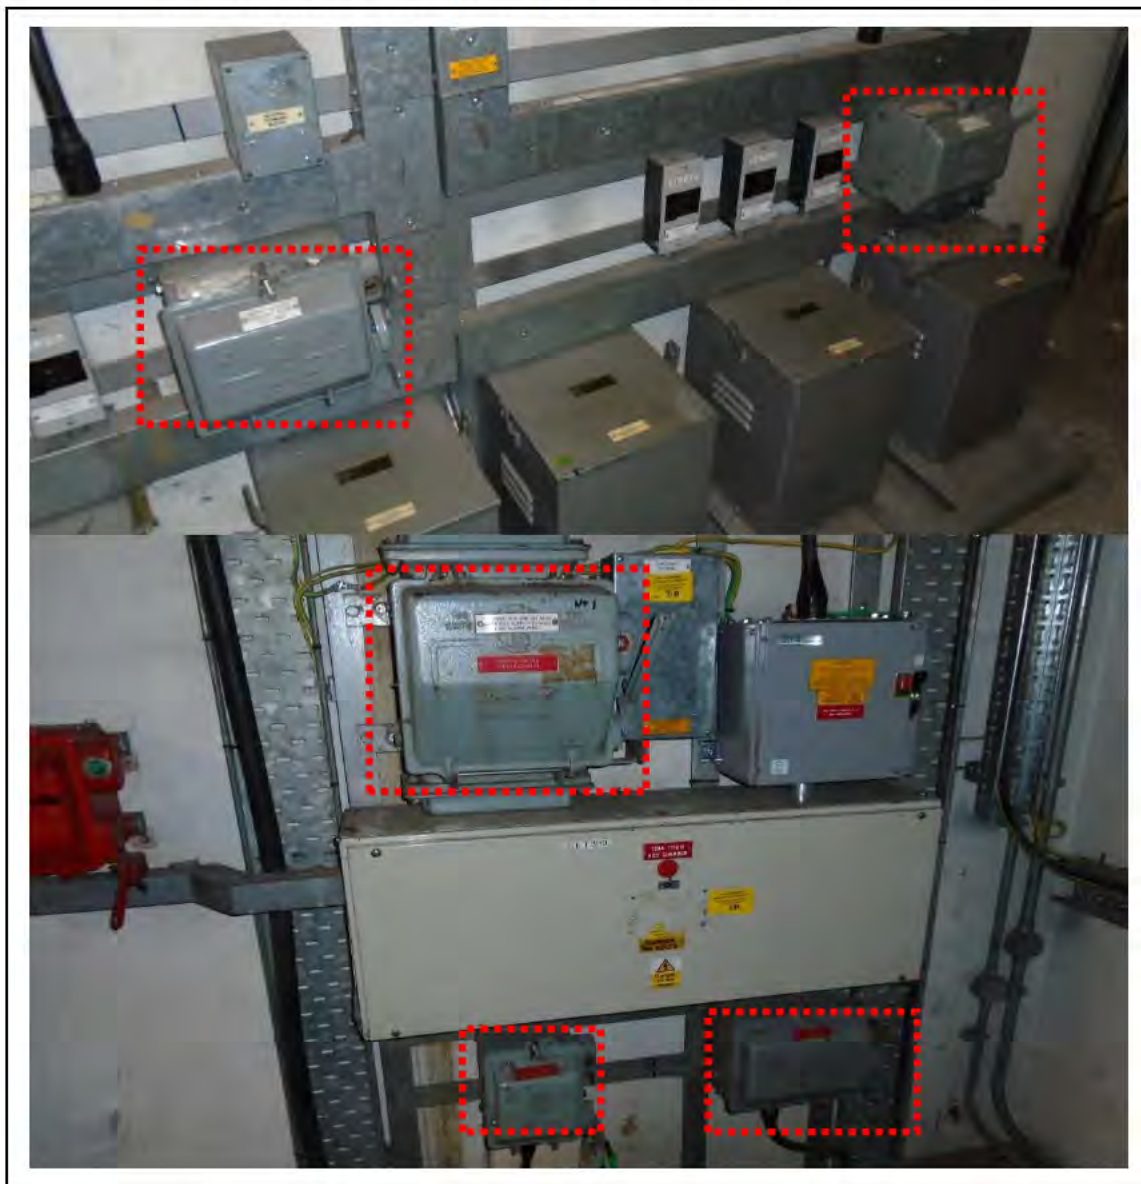
Sample Number	SP1 (5)
Location	Switchroom E4, 2/664
Material Description	Combination fuse switches
Material Comment	To wall 2, no isolation for inspection within
Quantity	5 no
Product Type	-
Current Condition	-
Surface Treatment	-
Asbestos Type	Strongly Presumed Chrysotile
Material Assessment Rating	-
Accessibility	-
Further Comment	Not applicable

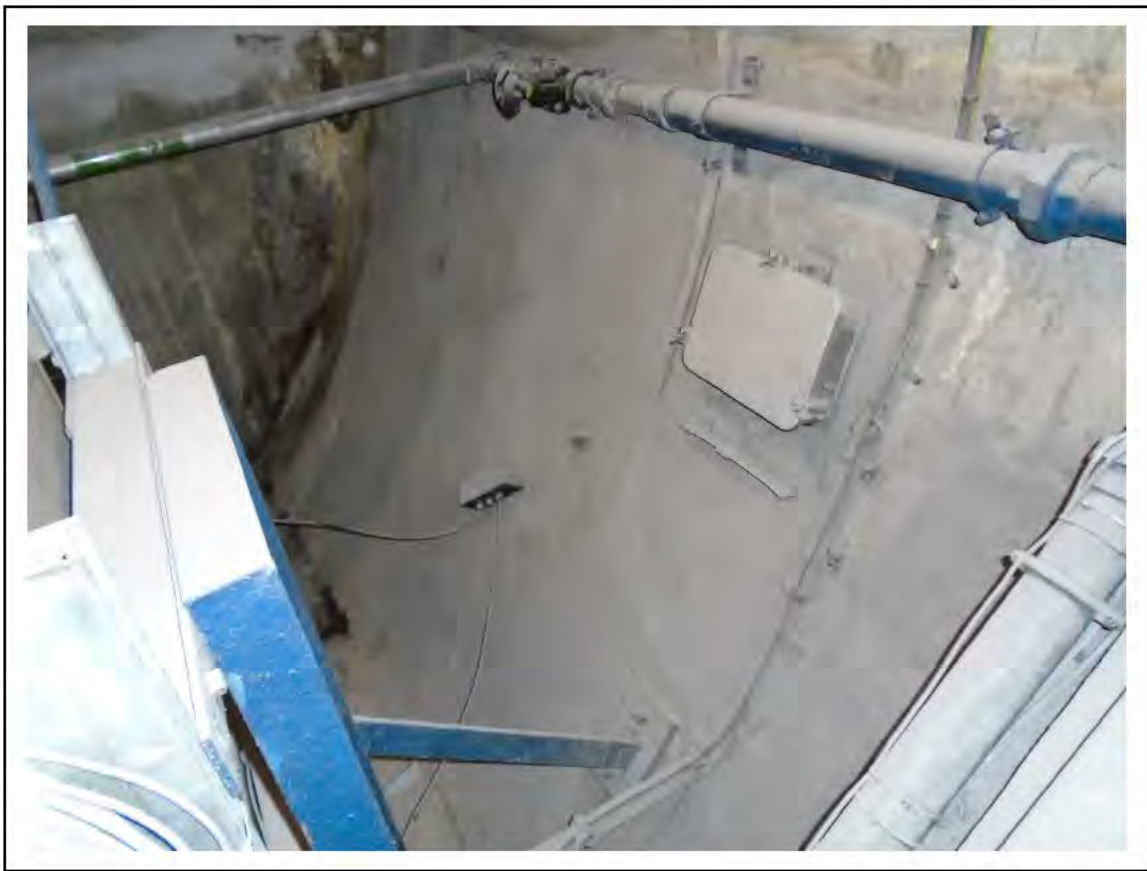
Sample Number	110714/071111/01 & 02
Location	LMC 6, 7, 8, 4/162
Material Description	Tunnel ring caulking
Material Comment	To joints - encapsulated with concrete, may remain below, to walls 4 and 1 previously sampled
Quantity	Throughout to all tunnel ring joints
Product Type	Highly friable
Current Condition	Good condition
Surface Treatment	Treated highly friable
Asbestos Type	Amosite & Chrysotile
Material Assessment Rating	Low
Accessibility	Very Low
Further Comment	Not applicable

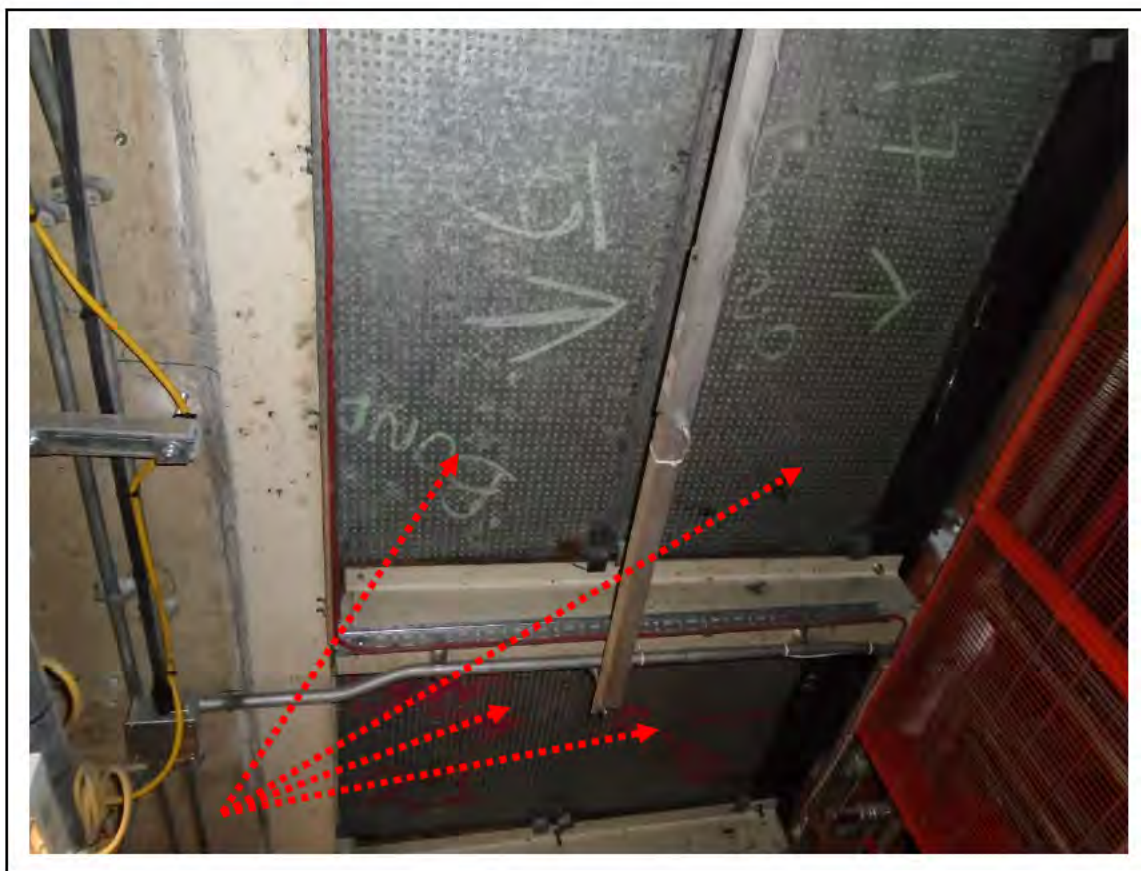
Sample Number	161057/220816/04
Location	LMC 6, 7, 8, 4/162
Material Description	Durasteel panels
Material Comment	To ceiling by escalators
Quantity	8 no x 1m ²
Product Type	Medium density
Current Condition	Slight damage
Surface Treatment	Encapsulated medium density
Asbestos Type	Amosite & Chrysotile
Material Assessment Rating	Low
Accessibility	Low
Further Comment	Not applicable

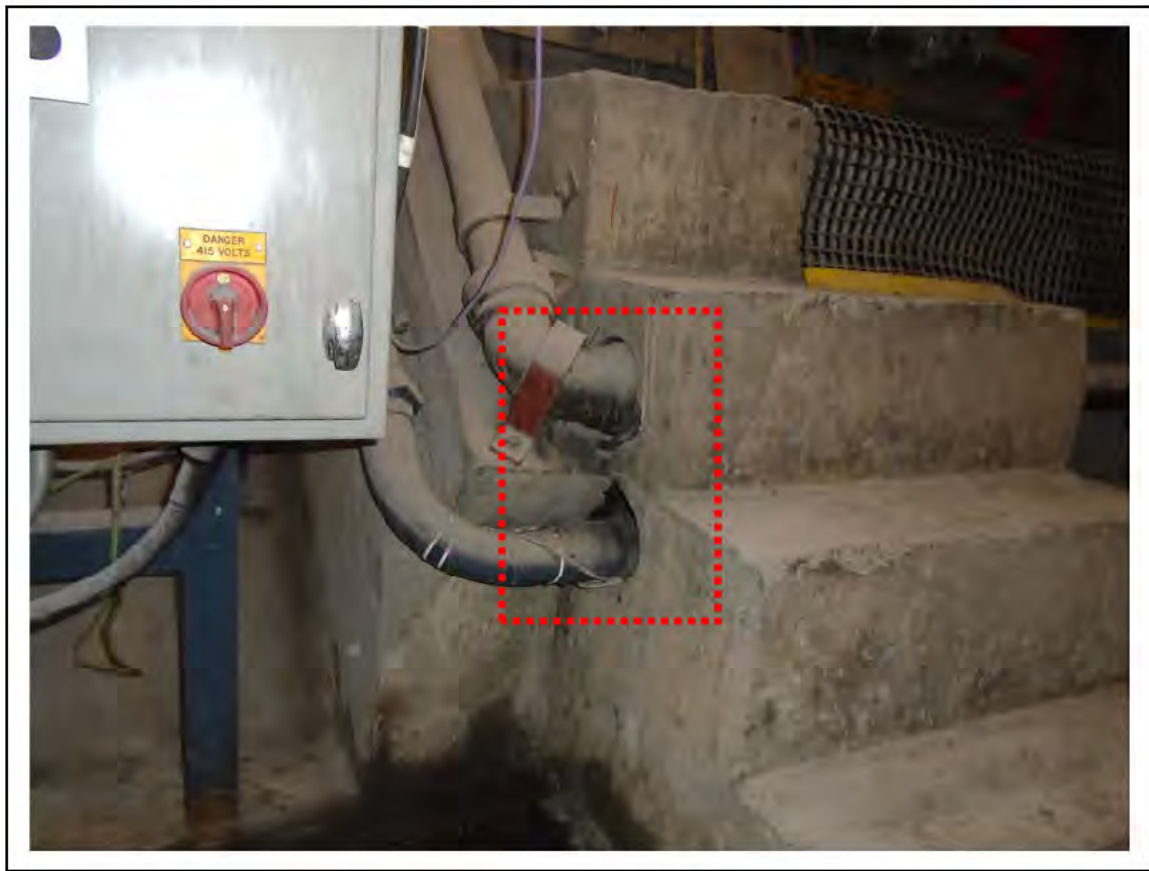
Sample Number	100674/241110/17
Location	LMC 6, 7, 8, 4/162
Material Description	Bitumen ducts
Material Comment	Within steps, by escalator 6, previously sampled
Quantity	2 no
Product Type	Composite
Current Condition	Slight damage
Surface Treatment	Composite
Asbestos Type	Chrysotile
Material Assessment Rating	Very low
Accessibility	Low
Further Comment	Not applicable

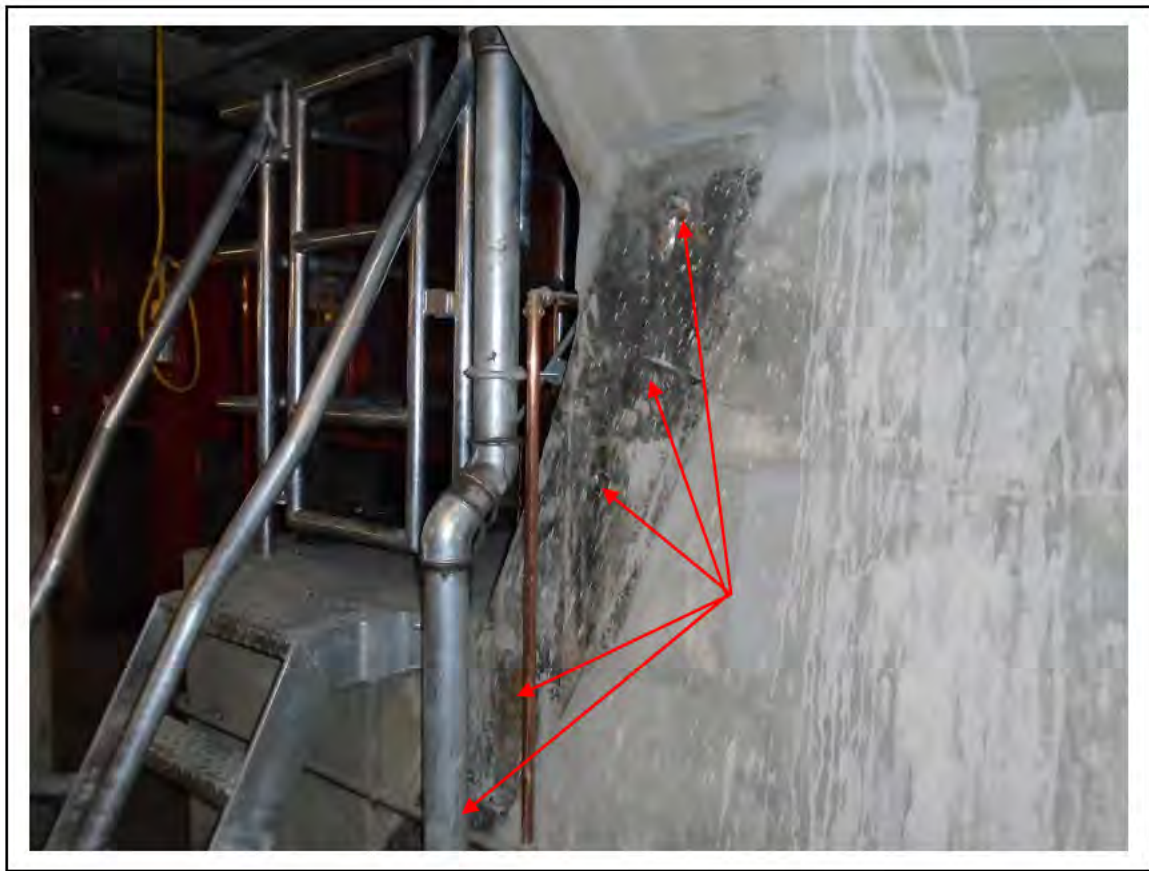
Sample Number	161057/220816/05
Location	LMC 6, 7, 8, 4/162
Material Description	Tunnel ring caulking
Material Comment	To removed tunnel ring bolts, by escalator 8
Quantity	5 no x <0.5m ²
Product Type	Highly friable
Current Condition	Moderate damage
Surface Treatment	Untreated highly friable
Asbestos Type	Chrysotile
Material Assessment Rating	Medium
Accessibility	Medium
Further Comment	Not applicable

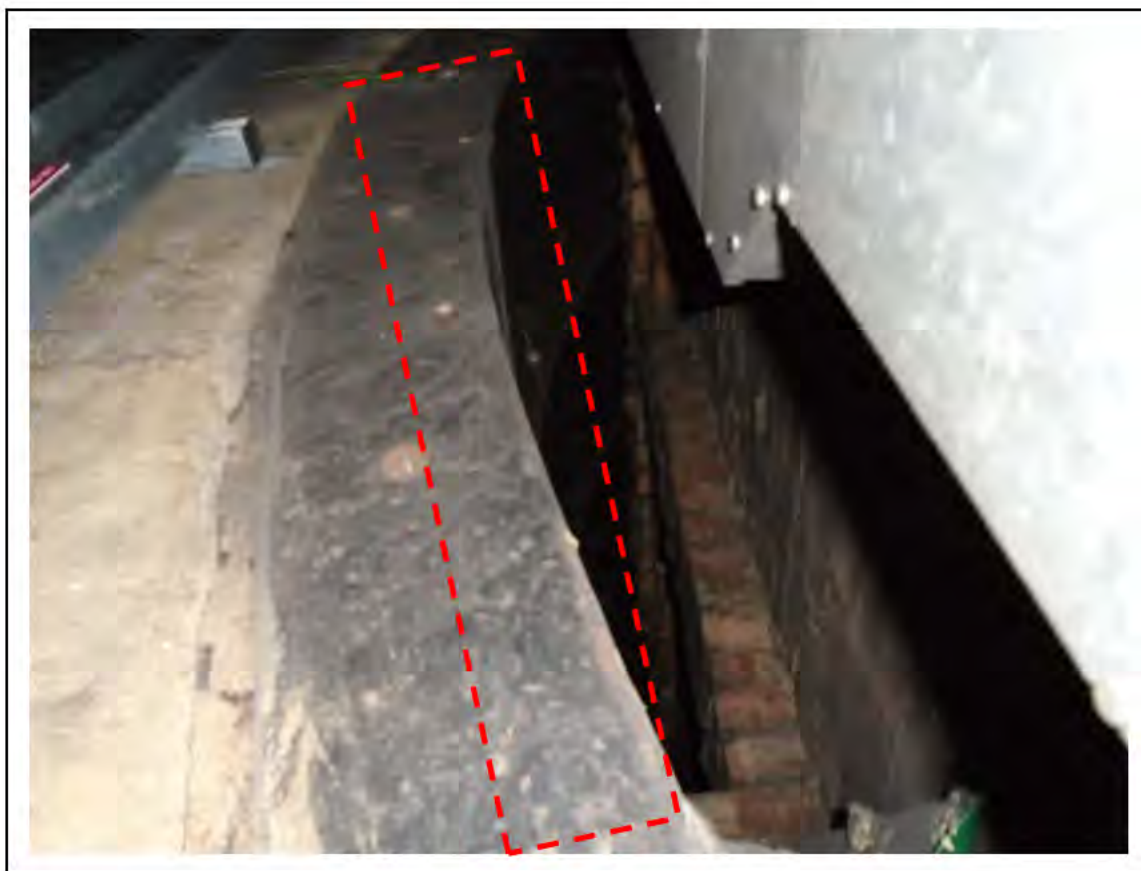
Sample Number	As 100558/141010/1
Location	LMC 3, 4, 5 Lobby, 6/161
Material Description	Tunnel ring caulking
Material Comment	To wall by entrance, previously sampled
Quantity	Throughout to all tunnel ring joints
Product Type	Highly friable
Current Condition	Slight damage
Surface Treatment	Untreated highly friable
Asbestos Type	Amosite & Chrysotile
Material Assessment Rating	Medium
Accessibility	Low
Further Comment	Not applicable
