Report No. 4RS-JP-161057-R524751

**MANAGEMENT ASBESTOS SURVEY
BOND STREET UNDERGROUND STATION**

Issue Date: 3rd January 2017

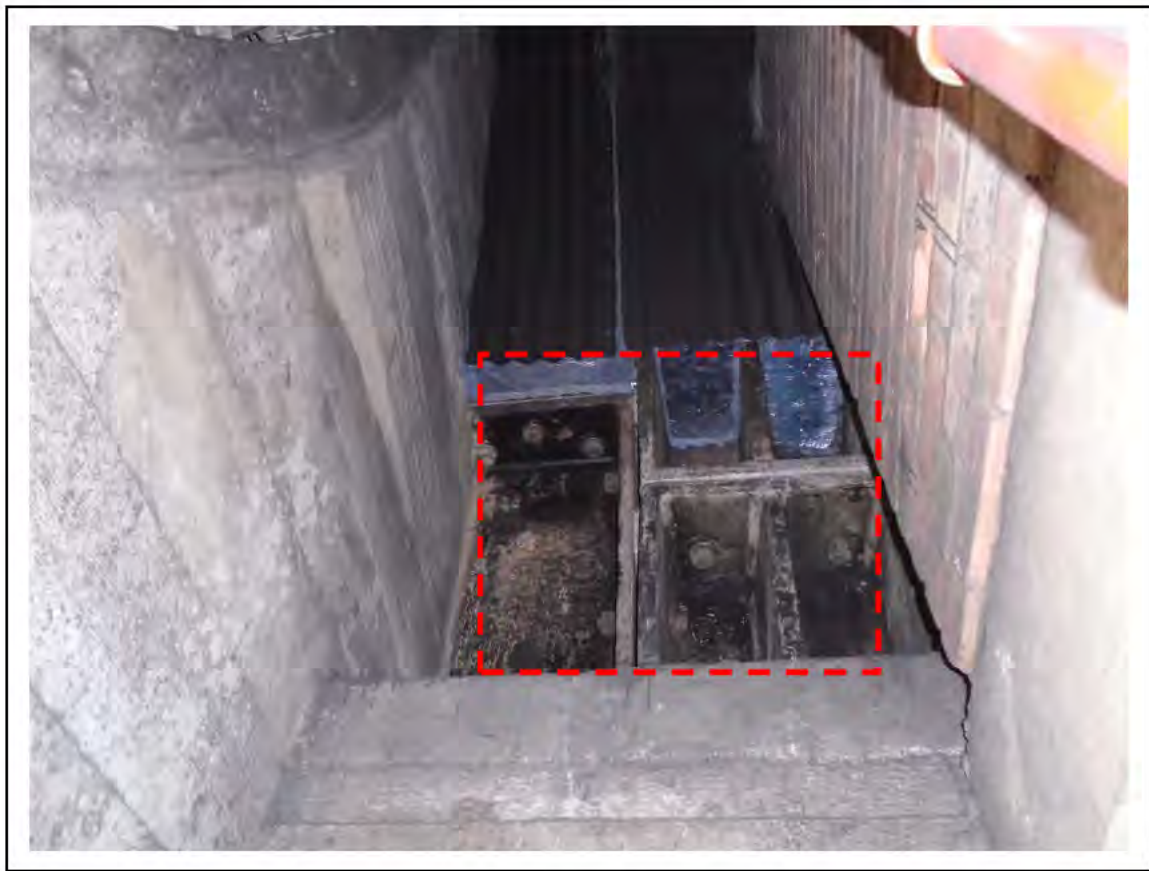
Sample Number	100558/141010/1
Location	LMC 3, 4, 5, 6/161
Material Description	Tunnel ring caulking
Material Comment	To wall 2 Throughout, previously sampled
Quantity	Throughout to all tunnel ring joints present
Product Type	Highly friable
Current Condition	Slight damage
Surface Treatment	Treated highly friable
Asbestos Type	Amosite & Chrysotile
Material Assessment Rating	Medium
Accessibility	Medium
Further Comment	Not applicable

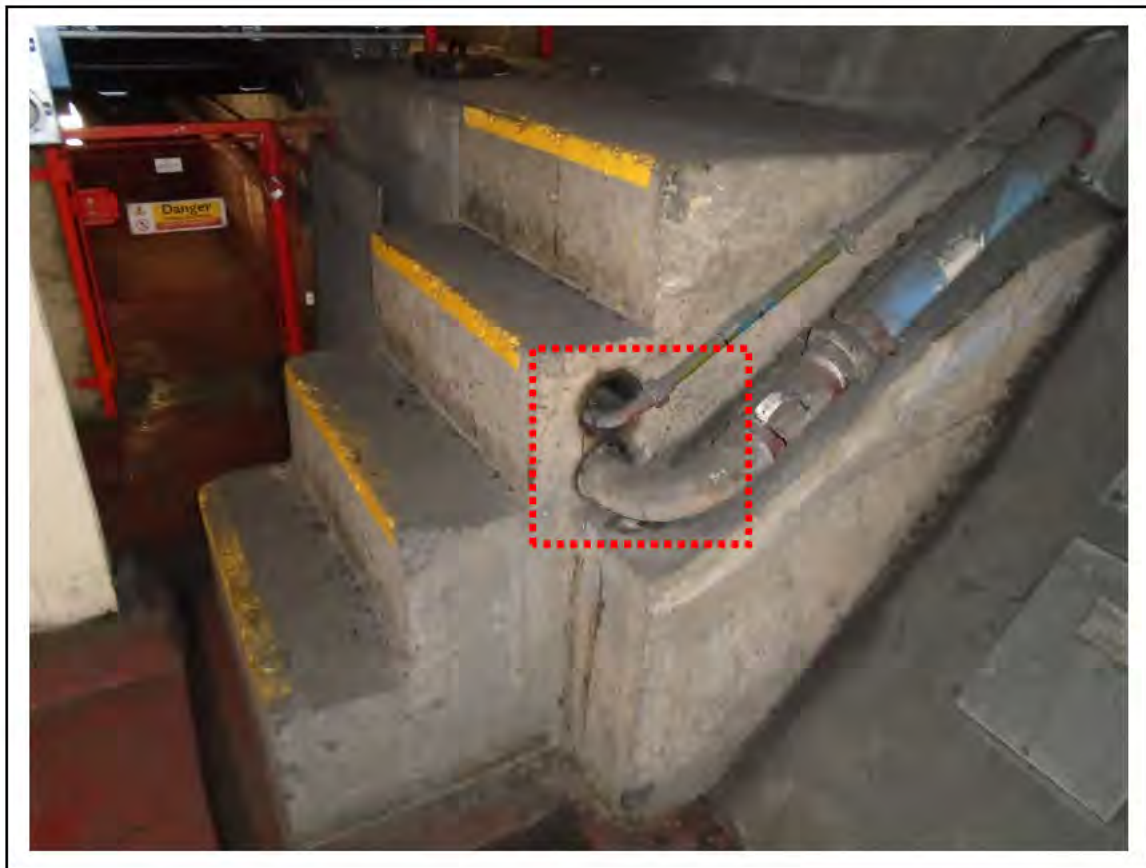
Sample Number	100558/141010/5
Location	LMC 3, 4, 5, 6/161
Material Description	Bitumen ducts
Material Comment	Within stairs, by escalator 5, previously sampled
Quantity	2 no
Product Type	Medium density
Current Condition	Slight damage
Surface Treatment	Unencapsulated medium density
Asbestos Type	Chrysotile
Material Assessment Rating	Low
Accessibility	Low
Further Comment	Not applicable

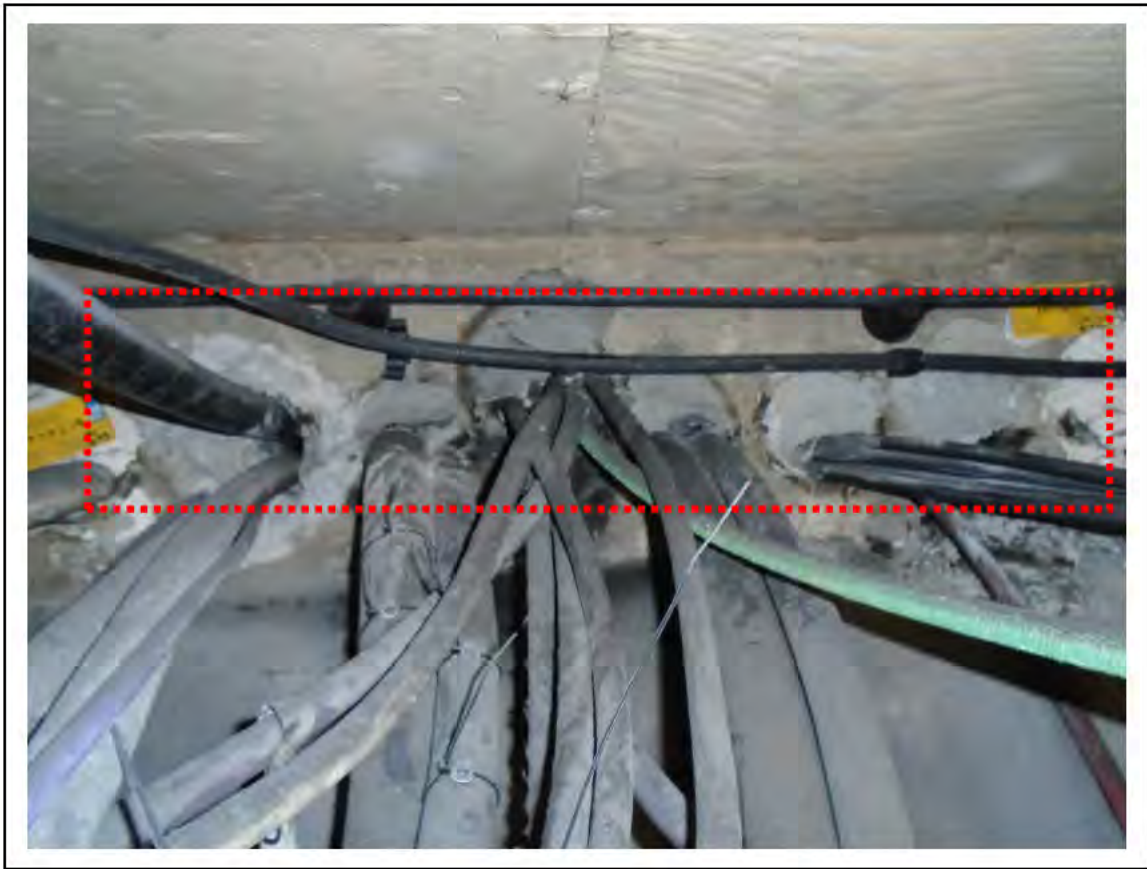
Sample Number	161144/190916/11
Location	LMC 3, 4, 5 Crawlway, 6/161
Material Description	Bitumen ducts
Material Comment	10 no, to RHS wall ~11m from machine chamber on east side crawl space
Quantity	10 no
Product Type	Composite
Current Condition	Slight damage
Surface Treatment	Composite
Asbestos Type	Amosite & Chrysotile
Material Assessment Rating	Very low
Accessibility	Low
Further Comment	Not applicable

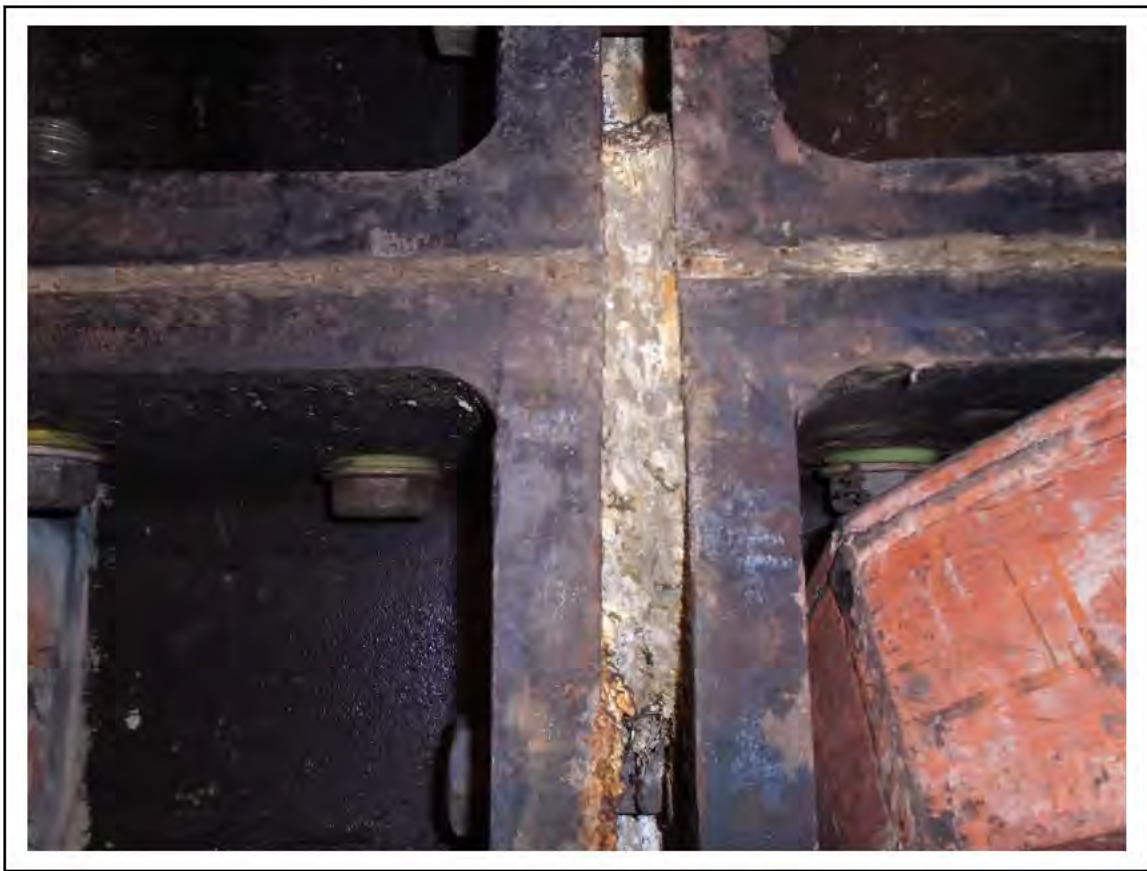
Sample Number	100558/131010/5
Location	Store, 4/571
Material Description	Tunnel ring caulking
Material Comment	To cast iron tunnel ring joints (previously sampled). Recommend encapsulation
Quantity	Throughout to all tunnel ring joints present
Product Type	Highly friable
Current Condition	Slight damage
Surface Treatment	Untreated highly friable
Asbestos Type	Amosite & Chrysotile
Material Assessment Rating	Medium
Accessibility	Medium
Further Comment	Recommend encapsulation

- 9.1 Figure 33, encapsulation is recommended to the slightly damaged and protruding asbestos containing caulking within the cast iron tunnel ring flanges to the walls of Store, 4/571.

- 9.2 Tunnel ring caulking is deemed a high risk material due to its friable nature however due to its location between cast iron tunnel ring flanges it is unlikely to be disturbed through normal workplace/maintenance activities. Due to the aforementioned circumstances further measures would be recommended if the caulking material is likely to be disturbed through intrusive/remedial works, possibly including a combination of: airborne fibre monitoring; further surveying/sampling of caulking within concealed tunnel rings to confirm the presence or otherwise of asbestos containing materials within the tunnel ring flanges; encapsulation or removal by a Health and Safety Executive (HSE) licensed asbestos removal contractor.

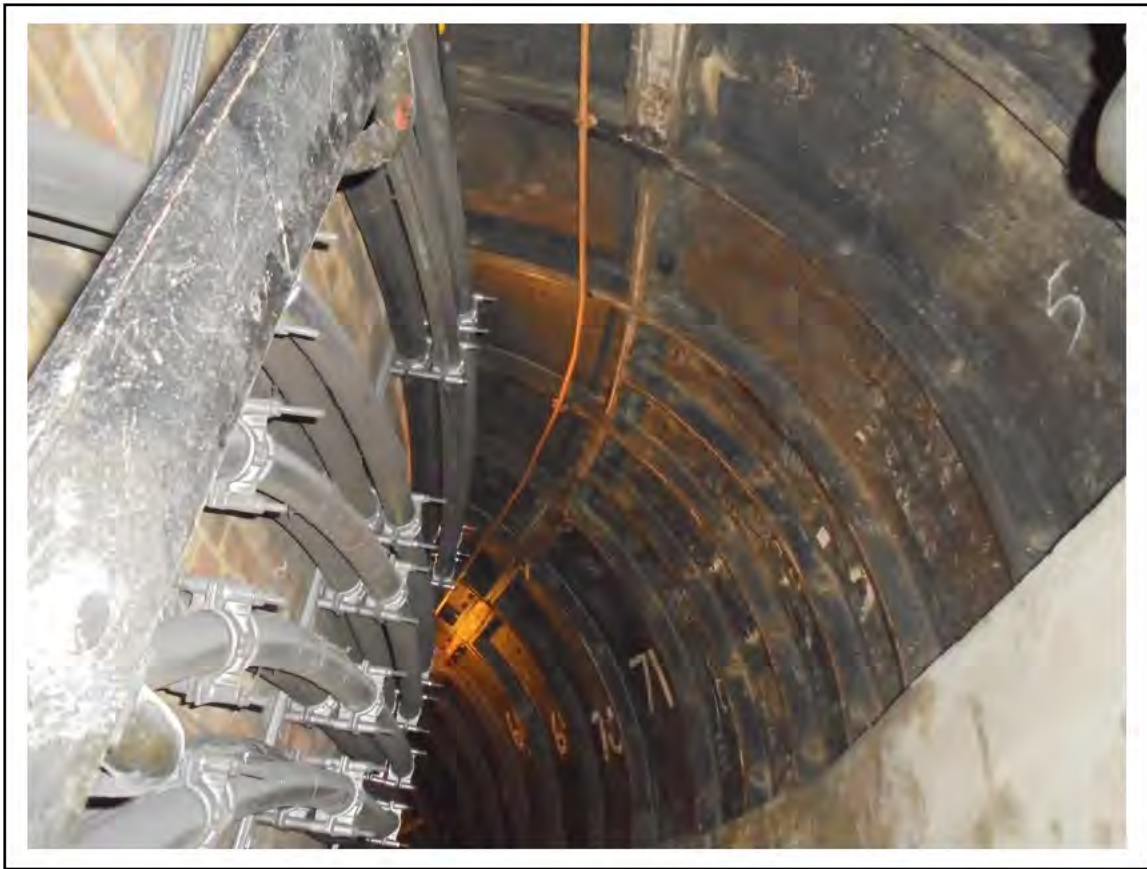
Sample Number	ECS 85380
Location	Cable Tunnel, 4/786
Material Description	Caulking
Material Comment	To tunnel ring joints to walls/ ceiling throughout
Quantity	Throughout (~300m)
Product Type	Highly friable
Current Condition	Moderate damage
Surface Treatment	Untreated highly friable
Asbestos Type	Amosite & Chrysotile
Material Assessment Rating	High
Accessibility	Medium
Further Comment	Not applicable

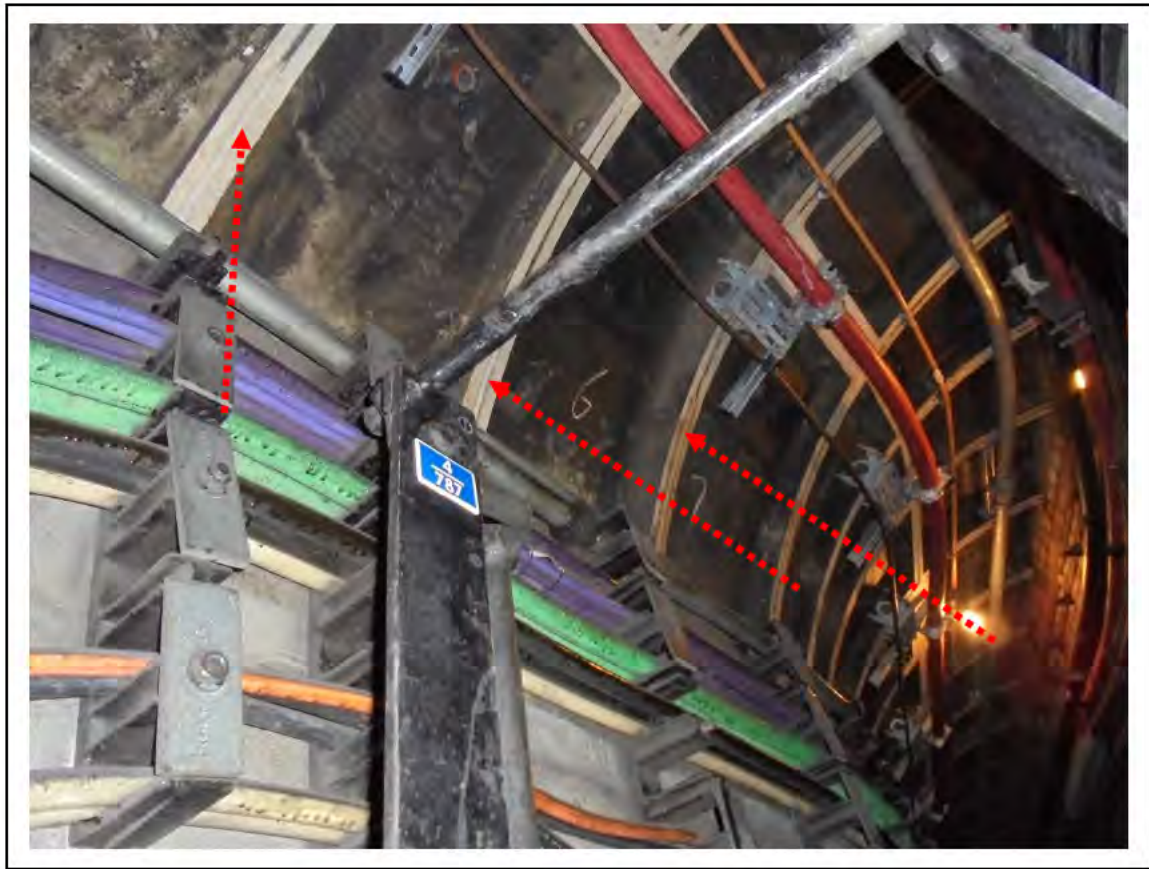
Sample Number	ECS 85381
Location	Cable Tunnel, 4/787
Material Description	Caulking
Material Comment	To tunnel ring joints to walls/ ceiling
Quantity	Throughout (~300m)
Product Type	Highly friable
Current Condition	Moderate damage
Surface Treatment	Untreated highly friable (partial encapsulation)
Asbestos Type	Amosite
Material Assessment Rating	High
Accessibility	Medium
Further Comment	Not applicable

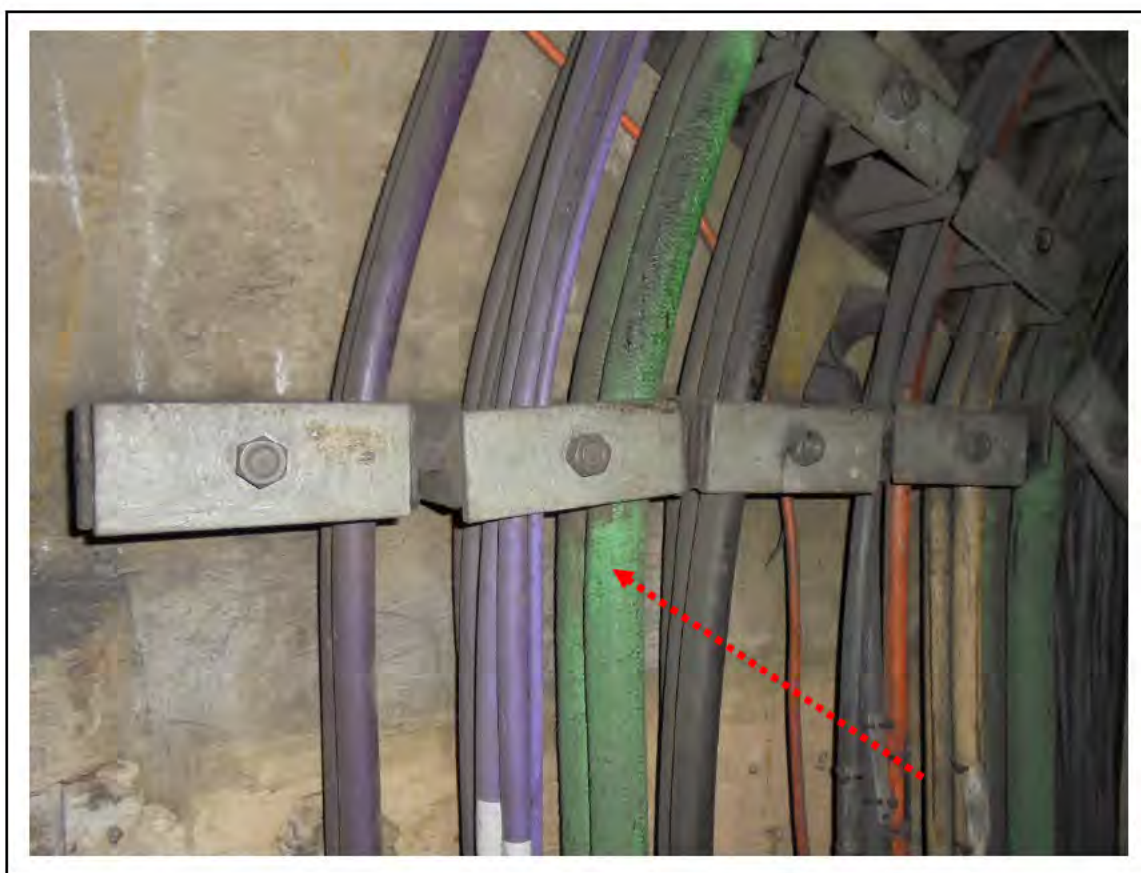
Sample Number	ECS 76823
Location	Cable Tunnel, 4/787
Material Description	Woven cable insulation
Material Comment	To cable run on LHS cable shaft down to central line (partial encapsulation with PVA)
Quantity	4 no x ~260m
Product Type	Medium density
Current Condition	Good condition
Surface Treatment	Unencapsulated medium density
Asbestos Type	Chrysotile
Material Assessment Rating	Low
Accessibility	Low
Further Comment	Not applicable

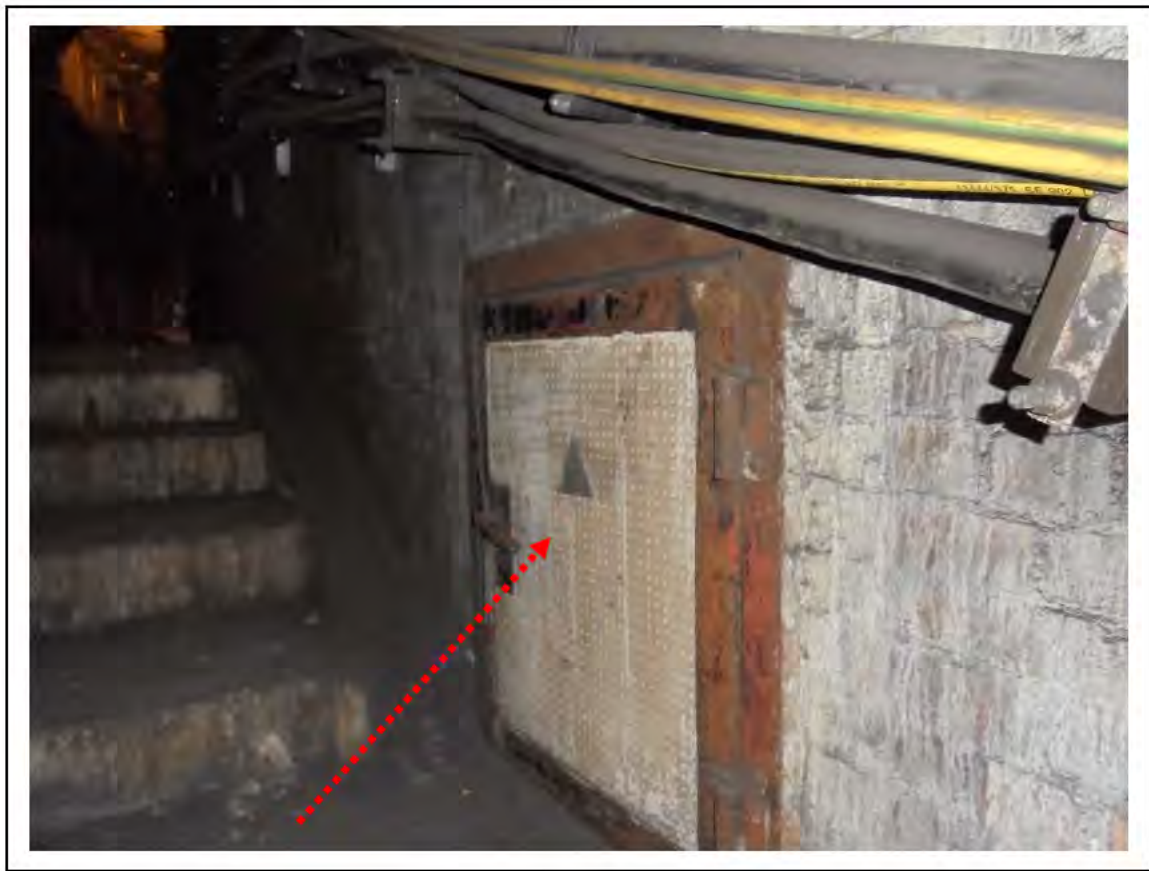
Sample Number	014003/18
Location	Cable Tunnel, 4/787
Material Description	Durasteel panel
Material Comment	To middle of cable tunnels (hatch) unencapsulated on 4/786 side, previously sampled
Quantity	1m ²
Product Type	Medium density
Current Condition	Slight damage
Surface Treatment	Encapsulated medium density
Asbestos Type	Amosite & Chrysotile
Material Assessment Rating	Low
Accessibility	Low
Further Comment	Not applicable

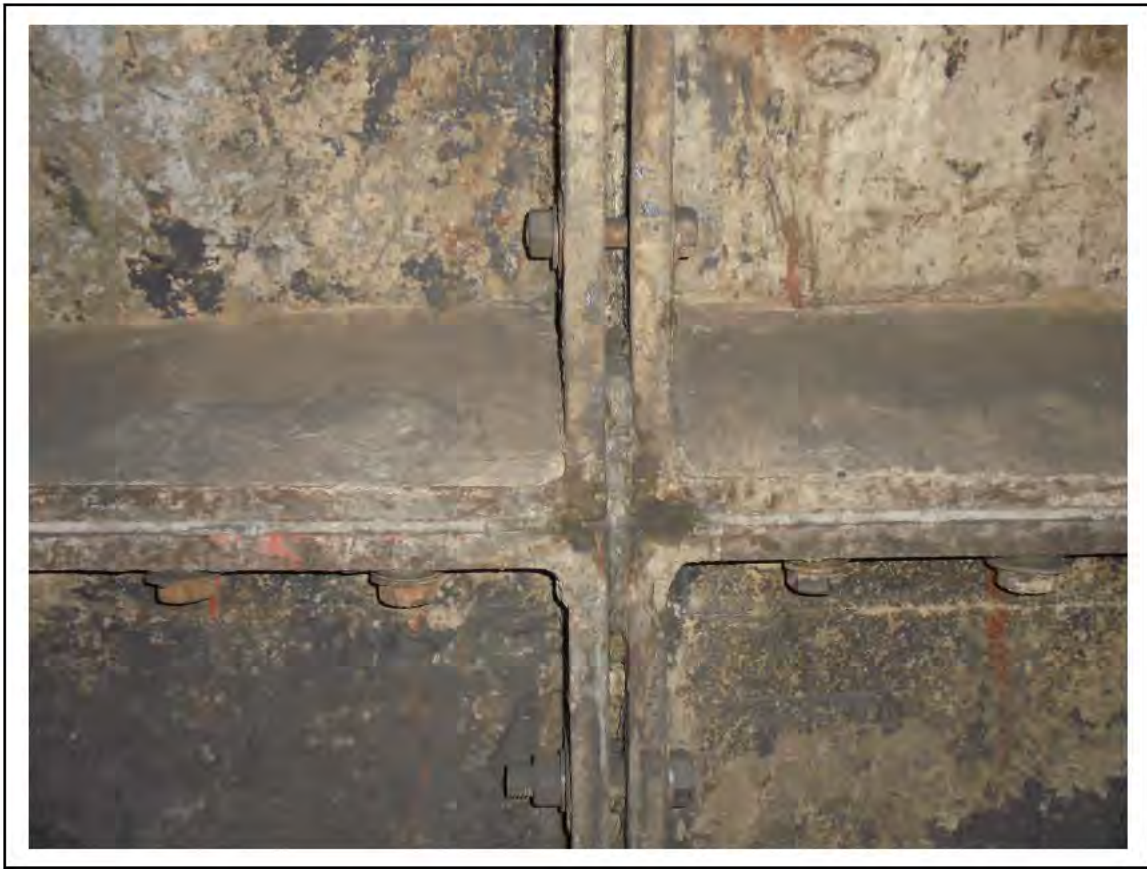
Sample Number	K1 (5)
Location	Cable Run Shaft, by end of Cable Tunnel 4/787
Material Description	Caulking
Material Comment	To tunnel ring joints, previously sampled
Quantity	Throughout to all tunnel ring joints present
Product Type	Highly friable
Current Condition	Moderate damage
Surface Treatment	Treated highly friable
Asbestos Type	Known Chrysotile
Material Assessment Rating	Medium
Accessibility	Medium
Further Comment	Not applicable

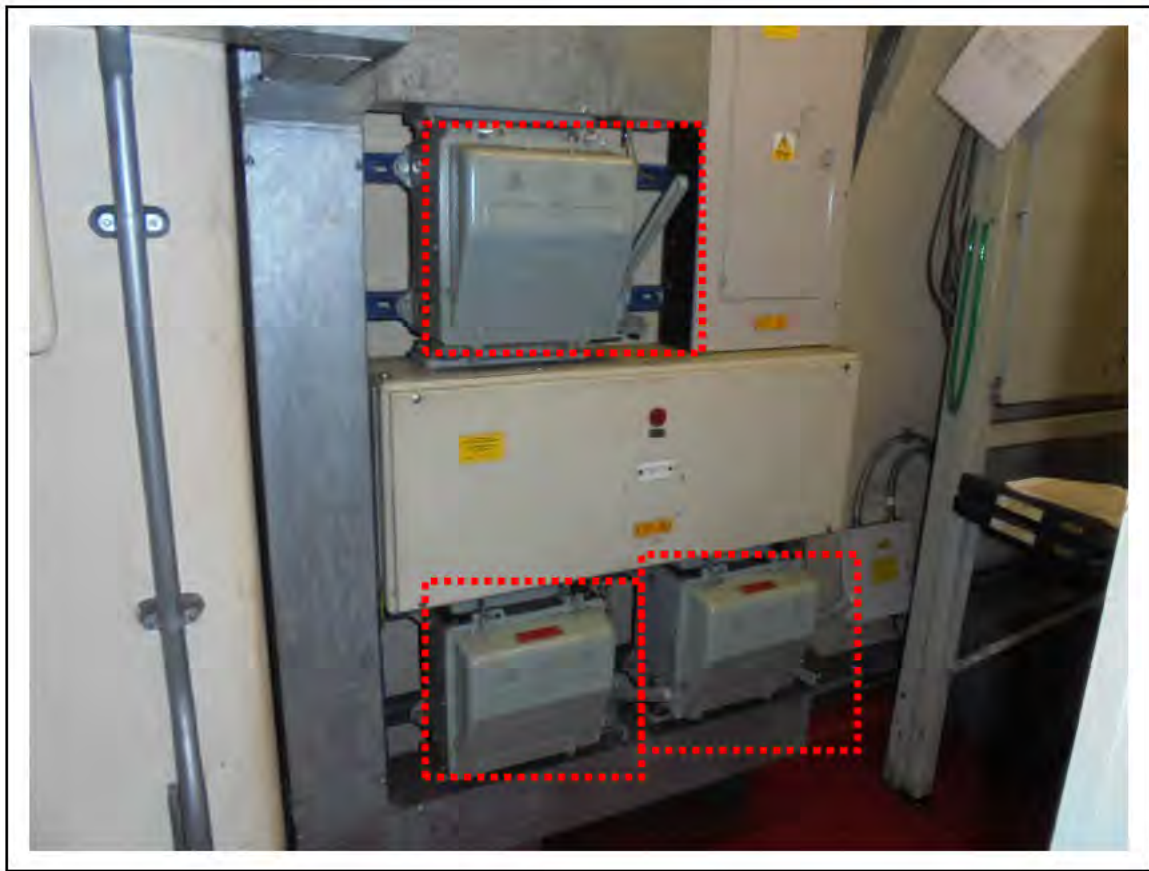
Sample Number	SP1 (6)
Location	SER, 4/711
Material Description	Combination fuse switches
Material Comment	To wall 1
Quantity	3 no
Product Type	-
Current Condition	-
Surface Treatment	-
Asbestos Type	Strongly Presumed Chrysotile
Material Assessment Rating	-
Accessibility	-
Further Comment	Not applicable

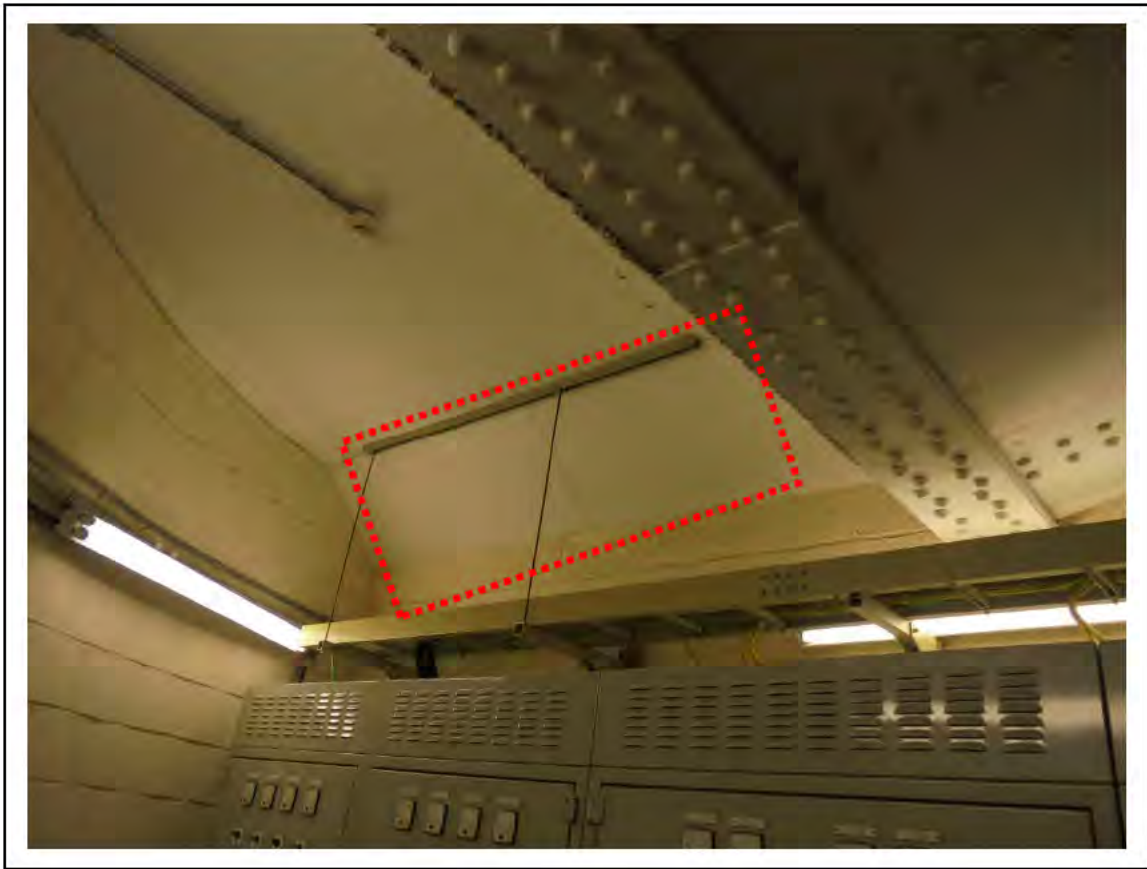
Sample Number	P3 (1)
Location	SER/CER, 4/762
Material Description	Panels/ board
Material Comment	To high level above electrical equipment - no access
Quantity	4m ²
Product Type	-
Current Condition	-
Surface Treatment	-
Asbestos Type	Presumed Crocidolite
Material Assessment Rating	-
Accessibility	-
Further Comment	Not applicable

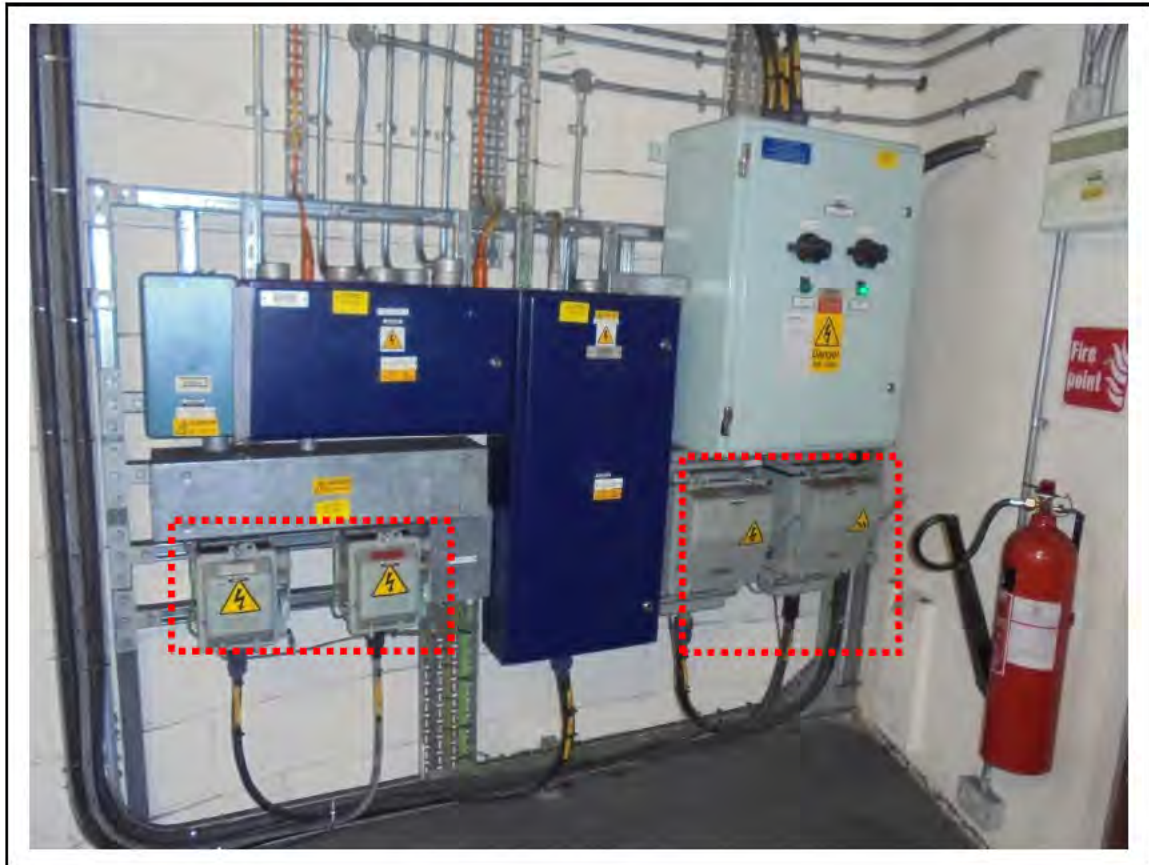
Sample Number	SP1 (8)
Location	Switch Room, 4/763
Material Description	Materials within combination fuse switches
Material Comment	2no large, 2 no small - no isolation
Quantity	4 no
Product Type	-
Current Condition	-
Surface Treatment	-
Asbestos Type	Strongly Presumed Chrysotile
Material Assessment Rating	-
Accessibility	-
Further Comment	Not applicable

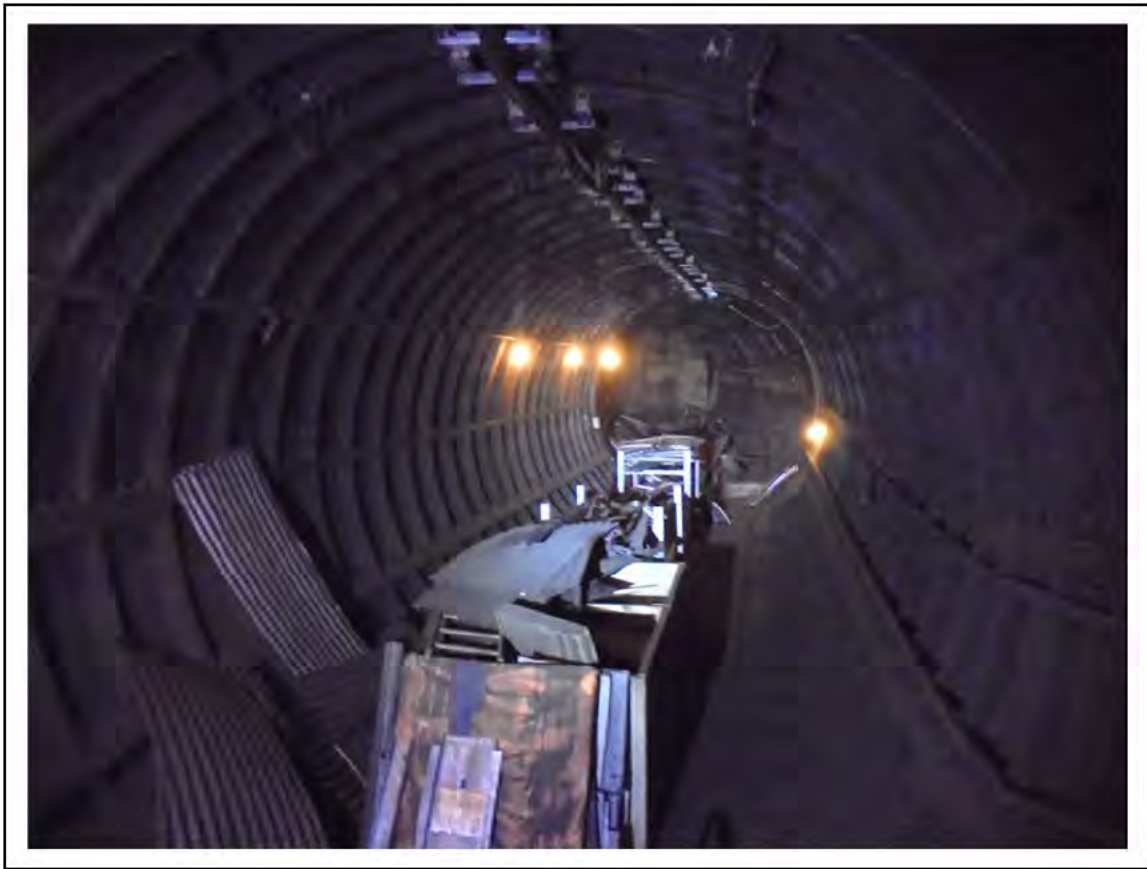
Sample Number	051008/7
Location	Draft Relief Tunnel, 4/793
Material Description	Caulking to tunnel rings
Material Comment	To central line vent shaft, jubilee line side of shaft
Quantity	Throughout to all tunnel ring joints present
Product Type	Highly friable
Current Condition	Moderate damage
Surface Treatment	Untreated highly friable
Asbestos Type	Amosite & Chrysotile
Material Assessment Rating	High
Accessibility	Low
Further Comment	Precaution advised throughout area for intrusive works

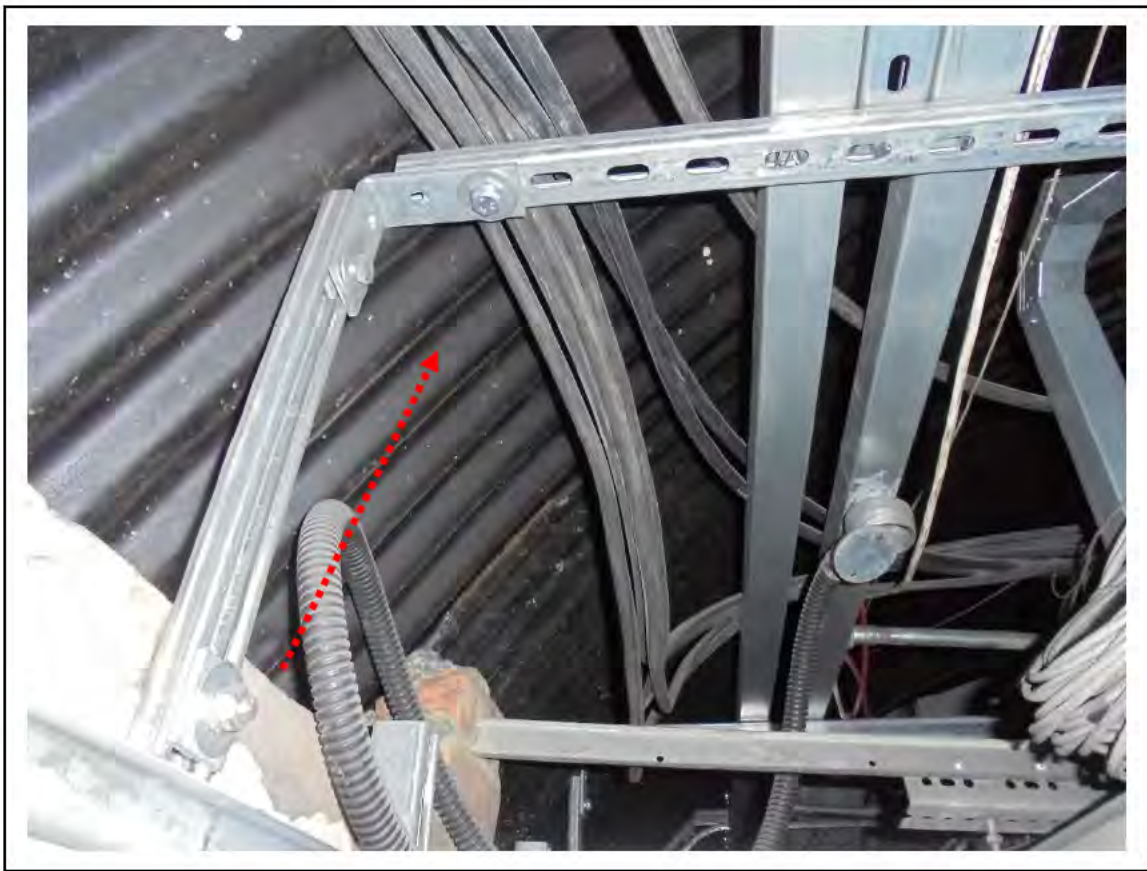
Sample Number	K1 (6)
Location	Passage, 6/236
Material Description	Cellactite sheeting
Material Comment	Throughout to ceiling within false ceiling and over adjoining rooms
Quantity	~30m ²
Product Type	Composite
Current Condition	Slight damage
Surface Treatment	Composite
Asbestos Type	Known Chrysotile
Material Assessment Rating	Very low
Accessibility	Low
Further Comment	Not applicable

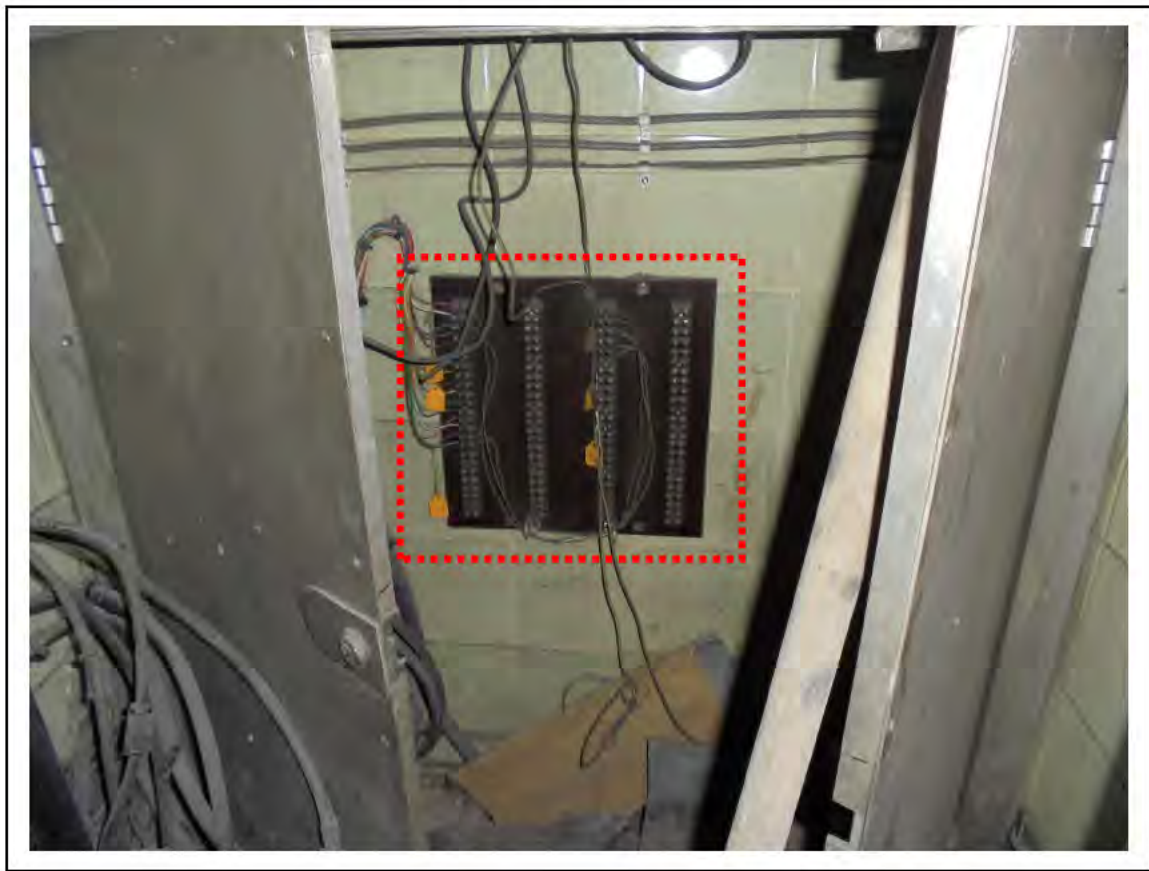
Sample Number	161057/191116/01
Location	Passage, 6/236
Material Description	Old brown composite board
Material Comment	To low level, wall 3 by access door within metal cabinet
Quantity	<0.5m ²
Product Type	Composite
Current Condition	Good condition
Surface Treatment	Composite
Asbestos Type	Chrysotile
Material Assessment Rating	Very low
Accessibility	Low
Further Comment	Not applicable

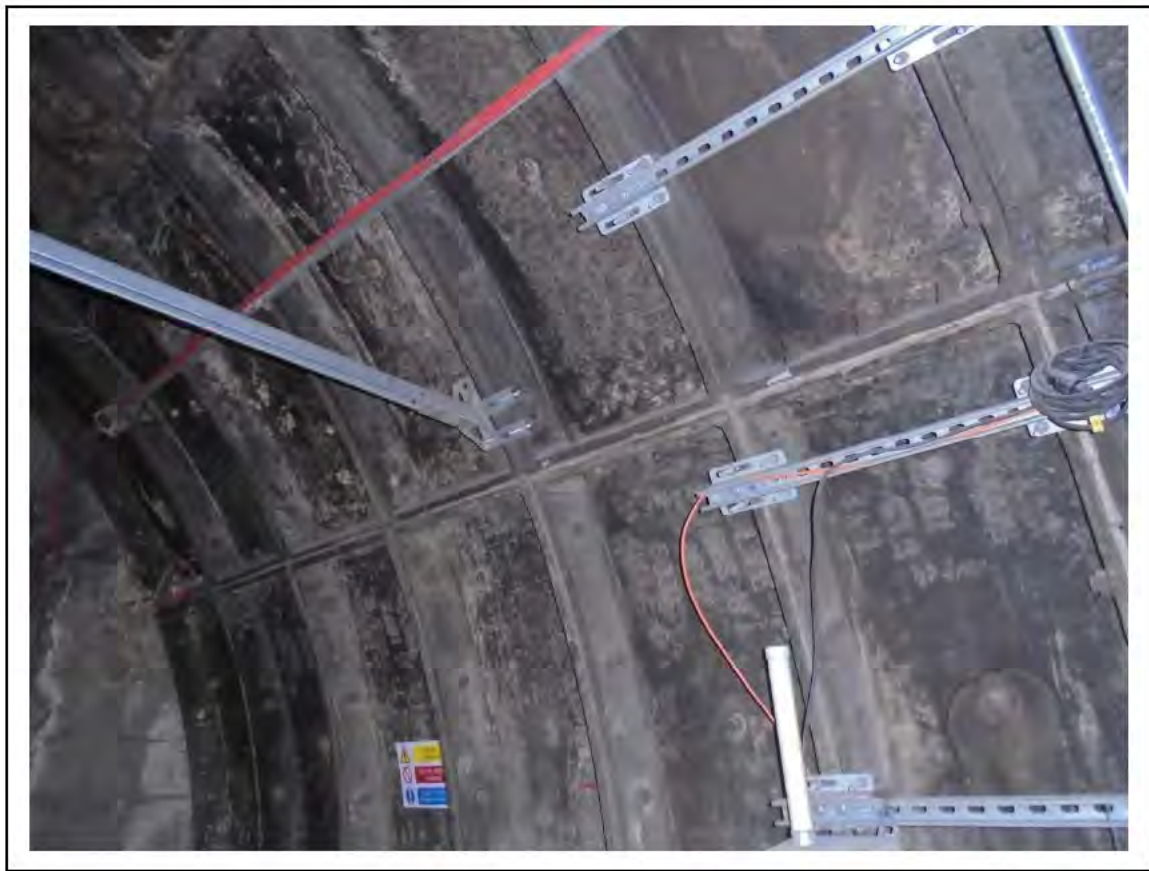
Sample Number	ECS 85356
Location	Draft Relief Tunnel, 6/792
Material Description	Caulking to tunnel rings
Material Comment	Partial encapsulation throughout tunnel rings to walls/ceiling (previously sampled)
Quantity	~300m
Product Type	Highly friable
Current Condition	Slight damage
Surface Treatment	Treated highly friable
Asbestos Type	Amosite & Chrysotile
Material Assessment Rating	Medium
Accessibility	Low
Further Comment	Not applicable

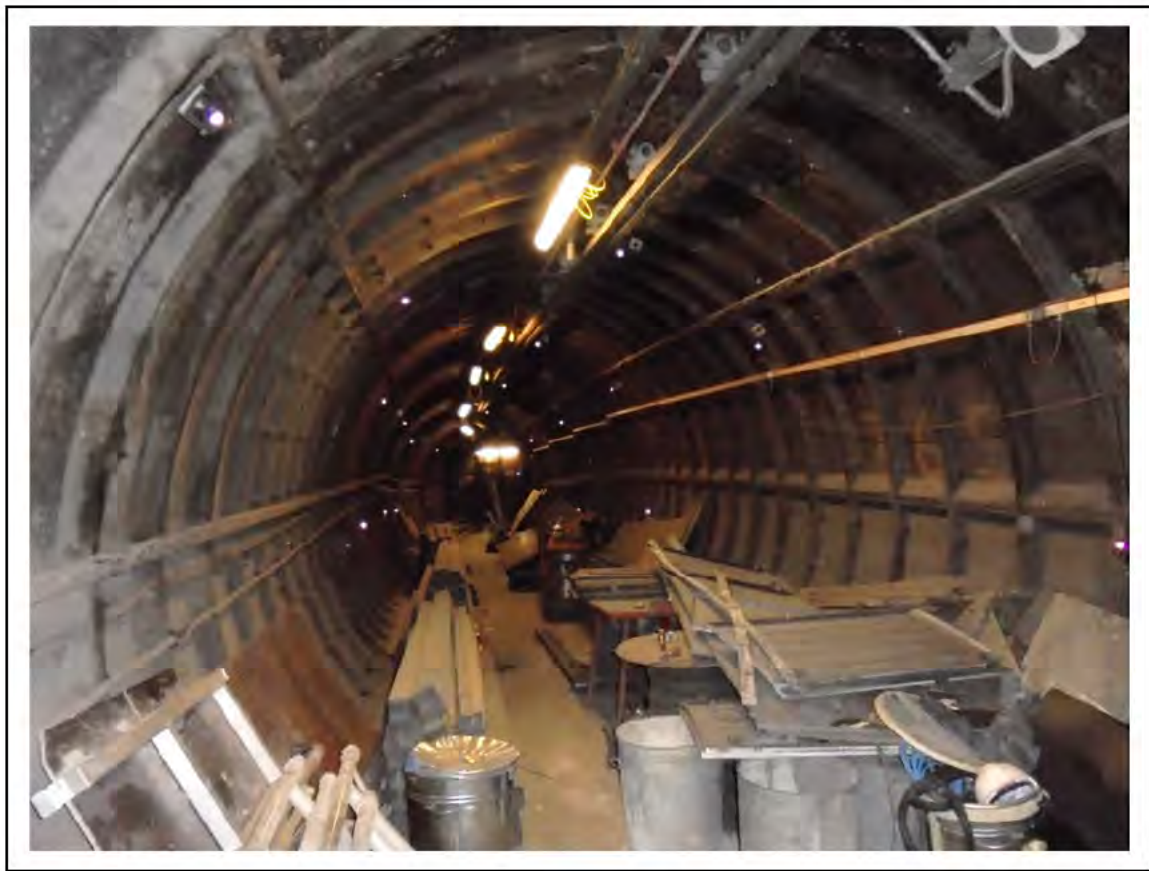
Sample Number	100675/110111/03
Location	Draft Relief Tunnel, 6/792
Material Description	Caulking to tunnel rings
Material Comment	Partial encapsulation throughout tunnel rings to walls/ceiling by room 6/716 (previously sampled)
Quantity	Throughout to all tunnel ring joints present
Product Type	Highly friable
Current Condition	Slight damage
Surface Treatment	Treated highly friable
Asbestos Type	Amosite
Material Assessment Rating	Medium
Accessibility	Low
Further Comment	Not applicable

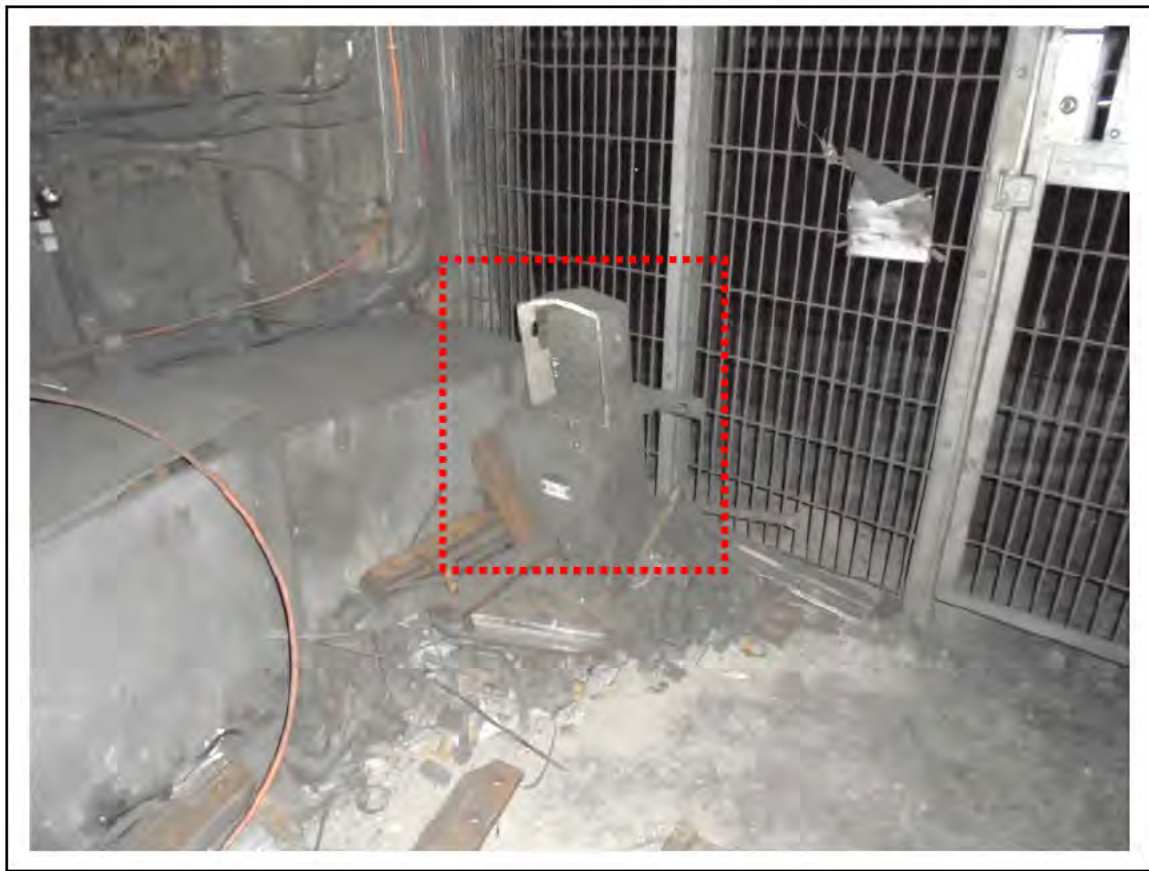
Sample Number	P1 (1)
Location	Draft Relief Tunnel, 6/792
Material Description	Materials within Westinghouse boxes
Material Comment	To floor by track access - no proven isolation for inspection, appear discarded
Quantity	2 no
Product Type	-
Current Condition	-
Surface Treatment	-
Asbestos Type	Presumed Chrysotile
Material Assessment Rating	-
Accessibility	-
Further Comment	Not applicable

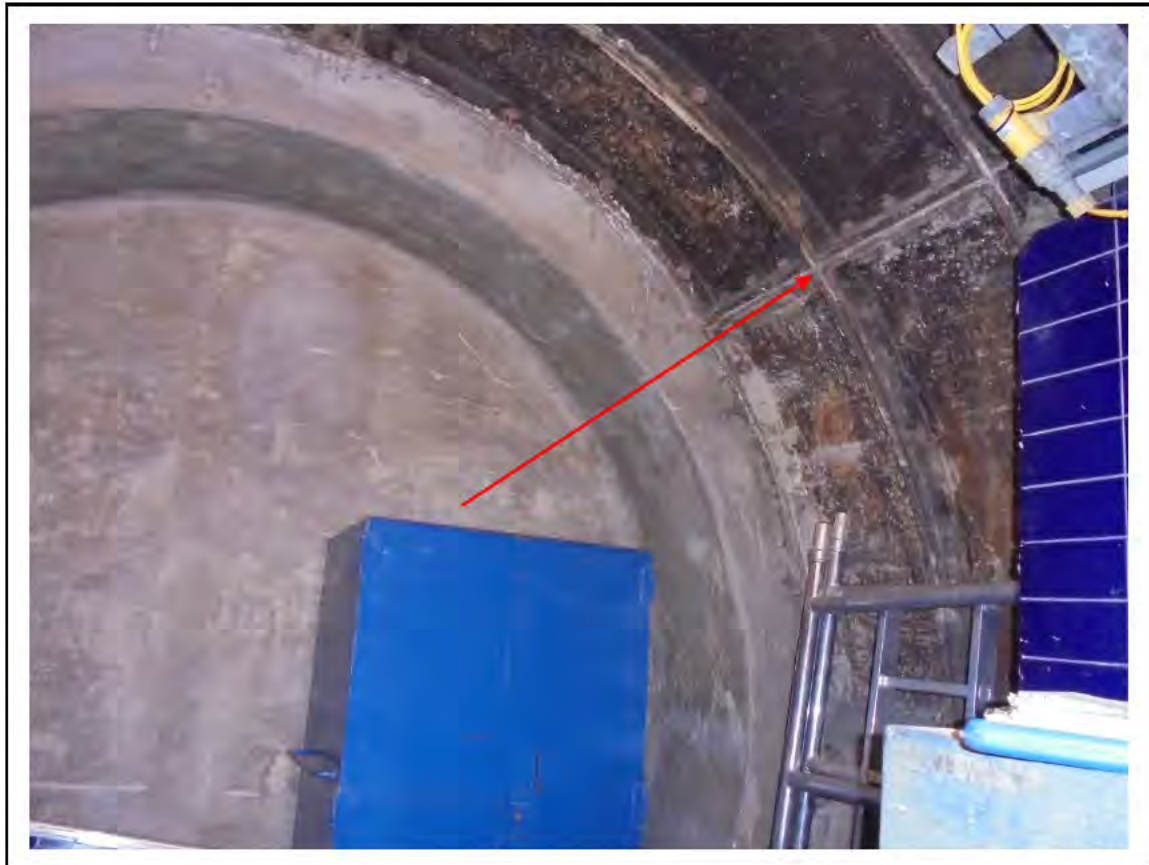
Sample Number	110714/071111/05 & 06
Location	Passage (blocked off both ends), 6/208
Material Description	Caulking to cast iron tunnel rings
Material Comment	Within joints/ flanges throughout to walls/ceiling, previously sampled
Quantity	~12m ²
Product Type	Highly friable
Current Condition	Moderate damage
Surface Treatment	Treated highly friable
Asbestos Type	Amosite & Chrysotile
Material Assessment Rating	Medium
Accessibility	Low
Further Comment	Not applicable

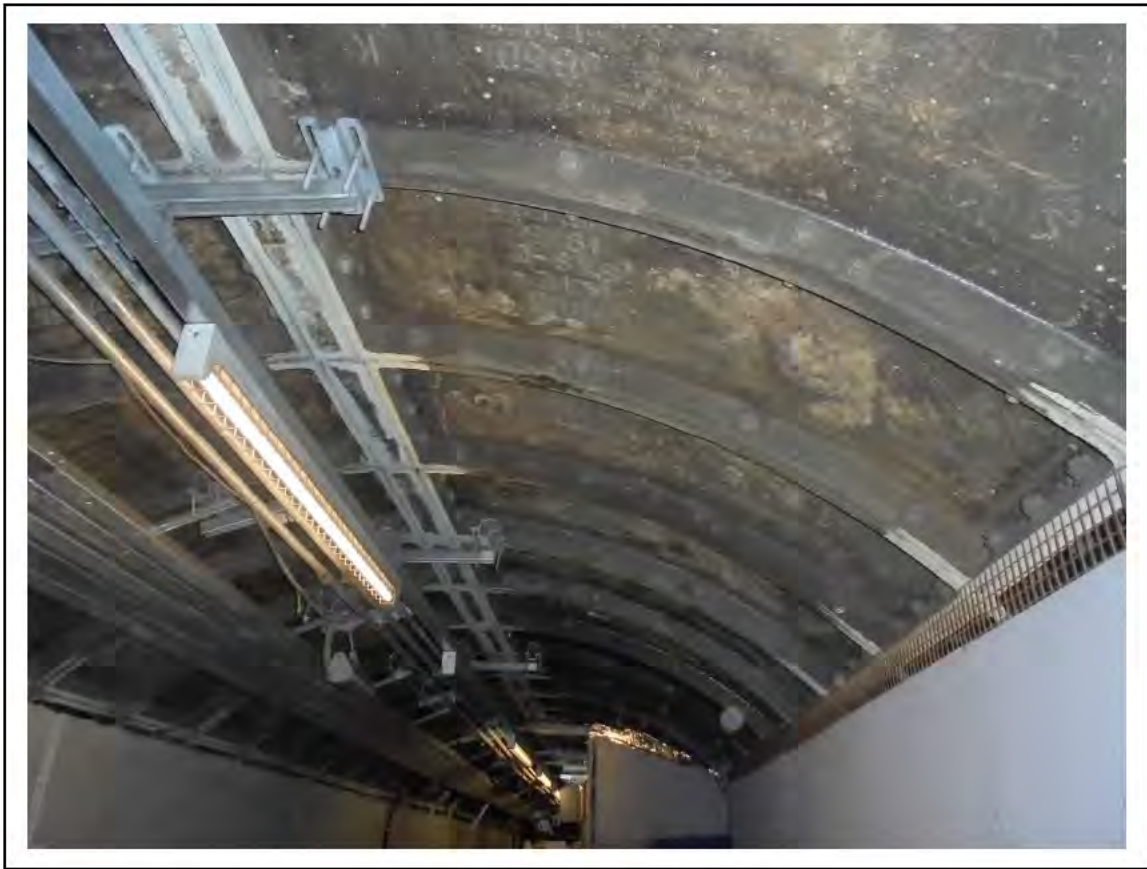
Sample Number	K1 (7)
Location	Passage, 6/201
Material Description	Caulking to tunnel rings
Material Comment	Throughout to joints/flanges partial encapsulation
Quantity	~192m ²
Product Type	Highly friable
Current Condition	Slight damage
Surface Treatment	Untreated highly friable
Asbestos Type	Known Chrysotile
Material Assessment Rating	Medium
Accessibility	Low
Further Comment	Not applicable
