Report No. 4RS-JP-161057-R524751

**MANAGEMENT ASBESTOS SURVEY
BOND STREET UNDERGROUND STATION**

Issue Date: 3rd January 2017

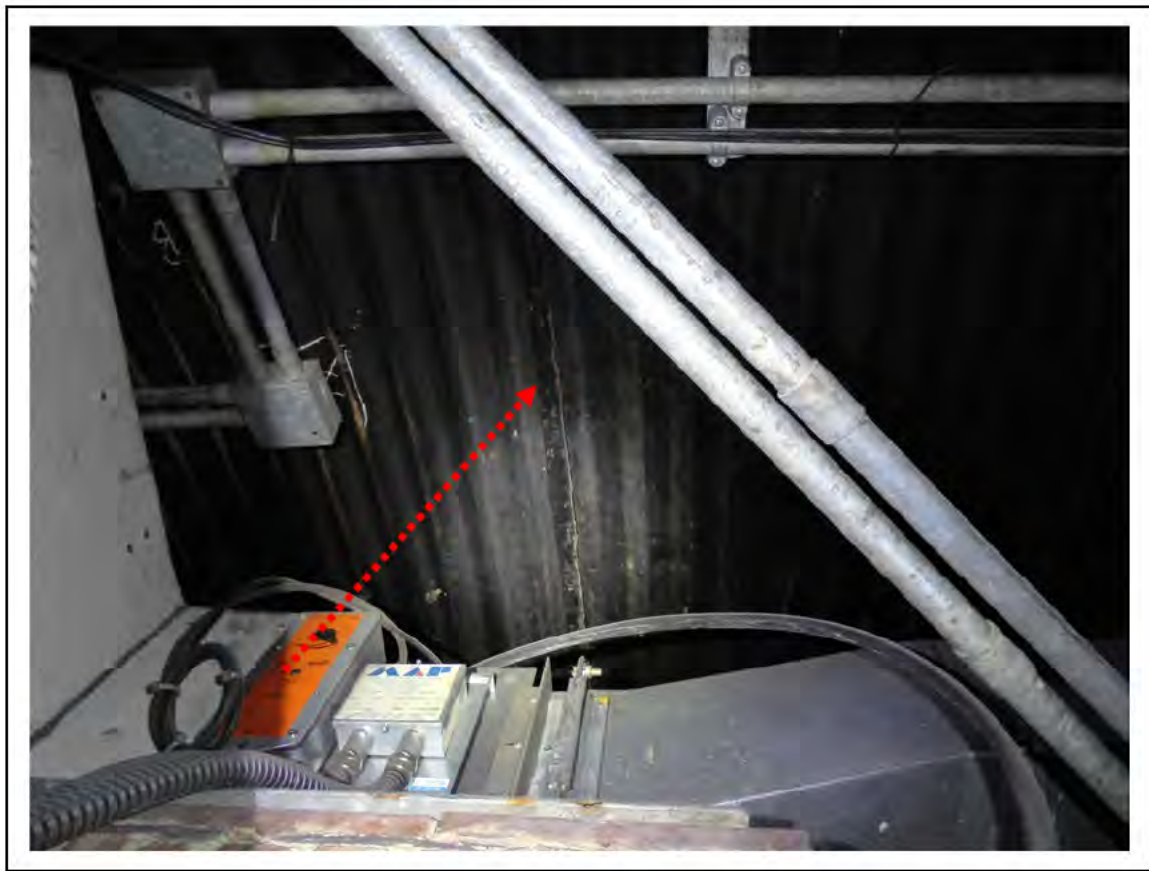
Sample Number	As ECS 85369
Location	Disused, 6/401
Material Description	Cellactite sheeting
Material Comment	Throughout to ceiling (above false ceiling) - continuation from 6/406
Quantity	~35m ²
Product Type	Composite
Current Condition	Slight damage
Surface Treatment	Composite
Asbestos Type	Chrysotile
Material Assessment Rating	Very low
Accessibility	Low
Further Comment	Not applicable

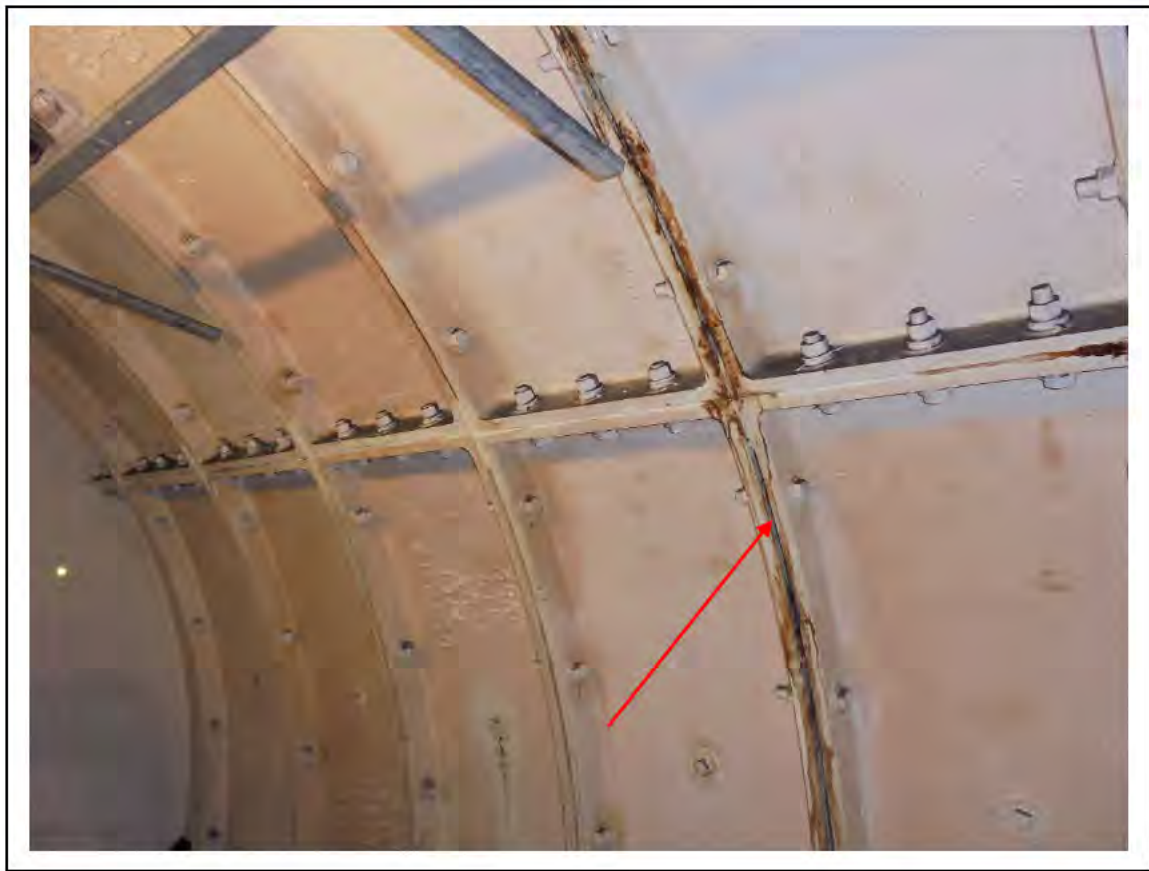
Sample Number	ECS 85359
Location	Flammable Store, 6/901
Material Description	Caulking
Material Comment	To tunnel ring flanges throughout to walls and ceiling (previously sampled)
Quantity	~40m
Product Type	Highly friable
Current Condition	Slight damage
Surface Treatment	Untreated highly friable
Asbestos Type	Amosite & Chrysotile
Material Assessment Rating	Medium
Accessibility	Medium
Further Comment	Partial encapsulation to low level

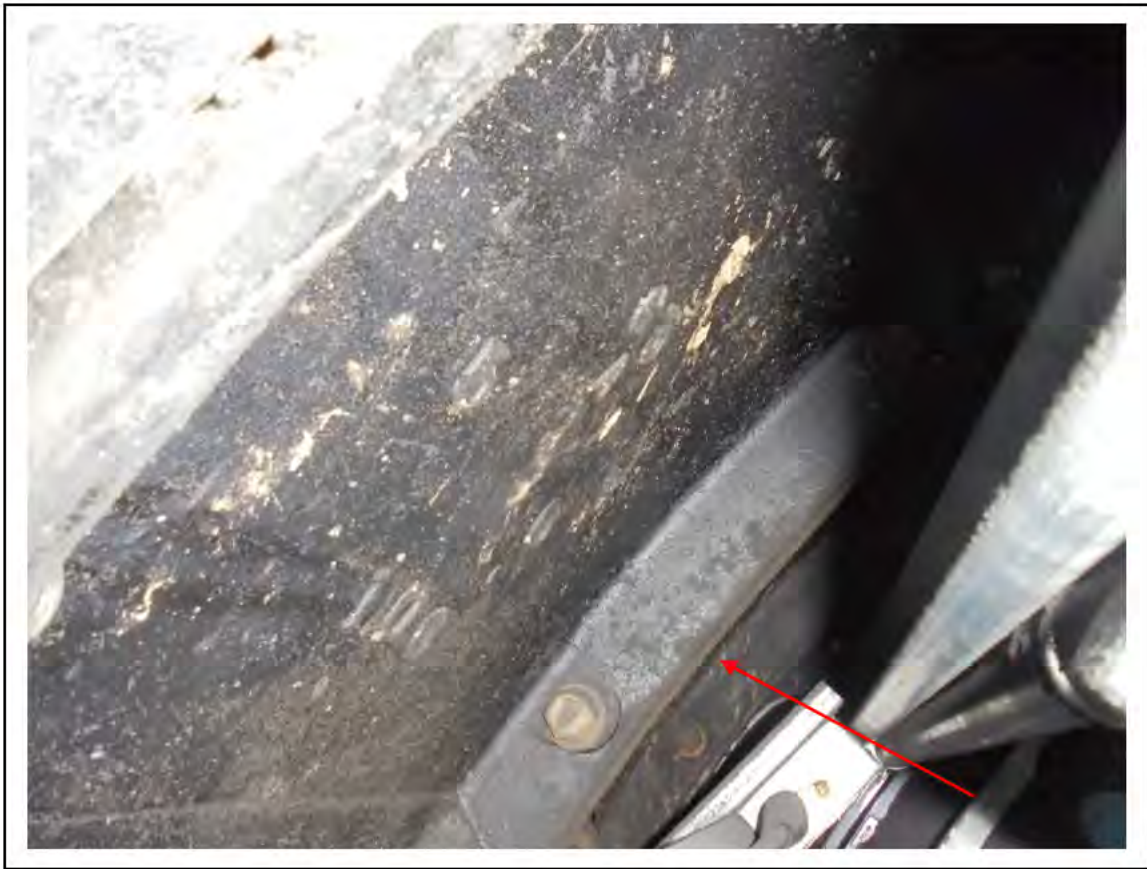
Sample Number	ECS 85377
Location	Intermediate Concourse, 4/203
Material Description	Tunnel ring caulking
Material Comment	To tunnel ring flanges within false ceiling throughout passage
Quantity	100m throughout to all tunnel ring joints present
Product Type	Highly friable
Current Condition	Slight damage
Surface Treatment	Untreated highly friable
Asbestos Type	Amosite
Material Assessment Rating	Medium
Accessibility	Low
Further Comment	Not applicable

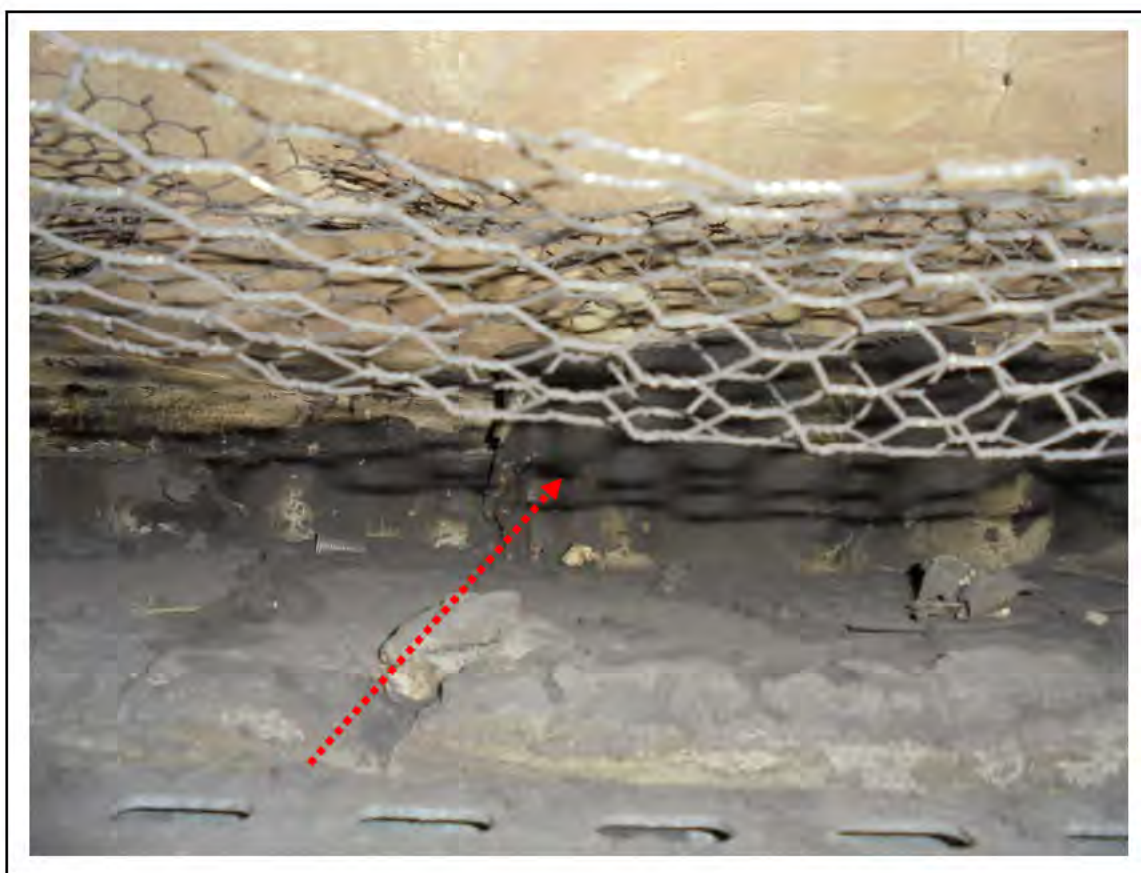
Sample Number	110452/160811/01
Location	Passage and Overbridge, 4/202 & 4/637
Material Description	Cellactite sheeting
Material Comment	Sporadic to cavity walls within false ceiling (previously sampled)
Quantity	<1m ² visible
Product Type	Composite
Current Condition	Slight damage
Surface Treatment	Composite
Asbestos Type	Chrysotile
Material Assessment Rating	Very low
Accessibility	Low
Further Comment	Not applicable

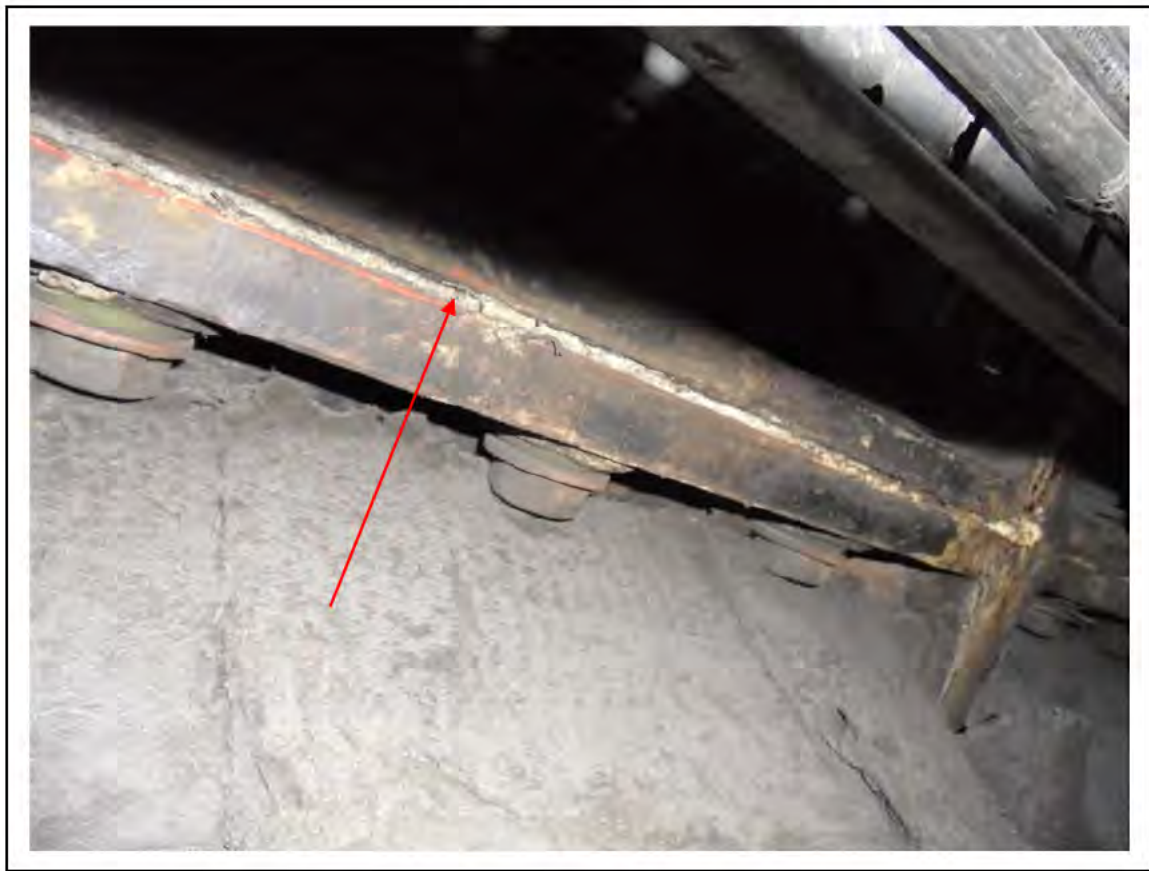
Sample Number	ECS85389
Location	Passage, 4/205
Material Description	Tunnel ring caulking
Material Comment	Throughout to flanges of tunnel rings (previously sampled)
Quantity	~60m throughout to all tunnel ring joints present
Product Type	Highly friable
Current Condition	Slight damage
Surface Treatment	Untreated highly friable
Asbestos Type	Amosite & Chrysotile
Material Assessment Rating	Medium
Accessibility	Low
Further Comment	Not applicable

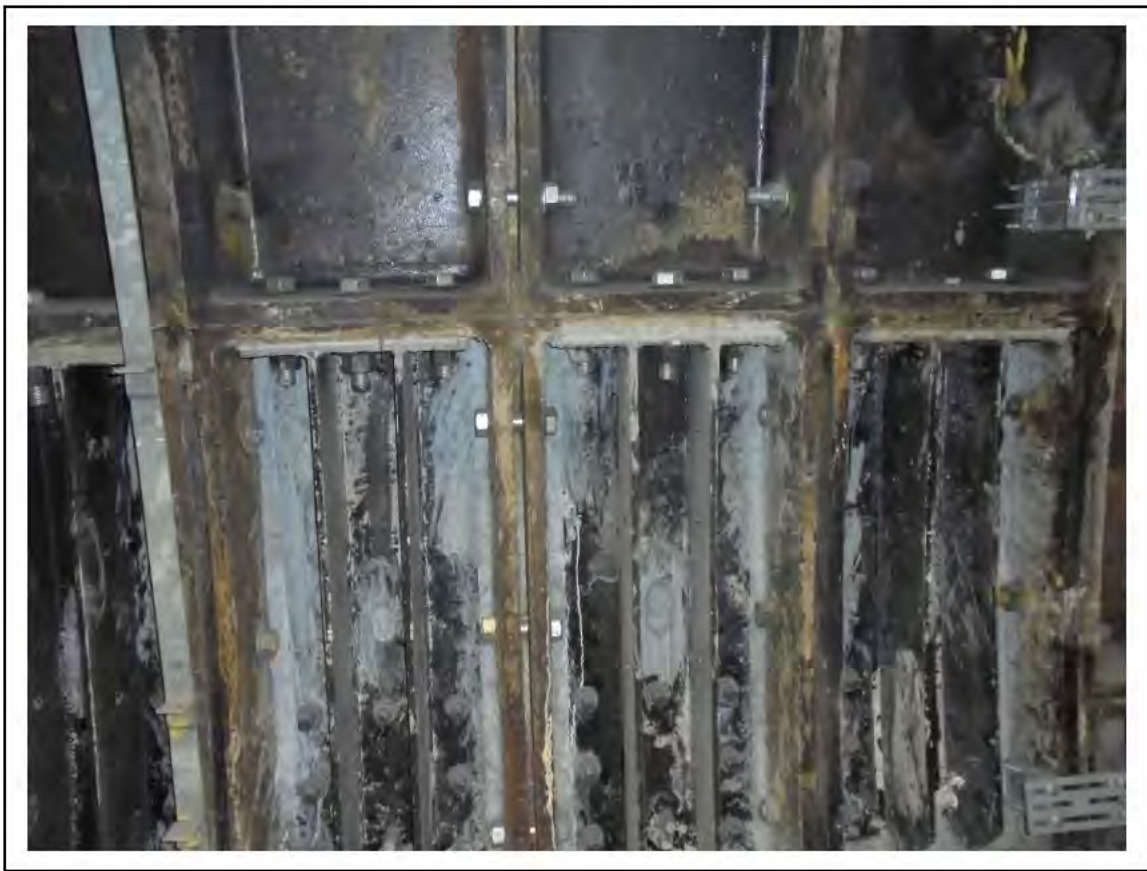
Sample Number	As 014003/12
Location	Circ Area, 4/092
Material Description	Tunnel ring caulking
Material Comment	To tunnel ring flanges throughout to ceiling and within false ceiling (previously sampled)
Quantity	Throughout to all tunnel ring joints present
Product Type	Highly friable
Current Condition	Slight damage
Surface Treatment	Untreated highly friable
Asbestos Type	Amosite & Chrysotile
Material Assessment Rating	Medium
Accessibility	Low
Further Comment	Not applicable

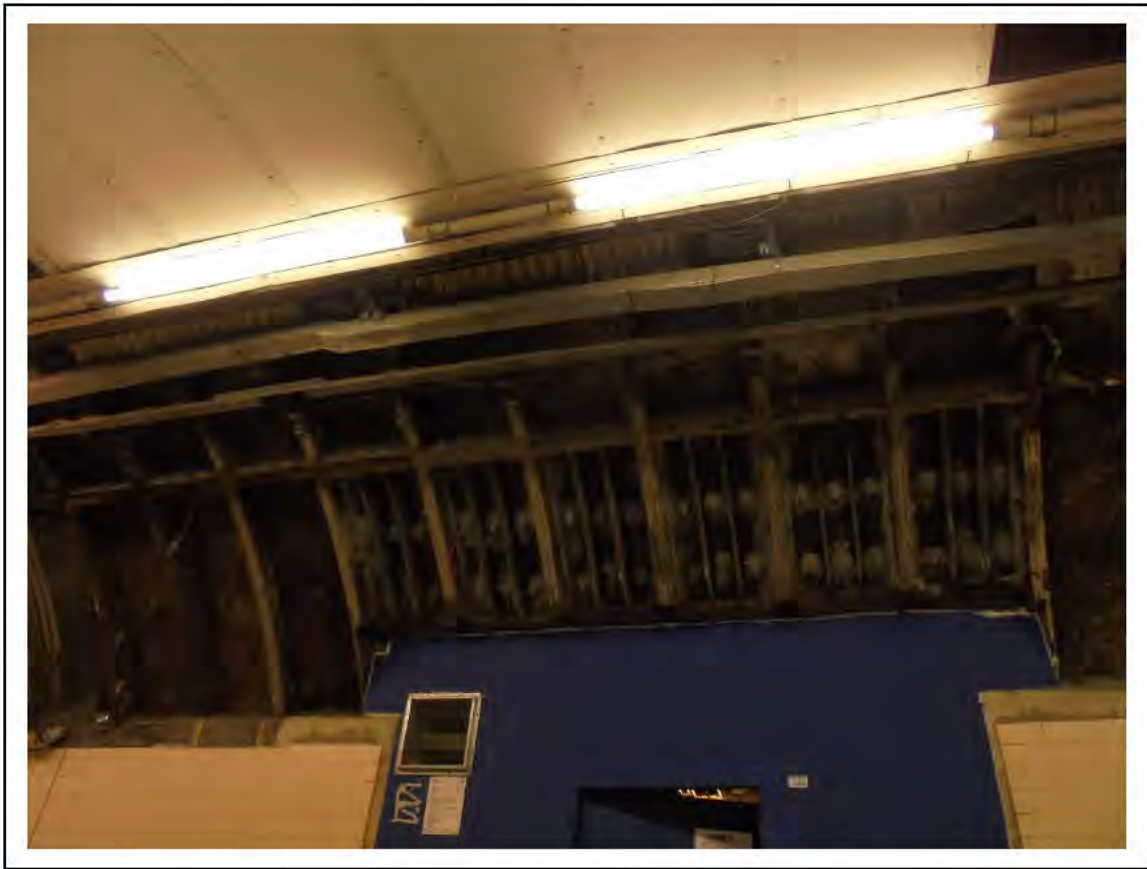
Sample Number	As 014003/12
Location	Circ Area, 4/091
Material Description	Tunnel ring caulking
Material Comment	To tunnel ring flanges throughout to ceiling and within false ceiling (previously sampled)
Quantity	Throughout to all tunnel ring joints present
Product Type	Highly friable
Current Condition	Slight damage
Surface Treatment	Untreated highly friable
Asbestos Type	Amosite & Chrysotile
Material Assessment Rating	Medium
Accessibility	Low
Further Comment	Not applicable
