From: Kelly Darren
Sent: 02 June 2020 11:54
To: Storer Richard
Cc: Forrest Jim; Venn Daniel
Subject: Kempton Court CCTV Survey
Attachments: PJ00366135_Socotec UK Limited_51 Durward Street_New Install (1).pdf; drainage sketch - mark up.pdf

Project Name: PJ00366135_Socotec UK Limited_51 Durvward Street_New Install

Project Description: CCTV survey - New Installation

This report is issued as part of C512-BBM-A-ITP-D061_WS106-50227, inspection number 5.9, showing conditions of the existing drainage within BBMV construction site boundaries in Kempton Court private car park on the completion.

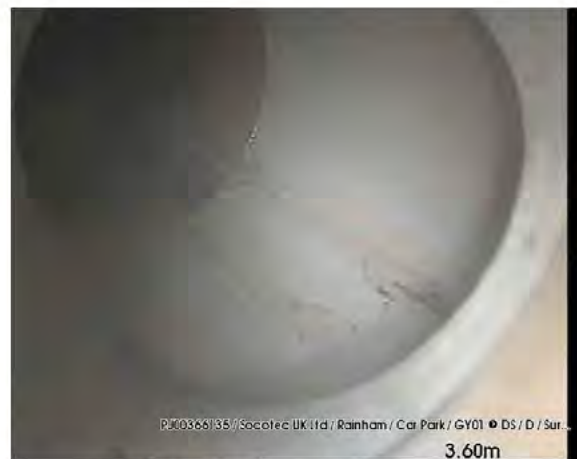
200317_1205E-Survey.jpg, 00:00:11, 2.45 m
Line deviates down

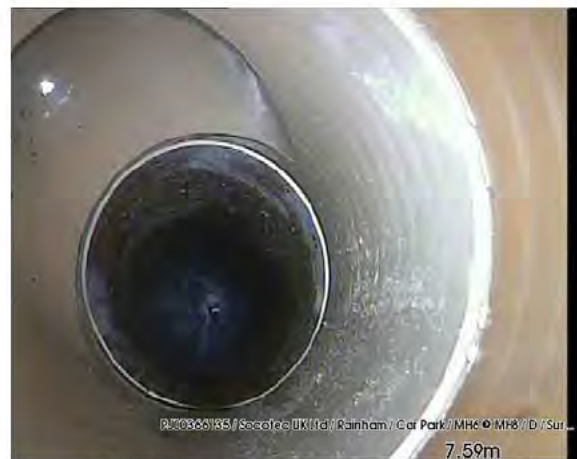
200317_1232B-Survey.jpg, 00:00:11, 2.79 m
Junction, at 11 o'clock, diameter: 150 mm

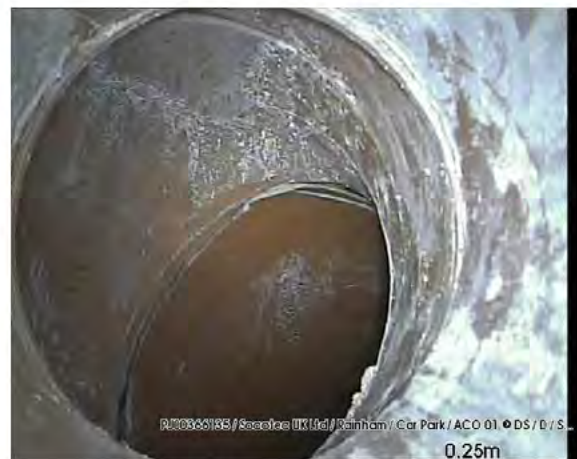
200317_1237E-Survey.jpg, 00:00:04, 0.00 m
Line deviates down

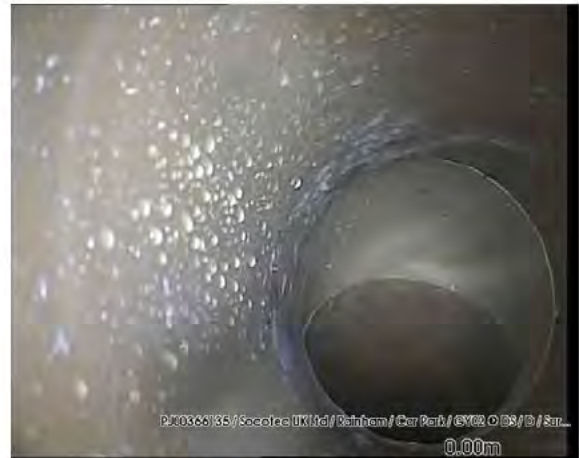
200317_1245A-Survey.jpg, 00:00:00, 0.00 m
 Start node type, gully, reference number: GY02

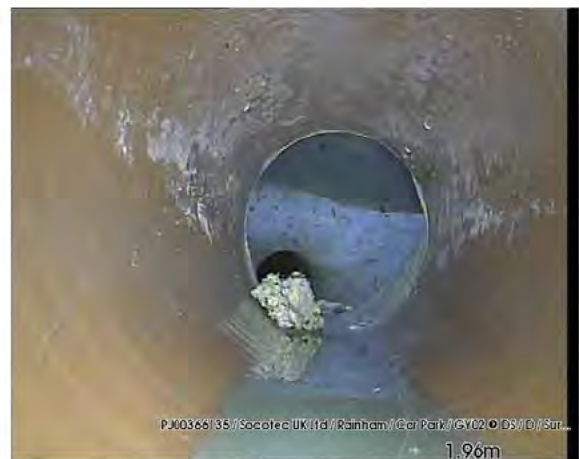
200317_1245C-Survey.jpg, 00:00:18, 0.31 m
 Line deviates down

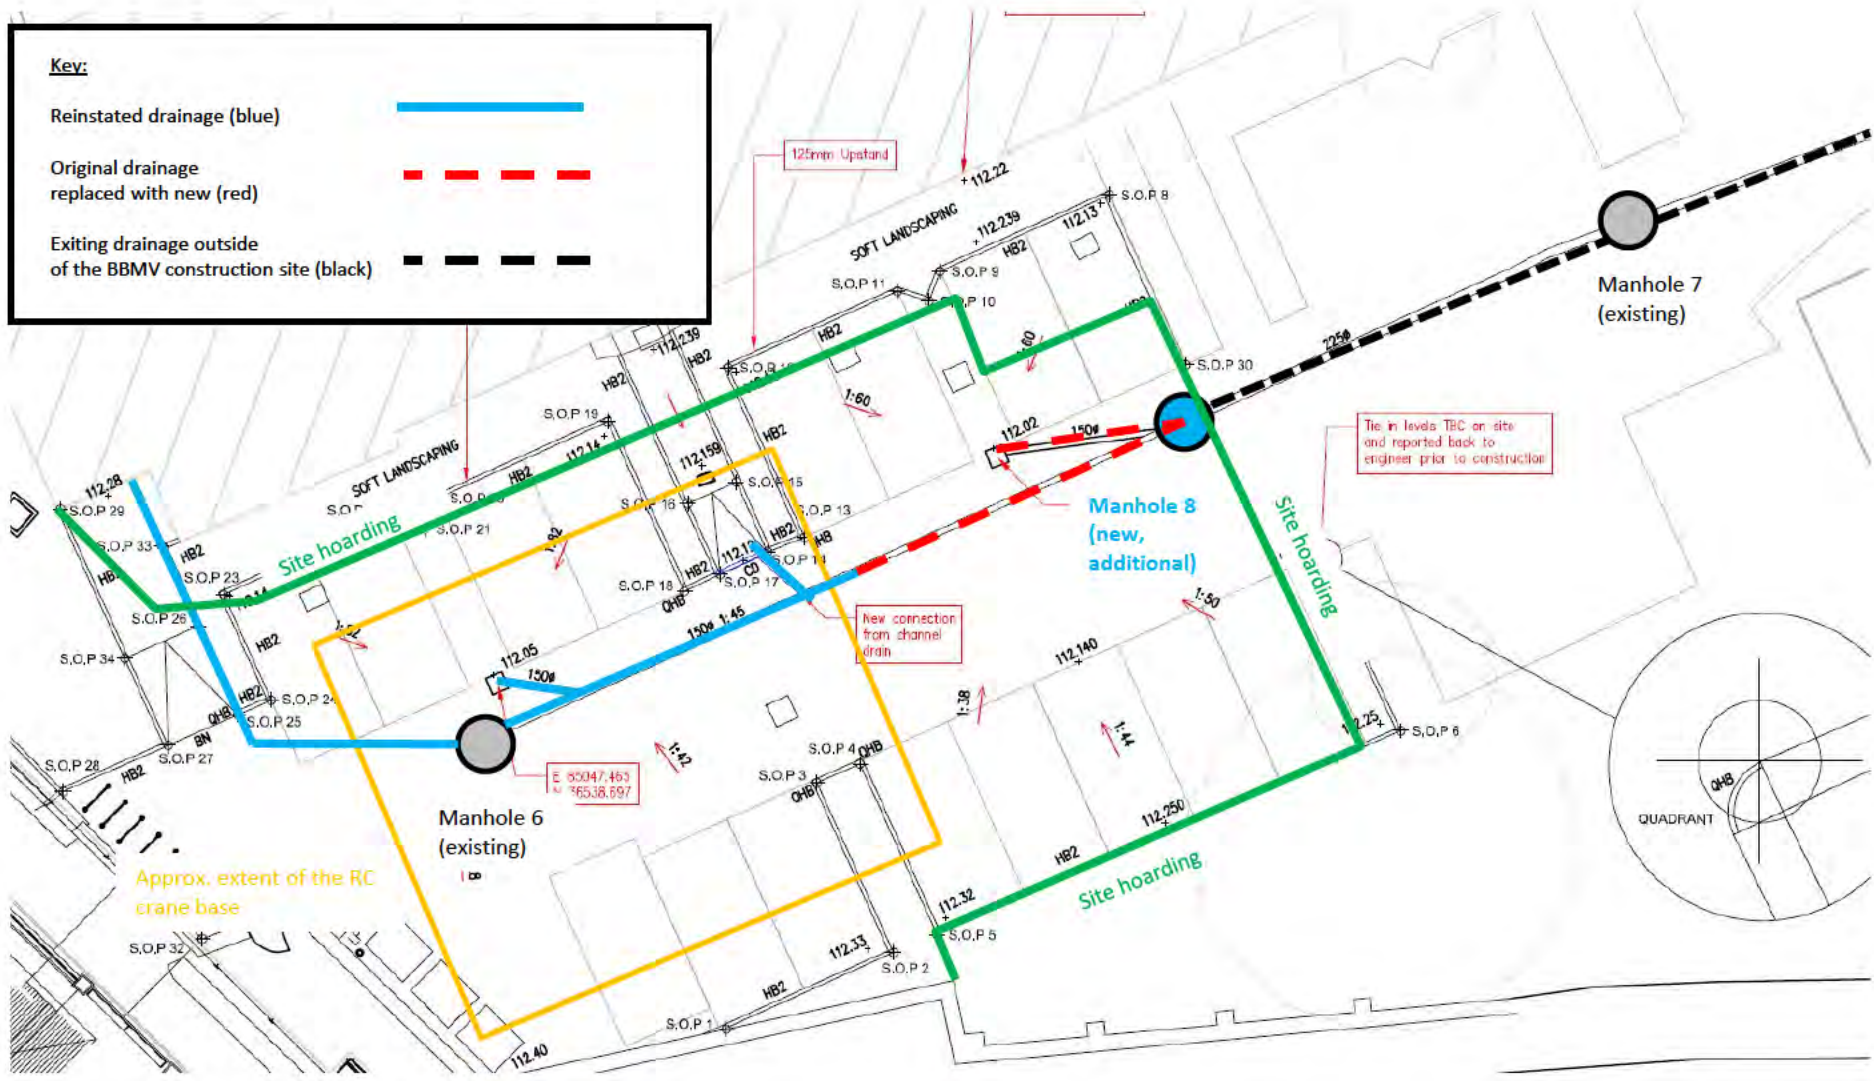
At the time of the survey, the section of the surface water drainage located under former RC crane base has been already replaced by BBMV, including road gully no. RG2. Refer to *Appendix 2 – CCTV report* for details.

- Reinstated drainage (blue)
- Original drainage replaced with new (red)
- Exiting drainage outside of the BBMV construction site (black)

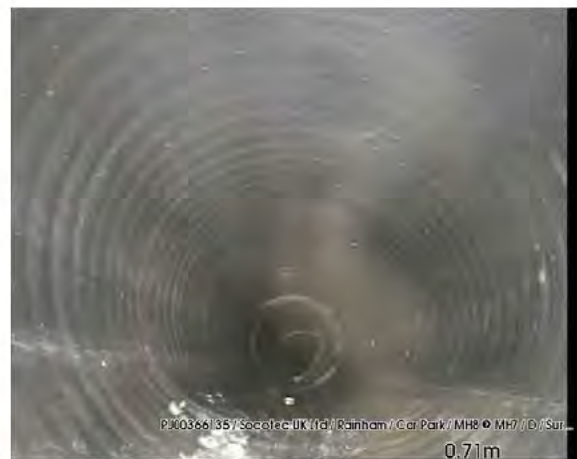
200317_1336B-Survey.jpg, 00:00:10, 0.64 m
 Material changes Polypropylene @REM

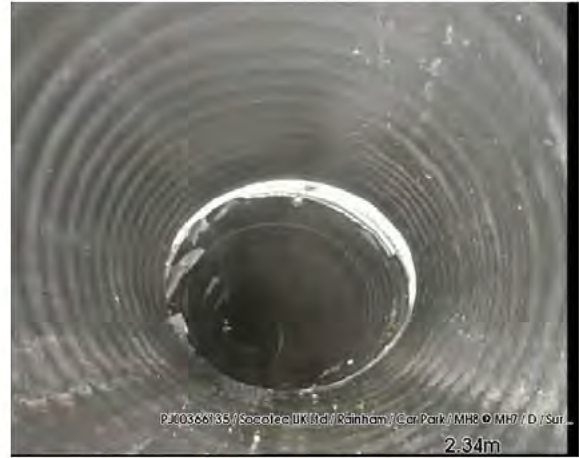
200317_1336D-Survey.jpg, 00:00:25, 1.80 m
 Junction, at 10 o'clock, diameter: 150 mm

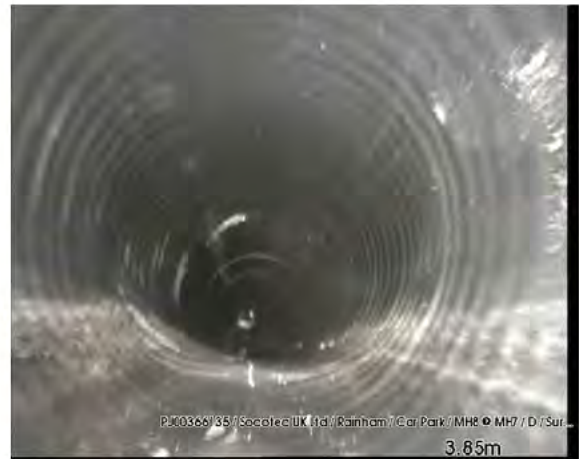
200317_1337B-Survey.jpg, 00:00:34, 2.86 m
 Line deviates down

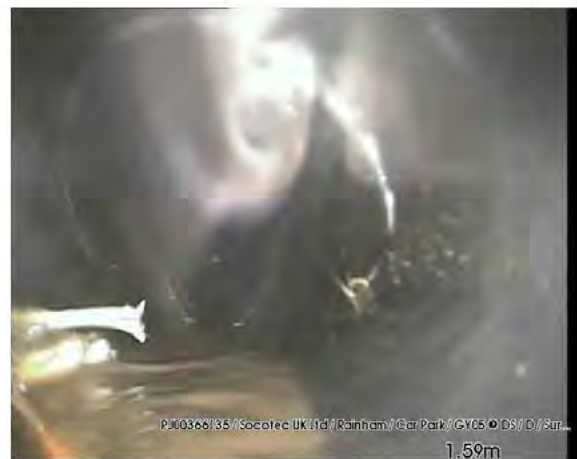
200318_1202E-Survey.jpg, 00:00:04, 0.00 m
 General remark, belly in pipe

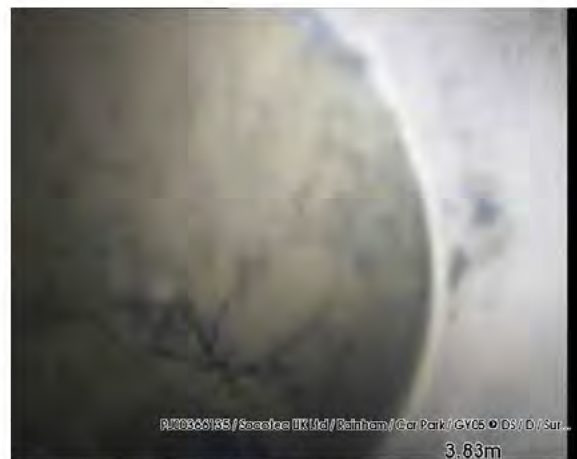
200318_1203B-Survey.jpg, 00:00:33, 3.27 m
 Material changes Vitrified clay pipe @REM

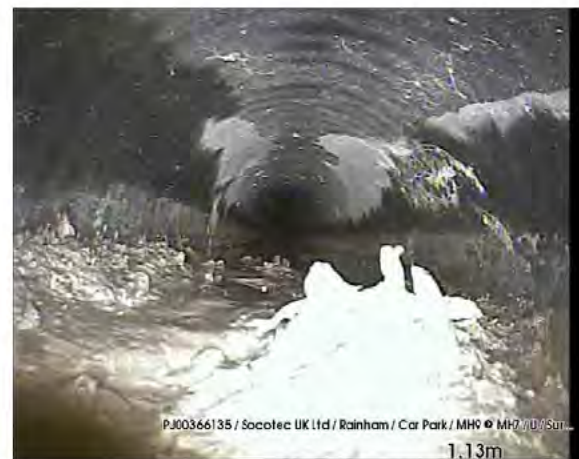
Section	PLR	Grade	Description
7	MH7X	4	Settled deposits, fine, 40% % cross-sectional area loss
8	MH9X	3	Multiple defects
13	GY06X	3	Settled deposits, fine, 10% % cross-sectional area loss
14	GY08X	3	Settled deposits, fine, 10% % cross-sectional area loss
16	GY07X	3	Settled deposits, fine, 10% % cross-sectional area loss

200317_1436A-Survey.jpg, 00:00:09, 0.00 m
 Settled deposits, fine, 40% % cross-sectional area loss

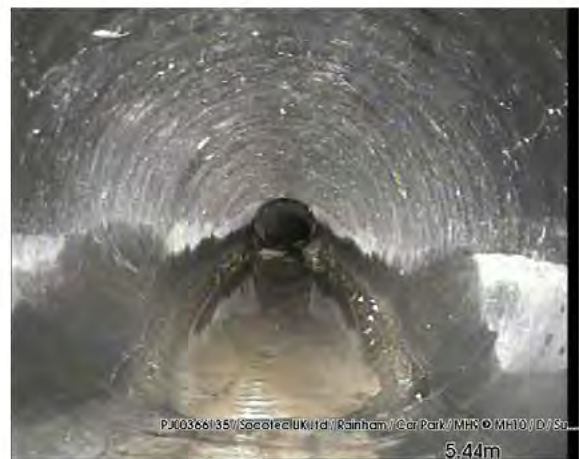
200317_1440E-Survey.jpg, 00:00:32, 3.94 m
 Settled deposits, fine, 10% % cross-sectional area loss

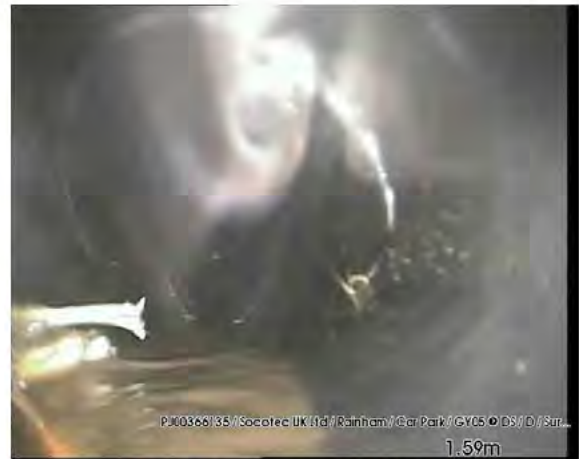
200318_1202E-Survey.jpg, 00:00:04, 0.00 m
 General remark, belly in pipe
