Northern Line Extension Arboricultural Impact Assessment

March 4th 2013

Report Reference: NLE-040313-JP-ARB

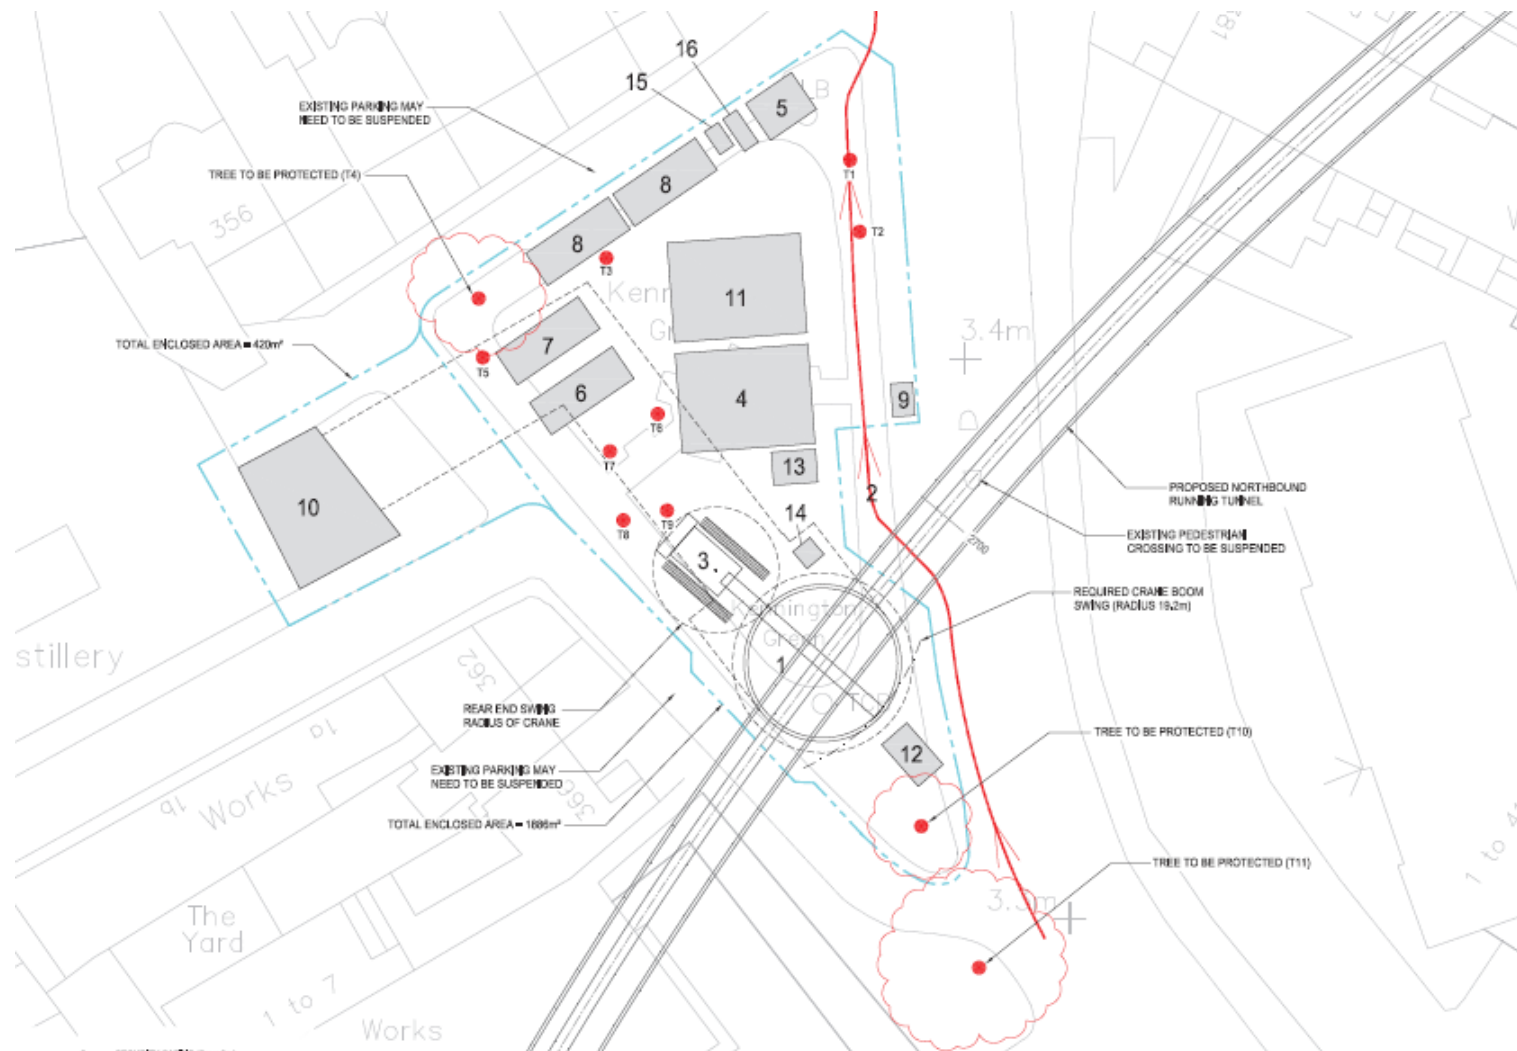
Kennington Green

4.2 Eleven trees were surveyed in total. TfL are responsible for maintaining four (T1, T2, T10 and T11), and the London Borough of Lambeth for the other seven.

4.3 The proposal requires the removal of eight trees from this site. These are T1, T2, T3, T5, T6, T7, T8 and T9.

4.4 Four of the trees (T3, T6, T7 and T9) are in poor condition and have been classified as Category U trees. Removal would be recommended independently of the NLE proposal.

4.5 T5 has been classified as a British Standard 5837 Category C tree. Please see the Appendices of this report for details relating to BS5837 Categorisation.

4.6 T8 has been classified as a Category B tree.

4.7 T1 and T2 have been classified as Category A trees.

T#	Location	Common name	Botanical name	Ht	DBH	N,S,E,W	Age	Phys Con	Stru Con	5837 Cat	Notes	Work Recommendations
1	Opp 344, on Kennington Road	Plane	Platanus	13	390	5,5,4,5	SM	G	G	A	No visible defects. Tfl tree.	Remove
2	On Kennington Rd, opp black entrance gates	Plane	Platanus	12	300	5,5,5,5	SM	G	G	A	No visible defects. Tfl tree.	Remove
3	Opp 350, on grass	Cherry	Prunus	7	330	3,4,5,2	M	P	P	U	Canopy decline, lean, dog damage, old pruning wounds	Remove
4	Opp 352, on pavement	Tree of Heaven	Ailanthus	14	680	5,4,5,6	M	F	F	B	Minor deadwood	No work required
5	Opp 354, on pavement	Ash	Fraxinus	12	390	5,4,5,5	SM	F	F	C	Basal damage, vehicle strikes, sparse foliage at top of crown	Remove
6	Opp Montford Place, adjacent central paving	Cherry	Prunus	7	420	6,1,4,3	M	P	P	U	Deadwood, tree generally in decline, old pruning wounds, black exudations from stem	Remove
7	Opp Montford Pl, adjacent pavement	Cherry	Prunus	6	330	2,3,4,3	M	P	P	U	Cavities, deadwood, unbalanced crown, dieback	Remove

8	Opp 362, on pavement	Tree of Heaven	Ailanthus	15	740	6,7,6,5	M	F	F	B	Minor deadwood, extensive suckering and epicormic growth	Remove
9	Opp 362, on grass	Cherry	Prunus	5	290	3,2,4,1	M	P	P	U	Canopy is 50% dead, fungal fruting bodies all over stem, lean, overshadowed by adjacent Ailanthus, stem decay, dog damage	Remove
10	Opp 366, on pavement	Maidenhair Tree	Gingko	11	210	4,4,4,4	SM	F	G	B	Sparse foliage towards top of crown, several crossing branches throughout. Tfl tree.	No work required
11	On Kennington Rd, adjacent to Clayton Street	Plane	Platanus	14	540	8,6,7,8	M	G	G	A	No visible defects. Tfl tree.	Remove

4.8 T4, T10 and T11 must all be adequately protected during the construction phase. Suitable methods of tree protection are to be found in BS5837, extracts of which are contained within the Appendices of this report.

4.9 All tree removals are to be mitigated by an extensive post-construction replanting programme – to be agreed with the Local Authority/TfL Tree Officer – with the intention of restoring the landscape to a higher standard than that which currently exists.

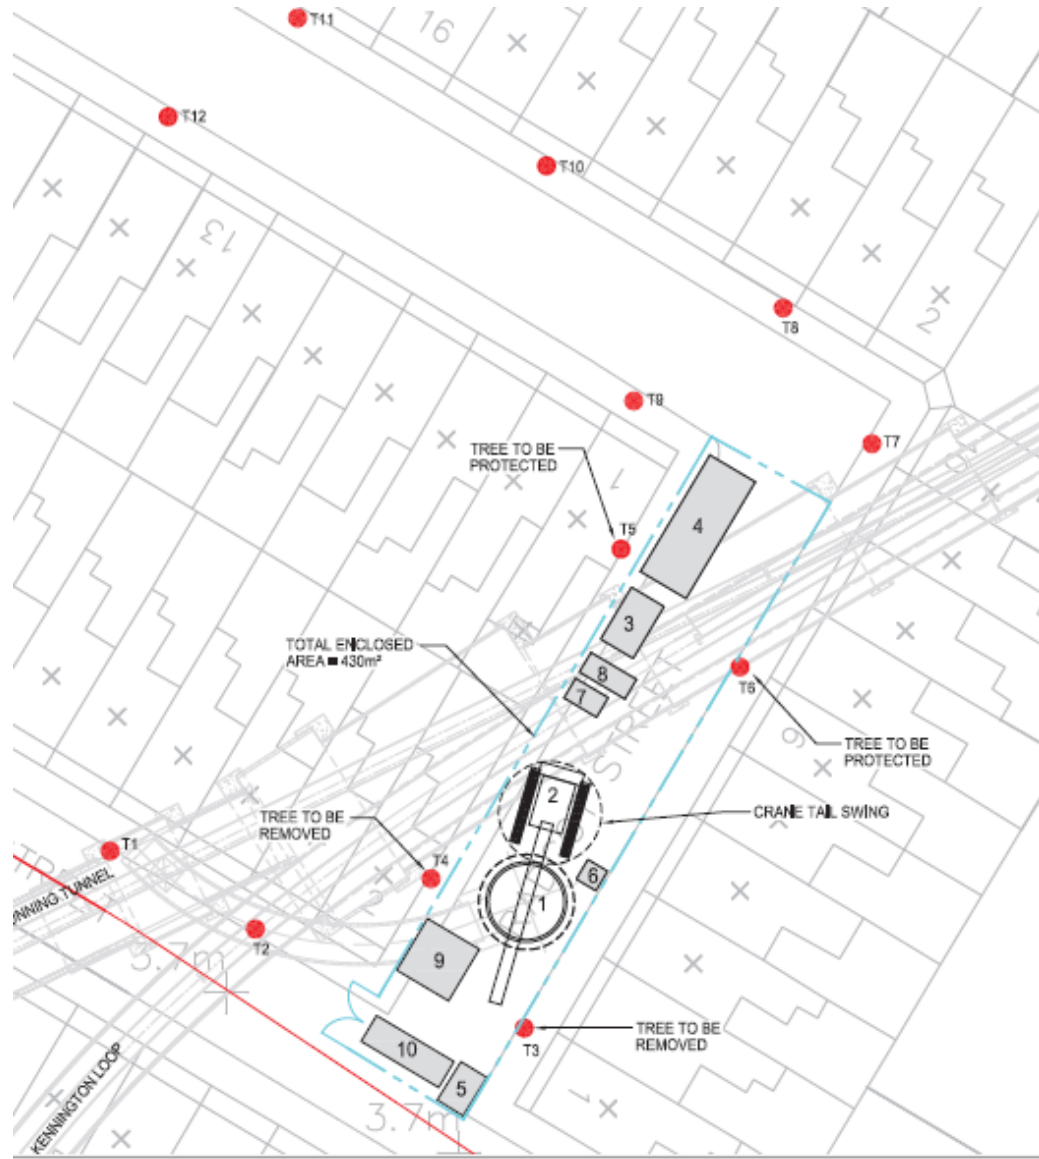
Radcot Street

5.2 Twelve trees were surveyed in total, all of which are the responsibility of LB Lambeth. Only four of these trees (T3, T4, T5 and T6) are to be affected by the proposal.

5.3 Two trees (T3 and T4) require removal. They have been classified as Category B and U respectively.

T#	Location	Common name	Botanical name	Ht	DBH	N,S,E,W	Age	Phys Con	Stru Con	5837 Cat	Defects	Work Recommendations
1	Os 6/8 Ravensdon	Photinia	Photinia	4	60	1,1,1,1	Y	G	G	C	No visible defects	No work required
2	Os 2 Ravensdon	Ash	Fraxinus	6	120	2,2,2,2	Y	G	F	C	Apparent weakness at graft point at 2m, weak branch unions	No work required
3	Os 2 Radcot	Birch	Betula	10	170	3,3,2,3	SM	G	F	B	Co-dominant stem from 3m	Remove
4	Opp 2 Radcot	ear	Pyrus	9	260	3,1,1,3	SM	P	P	U	Lean, dieback, conflicting with overhead cables, vehicle damage, significant torn-out limbs	Remove
5	Opp 5 Radcot	Honey Locust	Gleditsia	12	370	4,4,5,5	SM	G	F	B	Low crown, touching buildings, roots causing damage to pavements	Crown lift to facilitate hoarding
6	Os 6 Radcot	Pear	Pyrus	10	300	3,2,3,3	SM	F	F	C	Conflicting with overhead cables	Crown lift to facilitate hoarding
7	Os 9/10 Radcot	Whitebeam	Sorbus	10	380	4,2,3,3	SM	F	F	C	Black exudations at base	No work required

8	Os 2 Methley	Pear	Pyrus	8	180	3,4,2,2	SM	F	F	C	Minor vehicle damage on limb	No work required
9	Os 1 Methley	pear	Pyrus	10	150	2,2,2,2	SM	G	G	B	No visible defects	No work required
10	Os 8/10 Methley	pear	Pyrus	5	60	1,1,1,1	Y	G	G	C	No visible defects	No work required
11	Os 12 Methley	Golden Rain Tree	Koelreuteria	6	90	2,2,2,2	Y	G	G	C	No visible defects	No work required
12	Os 11 Methley	Hawthorn	Crataegus	7	270	4,2,2,1	M	P	P	U	Sparse crown, lean, cavity at base, substantial old pruning wounds, growing into overhead cables	No work required

5.4 Two trees (T5 and T6) require crown lifting to facilitate the installation of hoarding. Works are to be agreed with the LB Lambeth Tree Officer. They must be adequately protected during the construction phase. Suitable methods of tree protection are to be found in BS5837, extracts of which are contained within the Appendices of this report.

5.5 All tree removals are to be mitigated by an extensive post-construction replanting programme – to be agreed with the Local Authority/TfL Tree Officer – with the intention of restoring the landscape to a higher standard than that which currently exists.

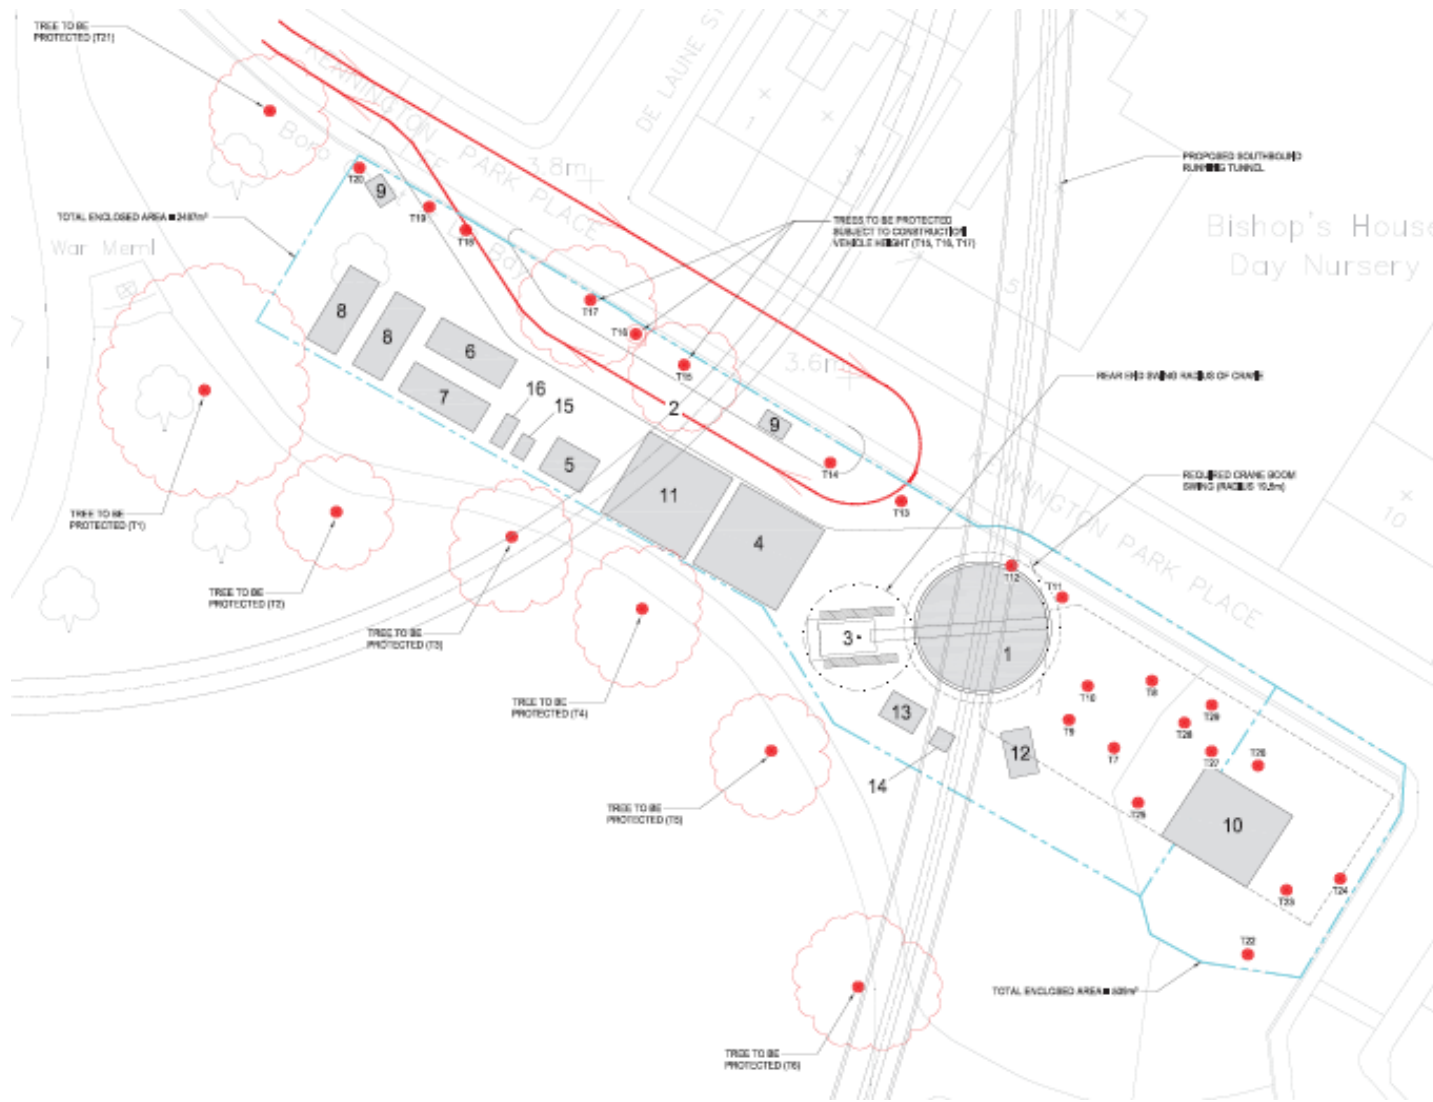
Kennington Park

6.4 Twenty two trees require removal in order to accommodate this proposal. These are T7, T8, T9, T10, T11, T12, T13, T14, T15, T16, T17, T18, T19, T20, T22, T23, T24, T25, T26, T27, T28 and T29.

6.5 None of the twenty two trees are of sufficient quality individually to warrant retention at the expense of this development.

6.6 Fourteen trees are located behind a fence within the allocated dog area. These are T7, T8, T9, T10, T11, T12, T13, T14, T15, T16, T17, T18, T19 and T20.

6.7 Four trees in the dog area (T14, T16, T18 and T20) have been classified as BS5837 Category U; T14 and T18 are dead. The other ten trees in the dog area have been classified as Category C.

T#	Location	Common name	Botanical name	Ht	DBH	N,S,E,W	Age	Phys Con	Stru Con	5837 Cat	Notes	Work Recommendations
1	South of memorial	Plane	Platanus	23	1300	13,11,10,10	M	G	G	A	Minor deadwood, risk of compaction from adjacent path	No work required
2	South of dog area, in avenue	Oak	Quercus	12	710	6,6,6,6	M	G	G	A	Minor deadwood	No work required
3	South of dog area, in avenue	Oak	Quercus	12	800	6,8,6,6	M	G	G	A	Black exudations from lowest scaffold limb, which has developed a large rib	No work required
4	South of dog area, in avenue	Oak	Quercus	12	670	6,8,5,6	M	G	G	A	No visible defects	No work required
5	South of dog area, in avenue	Oak	Quercus	12	740	6,7,6,6	M	G	G	A	No visible defects	No work required
6	South of dog area, in avenue	Oak	Quercus	12	730	7,6,8,6	M	G	G	A	No visible defects	No work required
7	North east corner of dog area	Birch	Betula	7	110	3,3,3,3	SM	F	F	C	No visible defects	Remove
8	North east corner of dog area	Birch	Betula	7	110	3,3,3,3	SM	F	F	C	No visible defects	Remove

9	North east corner of dog area	Birch	Betula	7	110	3,3,3,3	SM	F	F	C	No visible defects	Remove
10	North east corner of dog area	Birch	Betula	7	110	3,3,3,3	SM	F	F	C	No visible defects	Remove
11	Northern boundary of dog area	Tree of Heaven	Ailanthus	10	280	4,4,4,4	SM	F	F	C	Minor snapped limbs	Remove
12	Northern boundary of dog area	False Acacia	Robinia	8	190	2,2,2,2	SM	F	F	C	Sparse crown, very close to retaining wall	Remove
13	Northern boundary of dog area	Ash	Fraxinus	12	350	5,5,5,4	SM	F	F	C	Crossing branches, climbing plants up stem, very close to retaining wall	Remove
14	Northern boundary of dog area	DEAD	DEAD	9	150	3,3,3,3	D	D	D	U	Dead	Remove
15	Northern boundary of dog area	Ash	Fraxinus	12	460	4,7,5,5	SM	F	F	C	Sparse crown, slow recovery to previous pruning wounds	Remove
16	Northern boundary of dog area	False Acacia	Robinia	5	60	1,1,1,1	Y	P	P	U	Dead from 2m upwards	Remove
17	Opp De Cavne Street	Ash	Fraxinus	10	400	5,7,7,7	SM	F	F	C	Minor deadwood, sparse crown	Remove

18	Northern boundary of dog area	DEAD	DEAD	5	60	1,1,1,1	D	D	D	U	Dead	Remove
19	Northern boundary of dog area	Ash	Fraxinus	10	390	5,6,5,5	SM	F	F	C	Sparse crown	Remove
20	Northern boundary of dog area	Ash	Fraxinus	4	70	1,1,1,1	Y	P	P	U	Poor specimen, overshadowed by neighbours, no dominant leader	Remove
21	Northern boundary of dog area	Ash	Fraxinus	12	500	6,7,6,6	SM	F	F	C	Dog damage at base	No work required
22	Kennington Lodge, south of cottage adjacent to fence	Tree of Heaven	Ailanthus	12	530	7,4,8,7	SM	F	P	C	Substantial stem damage from 0.5m to 3m, twin stemmed from 3m, poor historic pruning, cavities, torn branches, relatively sparse crown	Remove
23	Kennington Lodge, south of cottage adjacent to path	Holly	Ilex	10	530	3,3,3,3	SM	F	F	B	Twin stemmed from 1m, poor historic pruning, top of tree has been removed in the past	Remove
24	Kennington Lodge, south of cottage adjacent to door	Thorn	Crataegus	8	280	4,3,4,4	M	F	F	B	Deadwood and old pruning stubs throughout crown, canopy is touching the cottage roof	Remove

25	Kennington Lodge, west of cottage adjacent to gate	Cherry	Prunus	7	450	6,6,5,5	M	F	F	B	Twin stemmed from 2m, stem features numerous decay pockets	Remove
26	Kennington Lodge, north of cottage	Thorn	Crataegus	10	590	9,4,4,4	M	F	F	B	Twin stemmed from 1m, triple stemmed from 1.5, substantial historic pruning wounds at base	Remove
27	Kennington Lodge, northwest of cottage	Magnolia	Magnolia	8	180	2,3,2,2	SM	F	F	B	No visible defects	Remove
28	Kennington Lodge, northwest of cottage	Pyracantha	Pyracantha	6	230	4,3,3,3	M	F	P	C	Substantial historic pruning wounds at base	Remove
29	Kennington Lodge, northwest of cottage	Magnolia	Magnolia	7	160	0,5,3,6	SM	F	F	C	Stem leans towards west but tree is attempting to compensate by straightening out over the fence	Remove

6.3 T1, T2, T3, T4, T5, T6 and T21 are to be protected during construction. Suitable methods of tree protection are to be found in BS5837, extracts of which are contained within the Appendices of this report. Very minor pruning may be required in order to facilitate the installation of the hoarding, to be agreed with the LB Lambeth Tree Officer.

6.12 All tree removals are to be mitigated by an extensive post-construction replanting programme – to be agreed with the Local Authority/TfL Tree Officer – with the intention of restoring the landscape to a higher standard than that which currently exists.

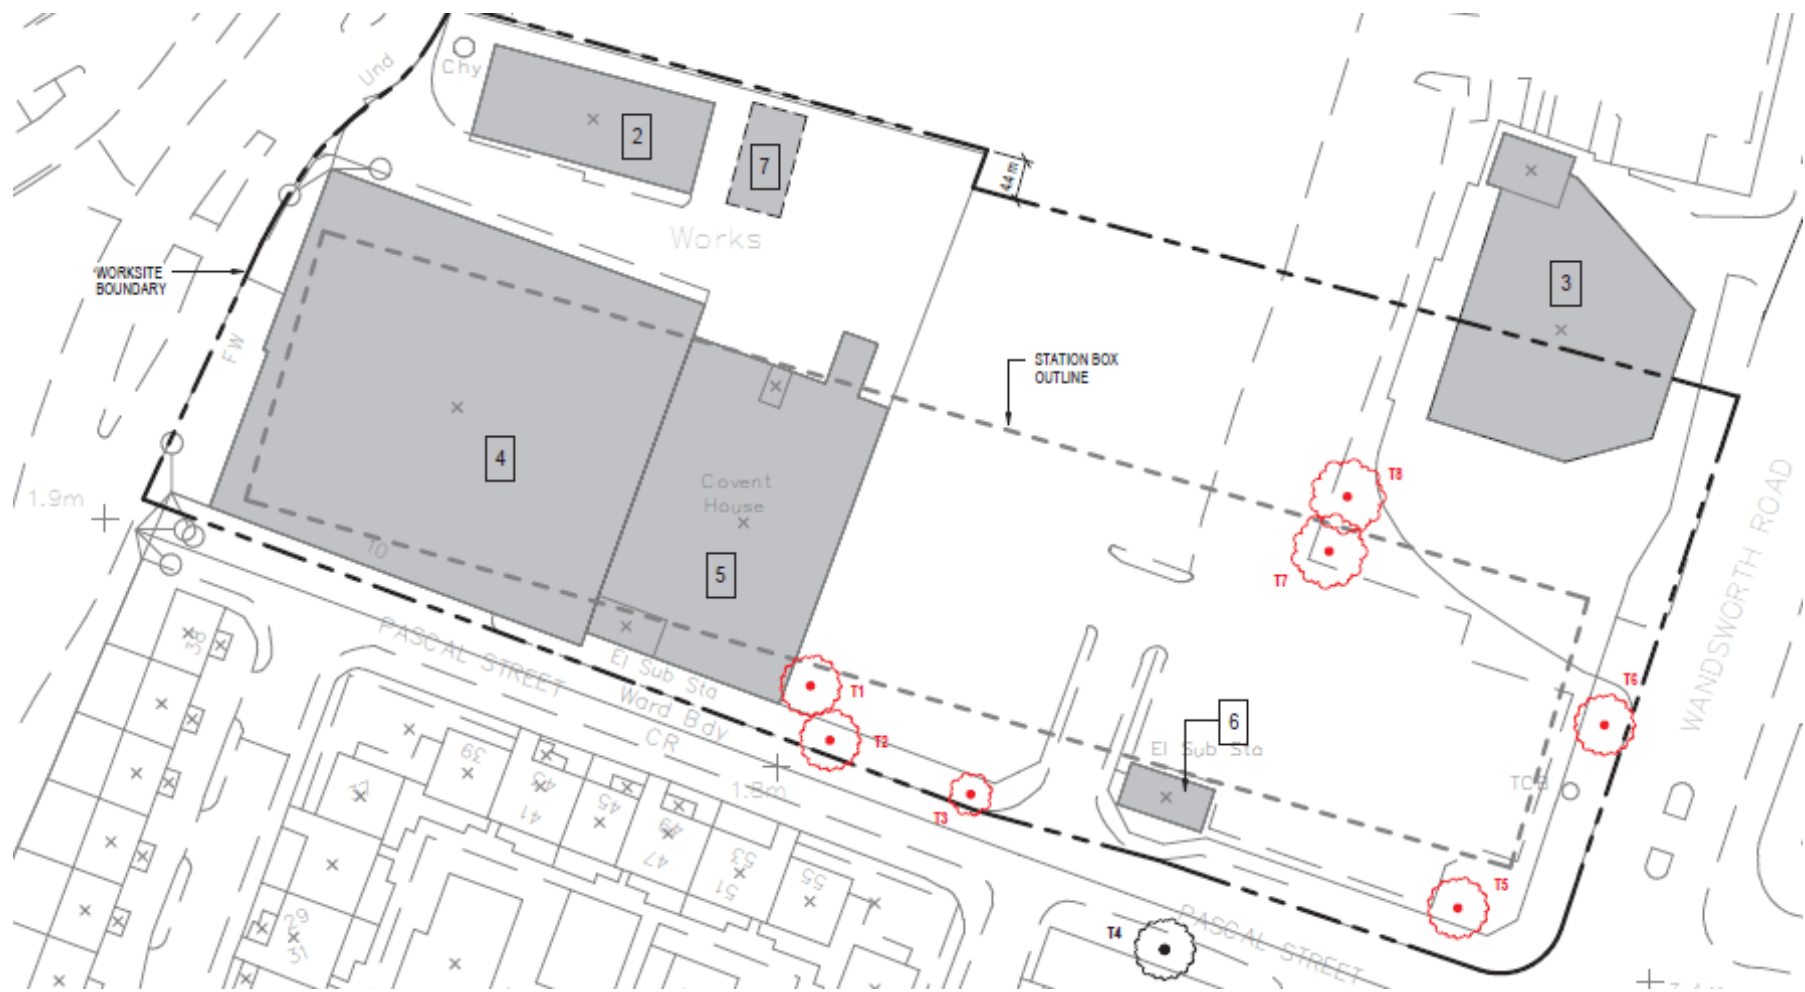
Nine Elms Station

7.3 Seven trees (T1, T2, T3, T5, T6, T7 and T8) require removal in order to facilitate the proposal.

7.4 This development does not require the removal of T4. However, it is a poor specimen in decline and should be considered for removal and replanting.

T#	Location	Common name	Botanical name	Ht	DBH	N,S,E,W	Age	Phys Con	Stru Con	5837 Cat	Notes	Work Recommendations
1	South western corner of Sainsbury's car park	Maple	Acer	8	25	4,3,4,3	SM	F	F	C	No visible defects	Remove
2	Opp 55 Pascal St	Maple	Acer	8	20	3,2,3,3	SM	F	F	C	Sparse crown, minor limbs torn out	Remove
3	Opp Bramley Crescent	Rowan	Sorbus	6	14	2,2,2,2	SM	F	F	C	Minor vehicle damage	Remove
4	Os Lockyer House	Hawthorne	Crataegus	7	36	3,3,3,3	M	P	P	U	Sparse crown, cavities, decay pockets, snapped limbs	No work required
5	South eastern corner of car park	Maple	Acer	6	17	3,3,3,3	SM	F	F	C	Guying system needs adjusting	Remove
6	Opp Wilcox Road	Maple	Acer	7	19	3,3,3,3	SM	F	F	B	No visible defects	Remove
7	Centre of car park, adjacent to petrol station	Plane	Platanus	12	36	5,3,4,4	SM	G	F	B	No visible defects	Remove
8	Centre of car park, adjacent to petrol station	Plane	Platanus	12	38	3,4,4,4	SM	G	F	B	No visible defects	Remove

7.5 All tree removals are to be mitigated by an extensive post-construction replanting programme – to be agreed with the Local Authority/TfL Tree Officer – with the intention of restoring the landscape to a higher standard than that which currently exists.
