REPORT TITLE: **ERAD Sub-Frame Bush Testing**

CUSTOMER: **London EV Company Limited**  
**Li Close, Ansty Park, Coventry, CV7 9RF**

REPORT No: **LEV0113**

DATE: **March 22**

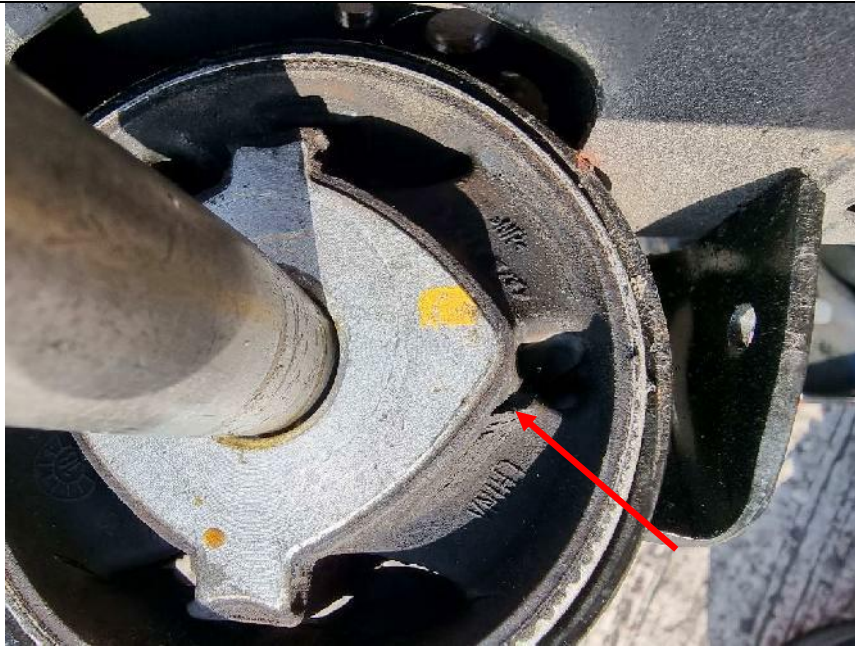
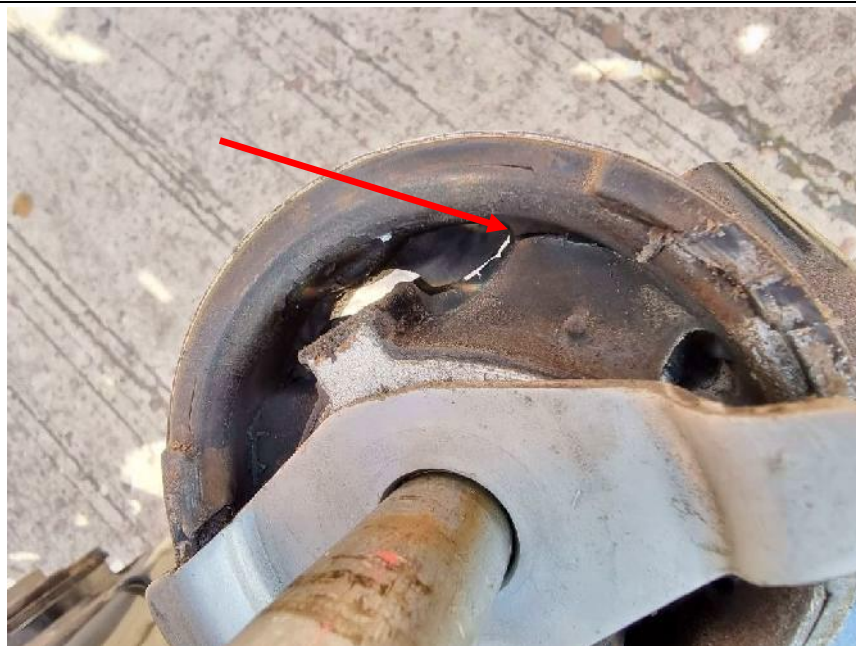
- 6.1. The stiffness of the 4 bushes on the used subframe and the bush on the new subframe were within the new production part stiffness specification of 500N/mm  $\pm$  10%. This criteria was specified by Boge, the bush manufacturer.
- 6.2. The older subframe bushes exhibited rubber cracks during post-test inspections. The same cracks were not visible on the new subframe bush.

**Figure 15 – 1A Bush Investigation**

**Figure 16 – 1A Bush Investigation**

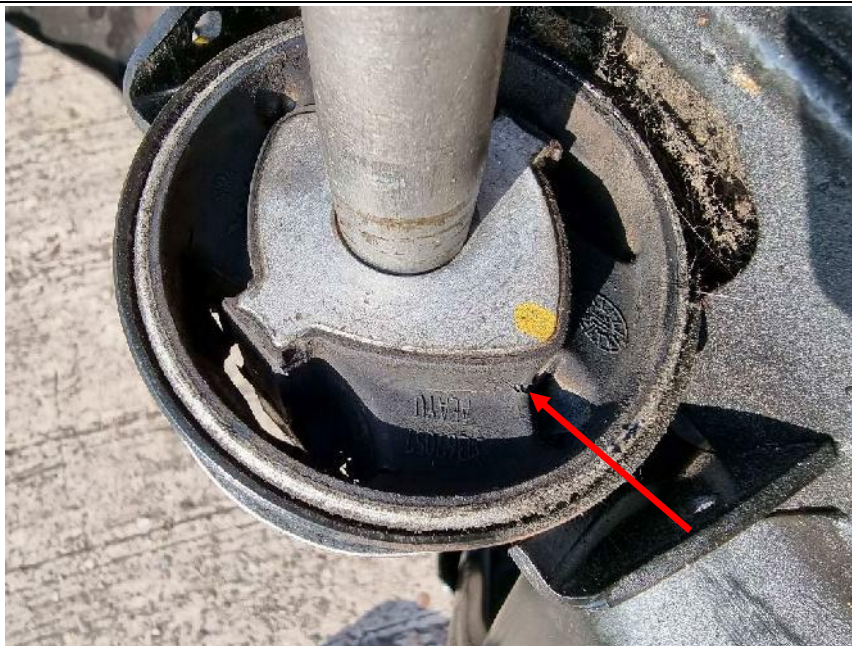
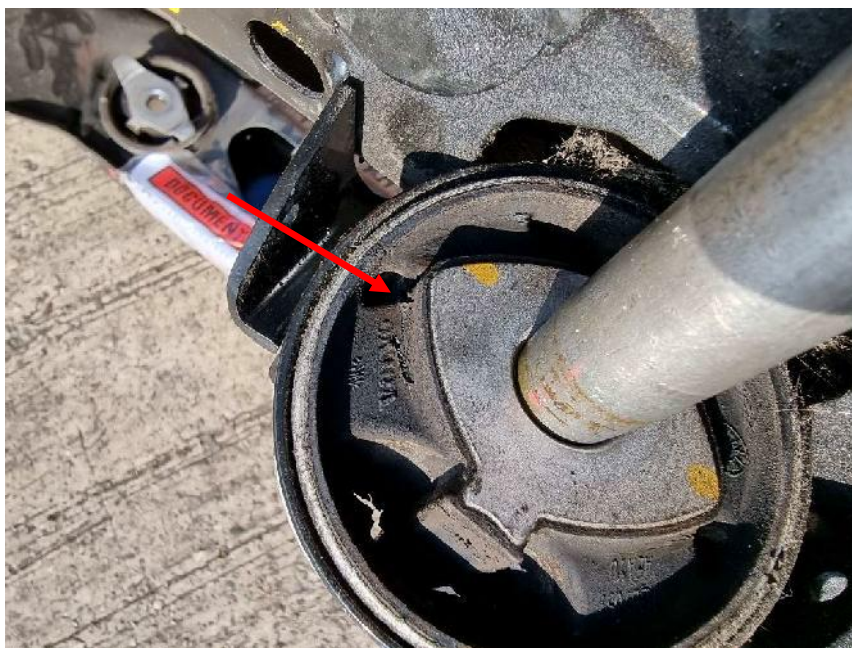
**Figure 17 – 1B Bush Investigation**

**Figure 18 – 1B Bush Investigation**

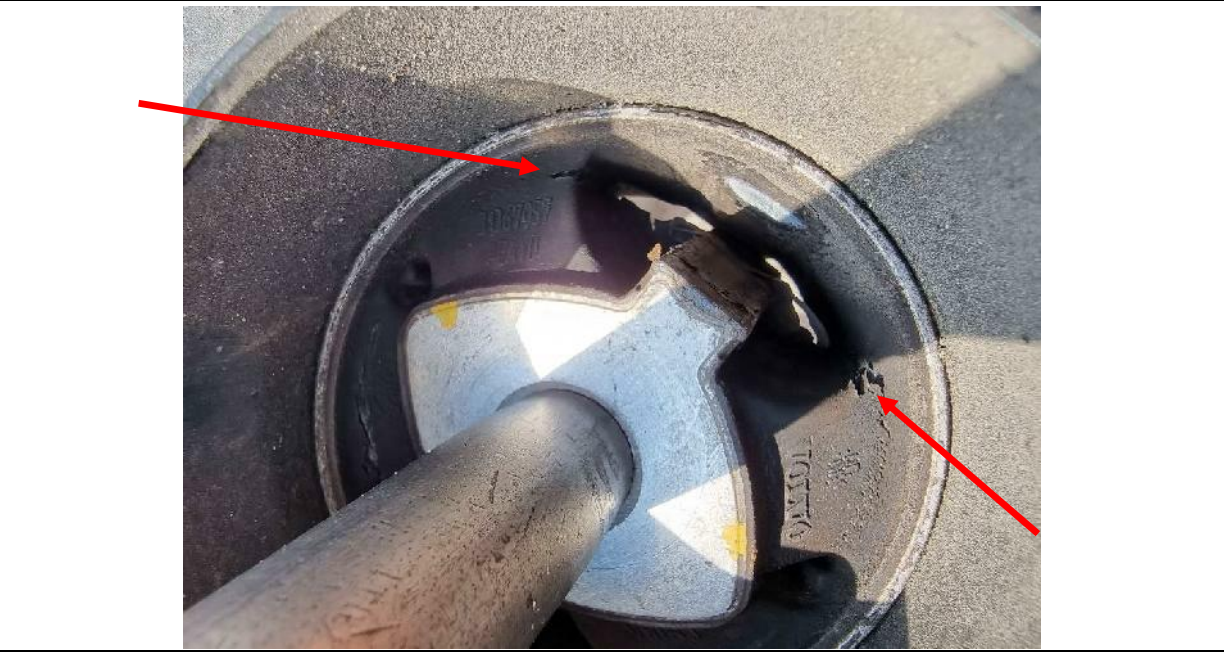
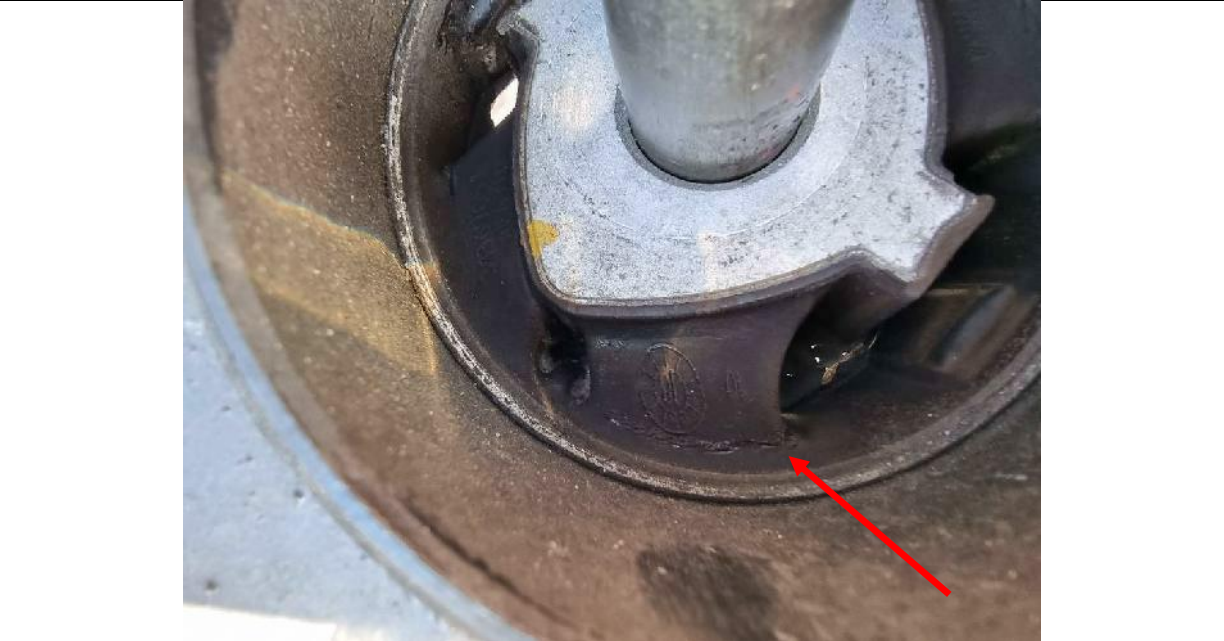
**Figure 19 – 1C Bush Investigation**

**Figure 20 – 1C Bush Investigation**

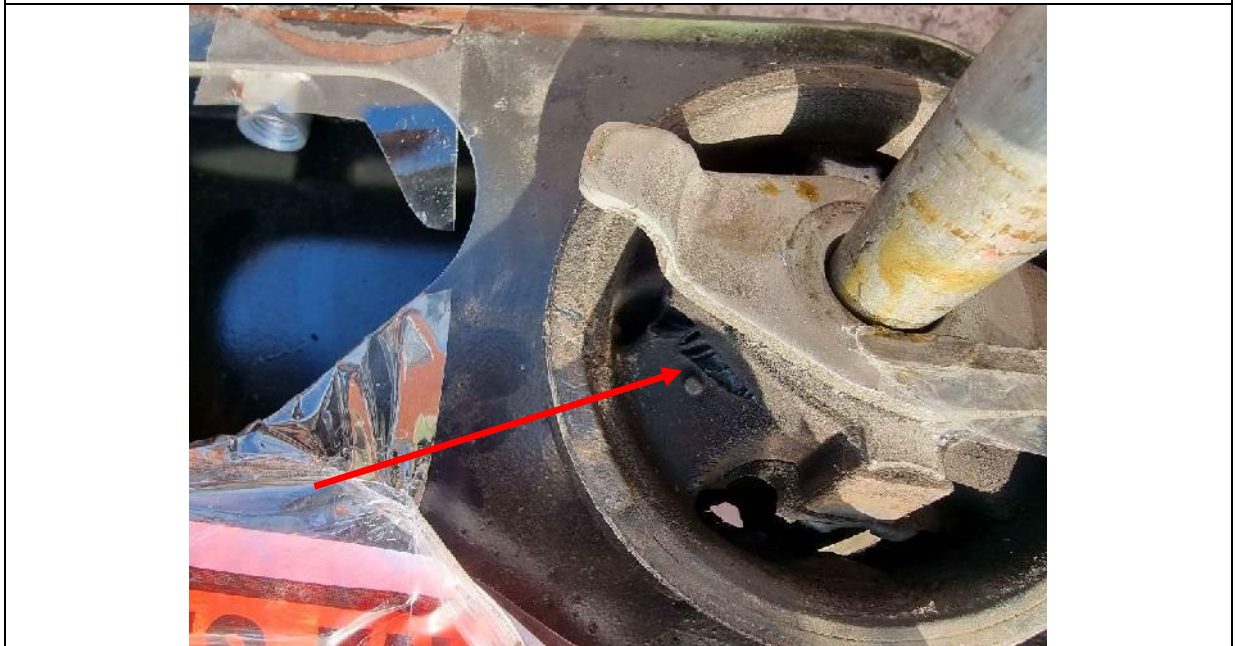
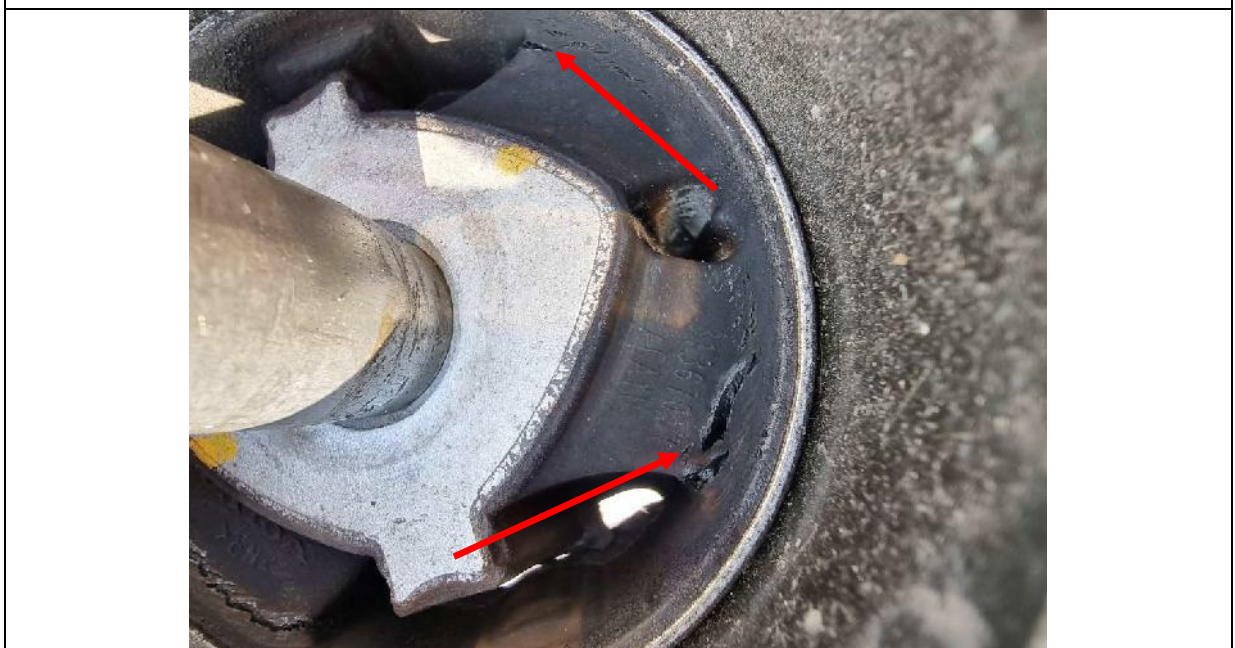
**Figure 21 – 1D Bush Investigation**

**Figure 22 - 1D Bush Investigation**

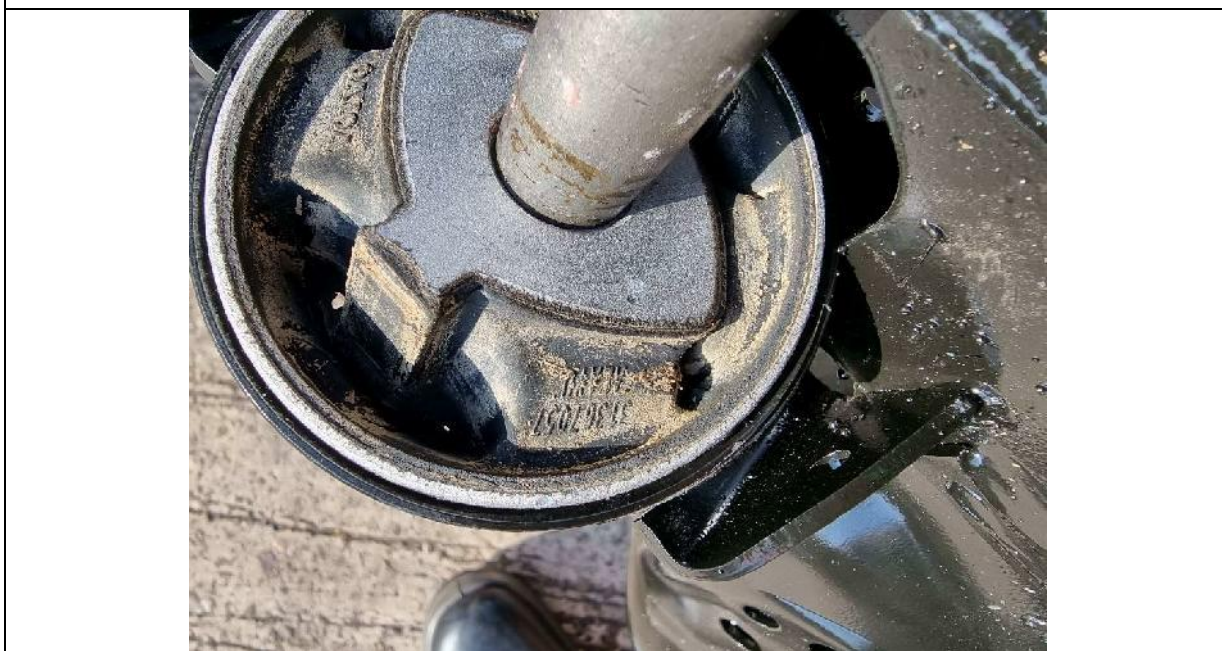
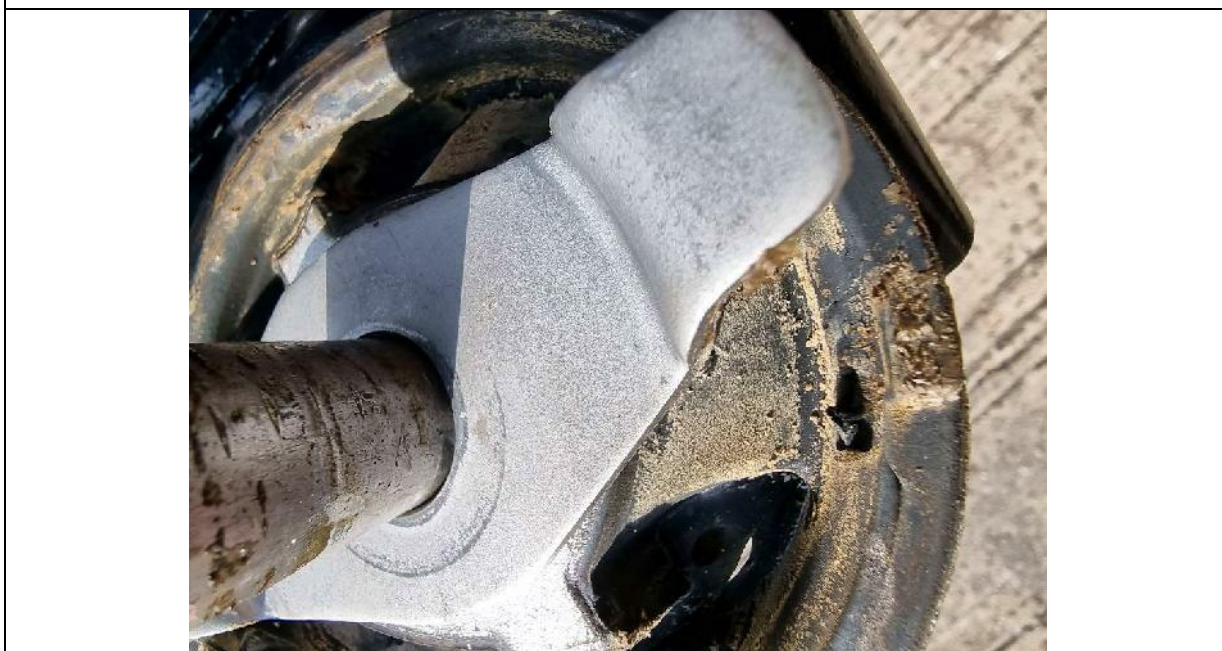
**Figure 23 - 3B Bush Investigation**

**Figure 24 - 3B Bush Investigation**
