Inspection for Assessment Report

East London Line

Bartlett tunnel

Report Ref: **ELM-TEC-206-04-09-0315** Issue **01**

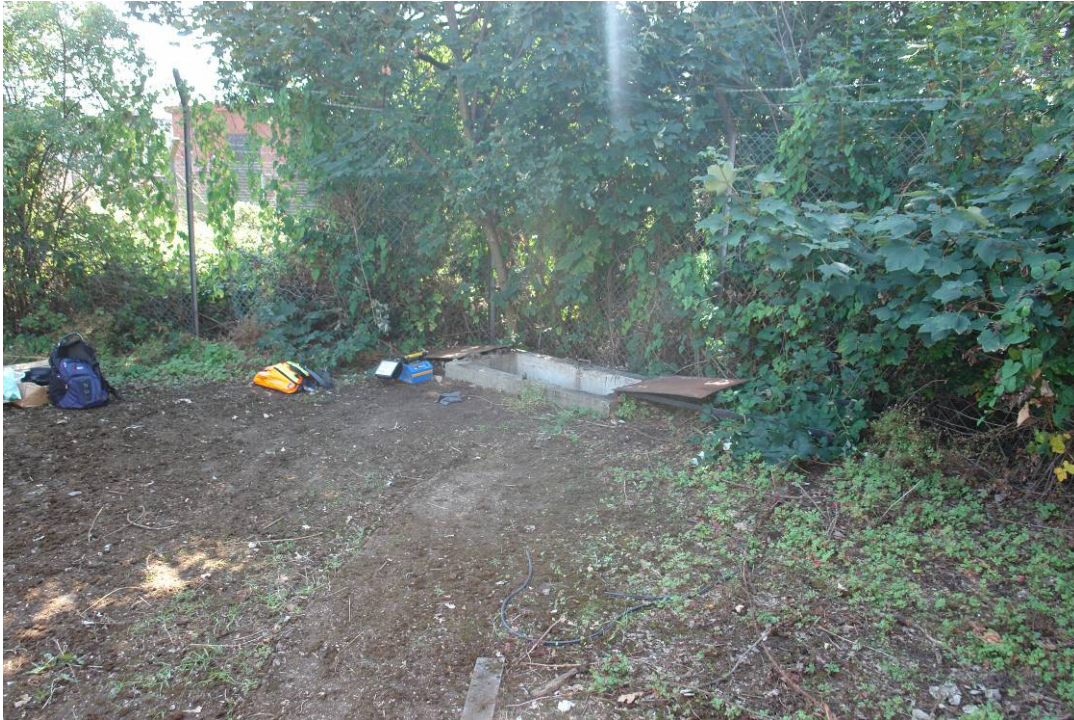
Bartlett Experimental Tunnel TT418	
Element	Description of Defects
Capping slab to shaft	<p>The concrete capping slab is in a good condition. The upper surface is covered in a thin layer of soil with some vegetation. There is some cracking that has allowed root penetration through the slab. (See Figure 1 and Figure 2)</p> <p>Over approximately ¾ of the area of the slab it is supported on a timber deck supported by a steel grillage. The timbers are approximately 300mm thick, but they show extensive signs of rotting, especially at the exposed ends next to the access stairs. (See Figure 3 and Figure 4)</p> <p>The steel grillage members have extensive surface corrosion but there appears to be little section loss.</p>
Walls to shaft	<p>The walls were cast in slurry trenches, leaving the rough faces that are visible in the shaft. Some of the joints between the walls were not fully concreted, leaving partial gaps for some of the thickness. There are some signs of water leakage through these joints. (See Figure 5 to Figure 7)</p>

Figure 1 Soil and vegetation on top of shaft capping slab

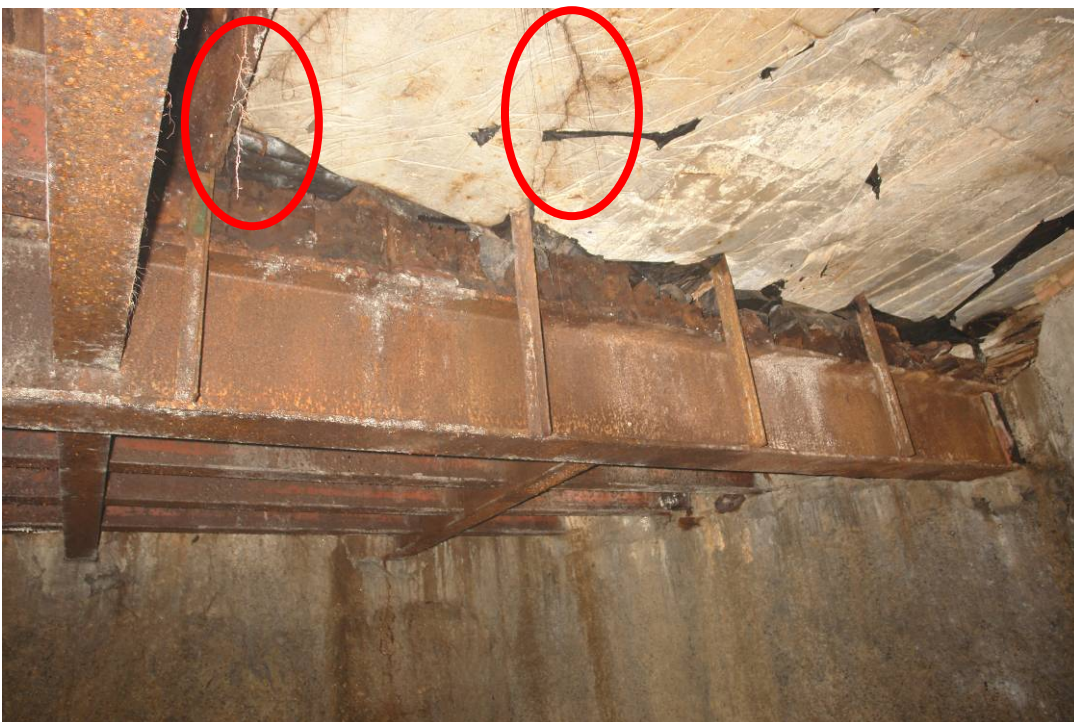
Figure 2 Underside of capping slab, showing some root penetration through crack

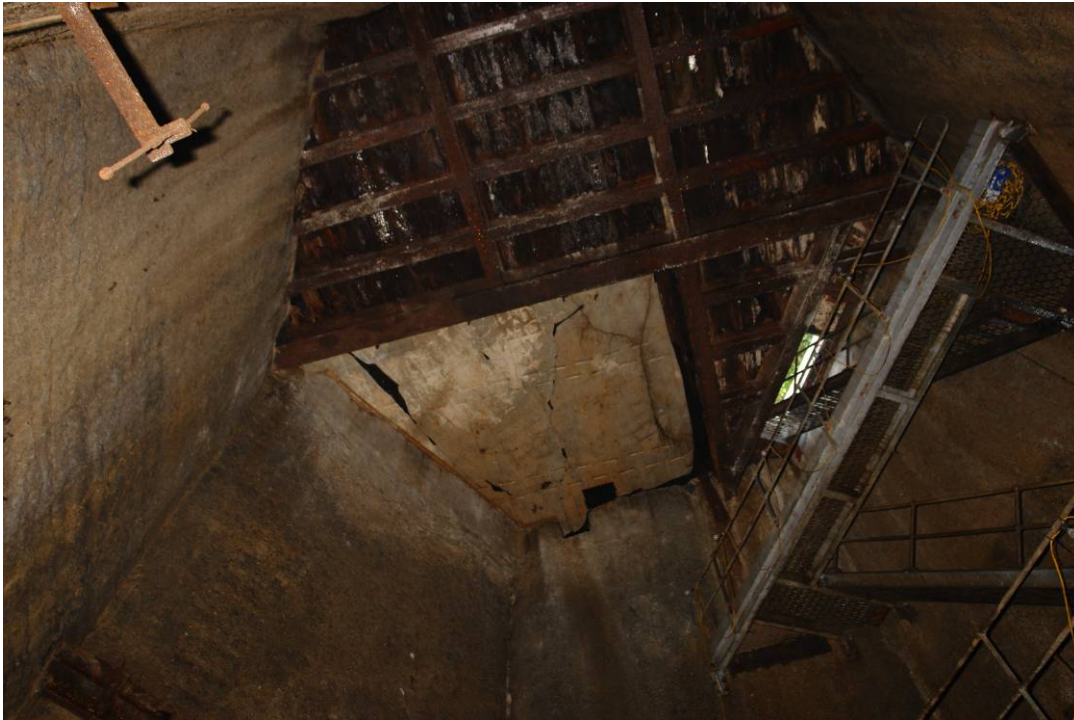
Figure 3 View of underside of slab, showing steel grillage and timber decking

1. The supporting steelwork and timber to the shaft capping slab need attention. The reinforcement details of the concrete capping slab are not known, so the allowable level of deterioration of the supporting structure cannot be quantified. Therefore, it is recommended that the timber elements of the capping slab supports are replaced with a more durable material, to allow for the permanently moist shaft environment. It may be possible to locally remove the timber; provide permanent, discrete supports between the steel beams and the concrete slab and then remove the remainder of the timber. The steel beams would then be repainted.

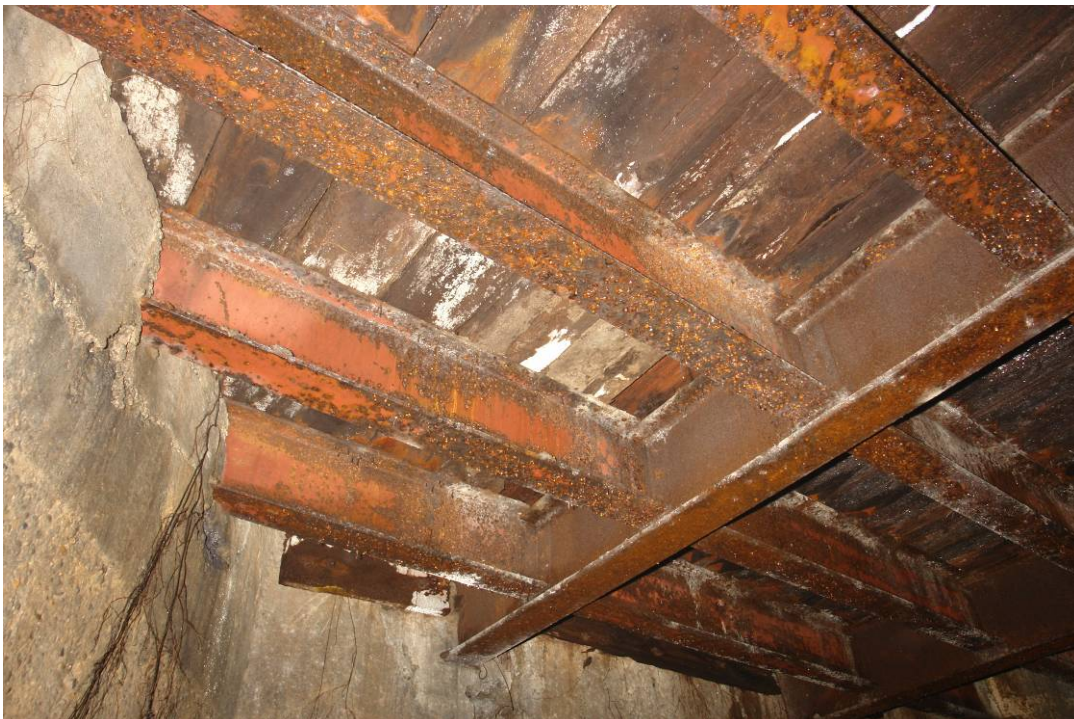
Figure 4 View of timbers and steel grillage supporting concrete slab

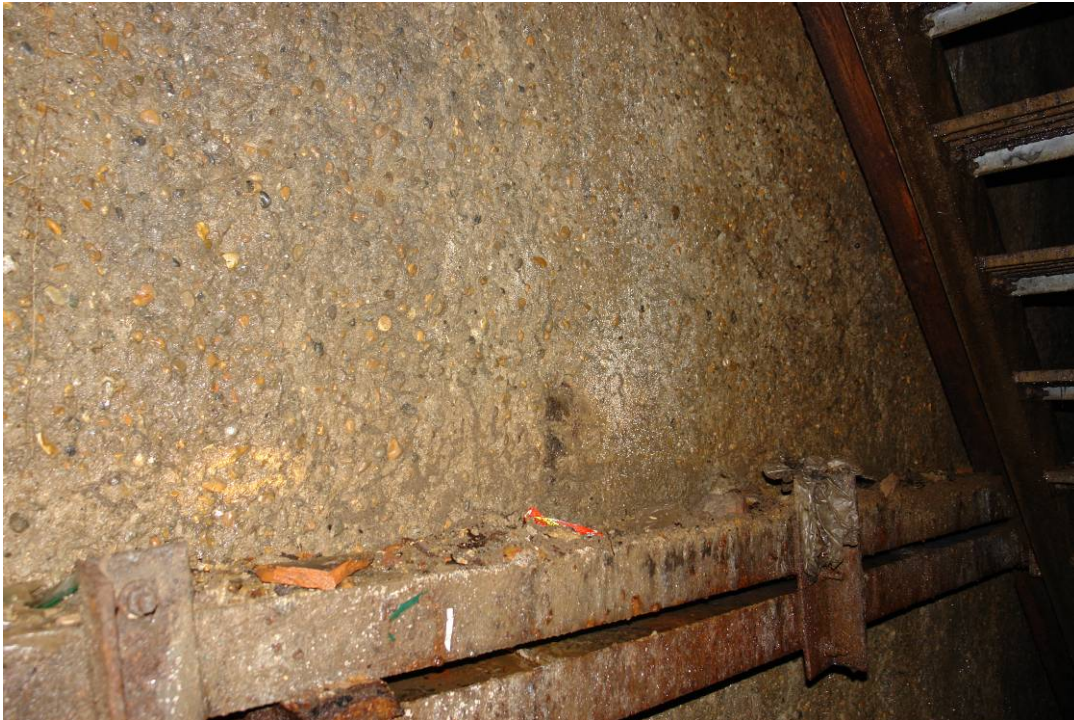
Figure 5 Rough surface finish on shaft walls

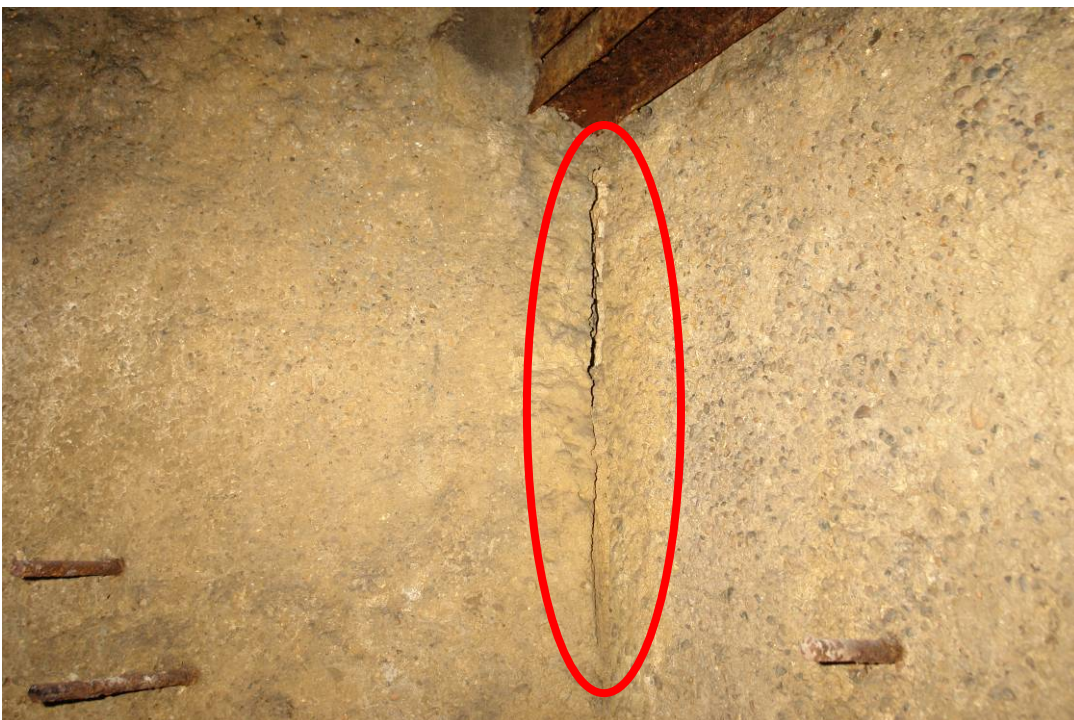
Figure 6 Gap in joint between wall panels

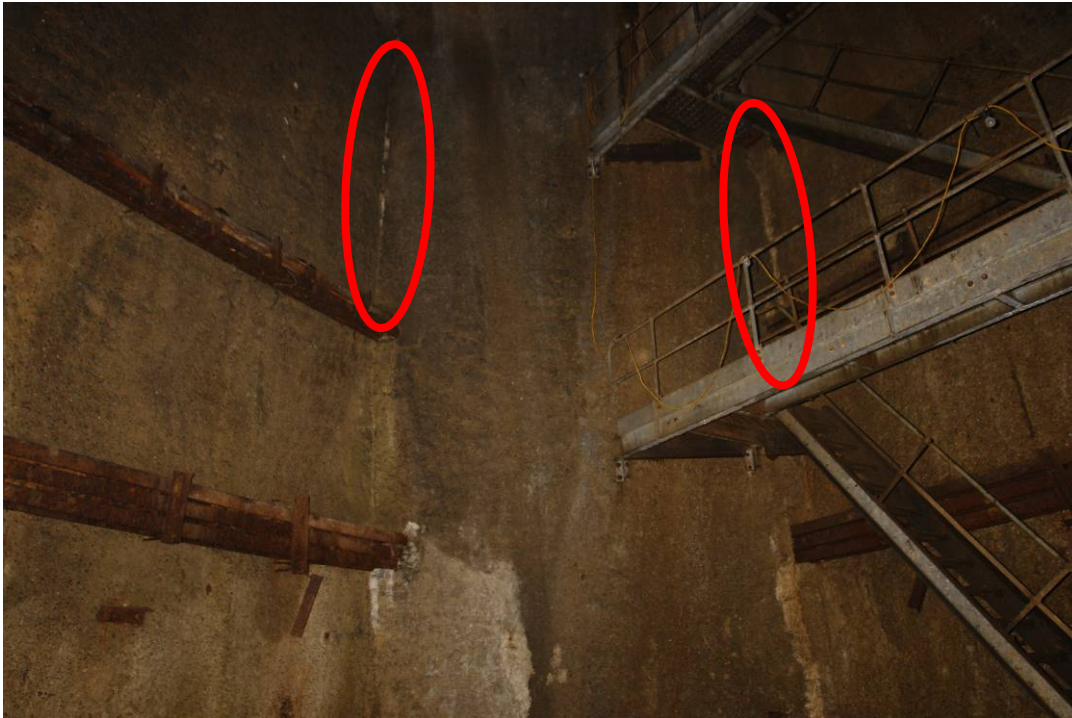
Figure 7 Signs of leakage through joints between walls

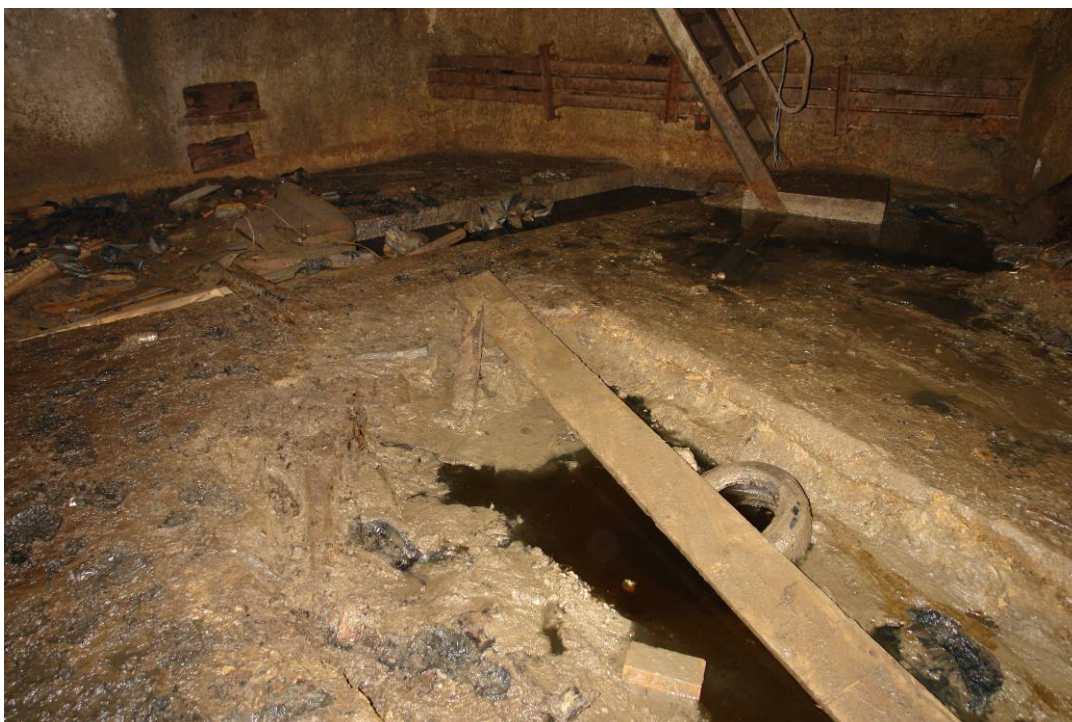
Base slab to shaft	<p>The concrete base slab was covered with a layer of mud and debris restricting inspection. (See Figure 8)</p>
Access stairs in shaft	<p>The access stairs consist of three flights and two landings of open galvanised steelwork. The steelwork is in good condition, though the fastening bolts into the concrete walls are showing some signs of corrosion. (See Figure 9)</p>
Cast iron lining segments	<p>The dimensions of the segments were confirmed as those shown on Drawing 448/3 (in Appendix C). The segment width was 20" (508mm), the radial and circumferential flanges were 1" (25mm) thick and 3" (76mm) deep. (See Figure 10 to Figure 15)</p> <p>There was no invert slab in the tunnel.</p> <p>Before pumping out, the tunnel contained water to a depth of approximately 0.75m at the shaft, increasing to a depth of 1.5m at the far end. The areas under water had an accumulation of silt on them but less corrosion than those areas just above the water line. (See Figure 16 and Figure 17)</p> <p>Much of the protective coating on the segments had failed, leading to widespread surface corrosion, though no significant loss of section was observed.</p>

Figure 8 Base slab of shaft covered in mud and debris

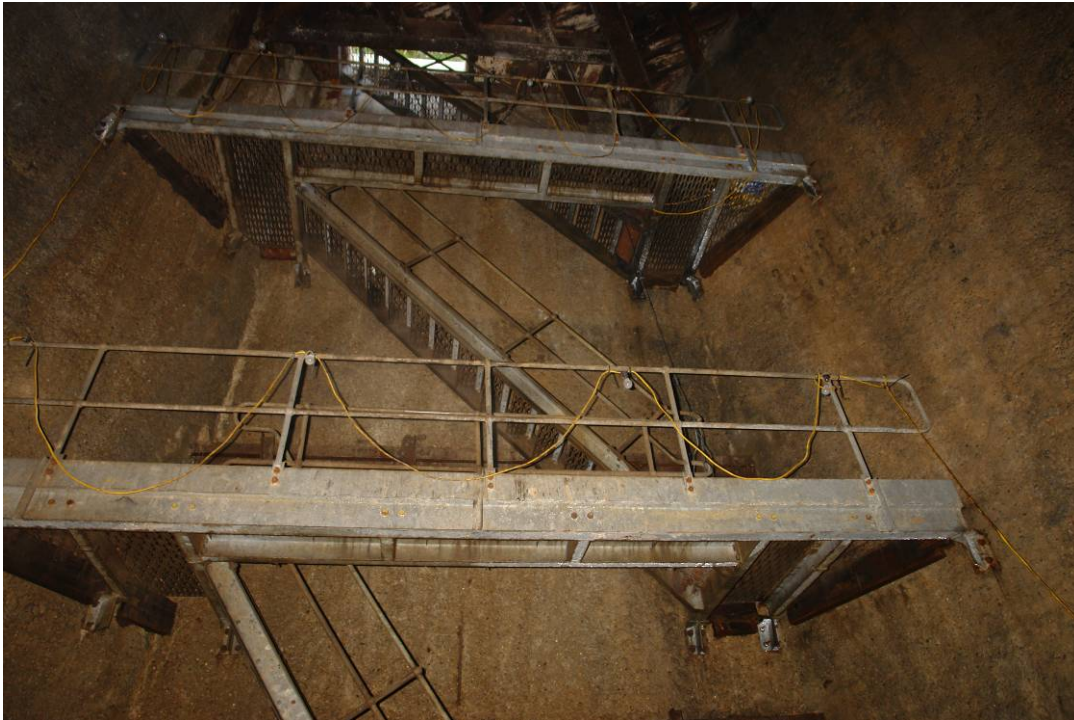
Figure 9 Access stairs and landings in shaft

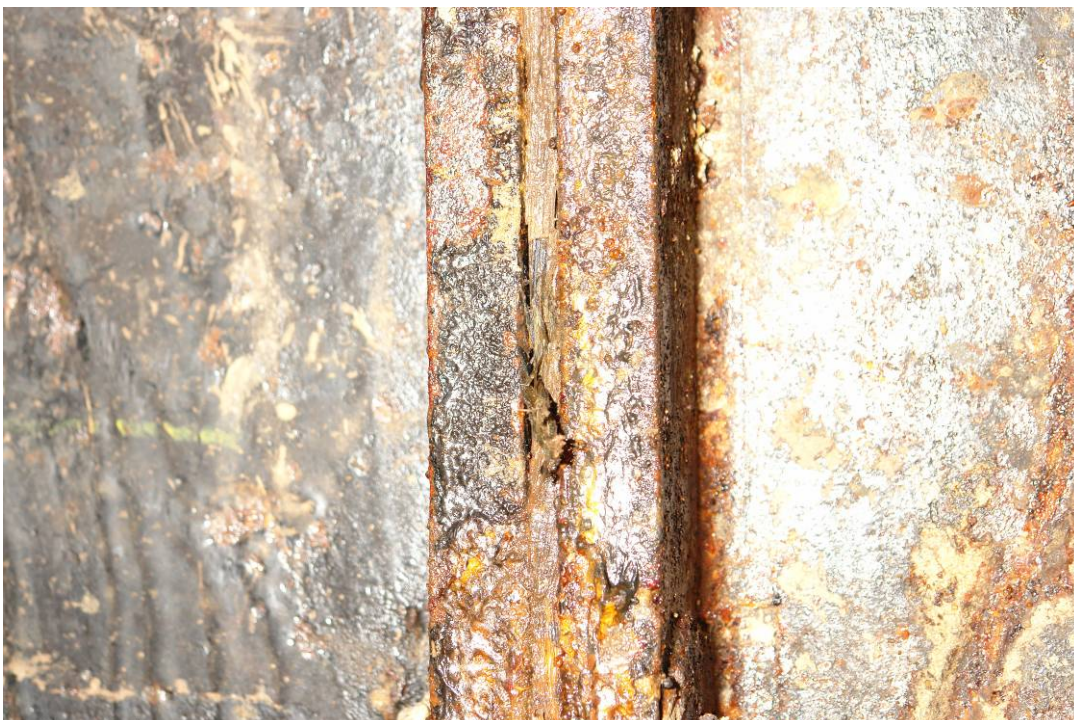
Figure 12 Packing between segments on circumferential joint

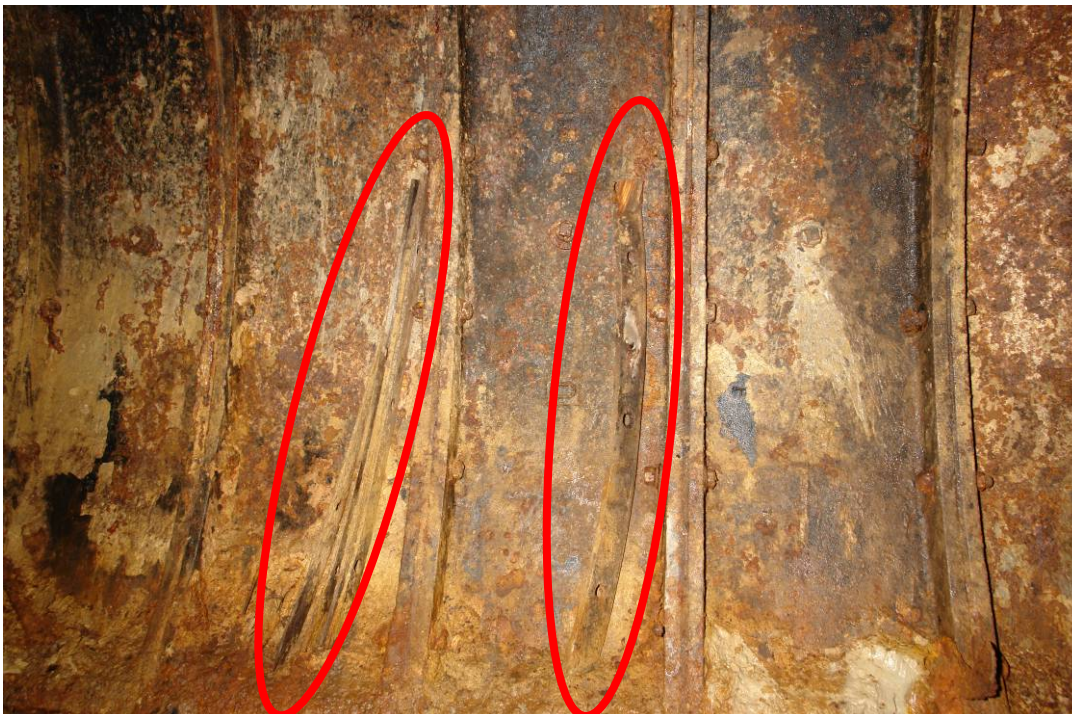
Figure 14 Timber packers for circumferential joints

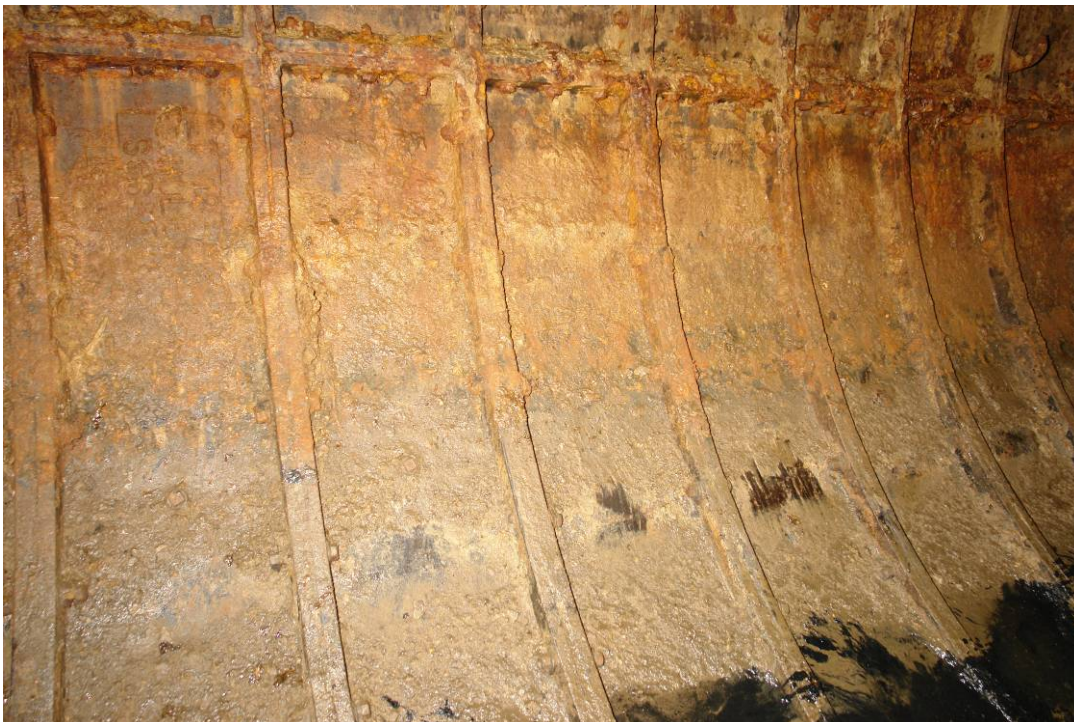
Figure 16 Higher levels of silting towards further end of tunnel (segment No 180)

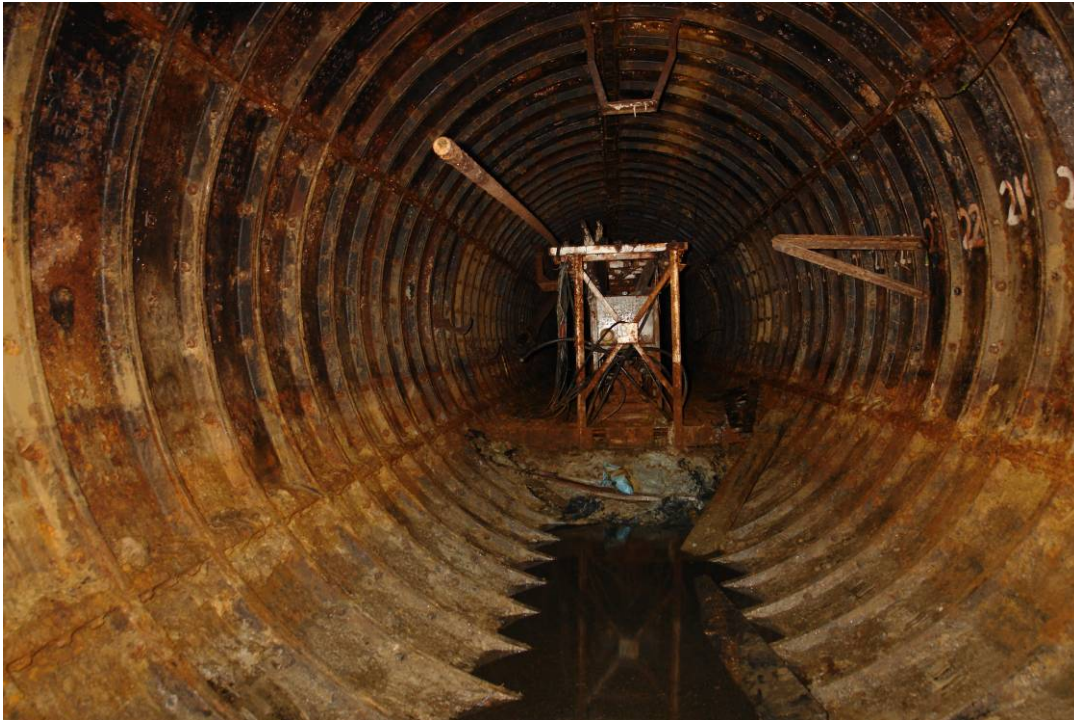
Figure 17 Rear of abandoned tunnelling machine (segment No 230); note water level at approximately 1.5m depth

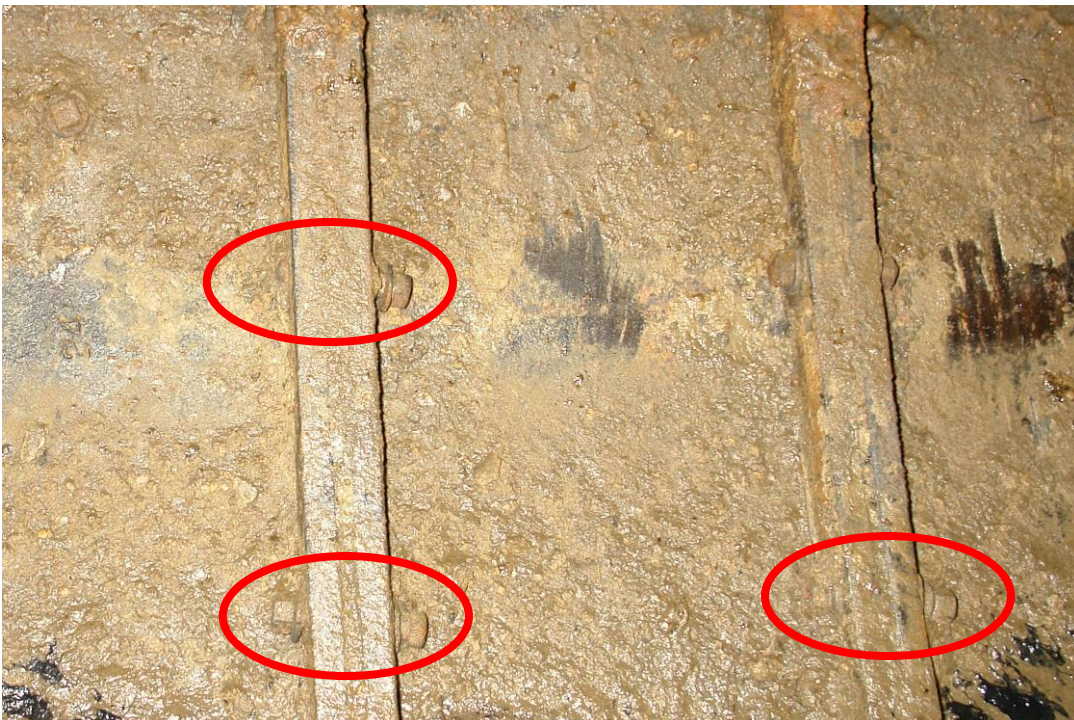
Bartlett Experimental Tunnel TT418	
	<p>The exposed surfaces of the lining bolts were corroded. There was no evidence of any loss of section in the bolt shanks. Some bolts in the circumferential joints were missing or mis-aligned and not tightened (see Figure 18).</p> <p>The end face of the tunnel consists of the cutter head of the tunnelling machine. As the machine was abandoned at the end of the drive, the face is fully retained behind the pressure bulkhead (see Figure 19).</p>

Figure 18 Mis-aligned bolts on circumferential joints

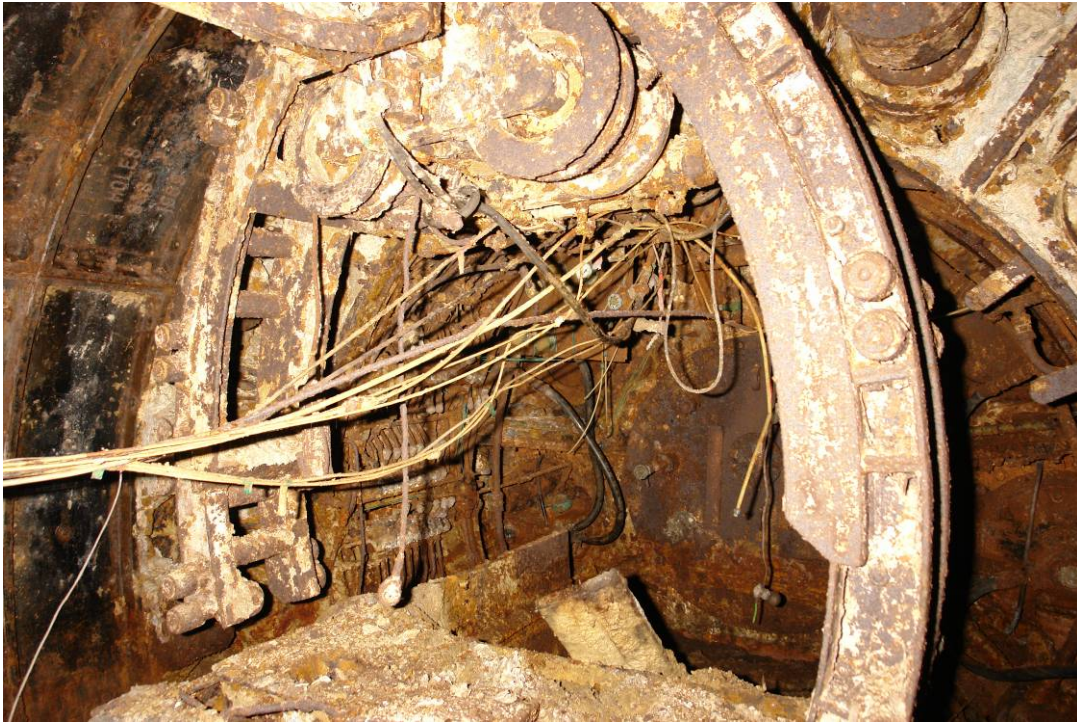
Figure 19 Pressure bulkhead of tunnelling machine retaining end face of tunnel
