# Formal Investigation Report – Passenger Fatality

## Waterloo Station – Bakerloo Line platform 3

26<sup>th</sup> May 2020

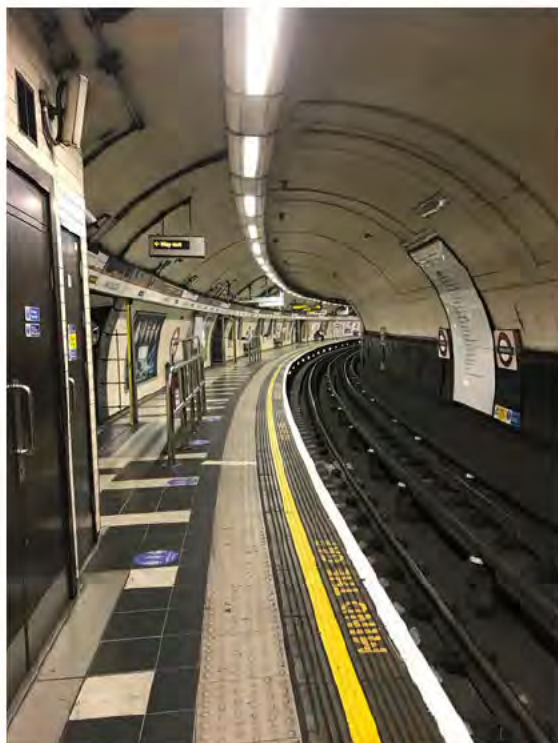
Figure 2 - North end (front) looking south (to rear).

The platform is lit by 5-foot twin 58-watt lighting tubes, which are ceiling mounted along the line of the PTI for the full length of the platform. This can be observed in figures 2 and 3. There were no lighting defects at the time of the incident.

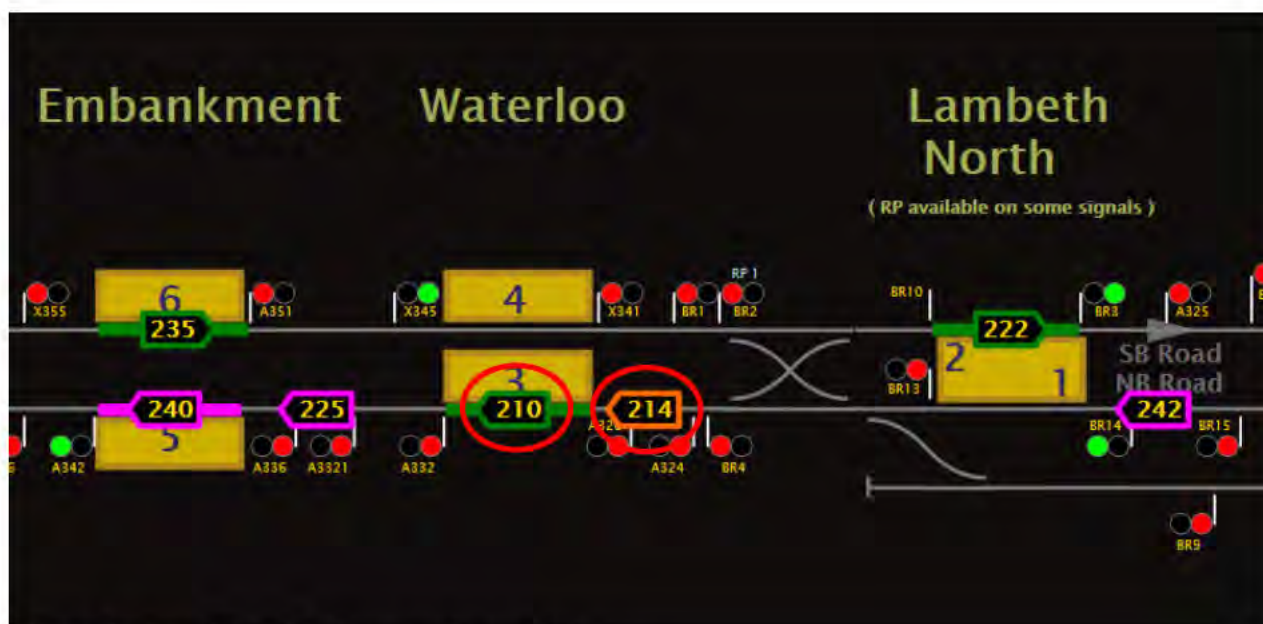
Figure 4 – Location of trains prior to incident.

The following train (train 214) was also delayed. This train was held at the signal prior to entering the platform (A326), in the single bore tunnel 158.1 metres to the rear of the start of the platform. The train operator of this train was able to see the rear of train 210 which was berthed in the platform, and on seeing it depart waited for a green signal and proceeded into the platform.

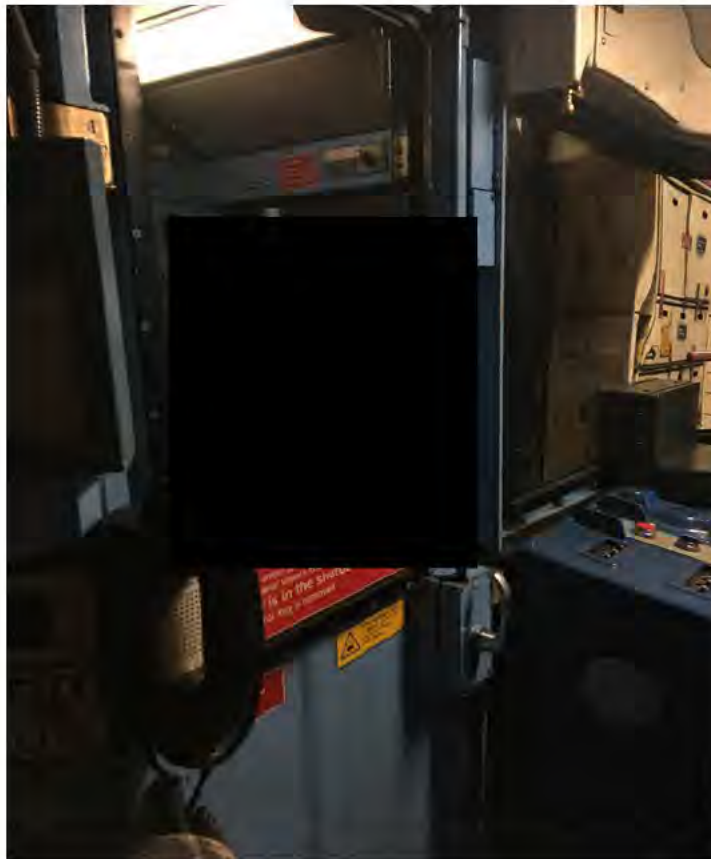
Figure 6 – View of OPO Monitor Array from Driving Position

The CSE-SCS-ST0002 standard does not cover any Human Factors or detailed performance requirements for the monitors. The standard does require a minimum displayed image height of 45mm for a person 1.83m height when standing on the PTI corridor. It does not have any requirements for conspicuity or viewing angle required for the train operator. There was never any requirement for delivering un-obscured views of the PTI, and this is reflected by all OPO systems that were delivered during this time.

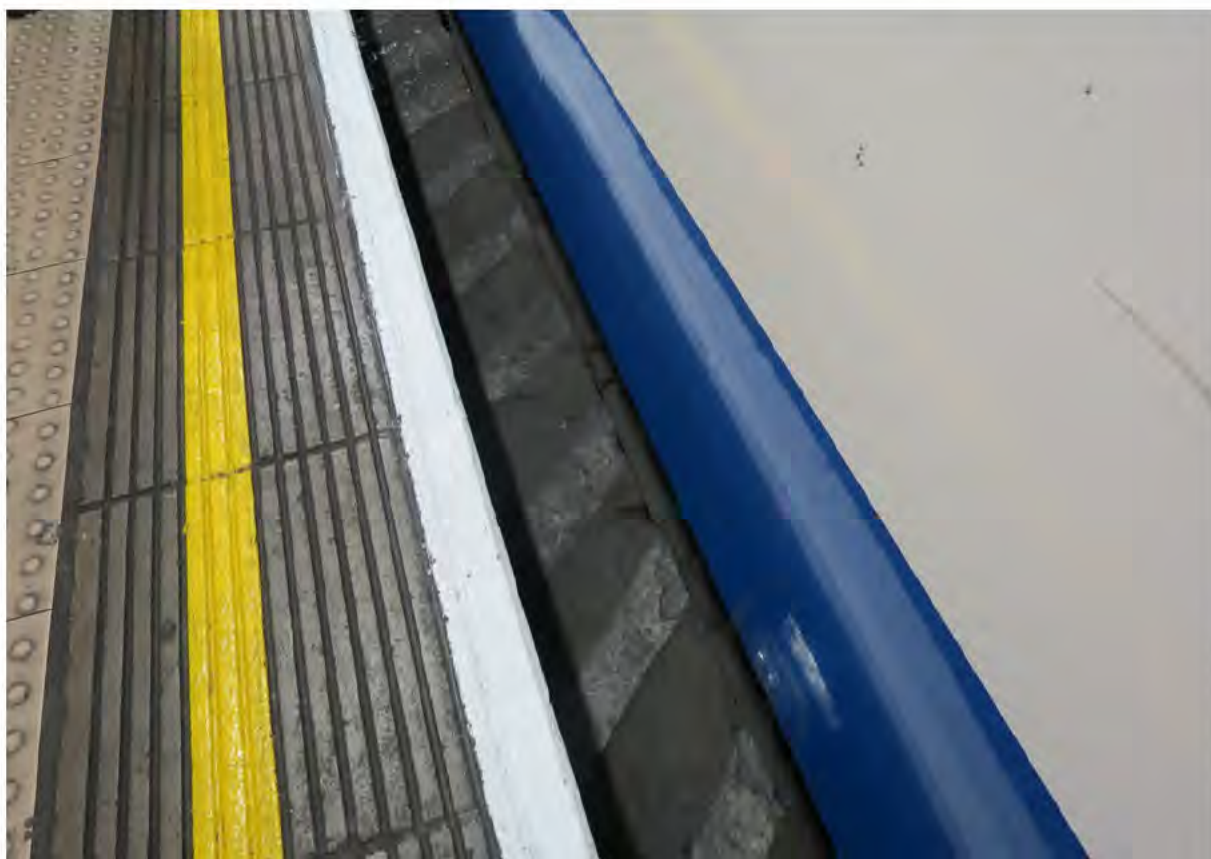
Figure 9 – PTI Track Bed Markings.

The physical state of the PTI was examined. All required markings (white painted platform edge, yellow line and 'mind the gap' text) were present and in good condition. It was noted that under platform lighting was present. The lighting seemed to have little effect and was present in conjunction with painted track bed markings, which were in poor condition [Figure 9]. Whilst not connected to this incident, the FIR questioned the effectiveness, purpose and process of installation of the under platform lighting and track bed marking. No risk assessment was found for these markings, but it was noted that they are in place on other curved platforms.

In regard to the track bed marking, further investigation found that there appears to be no standard for installation (for quality, materials, purpose or triggers for installation), and no ownership for maintenance.

Under-platform lighting and track bed paint enhancement is evident across the network, particularly in curved platform locations. Whilst it is understood that the general purpose of this is to draw attention to a hazard, there do not appear to be any standards, structure or maintenance regime for these installations. Without such processes in place, it is difficult to understand what triggers are for deployment, what the improvements achieve and if they continue to achieve them without maintenance. Recommendation 4.

Recommendation 4	
Linked to Observation 16.5	
Purpose	On the Bakerloo line, gain an understanding of the reasons for under-platform lighting and track pit painting, what the aim of them is, and what maintenance regimes are in place to achieve those aims. This should be compared against arrangements on other lines and used to inform network-wide arrangements.
Action	Identify current under-platform mitigation arrangements, processes and standards, and role of LU Asset Operations in relation to maintenance regime of under-platform mitigation measures.  Liaise with the Network PTI Group, SHE and Engineering to develop system wide arrangements.
Action Owner	Dave Johnson – Train Operations Manager and Bakerloo line PTI Lead
Action Target Date	Within 16 weeks of DRACCT Approval.
Validation	Production of report of findings for PTI group review
Validator	Dave Mead – Line Operations Modernisation Lead
Validation Target Date	4 weeks following PTI group review.
