**Jubilee line – Doors open on a train in service  
between Finchley Rd and West Hampstead  
stations**

**1<sup>st</sup> September 2018**

**HSE Info Exchange Reference Number: 949522**

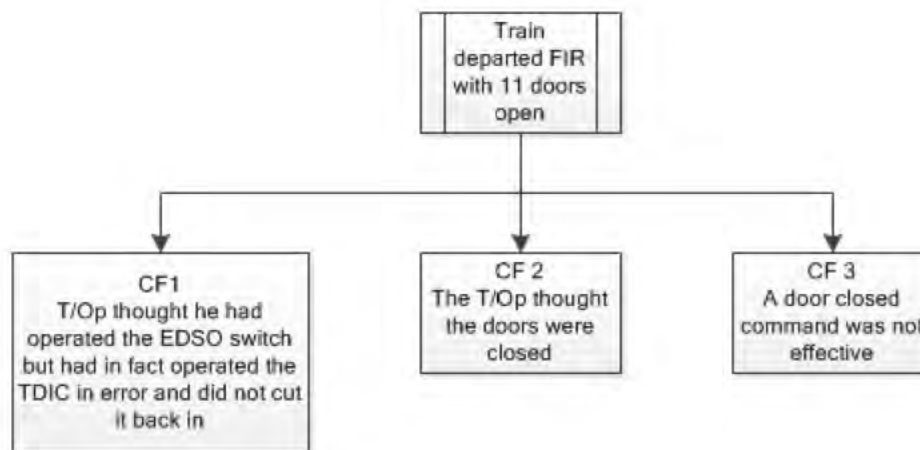
Figure 1 – The three causal factors

The FIR identified there were three causal factors; had any of these not been present the incident would not have occurred.

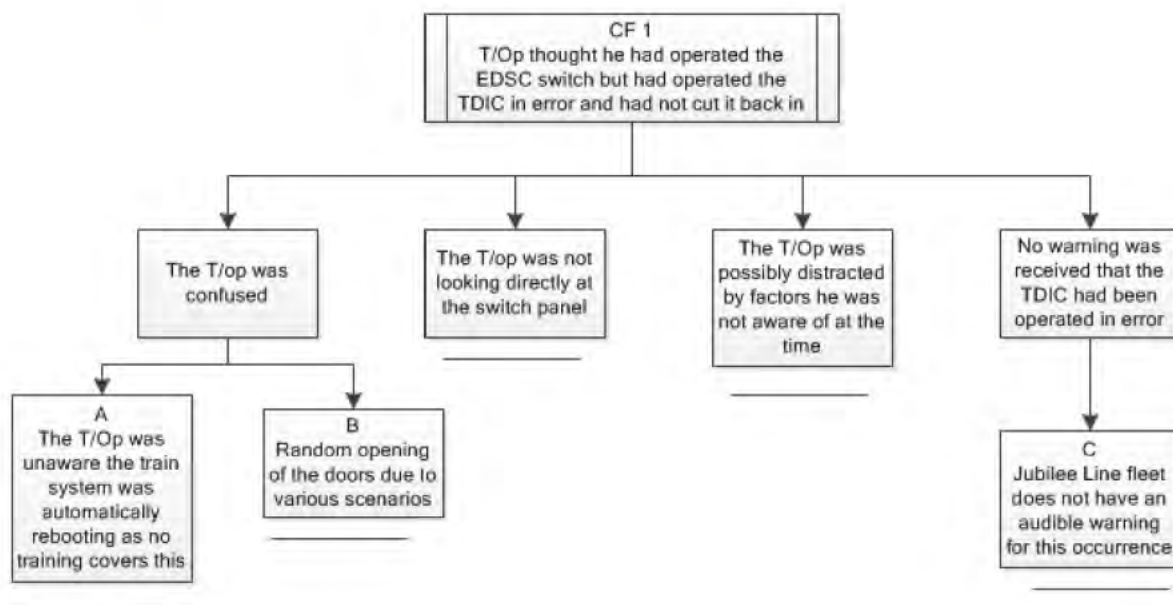
- A. The T/Op was unaware the train systems were automatically rebooting and were not in full communication with each other.
- B. Some but not all doors opening may have contributed to the confusion faced by the T/Op. There are three conditions that applied during this incident in terms of door operation:
  - Some of the I I doors that did open did so as a result of passengers pressing the “open” buttons whilst the train had defaulted to “passenger open” status.

- Some doors did not open when the door open buttons were pressed by passengers because the buttons were faulty. \*
- Some doors opened on their own without passenger intervention because the buttons were faulty. \*

(\*) As passenger mode had been withdrawn some years ago the door buttons were not subject to planned maintenance causing the above two conditions.

The defect scenario encountered by the T/Op during this incident is not covered in the Jubilee Line Defect Handling Guide and as per Defective in Service Instruction 99 the train should have been taken out of service.

Recommendation I	
To address Root Cause A	
Purpose	To provide an understanding to Jubilee Line T/Ops of how a train may perform in circumstances where an unmodified 96 stock train experiences a loss of communication between the TMRTs and the TMS.
Action	Communicate to all Jubilee Line T/Ops an understanding of how a Jubilee Line train may perform when there is a loss of communication between train management systems
Action Owner	K Rogan - Head of Jubilee Line Operations
Action Target Date	31 <sup>st</sup> October 2018
Validation	A sample of T/Ops questioned by DRMs to see they received it and understand it
Validator	Jubilee Line TOMs as instructed by the Jubilee Line Head of Operations
Validation Target Date	Within 4 weeks of the action being completed

Recommendation 3	
To address Root Cause A and B	
Purpose	To enhance the guidance provided to T/Ops to enable them to manage train faults.
Action	<ol style="list-style-type: none"> <li>1. A review shall be completed of similar incidents of this nature on the Jubilee Line to ascertain if this was an isolated incident or a more frequent occurrence.</li> <li>2. On the conclusion of the review in 1. Suitable communications and / or updating of existing T/Op documentation such as the Jubilee Line Defect handling Guide shall be completed.</li> </ol>
Action Owner	<ol style="list-style-type: none"> <li>1. Chris Welford – Interim Jubilee Line Fleet Engineering Manager</li> <li>2. J Brown – Jubilee Line Train Operations Manager (in association with Skills Development, LU).</li> </ol>
Action Target Date	<ol style="list-style-type: none"> <li>1. 31<sup>st</sup> December 2018</li> <li>2. 28<sup>th</sup> February 2019</li> </ol>

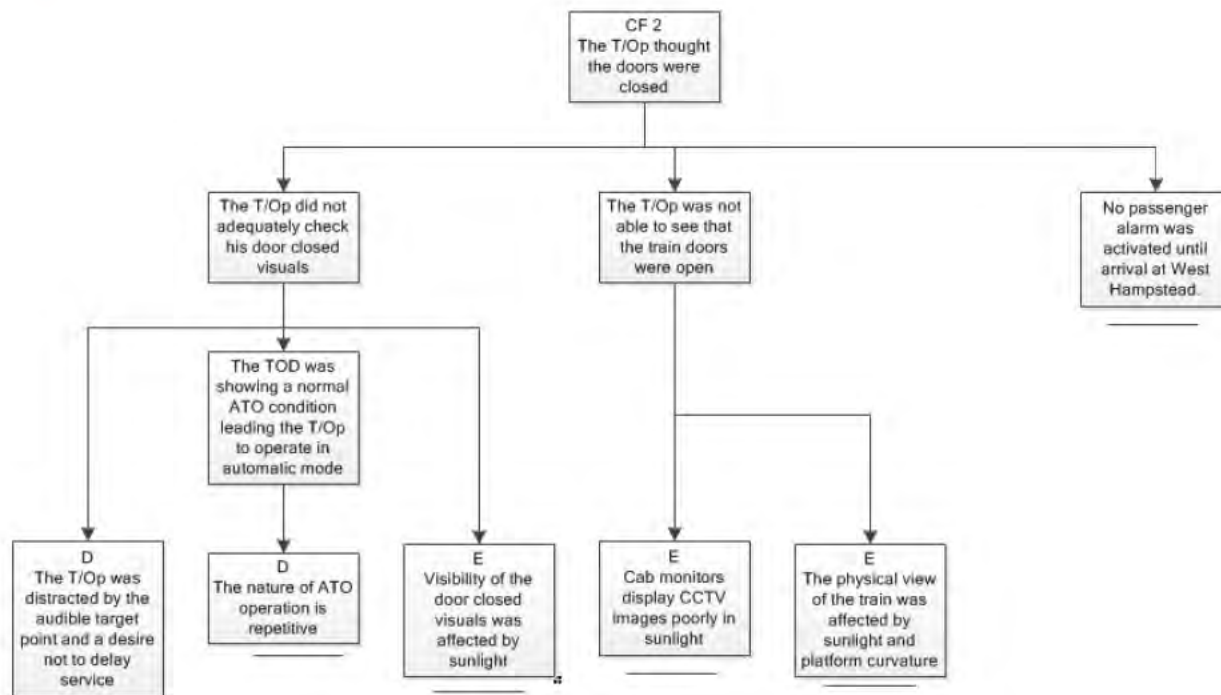
- D. The T/OP stated that ATO workload is very much a routine “Stop/Start/Stop” mode of operation. At the time of the incident the train was in an abnormal condition (TDIC operated) but the Train Operator Display (TOD) was showing a normal condition for ATO operation. The T/Op stated that whilst at Finchley Road platform he was distracted by the approaching ATO Target Point. It cannot be certain whether the Train Management System (TMS) screen would have shown an indication that the TDIC had been cut out as it has not proved possible to recreate the conditions of the fault. It is likely that the routine condition displayed on the TOD and the mundanity of the task, coupled with the audible warning that the ATO Target Point had been and the concern the T/Op had for not delaying the service reached led the T/Op to overlook the fact that he did not have his Door Closed Visual indications.

Recommendation 5	
To address Root Cause D	
Purpose	To ensure that Train Operators are fully aware that they are dealing with an abnormal condition having operated the TDIC's.
Action	<ol style="list-style-type: none"> <li>1. Review the current relevant standards (S1180 / S2180) and revise to ensure ATO operation is not possible following the operation of the TDIC switch</li> <li>2. Review the way the Train Operator Display/TMS and associated audible alarms currently operate during the operation of the TDIC switch and issue ALARP based recommendations to minimise the risk of an operational error having undertaken a cost/benefit analysis as part of any recommendations.</li> </ol>
Action Owner	D Borgese - Principal Door Systems Engineer.
Action Target Date	<ol style="list-style-type: none"> <li>1. 31<sup>st</sup> January 2019.</li> <li>2. 30<sup>th</sup> March 2019</li> </ol>
Validation	To review any output from the action to identify if the risks are reduced to a level which is as low as is reasonably practicable.

Recommendation 6	
To address Root Cause D	
Purpose	To ensure that Train Operators maintain sufficient levels of concentration when operating ATO trains.
Action	<p>Feed the conclusions of this report into the existing work being undertaken in regards to:</p> <ul style="list-style-type: none"> <li>• The study currently being undertaken by LU with regard to maintaining concentration.</li> <li>• The collaboration between LU and RSSB with regard to the impact of ATO on the health and wellbeing of train operators</li> </ul> <p>With particular regard to the impact on High/Low frequency on alertness and decision making.</p> <p>Note - The concentration study will be completed in November 2018 and the RSSB work will not be complete until March 2019.</p>
Action Owner	R Turner - Human Factors Specialist, TfL
Action Target Date	Both studies have experienced delays, the first draft of the concentration study has just been released and the ATO impact on T/Op health and wellbeing still have to complete their interviews. As a result it is proposed to move this date to June 2019.

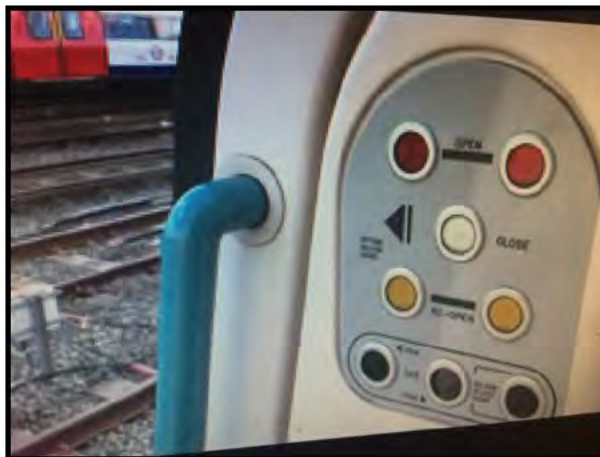
Figure 4 – Image of DCIVs with saloon doors open on a sunny day

- E. On the day of the incident the cab was in bright sunlight and the sunlight was impacting on the ability of the T/Op to adequately view the driving console and TOD. This is a common occurrence and T/Op's mitigate against the sunlight and glare by attempting to shield the CCTV and TOD displays, as the T/Op states he was doing that day. It is likely that the sunlight also impacted on the visibility afforded by the OPO cameras on the platform, although these images are not recorded. There was significant glare apparent on the platform images at Finchley Rd at the time of the incident as evidenced in the downloaded CCTV footage. Photographs were taken of the Door Closed Visual Indicators on the Driving Console and Rear Bulk Heads during an FIR site visit under similar conditions and the FIR considered it was very difficult to distinguish between active and inactive states of the indicators, particularly if the inactive state had not been witnessed prior to the active state.

It was noted that the Door Closed Visual Indicators were brighter on the Jubilee Line fleet until a change effected around 2003 in response to complaints from T/Ops that they were distracting in tunnel sections. It was also noted that there are variations in the intensity of the illumination of the DCVIs on the current fleet. Three trains were utilised during the FIR site visit and some indicators were illuminated considerably brighter than others and one had a sticker over the lens. However, it must be reiterated that in all cases the illumination was severely affected by sunlight.

Recommendation 7	
To address Root Cause E	
Purpose	To ensure Train Operators are more easily able to see the Door Closed Visual Indicators, Train Operator Display and In Cab CCTV Screen in degraded operating conditions.
Action	<p>Review incidents of visibility/glare in train cabs to understand the safety risk. Should this review identify an issue:</p> <ol style="list-style-type: none"> <li>1. Carry out a feasibility study with a business case for the recommended option to improve the visibility of the in-cab saloon door closed visuals, and</li> <li>2. Consider methods of limiting sunlight/glare from entering the cab that may lead to a reduction in the ability of the T/Op to see visual indications, this should include but not limited to improvements to the existing sun screening methods in place.</li> </ol>
Action Owner	Howard Taylor
Action Target Date	27 September 2019
Validation	To review any output from the action to identify if the risks are reduced to a level which is as low as is reasonably practicable and progress accordingly.

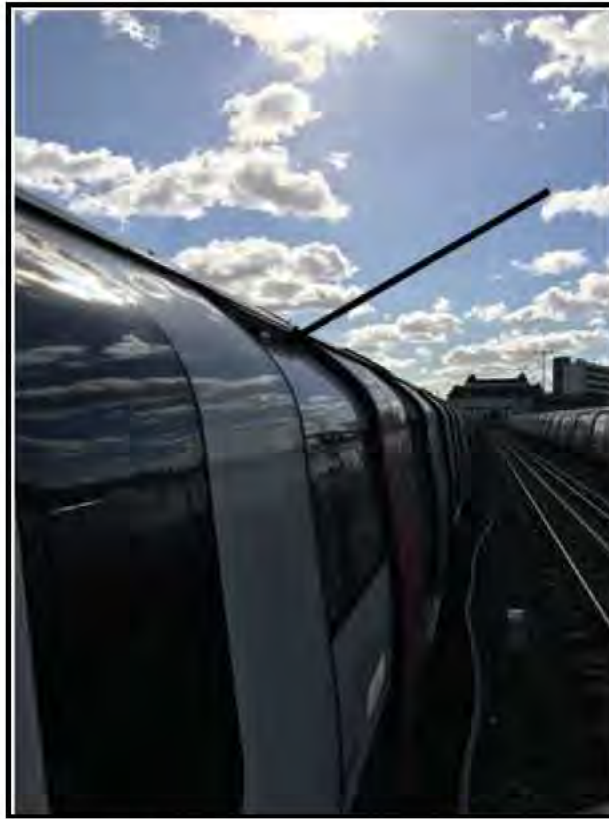
**Figure 6** – Physical view of ODILs from driving side cab door

The FIR also noted that the visibility of the Outside Door Indicating Lights (ODILs), which identify open saloon doors by means of an orange light, were also affected by both sunlight and the recessed design. When viewing the ODILs from the CCTV monitors in the driving cab it was impossible to distinguish between the ODILs being illuminated and not. Further, by physically leaning out of the train it was only possible to see the first ODIL in the front saloon due to the recessed nature of the lights. In this incident the doors of the first saloon remained closed at the departure point at Finchley Road until detraining commenced at West Hampstead, therefore the T/Op would have not had an indication that any doors were open from the ODILs.

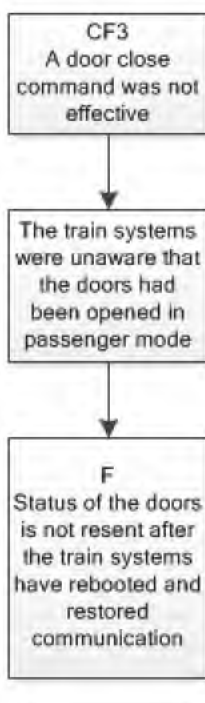
Train downloads have demonstrated that the train operator pressed the correct door close buttons on the rear bulk head.
