Newbury Park – Formal Investigation Report

Trap & Drag Incident – 17 May 2019

**HSE Info Exchange Reference Number: 001004688
and 001004681**

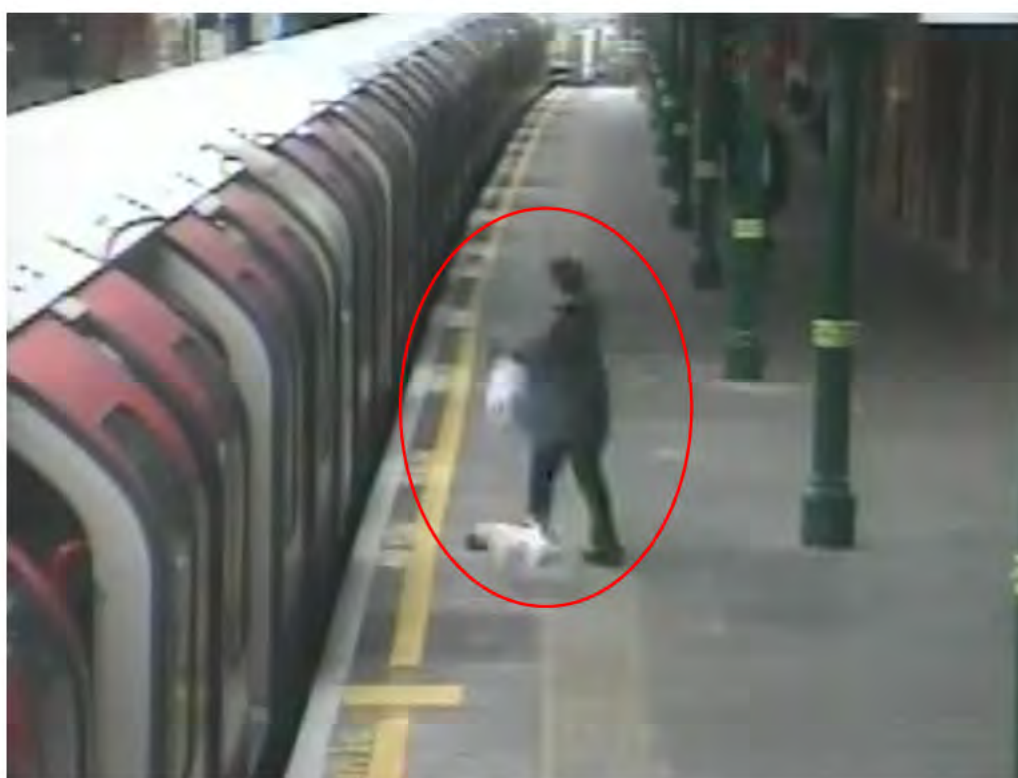
(Above) – Image No.4 - Passenger rushes to board train with dog on a leash.

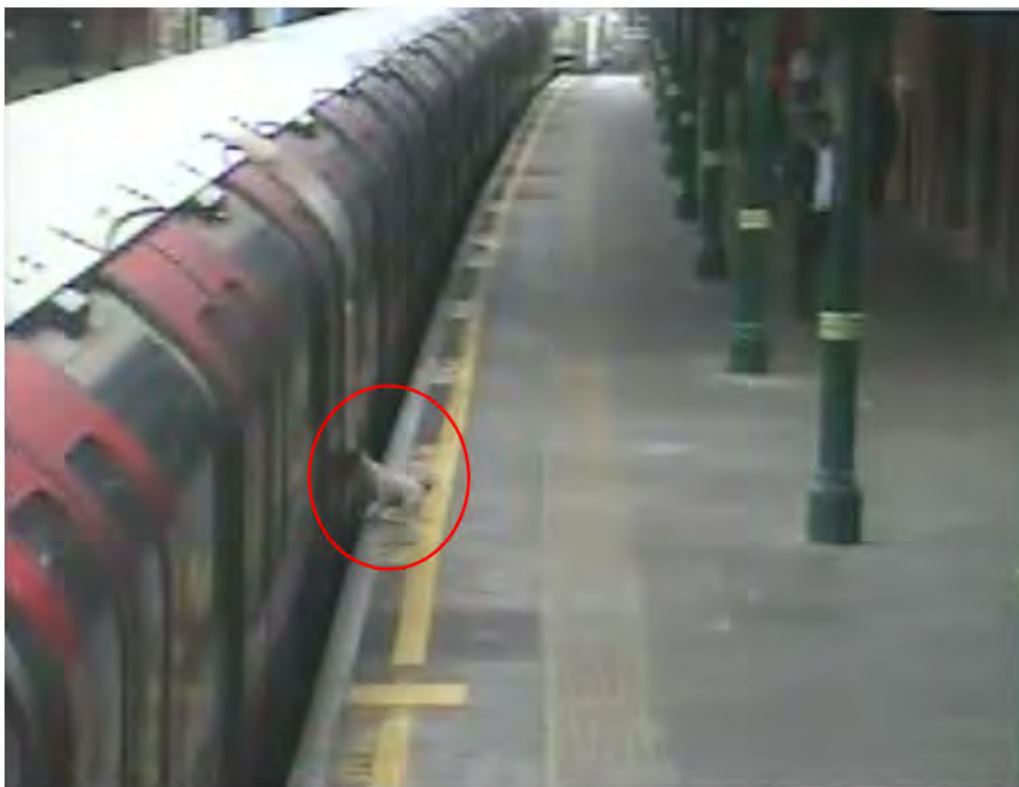
11:38:15	Customer seen going down the stairs towards the train.
11:38:22	Customer boards the train while doors are closing
11:38:24	Train 043 doors fully close with Customer on board and the small dog outside and still on the platform.

(Above) – Image No.5 - The dogs lead becomes caught in the doors

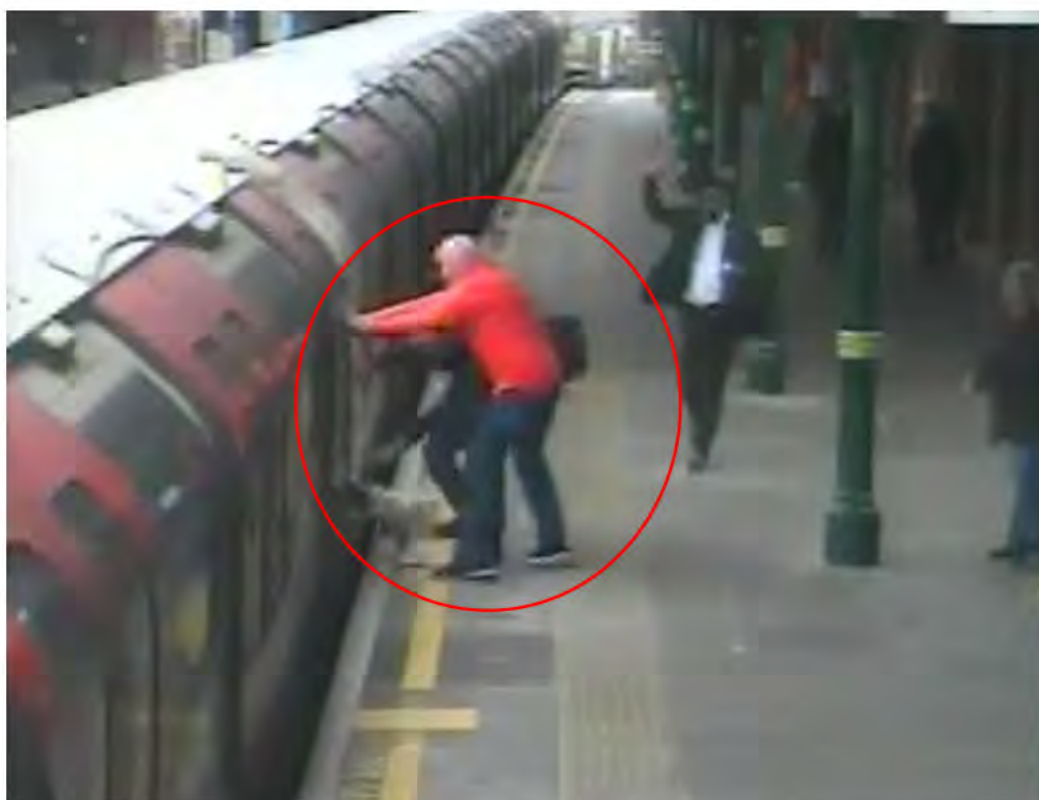
11:38:29	Two male passengers move towards the train in full view of the CCTV, they attempt to assist the dog.
11:38:33	Train 043 departs the platform.
11:38:34	Male passenger runs alongside of the platform while waving hand.

(Above) – Image No.6 - Passengers attempt to free the dog from the doors

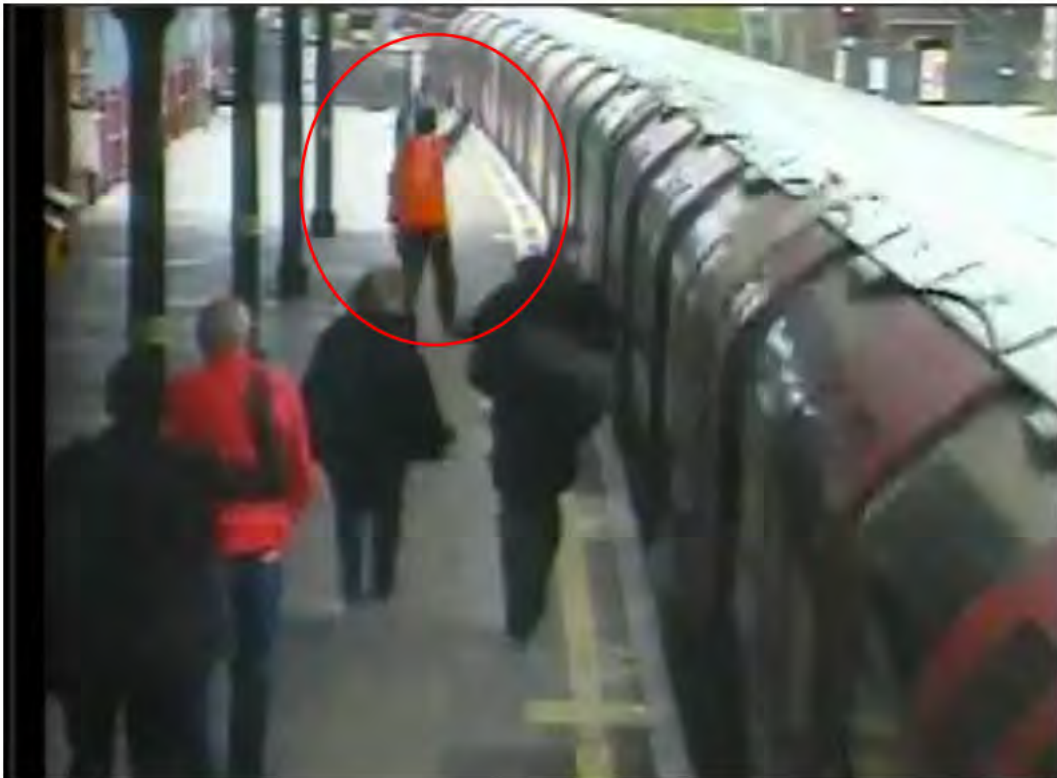
11:38:35	Customer Service Supervisor seen in camera image facing towards front of train waving arms above head as train moves out of the platform.
11:38:44	Train fully out of Station limits

(Above) – Image No.7 - Station staff attempt to get the train to stop as train departs

The station staff tried to stop the train by waving their hands above their head. This is a recognised emergency stop signal within London Underground. Despite this being seen by the driver, the train continued to depart the platform. This is the most concerning and significant finding in this investigation.

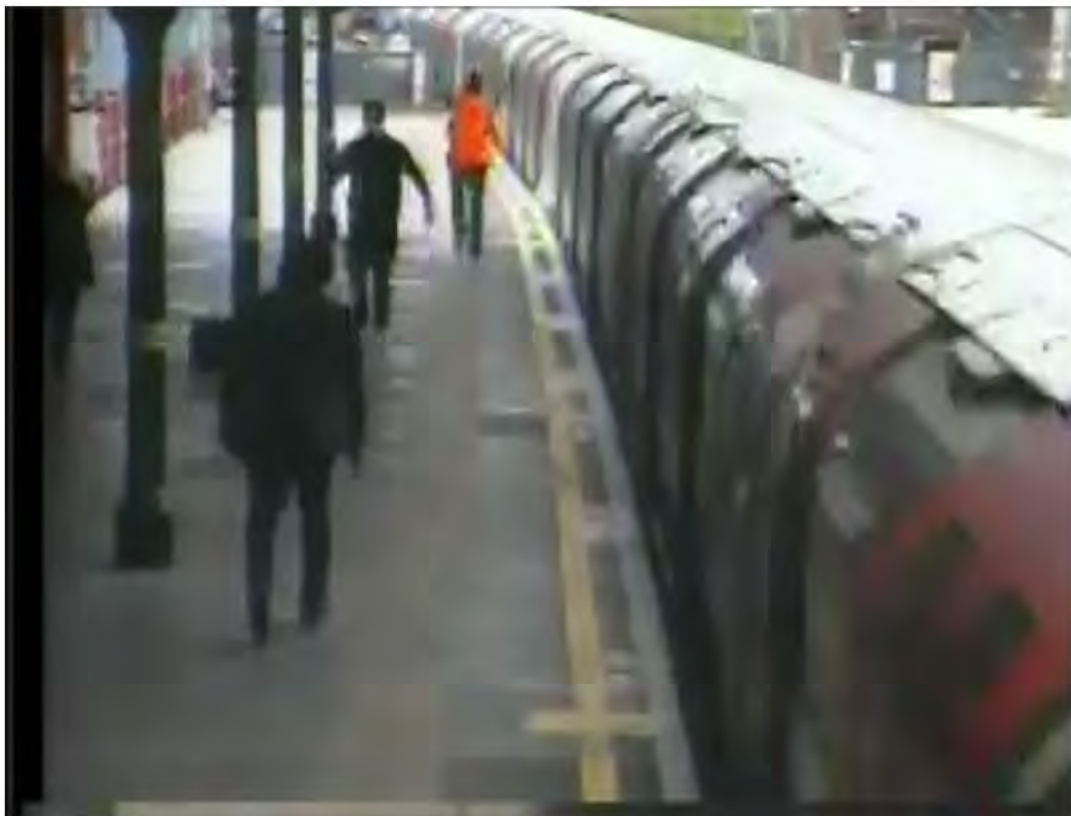
(Above) – Image No.8 - Train departs platform without stopping

The immediate cause of this incident is that a train departed the platform with the dog trapped in the door. There are 3 casual factors that have been identified. These are:

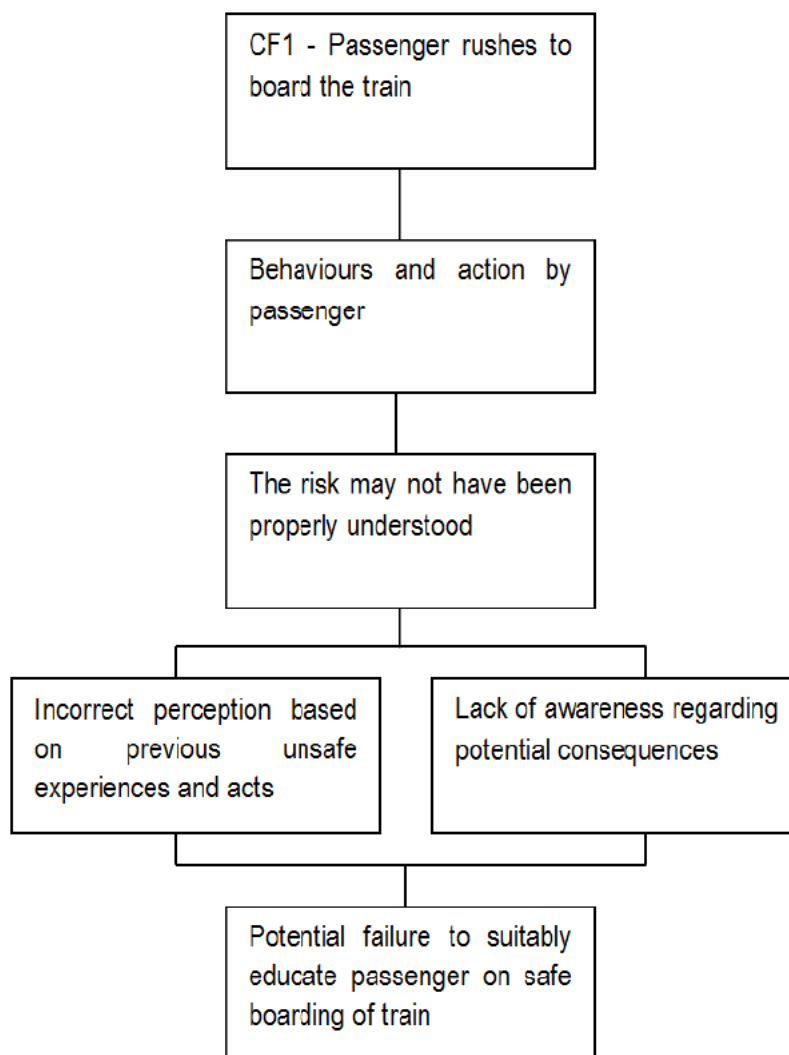
1. Causal Factor No.1 - Passenger rushes to board the train.

The diagram below deals with the actions and behaviours by the passenger. It also considers why the passenger may have acted in the manner that they did. Whilst the root cause suggests failures in education, this does not necessarily mean that the organisation has failed in its educational responsibilities, but instead it has potentially been unable to educate and influence this particular passenger in their behaviours. It is well recognised that LU invests extensive time and money on passenger safety programmes regarding boarding of trains.

(Above) – Diagram that sets out the factors relating to passenger actions and behaviours

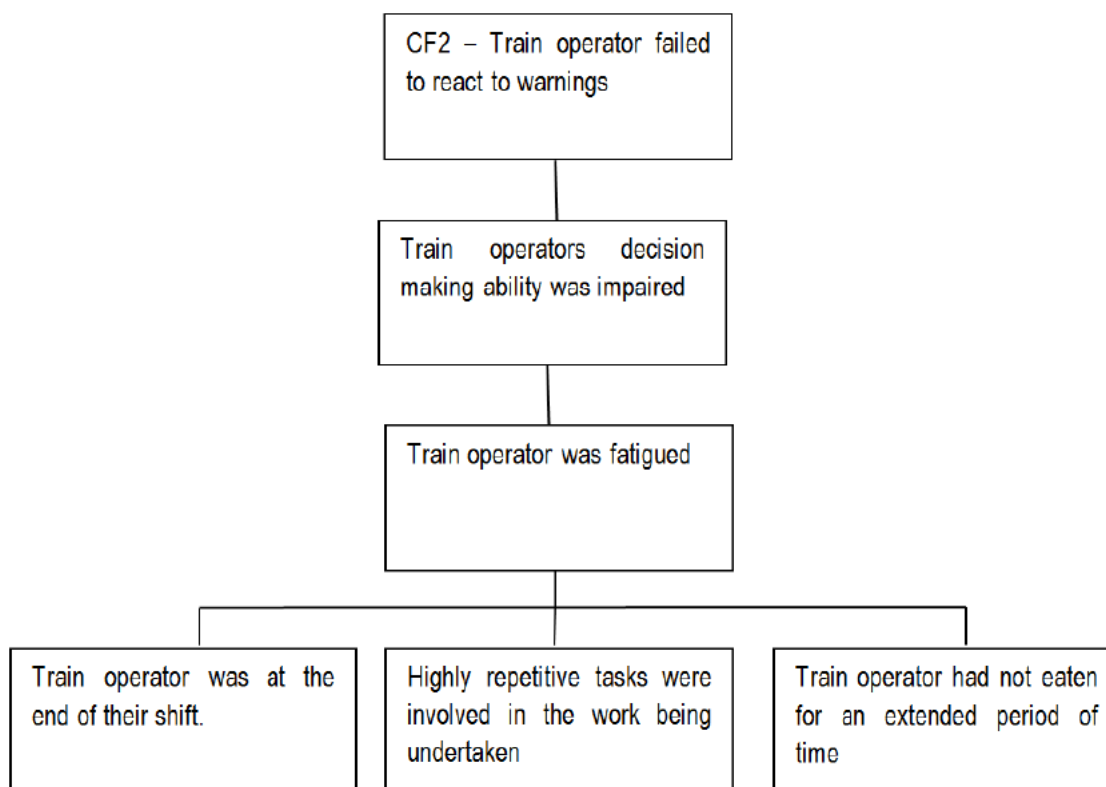
2. Causal Factor No.2 - Train operator failed to react to warning.

The investigation team has spent extensive time attempting to understand the actions of the train operator. This includes detailed review of CCTV footage and witness statements. It is of great concern that a train operator has failed to act on a known significant warning sign that was observed. However, their honesty in admitting this observation would suggest that they are likely fatigued to the extent that their decision making ability has been severely impacted. From an optimistic perspective, a wilful act can be ruled out given their honesty in admitting their failing. This is important to note as the investigation team would not have had knowledge of this if it was not for this honest admission. The underlying cause for this is likely to be fatigue caused by a lack of food and the fact that they were at the end of their shift. This can be substantiated by a variety of circumstantial evidence which includes trends in accident data. For staff who have ever been involved in highly repetitive work, they will better understand how this can effect a person's cognitive abilities. This causal factor is explained in the diagram below.

(Above) – Diagram that sets out the relevant factors relating to the actions by train operator.

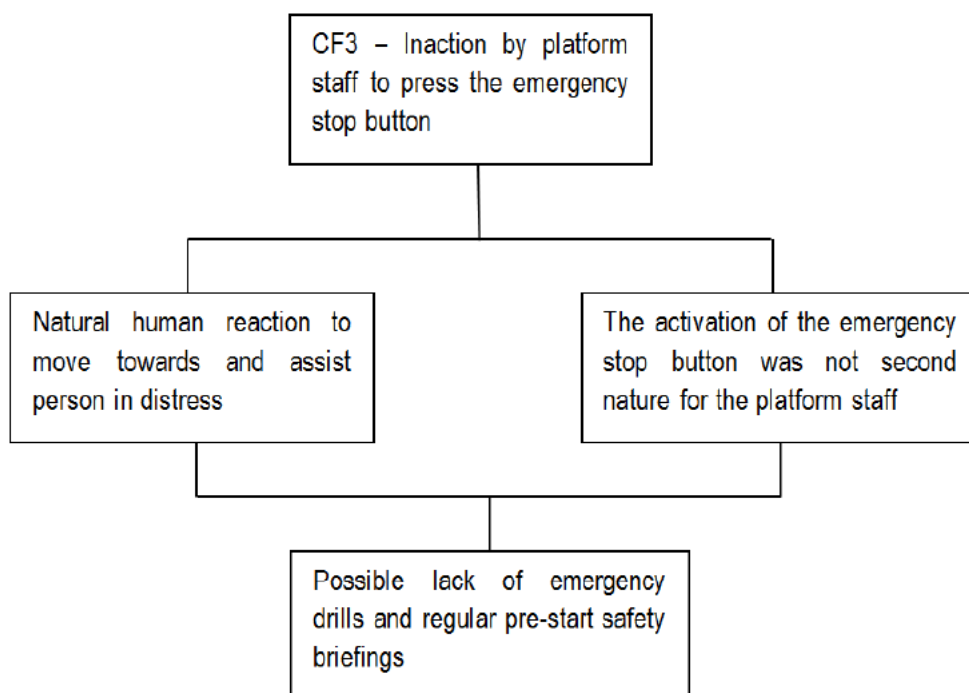
3. Causal Factor No.3 - Inaction by station staff to use platform emergency stop button

Emergency stop buttons are located on platforms so that trains at stations can be immediately stopped in the event of incident or accident. Had any of these emergency buttons been used in a timely manner during this incident, it is likely that this incident would have been prevented. This has been identified as a causal factor in this investigation. Where station staff have attempted to assist the passenger and alert the driver, this has caused a distraction that resulted in the emergency stop button not being considered as an immediate action. This is also supported by CCTV footage. Due to the positioning of the emergency stop buttons and the location of the incident, pressing this button may not have been intuitive for staff involved. There is however a need to remind staff about this so that this action is second nature. This has been detailed in recommendation No.4 of this report.

(Above) – Diagram that sets out the relevant factors relating to the inaction by station staff to press the emergency stop button located on the platform. This has been discussed in section 13.3 of this report. Staff need a further briefing on this so that initial emergency response becomes second nature.

Recommendation No.3 – Platform Emergency Stop Buttons	
Purpose	The use of platform emergency response buttons must be second nature to station staff where an incident or emergency has occurred. However, this was not the case in this incident. Staff must be regularly briefed on this.
Action	A briefing must be rolled out to all relevant operational staff (on lines where this technology exists) on the use of the emergency stop buttons located on platforms at stations. This should include staff making reference to the location of all emergency buttons at the start of their shift so that their knowledge on this is at the forefront of their mind in the event that an incident does occur.
Action Owner	Mercillina Adesida - Head of Customer Services, Central Line
Action Target Date	4 weeks from the date that this report is published
Validation	Yes
Validator	Nicki Selling – Central Line SHE manager
