# Wandle Park Tram Incident – Traction granted with tram door open at RVC06S

13<sup>th</sup> September 2021

HSE Info Exchange Reference Number: 949522

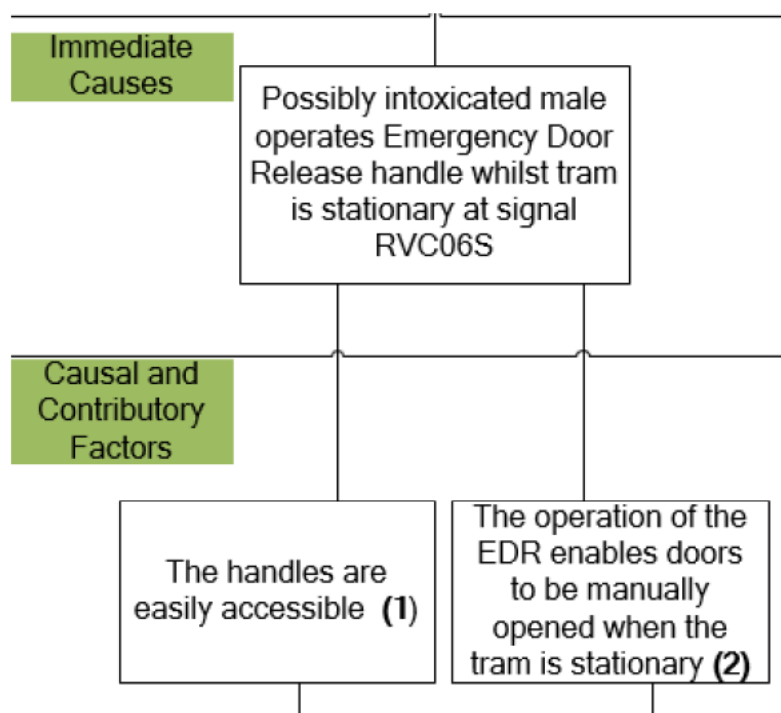
Figure 1 – The Causal Factors for Immediate Cause A

A) Possibly intoxicated male operates Emergency Door Release handle whilst tram is stationary at signal RVC06S

The FIR identified two causal factors with regard to Immediate Cause A

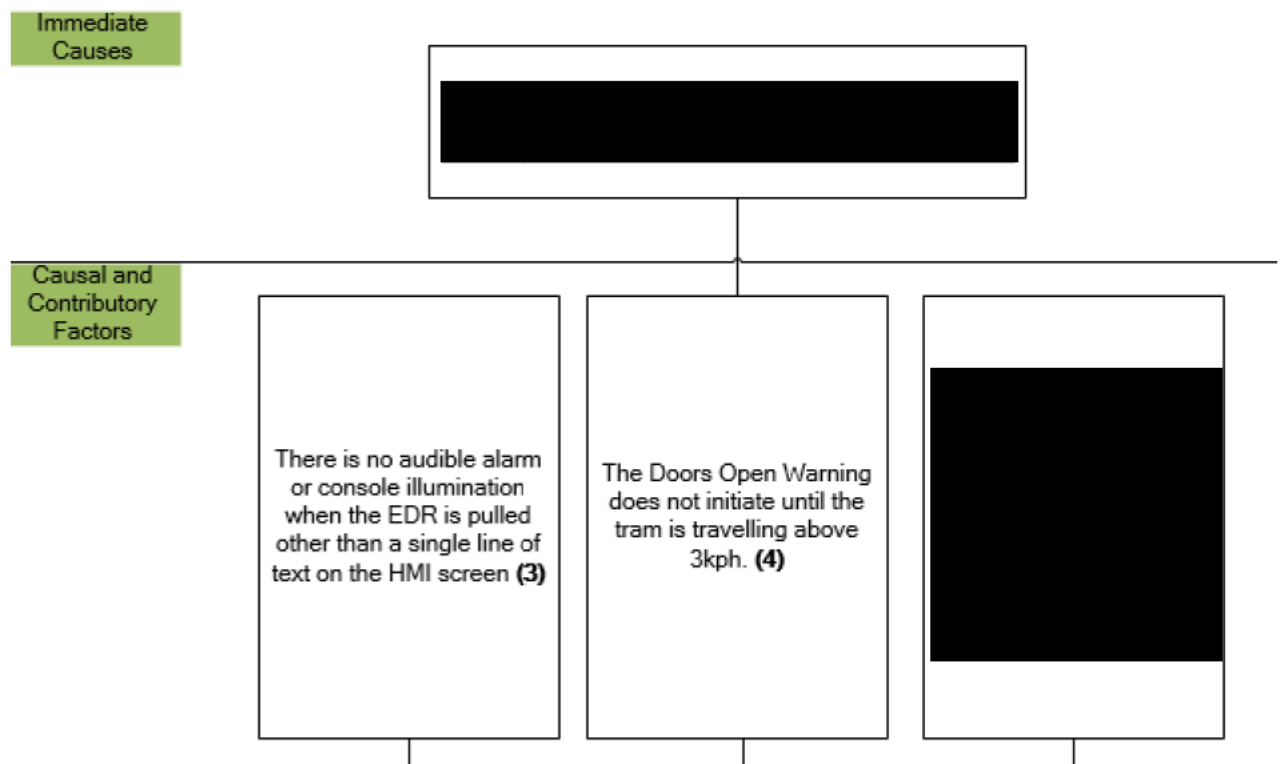
Figure 2 – The three causal factors for Immediate Cause B

The FIR identified there were three causal factors with regard to Immediate Cause B

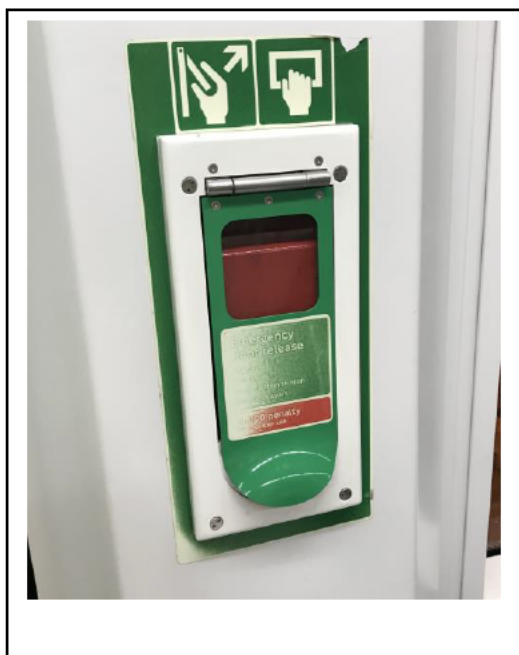
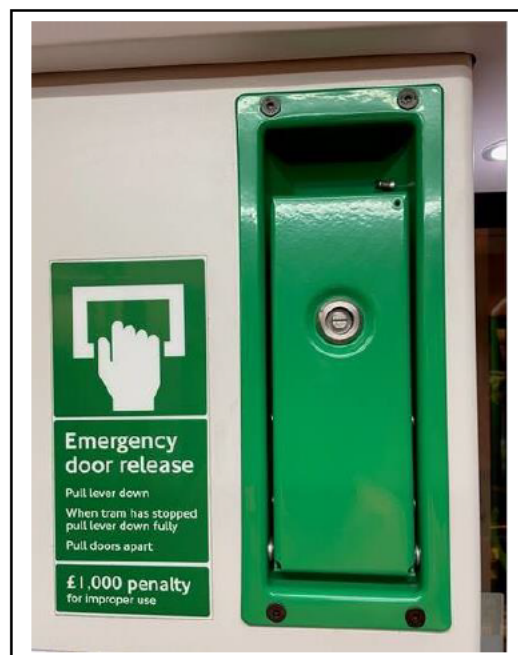
Figure 2 & 3 – A CR4000 EDR panel (left) and a SVT EDR Panel (Right)

Unlike on the CR4000 tram which requires a cover to be lifted in order to access the EDR, there are no impediments on the SVT tram. The signage warning against improper use is muted in comparison to that of the CR4000 tram. Data indicates, in percentage terms that there have been a greater number of EDR incidents on the Stadler tram in comparison to the CR4000 since 2019.

- A. The EDR panel on the CR4000 appears to have been modified between 2015 and 2016 as a consequence of one of several recommendations made by the RAIB in their March 2014 investigation into a previous incident involving a tram on London Tramlink running with its doors open on 13<sup>th</sup> April 2013, to include a metal cover to be lifted before access to the EDR handle can be obtained and modify the associated signage. The SVT was brought into service from 2012. It appears to have been purchased “off the peg” and The EDR configuration seems to be part of the original design. It is not clear why a retrospective modification to the SVT EDR panel to bring it into line with that done on the CR4000 was not done, as the prevailing standards do not preclude such a modification being made.

Additionally, both tram stocks have clearly stated notices warning against improper use. However, whilst on the CR4000 tram the warning is white text on a red background, on the SVT tram the warning is written in white text on a green background – removing a subtle

additional warning against improper use. The actual EDR handle on the CR4000 is red, whilst the handle of the SVT EDR is green, further removing a visual indication that the EDR is for emergency use only. The LRSSB TPG document references BS EN 1752 which states that the devices should be red. LT appear to be at variance with this standard.

**Recommendation 1** seeks to address this issue by proposing a review into the cost effectiveness of modifying the EDR panel on the SVT including relevant warning notices so it aligns with that of the CR4000.

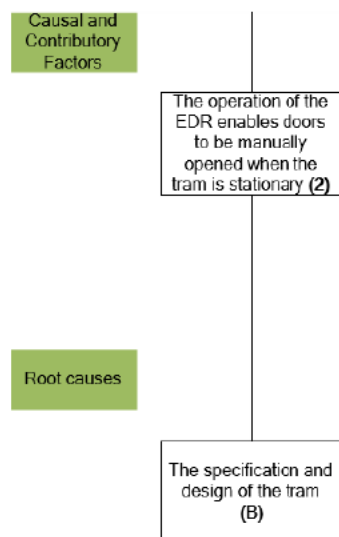
Figure 6 – Root Causes For Causal Factor 2

The tram operates, in this regard, entirely to the relevant standard. Indeed, were it not to do so, it is possible that a passenger(s) needing to exit the tram quickly in the event of an emergency situation could be harmed by their inability to do so. However, it was noted that there is a lack of signage warning of the dangers of exiting a tram at a location other than a designated tram stop, nor any guidance given to passengers on how to exit a tram safely in such a location, should they need to do so. This issue is addressed in **Recommendation 2**.

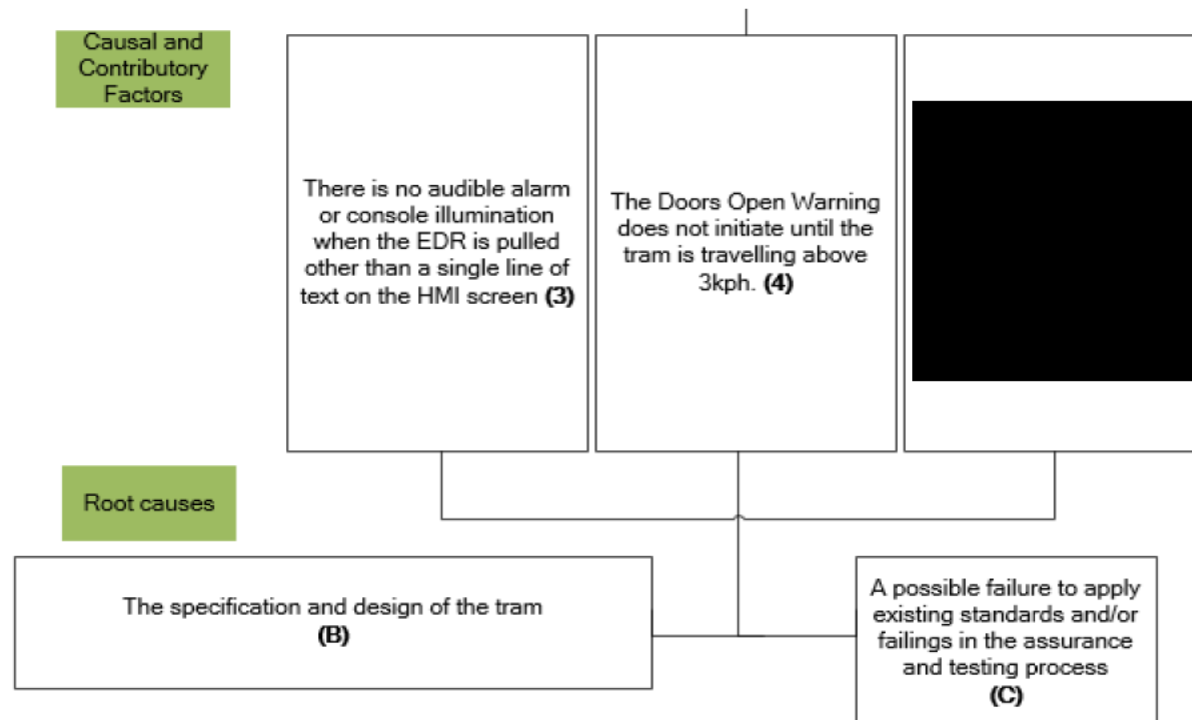
Figure 8 – Root Causes For Causal Factors 3,4 & 5

The investigation identified two root causes that were common to Causal factors 3, 4 & 5. Root Cause B and Root Cause C. Root Cause B is also the cause of Causal Factor 2 and the same conclusions should be applied.

- B. The SVT was commissioned in 2012, in response to a stated intention to extend the existing Croydon Tramlink. It is not clear how the tender process was conducted, nor if there was one. Documentation that would have provided illumination on the procurement, assurance and acceptance phases of the project is not readily available. It has been suggested that there was limited oversight by LT/TFL with regards to these processes and that assurances given by the manufacturer were taken as read.

The TPG guidelines are the standard for tram design. Whilst the version provided is dated 2016, which is after the introduction of the SVT tram, with reference to the behaviour of trams in the event of an EDR being pulled, the older tram – the CR4000, is compliant with the standards, whilst the SVT is not. Specifically, the TPL guidelines require the brakes to apply and remain applied until the EDR is physically reset. A review of the RSP2 guidelines that predated the adoption of the TPG guidelines shows no variation with regards to this point. This issue is addressed in Recommendation 4.
