## Near Miss with Track Worker

### Langley Station

Sunday 16<sup>th</sup> February 2020

HSE Info Exchange Reference Number: 117371

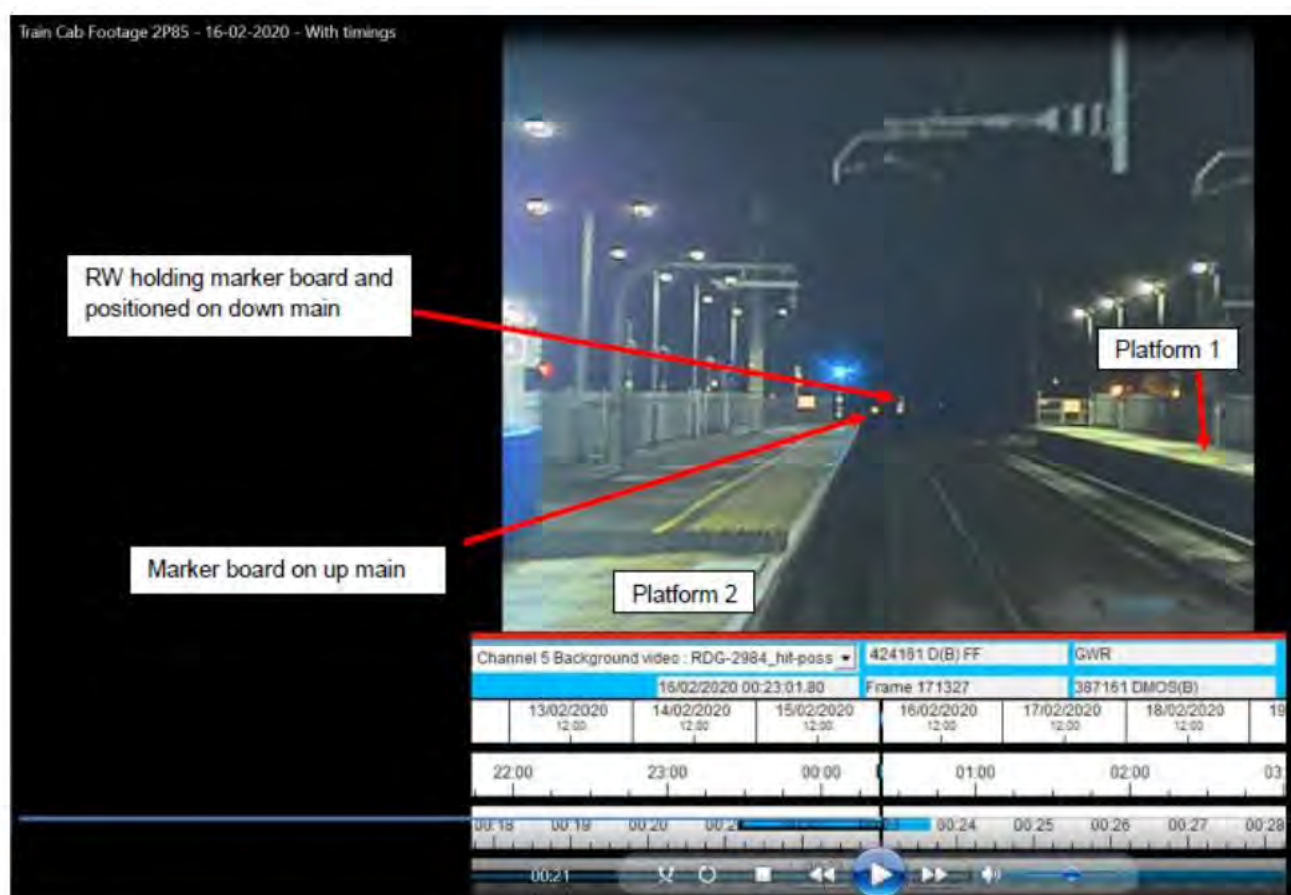
The train struck a marker board at the 16m 25ch at 00:22:56 hours.

Fig.02 - Photo/still taken from CCTV footage from inside the train (2P85 2358hrs Reading to London Paddington) – Marker boards at 16m 00ch

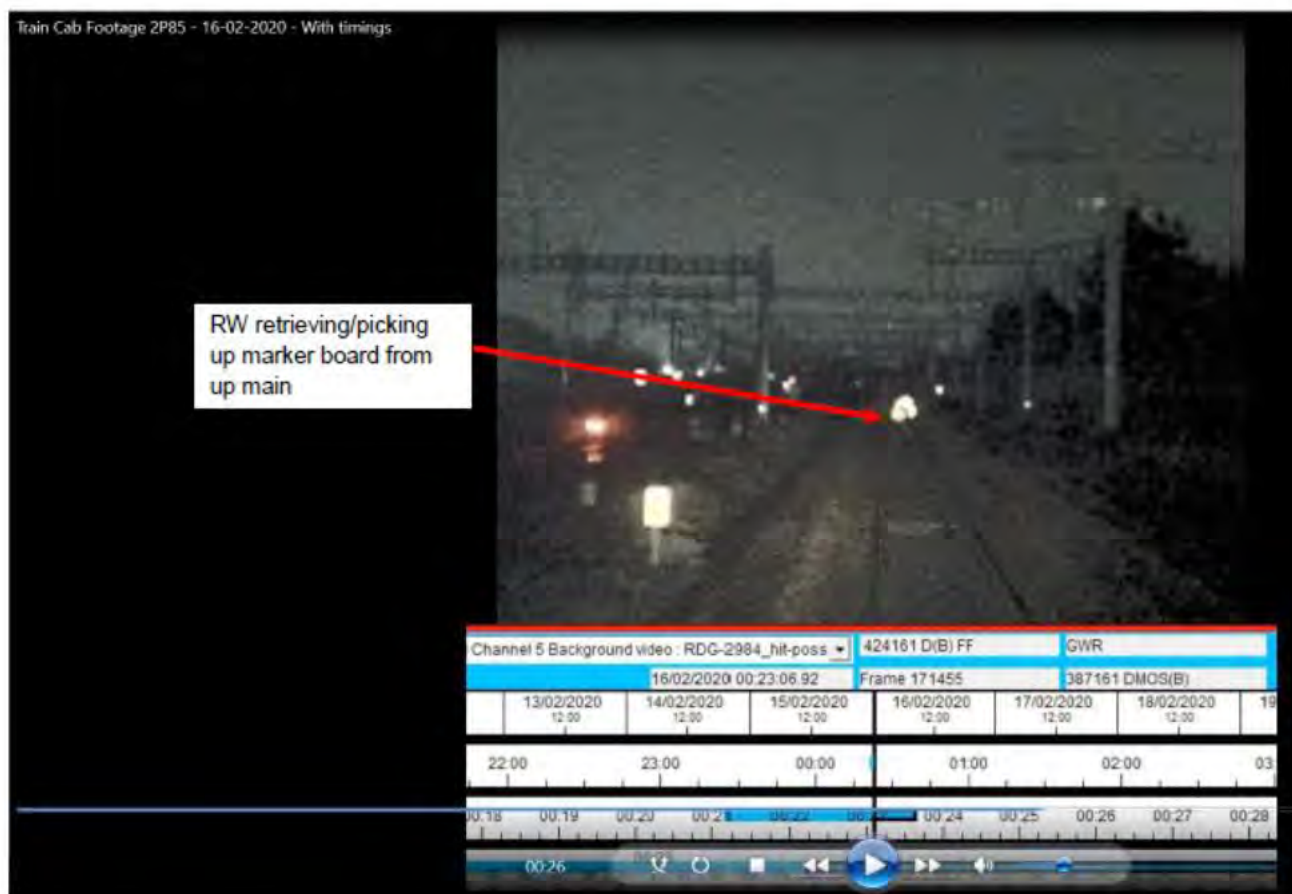
Fig. 03 - Photo/still taken from CCTV footage from inside the train (2P85 2358hrs Reading to London Paddington) – marker board and ES at 16m 00ch on up main

ES placed Marker boards on open road and when he saw a train approach, he attempted to retrieve the board to avoid collision.

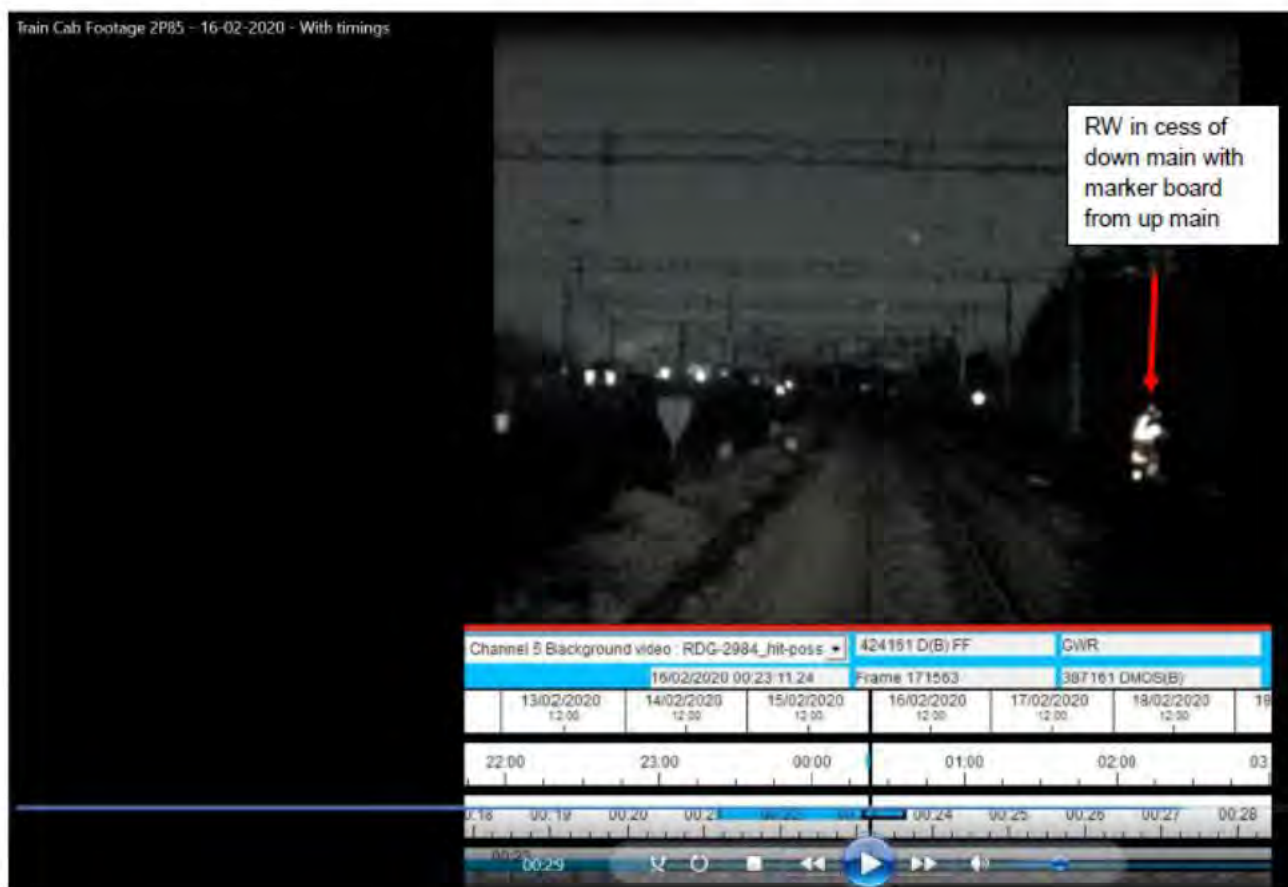
Approximately 5 seconds later at 00:23:13 hours the train passed by ES, where it then came to a stop further up the line – ES's position in relation to the train was approximately half way down the train length (i.e. half the train had passed him with the other half not having passed him).

Fig.04 - Photo/still taken from CCTV footage from inside the train (2P85 2358hrs Reading to London Paddington) – ES in cess of down main
