Formal Incident Investigation

Fracture of the longitudinal beam on the 96 tube stock

Stratford Market Depot

17th October 2019

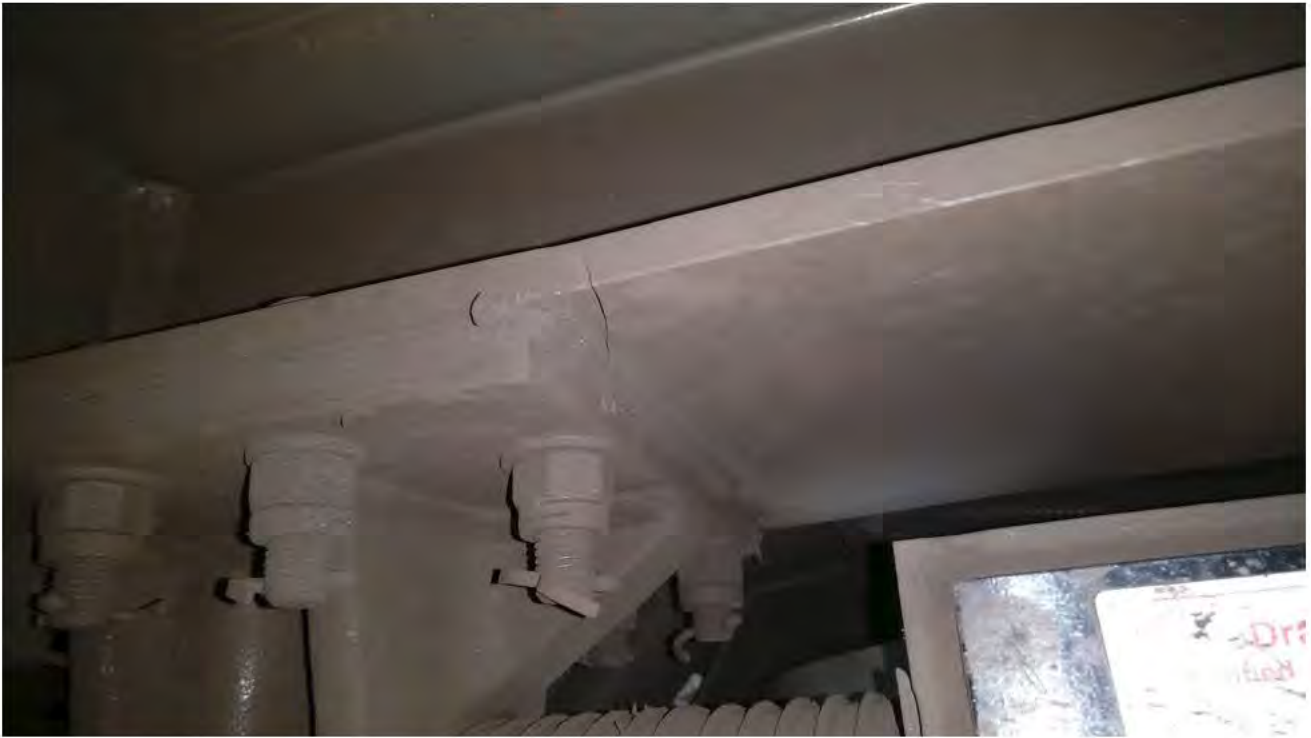
Figure 5: Image of car 96609 D End No. 1 side longitudinal beam fractures

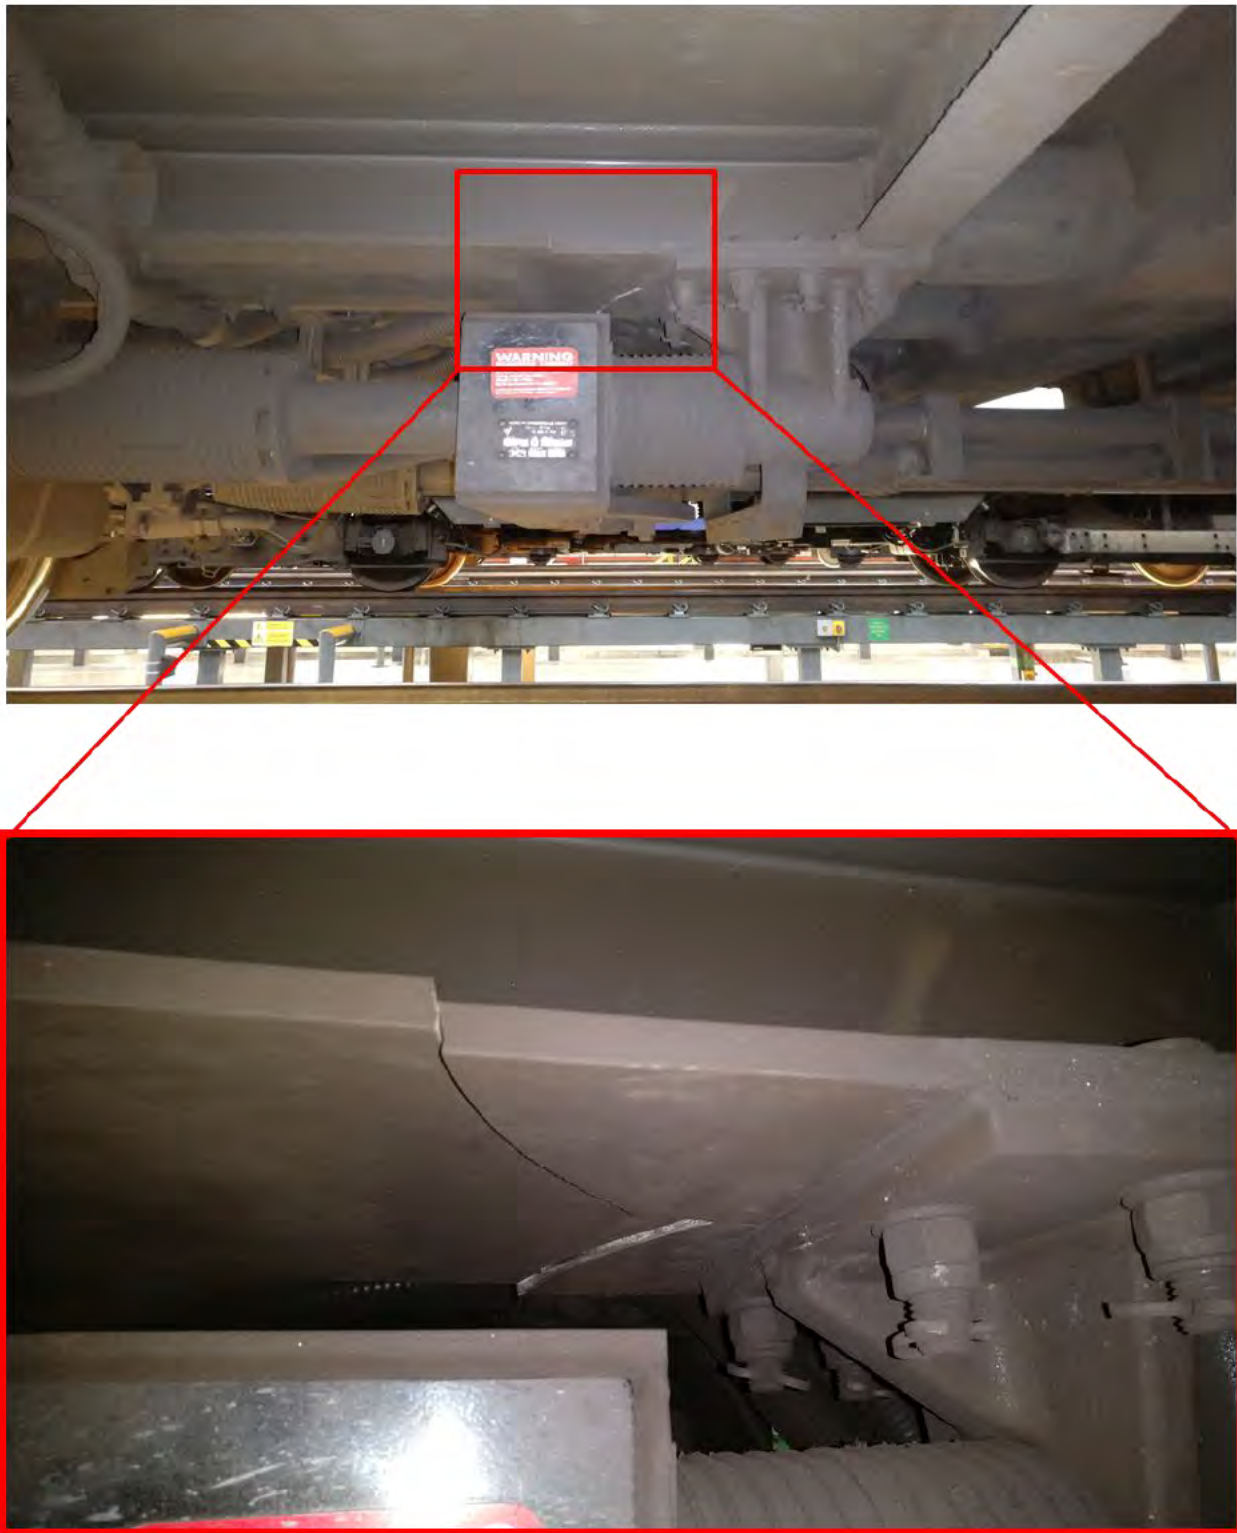
Figure 6: Image of car 96609 D End No. 2 side longitudinal beam fractures

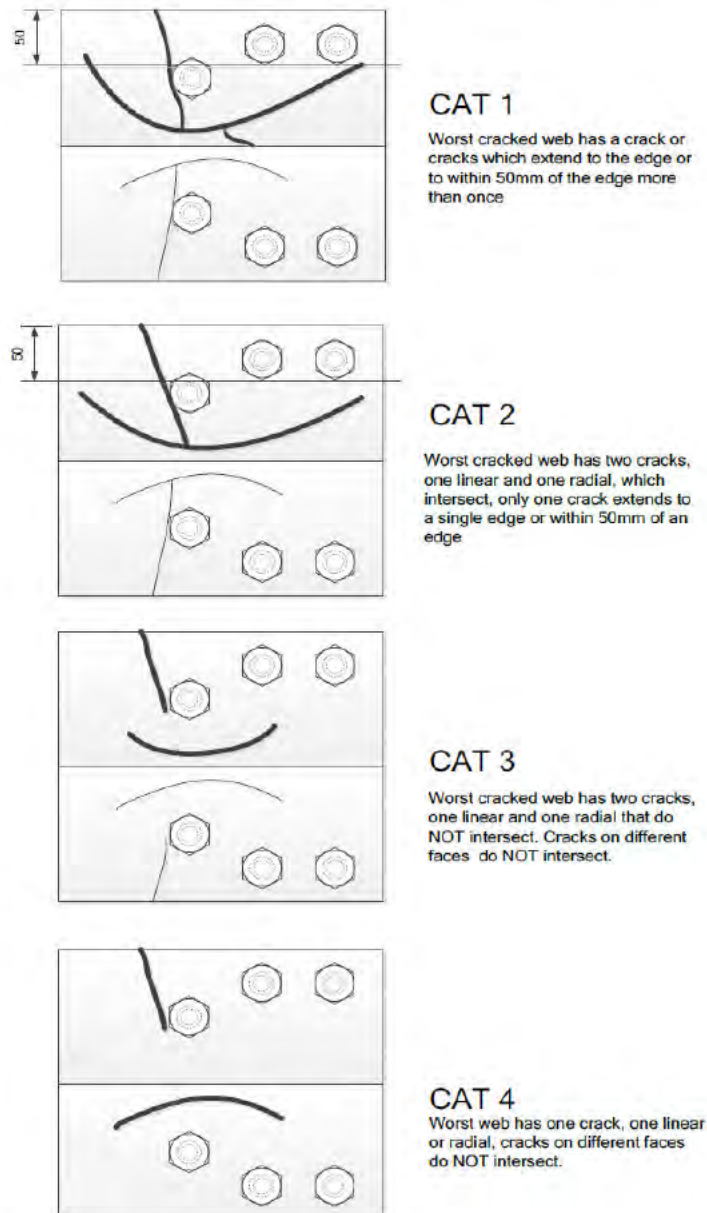
Figure 8: Diagrams of fracture categories

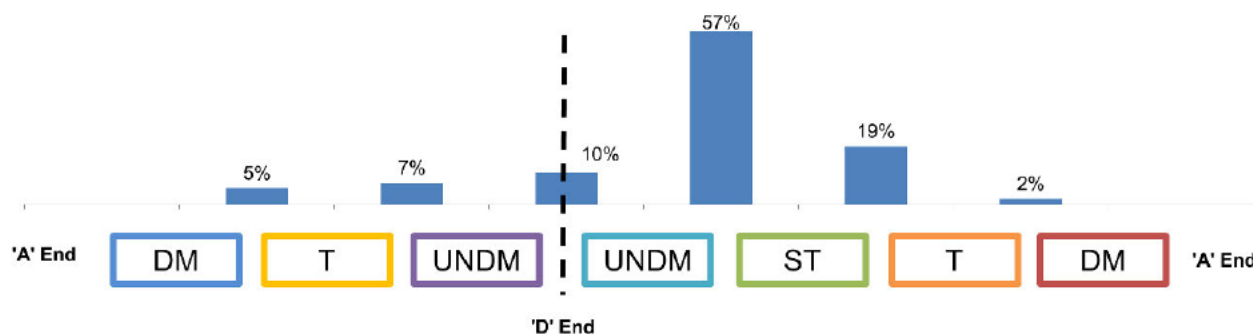
Figure 15 shows the distribution of fractures per coupling. The majority (57%), but not all, of the coupling fractures occurred between the ST and the UNDM. The forces in this area are high because there are two motor cars pushing/pulling the two trailer vehicles.

Figure 15: The percentage of fractures for each coupling for a 7-car train

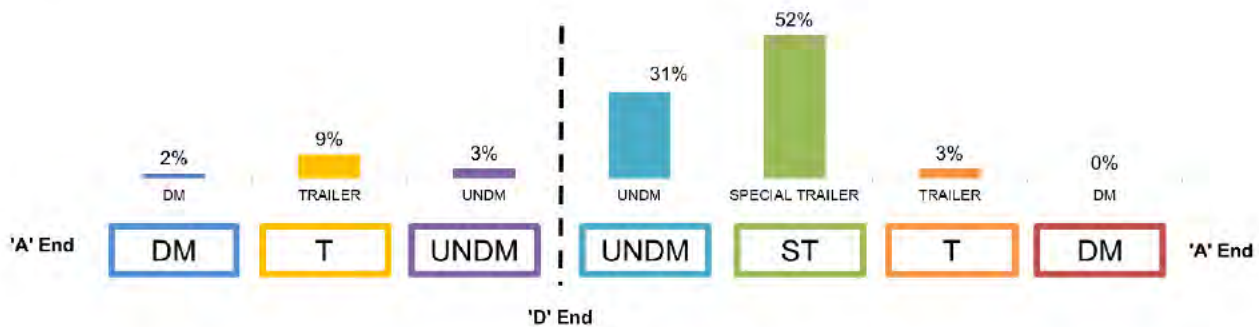
83% of the total number of fractures were discovered on the ST (52%) and the adjacent UNDM (31%) (Figure 16).

Figure 16: The distribution of fractures per car type for a 7-car train

The ST cars represent 14% of the fleet but exhibit 48% of the cars with fractures discovered. This may partially be due to build quality, but more likely due to the loading conditions at this position within the 7-car train composition.

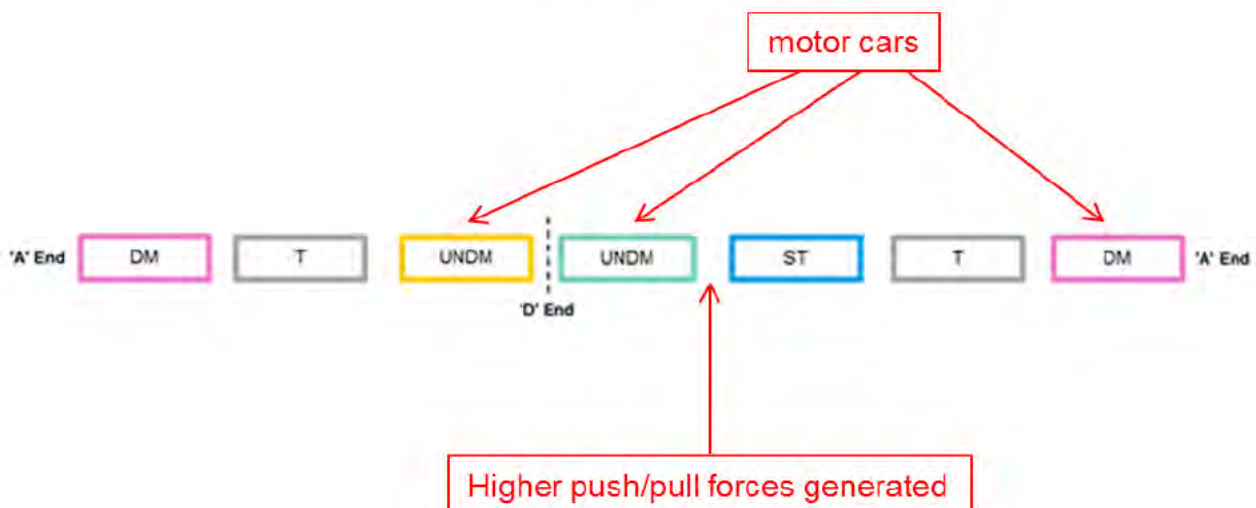
This analysis suggests that the design phase of the 7th Car Project did not fully appreciate the potential impact of these loading conditions i.e. the high forces generated from the two motor cars pushing/pulling the lighter trailer vehicles (see Figure 17).

Figure 17: Location of increased push/pull forces

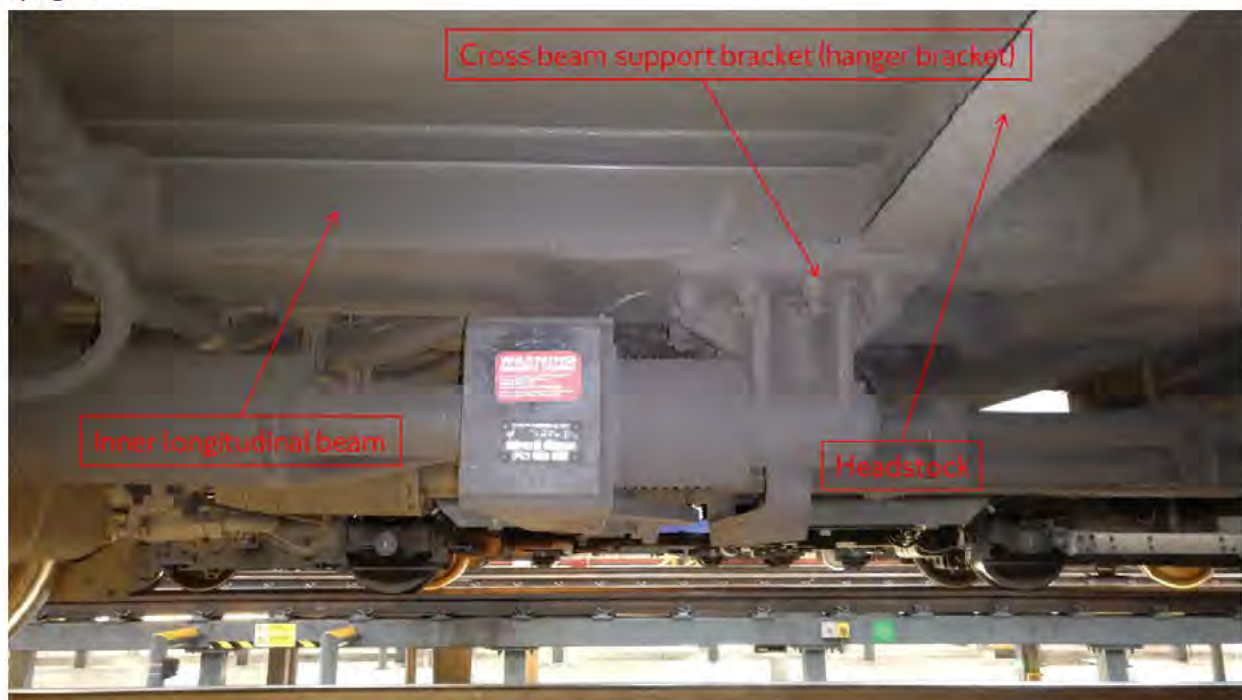
It is possible that design flatness parameters were not achieved at the build stage of the 96TS and this contributed to the fatigue of the longitudinal beam and subsequently to the fracture propagation.

Figure 20: Crossbeam support bracket arrangement

The area where the crossbeam support bracket connects to the underframe represent a complex zone as the welding between the headstock and the inner longitudinal beam generate stresses and distortions. These are key parameters to be controlled at manufacturing stages to ensure adequate quality is obtained. However, from the inspection it was observed that the headstock bottom flange is not horizontal, and therefore not parallel to the lower flange of the inner longitudinal beam.

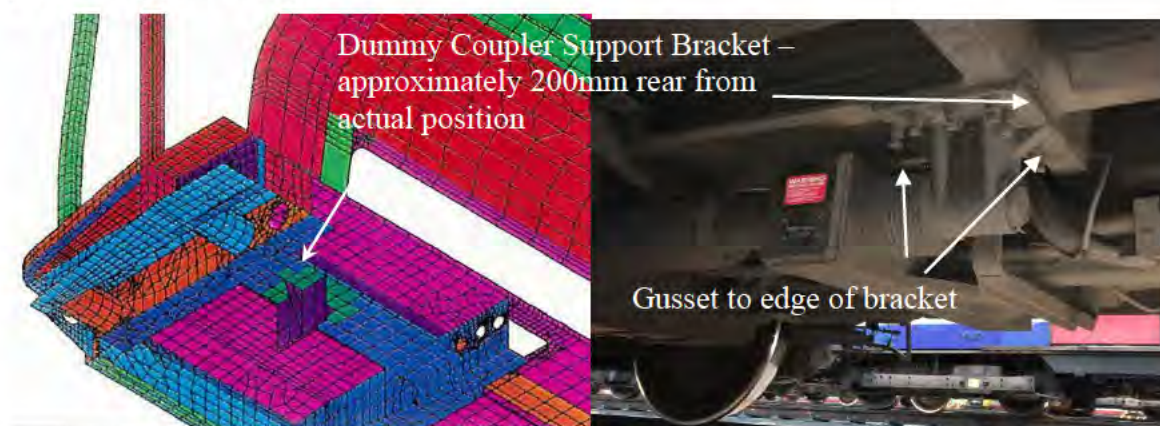
The FEA is comprised of a ¼ shell model and due to computational limitations at the time did not accurately model geometry in all areas; the application of coupler loads is one such area with the generation of a “Dummy Bracket”, the model also has a limited number of elements due to processing power, Figure 3.

Figure 3, FEA “Dummy Bracket” compared to current coupler support bracket arrangement

As can be seen from the model the “dummy bracket” is located wholly on the longitude flange and not from the front of the inner headstock as in the final design. Having the bracket so far to the rear of the much stiffer headstock and collapse tube is likely to have a significant impact on the validity of the results.

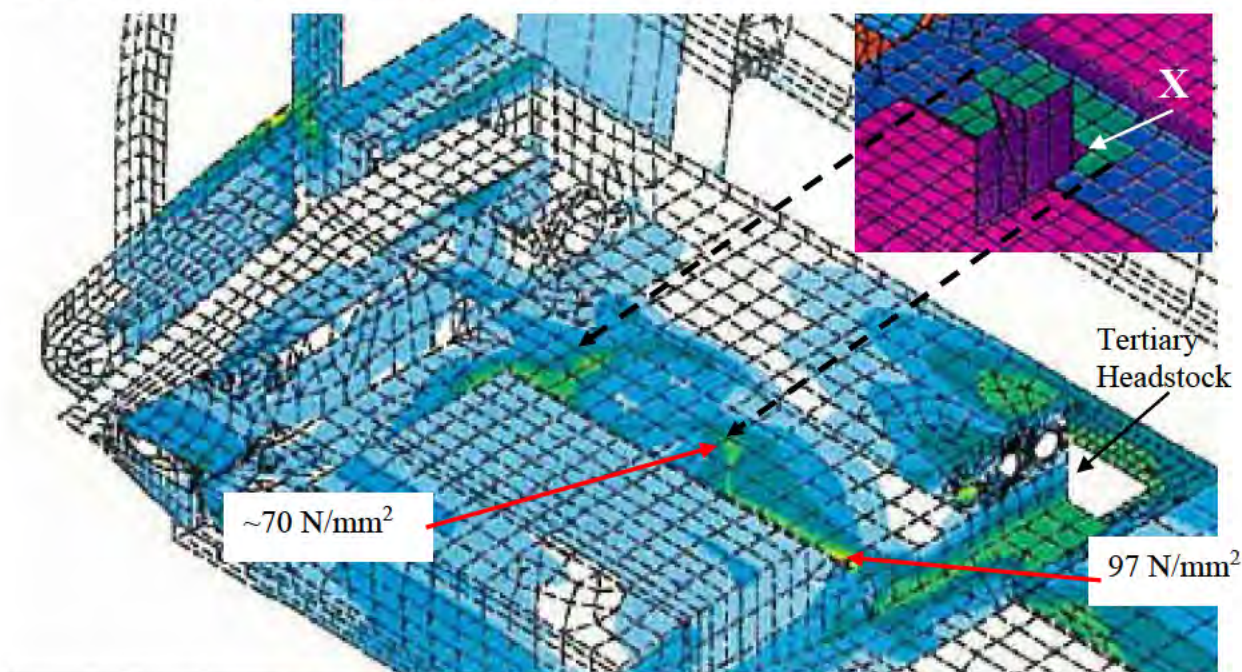
The model predicts a stress of around 70N/mm² at the bracket / longitude interface - well within the material yield, however with the number of assumptions that have been made in the model construction the stress pick up either side of the bracket would have been noteworthy and should have warranted further assessment in physical testing.

Figure 4, 1994 FEA results for 400kN couple compressive loadcase – intermediate end

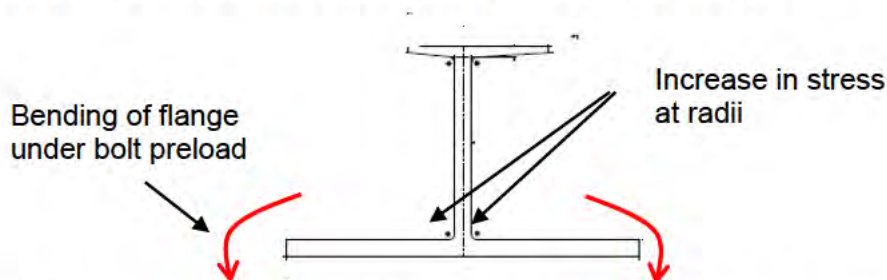
In this position the bracket straddles the headstock longitude weld which is considered a significant risk in maintaining a flat interface due to likely deformation of the both the headstock and longitude when welding. This can also build in residual stress around the joint. The concern would be that on assembly the weld line would create a pivot resulting in bending of the aluminium I beam downwards to meet the flat steel support bracket under bolt preload, Figure 5. Since the I beam web is very stiff vertically, this deformation would occur primarily in the flanges.

Figure 5: Bending of Longitude I beam under bolt preload on non-flat interface

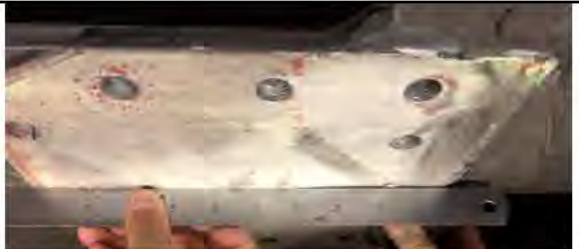
Table 2: Measured flatness across coupler support bracket interface

CAT 2	96661	Side 2 A-end	0.75mm	
CAT 2	96661	Side 1 A-end	1.2mm	
No crack	96461	Side 2 D-end	<0.05mm	
CAT 1	96461	Side 1 D-end	0.75mm	
CAT2	96479	Side 2 A-end	<0.05mm	
CAT1	96479	Side 1 A-end	4.5mm

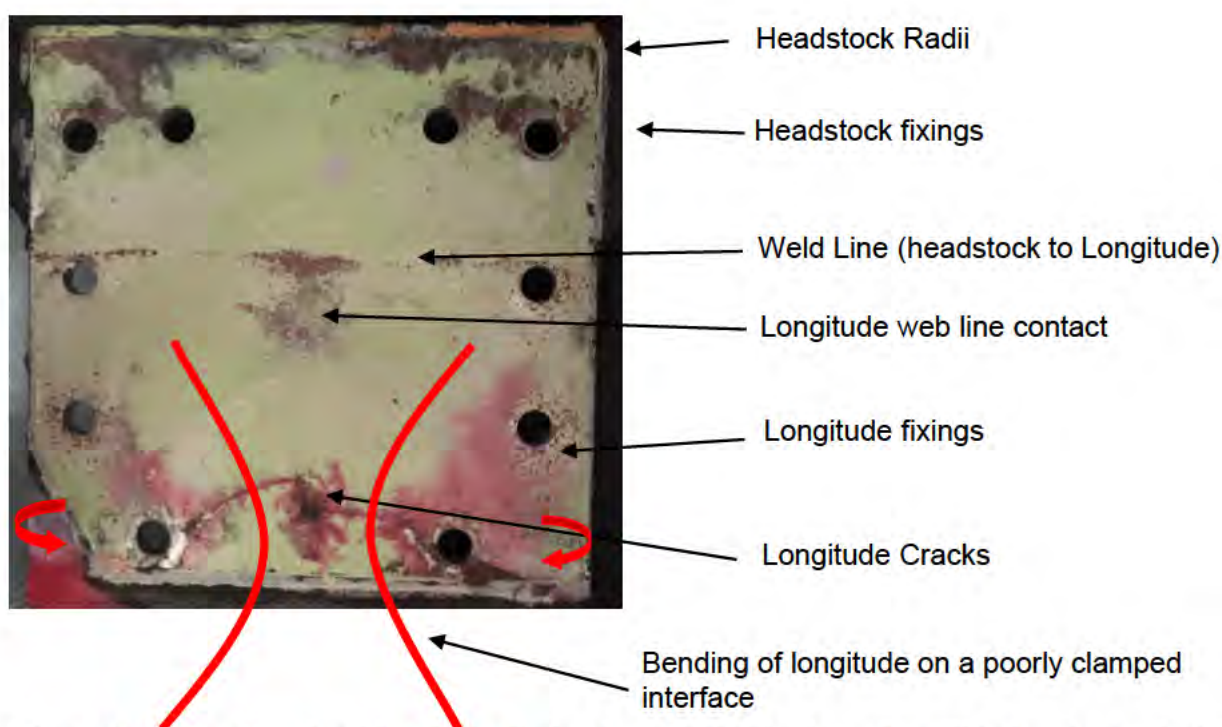
The arrangement has a total of 10 x M16 bolts grade 12.9 torqued to 230 Nm, 4 on the headstock and 6 on the longitude. The contact points between the bracket/longitude can be seen clearly on the headstock and longitude due to the darkened regions in the dissimilar material barrier material, the main contact points being the edge of the headstock radii, headstock fixings, weld line, longitude web rear of weld line and longitude fixings, Figure 6.

Figure 6: View of underside of longitude showing contact marks within barrier material

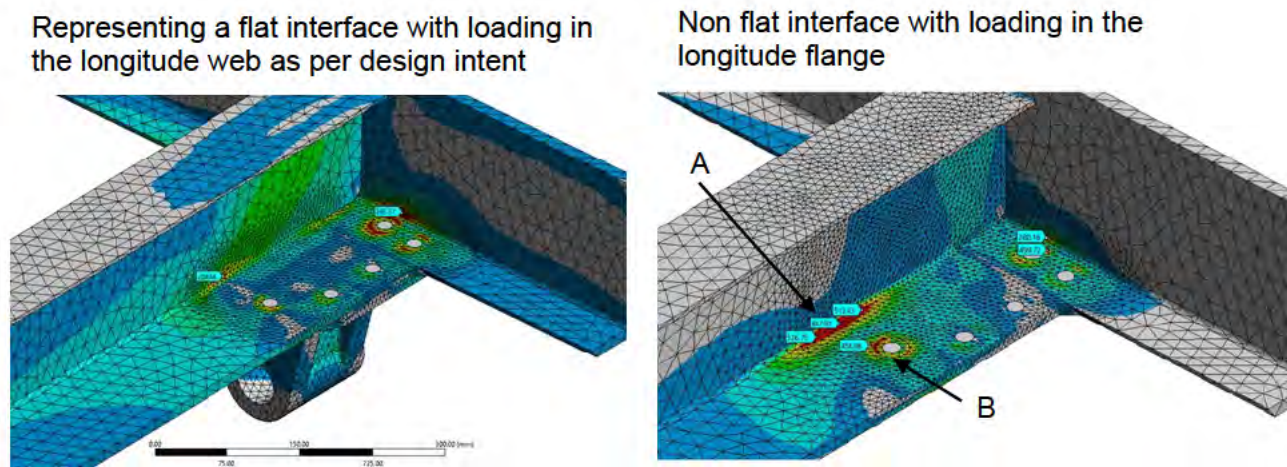
Figure 7: FEA representations of flat and poorly contacted interfaces at the coupler support bracket

As can be seen transferring the load through the flange rather than the web has a significant impact on the stress magnitude and location due to bending and results in high stress at the two main crack initiation locations at points A & B.

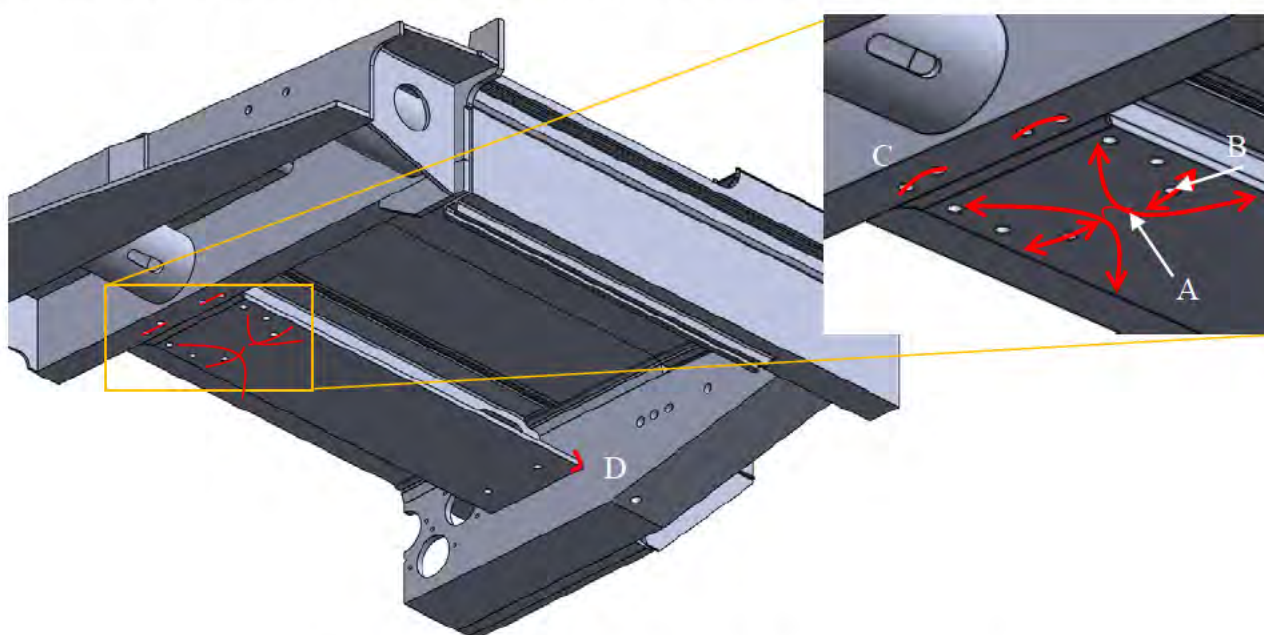
A review of the cracks which have been identified through NDT shows there are two main locations where cracks initiate in the longitude to the rear of the coupler bracket interface, points A & B. The cracks at (A) initiate at the flange to web radii and propagate in an arc in both directions. The cracks at (B) initiate in the vicinity of the rear fixing hole and propagate laterally across the flange. As B style cracks initiate on the underside of the flange these can grow to several cm before they propagate through the flange thickness and can be seen by NDT inspection meaning that the full extent of cracks will not be identified until brackets are removed during overhaul or repair, Figure 8.

Figure 8: Carbody inner Longitude crack locations

Cracks have also been identified at two other locations: at the headstock bracket fixings holes (C) - these cracks have only been found in conjunction with CAT 1 cracks or have grown to a detectable size due to increased stress in this area as part of the repair process; the fourth crack location being at the weld of the longitude flange to the tertiary headstock (high stress area identified within the original FEA). Only a very small number of cracks have been found at locations C and D and are not covered within the following data review.

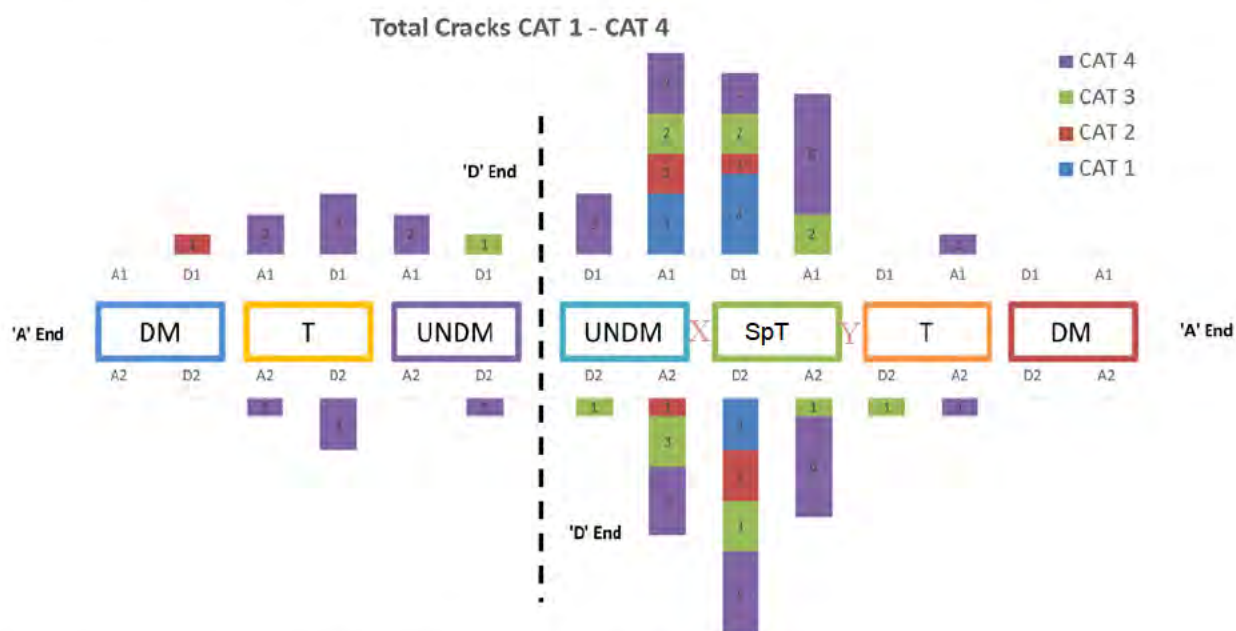
The cracks were divided by severity into four categories with CAT1 being the most severe. A review of the distribution of the crack severity (worst per car end) shows that most cracks are located at the coupler between the UNDM and special trailer (X), Figure 9. This is not surprising as this location is the highest loaded, however the crack distribution is not fully as would be expected if the cracks were being driven by coupler force alone.

Figure 9: Crack location and Category (data up to 14/05/2020)

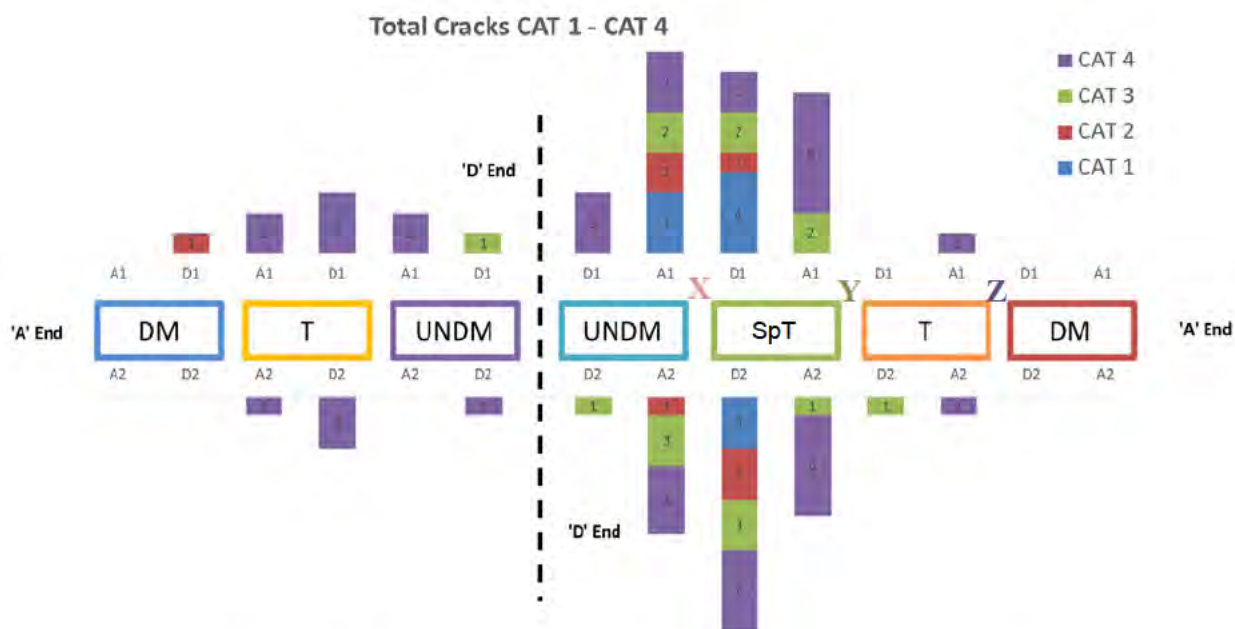
Due to the level of cracking on both the SpT and UNDM (X) it was not possible to directly assess the fatigue life at this position and following NDT checks a SpT / T position (Y) was chosen. All fatigue lives presented are for the lowest measured value which is at crack location A.

Figure 13: Seven car formation - cracks against coupler position

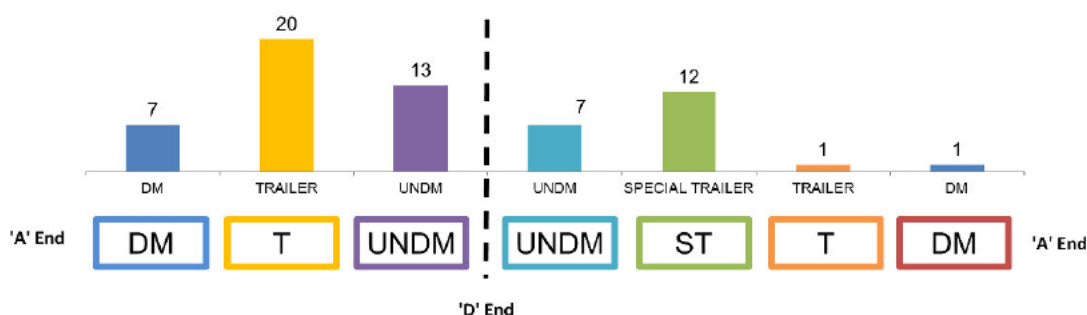
A review of recent fleet work orders relating to coupler release was made as part of the investigation into longitude cracks which identified that there was a total of 61 work orders for jaw resets or for the drawgear to be replaced (at least 7) between January 2019 and December 2019 and were distributed across the coupler positions, Figure 14. At this time drawbar release was known as "latching" and was considered a routine activity with low concern linked to the number of resets or replacements.

Figure 14: Locations of coupler jaw opening and reset and release and replace (Jan – Dec 19)

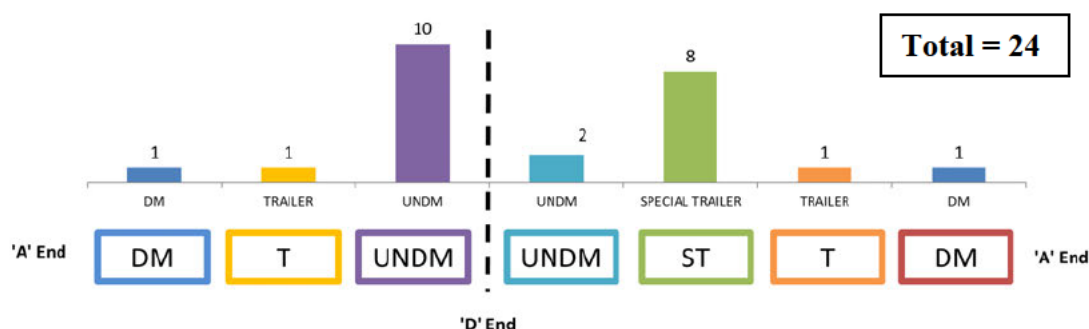
Due to the concerns around increased forces on the carbody as a result of coupler release and the possible effect on longitude crack growth CCSO 397 was put in place with the aim to eliminate coupler release in service. This was done by tightening up the process around inspection and reducing the allowable jaw opening width from 10mm (historical inspection) to 6mm, then reduced further to 4mm due to in-service failure. Between December 2019 and April 2020, a total of 24 resets / replacements were required. Of these there was one full release resulting in contact between anti-climbers in service and one partial release which could not be reset within the depot.

Figure 15: Locations of coupler jaw opening and rest and release and replace (Dec 19 – April 20)
