Report No. 4RS-JP-141704-R480481

**REFURBISHMENT ASBESTOS SURVEY
FINCHLEY ROAD
SPECIFIC AREAS**

Issue Date: 24th April 2015

Location: Finchley Road, Specific Areas

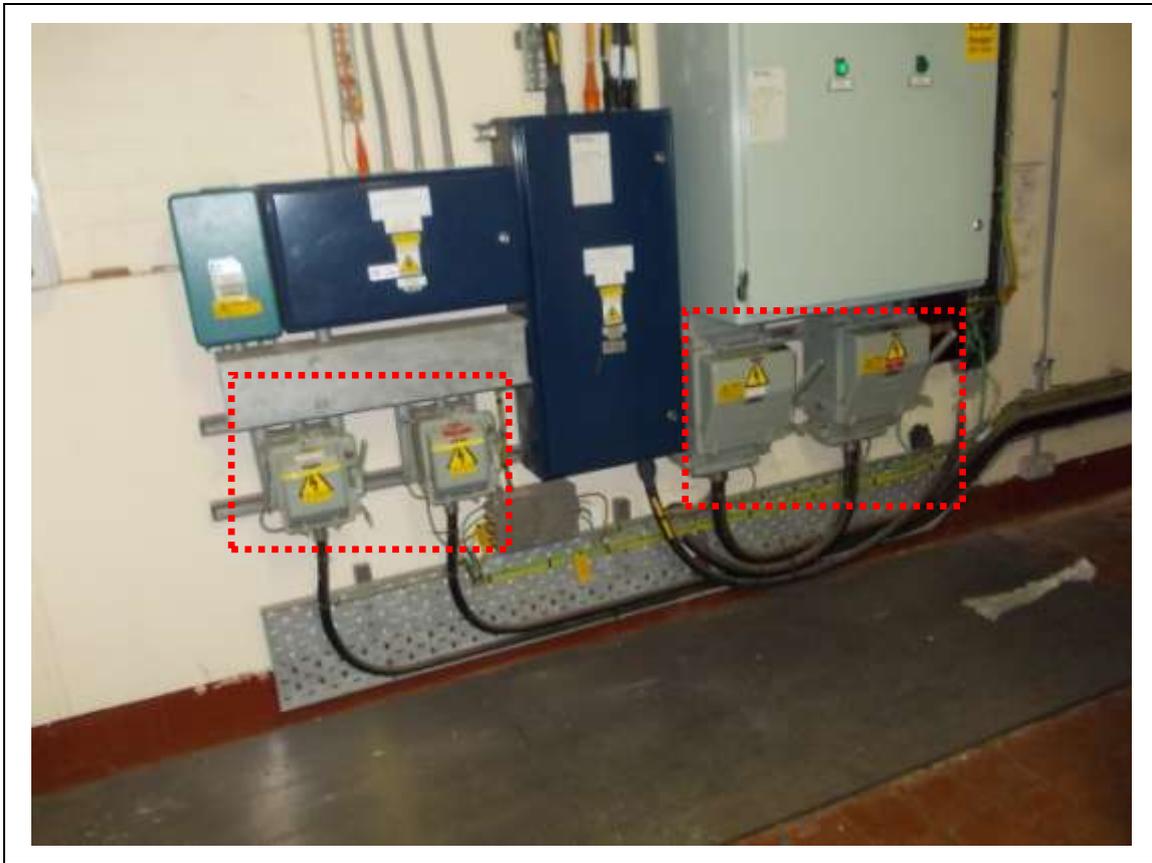
FIGURE 1: PRESUMED ASBESTOS IN MATERIALS WITHIN COMBINATION FUSE SWITCH BOXES IN UPS/ CONNECT, 0/662 - DESCRIPTION & RESULT OF ASSESSMENT (SAMPLE REF. P1 (1))

Materials within combination fuse switch boxes presumed to contain Chrysotile asbestos, Figure 1

Sample Number	P1 (1)
Location	UPS/ Connect, 0/662
Material Description	Materials within combination fuse switch boxes
Material Comment	To wall 3
Quantity	4 no.
Product Type	-
Current Condition	-
Surface Treatment	-
Asbestos Type	Presumed Chrysotile
Material Assessment Rating	-
Accessibility	-
Further Comment	Not applicable

- 9.1 Maintain the condition of the materials presumed to contain asbestos to prevent fibre release by implementing a full risk assessment and programme for re-inspection at periodic intervals. As discussed in Section 5 & 6. Material Assessment & Accessibility, the Client is advised to review and thus amend as required prior to the inclusion of actions within an asbestos management plan.

- 9.3 Confirm the asbestos content of presumed of materials before undertaking any refurbishment/modernisation/demolition works, or assume that they contain asbestos.

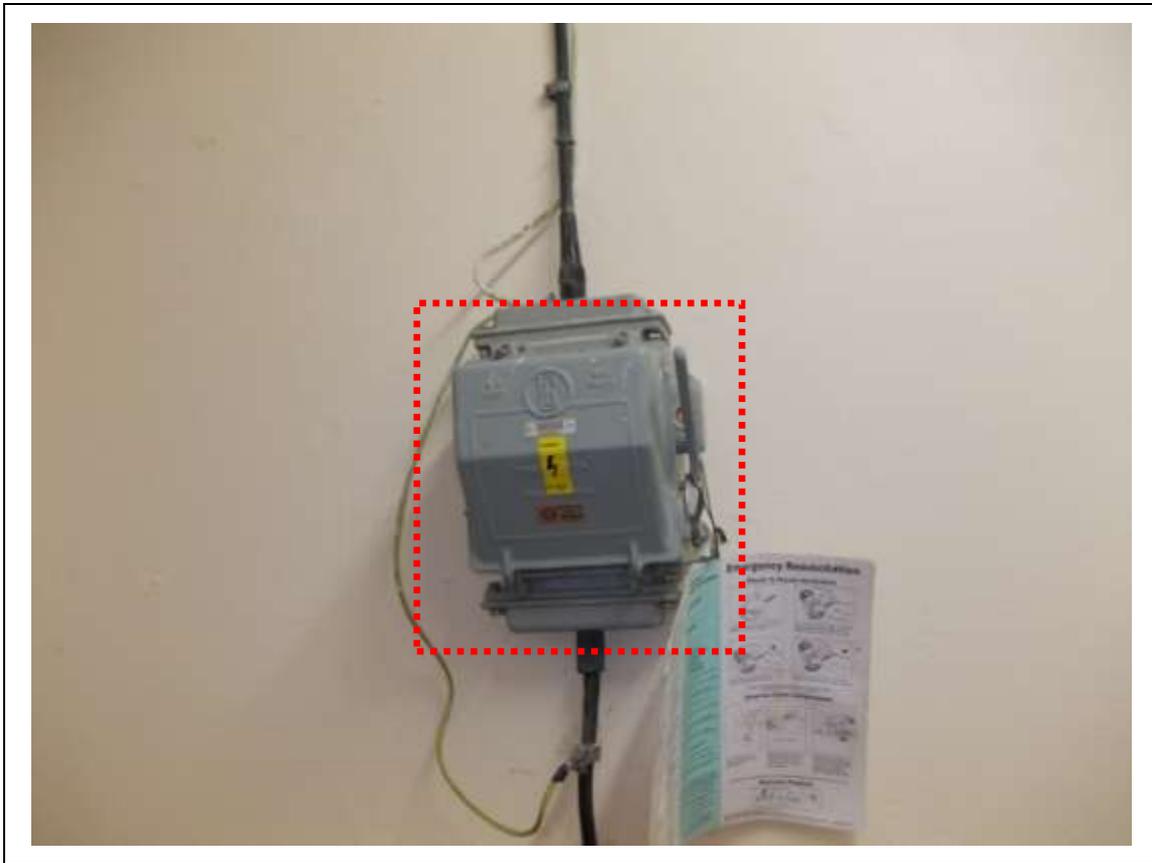
FIGURE 2: PRESUMED ASBESTOS IN MATERIALS WITHIN COMBINATION FUSE SWITCH BOX IN 0/081 - DESCRIPTION & RESULT OF ASSESSMENT (SAMPLE REF. P1 (2))

Materials within combination fuse switch box presumed to contain Chrysotile asbestos, Figure 2

Sample Number	P1 (2)
Location	0/081
Material Description	Materials within combination fuse switch box
Material Comment	To wall 2
Quantity	1 no.
Product Type	-
Current Condition	-
Surface Treatment	-
Asbestos Type	Presumed Chrysotile
Material Assessment Rating	-
Accessibility	-
Further Comment	Not applicable
