Report No. 4RS-JP-160000-R559180

**DEMOLITION ASBESTOS SURVEY
FINCHLEY CENTRAL ES7104C (REV 1)
SWITCH KIOSK AND UNDERSTAIRS SIGNAL CABIN
SPECIFIC AREAS ONLY**

Issue Date: 22nd March 2017

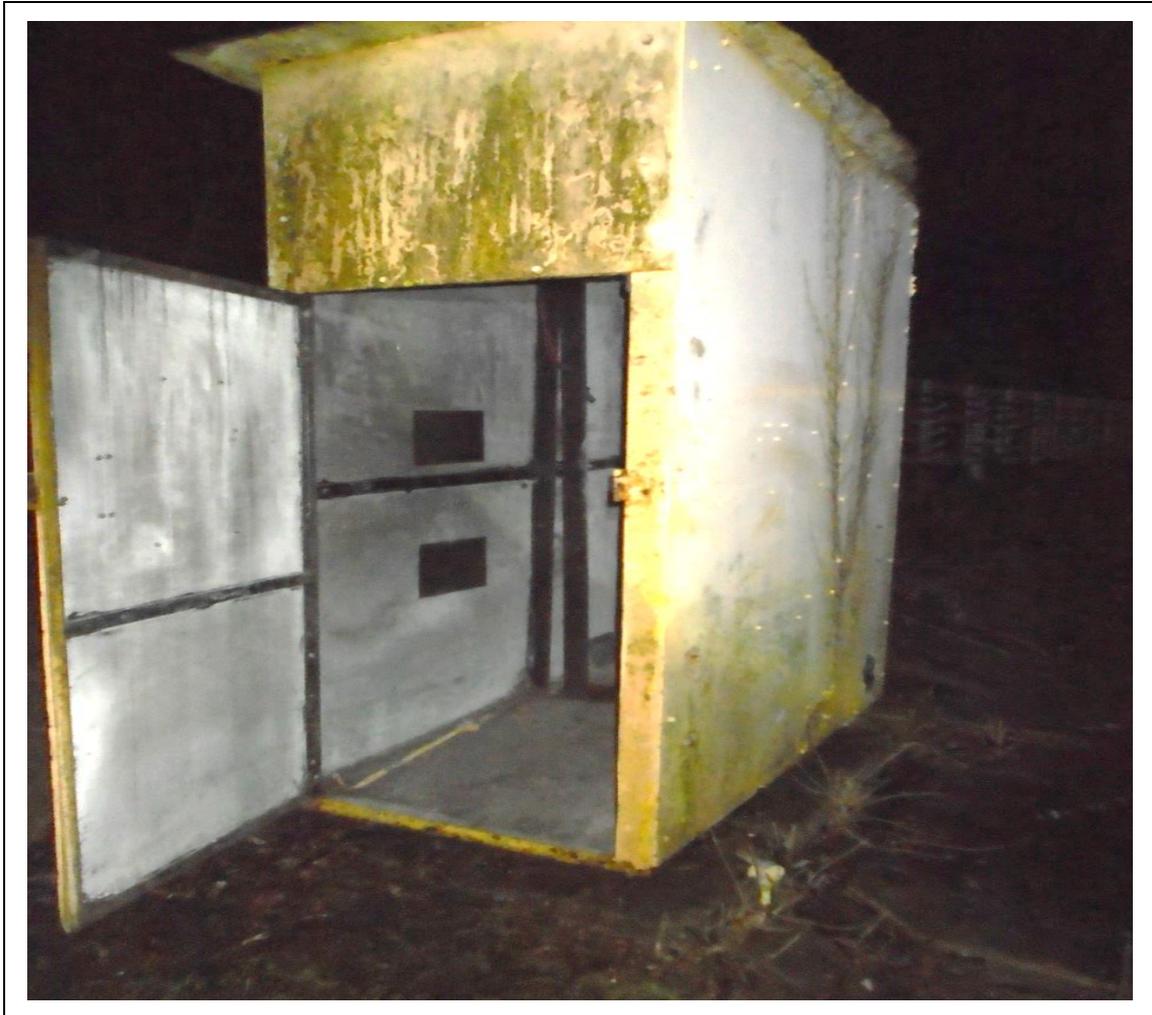
FIGURE 1: CONFIRMED ASBESTOS IN INSULATION BOARD PANELS IN SWITCH KIOSK - DESCRIPTION & RESULT OF ASSESSMENT (SAMPLE REF. 160000/050317/01)

Insulation board panels confirmed to contain Amosite asbestos, Figure 1 - Material assessment rating: Low

Sample Number	160000/050317/01
Location	Switch Kiosk
Material Description	Insulation board panels
Material Comment	Inside and outside to walls 1, 2, 3, 4 and door (damage to wall 1)
Quantity	18m ²
Product Type	Medium density
Current Condition	Slight damage
Surface Treatment	Composite
Asbestos Type	Amosite
Material Assessment Rating	Low
Accessibility	High
Further Comment	Not applicable

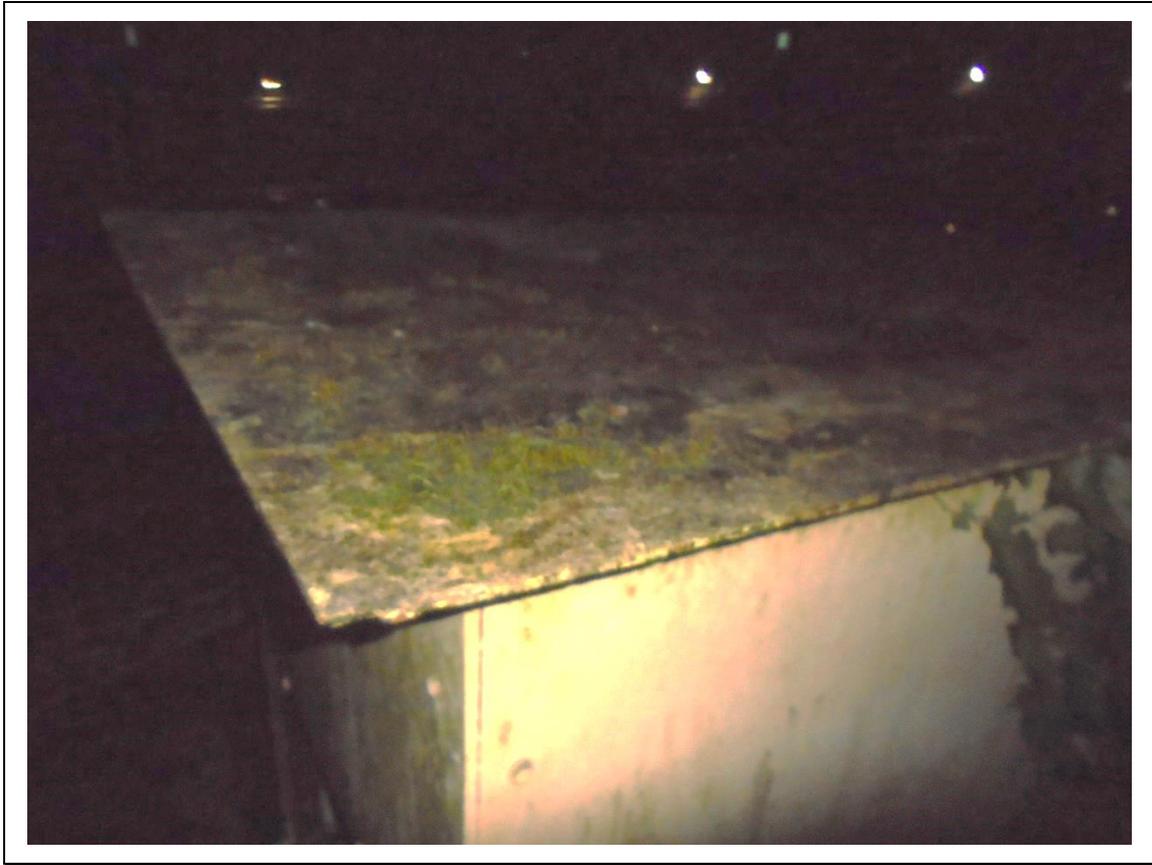
FIGURE 2: CONFIRMED ASBESTOS IN INSULATION BOARD PANELS IN SWITCH KIOSK - DESCRIPTION & RESULT OF ASSESSMENT (SAMPLE REF. 160000/050317/02)

Insulation board panels confirmed to contain Amosite asbestos, Figure 2 - Material assessment rating: Low

Sample Number	160000/050317/02
Location	Switch Kiosk
Material Description	Insulation board panels
Material Comment	To ceiling inside and outside
Quantity	3m ²
Product Type	Medium density
Current Condition	Moderate damage
Surface Treatment	Composite
Asbestos Type	Amosite
Material Assessment Rating	Low
Accessibility	Medium
Further Comment	Not applicable

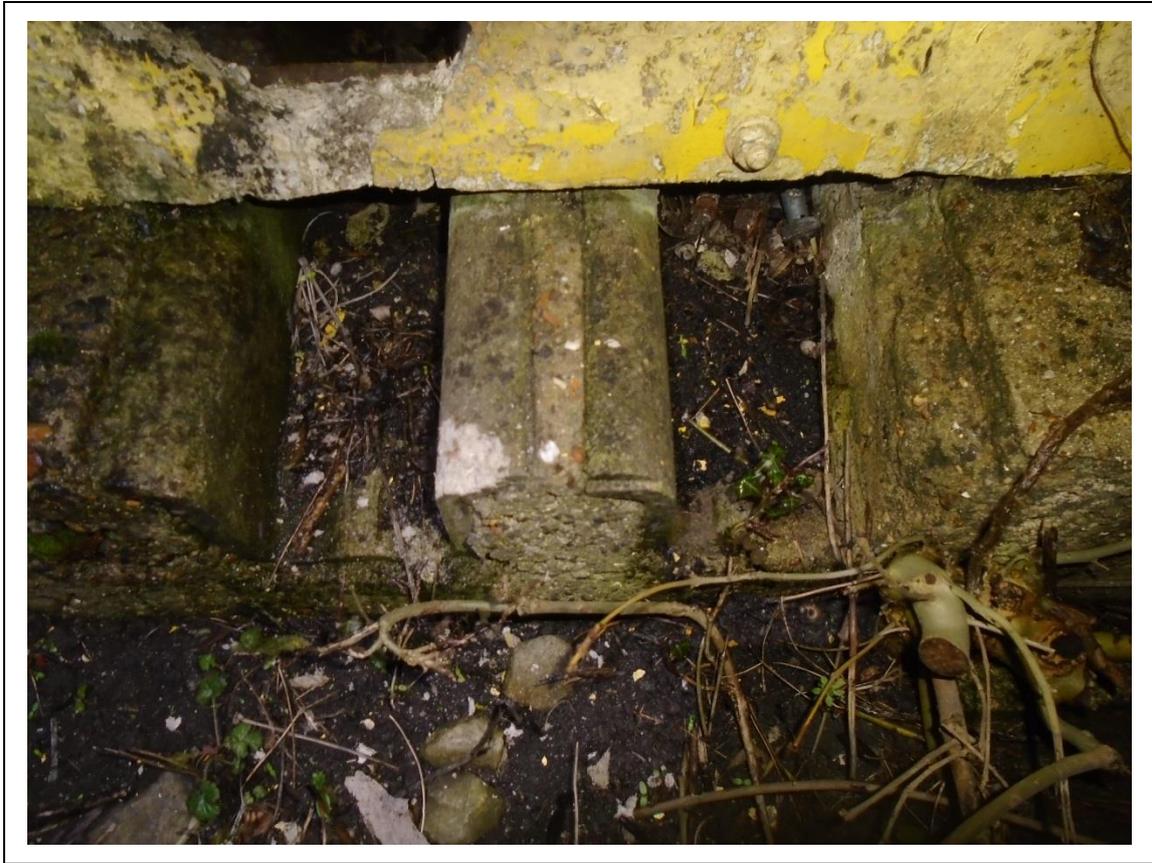
FIGURE 3: CONFIRMED ASBESTOS IN CEMENT TROUGHING IN SWITCH KIOSK - DESCRIPTION & RESULT OF ASSESSMENT (SAMPLE REF. 160000/050317/03)

Cement troughing confirmed to contain Chrysotile asbestos, Figure 3 - Material assessment rating: Low

Sample Number	160000/050317/03
Location	Switch Kiosk
Material Description	Cement troughing
Material Comment	To floor inside and outside
Quantity	2 x 0.25m ²
Product Type	Composite
Current Condition	Slight damage
Surface Treatment	Unencapsulated medium density
Asbestos Type	Chrysotile
Material Assessment Rating	Low
Accessibility	Medium
Further Comment	Not applicable

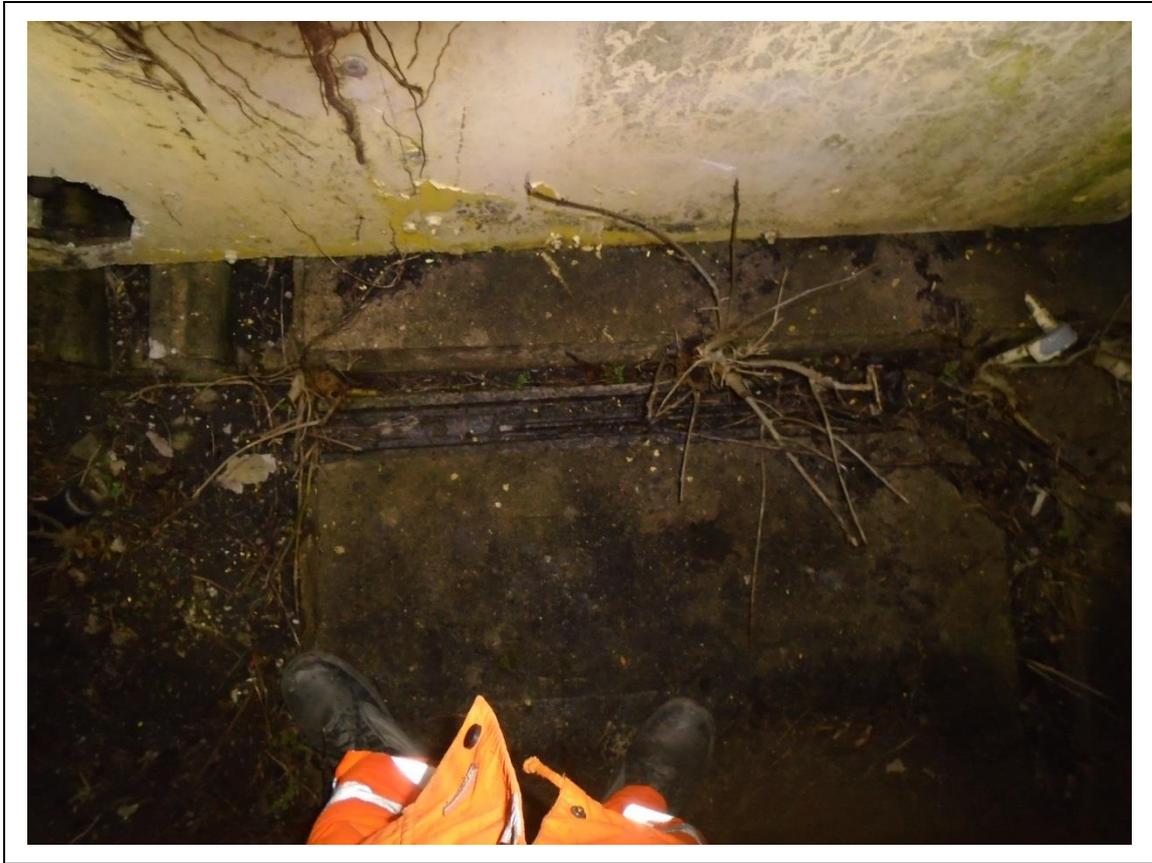
FIGURE 4: CONFIRMED ASBESTOS IN CEMENT TROUGHING IN SWITCH KIOSK - DESCRIPTION & RESULT OF ASSESSMENT (SAMPLE REF. 160000/050317/04)

Cement troughing confirmed to contain Chrysotile asbestos, Figure 4 - Material assessment rating: Low

Sample Number	160000/050317/04
Location	Switch Kiosk
Material Description	Cement troughing
Material Comment	To floor outside
Quantity	1 x 2m
Product Type	Composite
Current Condition	Slight damage
Surface Treatment	Unencapsulated medium density
Asbestos Type	Chrysotile
Material Assessment Rating	Low
Accessibility	Medium
Further Comment	Not applicable

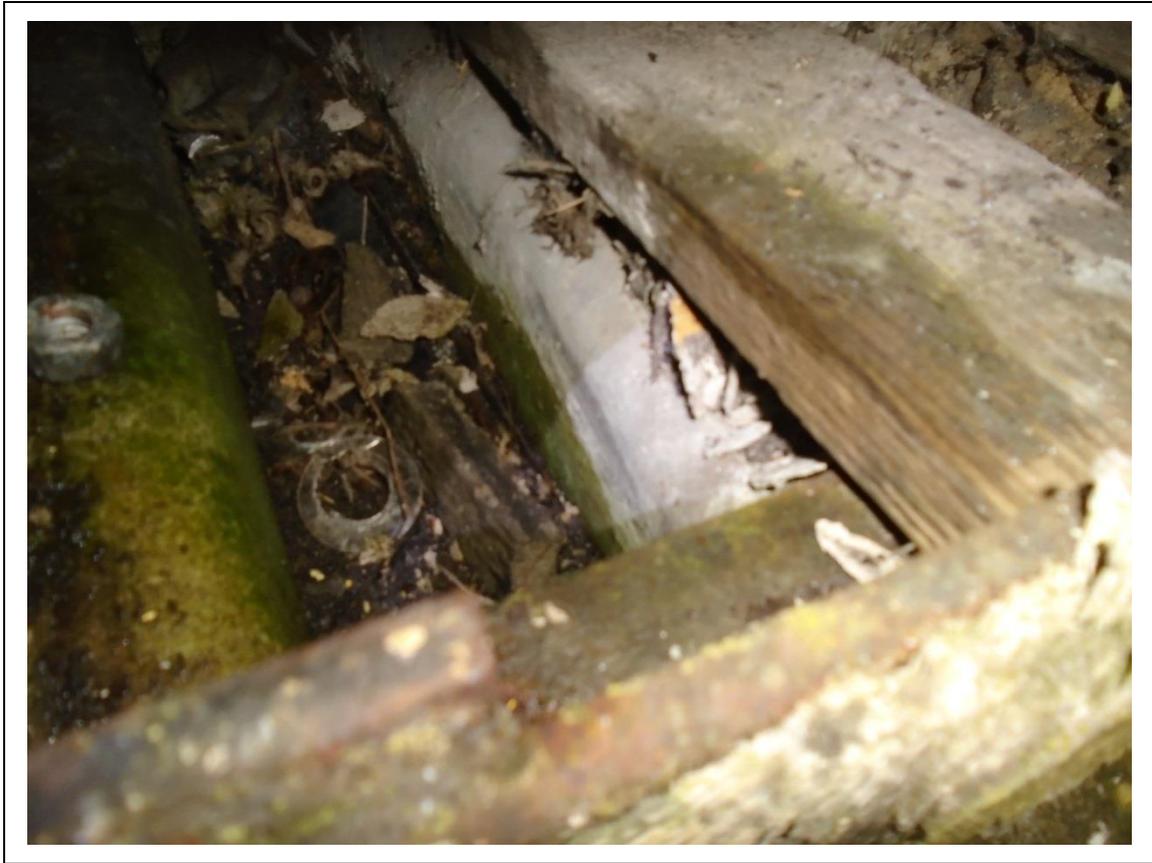
FIGURE 5: CONFIRMED ASBESTOS IN INSULATION BOARD DEBRIS IN SWITCH KIOSK - DESCRIPTION & RESULT OF ASSESSMENT (SAMPLE REF. 160000/050317/05)

Insulation board debris confirmed to contain Amosite asbestos, Figure 5 - Material assessment rating: Medium

Sample Number	160000/050317/05
Location	Switch Kiosk
Material Description	Insulation board debris
Material Comment	Inside to floor
Quantity	<1m ²
Product Type	Medium density
Current Condition	Extensive damage
Surface Treatment	Composite
Asbestos Type	Amosite
Material Assessment Rating	Medium
Accessibility	Medium
Further Comment	Not applicable

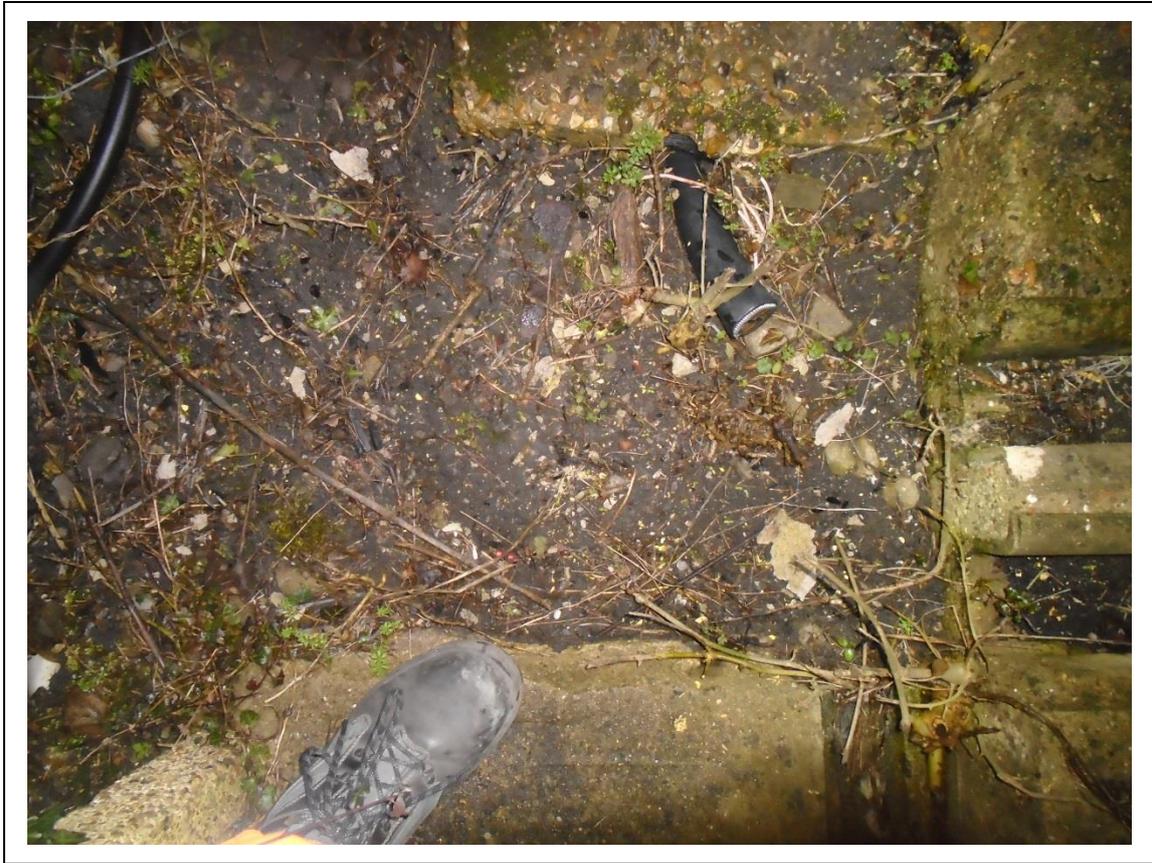
FIGURE 6: CONFIRMED ASBESTOS IN INSULATION BOARD DEBRIS IN SWITCH KIOSK - DESCRIPTION & RESULT OF ASSESSMENT (SAMPLE REF. 160000/050317/06)

Insulation board debris confirmed to contain Amosite asbestos, Figure 6 - Material assessment rating: Medium

Sample Number	160000/050317/06
Location	Switch Kiosk
Material Description	Insulation board debris
Material Comment	Outside to by adjacent to cable run
Quantity	<1m ²
Product Type	Medium density
Current Condition	Extensive damage
Surface Treatment	Composite
Asbestos Type	Amosite
Material Assessment Rating	Medium
Accessibility	Medium
Further Comment	Not applicable

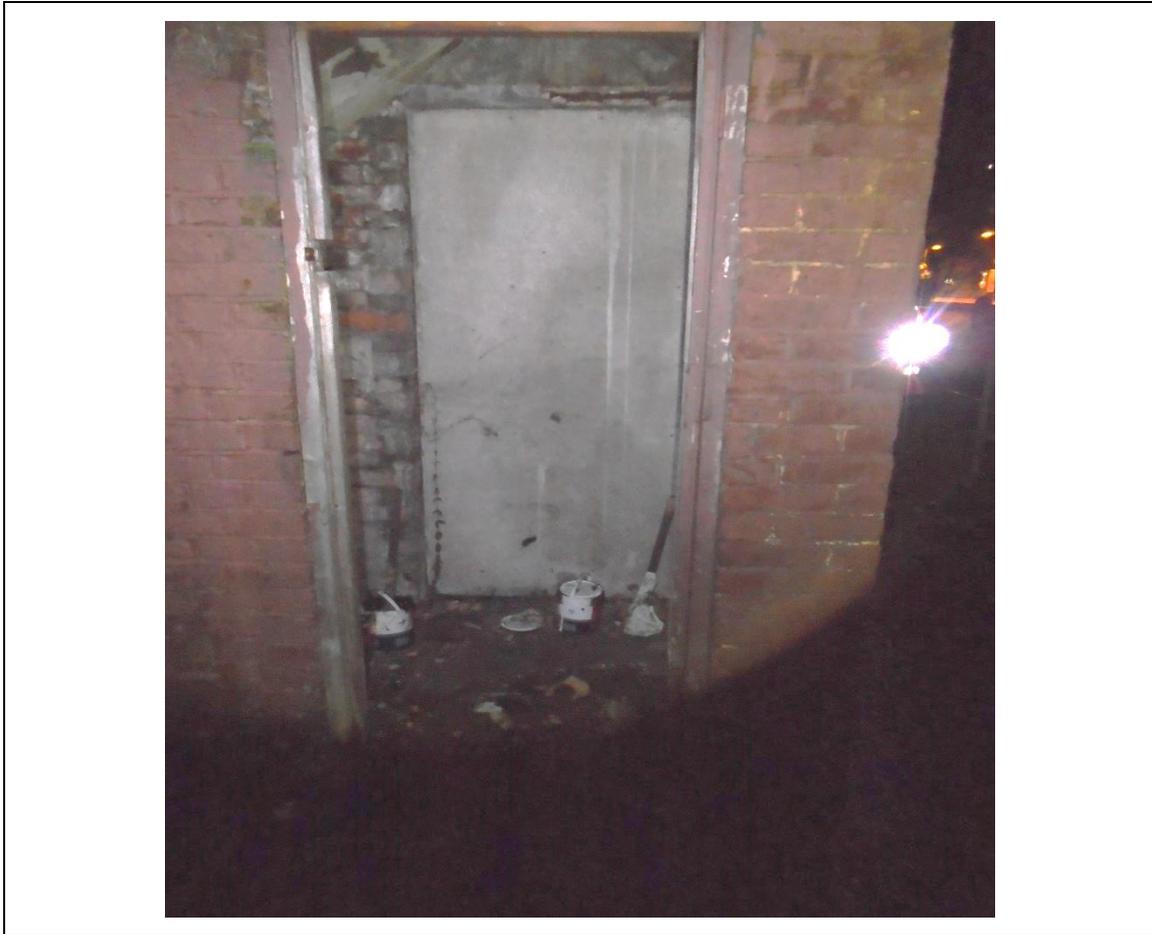
FIGURE 7: CONFIRMED ASBESTOS IN CEMENT PANEL IN UNDERSTAIRS SIGNAL CABLE - DESCRIPTION & RESULT OF ASSESSMENT (SAMPLE REF. 160000/050317/07)

Cement panel confirmed to contain Chrysotile asbestos, Figure 7 - Material assessment rating: Very low

Sample Number	160000/050317/07
Location	Understairs Signal Cable
Material Description	Cement panel
Material Comment	To door
Quantity	2m ²
Product Type	Composite
Current Condition	Slight damage
Surface Treatment	Composite
Asbestos Type	Chrysotile
Material Assessment Rating	Very low
Accessibility	Medium
Further Comment	Not applicable

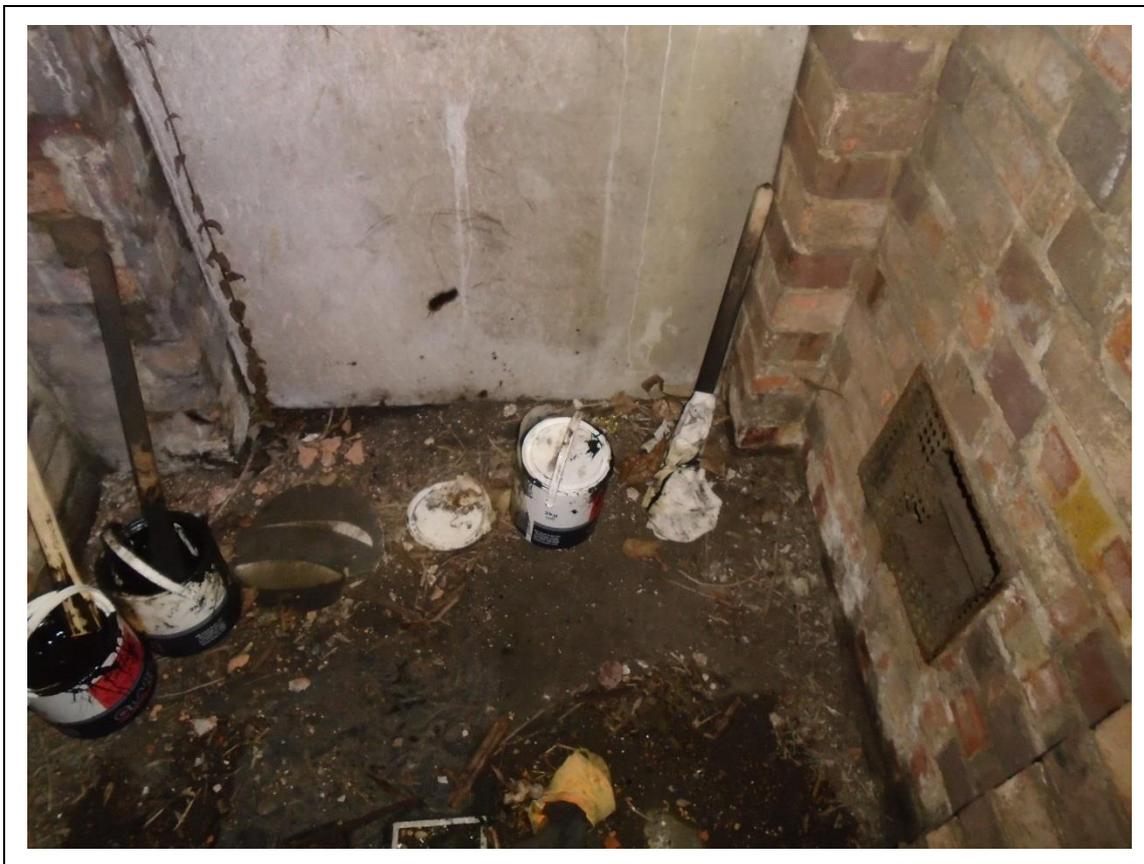
FIGURE 8: CONFIRMED ASBESTOS IN CEMENT PANEL IN UNDERSTAIRS SIGNAL CABLE - DESCRIPTION & RESULT OF ASSESSMENT (SAMPLE REF. AS 160000/050317/07)

Cement panel confirmed to contain Chrysotile asbestos, Figure 8 - Material assessment rating: Very low

Sample Number	As 160000/050317/07
Location	Understairs Signal Cable
Material Description	Cement panel
Material Comment	To floor inside downstairs
Quantity	<1m ²
Product Type	Composite
Current Condition	Moderate damage
Surface Treatment	Composite
Asbestos Type	Chrysotile
Material Assessment Rating	Very low
Accessibility	Medium
Further Comment	Not applicable
