## THE CANNING TOWN BUS STATION

### Glazing Feasibility Study

**Document title**  
The Canning Town Bus Station -  
Glazing Feasibility Study

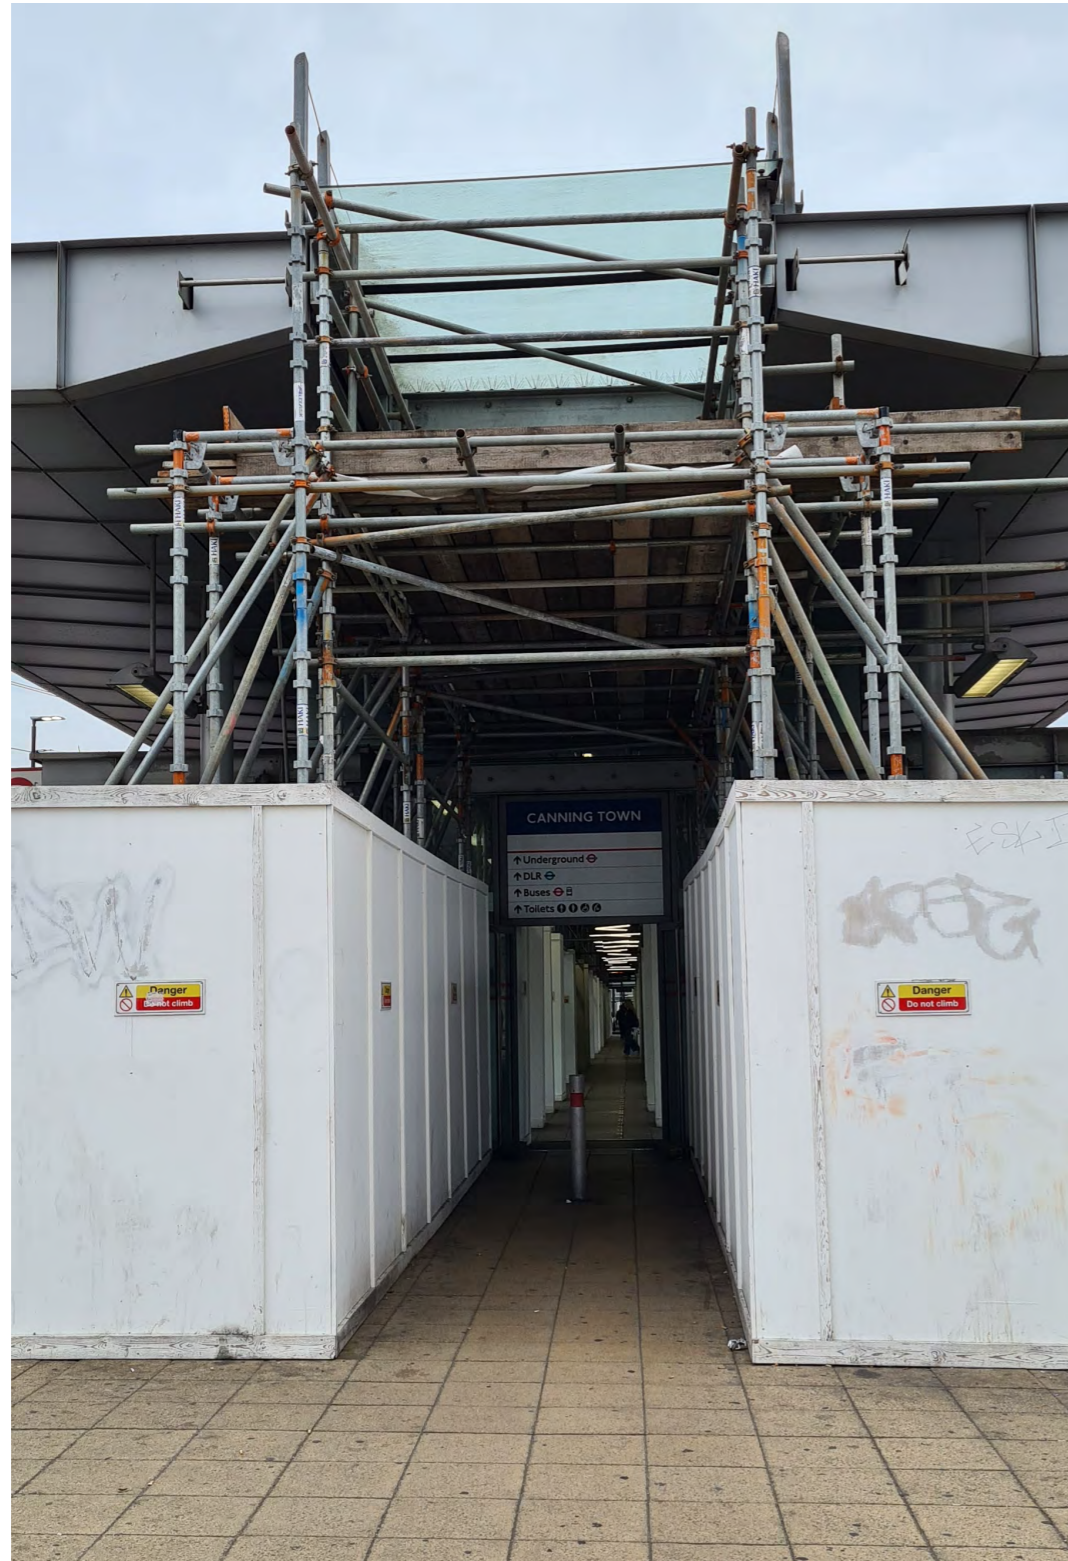
Figure 2: External view of Canning Town Bus Station entrance showing scaffolding in place under the glazed canopy.

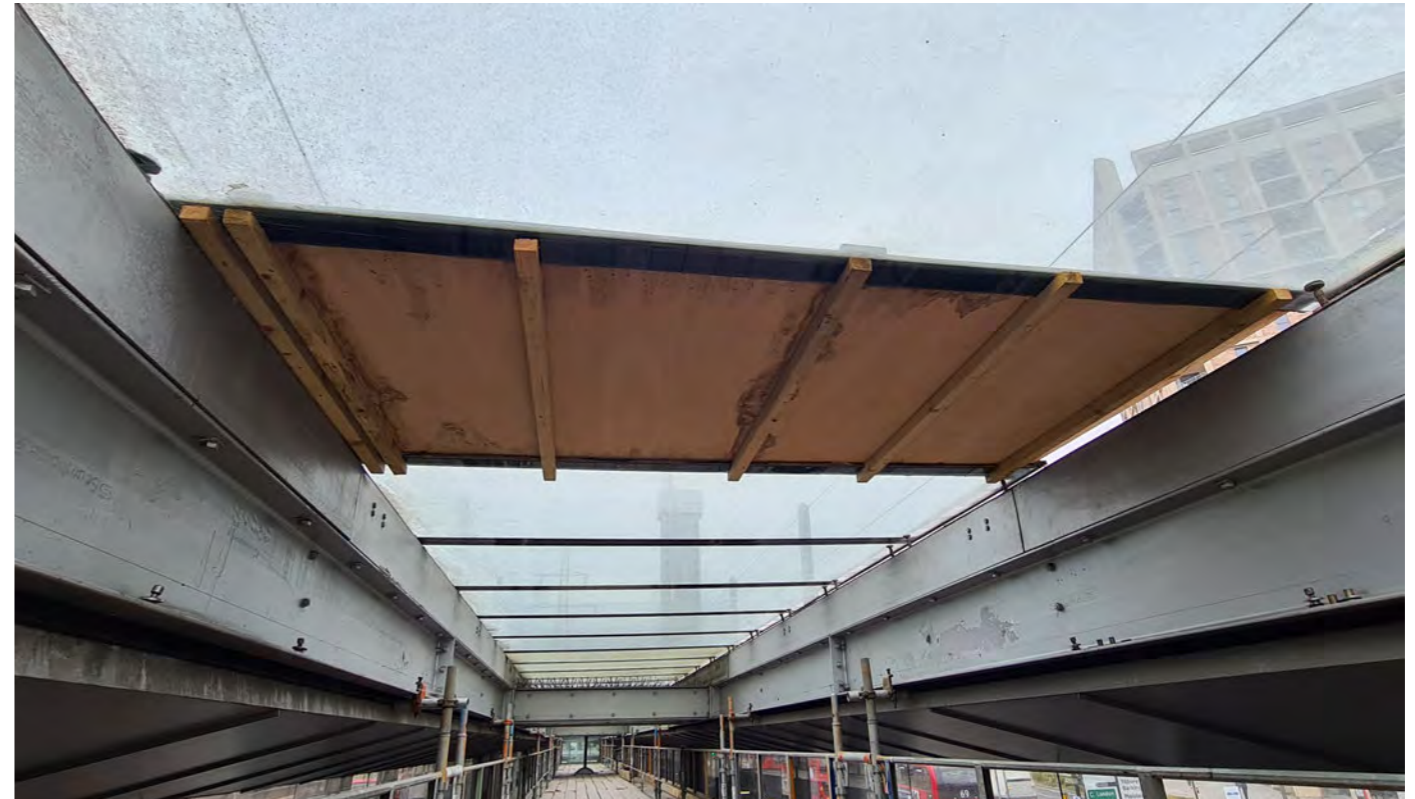
Following a breakage of a section of overhead glazing at Canning Town Bus Station, GL&SS was requested to conduct an investigation to establish the cause of the problem and present possible new design solutions to improve safety measures in the commuting complex.

Figure 3: The broken glass panel has been replaced with plywood board.

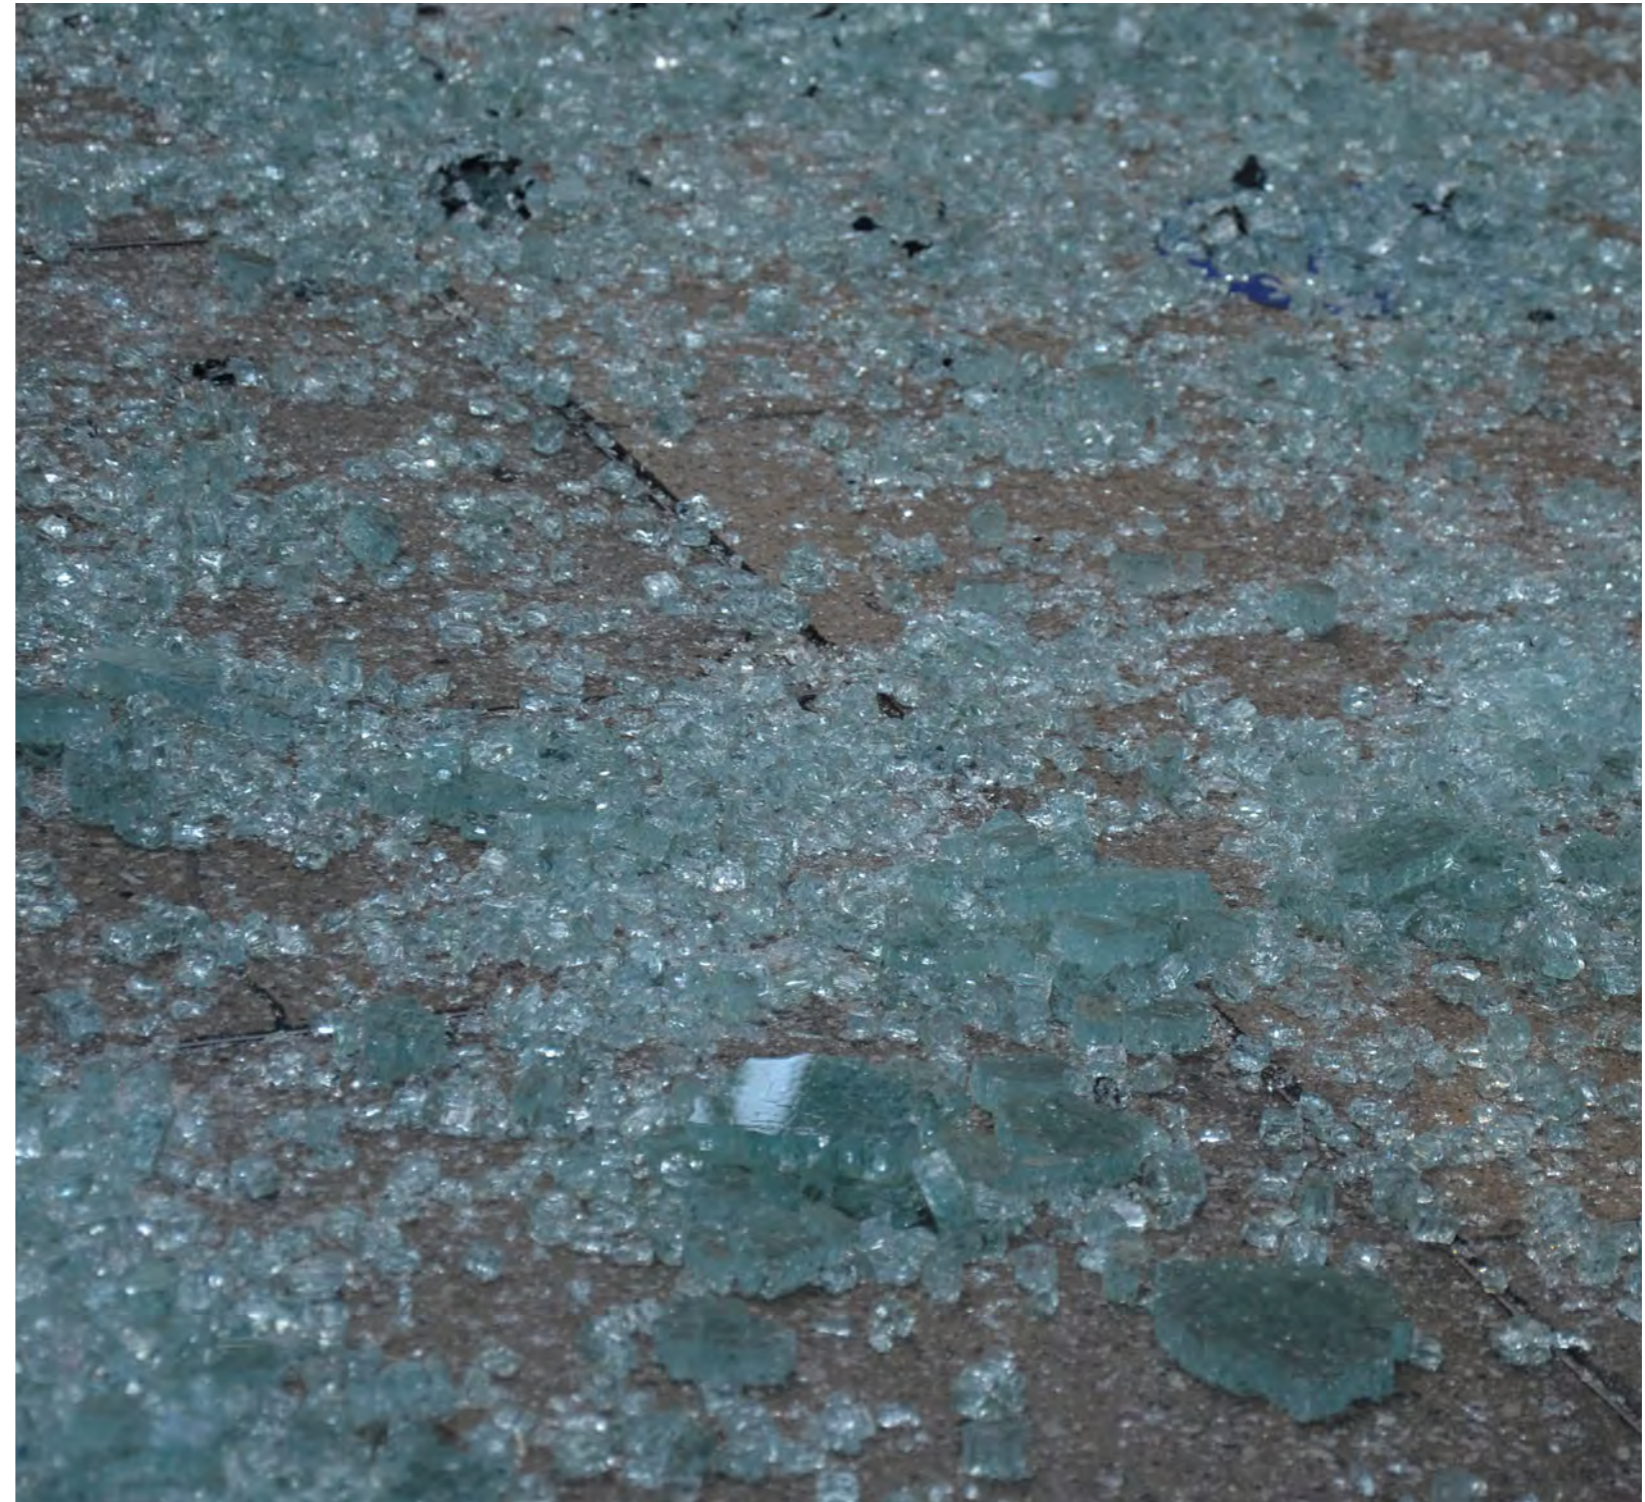
Based on observed and reported evidence gathered and previous case studies, the most likely cause of the recent failure of the toughened glass pane in the canopy glazing of the Canning Bus Station was due to the presence of nickel sulphide inclusions (NSI).

As observed on site, toughened glass with a thickness of more than 6 mm breaks into unacceptably large fragments.

3m<sup>2</sup> area of 6 mm thick glass weighs 45 kg - this is a significant weight of falling glass fragments.

Figure 6: Glass fragments from broken glazing panel strewn over the floor following the panel failure. Large chunk fragments can be seen mixed with smaller fragments.

We recommend the most feasible and optimum option is to replace the glass panes with laminated glass composed of an ionoplast interlayer insert and with glass panes of 6/6mm or 6/8mm thickness.

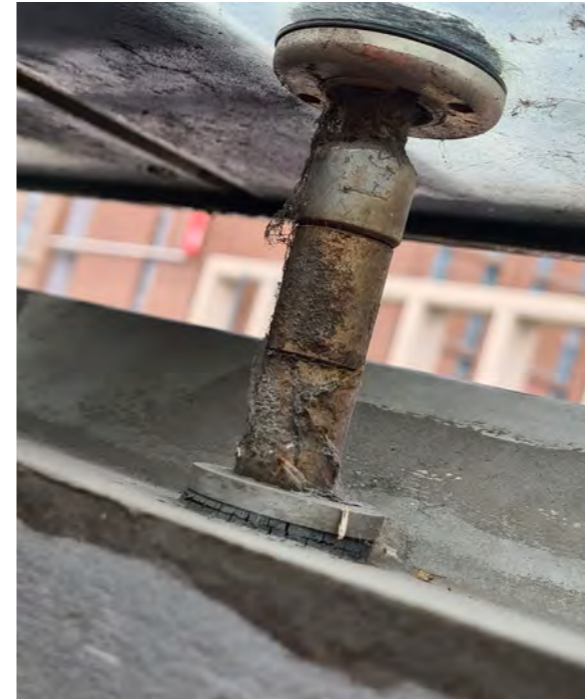
It was also observed that the spacers on the taller fittings were corroded, likely due to the wrong grade of steel being used for these. The bush used to separate the spider fitting from the steelwork had failed severely, showing extensive cracking and weathering.

Dirt accumulation was evident not only on the glass panels but also along the steelwork structure. The steelwork structure itself presented signs of flaking coating.

Figures 9-10: Left: Spider fitting viewed from underside of glass panel, showing pronounced corrosion on spacers, severely degraded bush between fitting and steelwork, and dirt accumulation. Right: Spider fitting from failed glass panel. Ball-joint appeared seized as it couldn't be moved by hand.

- the replacement of all spider fittings, including the spacers and bushes. The spacers should be sourced in a suitable grade of steel.
- the regular cleaning of the steelwork and the top-side of the glass panels.
- the assessment of the structural integrity of the steelwork structure and its repair and maintenance where required. At least, new coating should be applied on the steelwork.

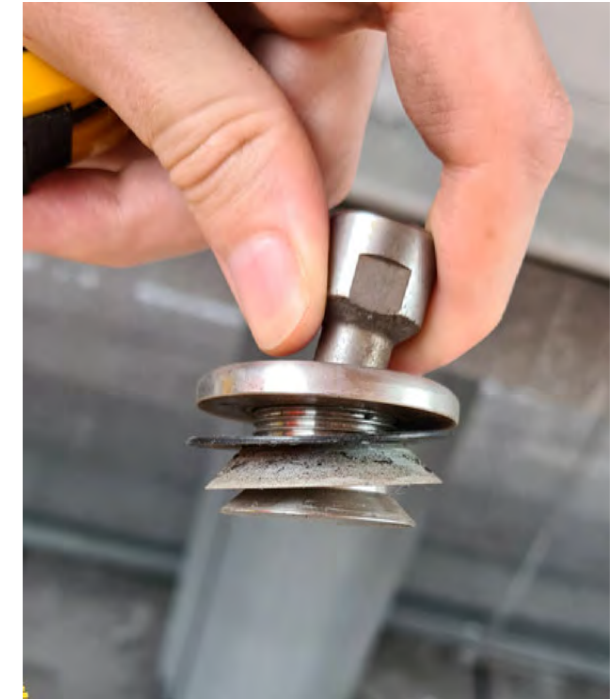
Another potential cause for the toughened glass failure could be the spider fitting ball-joint seizing and not allowing for glass movement under load, which would then cause the glass to fail at its weakest point (which could be at NSI, if present on the glass).

During a visit to site on the 21st September, it was observed that the spider fittings holding the glass panels could potentially have their ball-joints seized, which in turn could introduce a source of stress to the glass in the event it failed to allow for glass movement under load (e.g., wind or thermal load).

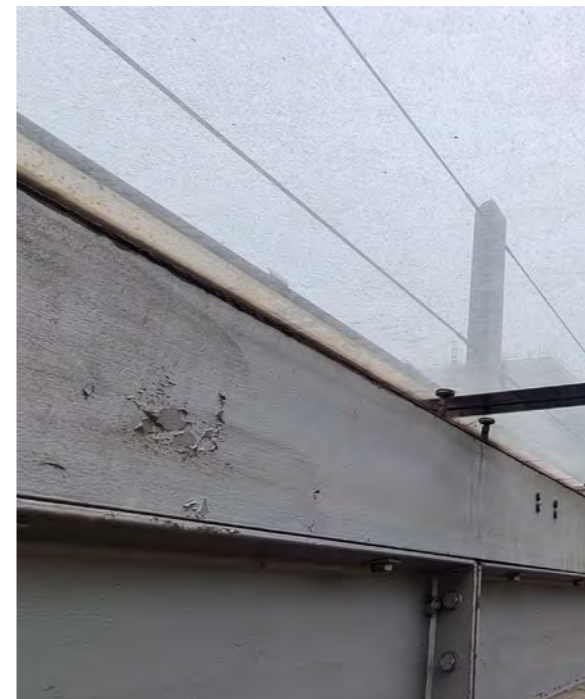
Figures 11-12: Left: Steelwork structure showing flaky coating. Right: Spider fitting on lower edge of glass panel, also showing a severely failed bush, and general dirt accumulation.

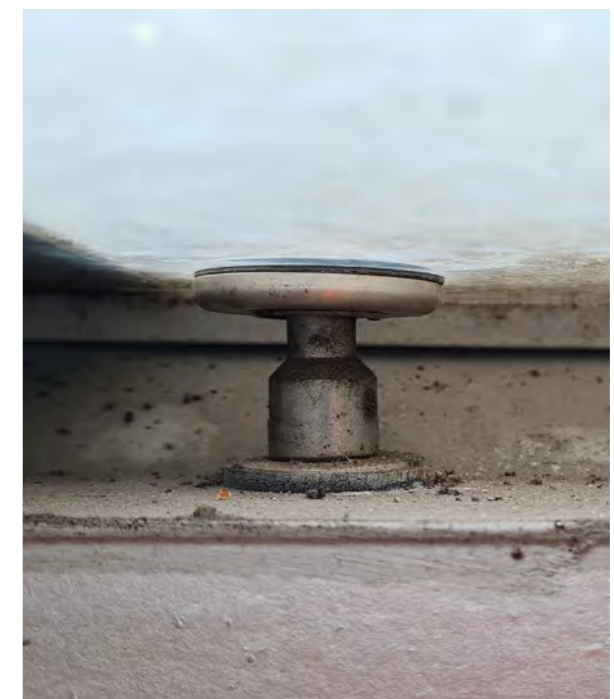
It was observed on site that the glass fixings gaskets are severely weathered, even though the service life is also lower than anticipated. The reduced service life is most likely due to exposure to the sun and UV radiation as well as night-day thermal cycles. Refer to section 4.1 on this report for recommendations on the fittings and gaskets.

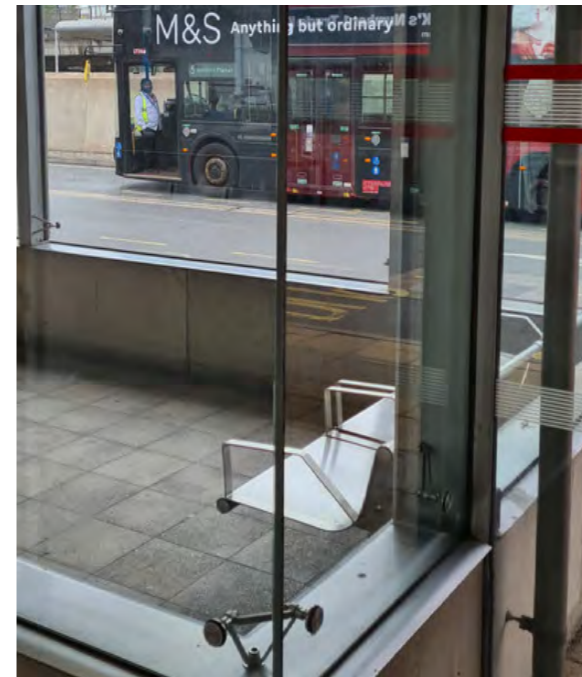
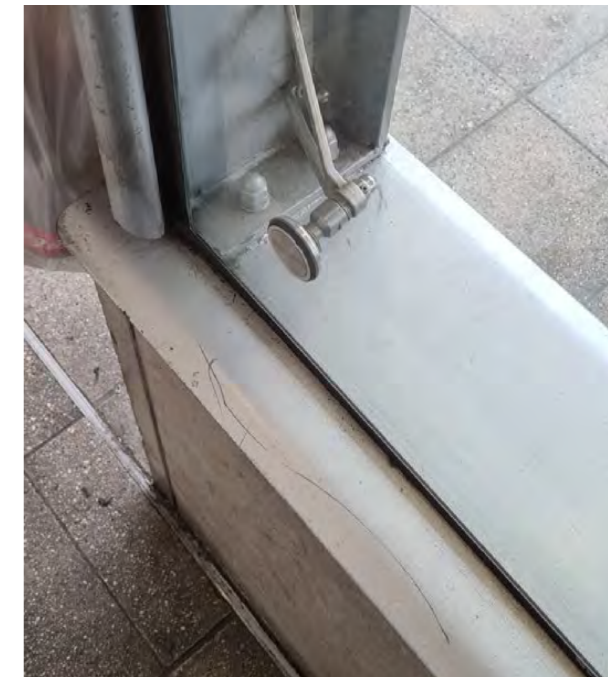
From the site observations, we believe the vertical glazing along the Station constitutes a low risk. Considering the glazing is not placed straight on the ground but on a plinth 30 to 50 cm high and the glazing panels are installed recessed in relation to the plinth face, there is a low probability that the glass panels will be impacted by a falling piece of luggage or similar.

Figures 17-18: Left: Vertical glazing corner to waiting area of Station. Right: Spider fitting on vertical glazing. Both photographs show the plinth offsetting the glass panels from the ground floor.
