Hazardous Material Asset Register - Detail for SharePoint

Hazardous Materials - Photographs for SharePoint

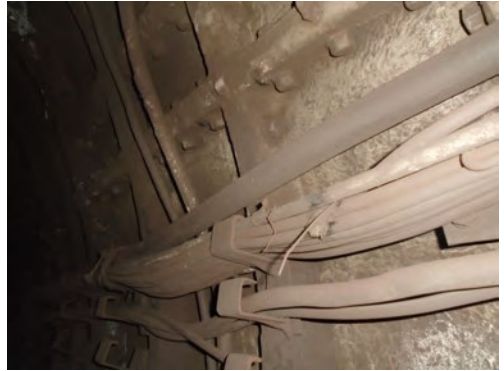
Reference:	27738

Description:	Asbestos: Known N126-N-SBFA: Road SBFA - NOR - Angel to Old Street Start(m): 0 Finish(m): Not Specified	
Hazard Area:	Cable Sheath	
Comments:	Woven cable sheath, Entry: platform wall, route: JH1 2x15mmØ, OTX 1x45mmØ Notes from 2021 re-inspection: No cable OTC on JH 1	
Reference:	27739

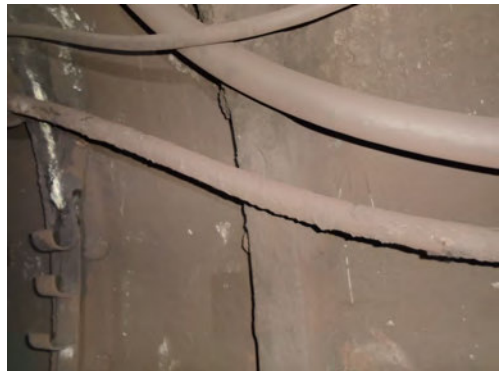
Description:	Asbestos: Known N126-N-SBFA: Road SBFA - NOR - Angel to Old Street Start(m): 3 Finish(m): 418	
Hazard Area:	Cable Sheath	
Comments:	Woven cable sheath, Entry: OTX, route: 1x45mmØ JH5	
Reference:	27740

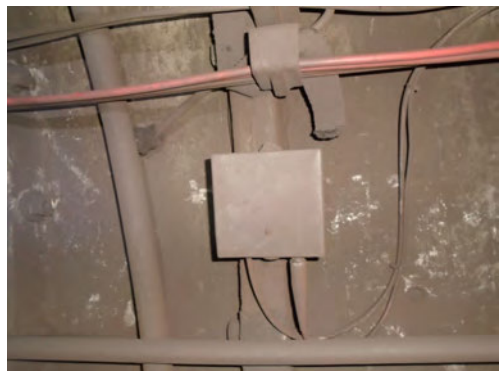
Description:	Asbestos: Presumed N126-N-SBFA: Road SBFA - NOR - Angel to Old Street Start(m): 4 Finish(m): Not Specified	
Hazard Area:	Westinghouse Boxes	
Comments:	Trackside equipment Westinghouse small	
Reference:	27741

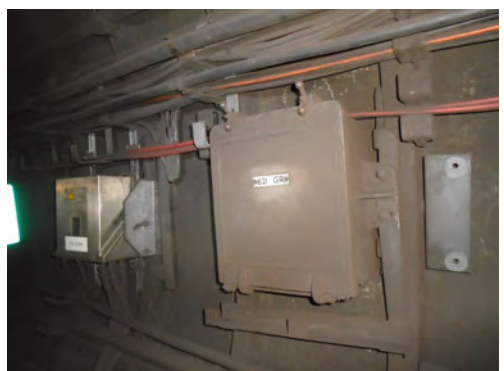
Description:	Asbestos: Presumed N126-N-SBFA: Road SBFA - NOR - Angel to Old Street Start(m): 9 Finish(m): Not Specified	
Hazard Area:	Westinghouse Boxes

Comments:	Trackside equipment Westinghouse large

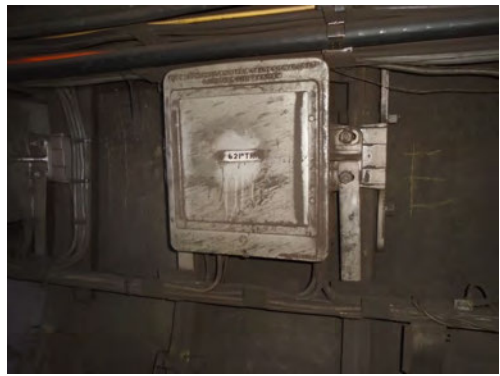
Reference:	27756

Description:	Asbestos: Presumed N126-N-SBFA: Road SBFA - NOR - Angel to Old Street Start(m): 611 Finish(m): Not Specified	
Hazard Area:	Westinghouse Boxes	
Comments:	Trackside equipment Westinghouse large	
Reference:	27757

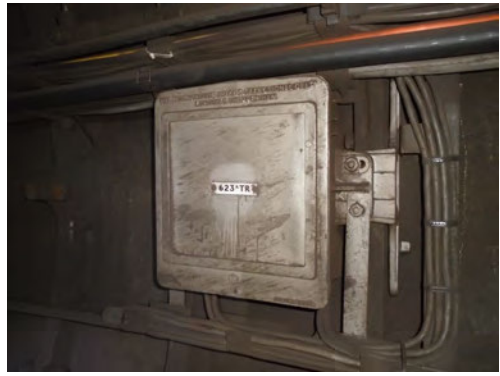
Description:	Asbestos: Presumed N126-N-SBFA: Road SBFA - NOR - Angel to Old Street Start(m): 611 Finish(m): Not Specified	
Hazard Area:	Westinghouse Boxes	
Comments:	Trackside equipment Westinghouse large	
Reference:	27759

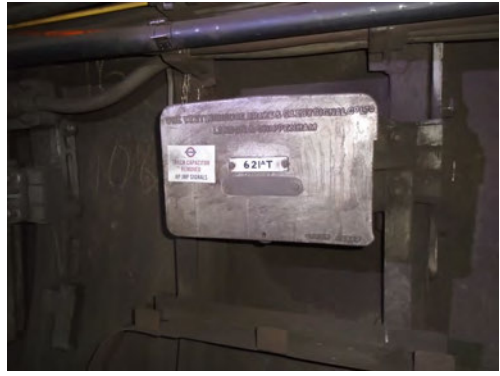
Description:	Asbestos: Presumed N126-N-SBFA: Road SBFA - NOR - Angel to Old Street Start(m): 613 Finish(m): Not Specified	
Hazard Area:	Westinghouse Boxes	
Comments:	Trackside equipment Westinghouse large	
Reference:	27761

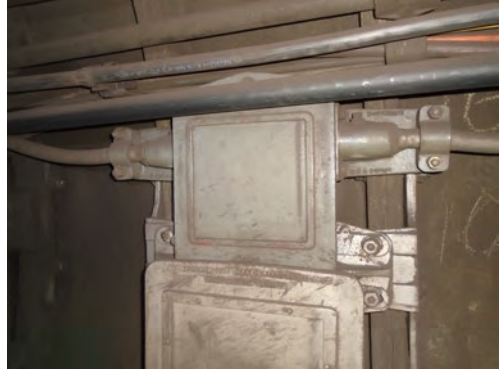
Description:	Asbestos: Presumed N126-N-SBFA: Road SBFA - NOR - Angel to Old Street Start(m): 614 Finish(m): Not Specified	
Hazard Area:	Westinghouse Boxes	
Comments:	Trackside equipment Westinghouse large

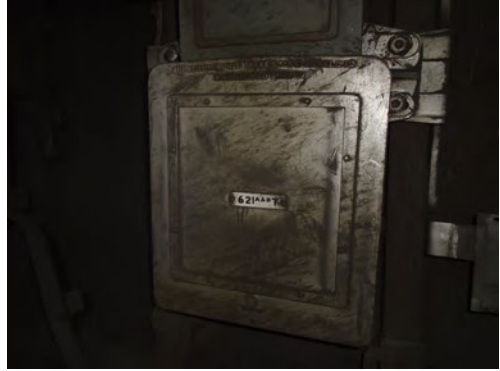
Reference:	27762

Description:	Asbestos: Presumed N126-N-SBFA: Road SBFA - NOR - Angel to Old Street Start(m): 614 Finish(m): Not Specified	
Hazard Area:	Westinghouse Boxes	
Comments:	Trackside equipment Westinghouse large	
Reference:	27764

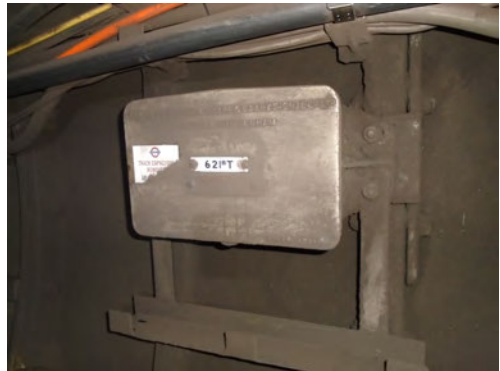
Description:	Asbestos: Presumed N126-N-SBFA: Road SBFA - NOR - Angel to Old Street Start(m): 617 Finish(m): Not Specified	
Hazard Area:	Westinghouse Boxes	
Comments:	Trackside equipment Westinghouse large	
Reference:	27765

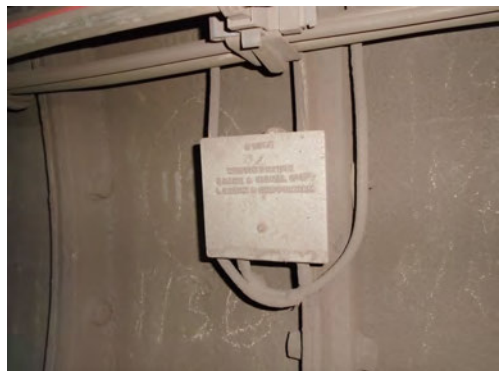
Description:	Asbestos: Presumed N126-N-SBFA: Road SBFA - NOR - Angel to Old Street Start(m): 639 Finish(m): Not Specified	
Hazard Area:	Westinghouse Boxes	
Comments:	Trackside equipment Westinghouse small	
Reference:	27767

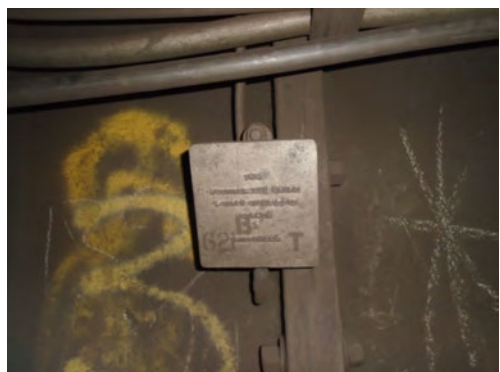
Description:	Asbestos: Presumed N126-N-SBFA: Road SBFA - NOR - Angel to Old Street Start(m): 778 Finish(m): Not Specified	
Hazard Area:	Westinghouse Boxes	
Comments:	Trackside equipment Westinghouse small

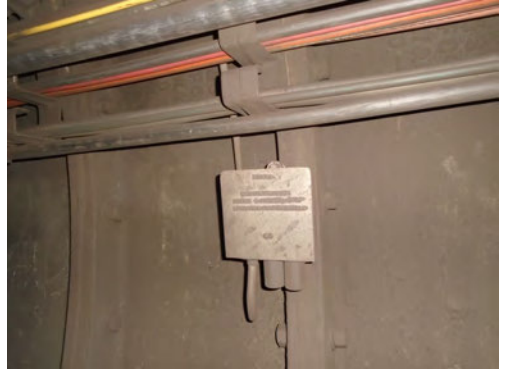
Reference:	27768

Description:	Asbestos: Presumed N126-N-SBFA: Road SBFA - NOR - Angel to Old Street Start(m): 782 Finish(m): Not Specified	
Hazard Area:	Westinghouse Boxes	
Comments:	Trackside equipment Westinghouse small	
Reference:	35016

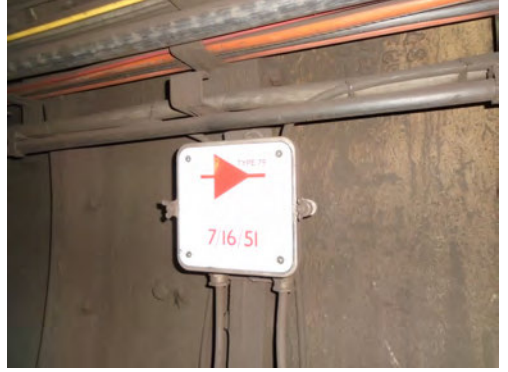
Description:	Asbestos: Presumed N126-N-SBFA: Road SBFA - NOR - Angel to Old Street Start(m): 929 Finish(m): Not Specified	
Hazard Area:	Signal Boxes	
Comments:	Trackside equipment type 79	
Reference:	35567

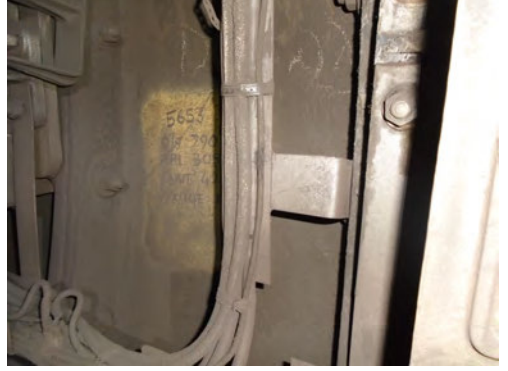
Description:	Asbestos: Known N126-N-SBFA: Road SBFA - NOR - Angel to Old Street Start(m): 1052 Finish(m): 1064	
Hazard Area:	Signal Boxes	
Comments:	Signal section cloth, Entry: trackside equipmentboxes, route: 5-15mmØ in between trackside equipment boxes	
Reference:	27769

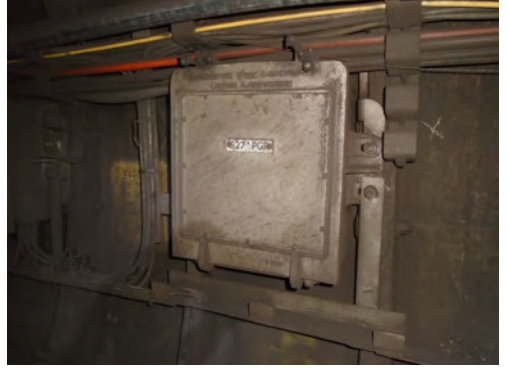
Description:	Asbestos: Presumed N126-N-SBFA: Road SBFA - NOR - Angel to Old Street Start(m): 1053 Finish(m): Not Specified	
Hazard Area:	Westinghouse Boxes	
Comments:	Trackside equipment Westinghouse large

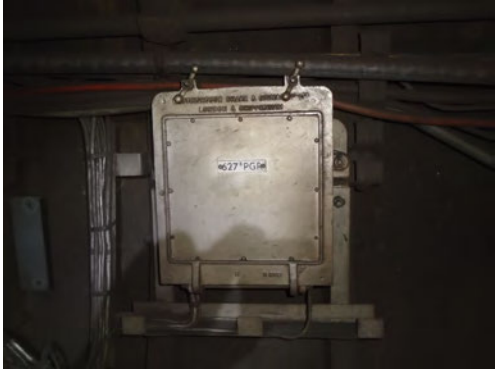
Reference:	27777

Description:	Asbestos: Presumed N126-N-SBFA: Road SBFA - NOR - Angel to Old Street Start(m): 1124 Finish(m): Not Specified	
Hazard Area:	Westinghouse Boxes	
Comments:	Trackside equipment Westinghouse large	
Reference:	27776	 
Description:	Asbestos: Known N126-N-SBFA: Road SBFA - NOR - Angel to Old Street Start(m): 1124 Finish(m): 1311	
Hazard Area:	Signal Boxes	
Comments:	Trackside equipment section cloth, Entry: trackside equipment boxes, route: 5-15mmØ in between trackside equipment boxes.	
Reference:	27778

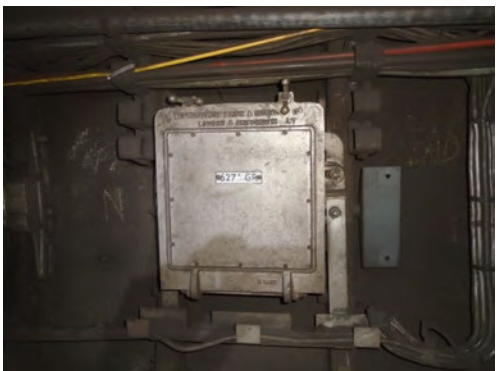
Description:	Asbestos: Presumed N126-N-SBFA: Road SBFA - NOR - Angel to Old Street Start(m): 1125 Finish(m): Not Specified	
Hazard Area:	Westinghouse Boxes	
Comments:	Trackside equipment Westinghouse large	
Reference:	27779

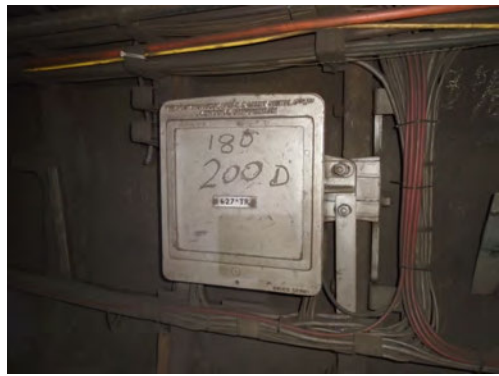
Reference:	27782

Description:	Asbestos: Presumed N126-N-SBFA: Road SBFA - NOR - Angel to Old Street Start(m): 1127 Finish(m): Not Specified	
Hazard Area:	Westinghouse Boxes	
Comments:	Trackside equipment Westinghouse large	
Reference:	27783

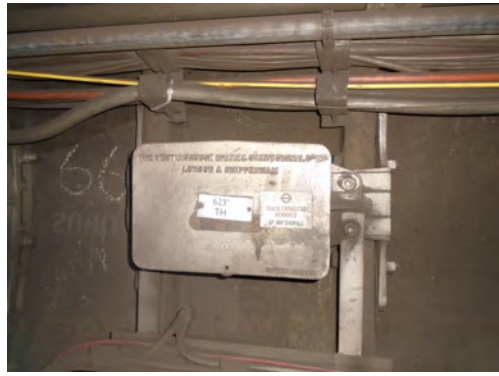
Description:	Asbestos: Presumed N126-N-SBFA: Road SBFA - NOR - Angel to Old Street Start(m): 1128 Finish(m): Not Specified	
Hazard Area:	Westinghouse Boxes	
Comments:	Trackside equipment Westinghouse large	
Reference:	27784	 
Description:	Asbestos: Presumed N126-N-SBFA: Road SBFA - NOR - Angel to Old Street Start(m): 1129 Finish(m): Not Specified	
Hazard Area:	Westinghouse Boxes	
Comments:	Trackside equipment Westinghouse large	
Reference:	35017	 
Description:	Asbestos: Presumed N126-N-SBFA: Road SBFA - NOR - Angel to Old Street Start(m): 1129 Finish(m): Not Specified	
Hazard Area:	Westinghouse Boxes	
Comments:	Trackside equipment Westinghouse large

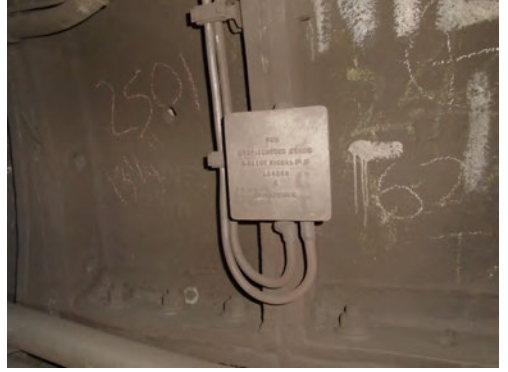
Description:	Asbestos: Presumed N126-N-SBFA: Road SBFA - NOR - Angel to Old Street Start(m): 1350 Finish(m): Not Specified	
Hazard Area:	Westinghouse Boxes	
Comments:	Trackside equipment Westinghouse small	
Reference:	27798

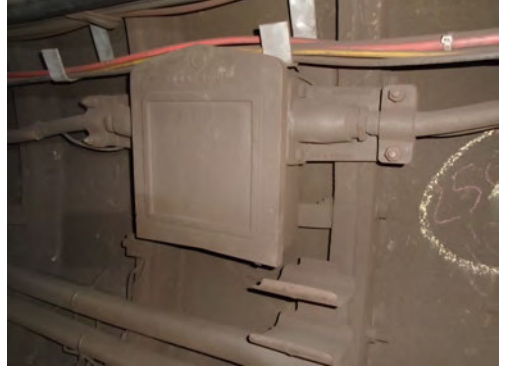
Description:	Asbestos: Presumed N126-N-SBFA: Road SBFA - NOR - Angel to Old Street Start(m): 1352 Finish(m): Not Specified	
Hazard Area:	Westinghouse Boxes	
Comments:	Trackside equipment Westinghouse large
