ARBORICULTURAL REPORT

Visual Tree Assessment

Galldris Site Compound

Galldris Group

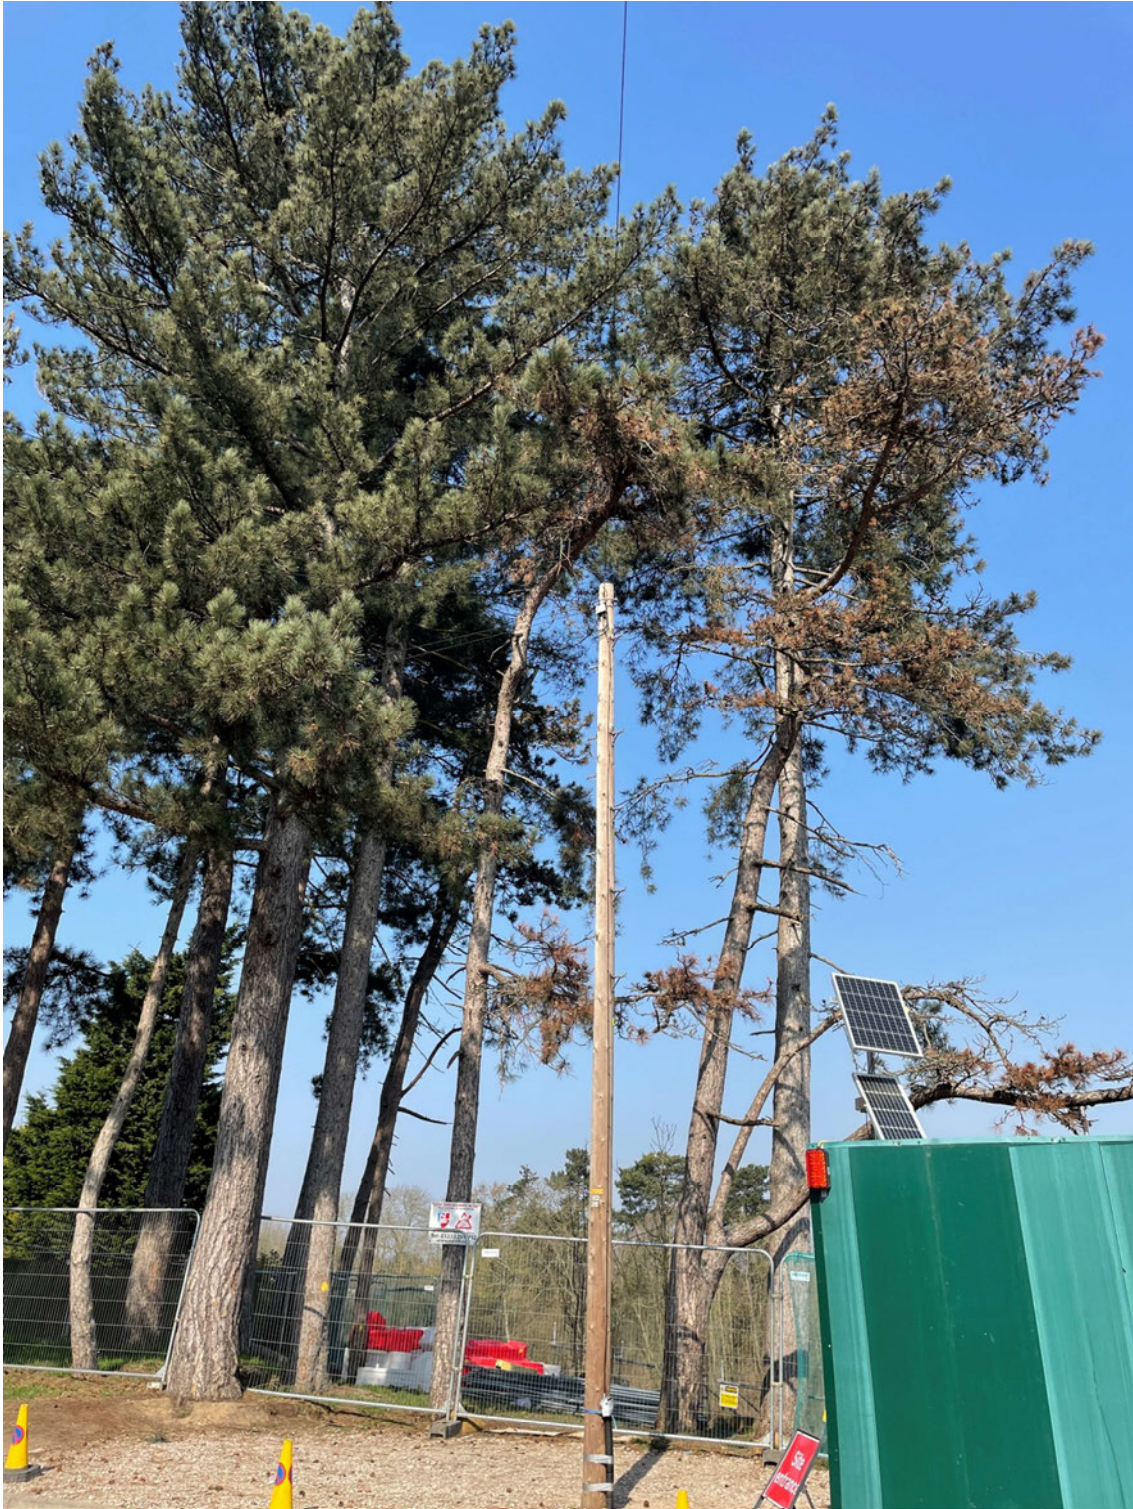
Tree ID: 1 Corsican Pine **Tag: 445** **Assessor:** [REDACTED]
Pinus nigra var.maritima **TPO:** **Date:** 23-Mar-22
Tree Comment:
Survey Comment: Significant dieback in canopy. All needles present are discoloured. Lateral limbs are over-extended with poor stem taper and at increased risk of failure. Dismantle tree to ground level.

Photo 1; East end of group. Tree 1 can be seen with discoloured foliage extending over Galldris site compound.

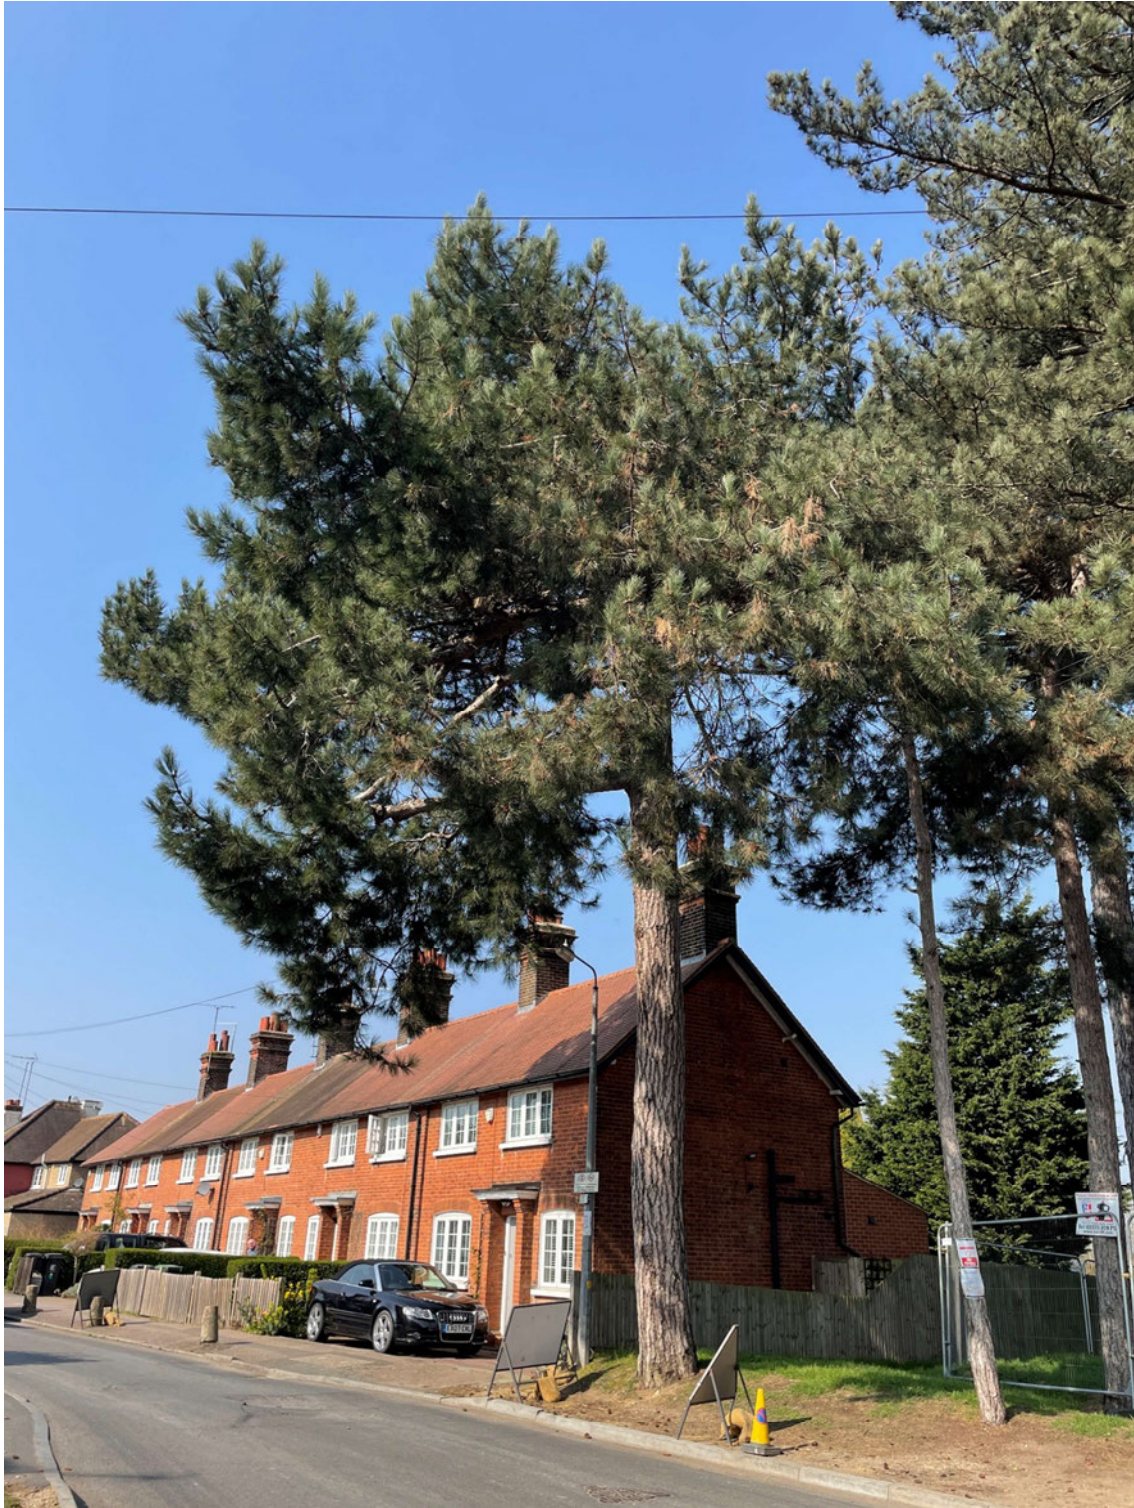
Within the mature specimens, trees 9, 10 and 12 have over-extended, heavily end weighted lateral branching with poor branch taper. These trees are at particular risk of branch failure and require reduction pruning to return them to a reasonable level of risk for the site.

Tree Comment:
Survey Comment: Canopy presently has adequate density and colour. Surveyor advised by site staff of recent branch failures in canopy during storm. Lateral branching is over-extended with heavy end weighting. Currently at increased risk of additional branch failures during inclement weather. Reduce lateral spread by 2-2.5m to reduce risk. Re-inspect in 12 months.

Photo 2; West end of group. Tree 12 central in photo.

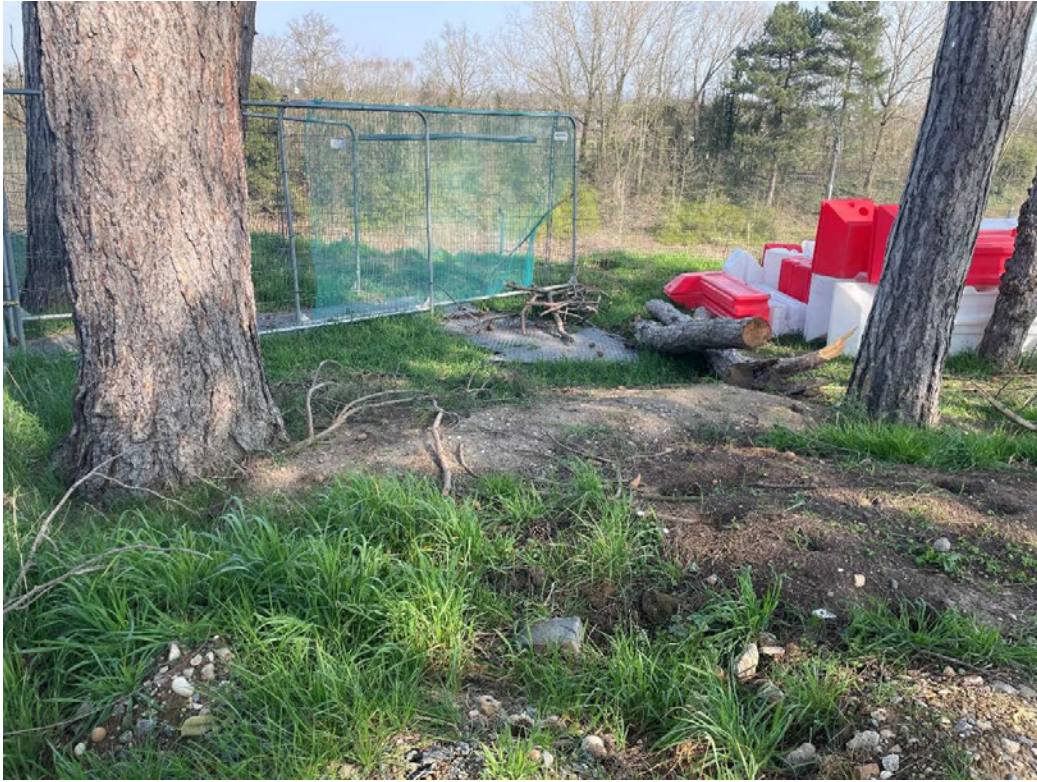
- 2.4.1 The British geological Survey Map (1:50,000) shows the area as London Clay formation clay, silt, and sand.
- 2.4.2 Currently the existing soils will support most common tree planting and the continuation of growth.
- 2.4.3 Bulk density of the soil was not assessed.
- 2.4.4 There are heaped areas of soil around the base of some of the trees. The lack of grass in these areas and the undulating aspect of the current ground suggest that this is spoil added to the area.

Survey Comment: Canopy presently in adequate condition with good density and colour. Soil level has been increased around base of tree, partially burying the root collar. Remove excess soil. Recent removal of adjacent trees on railway bank has increased exposure to elements. Re-inspect in 12 months to assess for decline in canopy.

Photo 3; Areas of raised soil around base of trees 8 and 9.

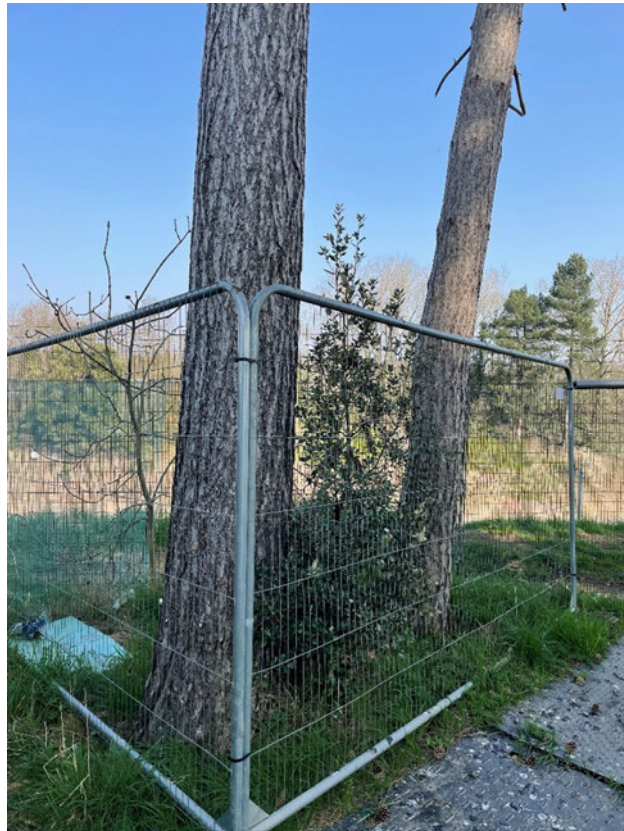
Photo 4; Base of trees 13 and 14, enclosed within Herras fencing.
