Referenced Document(s): Off-track Inspections W0135 and W0125

OFF-TRACK AND FENCING INSPECTIONS

Section 1 : Inspection details										
Inspection Type PM6 Sheet No1 of1 Inspection Work Order No. 54521171 DL1357										
Inspector's name	nspector's name District Line: Southfields – Wimbledon Date 28/08/2019									Date 28/08/2019
Section 2 : Fa	ection 2 : Faults/Description

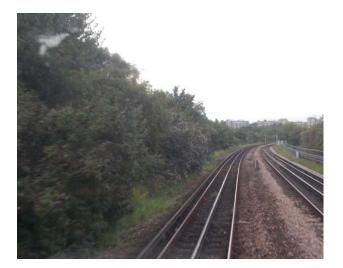
UNDMISC WO	RK REQUIRED	
IdentifiedWorksNumber:	U652D166	BRS D
RefNo:	U652	From Station
CoppicePerct:		To Station
PlantGaps		
AffectingSignals	□ D166	Line Dist
OverhangingCrun		Start Meterage
KillUnwantedSpec		Slope
RetainWantedSpecies		
CoppiceCycleYear:	5	DistBldg: 0
CommenceCycleYear:		
RetainMature		
FaceCablerun		OwnerID:
FaceFenceline		AssetOnID:
Coppice2mFenceline		StructureRef:
Coppice2mCablerun		Structureker:
TreatAllStumps		SoilID:
AgreeCoppice		HeightM:
FireRisk		Climber
Remove3mFromStructur		
FurtherInvestigation		Area:
WorkPackageID:		INSPI
Vegetation Sensitivity:		Inspection Type
		Inspection Date
Remarks		Access Category
	getation close to trains. rity P	Surveyor
	-	Α
Budget	Rate	Priority

LOCATION						
BRS	D16	6	Road: EB			
From Station		٧	Vimbledon P	ark		
To Station			Southfields			
Line	t:	Line Type LOCAL				
Start Meterage		024	8	Distance	346	
Slope	Е		l	GC		
DistBldg:	0.1		Dis	tTrack:	6	
OwnerID:			DISTRICT			
AssetOnID:			GR			
StructureRef:						
SoilID:						
HeightM:				4		
Climber						
Area:			2402			
IN	SPEC	CTIC	NC	REGIME		
Inspection Type			Superficial			
Inspection Date			28/08/2019			
Access Category			TH			
Surveyor			EP			
ASSESSMENT						
Priority				В

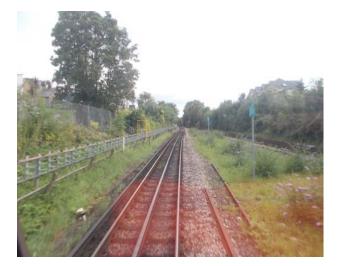
NON-WOO	LOCATION					
REQU	IRED	BRS	D166	Road:	WB	
IdentifiedWorksNumber:	NWCR2069D166	From Station		Southf	Southfields	
RefNo:	NWCR2069	To Station		Wimbledo	on Park	
HierarchyID:	NW Cablerun	Line	District	Line Typ	De LOCAL	
KillWoodyGrowth		Start Meterage	. 00	050 Distan	648	
CutVeg	✓	Slope	CEG	Legal Sta	itus	
WorkPackageID:			С	ATA		
Vegetation Sensitivity:		OwnerID:	OwnerID:		DISTRICT	
		AssetOnID:			GR	
		Min. Width:			1	
		Max. Permitted	Height		0.5	
		Area:			651	
		Contravenes St	andard			
Remarks		Aiding Bank Sta	ability			
28/08/2019: Cut vegetat	ion in cess. Priority NV	INSPECTION REGIME				
		Inspection Type	е	Sup	Superficial	
		Inspection Date	9	28/0	28/08/2019	
		Access Catego	Access Category		TH	
Budget	Rate	Surveyor			ΕP	
	D166 CTS3 EM3		ASSE	SSMENT		
	,	Priority			С

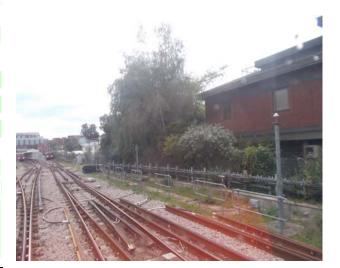
TREE COMP WORK REQUIRED								
IdentifiedWorksNumber: TC10526D168								
RefNo:		TC10526						
Retain								
RetainWantedS	pecies							
KillUnwantedPe	rct:		0					
TreatAllStumps		CutIvy						
CoppicePerct:								
CoppiceCycleYe	ar:							
CommenceCycl	eYear:							
PlantGaps								
ReplantingRequ	iired							
FurtherInvestig	ation							
FaceAndBalance	е		✓					
ReduceCrownPo	erct:							
WorkPackageID):							
Remarks								
28/08/2019: Fell birch leaning track, fell others in poor condition. Priority 2 Budget Rate								
		CATIC	אכ					
BRS & Road	D168	Roa		EB				
From Station		Wimbledon						
To Station		_	Vimbledon					
Line	District		Line Type	LOCAL				
Meterage	0053	B Dist	ance	158

OtherSpecies: EffectingSignals OverhangingCrun Area: Site Area Reference: Vegetation Sensitivity: INSPECTION REGIME Inspection Type Superficial Inspection Date 28/08/2019 Access Category TH Surveyor E P ASSESSMENT Priority E	DominantSpeciesID:		Birch			
Area: 297 Site Area Reference: Vegetation Sensitivity: INSPECTION REGIME Inspection Type Superficial Inspection Date 28/08/2019 Access Category TH Surveyor E P ASSESSMENT Priority E	SubDominantSpeciesID:					
Area: 297 Site Area Reference: Vegetation Sensitivity: INSPECTION REGIME Inspection Type Superficial Inspection Date 28/08/2019 Access Category TH Surveyor E P ASSESSMENT Priority E	OtherSpecies:		Viti			
INSPECTION REGIME Inspection Type Inspection Date Access Category Surveyor ASSESSMENT Priority E P	EffectingSignals		OverhangingCrun			
INSPECTION REGIME Inspection Type Superficial Inspection Date 28/08/2019 Access Category TH Surveyor E P ASSESSMENT Priority E	Area:		297

INSPECTION REGIME Inspection Type Superficial Inspection Date 28/08/2019 Access Category TH Surveyor E P ASSESSMENT Priority E	Site Area Reference:					
Inspection Type Inspection Date Inspection Date Access Category Surveyor ASSESSMENT Priority Superficial 28/08/2019 E P E P	Vegetation Sensitivity:					
Inspection Type Inspection Date Inspection Date Access Category Surveyor ASSESSMENT Priority Superficial 28/08/2019 E P E P						
Inspection Date Access Category Surveyor ASSESSMENT Priority E 9	INSPEC	CTIC	ON REGIME			
Access Category Surveyor E P ASSESSMENT Priority E	Inspection Type		Superficial			
Surveyor E P ASSESSMENT Priority E	Inspection Date		28/08/2019			
ASSESSMENT Priority E	Access Category		TH			
Priority E	Surveyor		EP			
	AS	SES	SMENT			
RiskScore: 18	Priority		Е			
	RiskScore.		18

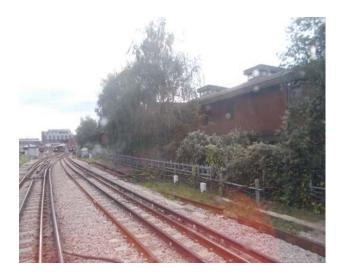
NON-WOODY WORK LOCATION REQUIRED BRS D168 Road: IdentifiedWorksNumber: NWCR2074D168 Wimbledon From Station RefNo: NWCR2074 To Station Wimbledon Park HierarchyID: **NW Cablerun** Line District Line Type Start Meterage 0063 Distance KillWoodyGrowth Slope G Legal Status **V** CutVeg WorkPackageID: **DATA** Vegetation Sensitivity: OwnerID: AssetOnID: Min. Width: Max. Permitted Height Area: Contravenes Standard Aiding Bank Stability Remarks 28/08/2019: Remove vegetation from cablerun. **INSPECTION REGIME** Priority 1. Inspection Type Inspection Date Access Category Budget Rate Surveyor **ASSESSMENT** Priority
