PUBLISHED PROJECT REPORT 746

Detection of vulnerable road users near buses

An evaluation of systems fitted to buses to detect vulnerable road users

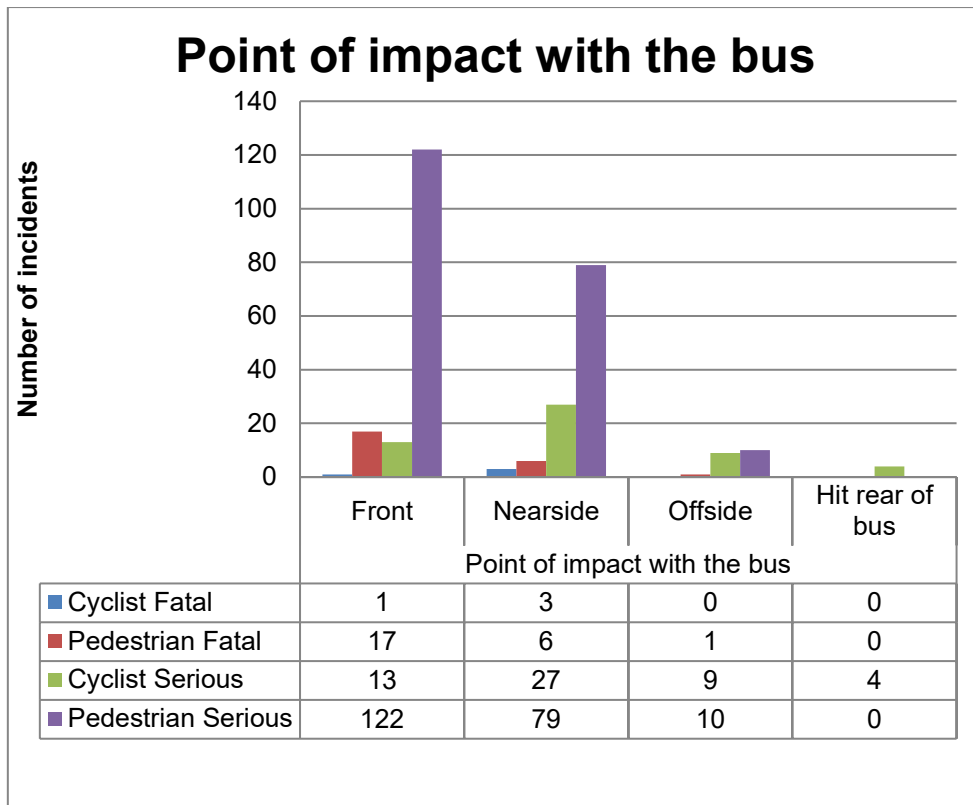
The relative scale of this issue can be seen in Figure 1, which indicates the Killed and Serious injury (KSI) statistics from the Stats19 data for pedestrians and cyclists in collisions with buses during the period 1st March 2011 to 28th February 2014 in London. Note that this excluded motorcycles. The key findings are that:

- The front and nearside of the bus were most commonly involved in collisions with pedestrians and cyclists.
- Pedestrians were involved in most of these KSI collisions (80%). Of these, 59% occurred at the front and 36% at the nearside of the bus).
- For cyclists, 53% of KSI collisions were with the nearside of the bus and 25% were at the front of the bus.

Figure 1 Pedestrian and Cyclist KSIs and point of impact with the bus (Stats19)

For these reasons, suitable detection technologies for buses might most usefully be focussed on the front for pedestrians, and the nearside for cyclists.

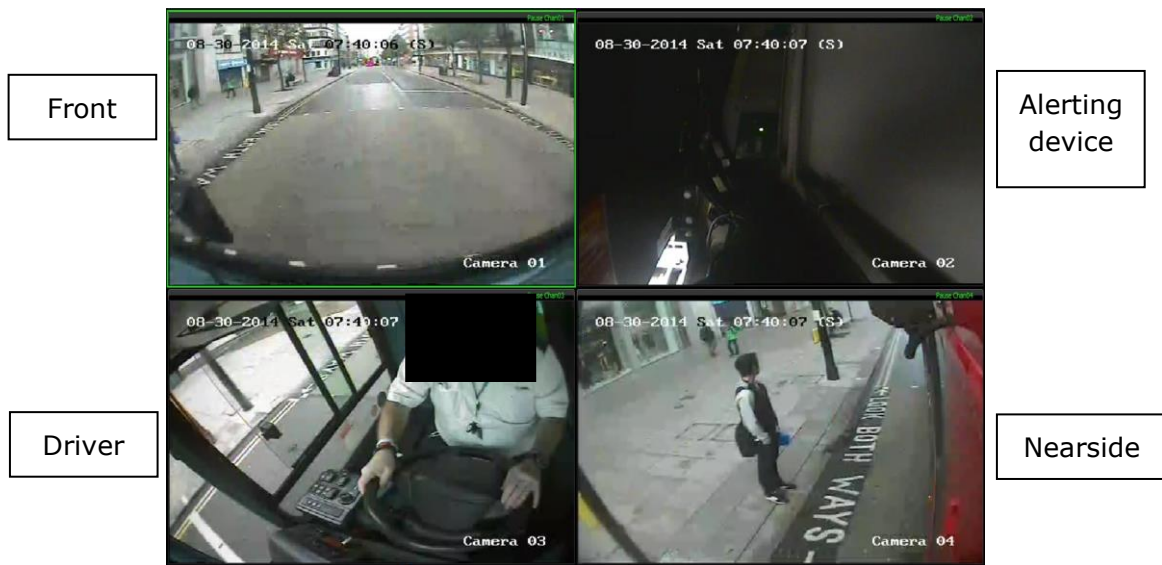
Figure 4: Video view for System B

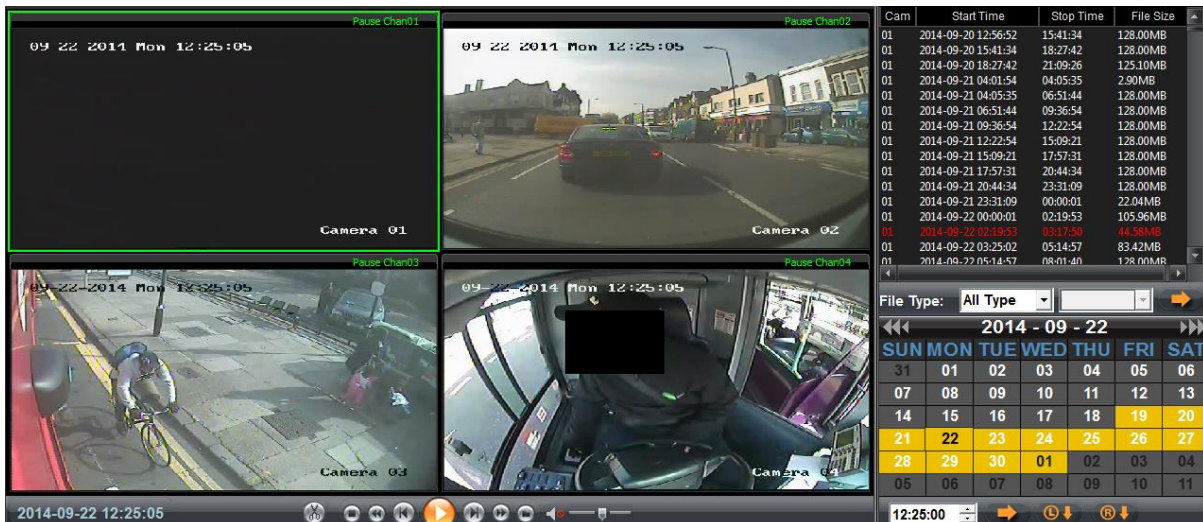
Figure 5 indicates a cyclist (in the bottom left video window) just about to exit the detection zone having travelled from the rear to undertake the bus. Had the alert been triggered, a red dot would have appeared in the video recorded in the top left video window, however it did not which indicates that the cyclist was missed.

Figure 5 False Negative example

Whilst TRL does not expect to understand the potential failure mechanisms of system A, we might hypothesise from examination of the video evidence that failures appear to be correlated in some way to:

1. low elevation sunlight hitting the detector
2. the effect of cyclists approaching relatively slowly (i.e. travelling just very slightly faster than the bus)
3. slightly unusual angles (such as appearing from immediately behind the bus)
4. being very close to the bus, or
5. being very close to another travelling or stationary object.

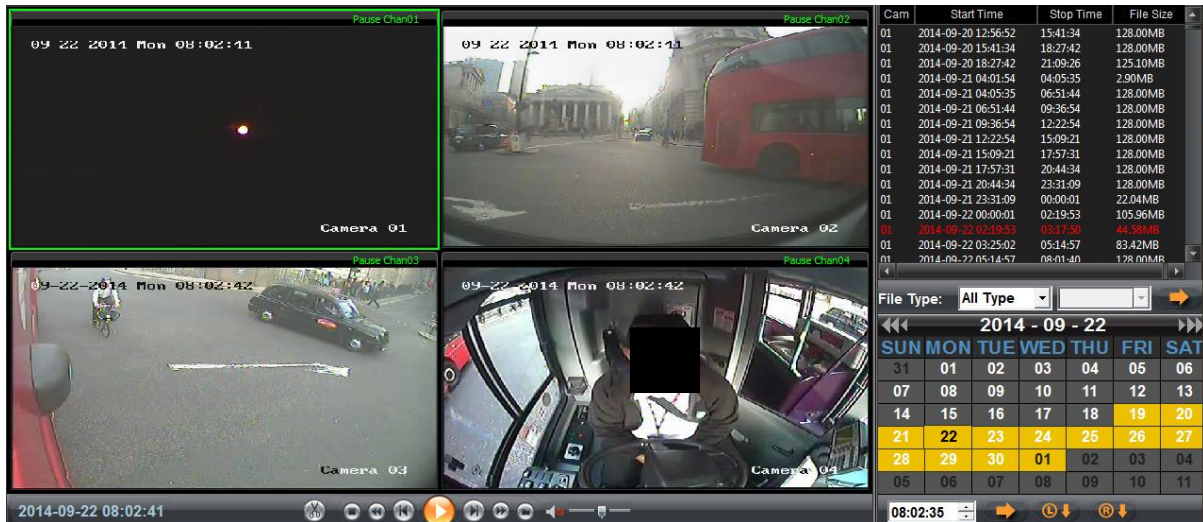
Figure 6 indicates a cyclist (in the bottom left window) entering the detection zone and being correctly identified (see LED spot in the top left window indicating a positive alert).

Figure 6 True Positive example

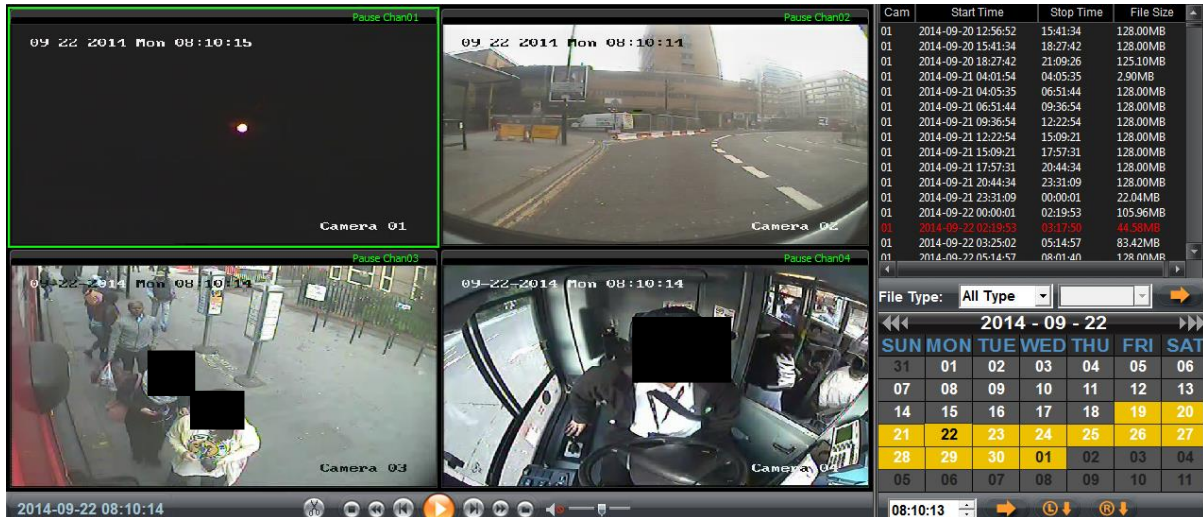
In Figure 7, the LED in the top left window is illuminated to indicate a detection alert, however as can be seen in the bottom left window (which shows the detection area at the nearside rear of the bus), only pedestrians can be seen. There was no equivalent record provided by the System A suppliers.

Figure 7 False Positive example

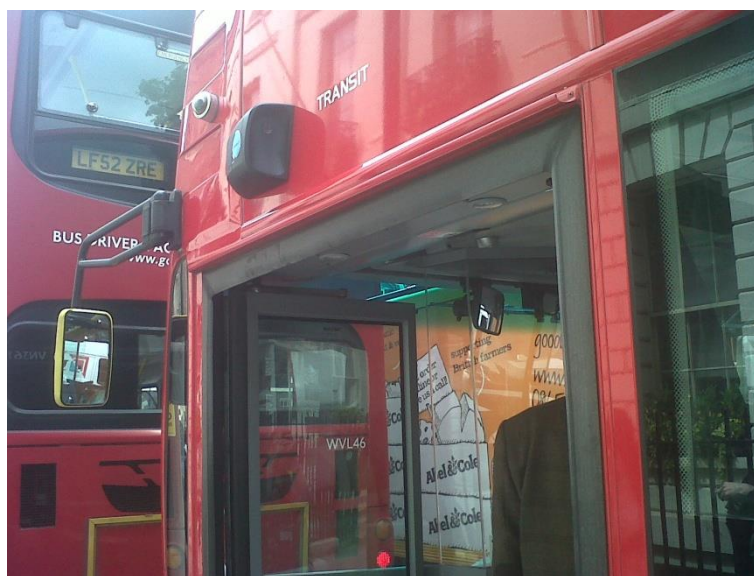
Figure 9: Processing equipment fitted to the nearside front of a London double-decker bus (curved black box fitted above the passenger door)

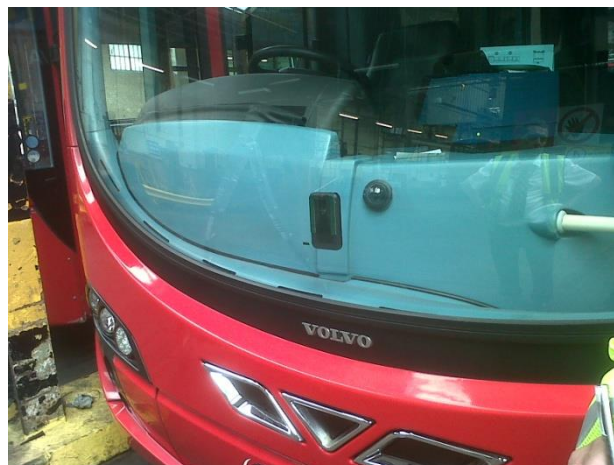
Figure 11: Front camera system (rectangular box in the windscreen)

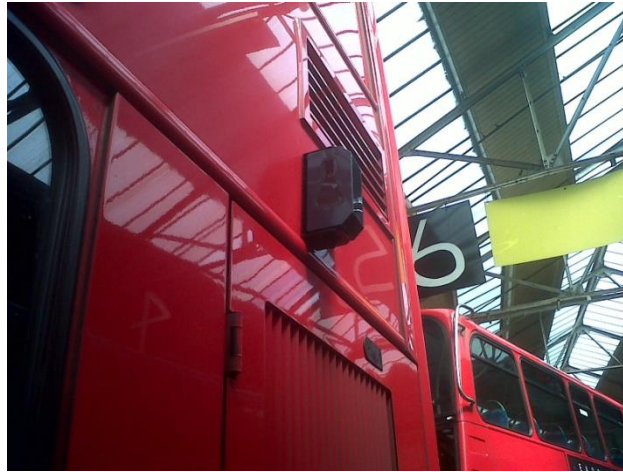
Figure 12: Rear-mounted nearside camera system (rectangular box mounted to outside of bus)
