Barclays Cycle Superhighway Route 8 CP15 Chelsea Bridge

Safety Audit Response Report

Stage 3 Road Safety Audit

Ref: 1478/CSH08-CP15/VAR/2011RR

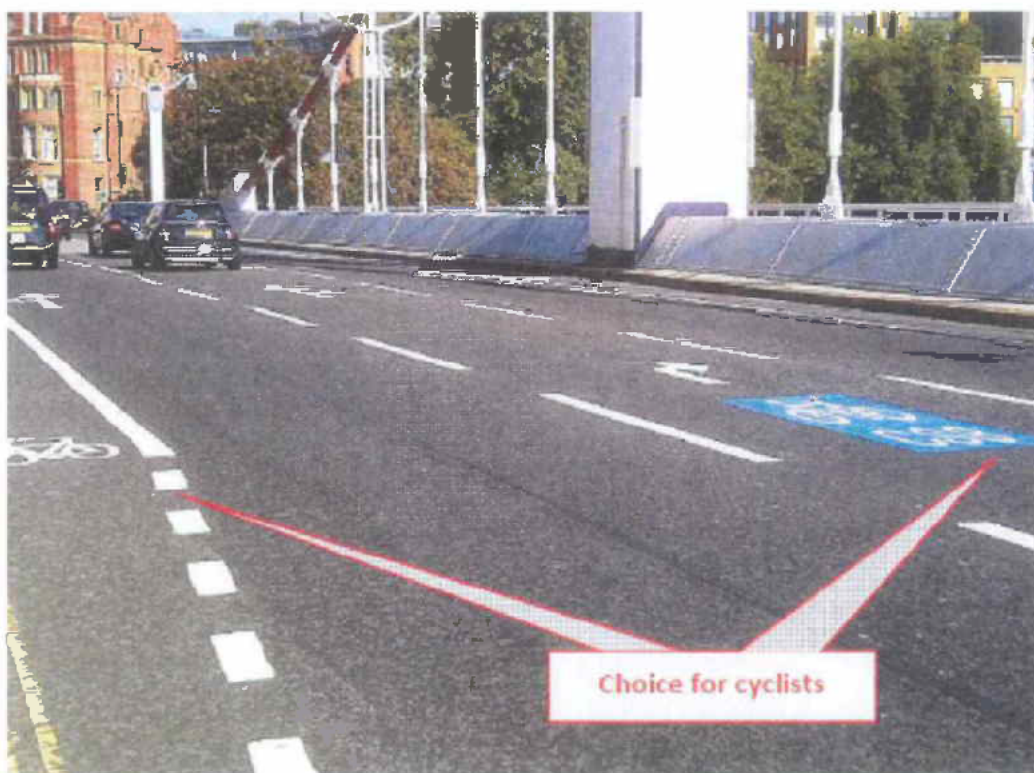
Location: A – Northbound approach to junction with Grosvenor Road

Summary: Risk of right turning cyclists conflicting with motor traffic

The current layout for northbound cyclists includes an un-shaded nearside cycle lane, CSH logos in the offside lane together with a coloured ASL at the stopline on the approach to this junction. This layout implies that users of the CSH are advised to make their way over to the offside lane following the termination of the bus lane. Since there will be some straight-ahead traffic in this lane cyclists with either adopted a position towards the offside or try to dominate the lane by travelling in its centre. This will result in cyclists travelling between opposing flows of traffic as they approach the junction or being pressurised by drivers wishing to overtake so being exposed to a high risk of collision. In addition the offside lane narrows to 2.8m towards the junction which is considered extremely hazardous for cyclists to attempt to travel alongside other motor vehicles.

- A virtual cycle lane is provided through the junction from ASL to the turn right reservoir although the Police are not keen on the application of virtual lanes at any location. In the event, an alternative of CSL patches is recommended.
- The third CSH panel, as shown on sheet 4 of the drawings but currently missing, should be provided

- a) Recommendation rejected: At the northern end of the junction there is already a cycle lane reservoir where cyclists wait before continuing their journey eastbound into Grosvenor Road. The design improves on the existing provision. The provision of extra cycle patches in the middle of a busy junction is not recommended and could be confusing to traffic approaching from different directions. Furthermore, due to the high volume of heavy vehicles potentially over running the markings, turning vehicles are likely to wear away the markings very quickly and therefore would require a high level of maintenance.
- b) Recommendation accepted: The CSH patch on drawing no. 60144895/CS8/CP15/DD/100/004 Rev A, should be installed on site.

- a) As per the Designer's Response this recommendation is rejected. This would not address the issue of cyclists moving across to access the ASL on the approach and the Client does not believe it would therefore have any benefit.
- b) The additional patch cannot be implemented as the highway authority (Royal Borough of Kensington & Chelsea) would not permit it.

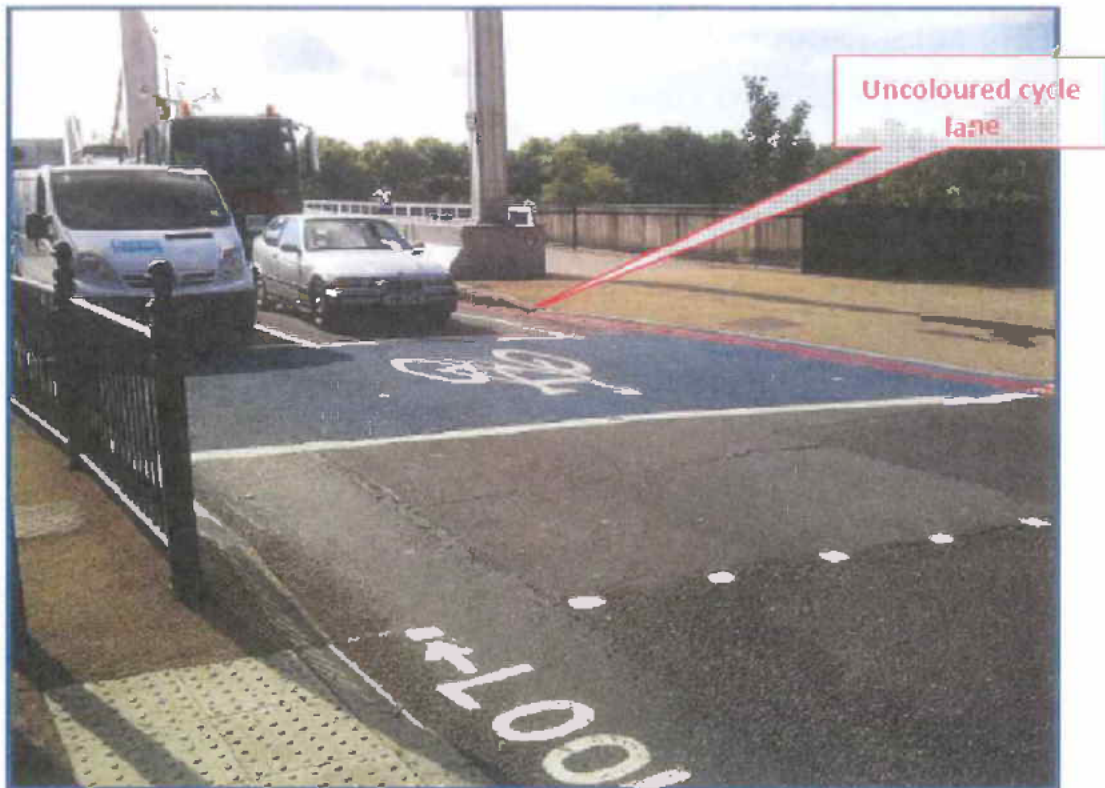
Location: B – Northbound approach to junction with Grosvenor Road

Summary: Risk of right turning cyclists conflicting with motor traffic

The existing cycle lane enters the existing blue-coloured ASL allowing cyclists to take up position for the right turn manoeuvre during any red time. If the northbound traffic entering the junction has a green, then cyclists using this lane have to wait for the end of the phase before positioning themselves in the ASL. If the nearside cycle lane was coloured in CSH blue, this would afford a choice of route to cyclists, particularly to cyclists less confident of accessing and using the offside lane. Having accessed the ASL, cyclists will be at risk of collision since there will be a mixture of straight-ahead and right turn traffic starting up from the offside lane.

- The nearside cycle lane over Chelsea Bridge is included in the CSH and coloured blue appropriately,
- The ASL should give the right turn cyclists priority in accessing the right turn reservoir, and
- Provide additional guidance in the form of a virtual cycle lane to assist in informing both cyclists and motorists of the intended cycle route. The reservations expressed by the Police on the use of virtual lanes also apply.

- Recommendation rejected: The traffic authority owning the bridge will not allow blue surfacing on the bridge as agreed with TfL.
- Recommendation rejected: A central feeder lane has been investigated, however due to the width constraints, it is not possible to maintain two traffic lanes on network capacity grounds as agreed with TfL.
- Recommendation rejected: It is not recommended due to Police concerns over the virtual lanes and maintenance issues regarding the replacement of CSH patches by high volumes of traffic (see also response to problem 3.1).

- Designer's Response agreed. In addition, the ahead movement is not part of BCS8.
- Designer's Response agreed. The ASL provided does afford priority for cyclists to reach the refuge; it is not clear what else could be done to improve it. For example, if an offside-only ASL was provided then that would penalise ahead movements (which is a strong desire line) for no benefit.
- See 3.1

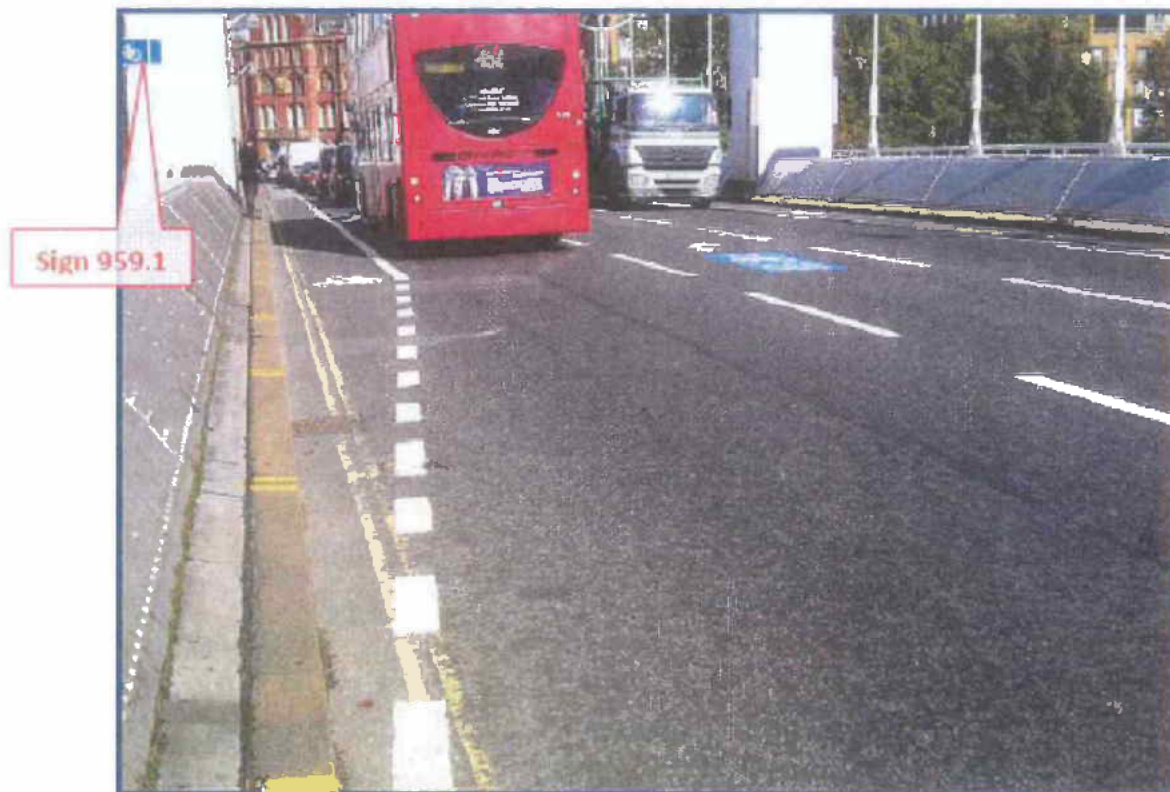
Location: C - start of cycle lane on Chelsea Bridge

Summary: Risk of side-swipe conflicts

There is a gap of approximately 20m between the end of the bus lane and the start of the taper with another 15m before the full width of the cycle lane is achieved.

Traffic will start to take up position across the two lanes immediately after the bifurcation marking (Diag. 1050), those entering the nearside lane only having to move out again at the start of the cycle lane. This double movement could lead to side-swipe crashes over the short section.

It is also noted that the with-flow cycle lane sign (Diag. 959.1) which is intended to be positioned on the bridge support is mounted in such a way that it is well out of the sight line of both cyclists and motorists.

- The cycle lane commences earlier immediately, without a taper, out of the bus lane.
- The sign to Diag 959.1 is relocated nearer to the carriageway so it can be seen by both cyclists and motorists.

- Recommendation rejected: Buses travelling northbound require this 20m gap to merge into lane 1 with the general traffic to avoid the mandatory cycle lane. No vehicles except cyclists are able to use the mandatory cycle lane.

- b) Recommendation accepted: The bridge provides limited suitable locations for cycle signs. However, if required the sign can be situated on an offset bracket, enabling the sign to be closer to the carriageway but still maintain a minimum lateral clearance of 450mm from the kerb edge

- a) Designer's Response agreed. The space between the end of bus lane and the start of the mandatory cycle lane is required to enable buses to merge out of the bus lane and avoid running into the cycle lane. The taper is as per design standards.
- b) The recommendation to relocate the signage is rejected. As above it is not proposed to move the start of the cycle lane. Also, Chelsea Bridge is a listed structure therefore no additional posts can be erected and signage has to be fixed to the existing structure - the Client does not believe there are any alternative sites. The Client believes the visibility of the existing signage is clear.

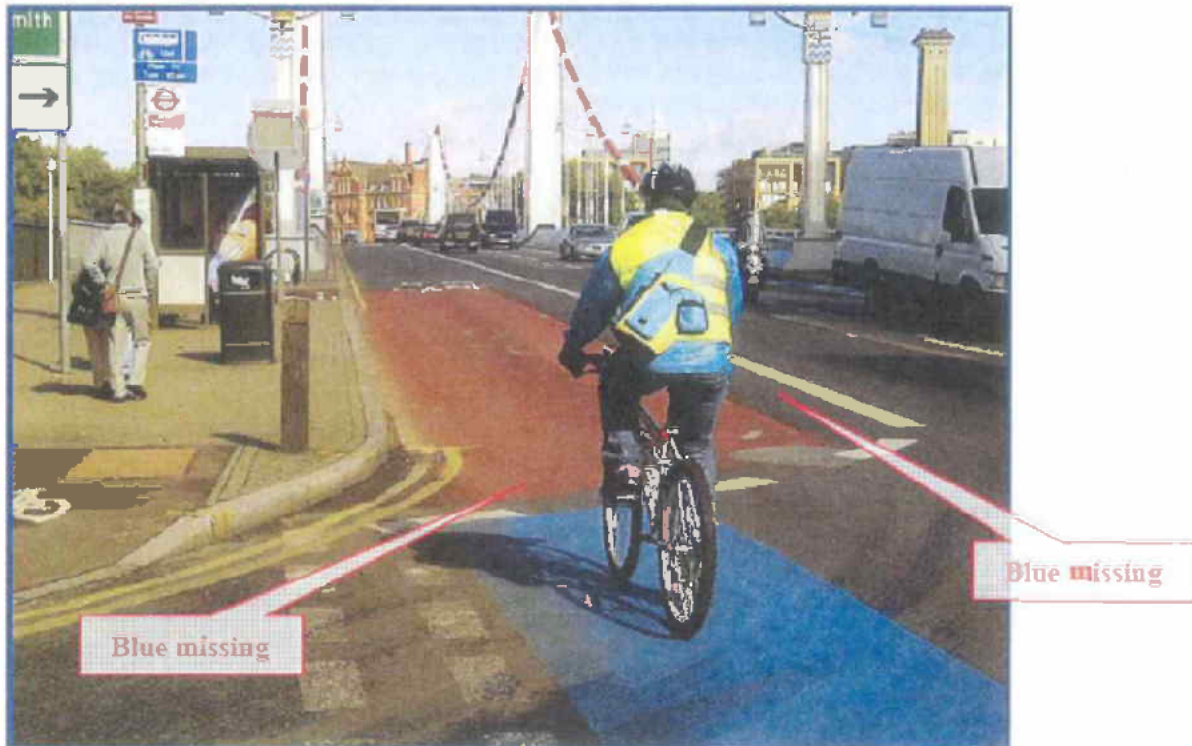
Location: D - start of bus lane on Queenstown Road

Summary: Risk of cycle/bus conflicts

Sheet 1 of the drawings shows the addition of blue non-HFS CSH surfacing to be applied to the carriageway immediately before and alongside the bus stop near to the park entrance. This has not been laid in accordance with the drawings. There still exists some red surfacing which is outside the limits of the bus stop.

It is recommended that the CSH blue surfacing is applied as shown on the drawings supplied at the commencement of the bus lane.

Recommendation rejected: The drawing shows the area to be surfaced in red SMA not blue. The photograph in the report shows black SMA has been used. Despite the difference in the surfacing colouration, it is unclear what safety issue is posed at this location.

Remarking of the existing faded bus cage markings and text would help to highlight the conspicuity of the bus cage and improve the scheme aesthetics at this location. This would avoid costly resurfacing works.

The recommendation is rejected. The design drawing shows red surfacing to be used in the bus lane, which is what has been installed on site. Blue surfacing is never used on the outside of a bus lane or across its full width.

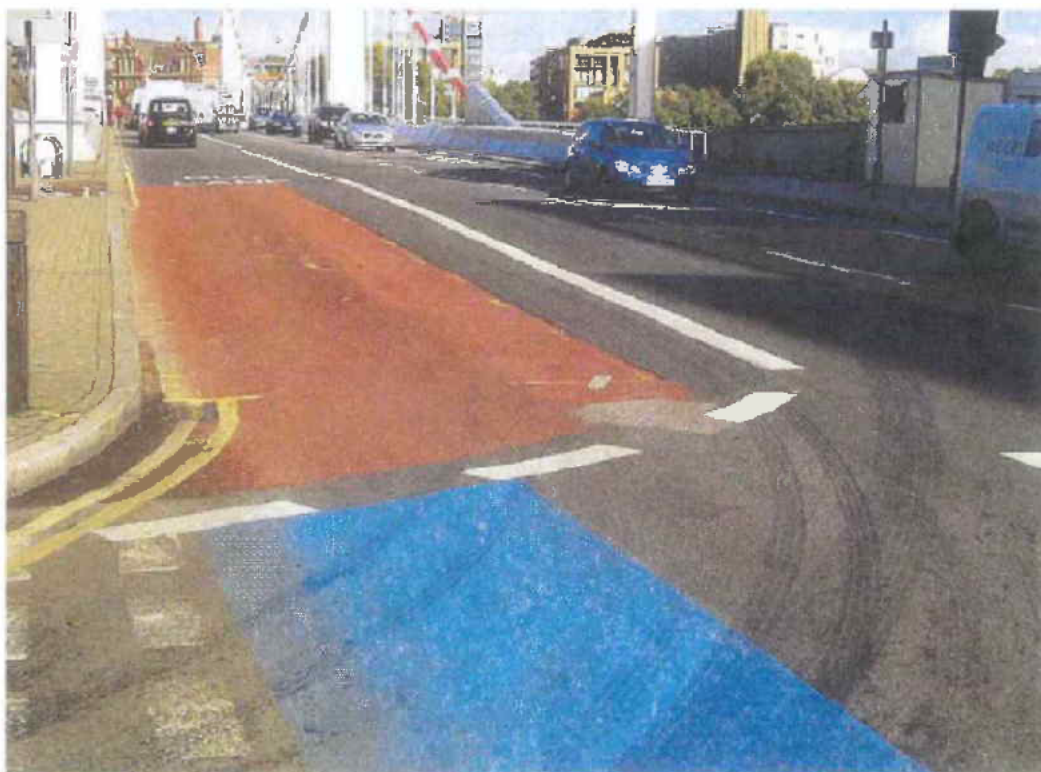
Location: E – On-road cycle lane on Queenstown Road at Park Entrance

Summary: Loss of control collisions.

This section of cycle superhighway crosses a well used vehicular access/egress to Battersea Park, which will result in this section being traversed continually by motor traffic, particularly buses along Queenstown Road, and turning traffic to and from the park.

The auditors have reservations regarding the specification of the material that has been used for cycle superhighway lanes and whether it is sufficient to withstand being driven over by other heavier vehicles and to continue to provide sufficient skid resistance in wet conditions.

It is recommended that a material with a greater skid resistance is used in locations on the highway where other traffic may frequently overrun the cycle lane.

The surfacing installed is in accordance with the specification as agreed with TfL. It is understood that the surface materials have been tested and have been deemed suitable for this application.

However, in acknowledgement of the concerns raised by the audit team, TfL may deem it appropriate to undertake localised testing of the skid resistance of the blue surfacing. If issues of skid resistance are identified, an alternative surface material or other mitigating measures may be required.

The Client accepts that there is a need to review blue surfacing performance over time, and have commissioned a comprehensive series of tests to identify the scale of any issues and to recommend - and then undertake - any necessary remedial measures.

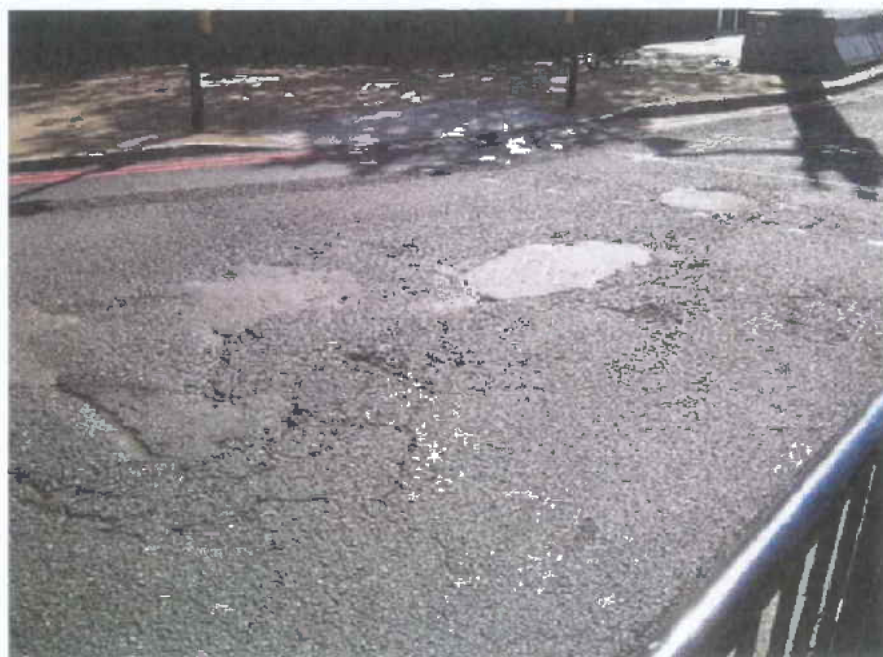
Location: F – southbound exit from Grosvenor Road junction

Summary: Risk of loss of control collisions

Sheet 5 of the drawings shows an area at the southbound exit from this junction which is earmarked for surface treatment. However judging from the state of the carriageway at this location it would be apparent that no remedial work has recently been undertaken. The current state of the surface constitutes a hazard particularly for two wheel vehicles.

It is recommended that the area of carriageway within the Grosvenor Road junction is treated in accordance with that as specified in the scheme.

Recommendation accepted: Agreed - carriageway work specified should be carried out following consultation and agreement with TfL.

The recommendation is accepted. The resurfacing was not carried out as part of the works due to the strict constraints on working hours and therefore the limited time available to deliver the scheme. It is proposed that the Client liaise with the highways maintenance team to agree when the resurfacing could be carried out.

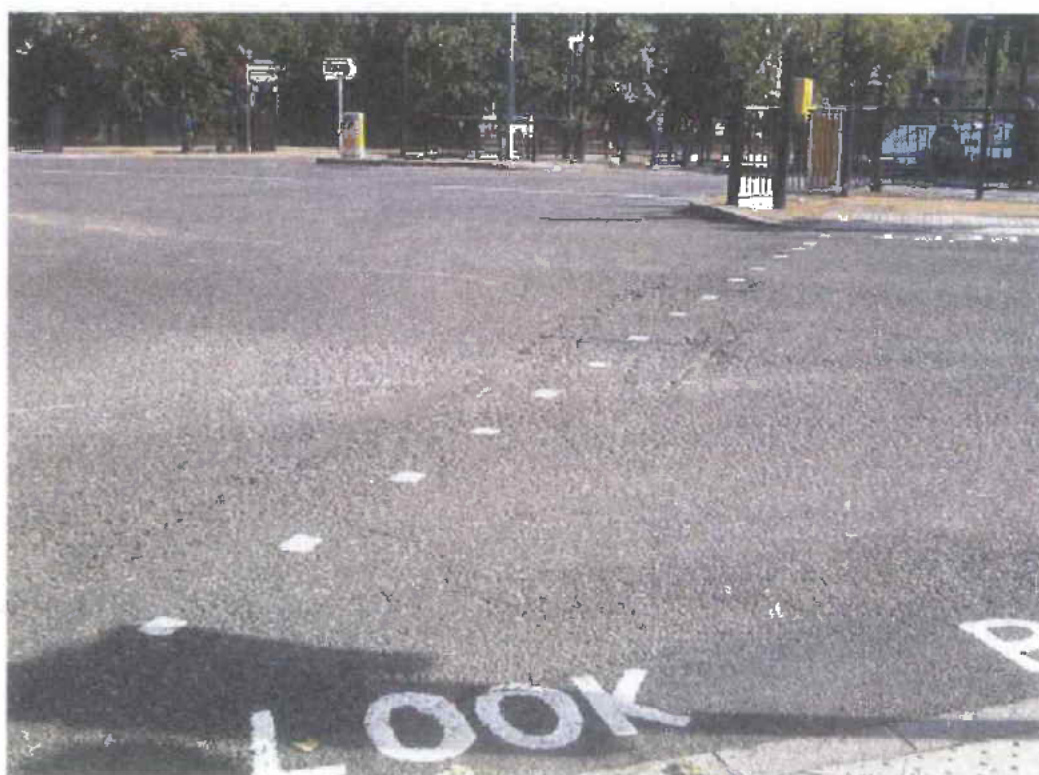
Location: G – Grosvenor Road junction and approaches

Summary: Risk of loss of control collisions

Sheet 4 of the drawings shows an extensive area consisting of much of the junction and its approaches being treated with either Charcoal grey high friction surfacing or, in the case of Chelsea Bridge, a resin-based high skid resistant surfacing with buff Chinese bauxite chippings. None of this work appears to have been completed. The existing state of the surfacing within the junction is not good and increased use by cyclists will need an improvement to offset the increased risk of loss of control collisions.

It is recommended that the area of carriageway within the Grosvenor Road junction is treated in accordance with that as specified in the scheme.

Recommendation accepted: Agreed - carriageway work specified should be carried out following consultation and agreement with TfL.

The recommendation is accepted. This will be addressed within the action proposed in the Client Response to issue 3.6.
