Engineering

Groundwater Level Monitoring

Document Number: CRL1-GCG-C2-RAN-CRG03-00002

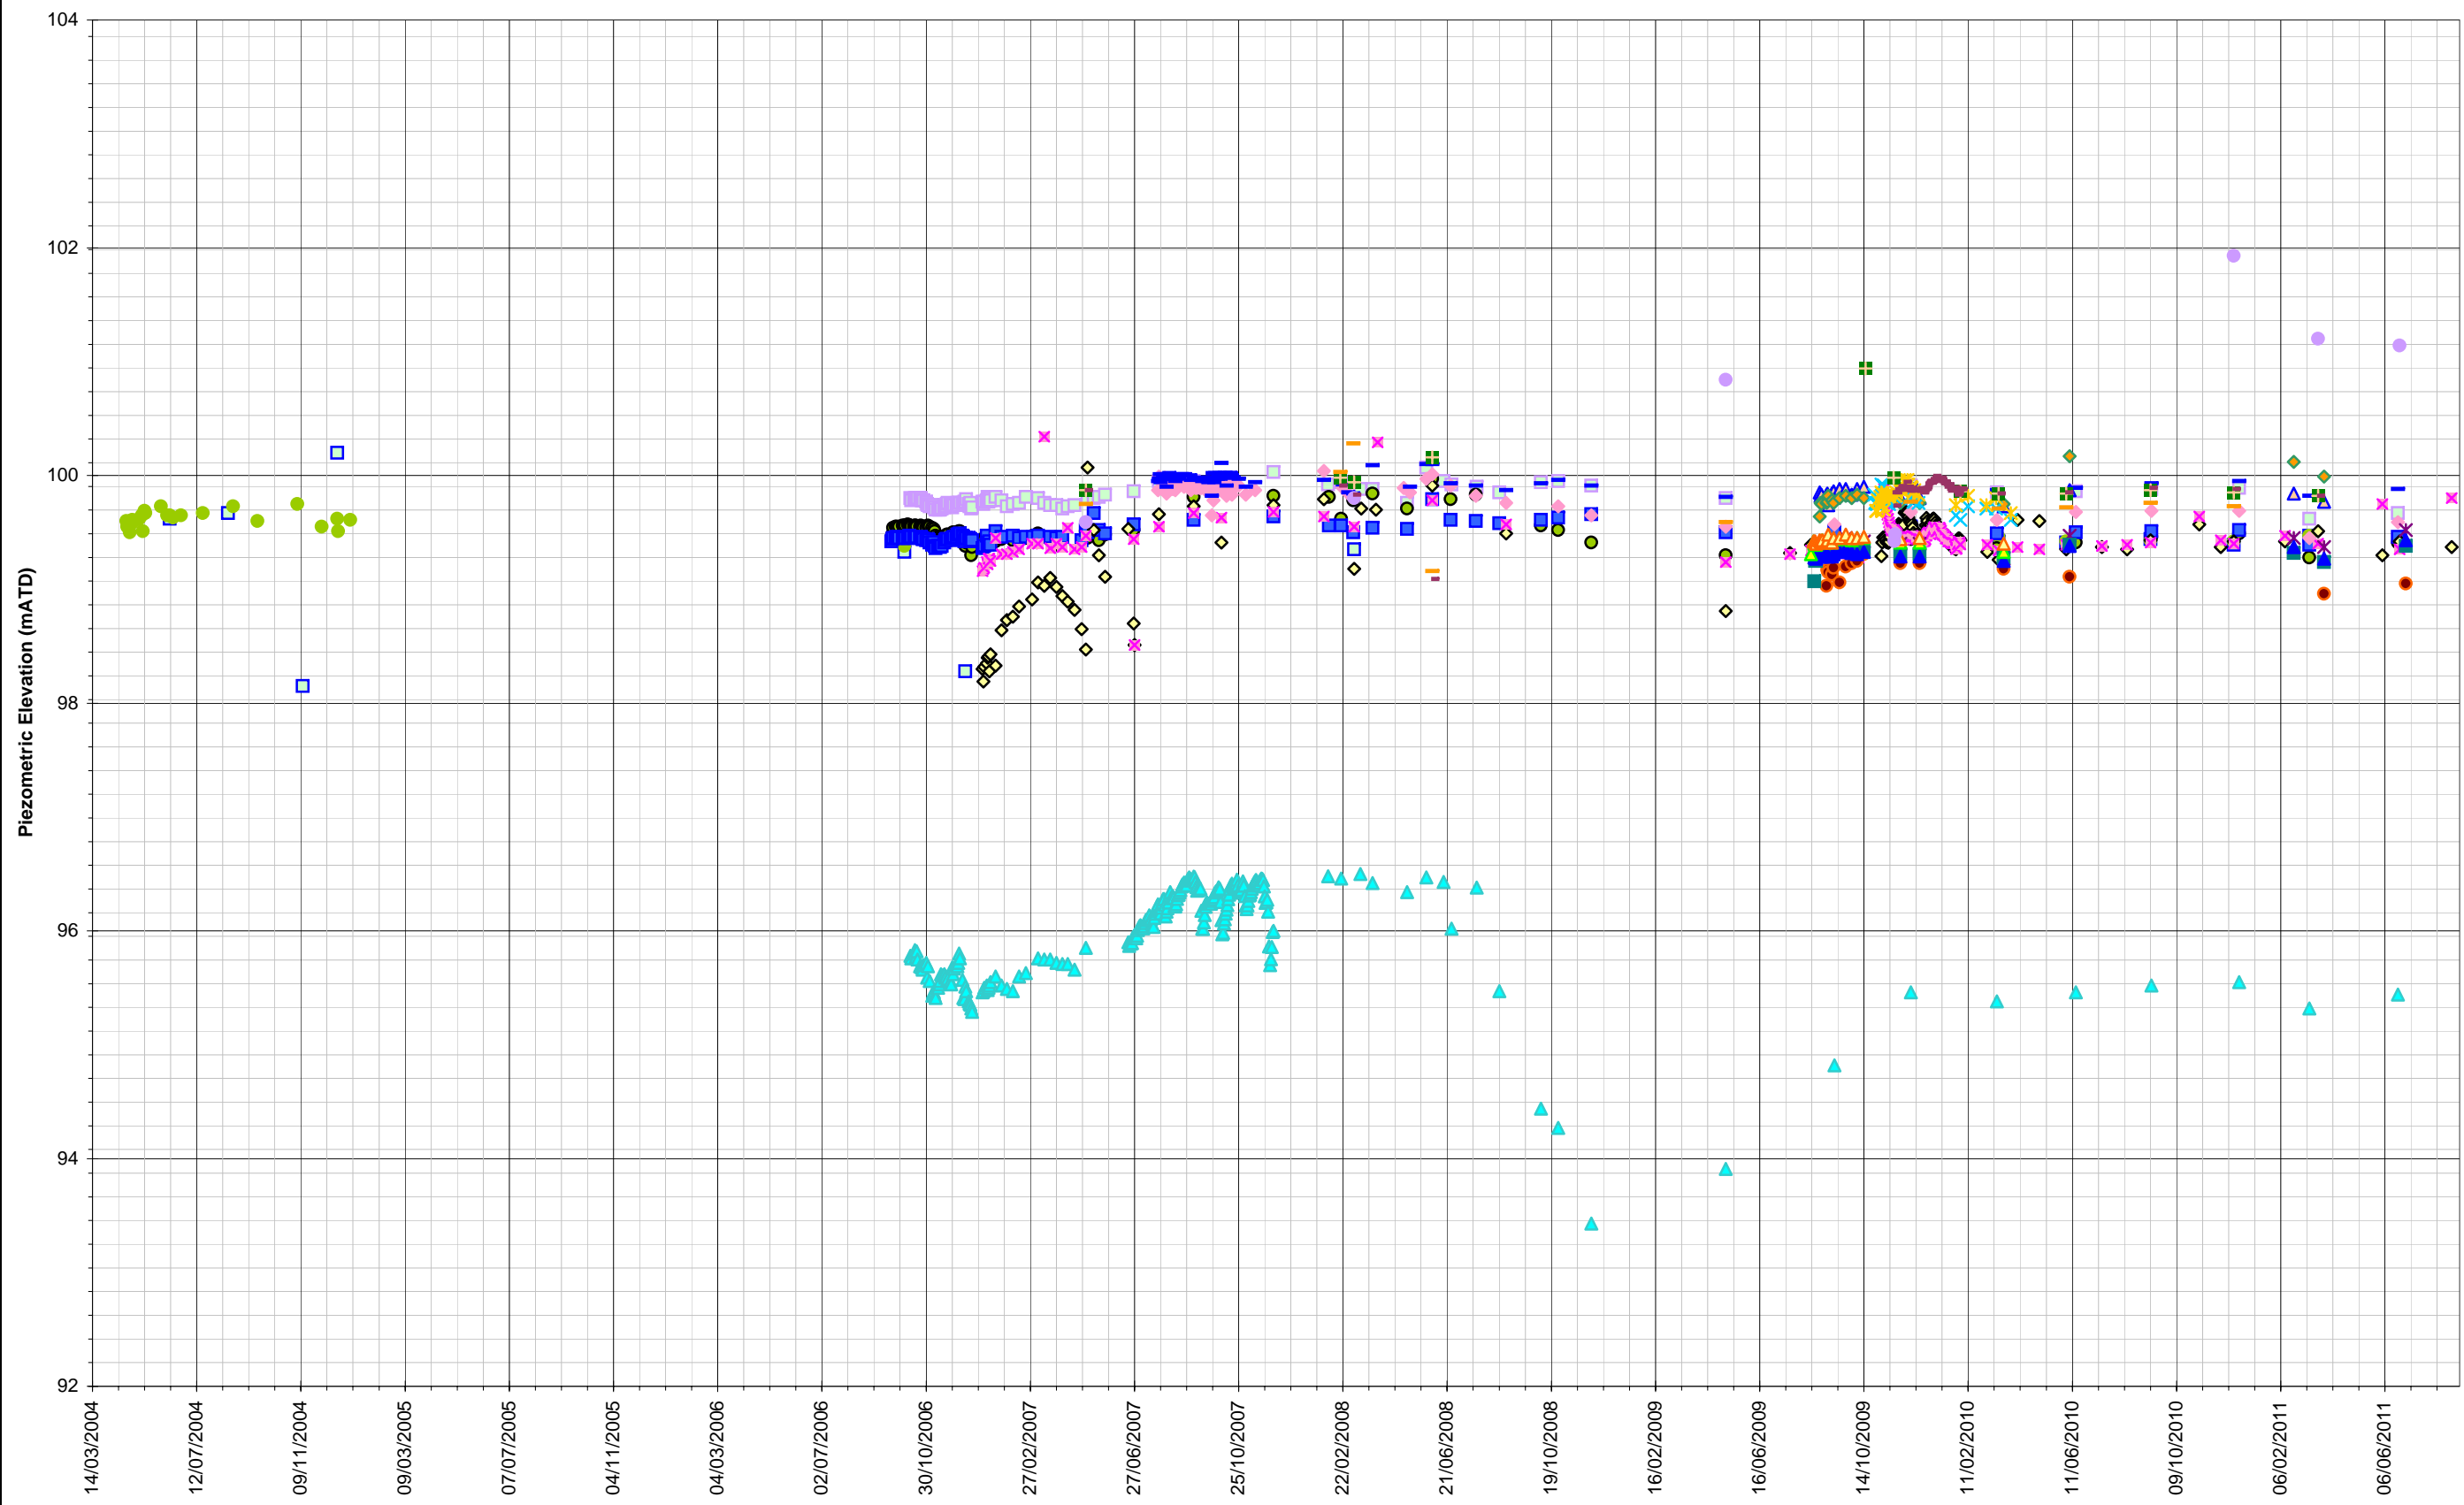
Figure 4.3.14

| □ CH23 AL/RTD | ● CH23 HF | □ CH26R RTD | ▲ CH26R LMB | ● CH34 HF | ■ CH34 RTD | ◇ CH31P CK | ✕ CH31P LC (A2) | ◇ CH37 LC (A2) | — CH37 RTD | ▲ CH38 RTD | ◇ CH38 HF/LTB |
