*Appendices to the Liveable Neighbourhood Bid Pro Forma*

***LIVEABLE  
WALWORTH***

*London borough of Southwark*

*20<sup>th</sup> October 2017*

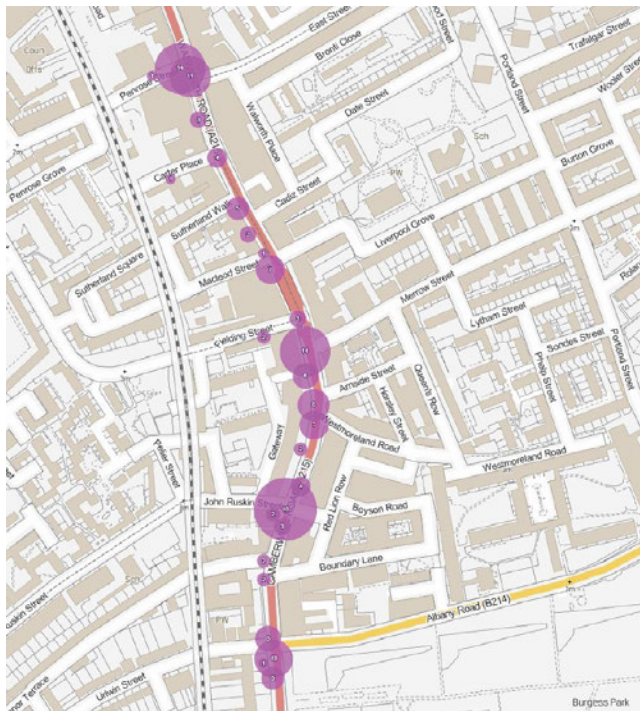
Clusters of collisions from 2014 to 2016:

Collisions are concentrated in Walworth Road, with only few collision happening in side roads (Carter Place and Fielding Street). A majority of the pedestrian collisions happened at the junction with Merrow Street and between Cadiz Street and Liverpool Grove. At this location the Walworth Road widens, increasing pedestrian crossing distance as pedestrian cross four lanes of traffic often away from the controlled facilities. Cyclist casualties are more spread across the area. The total number of collision has been increasing. There has been a steep increase of Motorcycle casualties from zero in 2014 to 19 in 2016, while pedal cycle casualties have decreased from 25 to 13.
