Gallows Corner Flyover Refurbishment Concept Design

Stage 1 Road Safety Audit

Document Ref: STPJ388-CST-MAC-15_XX-ASM-HE-00001

A127 Gallows Corner Refurbishment Scheme

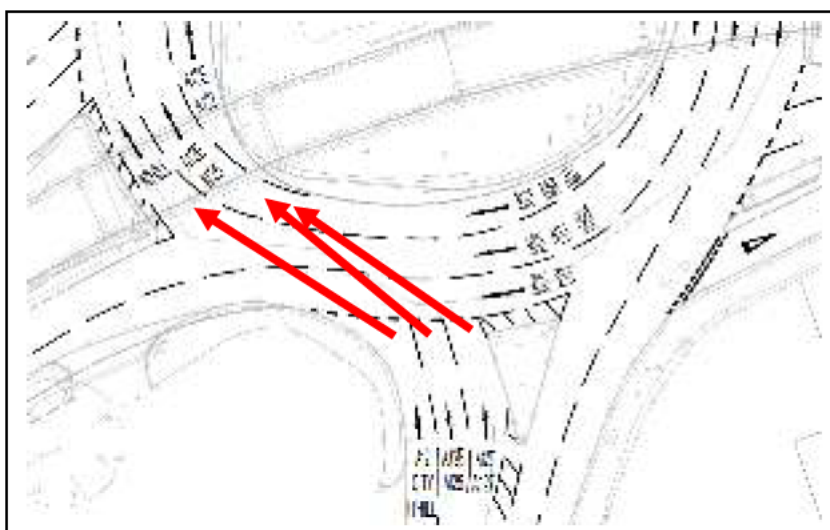
Location: A – Eastern Avenue East & Main Road entries to Roundabout

Summary: Risk of side swipe collisions on the roundabout.

Both the Eastern Avenue East and Main Road entries onto the circulatory carriageway of the roundabout have three lanes proposed (as per the existing layout). However, the circulatory carriageway adjacent to these entries both have two circulatory lanes. Site observations have shown this leads to drivers entering the roundabout in the offside lane being forced to brake sharply and give way to vehicles located in the centre lane – due to their being insufficient carriageway space to accommodate three vehicles side by side.

The proposed slight amendments to the road markings on the circulatory carriageway appear to further limit the available carriageway for vehicles entering the roundabout in the offside (third) lane (see annotated drawing below). This could therefore increase the risk of a side swipe collision between vehicles in lanes two and three when entering the roundabout.

It is recommended that if three entry lanes be provided onto the roundabout, sufficient carriageway space should be provided to allow vehicles to safely enter the roundabout without the need to brake/swerve to avoid vehicles in adjacent lanes.

Design Organisation Response	Accepted / Part Accepted / Rejected
The current road marking layout has been amended on the northbound left lane to confirm 'left only' which resolves any issue.	
Client Organisation Comments	
The "left only" markings proposed to resolve the issue will need to be reviewed in the Detailed Design to confirm that there is no impact on the traffic capacity.

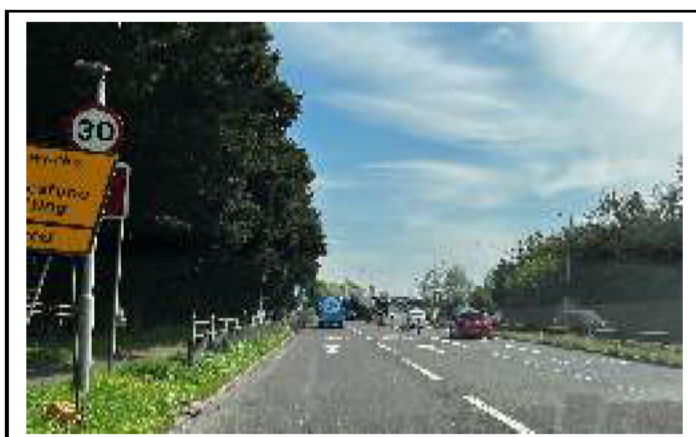
Location: B – Eastern Avenue East & A127

Summary: Removal of speed limit markings could increase vehicle speeds and therefore increase the risk of collisions at the roundabout.

On both the A127 approaches to the roundabout, the speed limit reduces down to 30mph. Adjacent to the speed limit terminal signs, carriageway roundels have been provided to compound the change in speed limit to drivers and encourage them to slow on approach to the roundabout (see photo below). However, the proposed alterations to the road markings don't appear to show these are to be replaced as part of this scheme. There is an increased risk of higher vehicle speeds should the roundels not be replaced, resulting in shunt type or overshoot collisions at the roundabout entry.

It is recommended that the speed limit roundels be provided.

Design Organisation Response	Accepted / Part Accepted / Rejected
The location of the start of the 30mph speed limit has been moved further to the west on Eastern Avenue East and speed limit roundels have been included. Also, on the A127 westbound the existing speed has been moved further east and 30mph speed limit roundels will be provided at this location, General Arrangement drawing updated as per comment.	
Client Organisation Comments	
Proposal accepted. The exact position of the speed limit markings and signs to be confirmed in the Detailed Design and reviewed again in the Stage 2 Road Safety Audit.

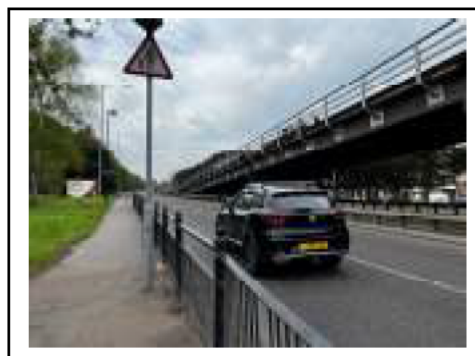
Location: D – Eastern Avenue East

Summary: Increased risk of pedestrians being struck by vehicles whilst crossing.

At the Eastern Avenue East exit from the roundabout, there is an uncontrolled pedestrian/cyclist crossing. The scheme proposals include the widening of the carriageway at this location, therefore increasing the crossing distance and exposure time between pedestrians/cyclists and vehicles.

There are existing warning signs at the Eastern Avenue East exit from the roundabout to inform drivers that pedestrians may be crossing ahead. However, the audit team have concerns that they are not ideally mounted to adequately inform drivers of the risk of pedestrians in the carriageway ahead. The signs appear to have been mounted too high and are therefore out of the eyeline of drivers.

With the carriageway being widened at the location of the crossing, it is increasingly important that the warning signs are mounted/positioned correctly to adequately warn drivers of the risk of pedestrians and cyclists in the carriageway ahead. Failure to do so could increase the risk of collisions between vehicles and pedestrians/cyclists.

It is recommended that adequate warning be provided to inform drivers of the risk of pedestrians in the carriageway ahead.

Design Organisation Response	Accepted / Part Accepted / Rejected
Sign relocated to grass verge as part of new proposals (due to carriageway widening in this area), correct height for signage will be reviewed/specified at detailed design to ensure it's visible to road users whilst being compliant to the design standards.	
Client Organisation Comments	
Proposal accepted. The exact position of the signs and signing strategy to be confirmed in the Detailed Design and reviewed again in the Stage 2 Road Safety Audit.

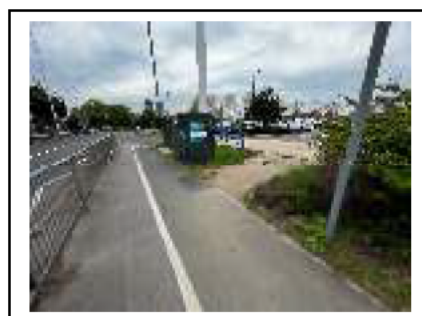
Location: 1 - A127 at the eastern exit from the roundabout

Between the A127 and the retail park, pedestrians have created an obvious pathway through the verge/hedge to access the retail park from the footway alongside the A127. This is a clear desire line here and it would benefit the pedestrians' safe passage if it were to be formalised.

Design Organisation Response	Accepted / Part Accepted / Rejected
<p>Although this issue is outside the main proposals, a simple fencing/pedestrian guardrail or hedge addition could be proposed to remove this desire line. There is a suitable option for pedestrians in utilising existing routes and an unofficial zebra crossing within retail park.</p> <p>However, the desire line is there as it's a shorter route to the retail park and it may be prudent to discuss with the local stakeholder as to whether they would be willing to install a crossing at this location across their 'service road'.</p>	
Client Organisation Comments	
<p>This is outside the scope of the project, however opportunities to improve the current situation will be investigated at Detailed Design Stage.</p>

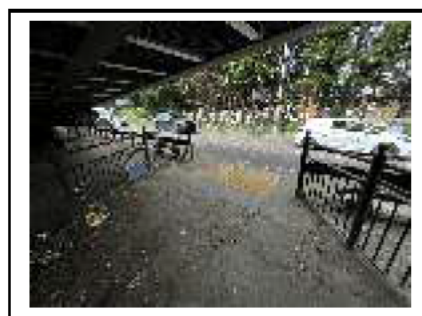
Location: 2 - Eastern Avenue East

Between the Eastern Avenue East carriageways, there is a pedestrian/cyclist crossing. The height clearance is greatly restricted by the A127 structure. Considering cyclists could be cycling under this structure, there didn't appear to be sufficient clearance for them to not risk head injuries. There was a single cyclists dismount sign mounted at ankle height on the northern side of the crossing, but no other warning or instruction was provided.

Design Organisation Response	Accepted / Part Accepted / Rejected
<p>Although this issue is outside the main proposals, there could be some consideration at detailed design to relocate the crossing further along where the higher section of flyover construction exists, to ensure sufficient headroom is available. Alternatively, cyclists could be asked to dismount ahead of this crossing point to reduce the likelihood of any injuries.</p>	
Client Organisation Comments	
<p>This is outside the scope of the project , however opportunities to improve the current situation will be investigated at Detailed Design Stage. It is unlikely that cyclist will dismount. The clearance to the underside of the new flyover to be reviewed at Detailed Design. Relocating the Pedestrian Crossing should be investigated if this can be archived without reducing Traffic Capacity.</p>

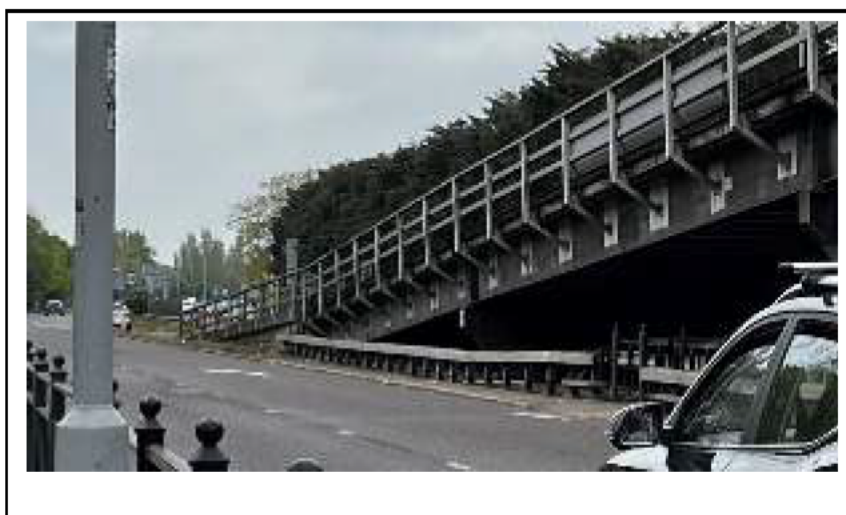
Location: 3 - Eastern Avenue East & A127

Where the A127 overbridge deck joins the Gallows Corner slip roads, the parapet steel supports encroach into the space above the road restraint. Should a vehicle lose control and then collide with the road restraint, the parapet supports could strike the vehicle windscreen and encroach into the vehicle cabin, striking the driver or passengers. It is unclear whether this is to be mitigated as part of the proposed scheme.

Design Organisation Response	Accepted / Part Accepted / Rejected
<p>The road safety auditors were issued the DfS information for the existing arrangement and issues. Part of the proposals are to replace the existing road restraint and parapet, therefore removing the issue stated above.</p> <p>The kerbline below the structure is also being 'pulled out' to help resolve this issue, as shown on the drawings issued to the auditors (STPJ388-CST-MAC-15_XX-DRG-</p>

This issue has been designed out in the Concept Design and will be taken forward to Detailed Design
