Impacts of Automatic Train Operation on track & infrastructure

AUTHOR: Andy Vickerstaff

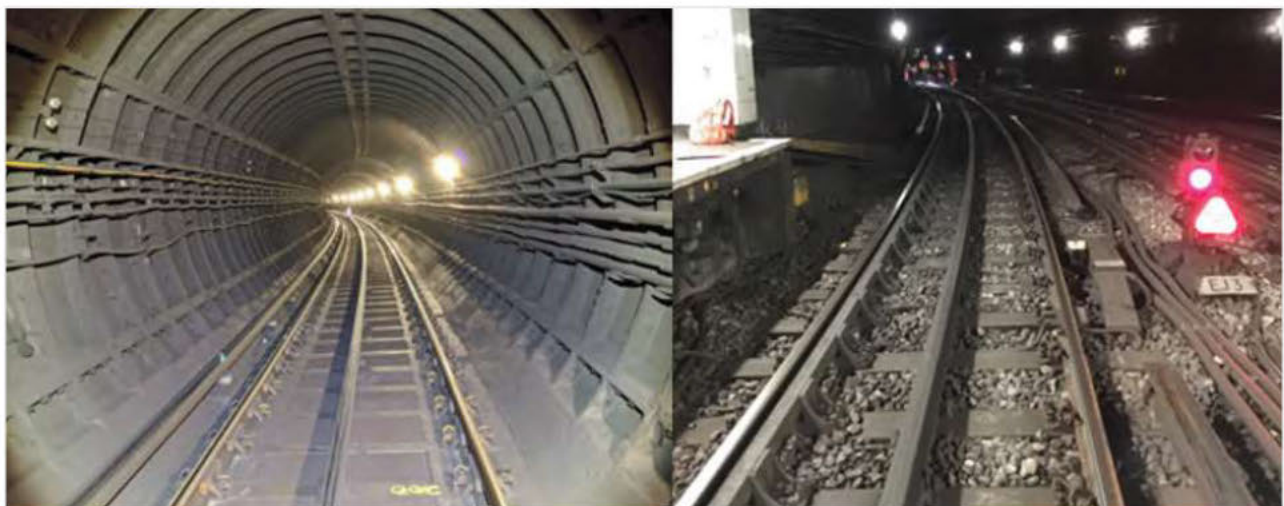
Figure 1: Deep tube concrete (left) and sub surface ballast (right) track-forms

on the mainline UK network the inherent gauge limitations of the infrastructure prohibit this, and this is an even more acute challenge for LUL. Since the construction of tunnels switched to the 'deep tube' method in the 1890s, rather than the 'cut and cover' method used for the first sections of the underground from 1863, which was enabled by the change from steam to electric trains, the maximum gauge of 'tube' trains has been severely limited (Figure 1).

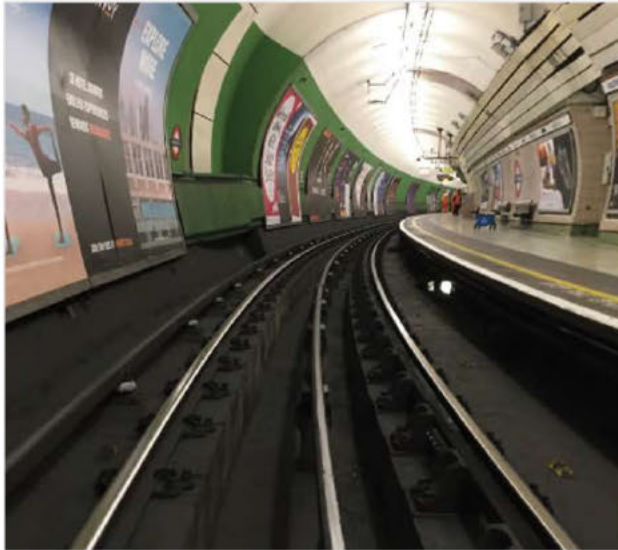
Figure 2: Paddington Southbound platform on the Bakerloo line

Another option is to run longer trains with more carriages, however longer trains require longer platforms to allow that capacity to be effectively utilised, especially when dwell times are so short in order to keep throughput high. Extending platforms in deep tube stations is enormously expensive as it would require significant tunnelling to increase the size of the wider station boxes (Figure 2).

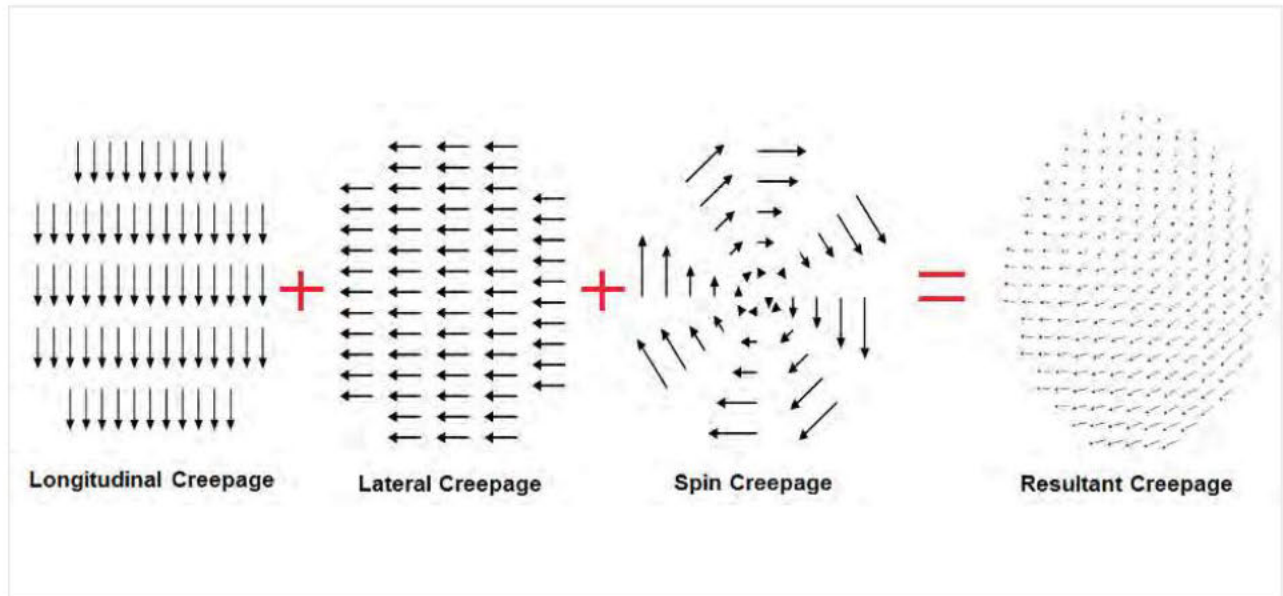
Figure 6: Resultant creepage in curving

However, so far, we have only considered the relationship between creep-creepage in the longitudinal direction but as soon as we start attempting to curve there is also demand on the contact patch to support lateral creepage, as well as a much smaller spin element due to the relative rotation of the surfaces (Figure 6).

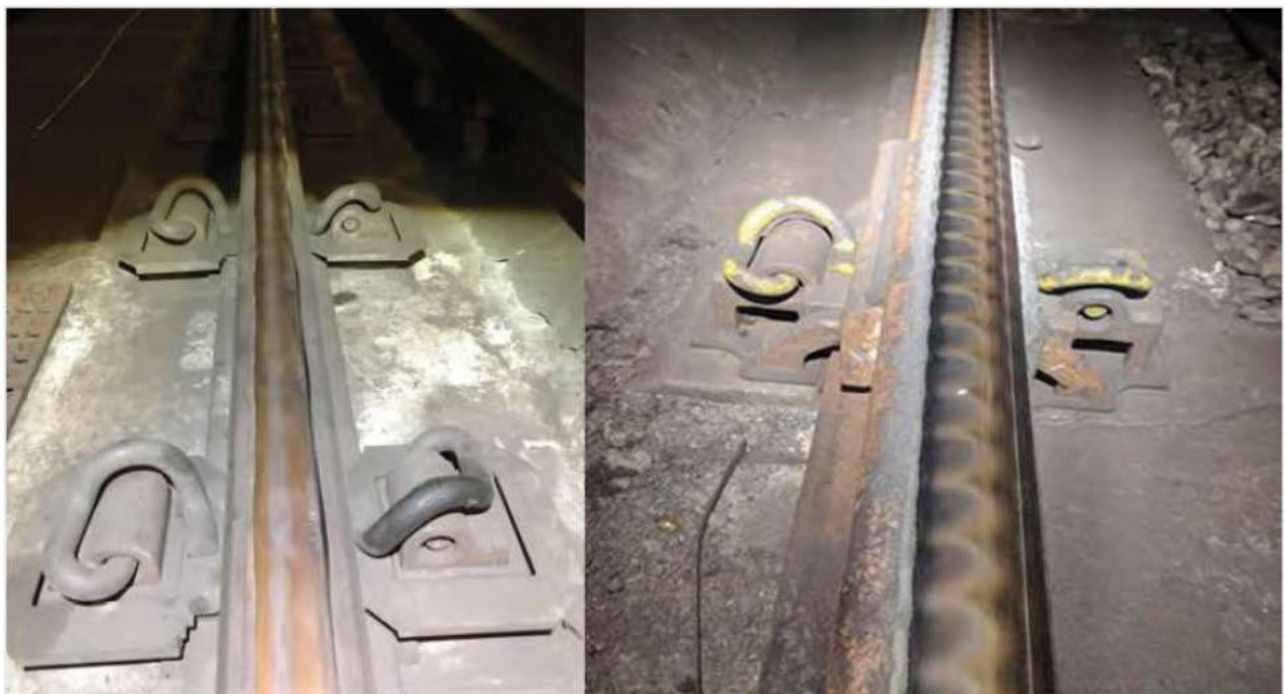
Figure 7: Short wavelength corrugation on LUL

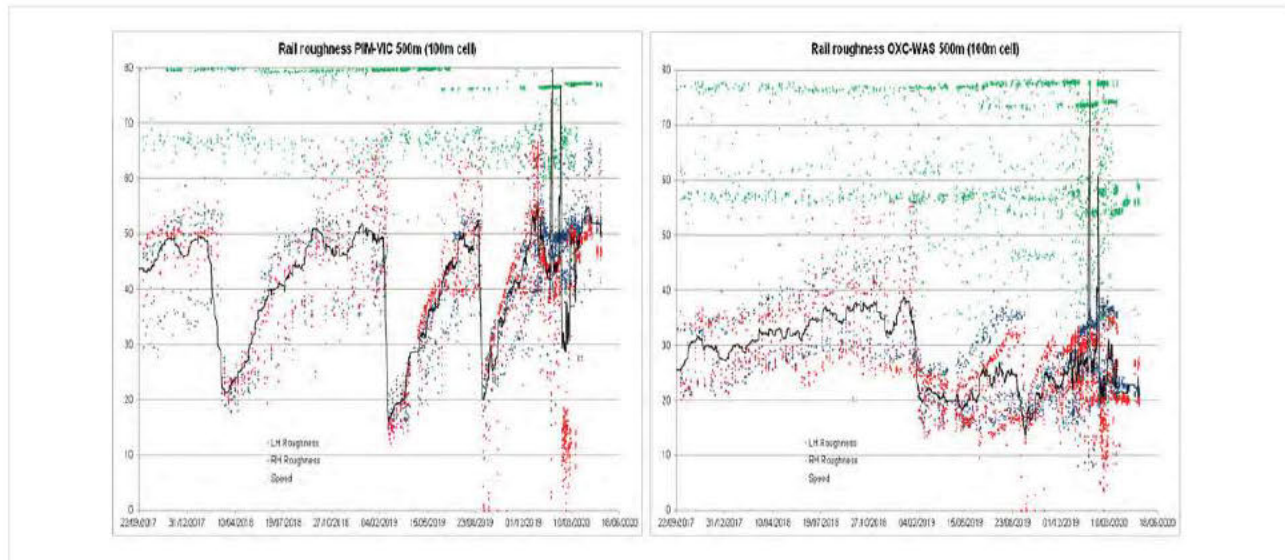
Figure 8: Rail roughness growth Pimlico to Victoria (left) and Oxford Circus to Warren St (right)

The two sites in question both consist of c.500m radius curves with a speed limit of 80kph, an annual 40MGT and consist of Pandrol Vanguard retrofit on NTF415 sleepers. They have both been identified as suffering from pinned-pinned corrugation by the wavelength of 50mm equating to a frequency of 441Hz, the sleeper spacing being approximately 1m in both sites. However, as can be seen in Figure 8, corrugation growth rates are vastly different; the blue and red dots indicate roughness on the left and right rails, with the black line a rolling average (there were some issues with the ATMS equipment towards the end of the period analysed). The grinding interventions (three times at the first site Pimlico to Victoria and once at Oxford Circus to Warren St) also clearly shows how effective it is at reducing rail roughness.

The green dots also seen in Figure 8 give the speed of the train when the measurements were taken, and this was further analysed across the two ATMS units for a period of 2 months to give a speed distribution. The results from this for each of the sites can be seen in Figure 9, which shows the distribution of speeds at 500m where for the quickest corrugation growth site nearly 70% of trains reach 80kph, whereas in the lower growth site this is only around 35% of trains (the y-scale is unfortunately different due to the graphs being automatically generated).

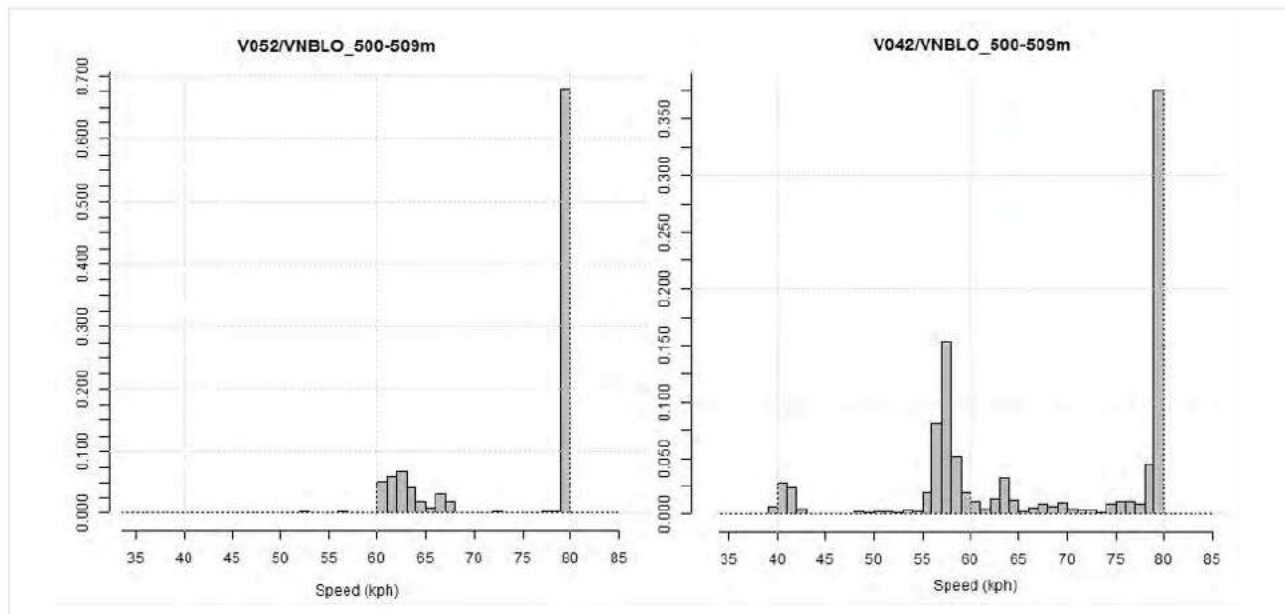
Figure 9: Speed distributions Pimlico to Victoria (left) and Oxford Circus to Warren St (right)

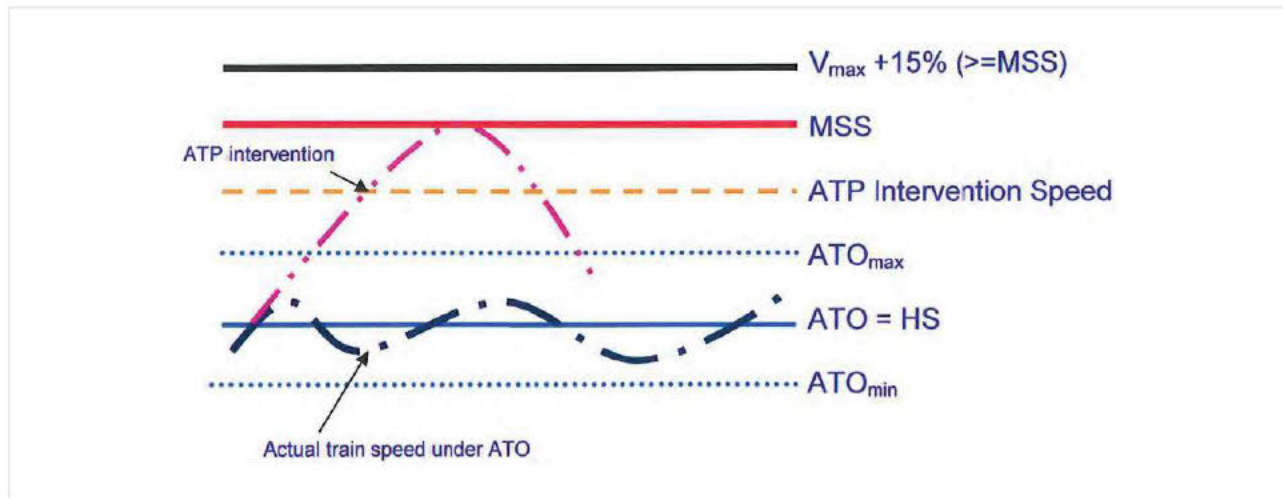
Figure 10: Conceptual relationships for ATO on Central Line

in as conceptually shown in Figure 10 by the black line to achieve the Headway Speed (HS). Therefore, even in areas where constant speed is achieved, we can still be making even more demands on the adhesion available to achieve it.

Figure 10 demonstrates another area in which much better understanding of the relationship between ATO and ATP (Automatic Train Protection) will allow track design to be better optimised for whole life cost. During the Northern line upgrade new track installations were designed using the principle that the ATP intervention speed would result in a maximum of 8kph over the HS, yet there was no statistical analysis carried out which would give a risk of this occurring, indeed the examples in Figure 9 show that the actual speeds through a section may even be lower in some cases.

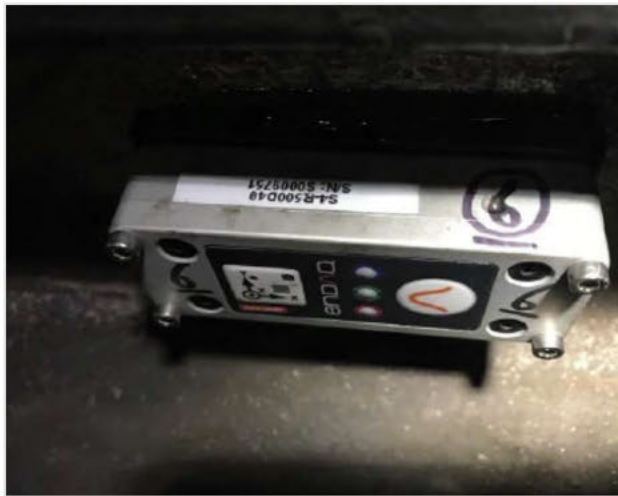
Figure 11: Stock rail fitted enDAQ Sensor

Corrugation has also been the root cause of several issues for signalling components mounted on the track. One such issue was on a set of points on the Jubilee line extension which has historic issues with developing corrugation and where several failures occurred on KLM clips associated with the points resulting in costly delays. Initial monitoring was carried out using an enDAQ sensor (Figure 11) which is a tri-axial accelerometer which can be simply attached to the rails, or point operating equipment, and records a number of train passes to identify the Power Spectral Density (PSD) of the vibration. This is a method used to identify the relative power of the signal (in this case the acceleration of the vibration) against the frequency (rather than time) which enabled us to establish if the corrugation was causing the damage.

The initial monitoring carried out in February 2020 identified that the frequency of vibration with the greatest power at the stock rail was 355Hz. The speed through this particular trailing set of points is 56kph, which equates to a wavelength of 44mm which tied up pretty accurately with measurements taken on site during maintenance. As they say in politics 'don't waste a good crisis' and given the ridership at this point was so low, operations were consulted as to whether putting a speed restriction on would be acceptable. A 40kph speed restriction across the points was agreed (approximately a seven second increase in journey time) and implemented with the intention of trying to wear out the corrugation which had developed, a result which had previously been achieved using this method on the Victoria line¹⁰.

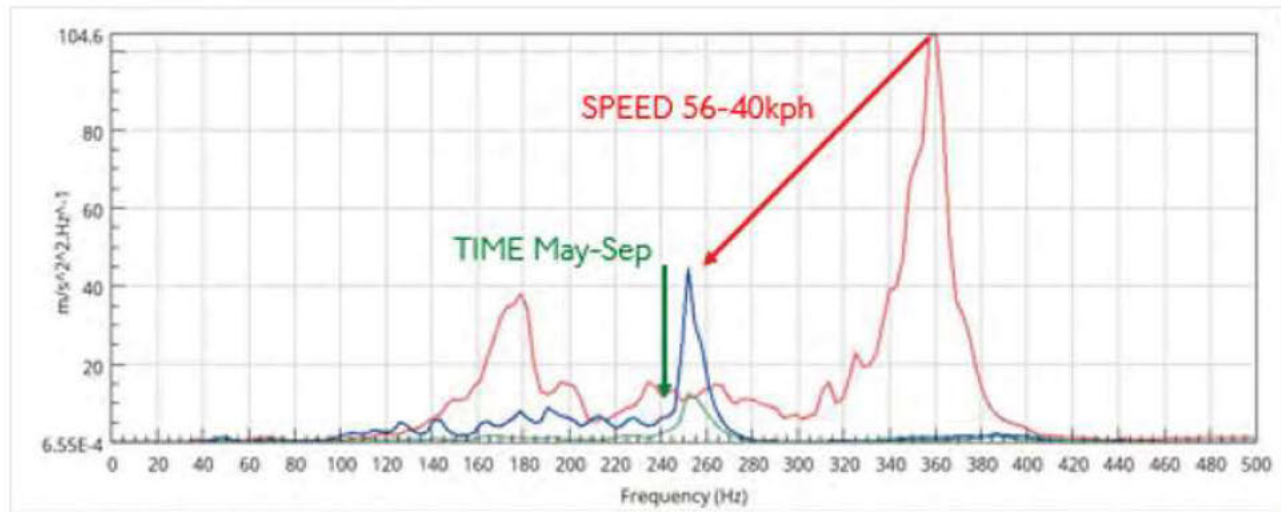
Figure 12: Impact on frequency of speed and time

Figure 12 shows that the speed restriction had an immediate impact, in both reducing the power of vibration being experienced (y-axis) and a change in the frequency (x-axis) from 56kph (red) to 40kph (blue) as the speed restriction was applied between these two sets of measurements on the same day in May 2020. The speed restriction then remained in place until the next set of measurements in September 2020 (green) which shows the reduction in power, but the frequency remains constant.

The initial change in frequency is achieved by the new train speed running over already corrugated rails (40kph @ 44mm = 253Hz), the reduction in the power of the vibration was achieved over time due to the constant frequency nature of corrugation. The root cause of the corrugation, in this case most likely a trackform specific issue due to the lateral track stiffness, remains the same at 355Hz but now we are running at 40kph the wavelength it is trying to generate is 31mm and hence it starts to wear out the 44mm.

The results from September 2020 indicate that we may have nearly worn out the 44mm wavelength, but we are now expecting to see the 355Hz increasing as the 31mm is being generated.

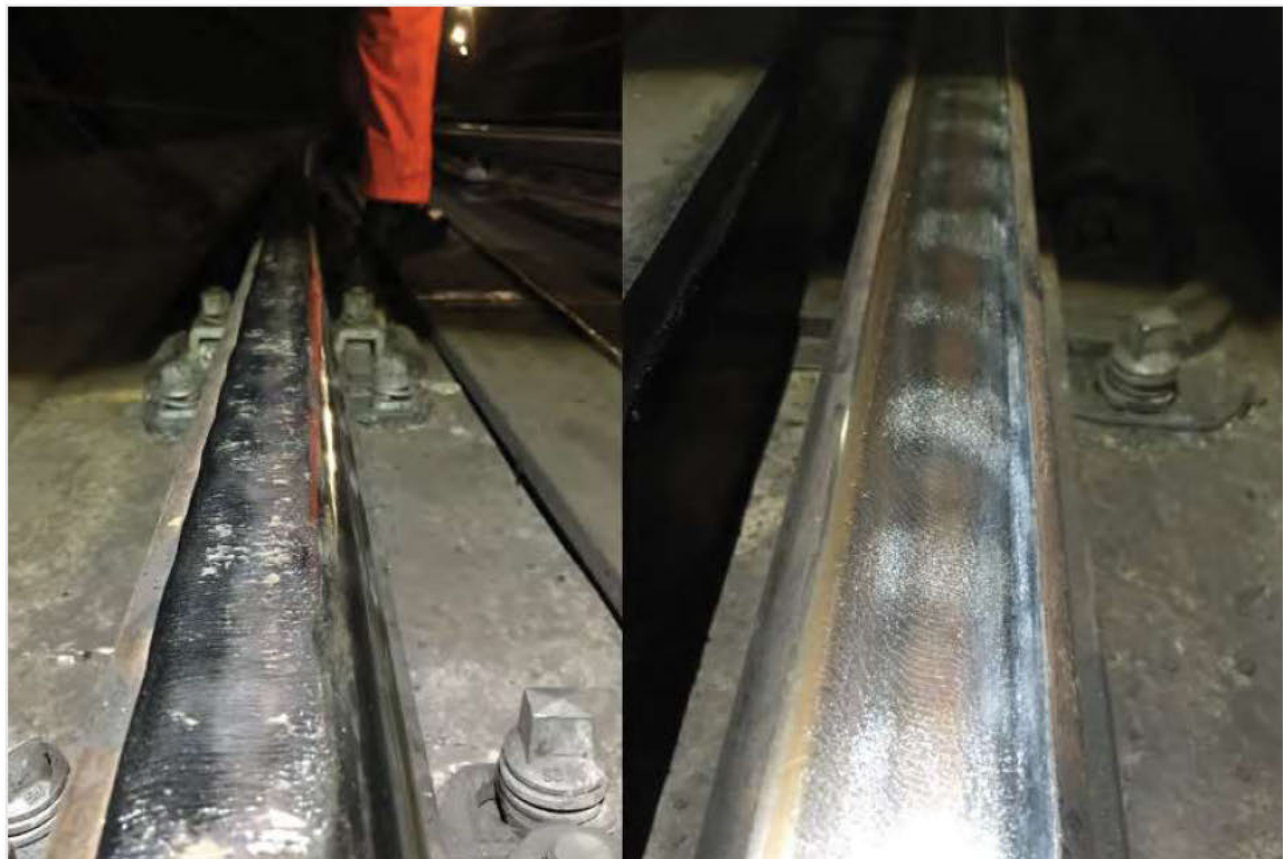
Figure 13: Rutting corrugation on modern track-form

Whilst the majority of corrugation on LUL which falls into the pinned-pinned or track-form frequency ranges affects curves in the 400-600m radius, once 200m is approached then rutting corrugation develops (50-150Hz)⁹ as can be seen in Figure 13, and at sub-100m radius curves corrugation becomes less of an issue but often results in low rail wheel squeal, causing airborne noise issues.
