Contents

Executive Summary

C422 - Tottenham Court Road Station -Stage D+ Report on Cellars
 C422-LAO-C-RGN-N105_WS089-50005
 Rev 1.0

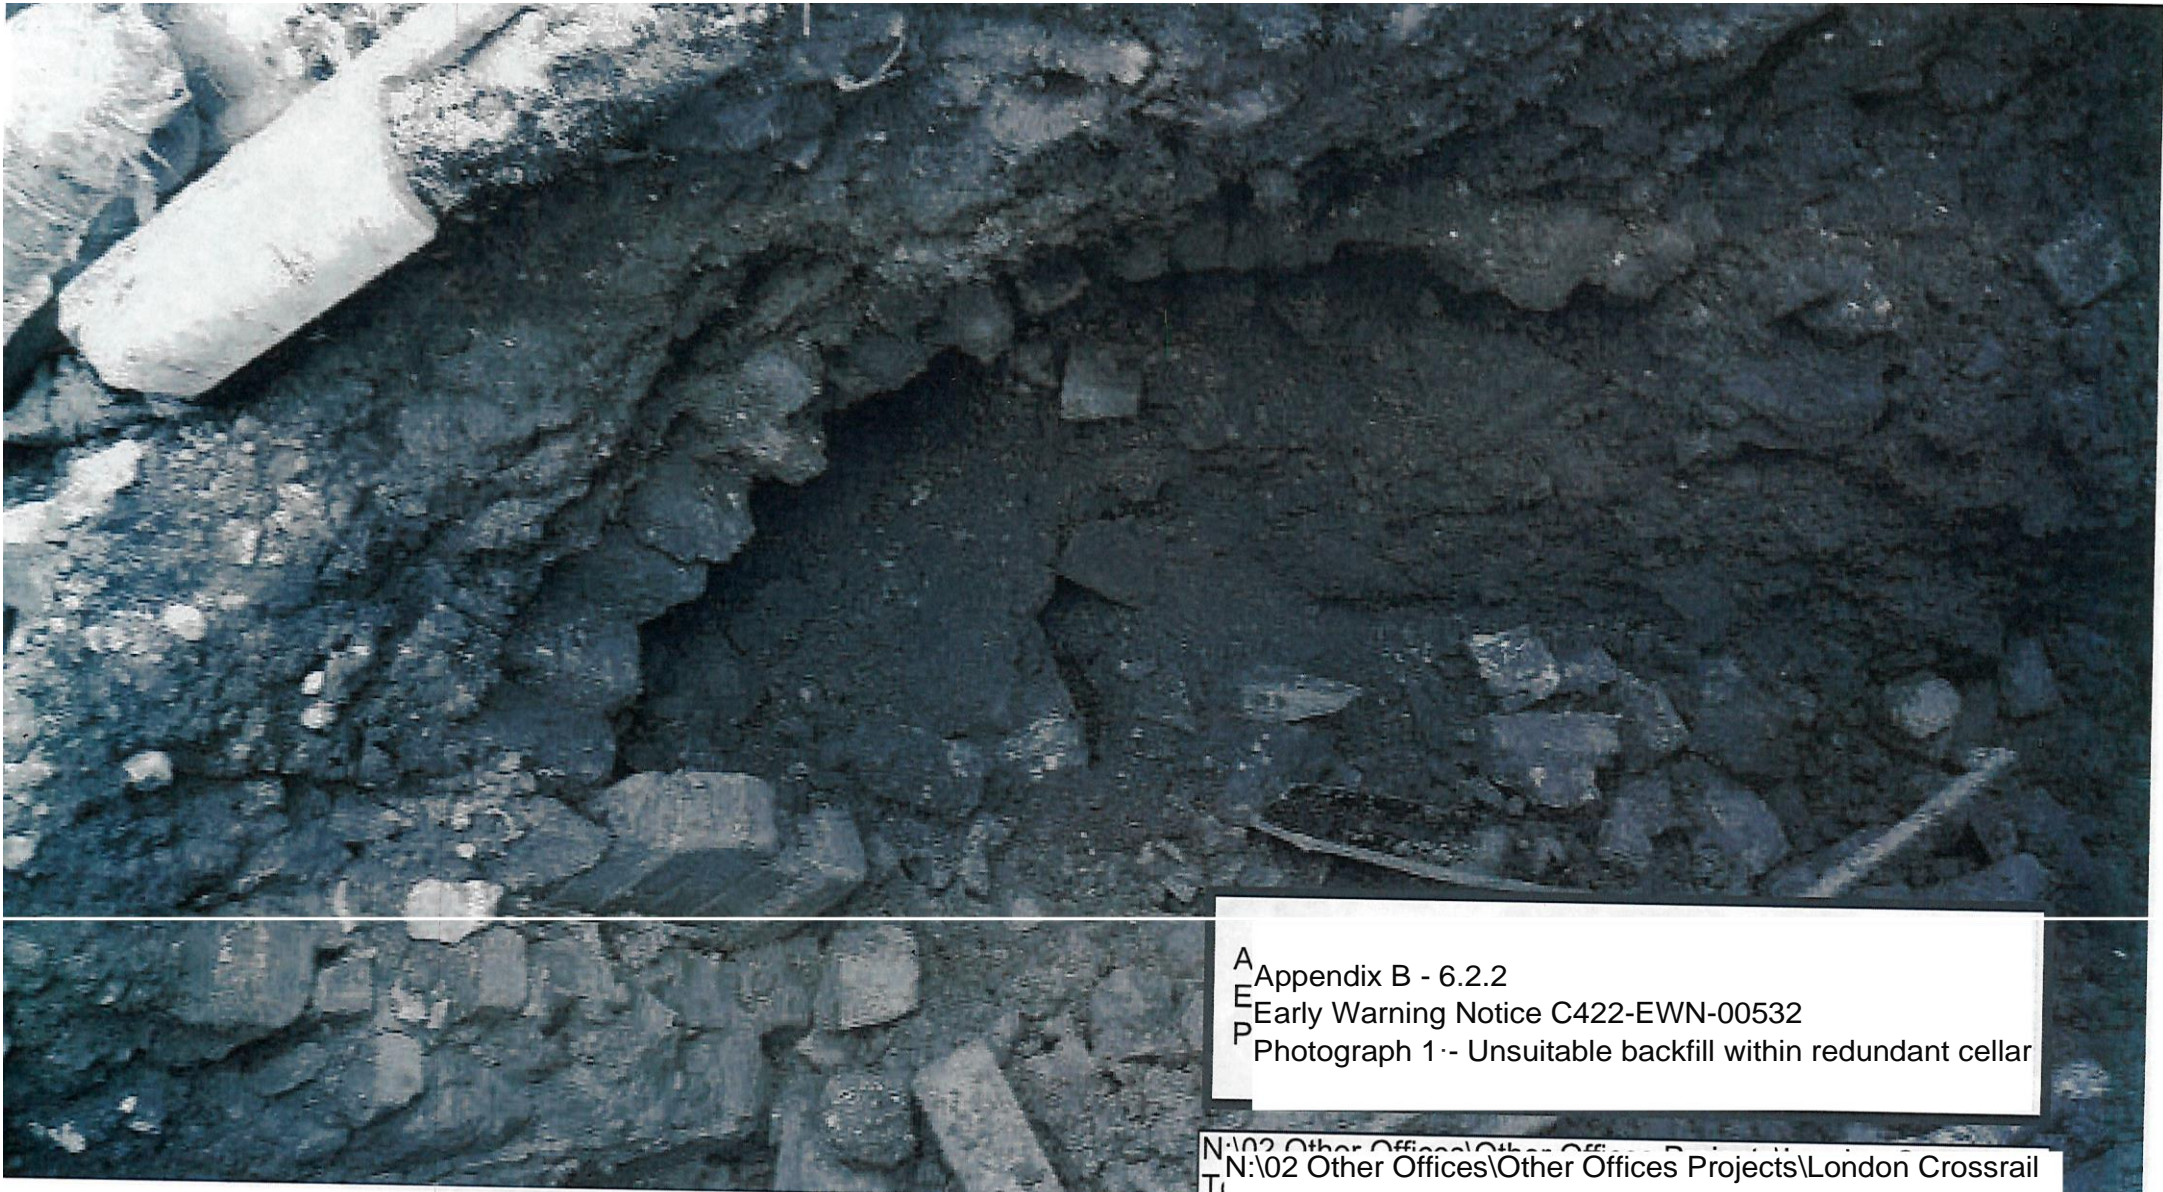
"During the removal of reinforced concrete guidewall on Dean street between gridlines 4 and 5 the Contractor observed unexpected subsidence and uncovered unexpected brick arch structures. The structures have not been back filled with concrete. Photographs are attached to this EWN.

The Contractor is concerned that these voids could affect the urban realm works and the quality/durability of the architectural paving adjacent to the ground floor ticket hall entrance in particular.

A Appendix B - 6.2.2
E Early Warning Notice C422-EWN-00532
P Photograph 1 - Unsuitable backfill within redundant cellar

1. The backfill to basement and cellars is not suitable for the construction of the urban realm works above. We recommend that the Consultant is instructed to consider "full depth" pavement design in these areas

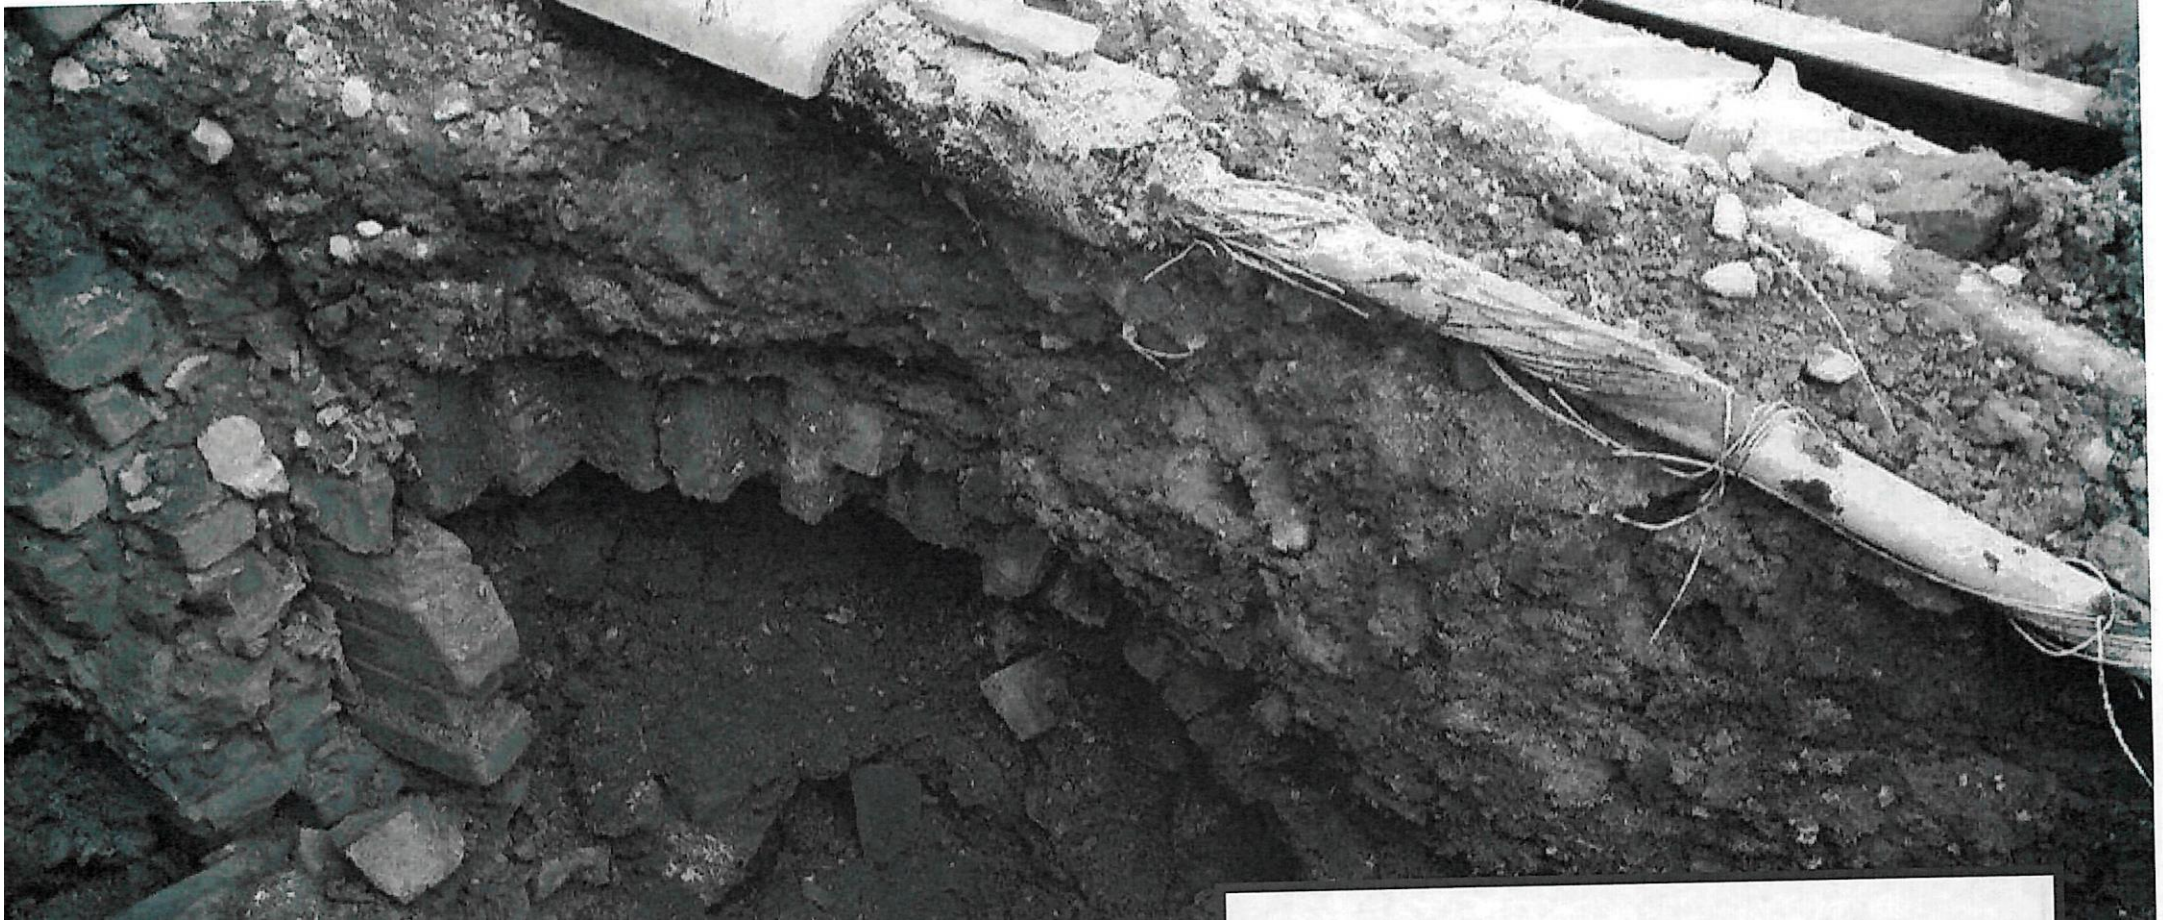
Appendix B - 6.2.2
Early Warning Notice C422-EWN-00532
Photograph 2 - Unsuitable backfill within redundant cellar

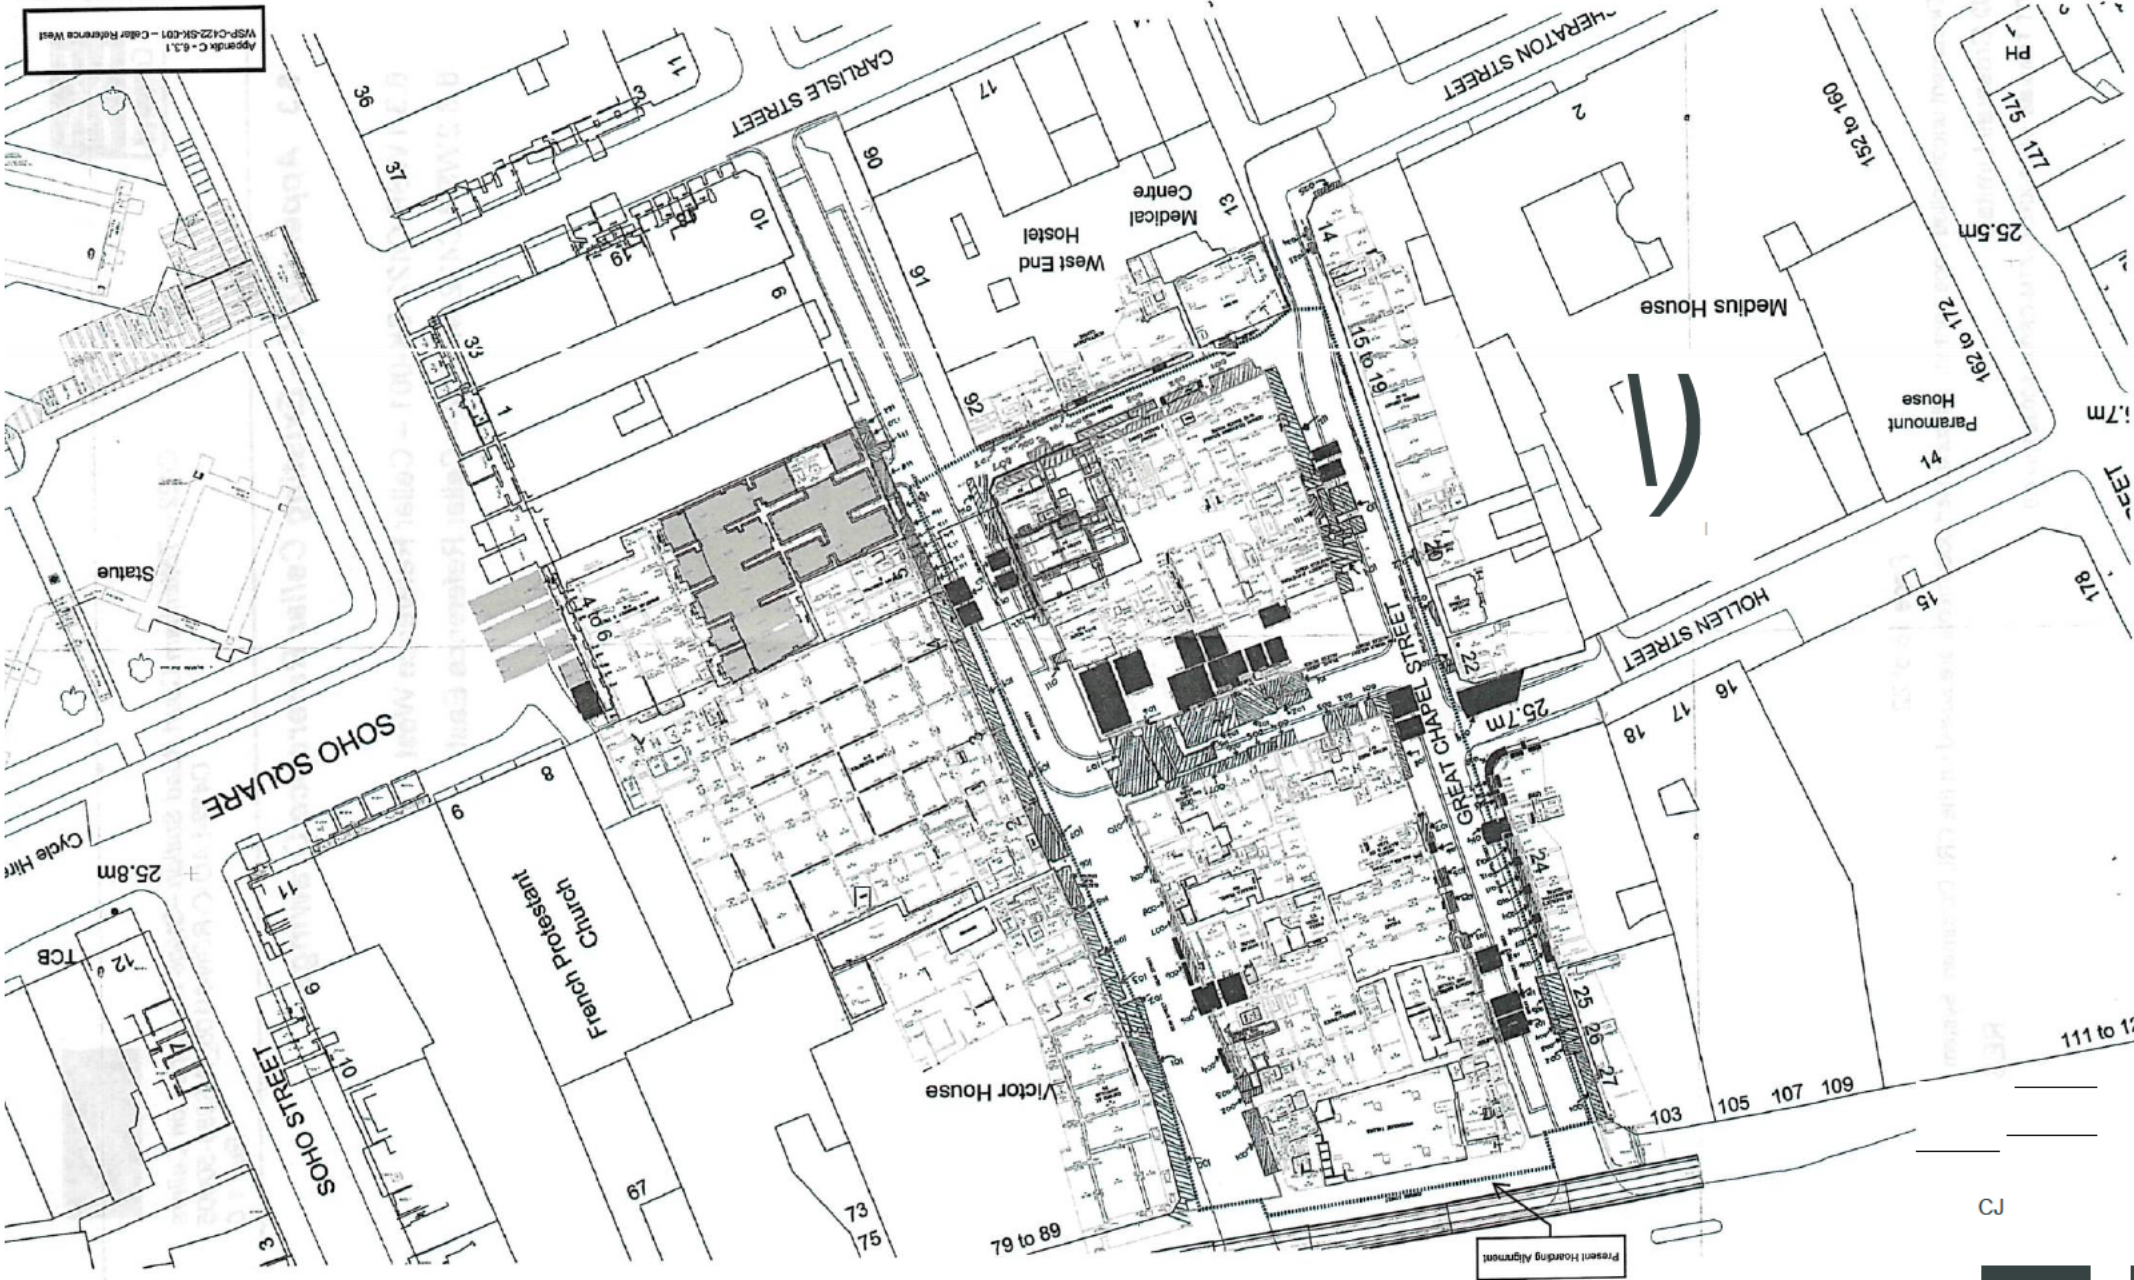
Appendix C-6.3.1
 VSP-C-22-5K-001 - Color Reference West
 Appendix C-6.3.1
 VSP-C-22-5K-001 - Color Reference West
 1422 Other Office/Other Offices
 Project/London Crossrail Test Court Plot
 Document/Other/Color Reference Report
 Rev 0.3/Appendix C - Existing Color Reference
 Drawings.pdf

Sketches WSP-C422-SK-001 and 002 identify the locations of the existing cellars prior to the project commencing. Located within **Appendix C** the existing cellar locations prior to construction work have been used to produce the cellar schedule. The numbering is shown on the sketches.

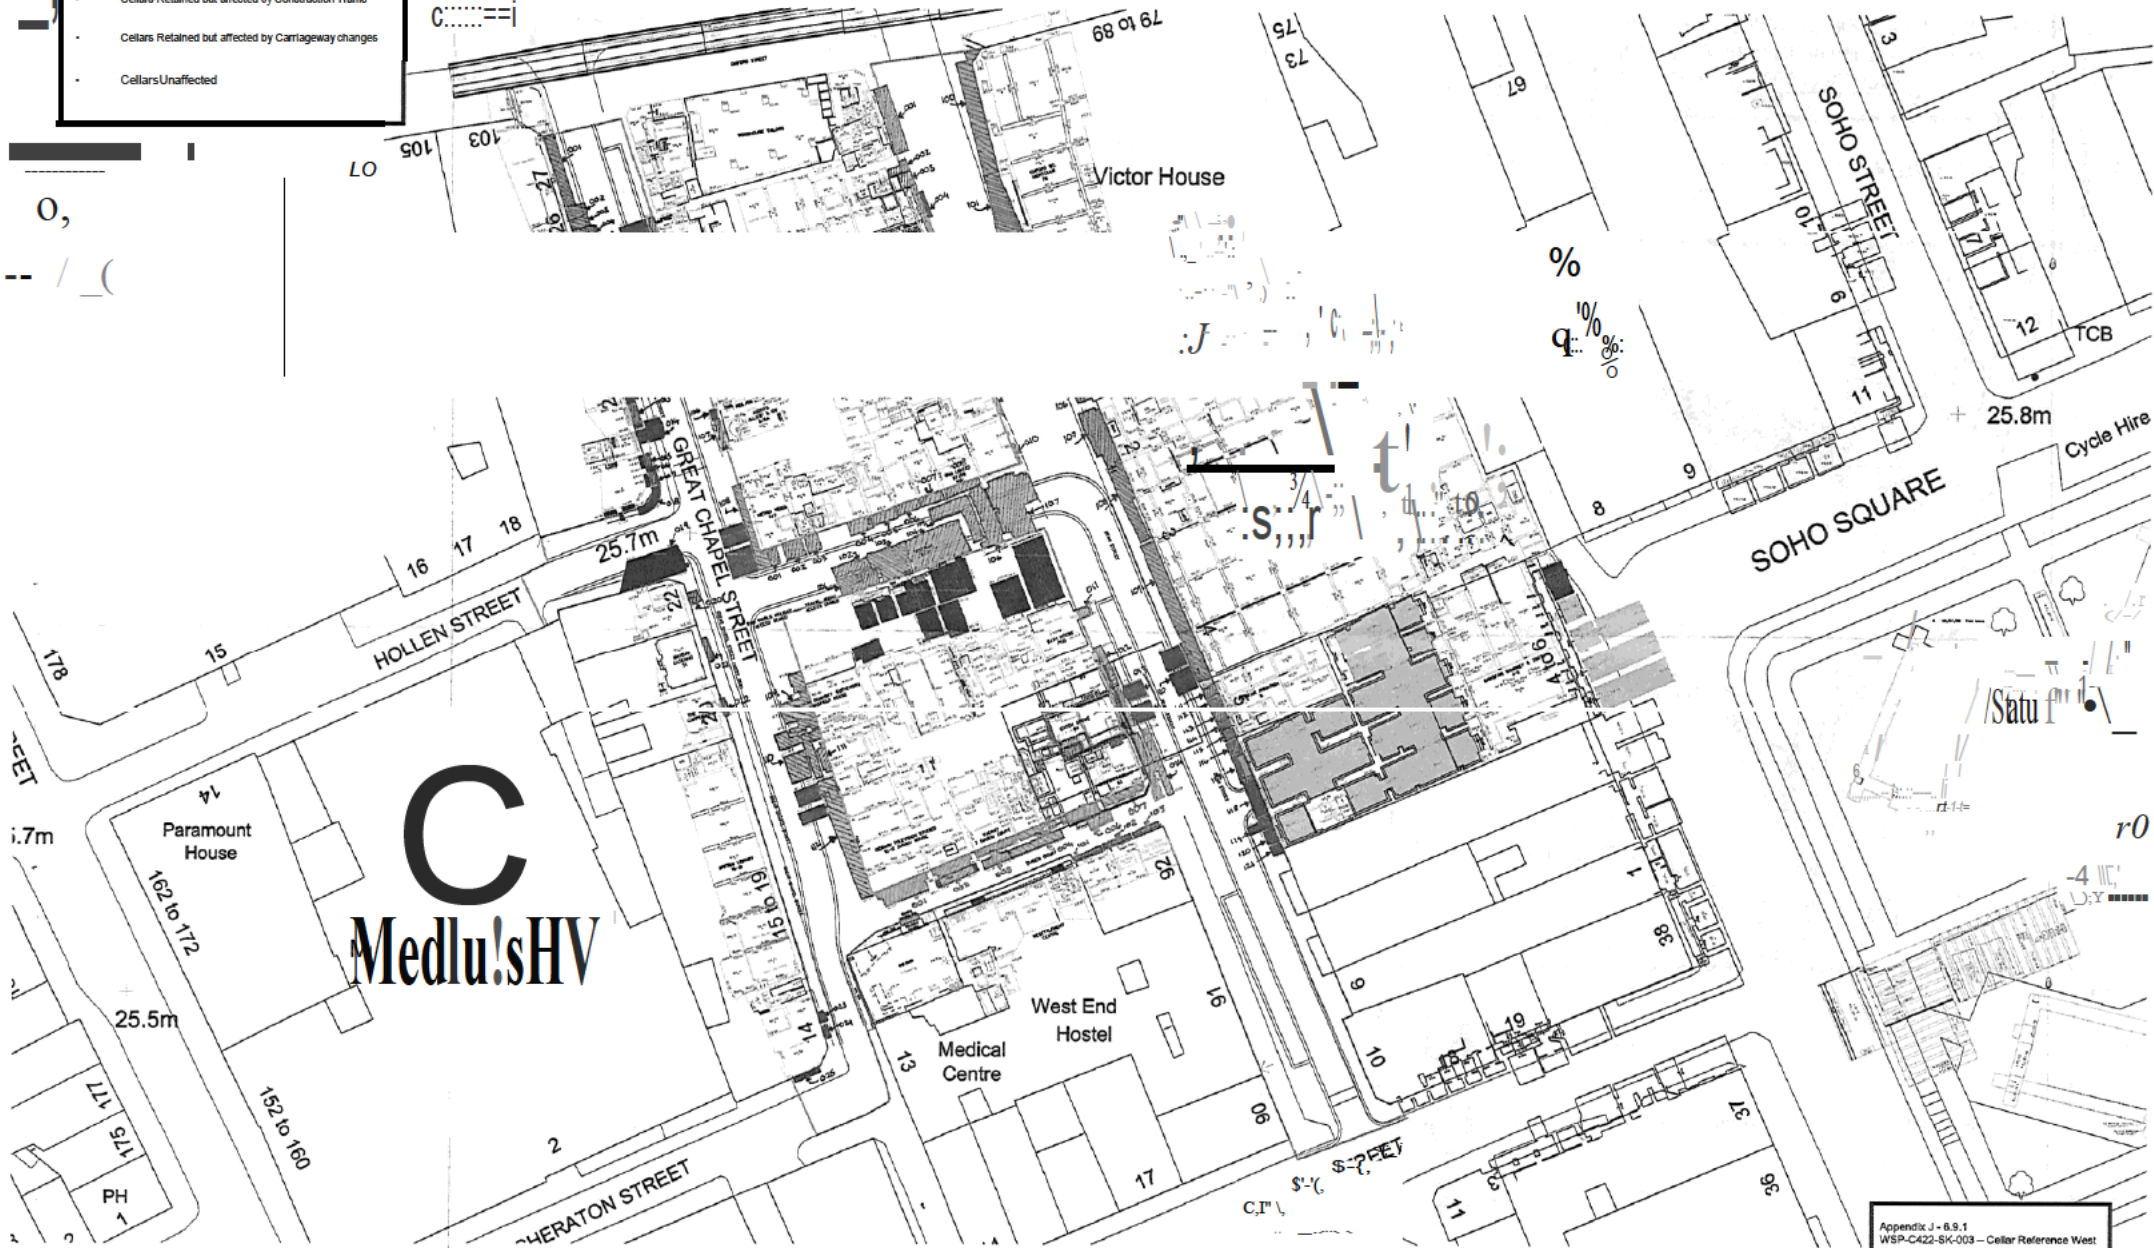
Appendix J - 6.9.1
 WSP-C422-SK-003 - Cellar Reference West

- Cellars Back filled
- Cellars Retained but affected by Construction Traffic
- Cellars Retained but affected by Carriageway changes
- Cellars Unaffected

Plans showing the above categories is contained in **Appendix J**.
